YOUR INSPECTION REPORT

855 Windermere Avenue
Toronto, ON M6S 3M5

INSPECTION DATE:
Thursday, July 12, 2018

RE: Report No. 2302
855 Windermere Avenue
Toronto, ON
M6S 3M5

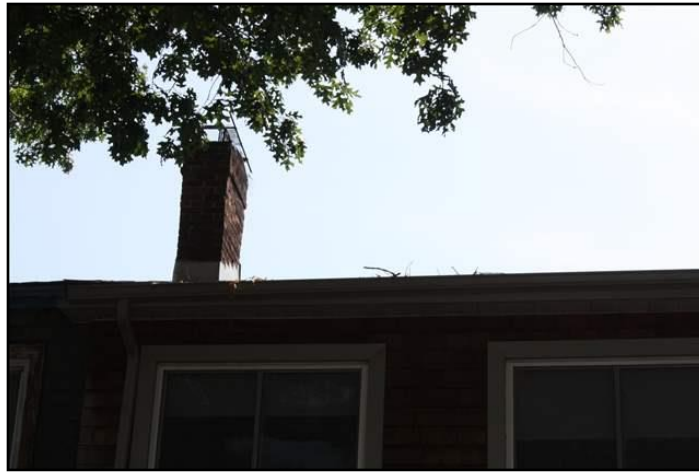
Condition: • [Clogged](#)

1. Clogged

Task: Clean

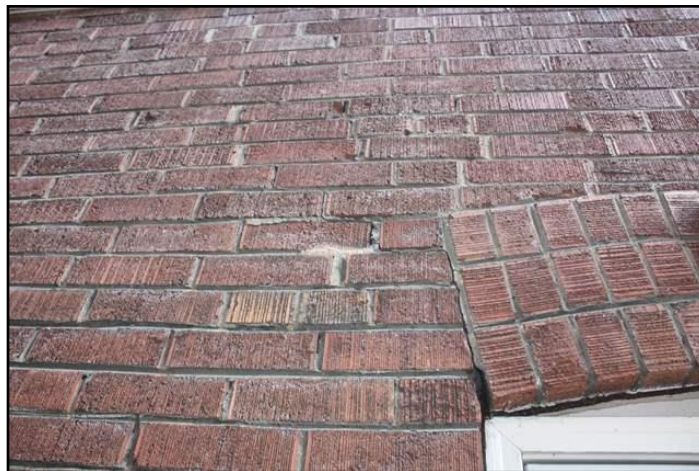
Condition: • Most masonry walls have small cracks due to shrinkage or minor settlement. These will not be individually noted in the report, unless leakage, building movement or similar problems are noted

2. Example of typical cracking

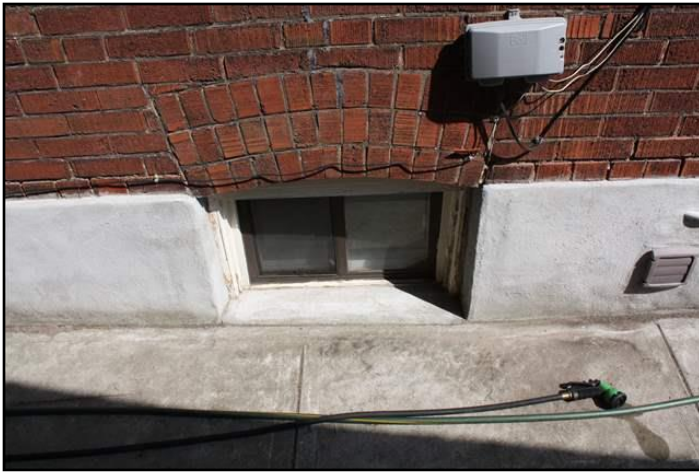
Modern standards require 6-8 inch threshold above grade. Most older homes do not meet this requirement.

3. Sill - Near or at Grade Level

Task: Monitor / Improve

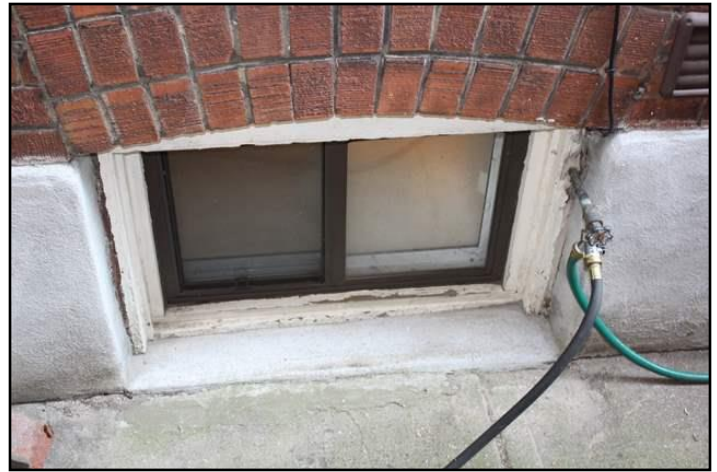
4. Sill - Near or at Grade Level

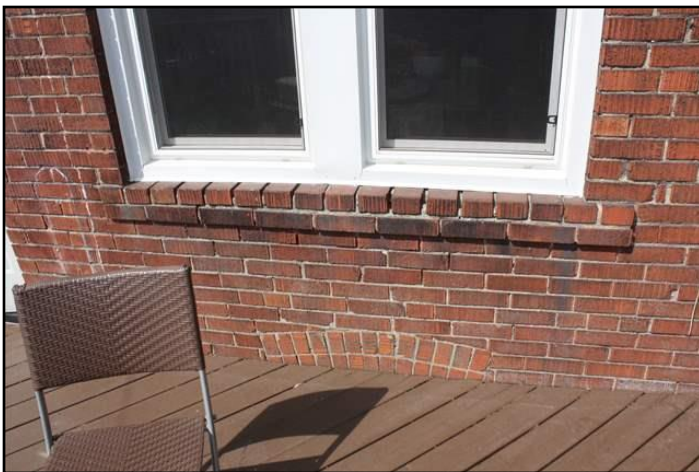
Mortar repairs needed (repointing, tuckpointing)

5. Sill deteriorated

Task: Improve

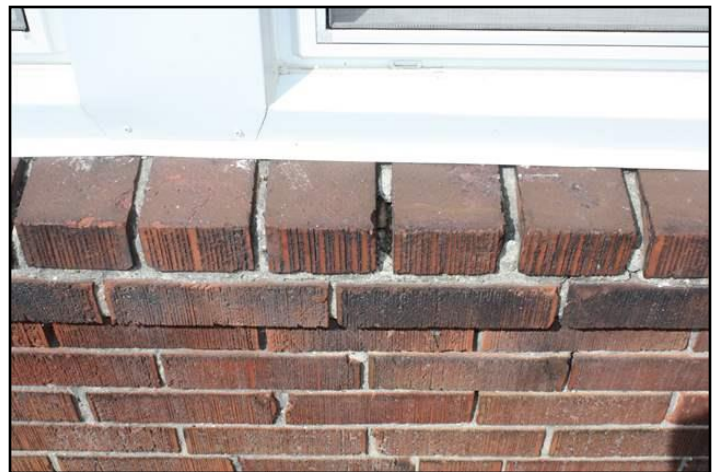
6. Sill deteriorated example

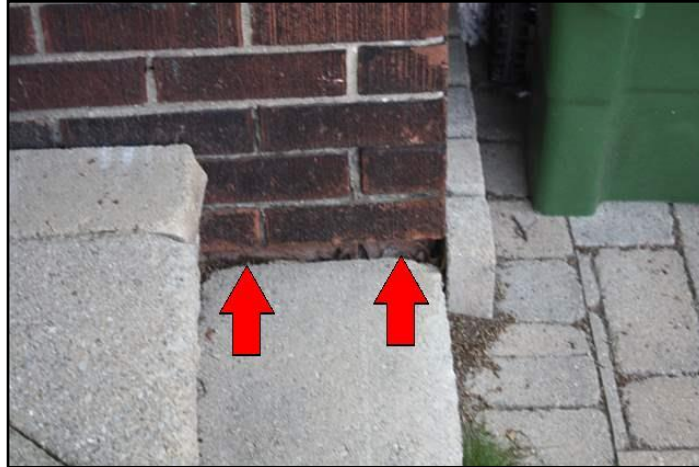
Condition: • [Spalling](#)

Implication(s): Weakened structure | Chance of movement

7. Example Spalling

Task: Patch

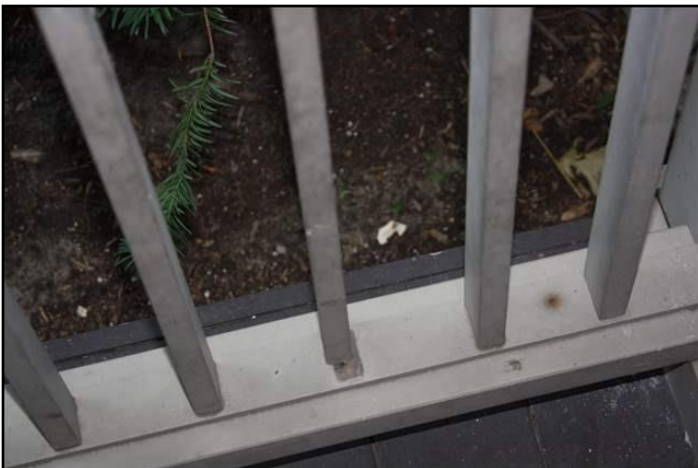
Condition: • [Damage at bottom](#)

Implication(s): Fall hazard

8. Damage at bottom

Task: Repair spindles

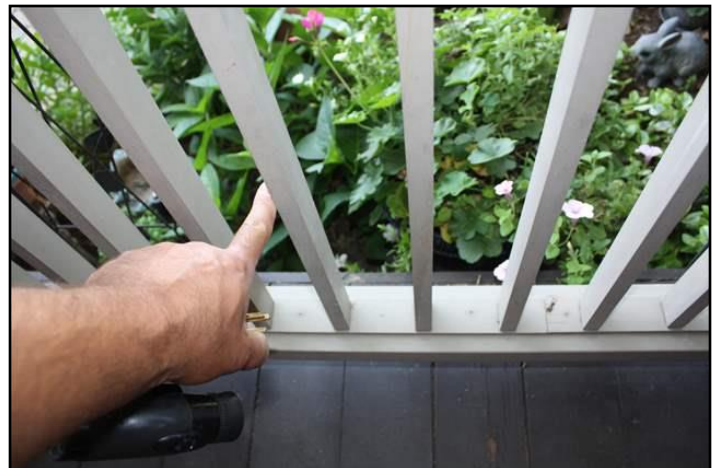
9. Damage at bottom

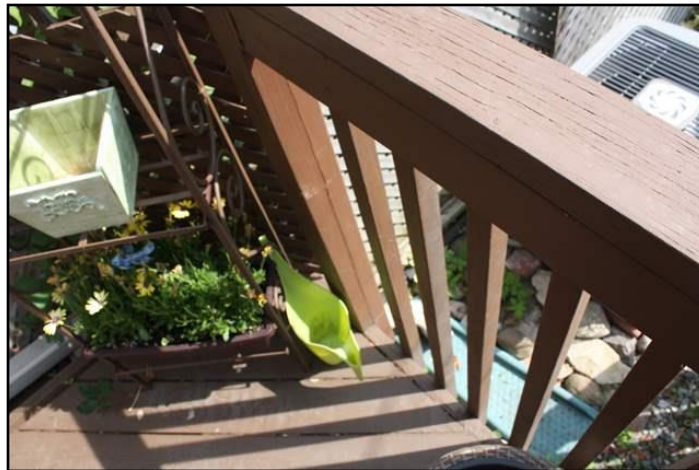
Condition: • [Weak](#)

Implication(s): Fall hazard

10. *Weak*

Task: Improve

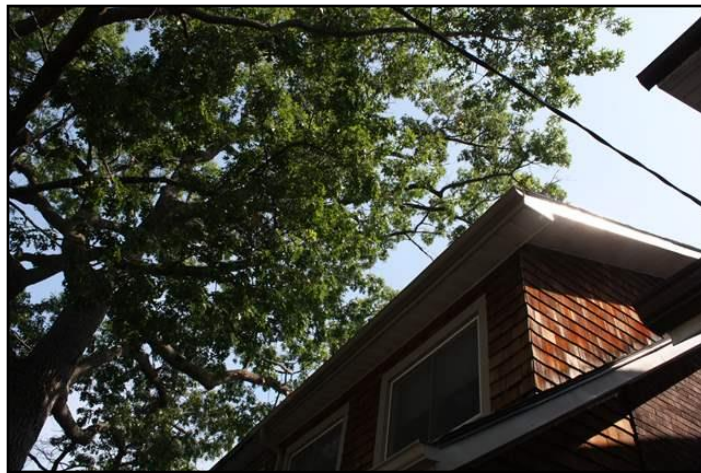
Condition: • [Trees or shrubs too close to building](#)

Implication(s): Chance of water damage to contents, finishes and/or structure | Chance of pests entering building |

11. Trees or shrubs too close to building

Keep tree branches trimmed back 3 feet from roof line.

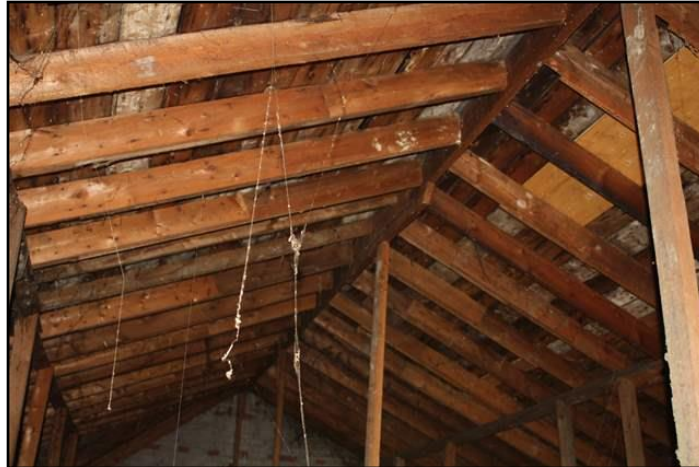
Condition: • [Incomplete in attic](#)

Implication(s): Increased fire hazard

12. *Incomplete in attic*

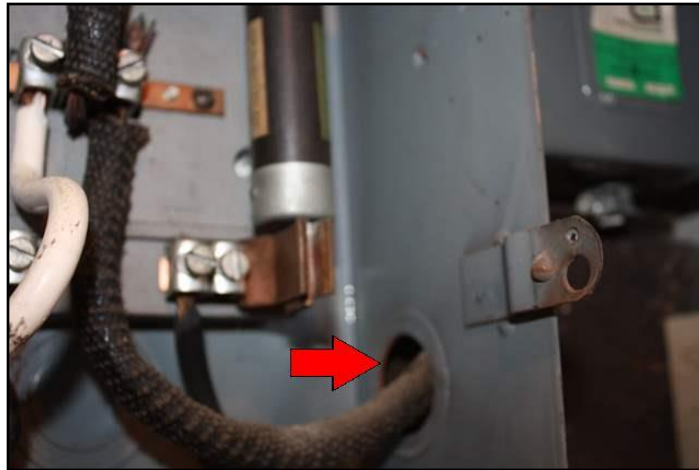
Condition: • [Unprotected openings](#)

15. Unprotected openings

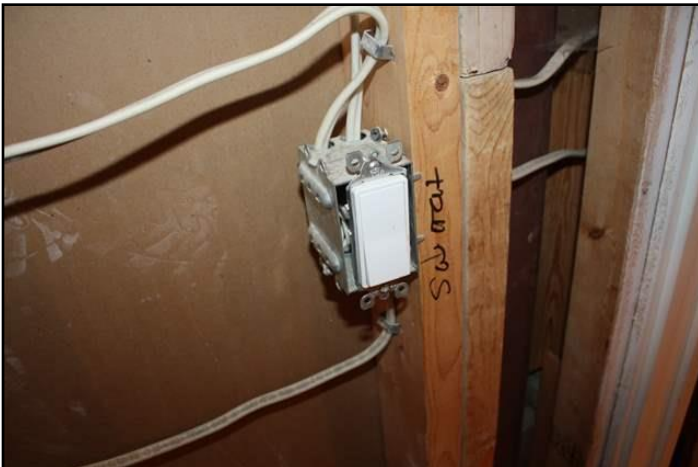
Condition: • [Missing](#)

16. Missing

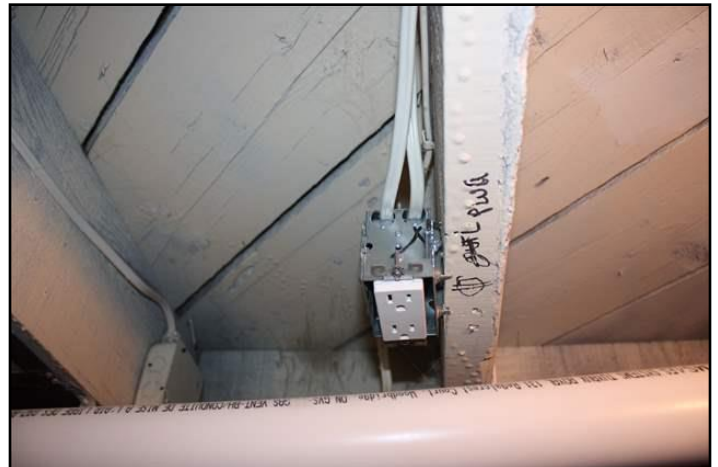
17. Missing

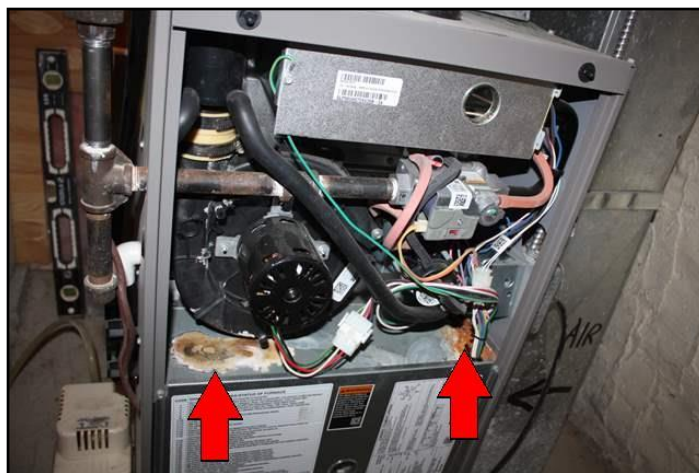
Condition: • [Rust](#)

Rust noted inside furnace cabinet. Prior condensate leak. Unknown if still active or intermittent. Dry at time of inspection

18. Rust

Task: Service

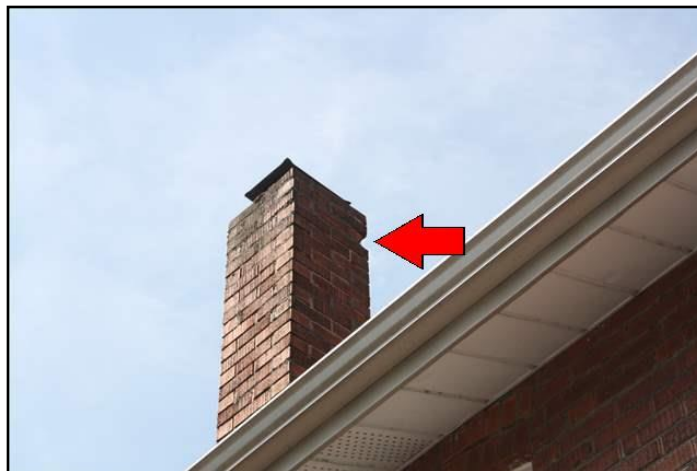
Condition: • [Spalling](#)

Implication(s): Material deterioration

19. Spalling

Task: Repair

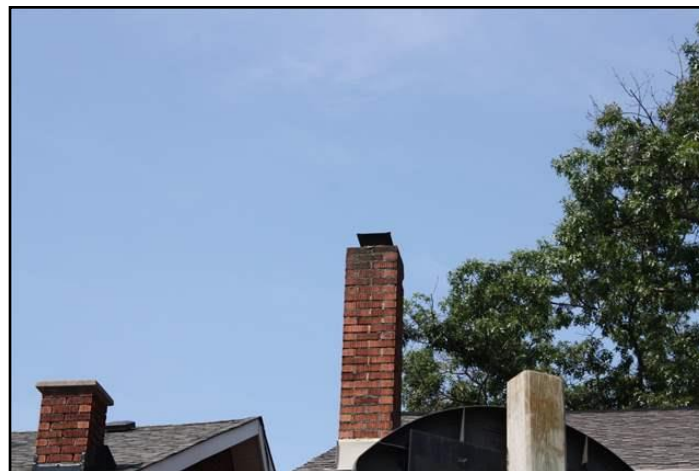
Condition: • [Missing](#)

Implication(s): Chance of water damage to contents, finishes and/or structure | Shortened life expectancy of

20. Missing

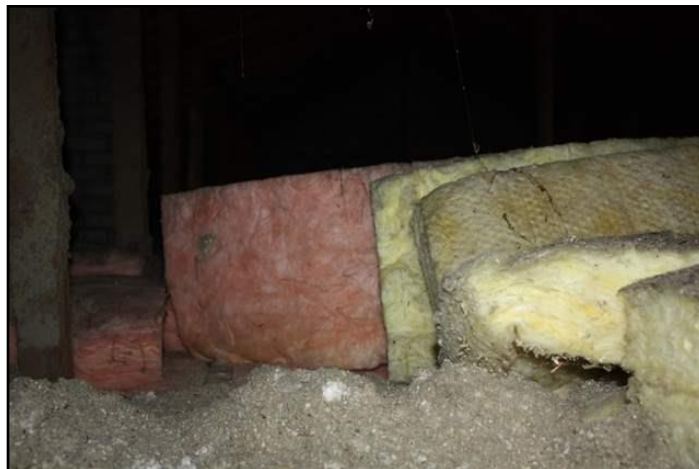
Condition: • [Amount less than current standards](#)

21. Amount less than current standards

Task: Upgrade

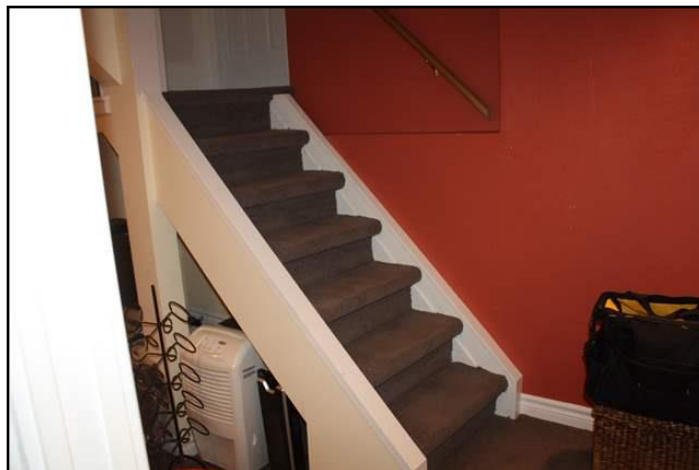
Condition: • [Missing](#)

Implication(s): Fall hazard

22. Missing

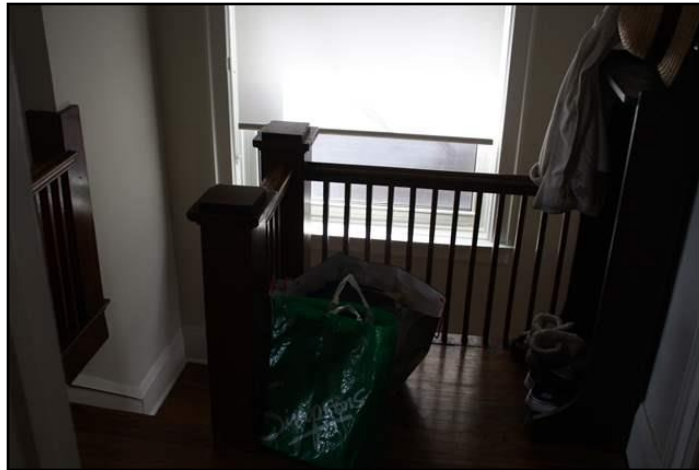
Condition: • [Too low](#)

Implication(s): Fall hazard

23. Too low

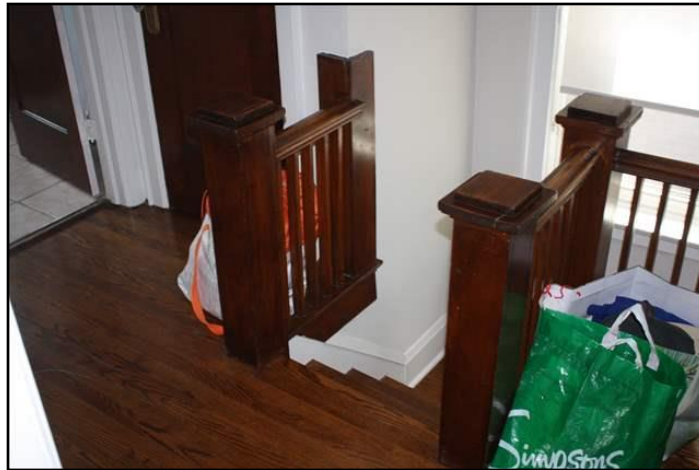
Condition: • [Loose](#)

Implication(s): Fall hazard

24. Loose
