INSPECTION REPORT

For the Property at:
123 ROAD STREET
ALBERTA, AB

Prepared for: JOE SMITH
Inspection Date: Monday, June 17, 2019
Prepared by: Trevor Sczesny

RE: Report No. 1721, v.2
123 Road Street
Alberta, AB

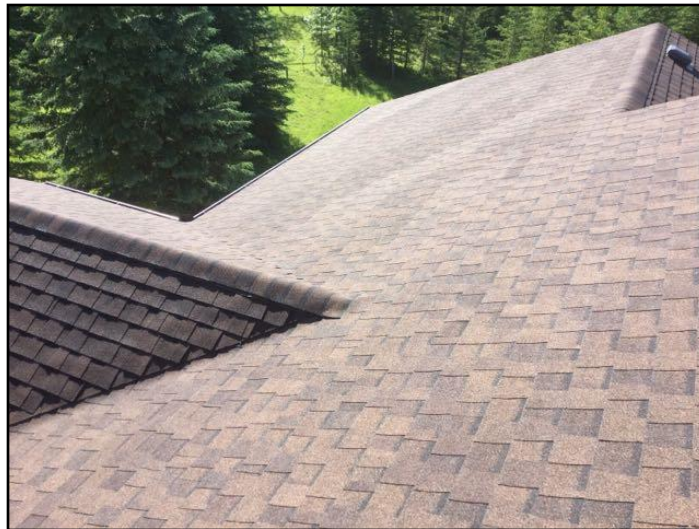
General: • The shingles appeared to be in fair/good condition. Leaks can happen anytime and recommend regular visual inspections of the roof line.

1. The shingles appeared to be in fair/good...

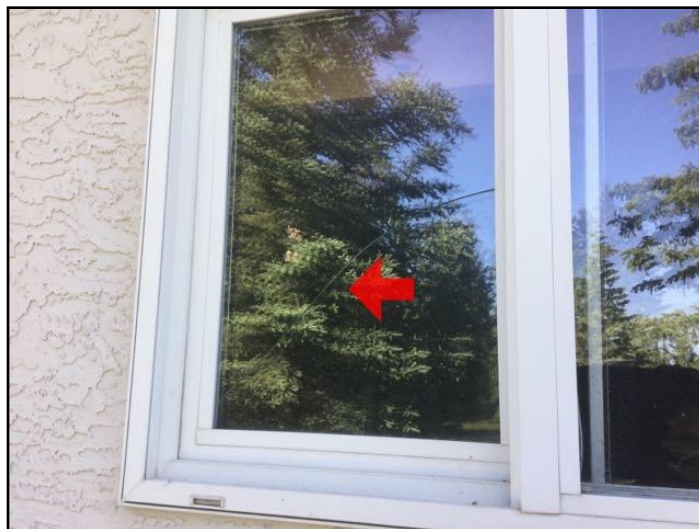
2. Condition: • [Cracked](#)

3. Cracked

Task: Repair or replace

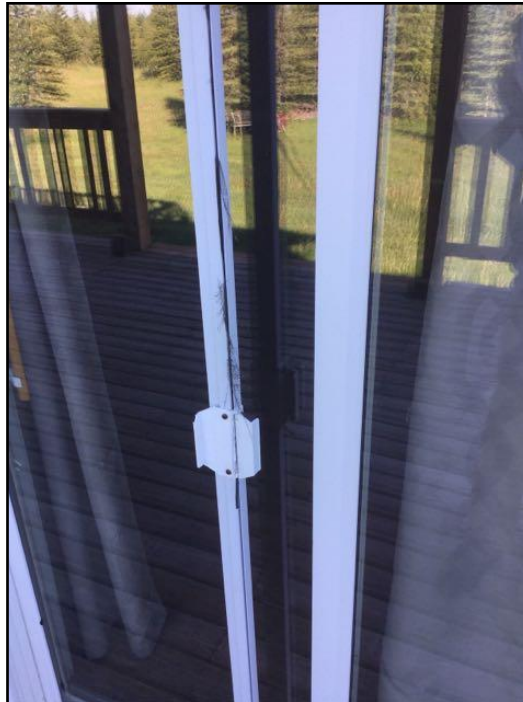
3. Condition: • [Missing](#)

4. Missing

Task: Repair or replace

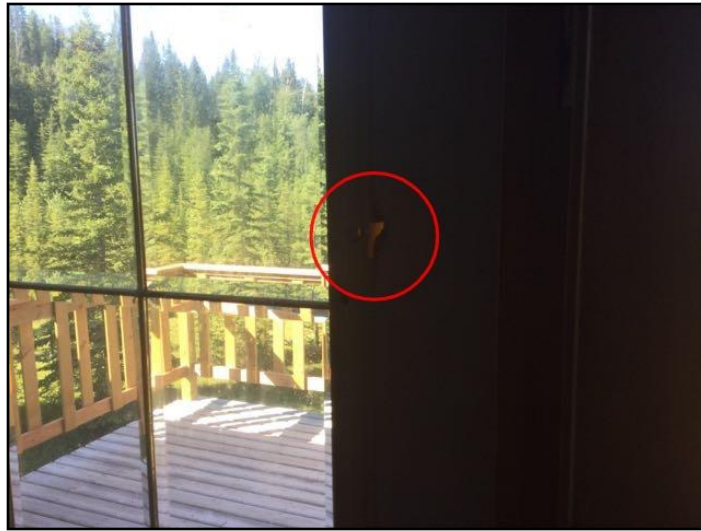
4. Condition: • [Damage](#)

Implication(s): Chance of damage to finishes and structure | Poor security

5. Damage

Task: Repair or replace

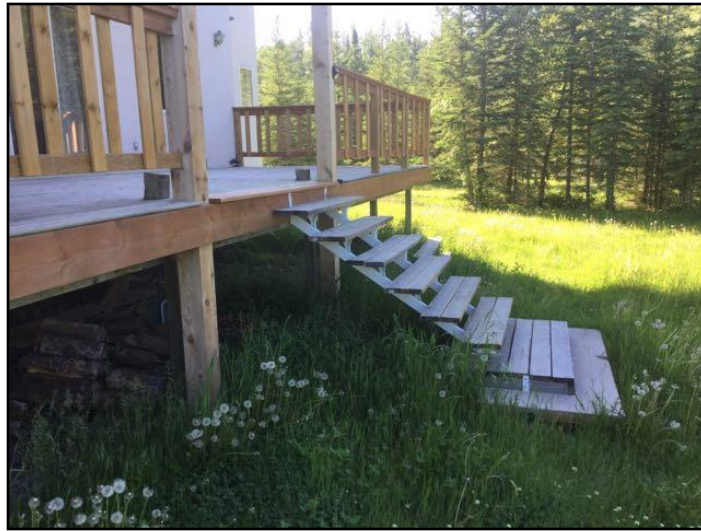
5. Condition: • [Missing](#)

Implication(s): Fall hazard

6. Missing

Task: Provide

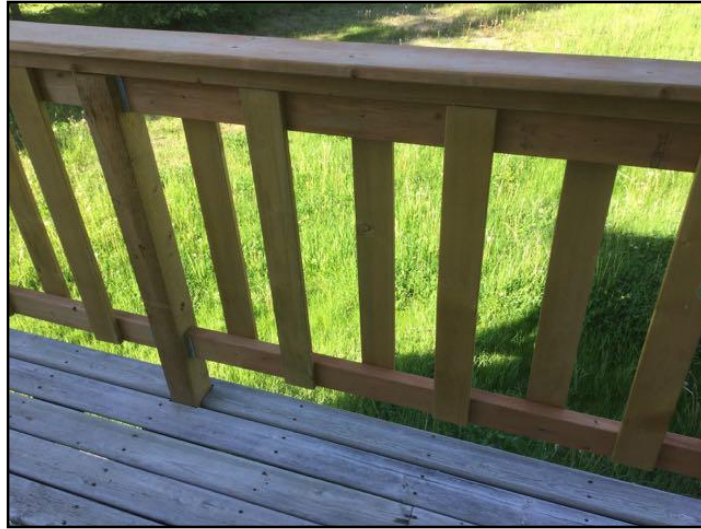
6. Condition: • [Spindles \(balusters\) too far apart](#)

Implication(s): Fall hazard

7. Spindles (balusters) too far apart

Task: Improve

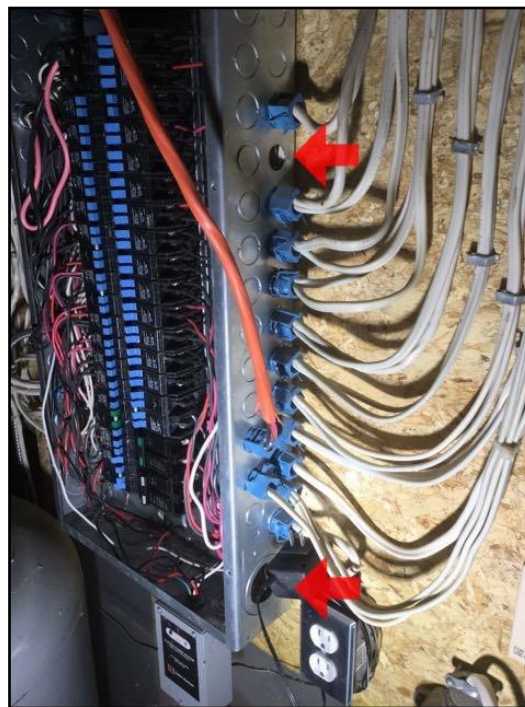
9. Condition: • [Openings in panel](#)

Implication(s): Electric shock | Fire hazard

8. Openings in panel

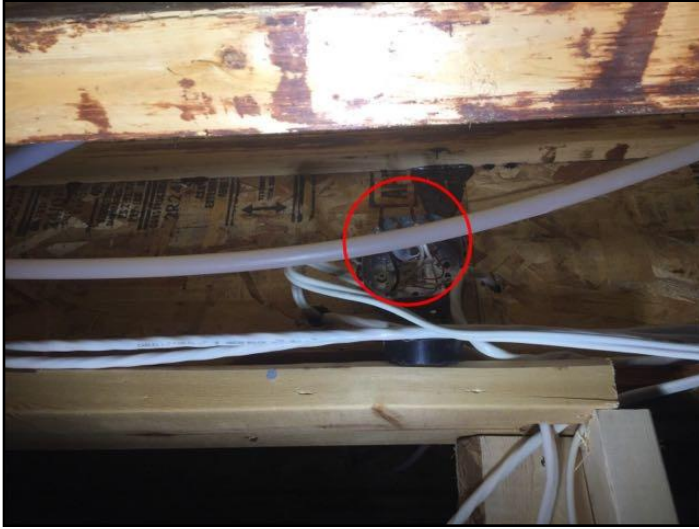
10. Condition: • [Open splices](#)

9. Open splices

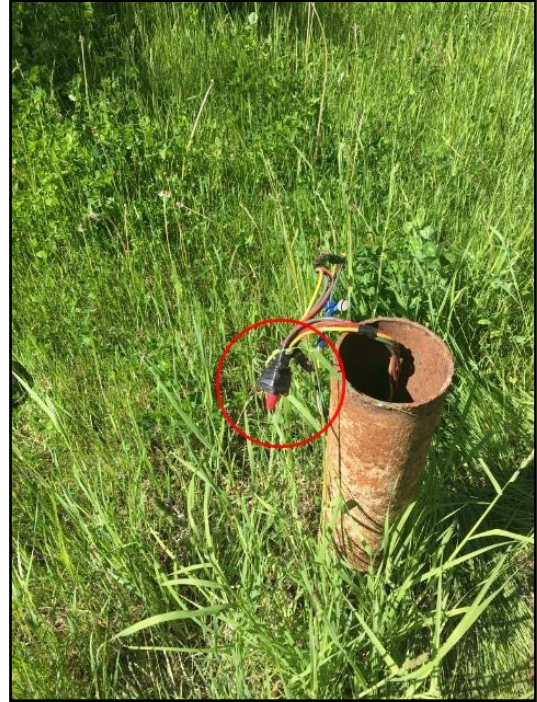
10. Open splices

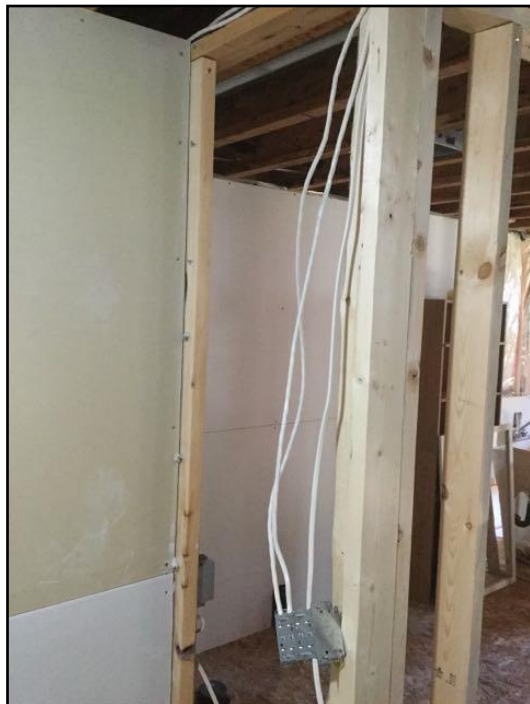
11. Condition: • [Not well secured](#)

Implication(s): Electric shock | Fire hazard

11. Not well secured

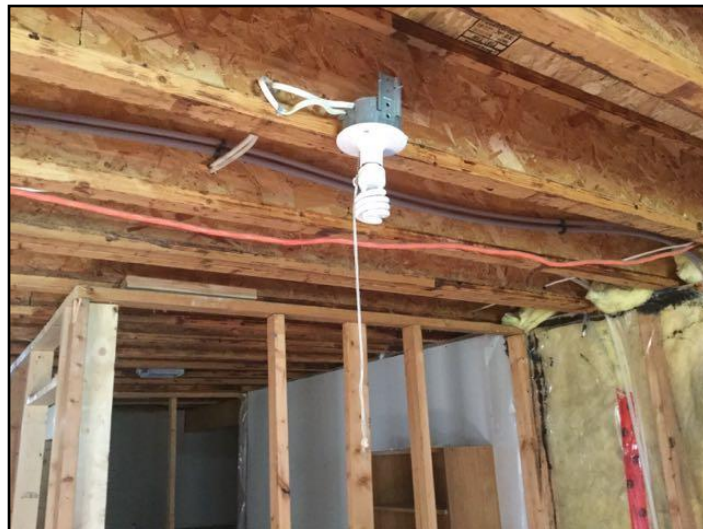
12. Not well secured

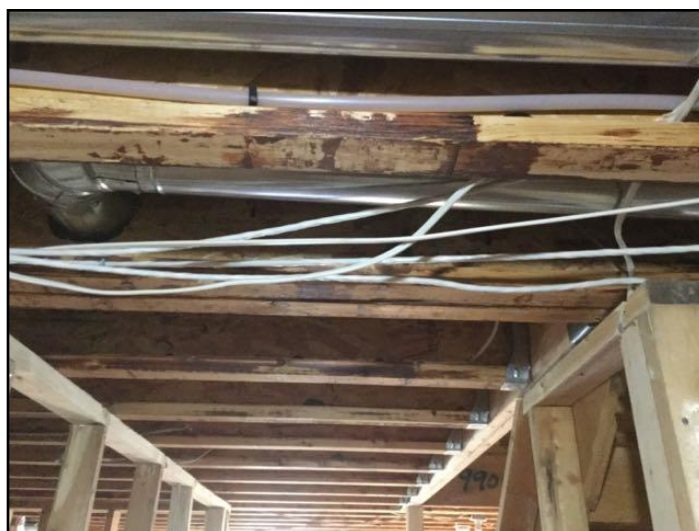
13. Not well secured

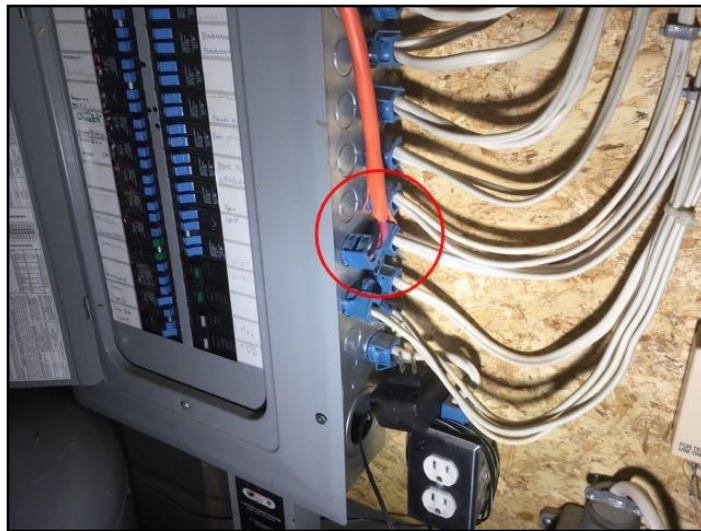
12. Condition: • [Loose connections](#)

Implication(s): Electric shock | Fire hazard | Interruption of electrical service

14. Loose connections

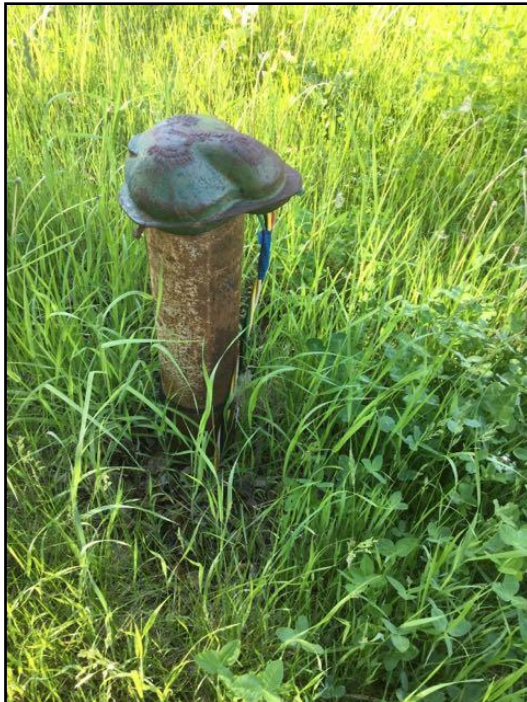
13. Condition: • [Flexible conduit needed](#)

15. Flexible conduit needed

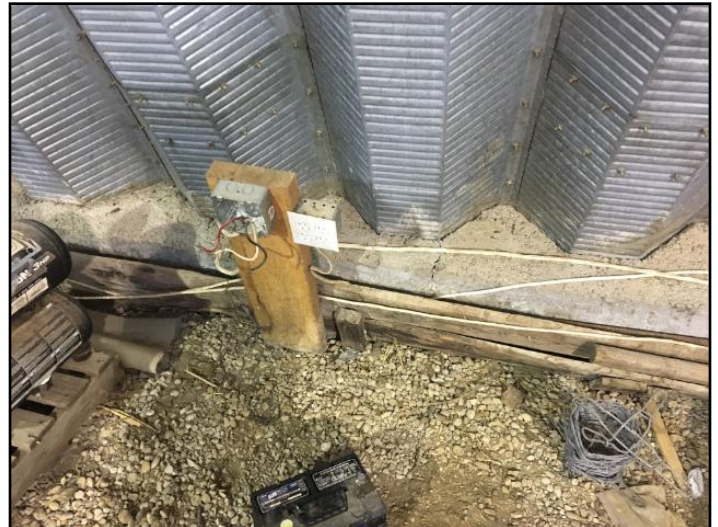
16. Flexible conduit needed

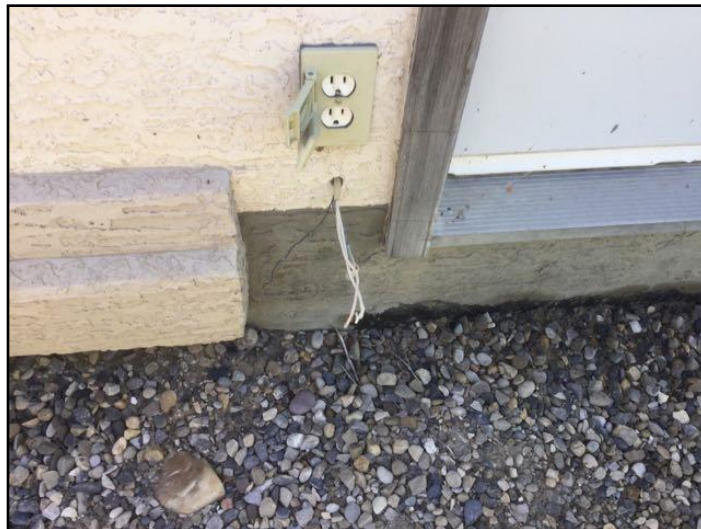
14. Condition: • [Missing](#)

Implication(s): Electric shock | Fire hazard

17. Missing

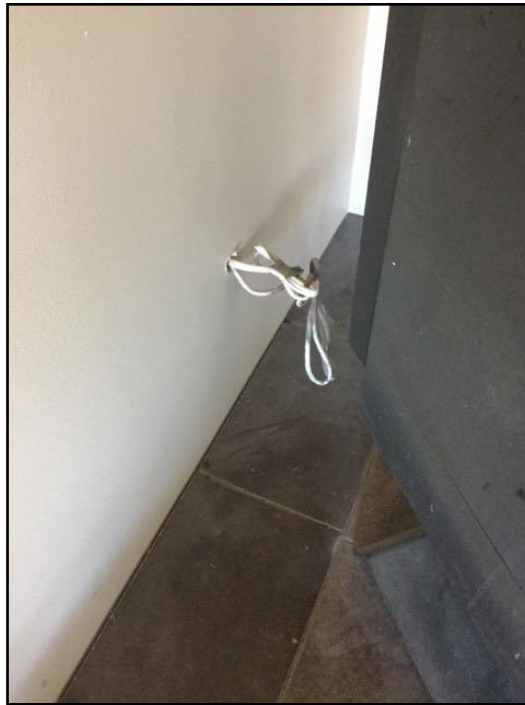
15. Condition: • [Missing](#)

Implication(s): Electric shock | Fire hazard

18. Missing

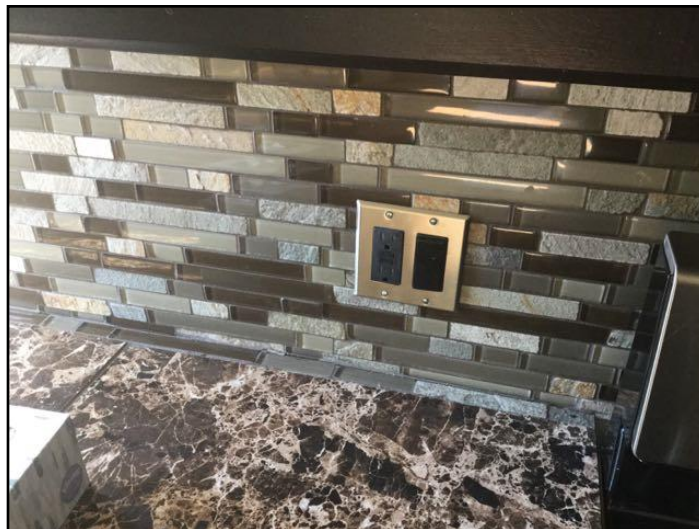
16. Condition: • [Wrong type](#)

Installing GFCI on 3 wire split circuits is not recommended and will increase nuisance tripping. GFCI is not required near kitchen sinks for the time the home was built. Recommend removing and installing standard split plugs as it was previously.

Implication(s): Electric shock | Fire hazard

19. Wrong type

Task: Replace

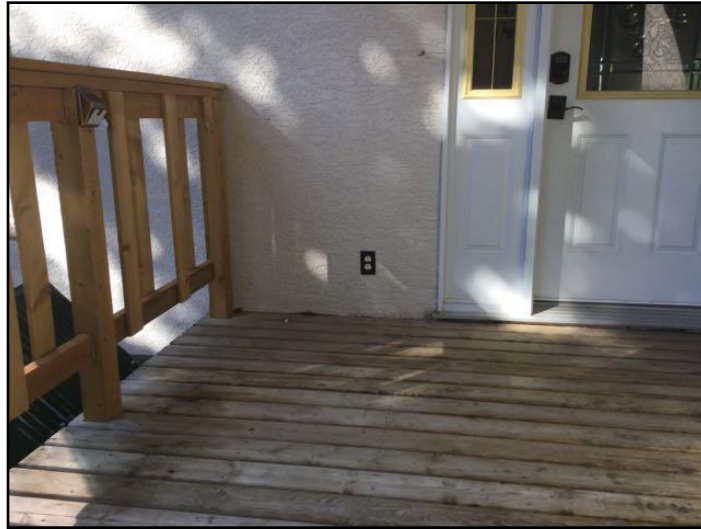
18. Condition: • Not weather proof/Water tight

20. *Not weather proof/Water tight*

Task: Improve

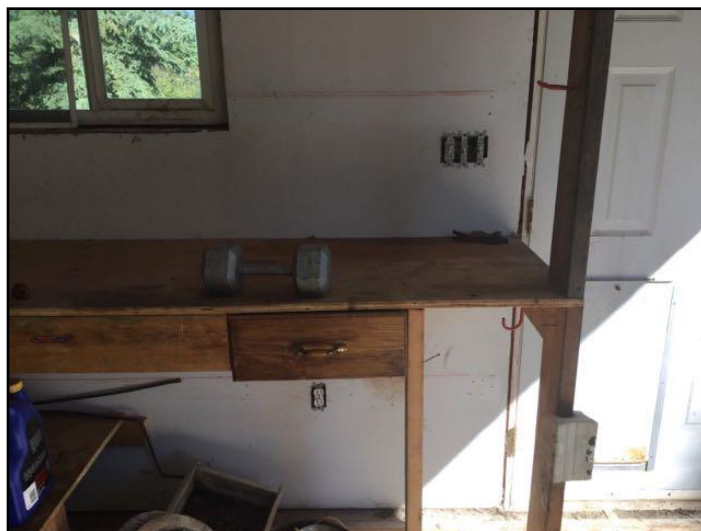
19. Condition: • [Missing](#)

21. *Missing*

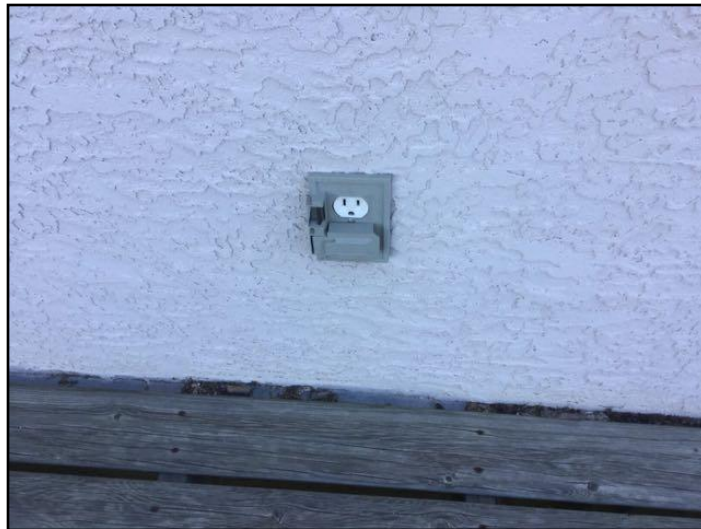
20. Condition: • For outlet (receptacle) is damaged

22. For outlet (receptacle) is damaged

Task: Replace

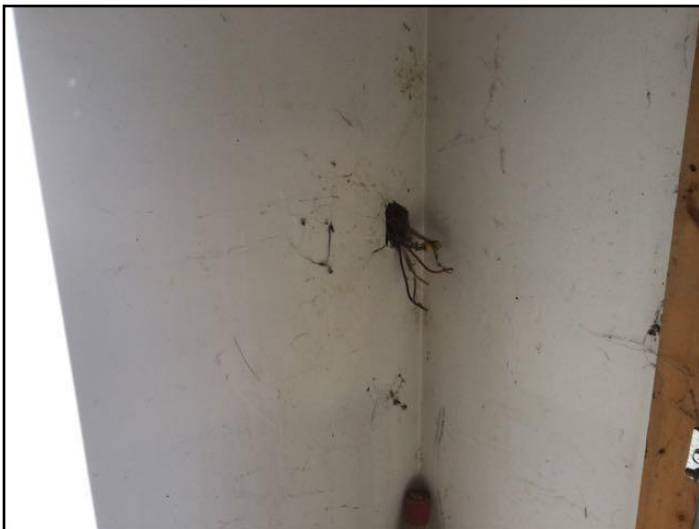
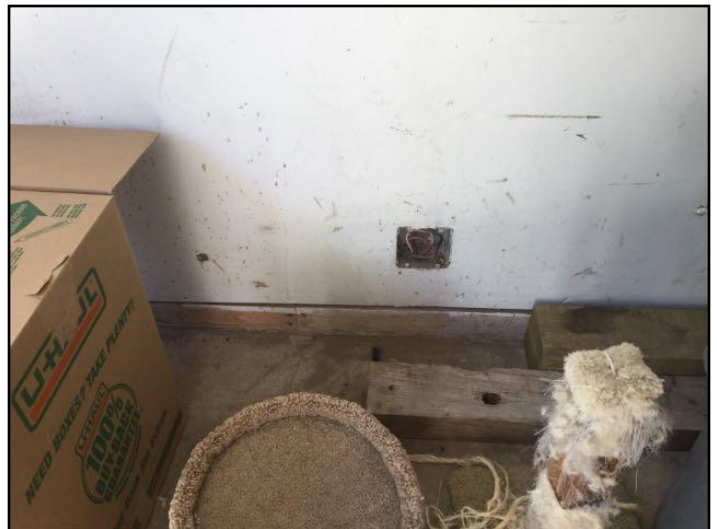
21. Condition: • For junction box is missing

23. For junction box is missing

24. For junction box is missing

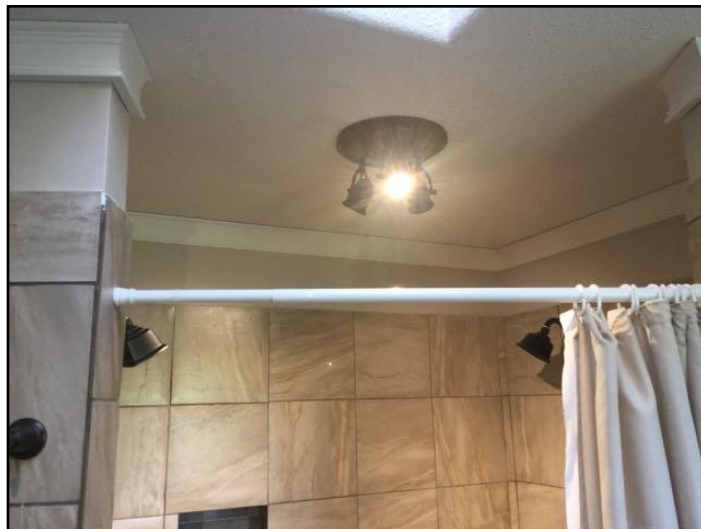
23. Condition: • [Conventional lights in wet areas](#)

Implication(s): Electric shock | Fire hazard

25. *Conventional lights in wet areas*

Task: Replace

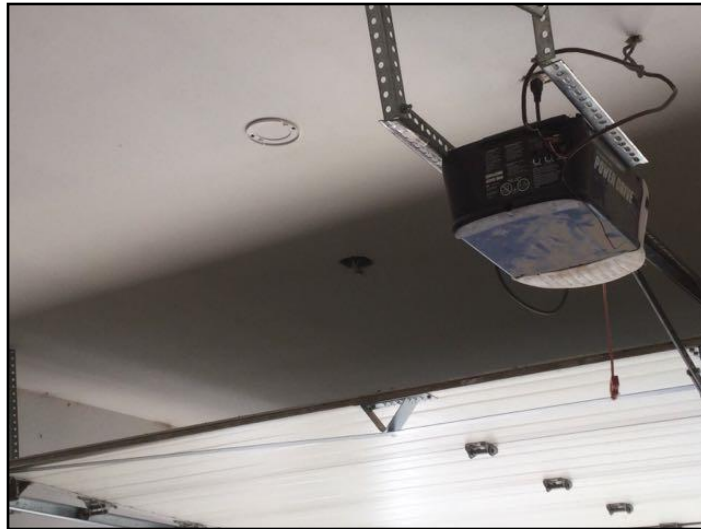
24. Condition: • [Missing](#)

Implication(s): Inadequate lighting

26. Missing

Task: Provide

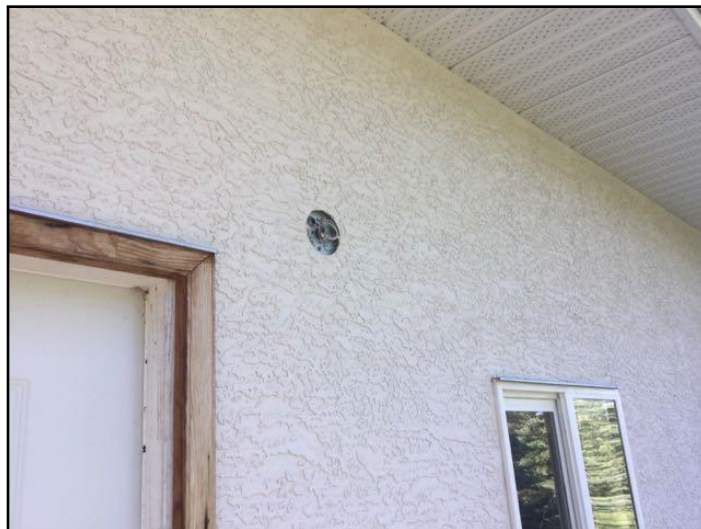
25. Condition: • [Missing](#)

Implication(s): Inadequate lighting

27. Missing

Task: Provide

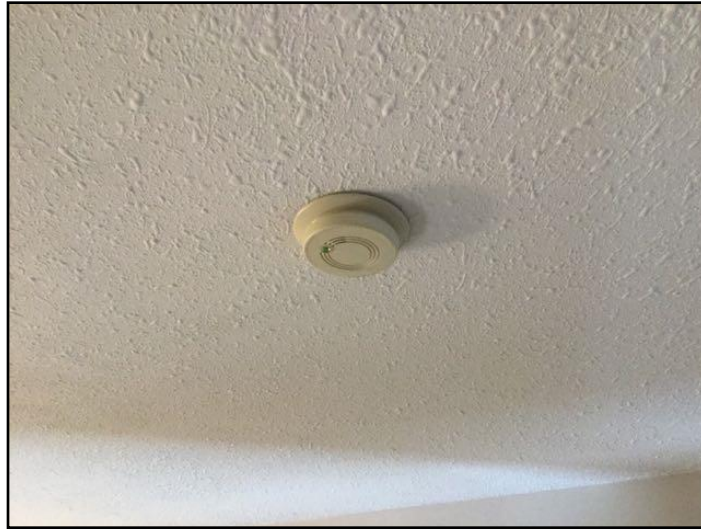
26. Condition: • Past life expectancy

Implication(s): Life safety hazard

28. *Past life expectancy*

Recommend installing new smoke/co combo hard wired units with battery back up on both levels with the presence of gas and wood appliances and access to the garage doors.

Task: Replace

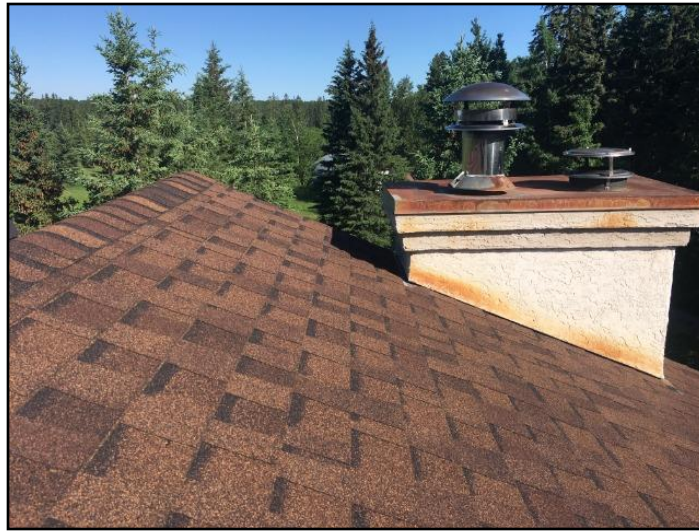
30. Condition: • [Inadequate chimney height above roof](#)

Implication(s): Equipment not operating properly | Hazardous combustion products entering home

30. *Inadequate chimney height above roof*

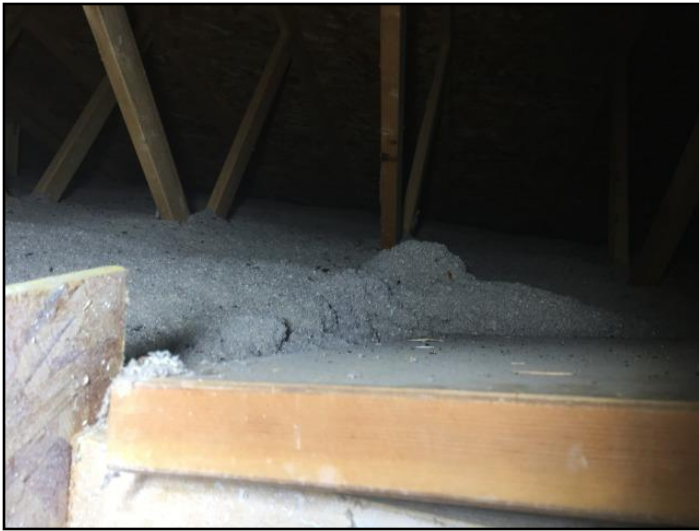
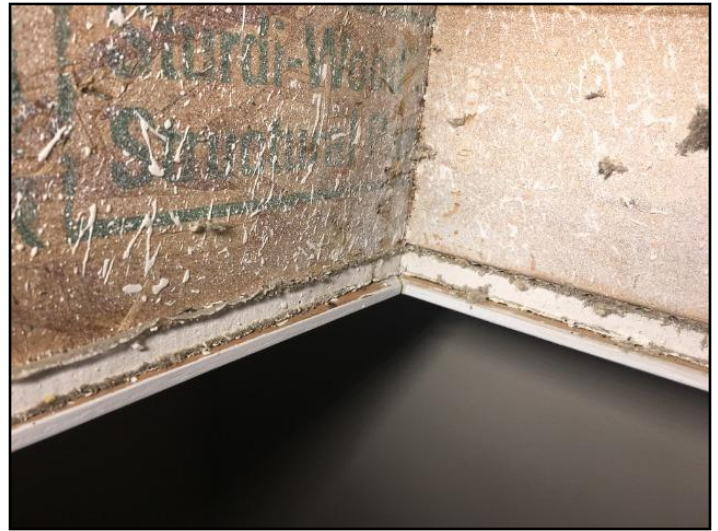
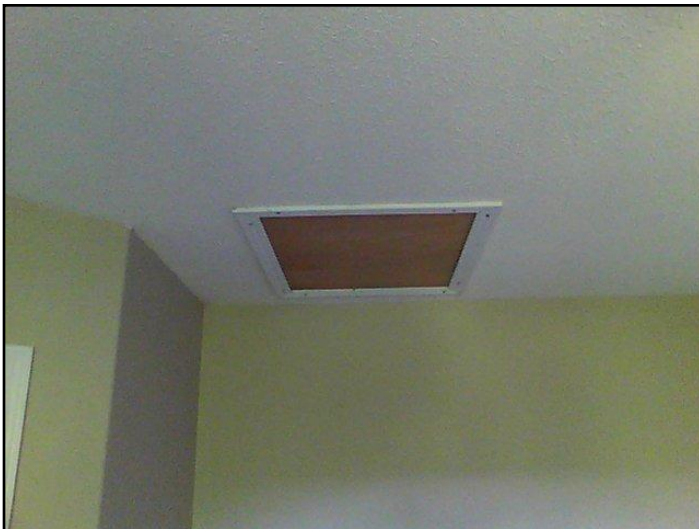
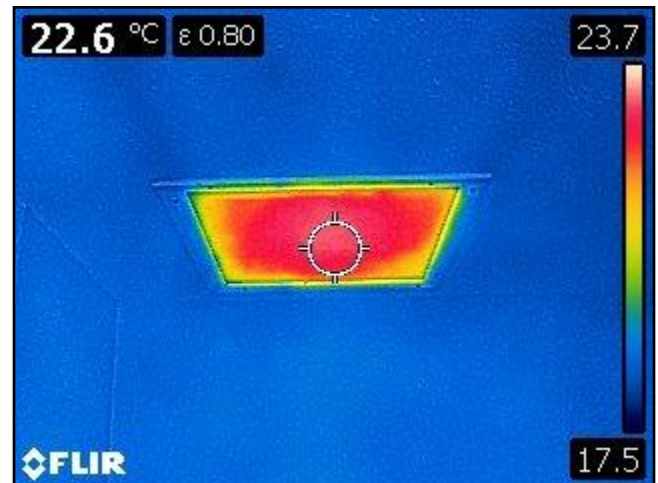
33. Condition: • [Not insulated and not weatherstripped](#)

Implication(s): Chance of condensation damage to finishes and/or structure | Increased heating and cooling costs | Reduced comfort

32. Not insulated and not weatherstripped

33. Not insulated and not weatherstripped

34. Not insulated and not weatherstripped

35. Not insulated and not weatherstripped

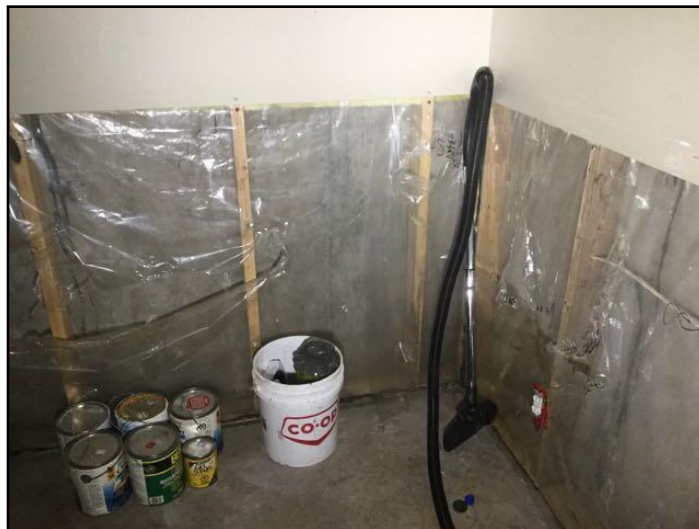
34. Condition: • [Missing](#)

36. Missing

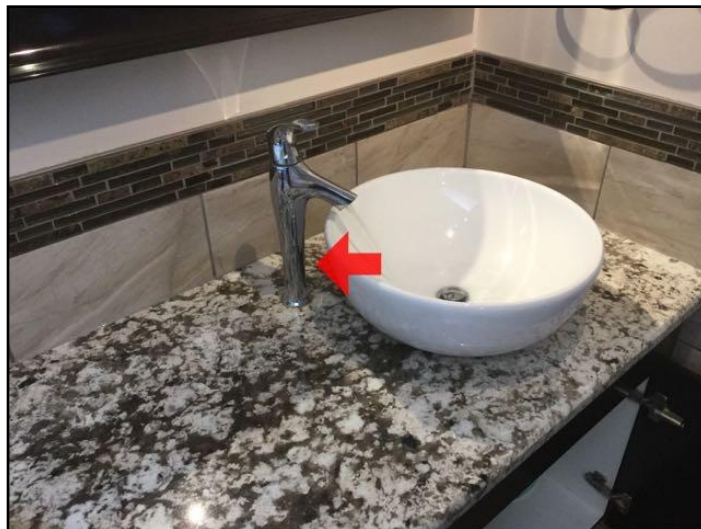
36. Condition: • [Loose](#)

Implication(s): Equipment failure

38. *Loose*

Task: Repair

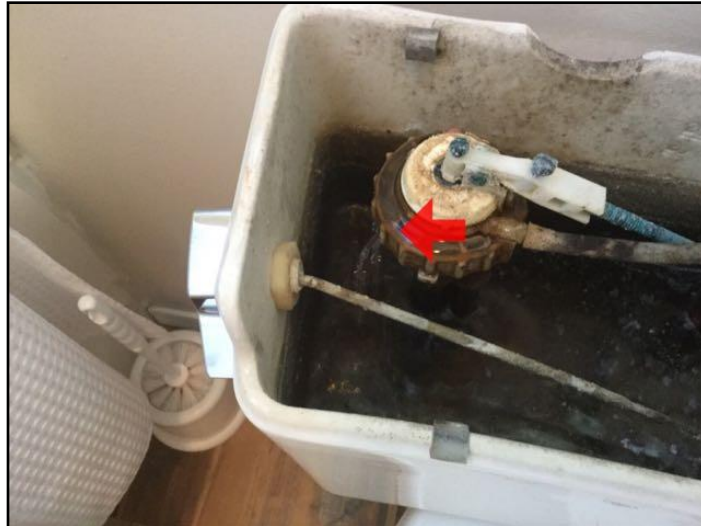
37. Condition: • [Leak](#)

Implication(s): Chance of water damage to contents, finishes and/or structure

39. Leak

Task: Repair

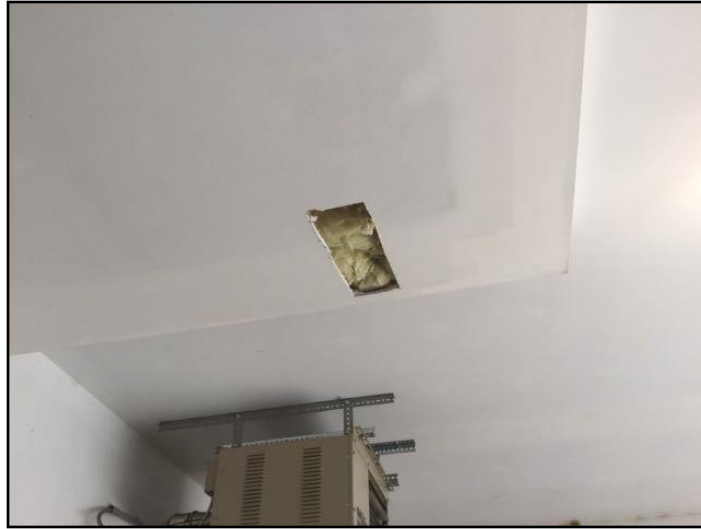
40. Condition: • Damage

Implication(s): Damage or physical injury due to falling materials

40. Damage

Task: Repair

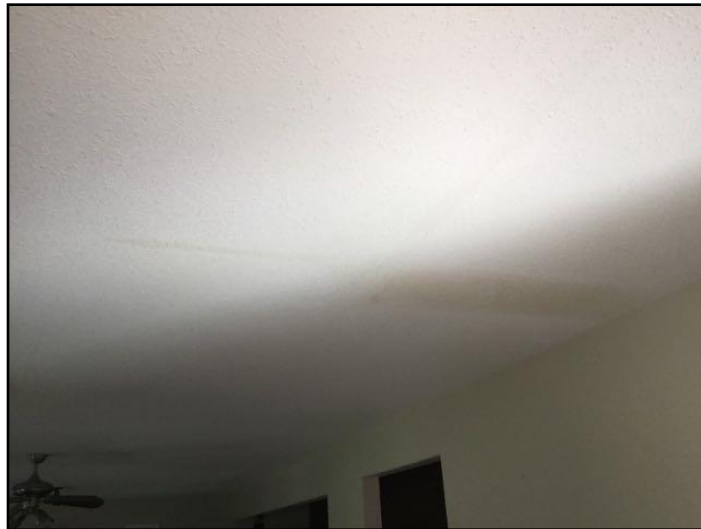
41. Condition: • Stains

Implication(s): Chance of water damage to contents, finishes and/or structure

41. Stains

Task: Further evaluation

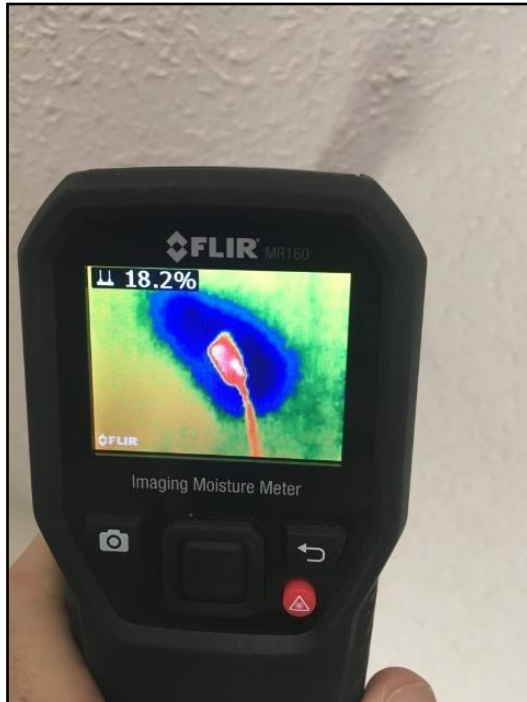
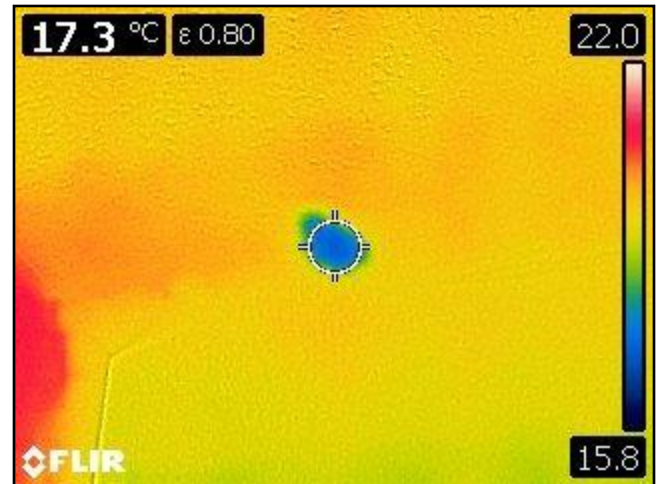
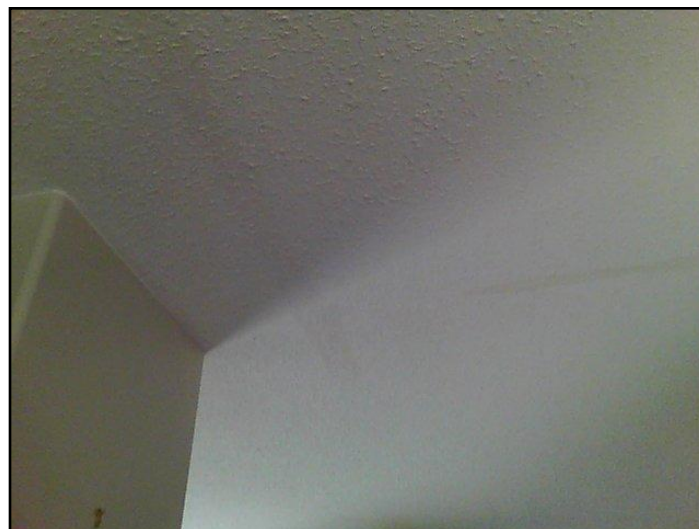
42. Condition: • Water stains

Implication(s): Chance of water damage to contents, finishes and/or structure

42. Water stains

43. Water stains

44. Water stains

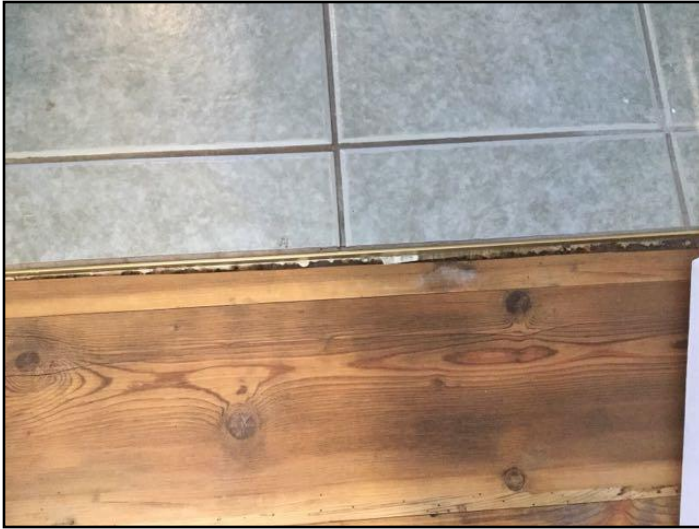
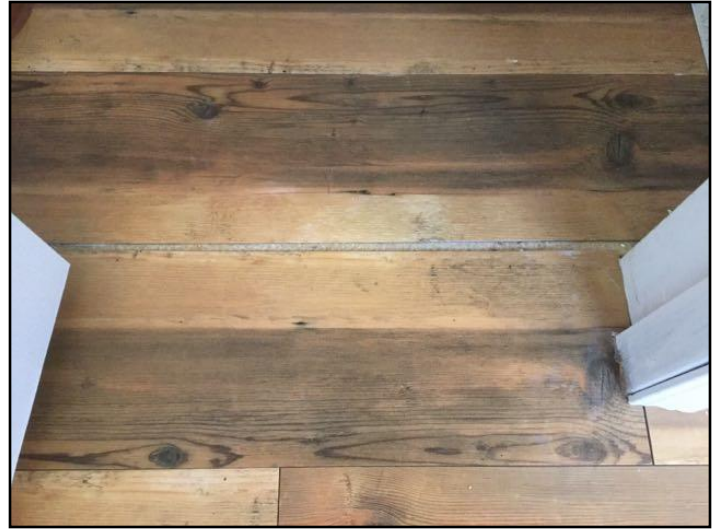
43. Condition: • [Loose or missing sections](#)

Implication(s): Trip or fall hazard

45. Loose or missing sections

46. Loose or missing sections

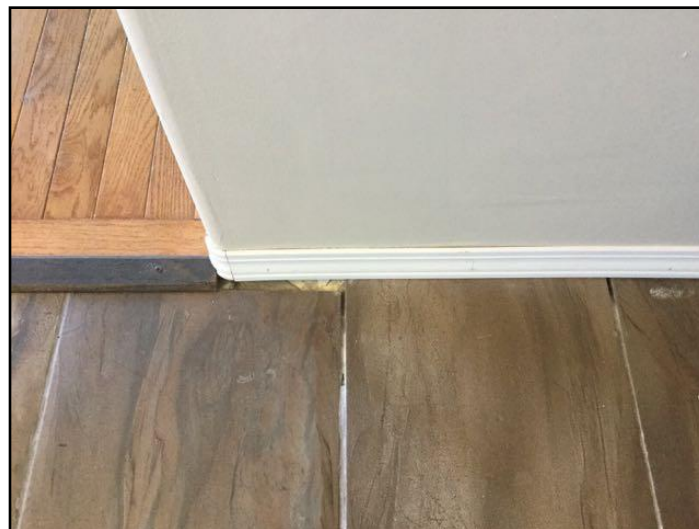
44. Condition: • [Tiles missing](#)

Implication(s): Trip or fall hazard

47. Tiles missing

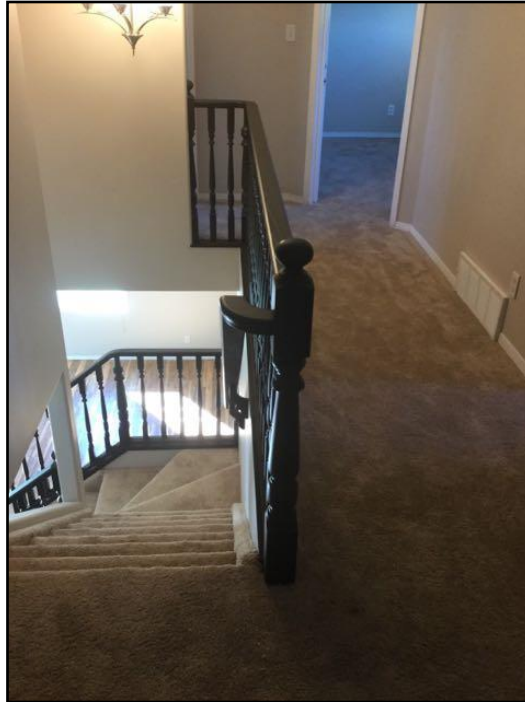
48. Condition: • [Loose](#)

Implication(s): Fall hazard

48. Loose

Task: Improve

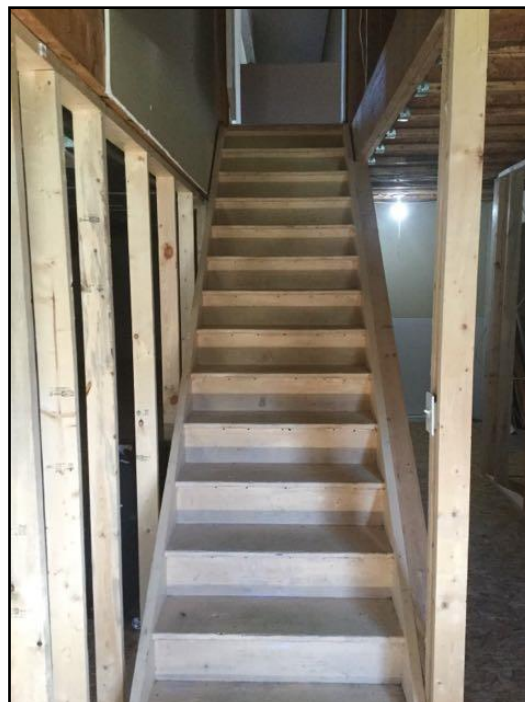
49. Condition: • [Missing](#)

Implication(s): Fall hazard

49. Missing

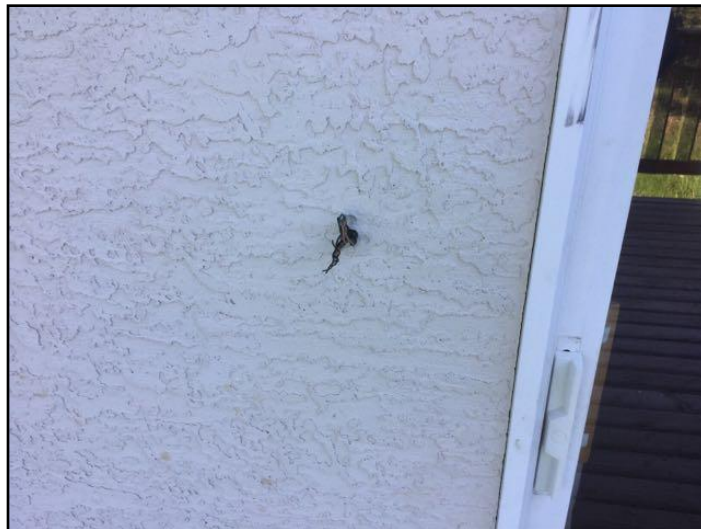
52. Condition: • Missing button

51. Missing button

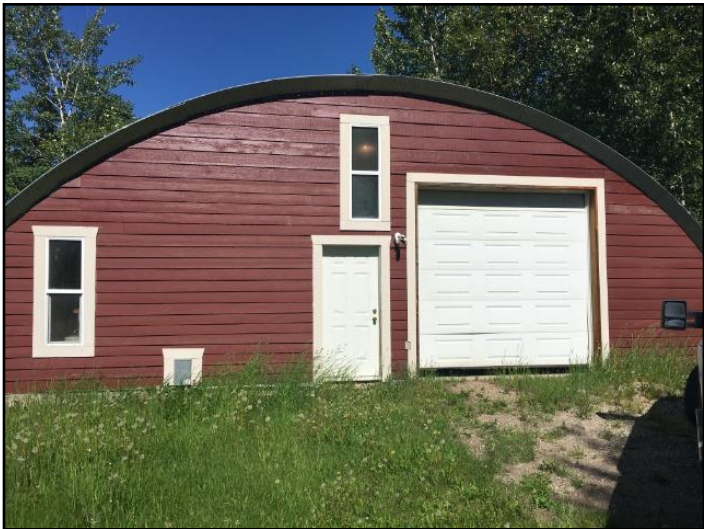
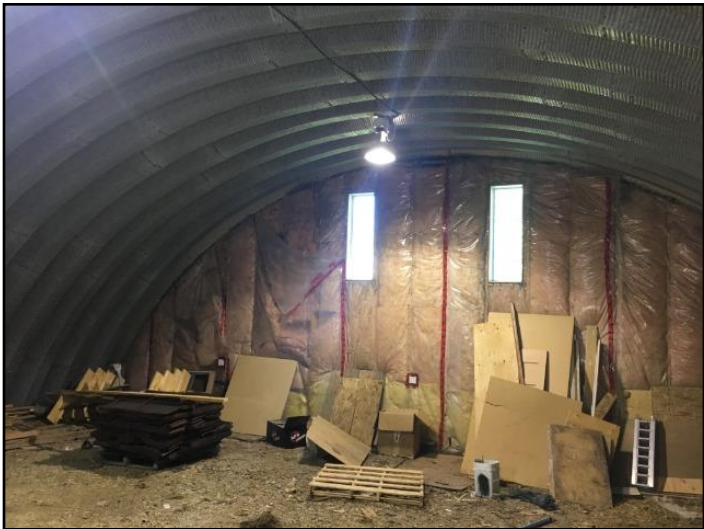
General: • A basic visual overall inspection of the outbuildings was conducted. The building is showing signs of age and requires varying degrees of maintenance work and improvements. The structure is in reasonable condition at the time of the inspection.

52. A basic visual overall inspection of the...

53. A basic visual overall inspection of the...
