# YOUR INSPECTION REPORT

56 Fairview Avenue  
Toronto, ON M6P 3A4

Friday, May 4, 2018

RE: Report No. 2266, v.2  
56 Fairview Avenue  
Toronto, ON  
M6P 3A4

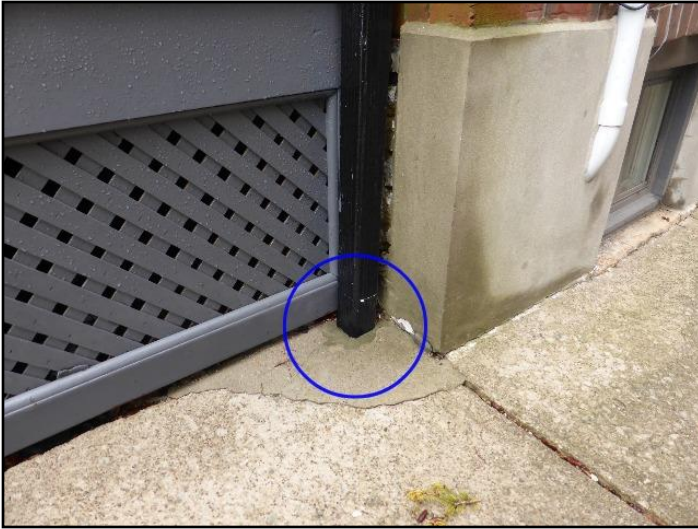
Condition: • [Discharge below grade](#)

2. Discharge below grade

Recommend install downspout extension to divert rainwater away from foundation.

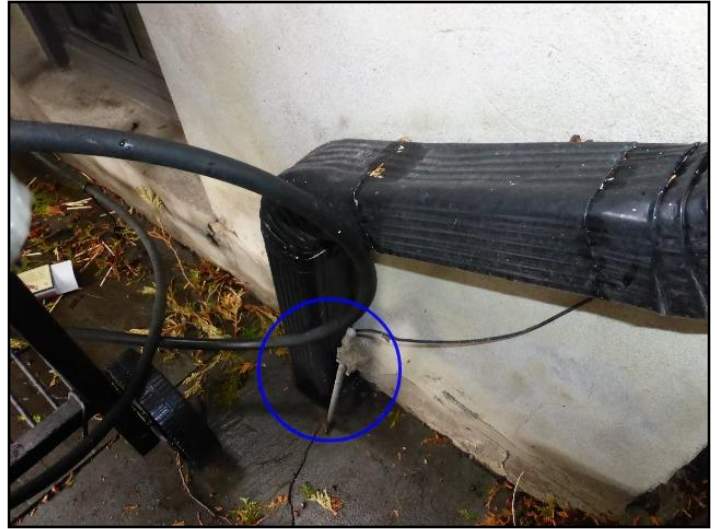
3. Discharge below grade

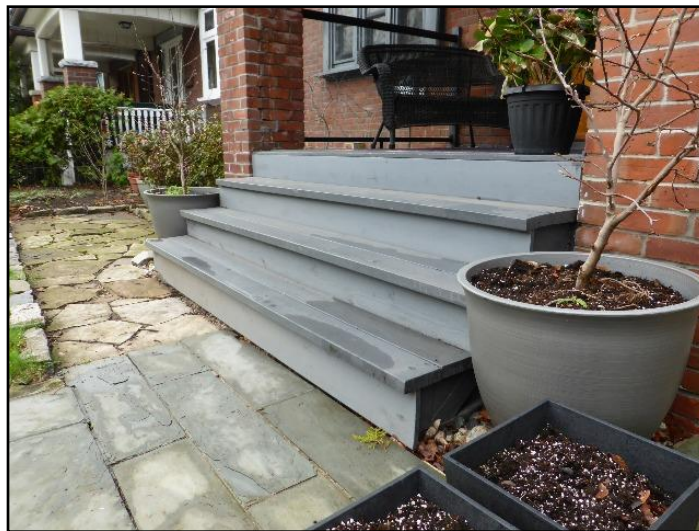
**Condition:** • [Missing](#)

4. Missing

Exterior stairs with 4 or more risers are required to have a handrail installed in the interest of personal safety. Corrective action should be taken.

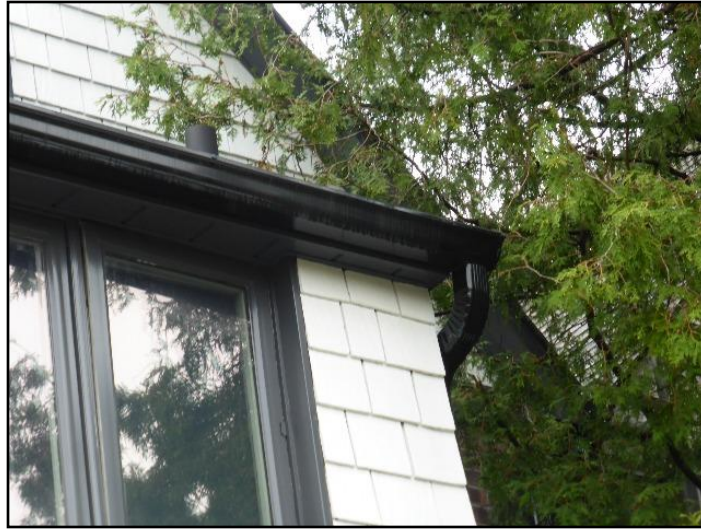
**Condition:** • [Large trees close to building](#)

limbs are noted in close proximity to the roof. Movement of the limbs can cause wear and gouging of roofing material, puncturing shingles or roofing surface. Also, moisture can be trapped Tree contributing to rotting of roof structures. Leaves can be trapped in gutters causing water to back-up damaging roof and exterior wall structures. Tree limbs should be cut back to reduce potential damage. A qualified professional should be consulted for corrective action.

6. Large trees close to building

**Task:** Trim/Prune

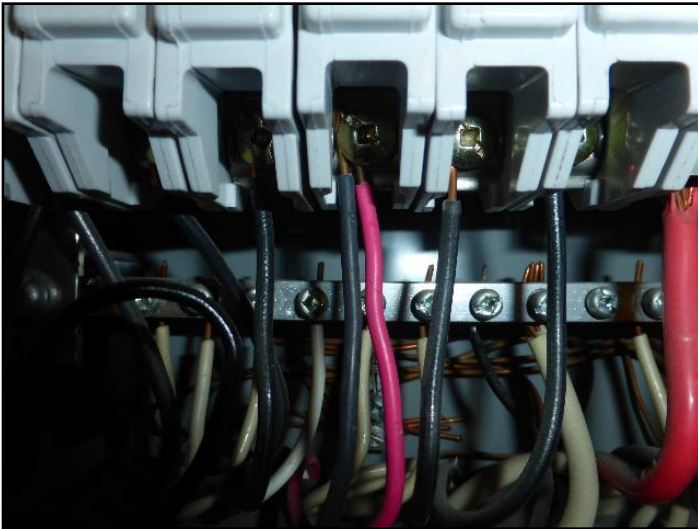
Condition: • [Double taps](#)

10. Double taps

Double taps should be corrected by a licensed electrician.

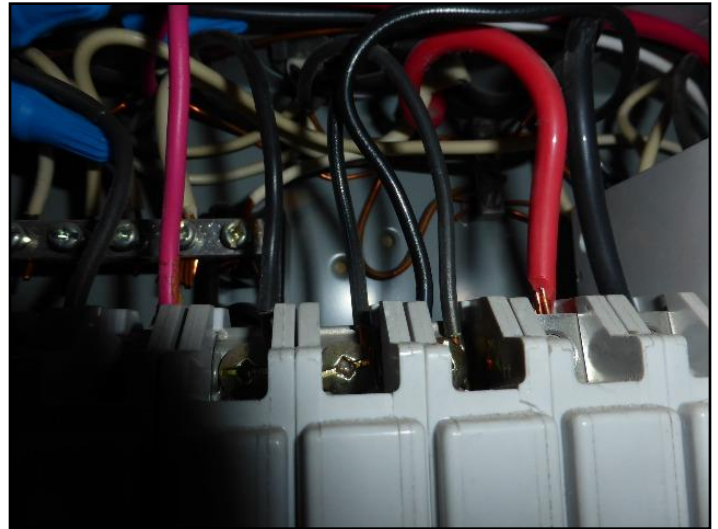
11. Double taps

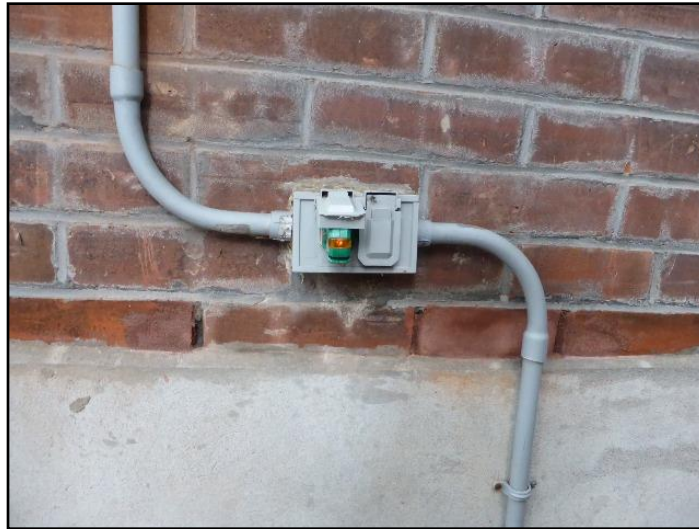
**Condition:** • [GFCI/GFI needed \(Ground Fault Circuit Interrupter\)](#)

12. GFCI/GFI needed (Ground Fault Circuit...

**Task:** Replace

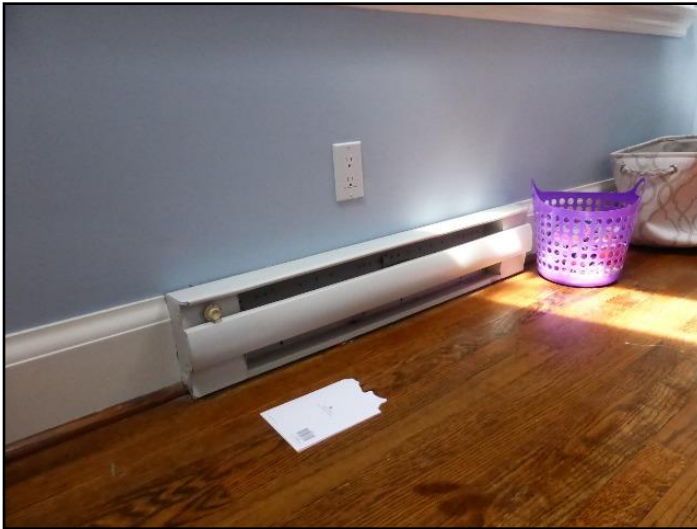
**Condition:** • [Above electric baseboard heaters](#)

cords plugged into outlets above electric baseboard heaters could overheat if accidentally draped over the heater

13. Above electric baseboard heaters

outlets should be located at either end of the heater

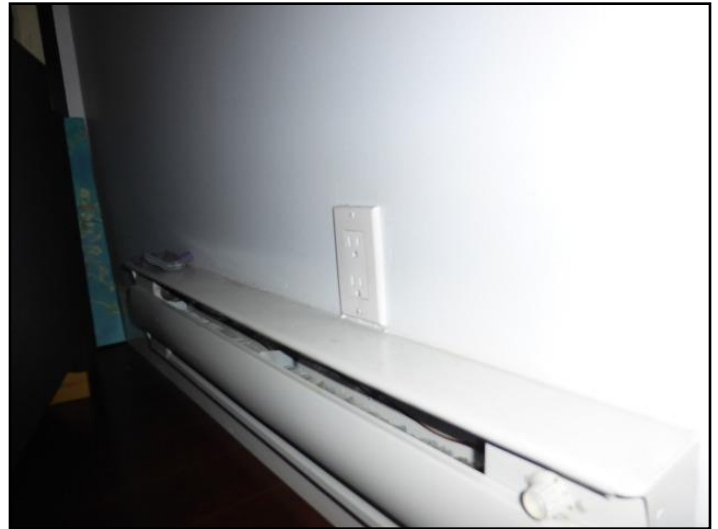
14. Above electric baseboard heaters

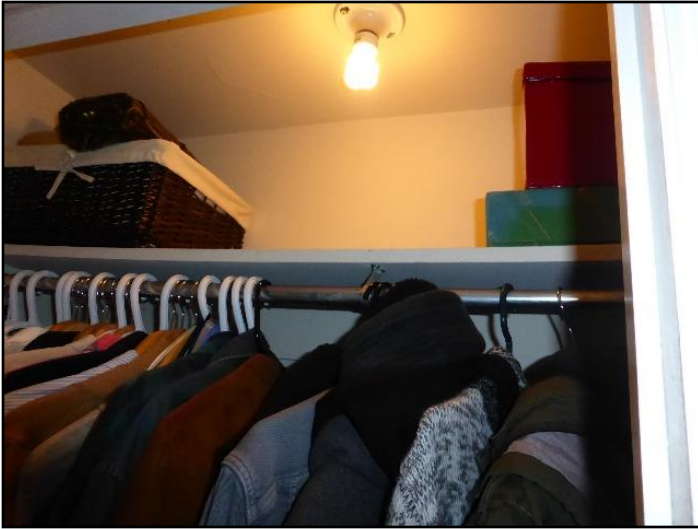
**Condition:** • [Improper closet lighting](#)

15. Improper closet lighting

Install a light fixture's that are approved for closet enclosure in all walk-in closets.

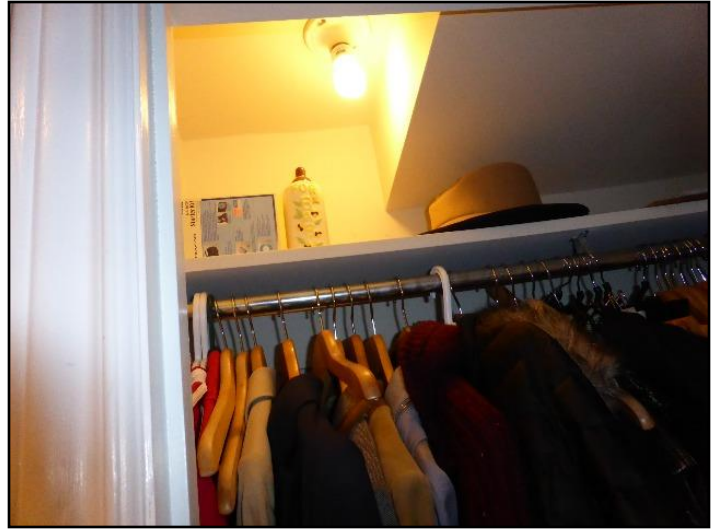
16. Improper closet lighting

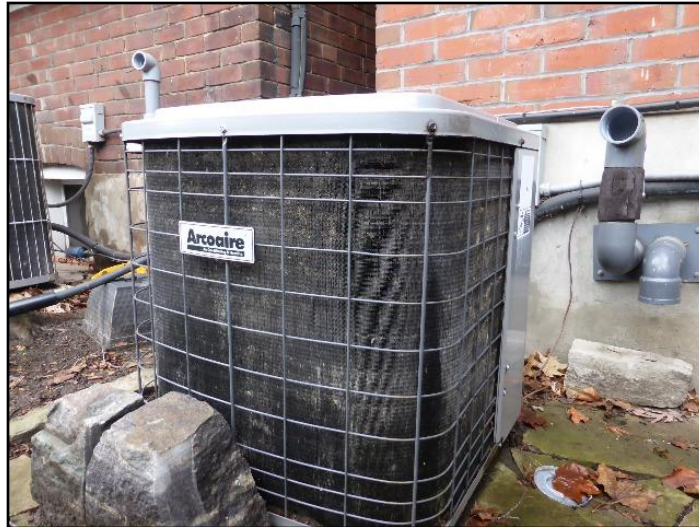
20. Arco

Compressor approximate age: • 16 years

Typical life expectancy: • 12 to 15 years

Condition: • [Near end of life expectancy](#)

Task: Replace

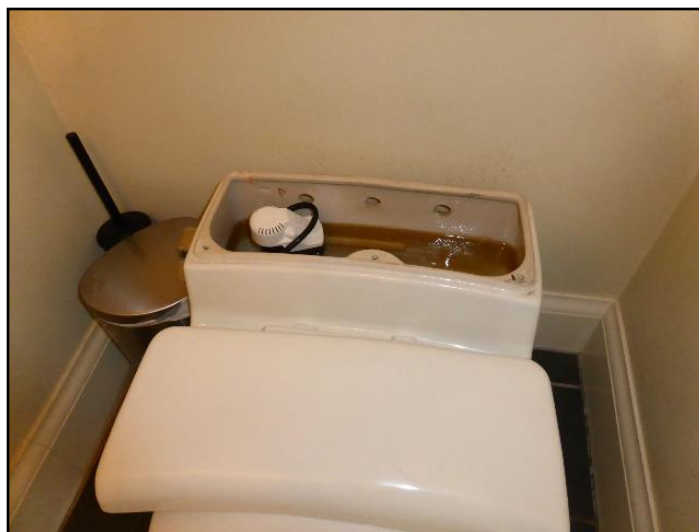
**Condition:** • [Running continuously](#)

22. Running continuously

Recommend replace ballast in main level powder room.

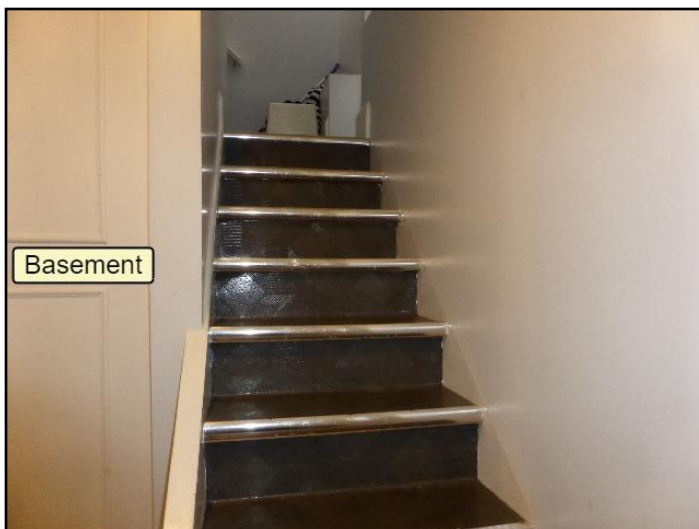
**Condition:** • [Missing](#)

23. Missing

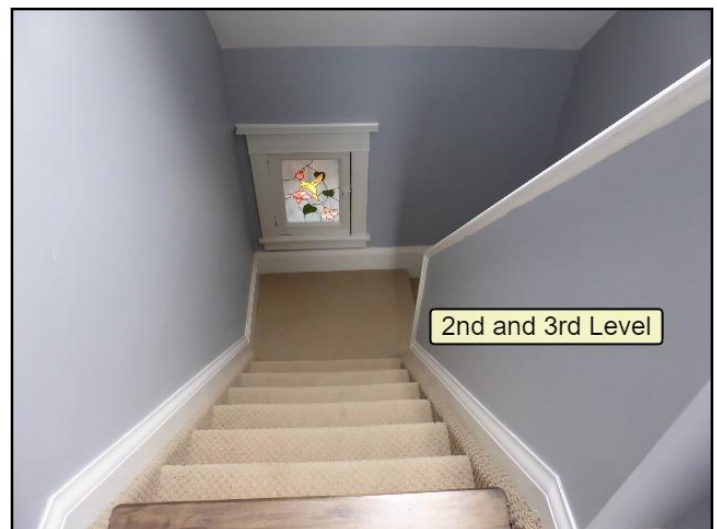
24. Missing

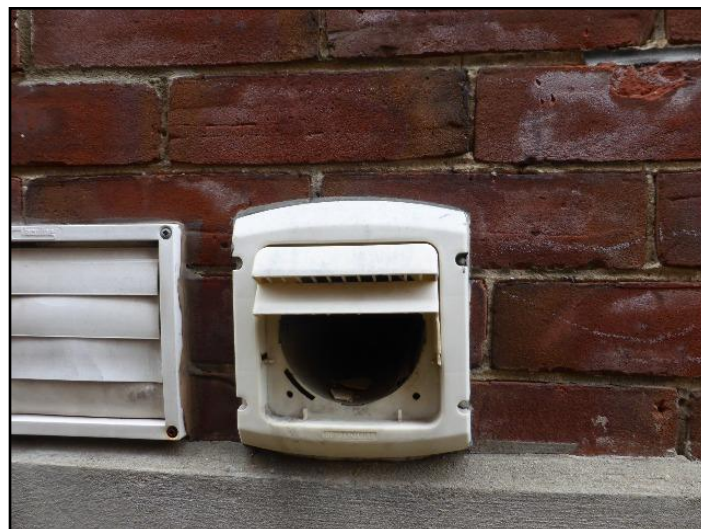
**Condition:** • [Weather hood missing or loose](#)

25. Weather hood missing or loose

**Task:** Replace
