# INSPECTION REPORT

For the Property at:  
**1800 YOUR STREET**  
NEW ORLEANS, LA 70119

Prepared for: YOUR HOUSE  
Inspection Date: Tuesday, September 27, 2016  
Prepared by: Turk Schexnayder LHI Lic.10679

RE: Report No. 1575, v.3  
1800 Your Street  
New Orleans, LA  
70119

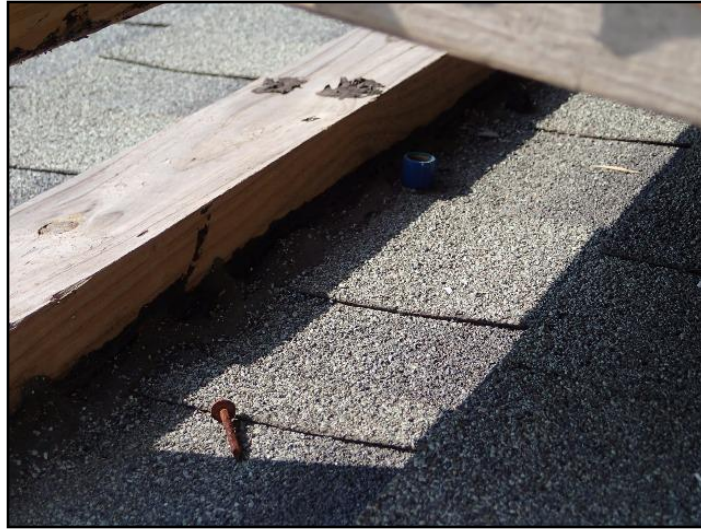
3. Flat board on roof.

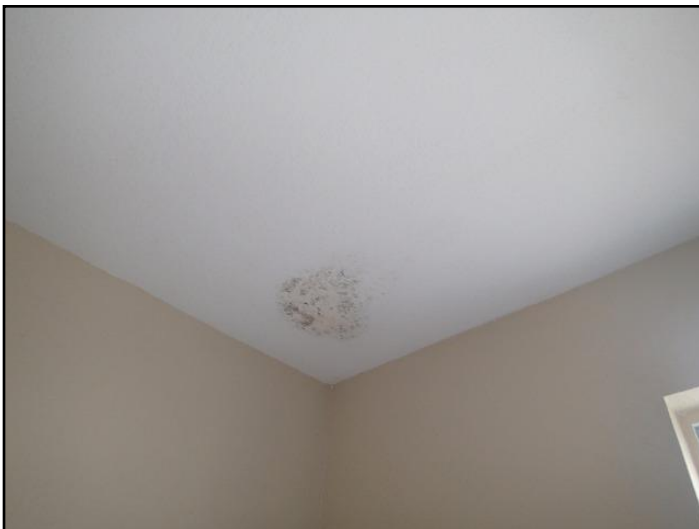
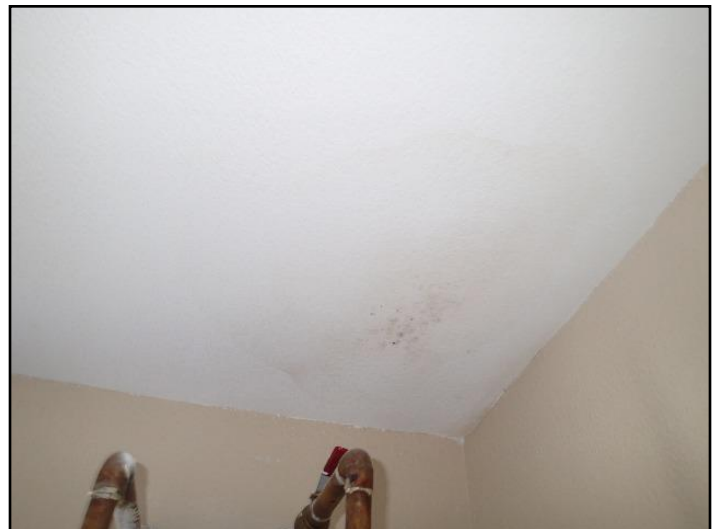
### 3. Condition: • [Leak](#)

Stains noted on right side rear addition ceiling. Stains are likely from a leak in the roof.

**Implication(s):** Chance of water damage to contents, finishes and/or structure

4. Stains

5. Stains

**Task:** Repair or replace

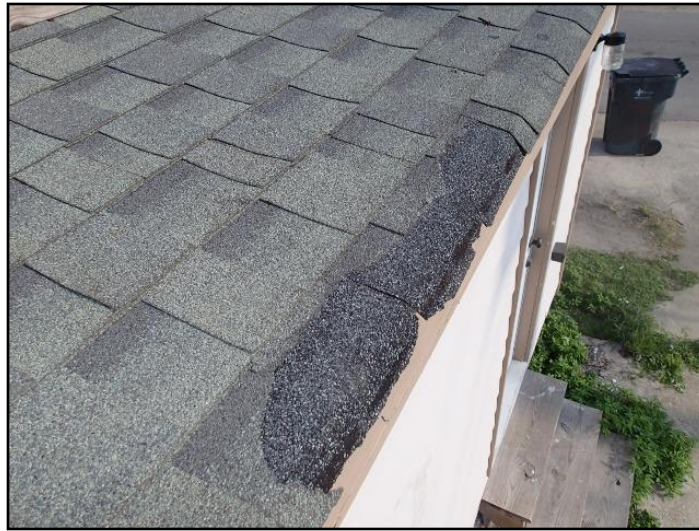
### 4. Condition: • [Missing, loose or torn](#)

**Implication(s):** Chance of water damage to contents, finishes and/or structure

6. Missing or torn

**Task:** Repair or replace

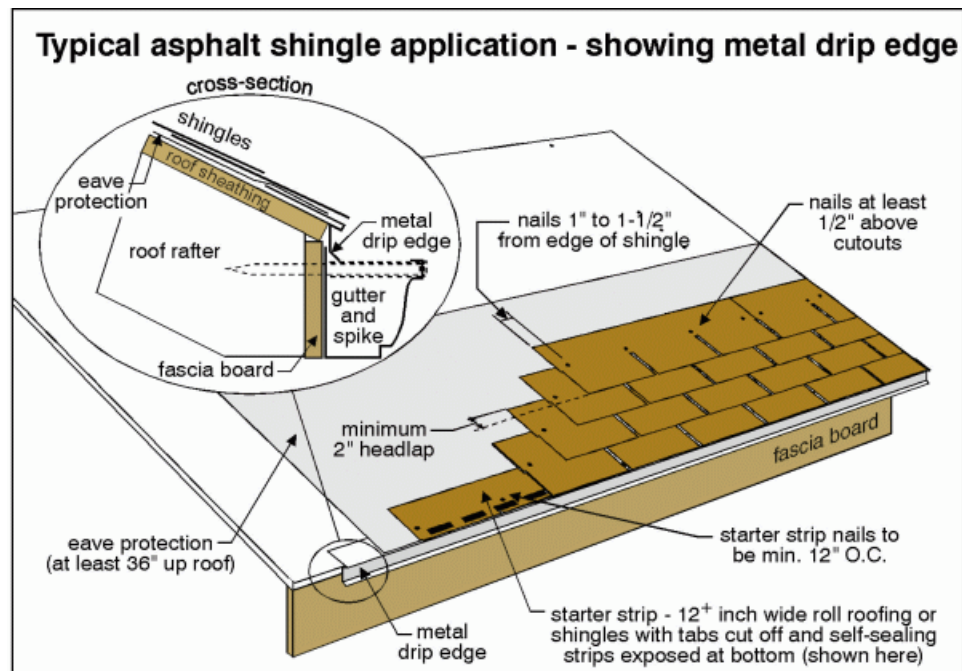
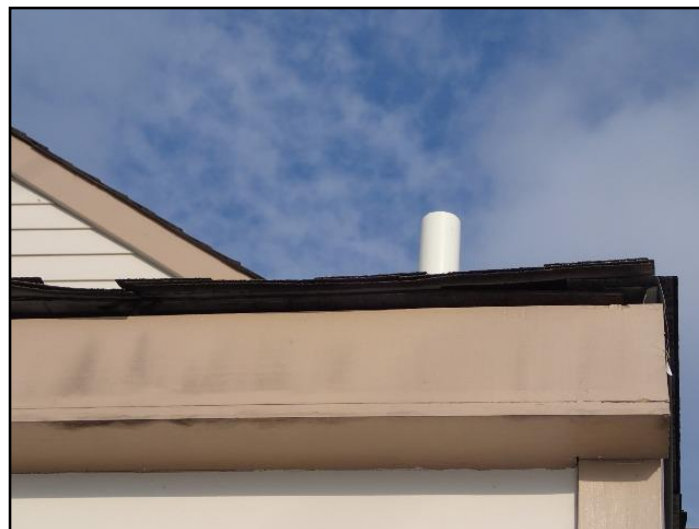
### 6. Condition: • [Missing](#)

Missing drip edge and rake edge flashing.

**8. Missing drip edge flashing**

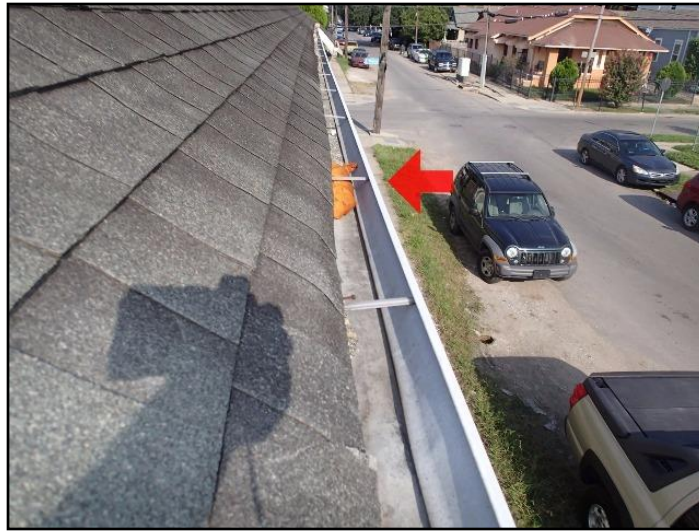
8. **Condition:** • Foam in gutter on left side near rear.

12. Foam

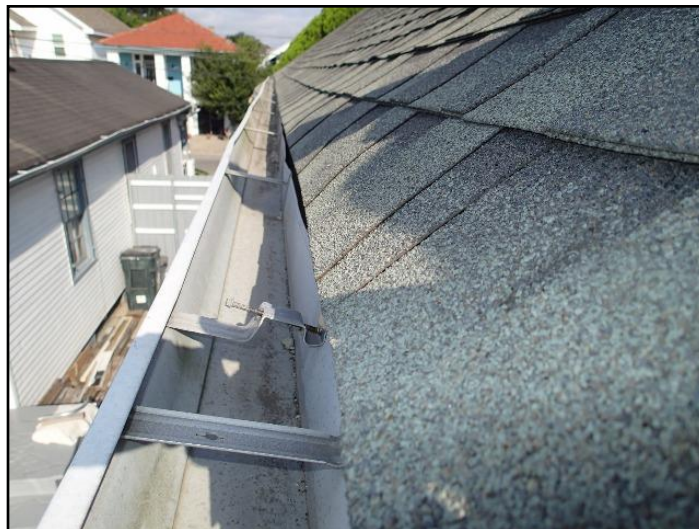
**9. Condition:** • [Loose or damaged](#)

Right side gutter was loose near rear.

13. Loose

**Task:** Repair or replace

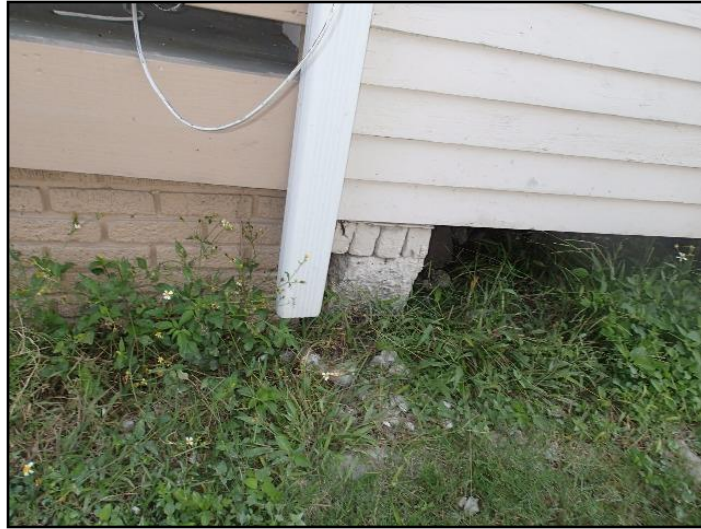
**10. Condition:** • No diverter at end of downspout

Lower portions of some downspout's are missing. This can create erosion issues, and isolated settlement, and may exacerbate the issue of soil subsidence.

14. No diverter at end of downspout

**Task:** Improve roof drainage with proper downspout discharge, add splash blocks etc. to move water away from foundation.

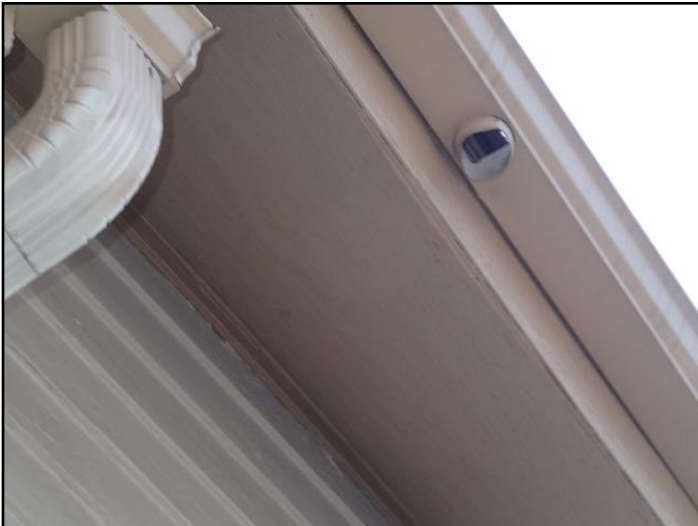
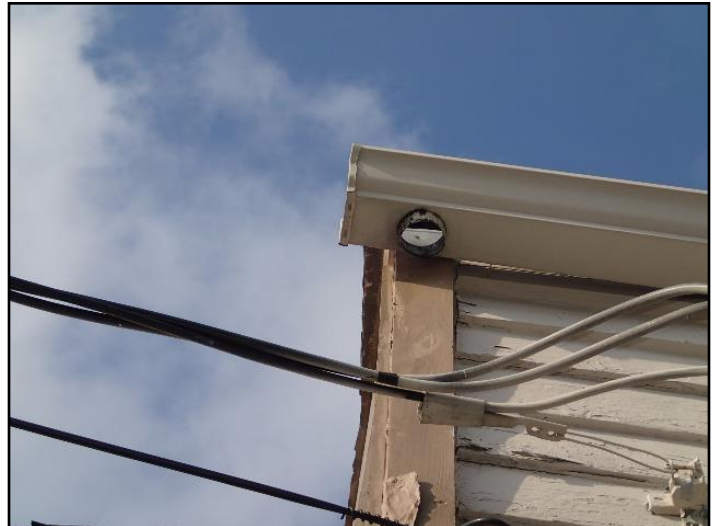
## 11. Condition: • [Missing](#)

Missing downspouts on both sides of house. Holes or tears also noted on right side gutter.

15. Missing

16. Missing

**Task:** Repair or replace

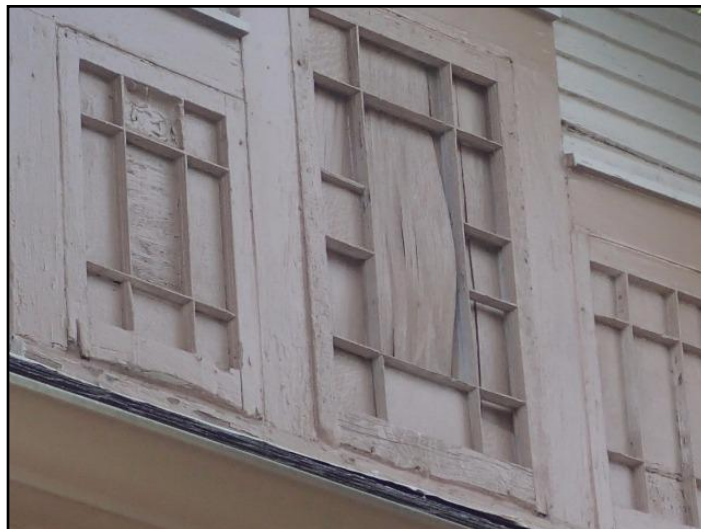
**13. Condition:** • Front gable windows were painted. Some panes were missing and were replaced with plywood. Plywood appears to be buckling and/or warping.

18. Gable windows.

**Task:** Replace missing glass.

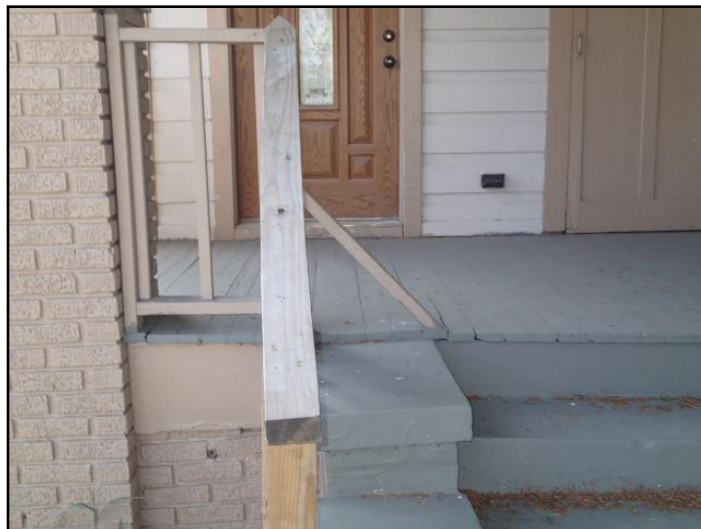
**15. Condition:** • Handrails should be easy to grasp. Handrails should be continuous from the lowest riser to the top riser interrupted only by a newel post at the turn. The intent of a handrail is to provide a hand-grip for people using a stairway. If a handrail cannot be gripped securely, it is unsafe.

20. Handrails should be easy to grasp.

**Task:** Repair or replace

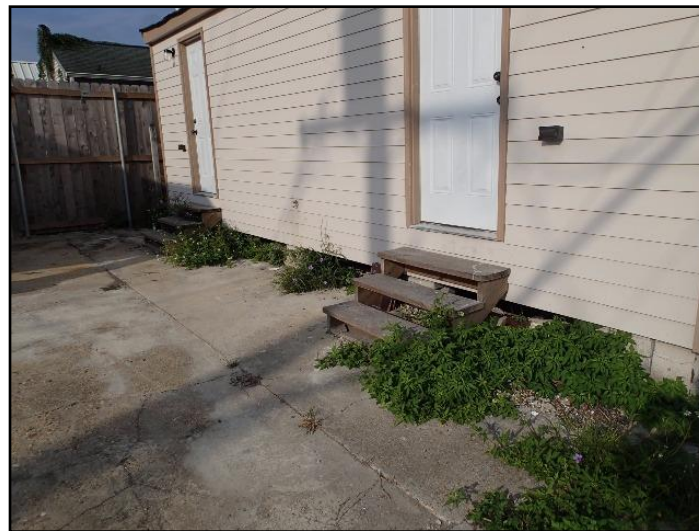
**16. Condition:** • [Missing](#)

**Implication(s):** Fall hazard

21. Missing

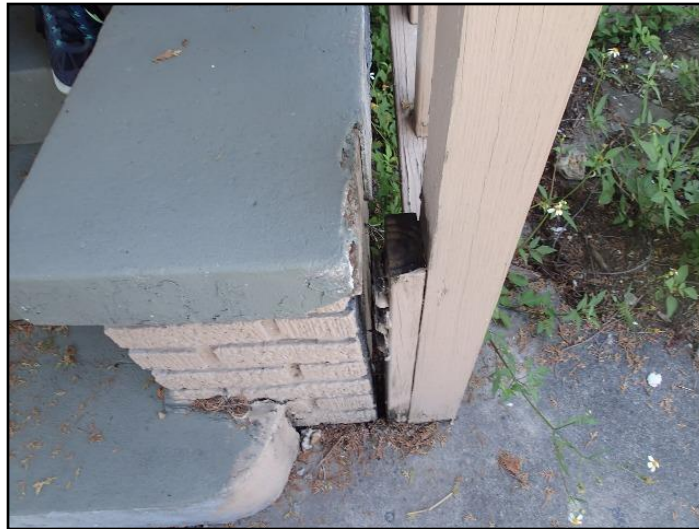
17. Condition: • [Loose](#)

Implication(s): Fall hazard

22. Loose

Task: Repair or replace

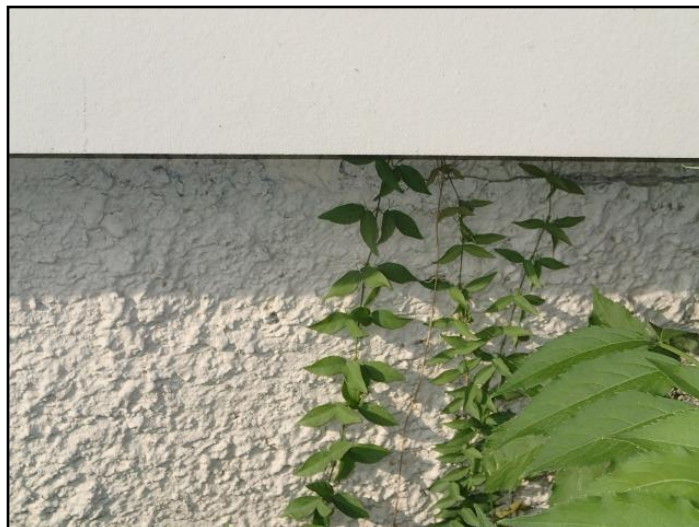
### 18. Condition: • [Vines](#)

Vines on exterior masonry or wood. While masonry walls are more tolerant of vine damage than wood or siding, vines will facilitate insect and pest entry and moisture damage due to slow drying. Damage to mortar can also occur. Roots create the most serious mechanical damage. Wood trim is especially susceptible to rot caused by vines. Some people are prepared to live with the disadvantage of the plants due to the cosmetic effect, but the removal of vines on any exterior surface is recommended.

23. Vines

**Task:** Remove vines to prevent material deterioration

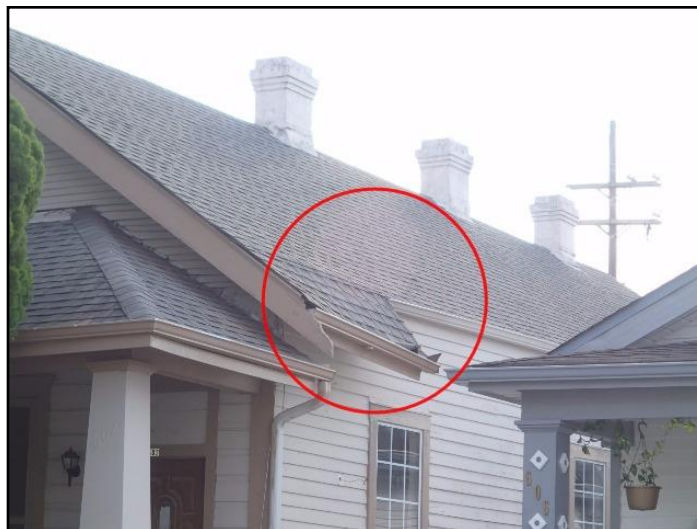
**20.** • Roof extension on right side appeared to be falling. Exposed rafter tails would normally be exposed, but these are boxed in and not visible.

**24.** *Falling roof/framing*

**Task:** Further evaluation

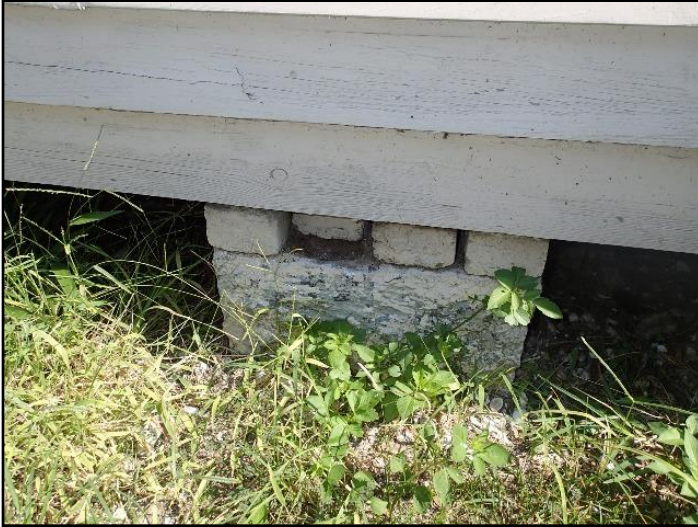
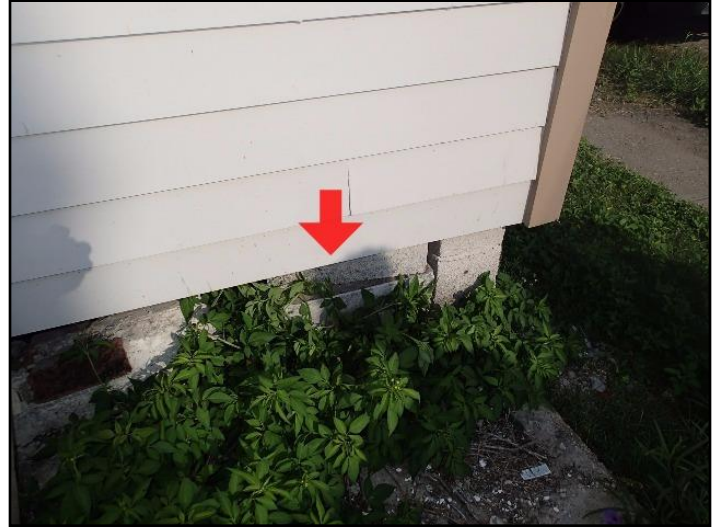
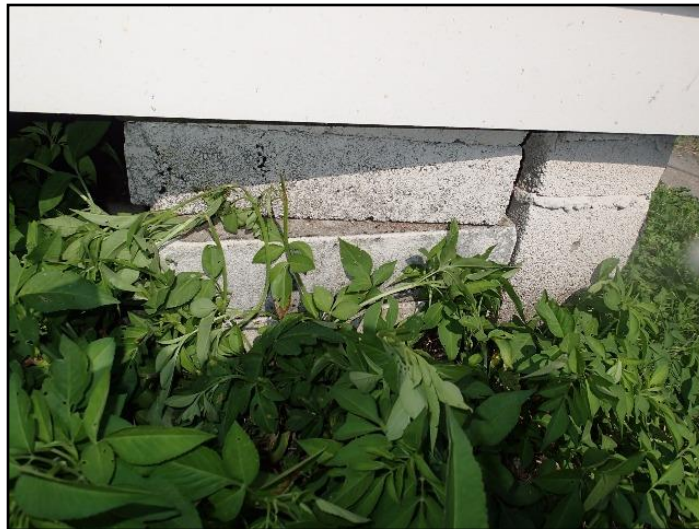
**22. Condition:** • Loose or missing bricks.

25. Loose or missing bricks.

26. Loose or missing bricks.

27. Loose or missing bricks.

**Task:** Further evaluation

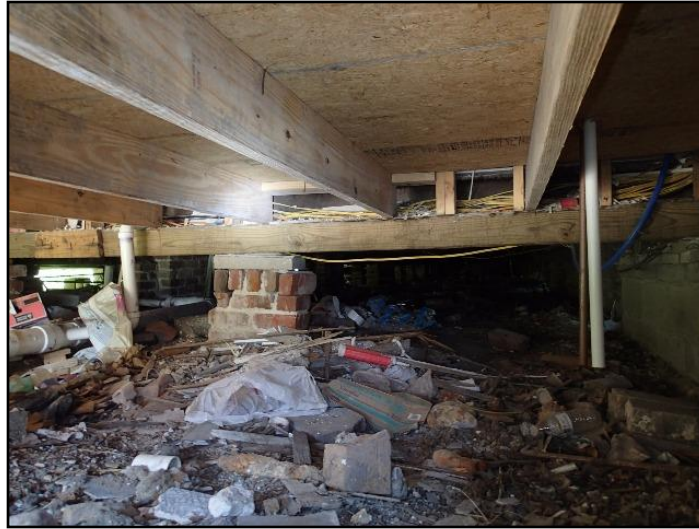
## 23. Condition: • [Mortar deterioration](#)

Some piers are showing signs of mortar deterioration. This is common for piers of this age. Re-point piers where needed to prevent further deterioration. Photo is an example of some of the piers found, not all piers with mortar deterioration are pictured.

28. Mortar deterioration

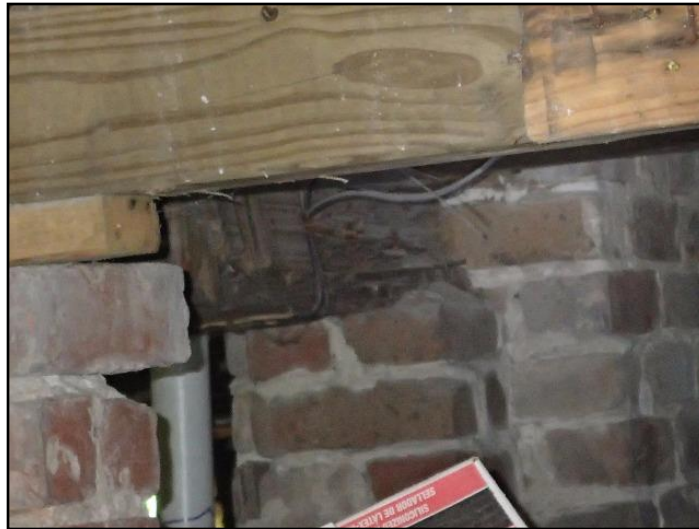
24. Condition: • Center beam at rear.

29. Center beam

Task: Further evaluation

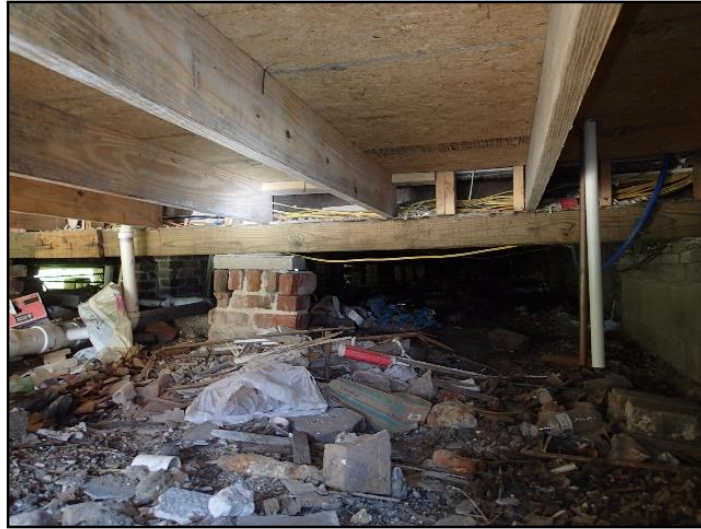
25. Condition: • Joists on rear addition appear to be over spanned.

30. Over spanned.

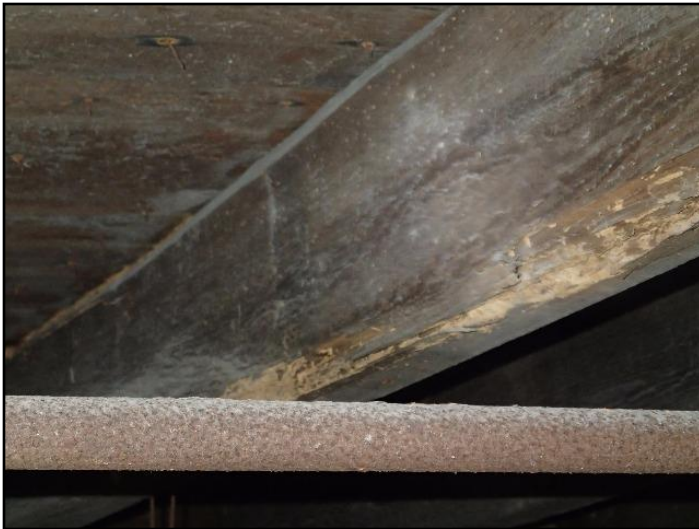
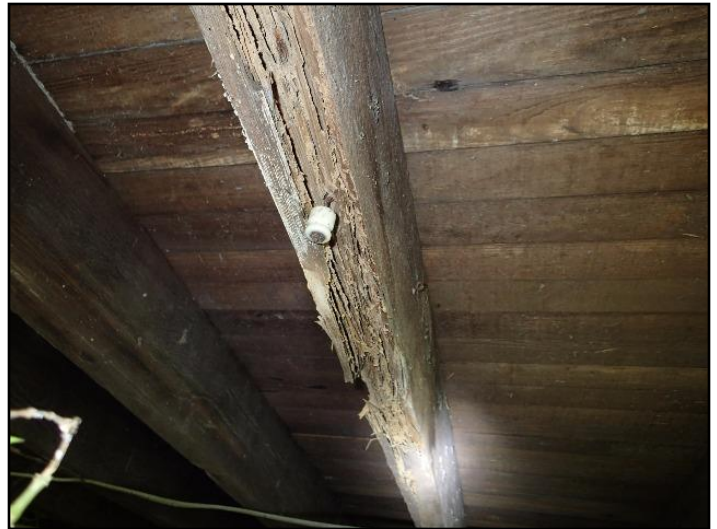
26. Condition: • [Rot, insect or fire damage](#)

Implication(s): Weakened structure

31. Rot, insect or fire damage

32. Rot, insect or fire damage

Task: Further evaluation

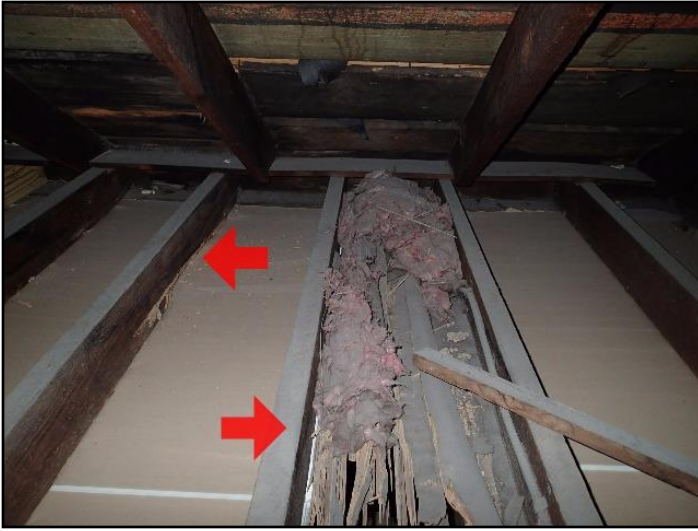
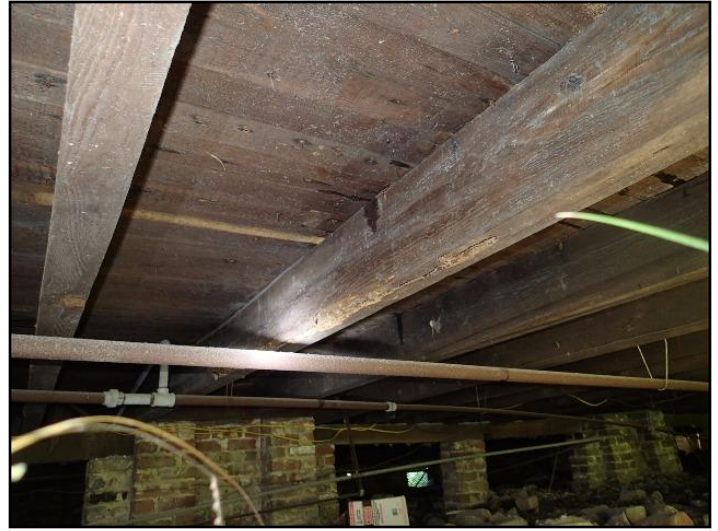
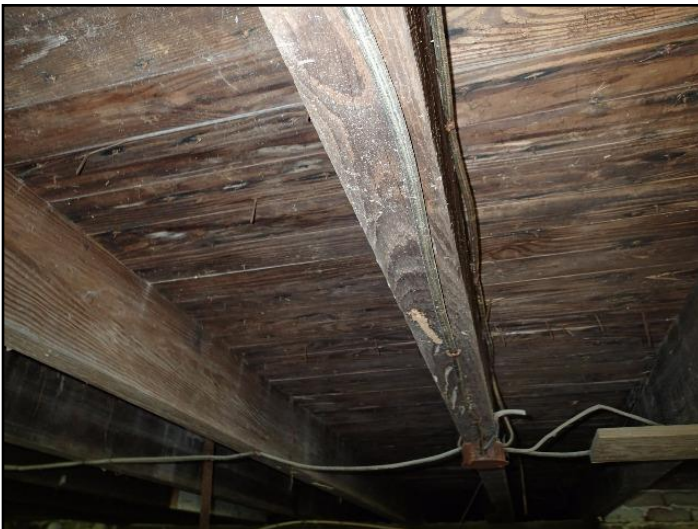
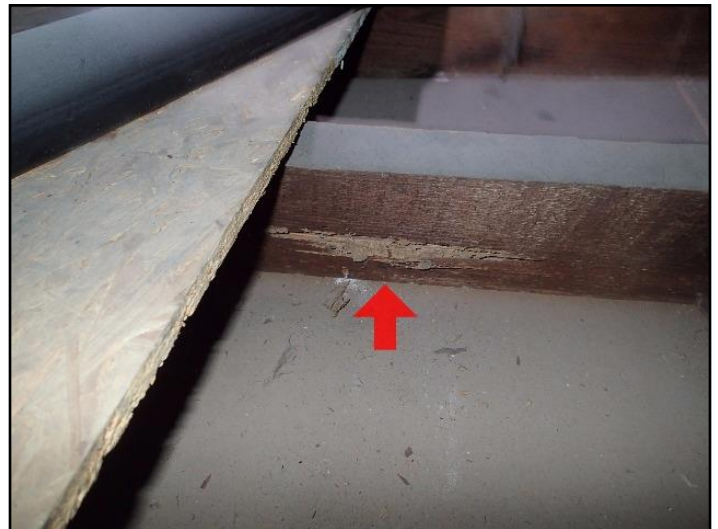
33. Damaged ceiling joist

34. Rot, insect or fire damage

35. Rot, insect or fire damage

36. Damage

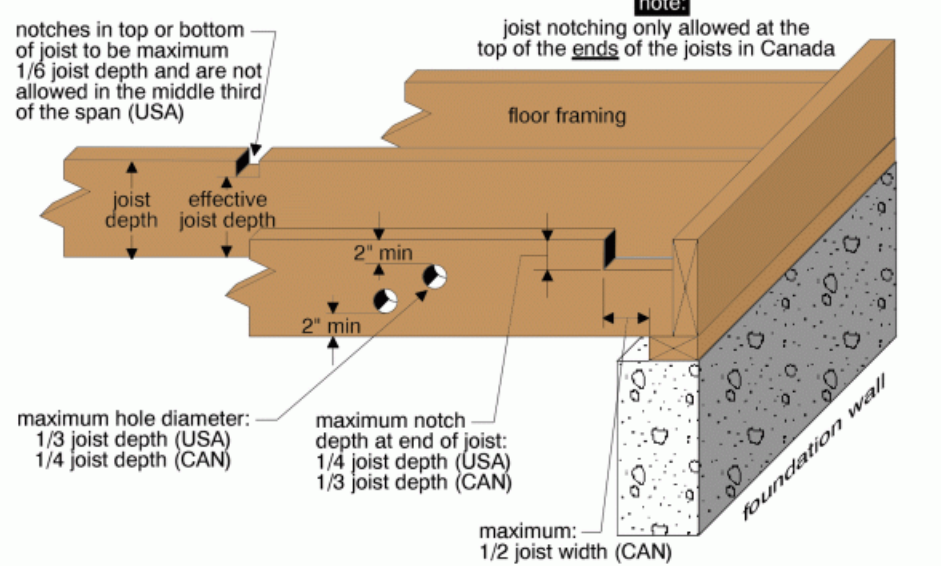
27. Condition: • [Notches or holes](#)

37. Notches or holes

**Task:** Further evaluation

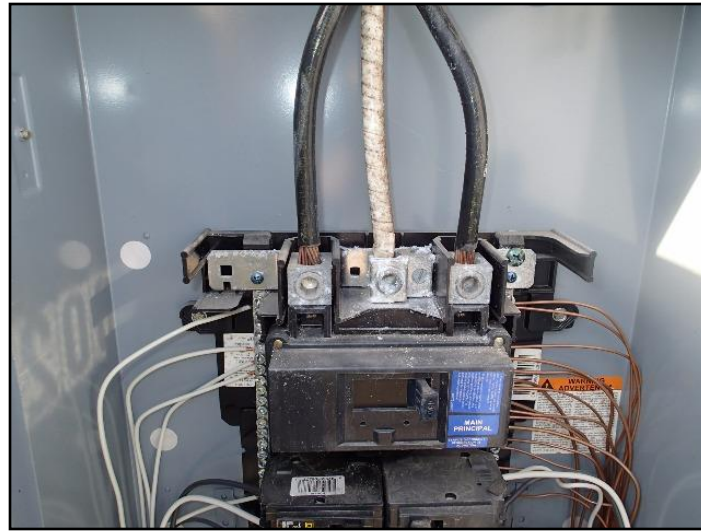
**30. Condition:** • No dielectric grease on service wires. Corrosion visible at center connection.

40. No dielectric grease

**Task:** Correction by a licensed electrician

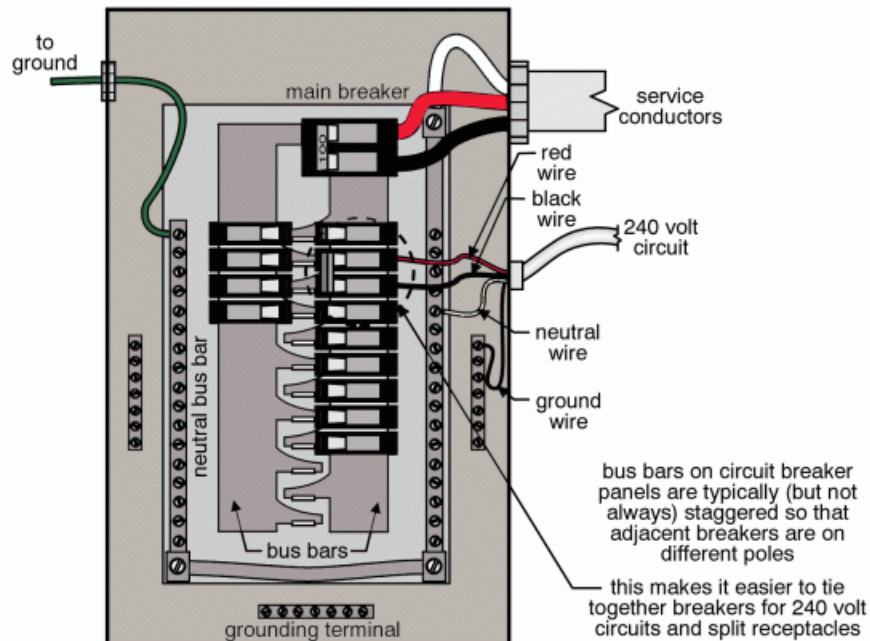
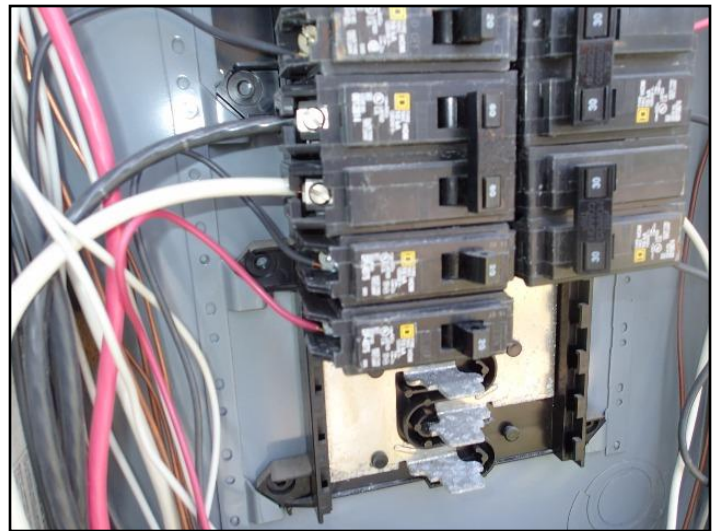
**SERVICE BOX, GROUNDING AND PANEL \ Distribution fuses/breakers****31. Condition:** • [No links for multi-wire circuits](#)

**Implication(s):** Electric shock

41. No links for multi-wire circuits

42. No links for multi-wire circuits

**Task:** Contact a licensed electrician for further evaluation and/or correction

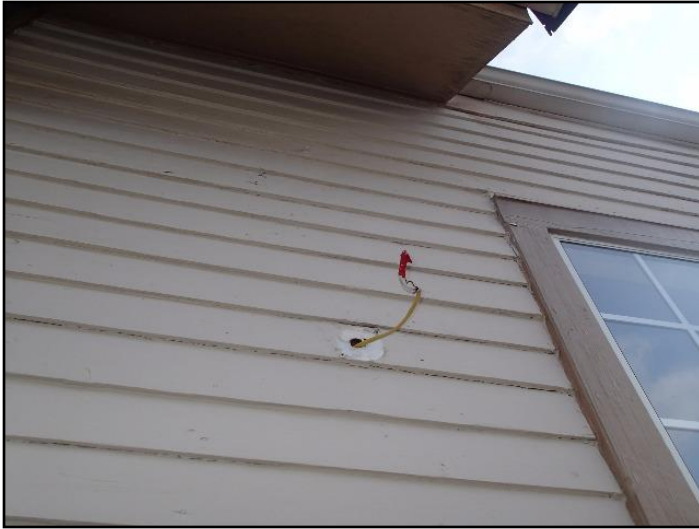
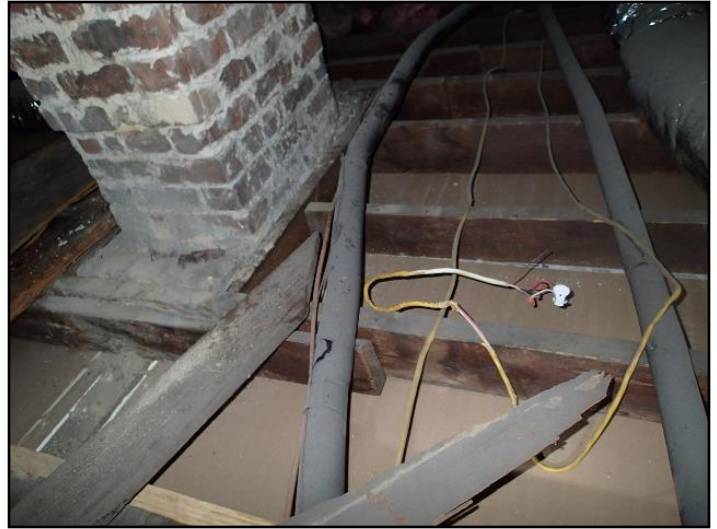
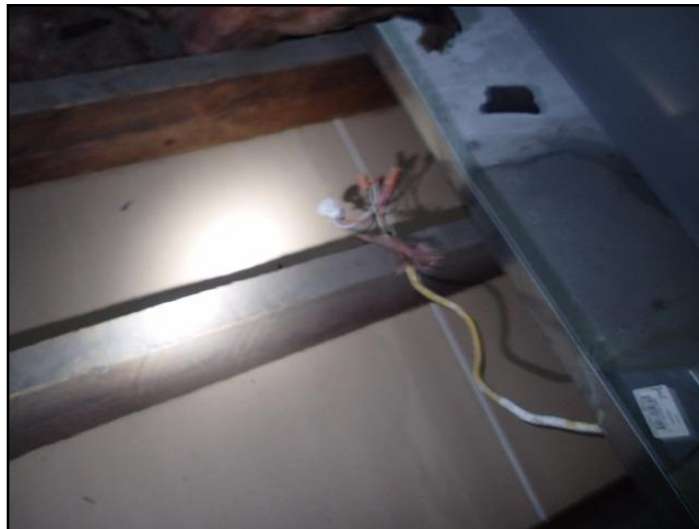
### 32. Condition: • [Missing, loose](#)

**Implication(s):** Electric shock | Fire hazard

43. Missing

44. Missing, loose

45. Missing, loose

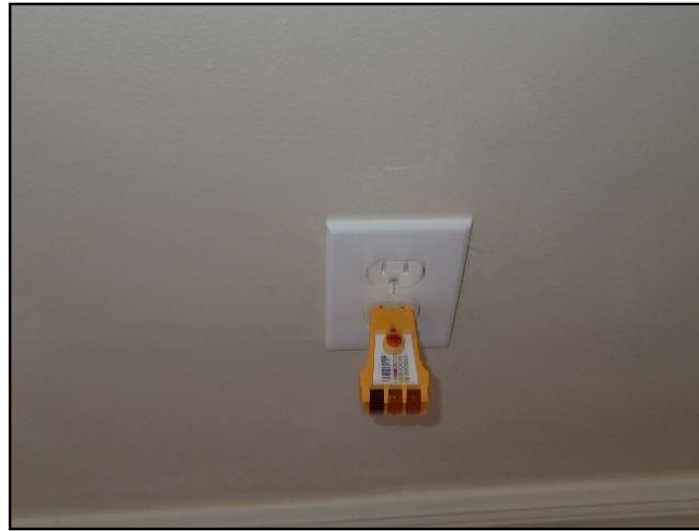
### 33. Condition: • [Inoperative](#)

**Implication(s):** Equipment inoperative

46. Inoperative

**Task:** Contact a licensed electrician for further evaluation and/or correction

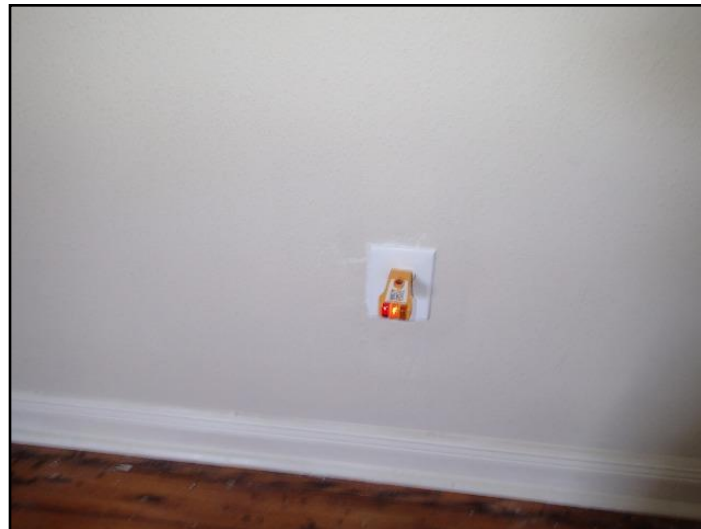
**34. Condition:** • [Reversed polarity](#)

Modern outlets have a large slot (neutral) and small slot (hot). If the wires are connected improperly, this is referred to as reversed polarity. A reversed polarity outlet can compromise the safety of an electric appliance. Some outlets found had open neutral, hot and ground reversed and hot and hot and neutral reversed. A grounded appliance may have its grounding made ineffective by any one of these issues.

47. Reversed polarity

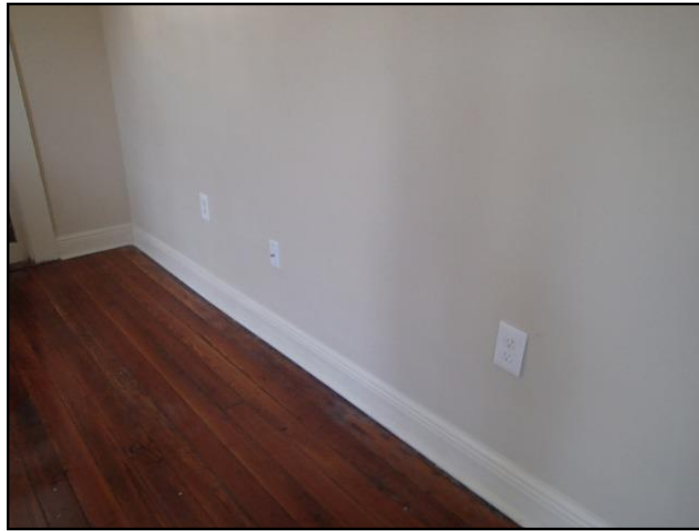
### 35. Condition: • [Loose](#)

Several outlets were loose or poorly secured.

**Implication(s):** Electric shock | Fire hazard

48. Loose

**Task:** Contact a licensed electrician for further evaluation and/or correction

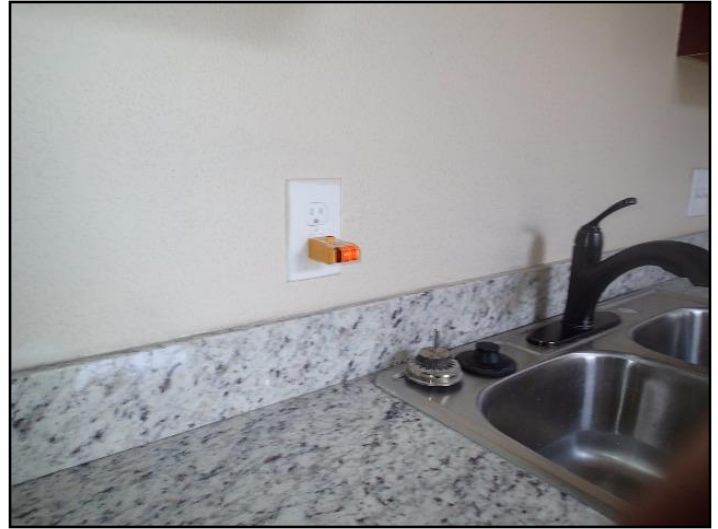
**36. Condition:** • [GFCI/GFI needed \(Ground Fault Circuit Interrupter\)](#)

50. Ground Fault Circuit Interrupter (GFCI)...

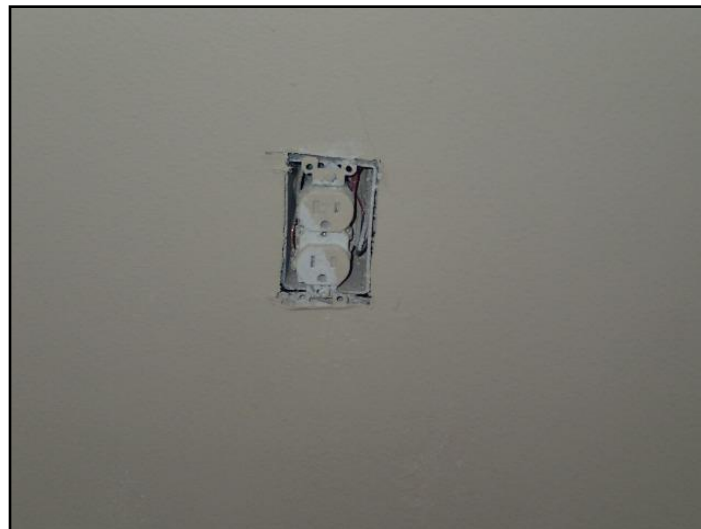
37. Condition: • [Missing](#)

Some cover plates were missing and/or damaged on outlets and/or switches.

51. Missing

**Task:** Replace cover plates where needed.

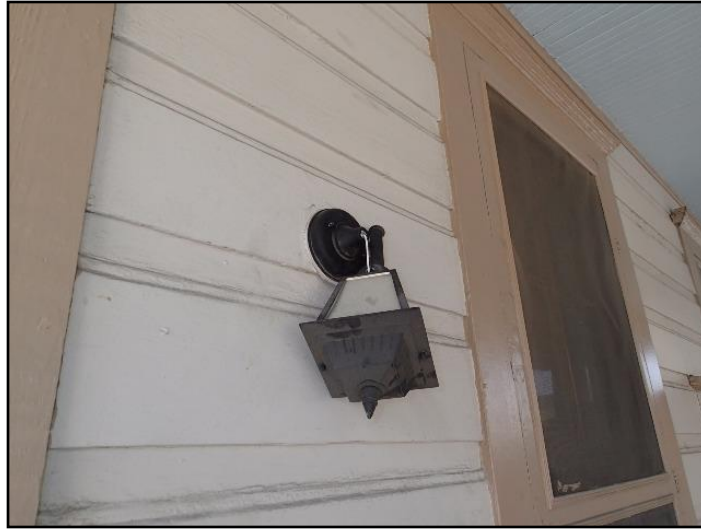
38. Condition: • [Damage](#)

Damaged fixture on exterior wall of left unit.

**Implication(s):** Electric shock | Fire hazard

52. Damage

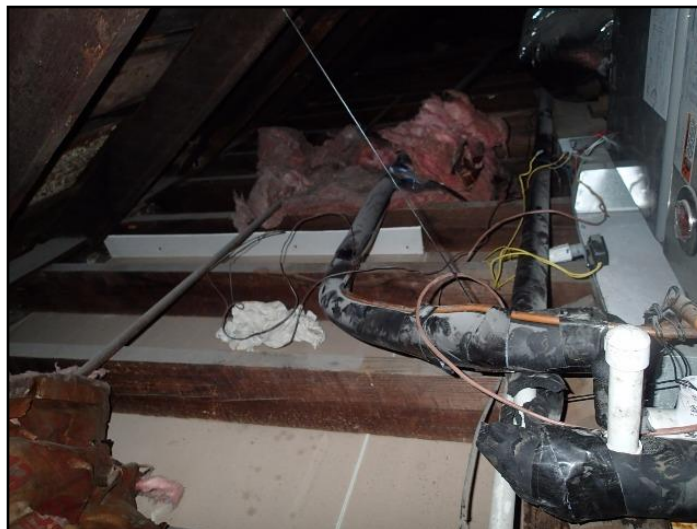
**41. Condition:** • There should be a minimal 30 inch by 30 inch level flooring work space on control side of unit for servicing.

57. No flooring for servicing unit

**Task:** A licensed HVAC technician is recommended for further evaluation and/or correction.

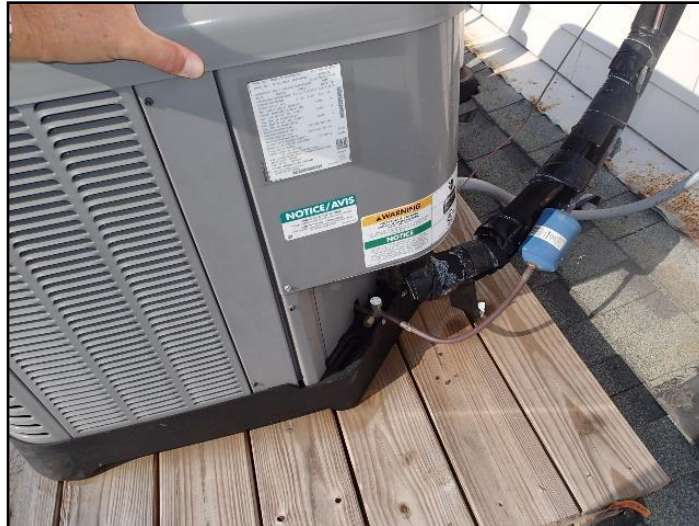
**43. Condition:** • Outdoor compressors were not secured to platform. Units should be secured to prevent walking effect or movement from vibration. Strap units to prevent damage.

61. Net secured to platform

**Task:** A licensed HVAC technician is recommended for further evaluation and/or correction.

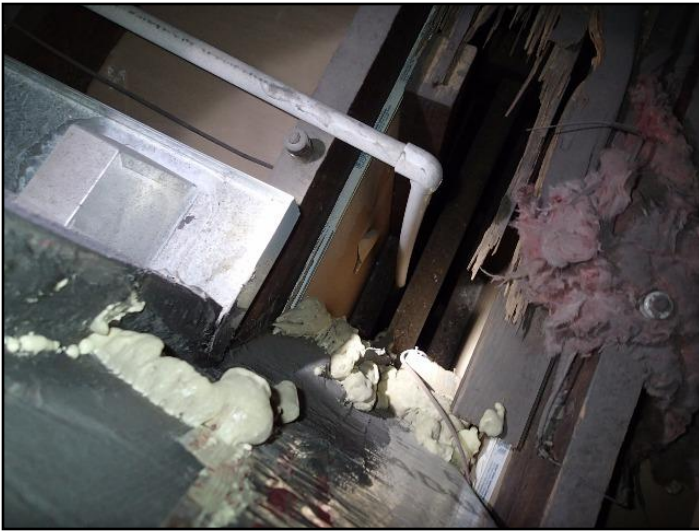
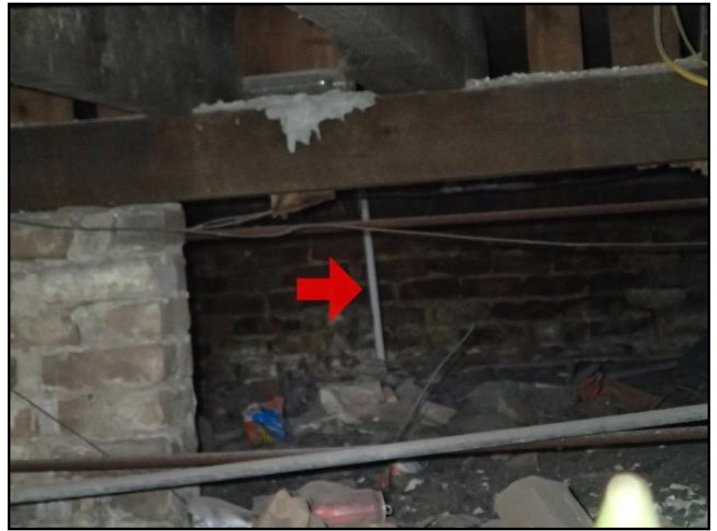
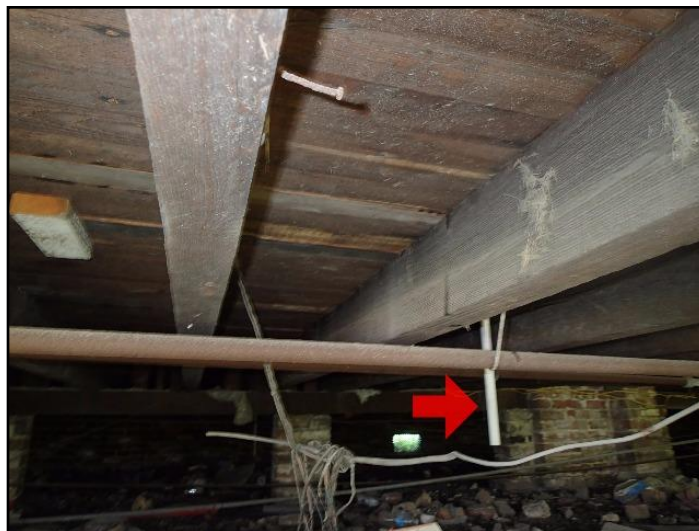
### 46. Condition: • [Improper discharge point](#)

**Implication(s):** Chance of water damage to contents, finishes and/or structure | Damage to equipment | Contaminants may enter building air

63. Improper discharge point

64. Improper discharge point

65. Improper discharge point

**Task:** A licensed HVAC technician is recommended for further evaluation and/or correction.

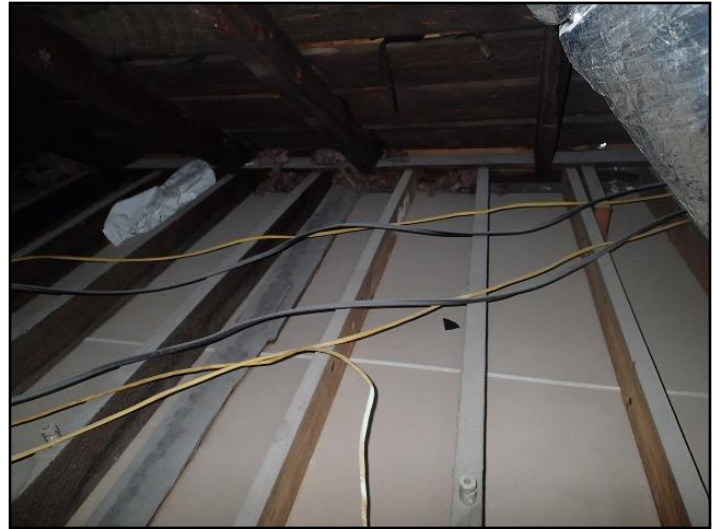
**48. Condition:** • [Amount less than current standards](#)

Isolated piles of insulation were noted in attic. Most areas were not insulated. Increasing attic insulation up to a recommended amount of R-30 would increase comfort and reduce utility bills.

68. Amount less than current standards

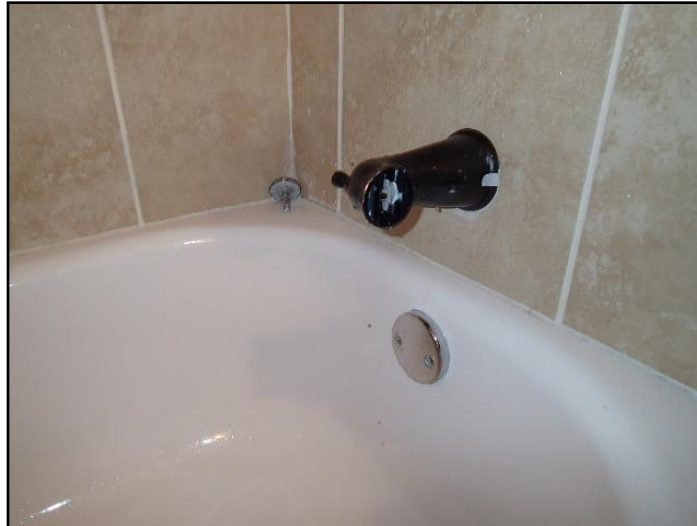
### **52. Condition:** • [Poor support](#)

**Implication(s):** Chance of water damage to contents, finishes and/or structure | Leakage

73. Poor support

**Task:** A licensed plumber is recommended for further evaluation and/or correction.

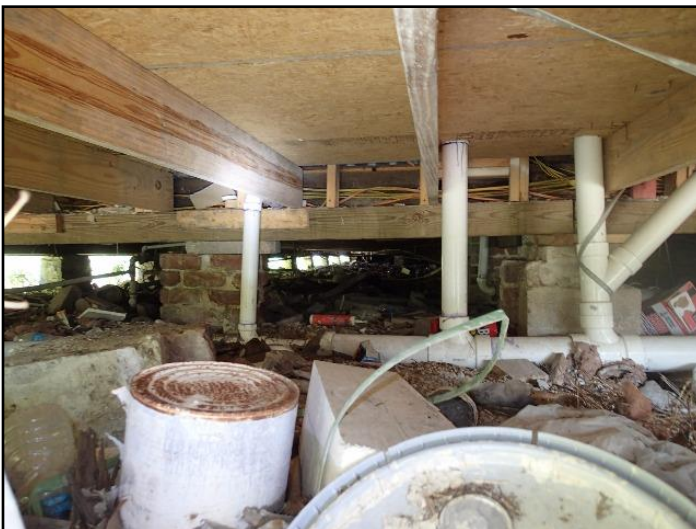
### **53. Condition:** • [Poor support](#)

No supports noted on waste lines in crawl space. Waste lines laying on ground. Primer was not visible on all connections.

74. Poor support

**Task:** A licensed plumber is recommended for further evaluation and/or correction.

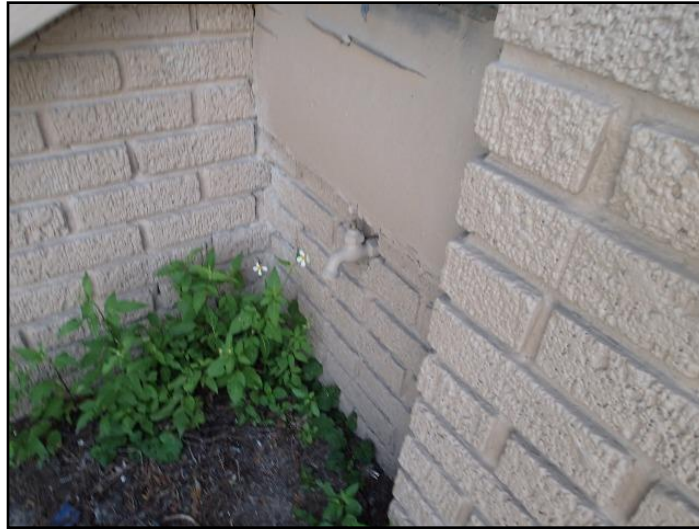
54. Condition: • [Damage](#)

**Implication(s):** Leakage | Equipment inoperative

76. Missing handle

**Task:** A licensed plumber is recommended for further evaluation and/or correction.

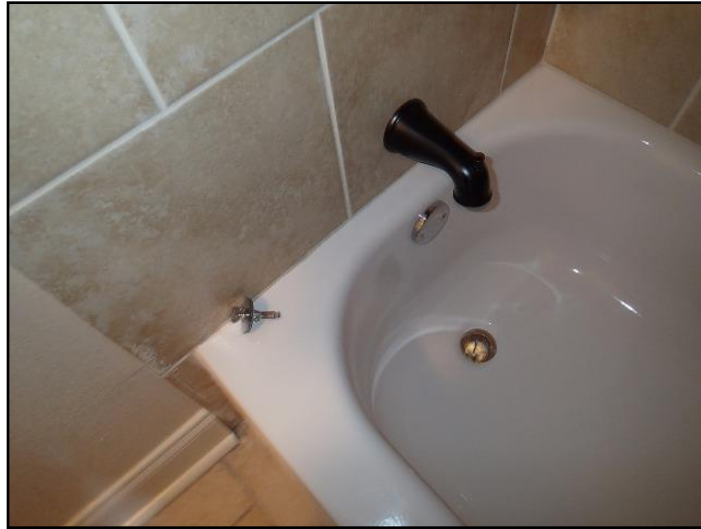
56. Condition: • Drain stop missing

**78.** *Drain stop missing*

**Task:** A licensed plumber is recommended for further evaluation and/or correction.

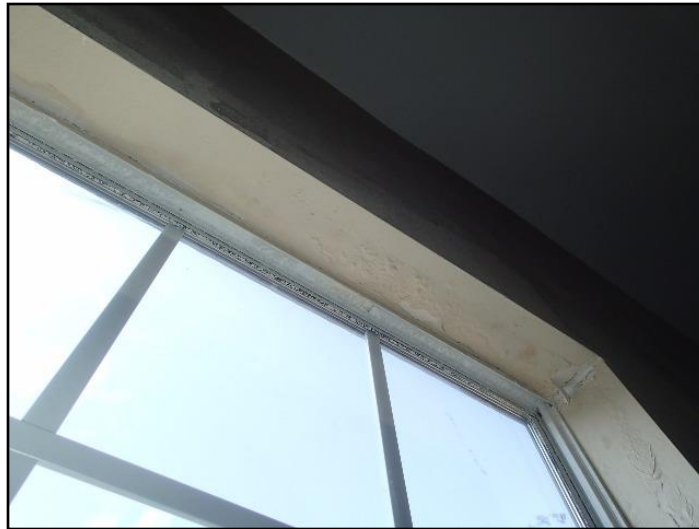
#### **57. Condition:** • [Water damage](#)

**Implication(s):** Chance of water damage to contents, finishes and/or structure

79. Water damage

**Task:** Further evaluation and correction.

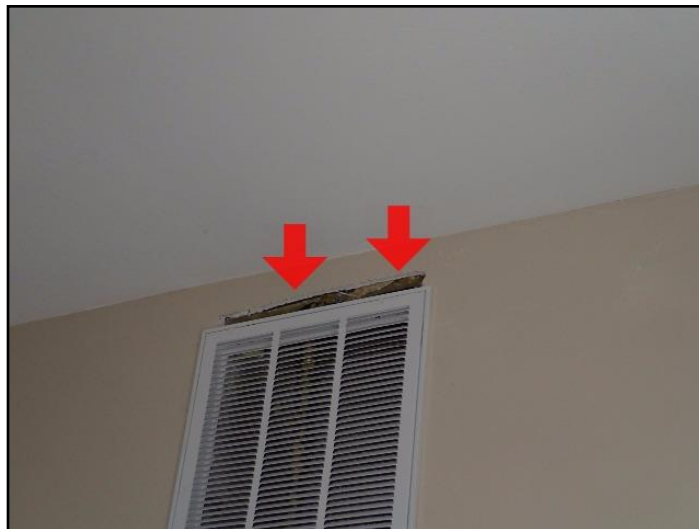
#### **58. Condition:** • [Poor joints](#)

**Implication(s):** Damage or physical injury due to falling materials

80. Poor joints

**Task:** Repair hole/opening.
