# INSPECTION REPORT

For the Property at:  
**1800 YOUR STREET**  
NEW ORLEANS, LA 70119

Prepared for: YOUR HOUSE  
Inspection Date: Tuesday, September 27, 2016  
Prepared by: Turk Schexnayder LHI Lic.10679

RE: Report No. 1575, v.3  
1800 Your Street  
New Orleans, LA  
70119

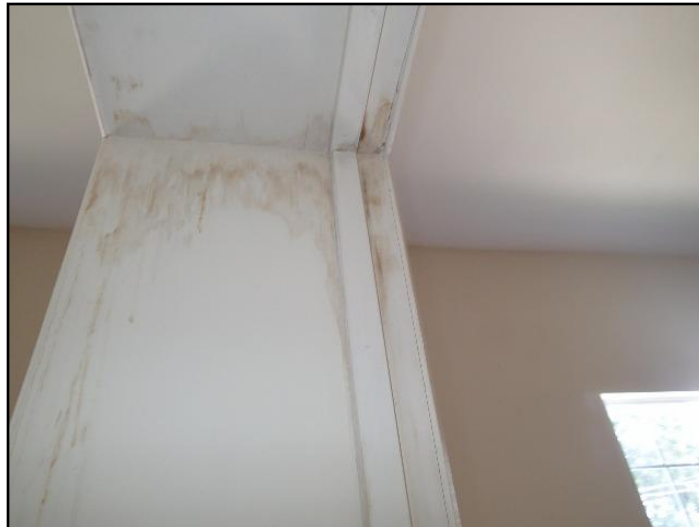
**61. Condition:** • Possible water stains on door frame below return air vent.

83. Stains

**Task:** Further evaluation to determine cause of water stains.

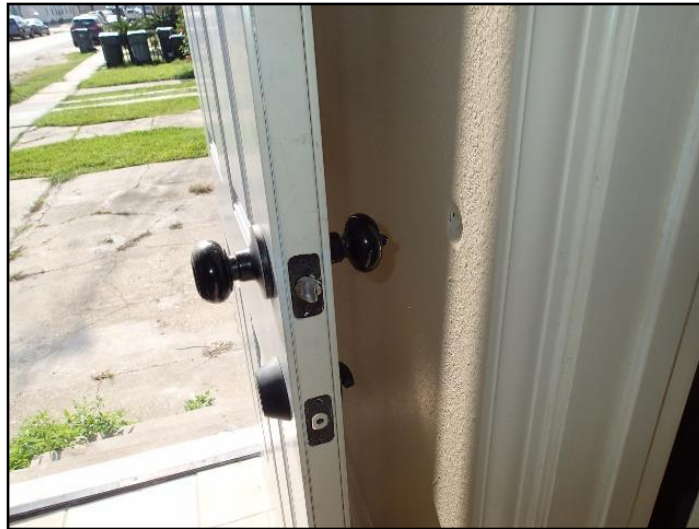
84. Door stop missing.

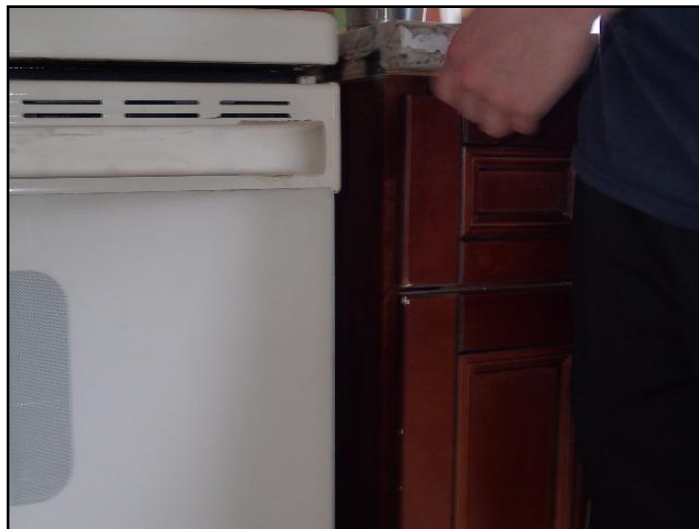
**Implication(s):** Damage to equipment | Damage or physical injury due to falling materials

85. Not well secured to wall

**Task:** Secure cabinet.

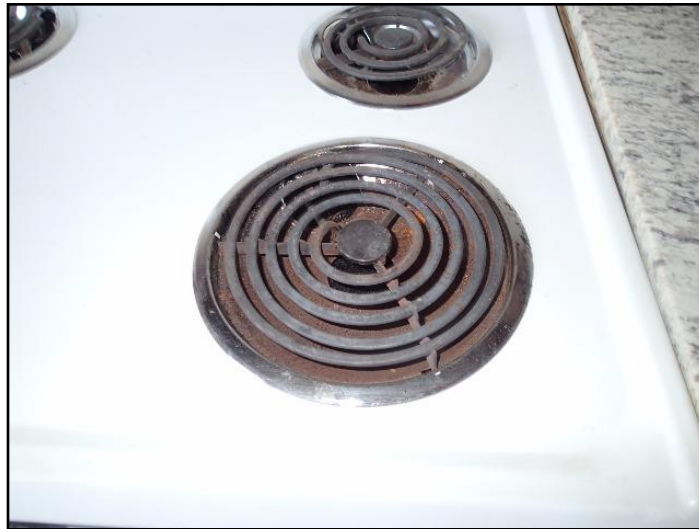
Right side unit - Front right burner did not function when tested.

**Implication(s):** System inoperative

**86.** *Burner inoperative*

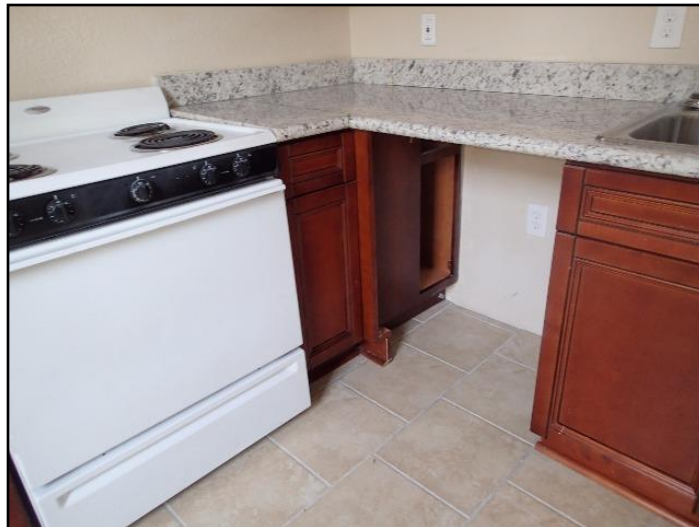
**66. Condition:** • No dishwasher installed on right side.

**87.** *Missing*

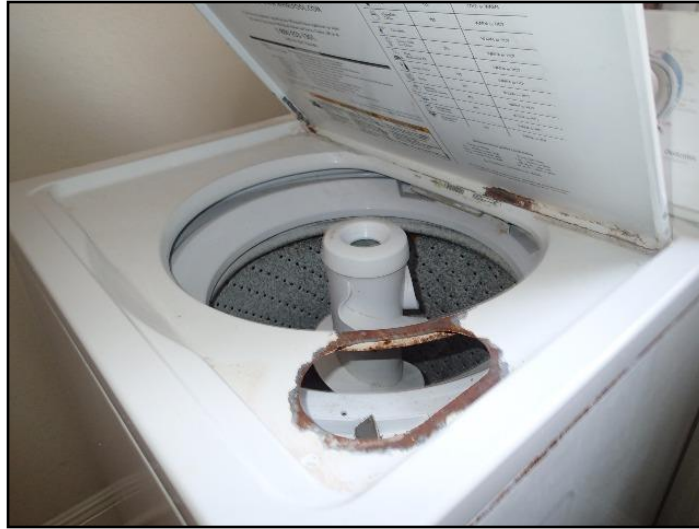
90. Rust/opening

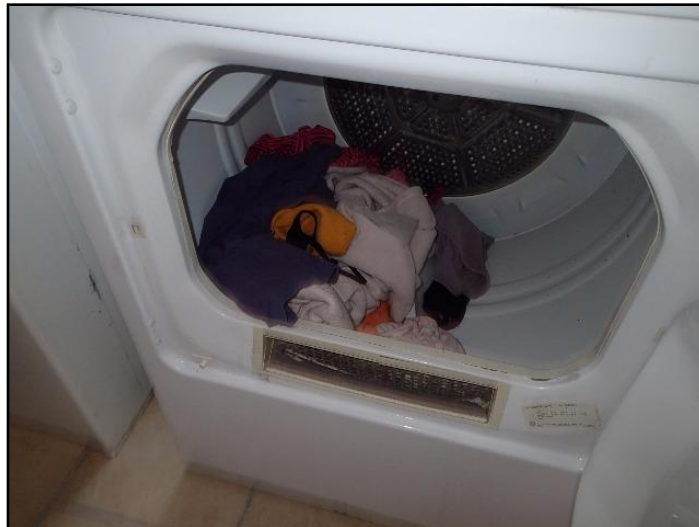
70. Condition: • Clothes left in dryer.

91. Clothes in dryer.
