# YOUR INSPECTION REPORT

44 Old Mill Terrace  
Toronto, ON M8X 1A1

Thursday, September 5, 2019

RE: Report No. 2530  
44 Old Mill Terrace  
Toronto, ON  
M8X 1A1

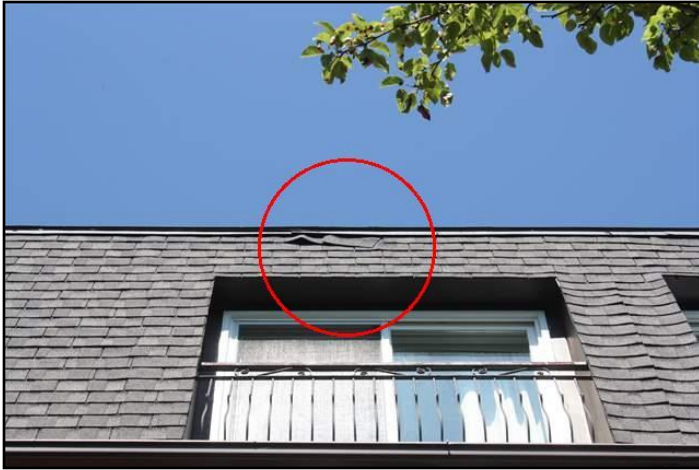
1. Loose, missing or torn tabs

**Condition:** • [Loose, missing or torn tabs](#)

**Implication(s):** Chance of water damage to contents, finishes and/or structure

**Location:** Rear Exterior

**Task:** Repair

**Time:** As Soon As Possible

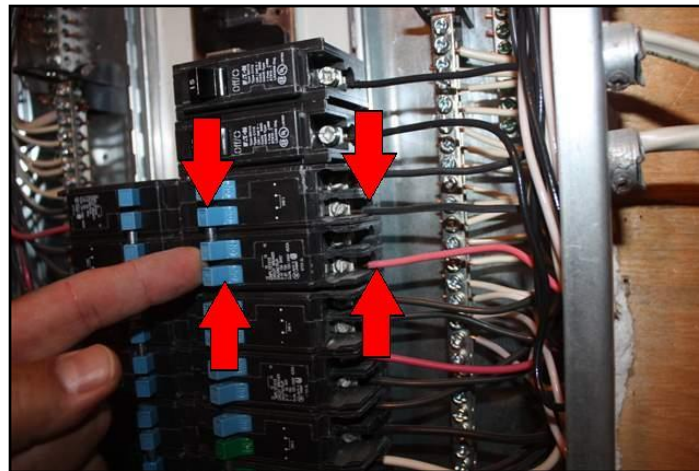
4. No links for multi-wire circuit

**Condition:** • [No links for multi-wire circuits](#)

The link is on the wrong breaker

**Implication(s):** Electric shock

**Location:** Garage Panel

**Task:** Correct

**Time:** As Soon As Possible

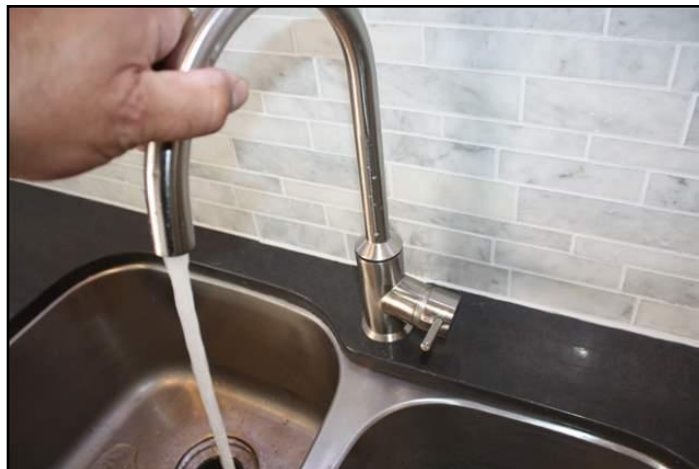
5. Loose

Condition: • [Loose](#)

Implication(s): Equipment failure

Location: Kitchen

Task: Adjust

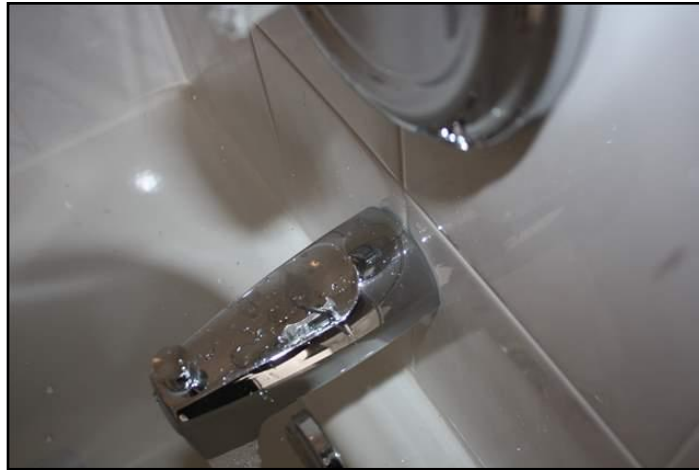
6. Caulking loose, missing or deteriorated

Condition: • [Caulking loose, missing or deteriorated](#)

Implication(s): Chance of water damage to contents, finishes and/or structure

**Location:** Bathroom

**Task:** Improve

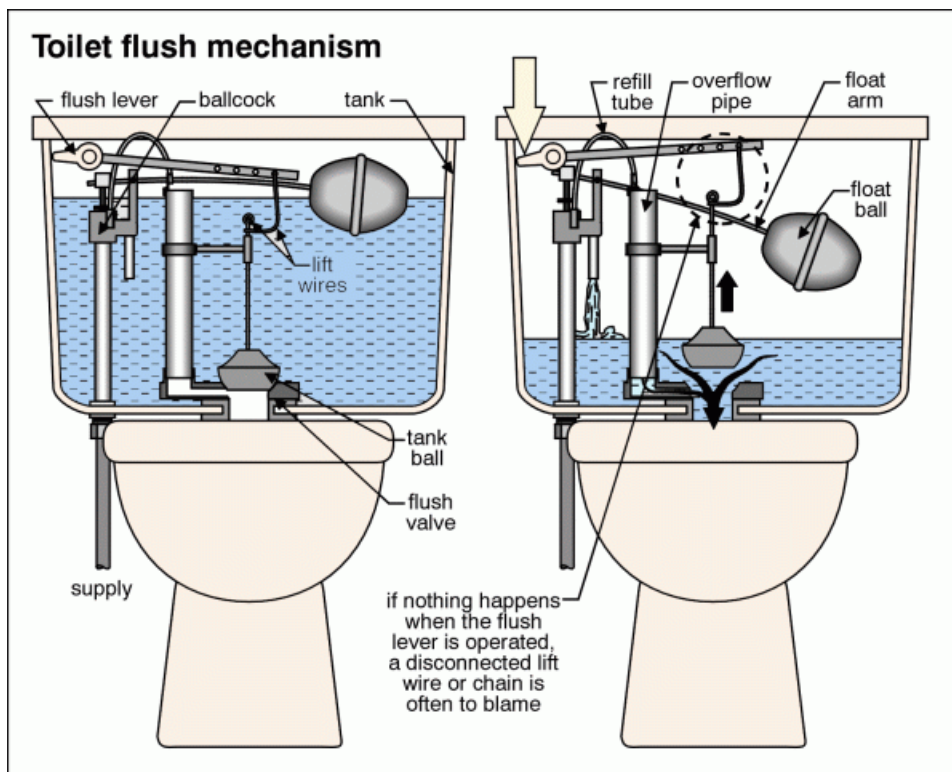
**Condition:** • [Running continuously](#)

**Implication(s):** Increased water consumption | Chance of condensation damage to finishes and/or structure

**Location:** Bathroom (with jacuzzi)

**Task:** Repair

**Time:** As Soon As Possible

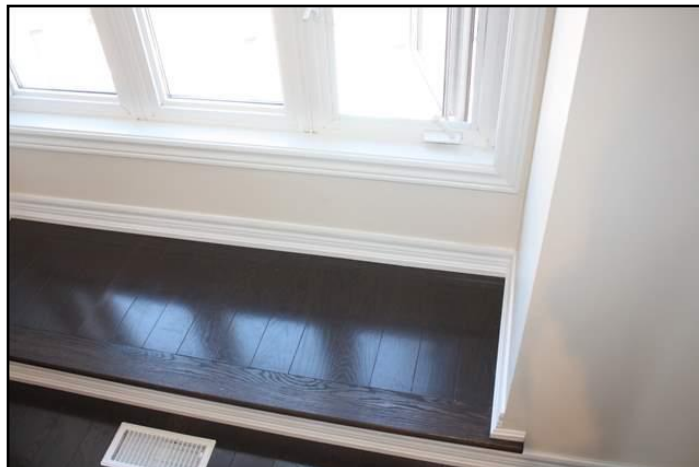
7.

**Condition:** • Installing a Window Stop is recommended due to the height of the third storey and low window frame.

This is a Fall/Life Safety Hazard for children.

**Implication(s):** Life safety

**Location:** Front Third Floor Bedroom

Window stop should prevent window from opening more than 4 -inches.

**Task:** Provide window stop

**Time:** As Soon As Possible

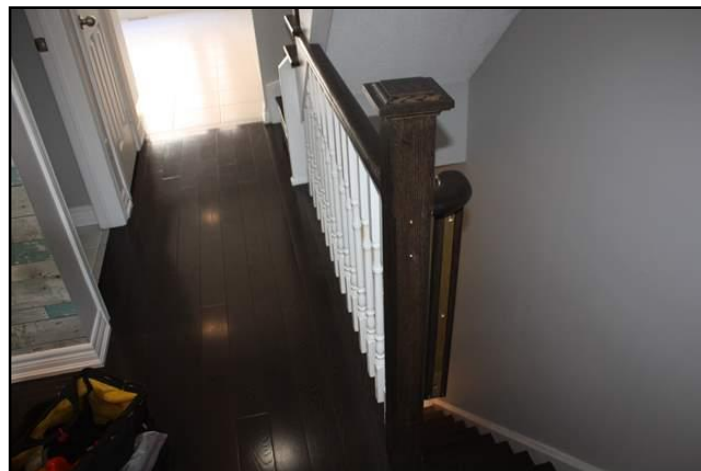
8. Loose

**Condition:** • [Loose](#)

**Implication(s):** Fall hazard

**Location:** First Floor Staircase

**Task:** Improve
