YOUR Inspection Report

123 West Main St
Louisville, KY 40204

Gary Witt

RE: Report No. 1249
123 West Main St
Louisville, KY
40204

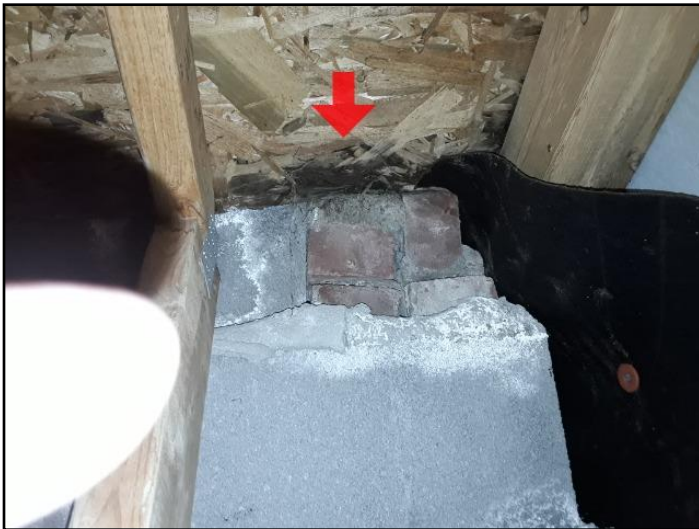
Evidence of past leak noted on the high side of the chimney over the garage space. It appears the roof may trap water during a rain event. The leak has also damaged the garage ceiling.

Implication(s): Chance of water damage to contents, finishes and/or structure

Signs of past leak (viewed from attic)

Task: Further evaluation by a qualified roofer recommended, preform recommended repairs

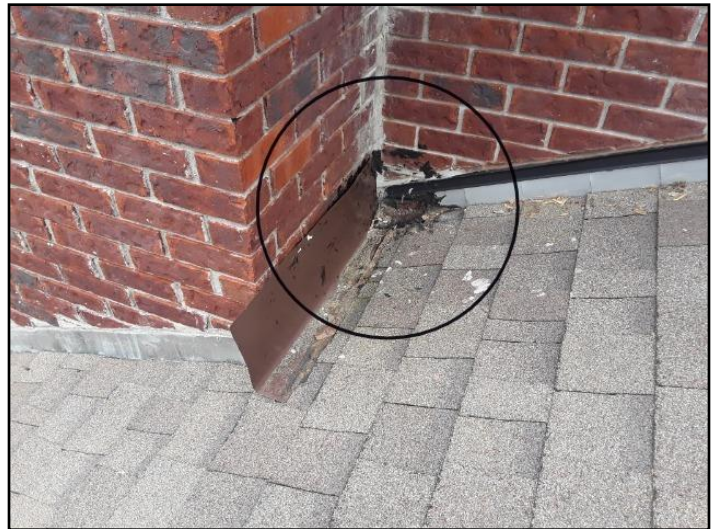
Evidence of trapped water

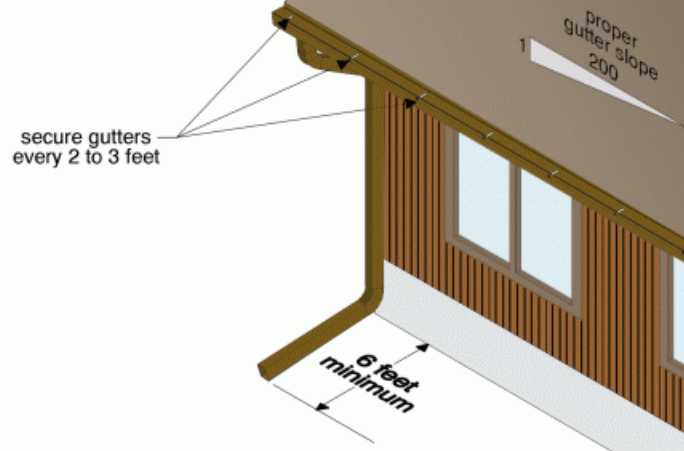
Downspout extension too short

Recommend downspout discharge be direct via drain pipe to a point past the end of the retaining walls. Swales may also be created to direct drainage away from foundation and towards creek on side of house.

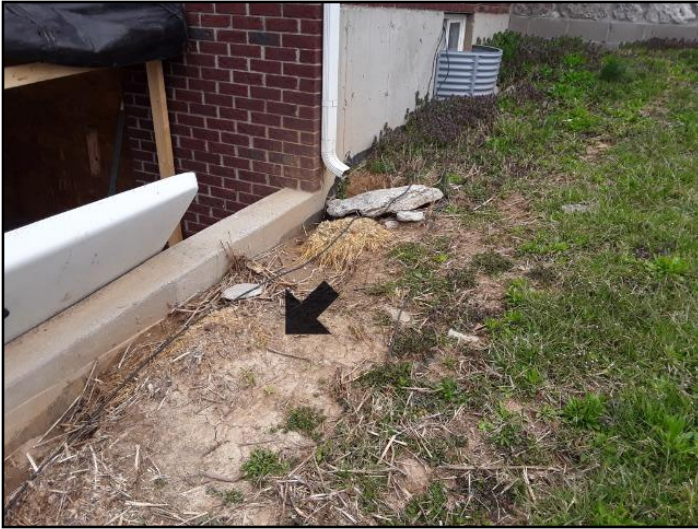
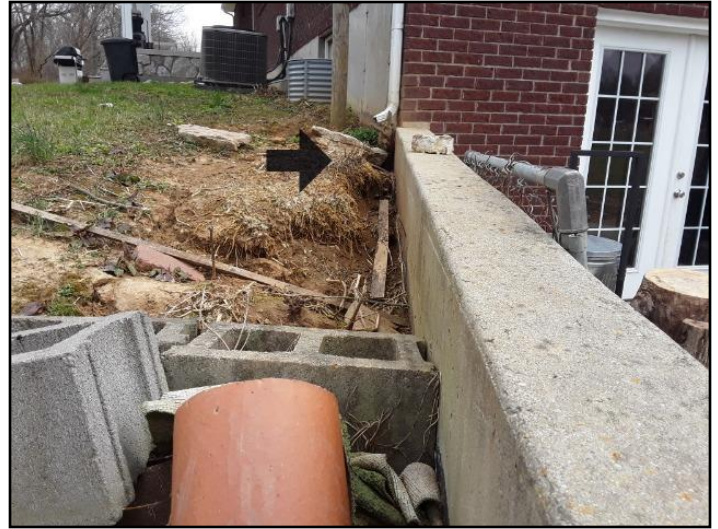
2. Condition: • Discharge too close to building

Discharge too close to building

Task: Further evaluated by a qualified contractor recommended

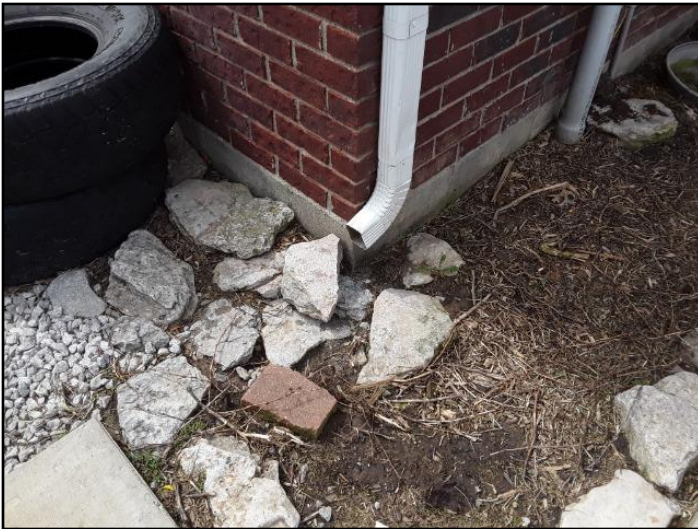
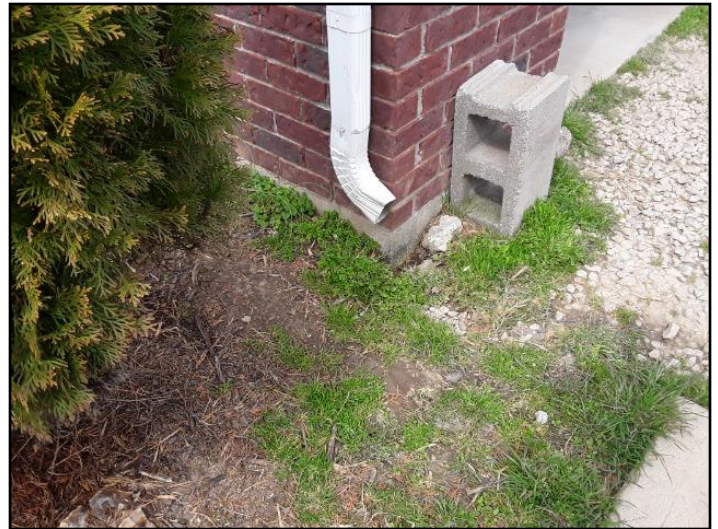
3. Condition: • Missing splash block

Missing splash block

Task: Furnish and install splash blocks

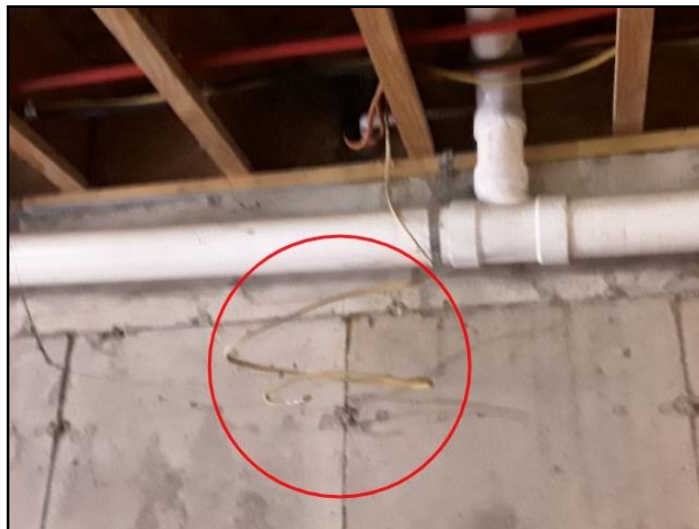
4. Condition: • [Open splices](#)

Implication(s): Electric shock | Fire hazard

Exposed "Hot" wires

All electrical splices should be protected inside a secured electrical junction box

Task: Have evaluated by a qualified contractor

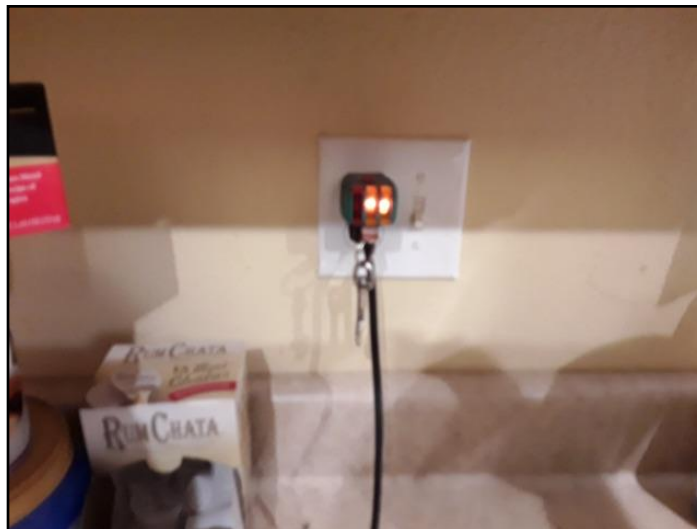
Outlet on the left side of the kitchen sink was not the GFCI type.

Implication(s): Electric shock

GFCI Outlet recommended

Task: Furnish and install GFCI type outlets in the location recommended

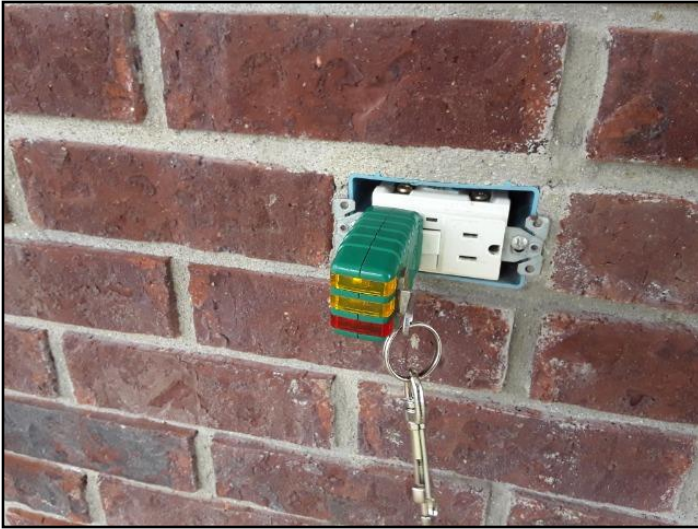
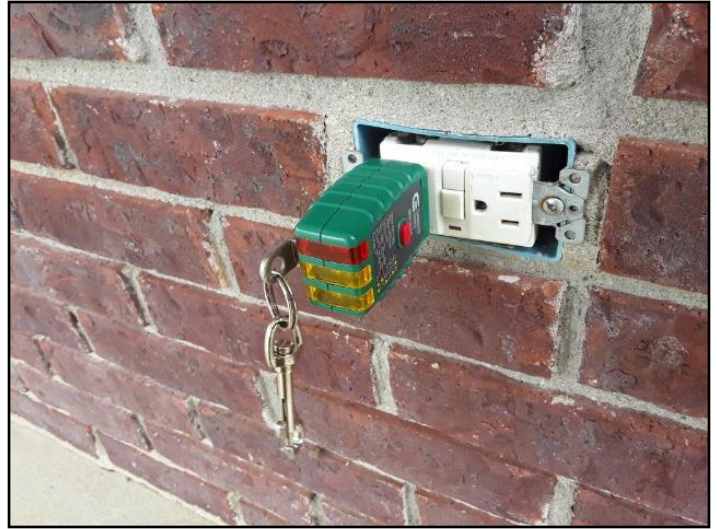
Three GFCI outlets on the front (2) and rear (1) porches did not work.

Inoperative - Front porch

Task: Have evaluated by an electrical contractor

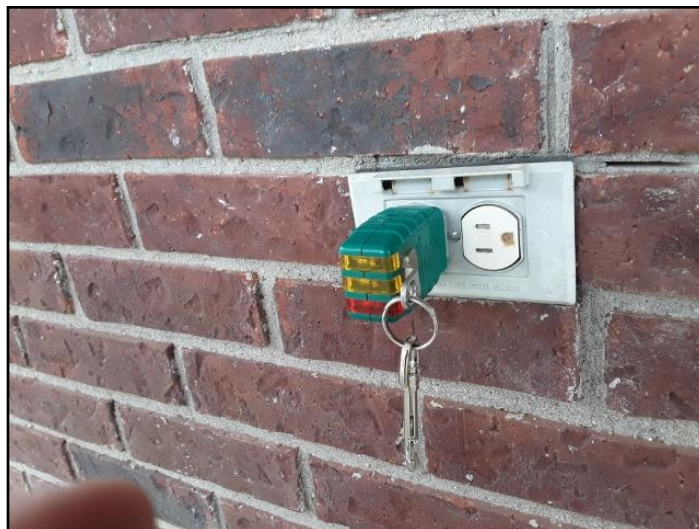
Inoperative - Rear porch

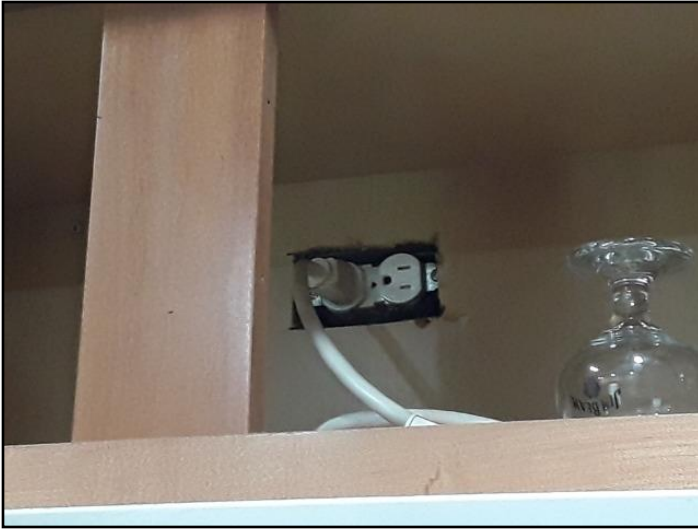
Multiple wall switch, outlets and electrical junction boxes did not have covers on them. (not all missing covers shown)

Missing cover - Microwave

Task: Furnish and install missing items

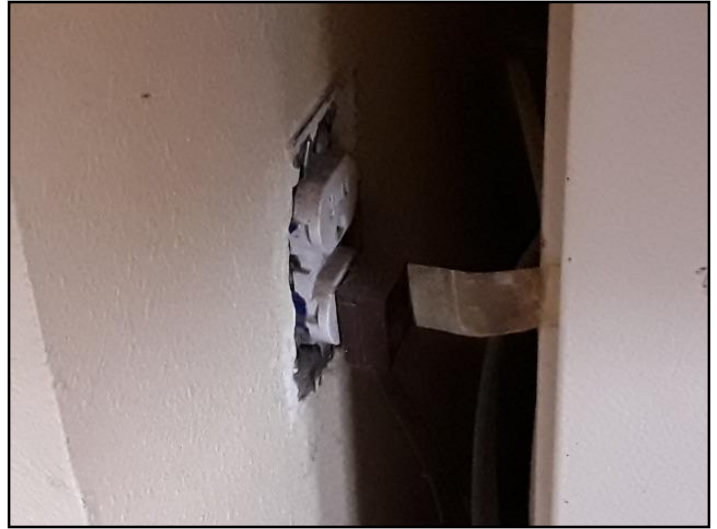
Missing cover - Refrigerator

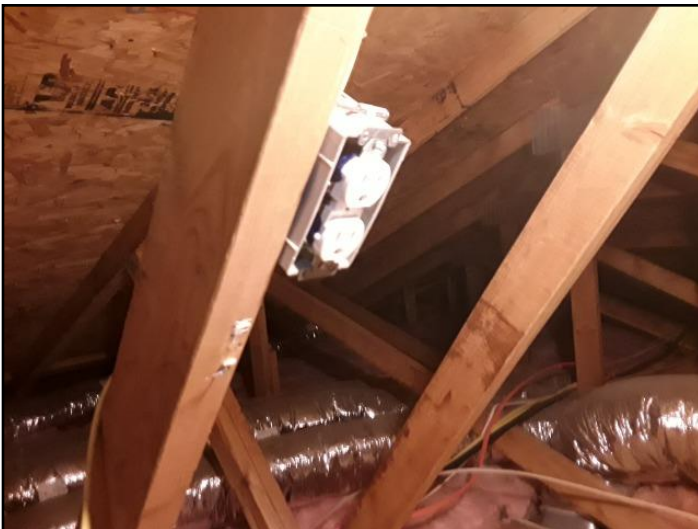
Missing cover - Attic

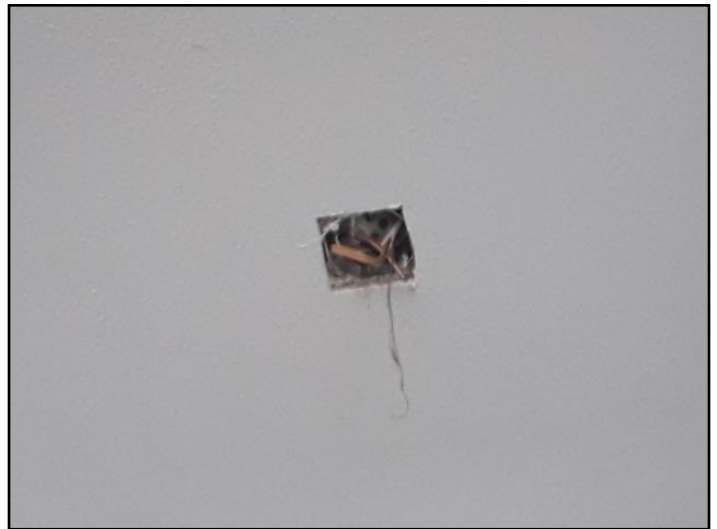
Missing cover - Garage ceiling

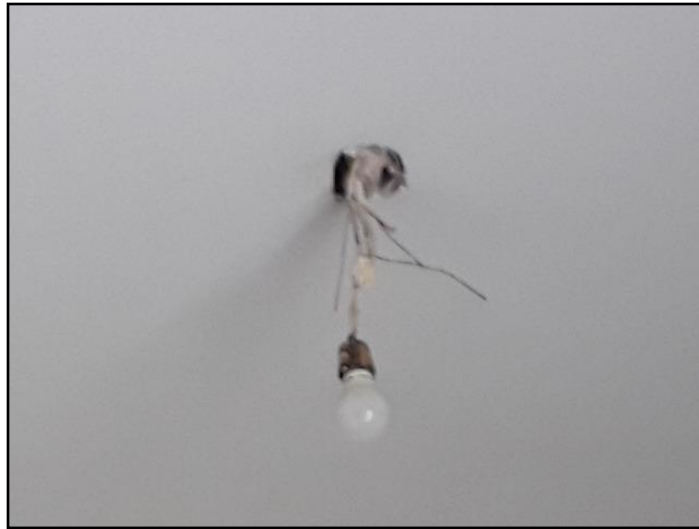
8. Condition: • [Damage](#)

Implication(s): Electric shock | Fire hazard

Damage light fixture

Task: Repair or replace as needed

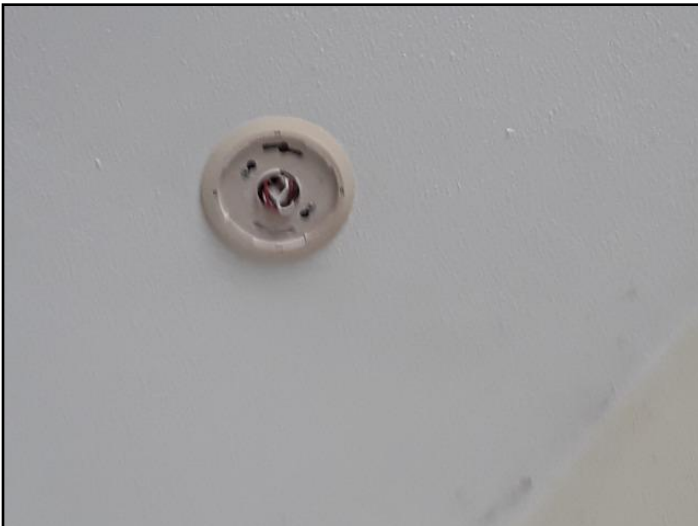
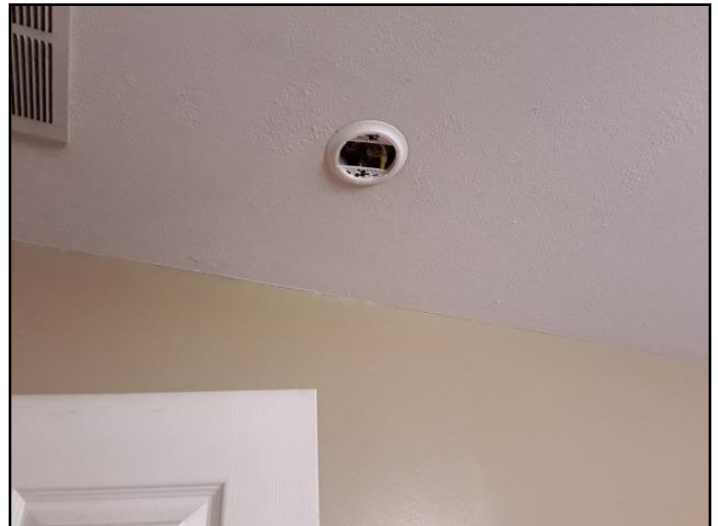
Damaged or removed smoke detectors noted. Current standards require smoke detector in each bedroom, one in each hallway outside the bedrooms, and in the garage. A minimum of one is required on each level including basements and habitable attics. Smoke detectors are not required in kitchens. This house did not appear to have all the recommended smoke detectors.

Damaged smoke detectors - Garage

Damaged smoke detectors - Bedroom

Task: Furnish and install smoke detectors as needed

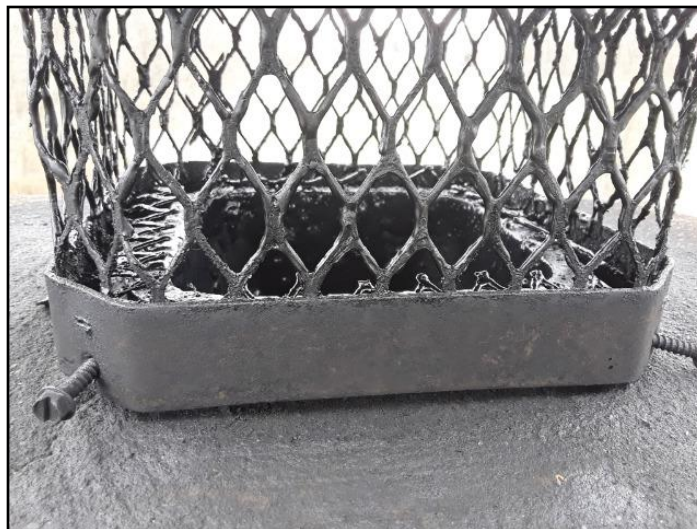
Heavy creosote build-up noted on the chimney flue connected to the basement wood stove (front flue in chimney)

Implication(s): Increased fire hazard

Creosote build-up (front flue)

Task: Further evaluation by a qualified chimney sweep recommended

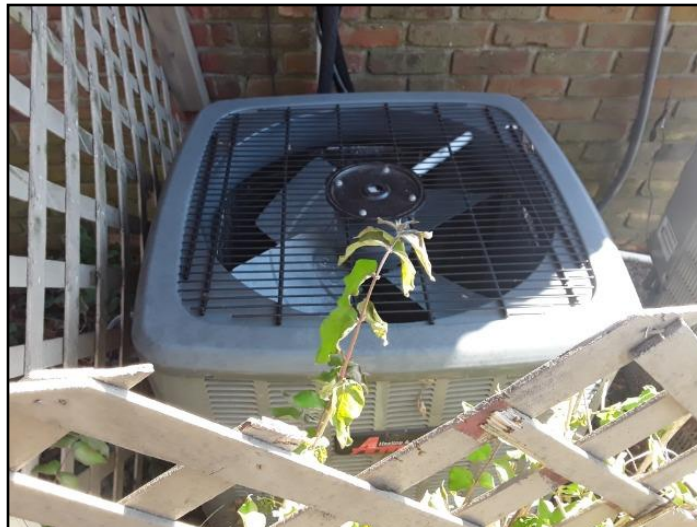
11. Condition: • Air flow around A/C was restricted

Air flow around A/C was restricted

Task: Trim back shrubs & remove wood lath to a point 2 feet around A/C unit

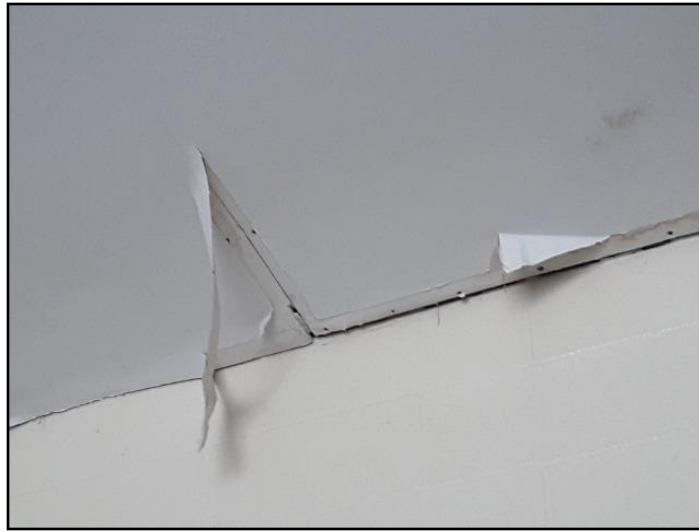
Roof leak (see Roofing Recommendations section) has caused ceiling drywall damage. Once the roof is fixed, recommend fixing the drywall.

Ceiling drywall damage

Task: Further evaluated by a qualified contractor recommended

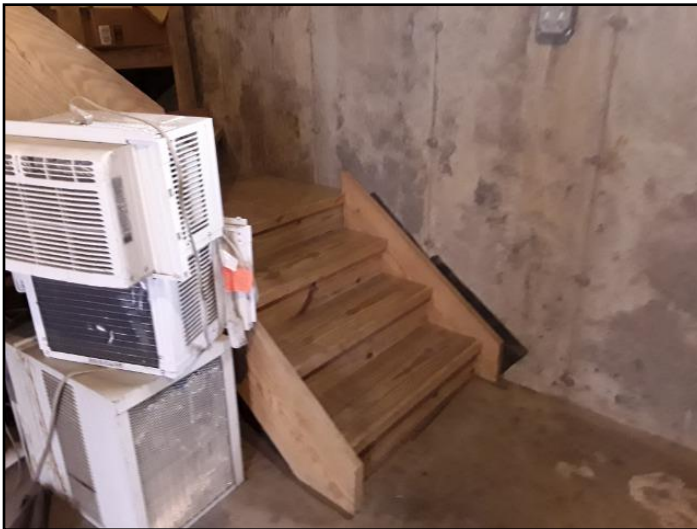
Missing or sub-standard handrails on steps leading to the basement

Implication(s): Fall hazard

Missing handrails

Task: Recommend installing handrails on stairs (both sides)

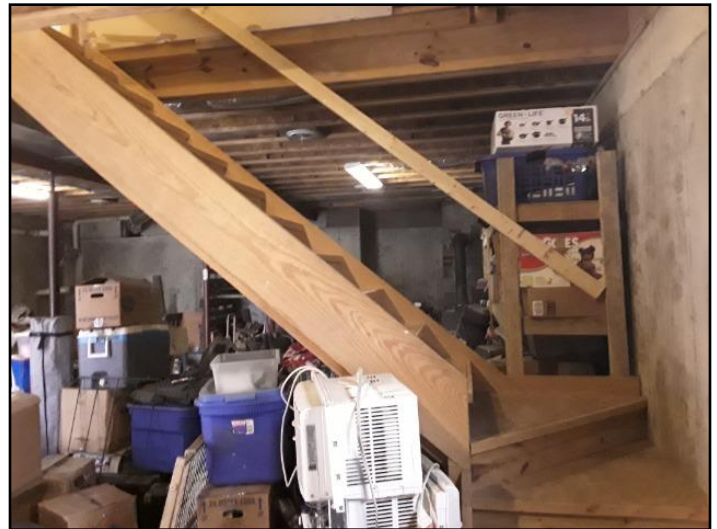
Sub-standard handrails

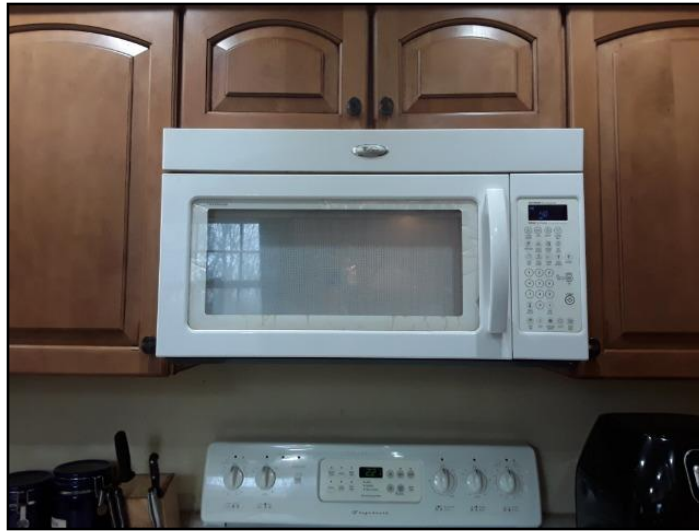
14. Condition: • Inoperative

Inoperative

Task: Repair or replace as needed

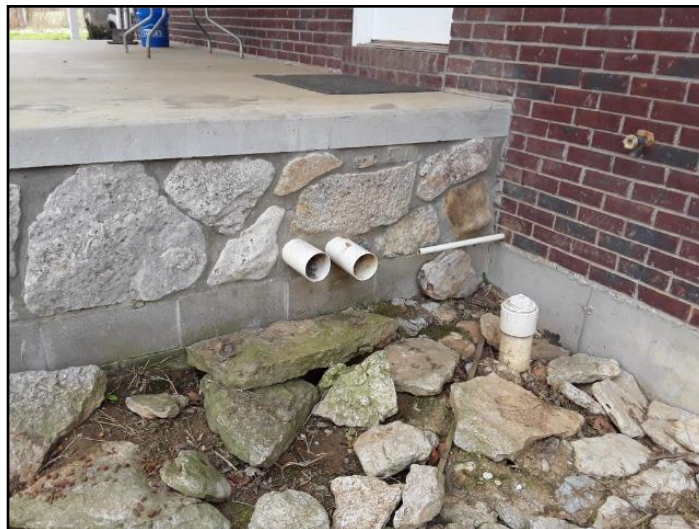
15. Condition: • No vent cap

Implication(s): Weather and vermin may enter house

Missing vent caps (2)

Task: Furnish and install missing items
