YOUR INSPECTION REPORT

47 Laws Street
Toronto, ON M6P 2Y8

INSPECTION DATE:
Tuesday, April 23, 2019

RE: Report No. 2438
47 Laws Street
Toronto, ON
M6P 2Y8

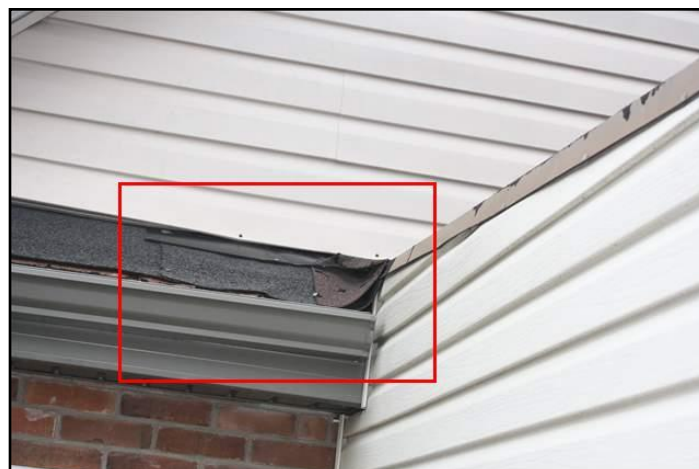
1. Vulnerable areas

Condition: • [Vulnerable areas](#)

Implication(s): Chance of water damage to contents, finishes and/or structure

Location: Rear Exterior Roof

Task: Improve

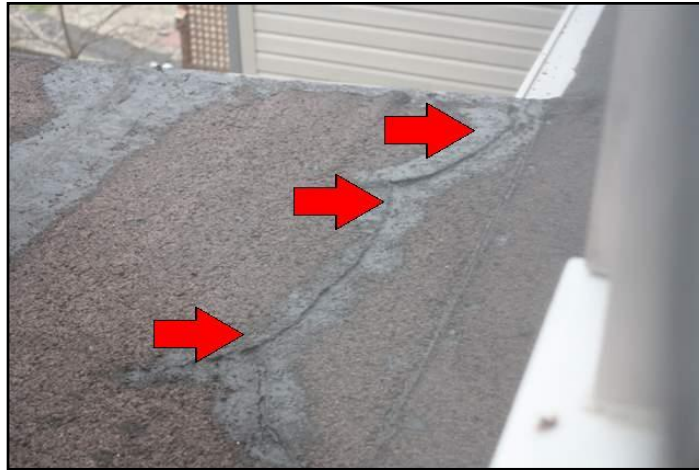
2. Damage, punctures, tears

Condition: • [Damage, punctures, tears](#)

Previous repair noted. Maintain annually

Implication(s): Chance of water damage to contents, finishes and/or structure

Location: Rear Exterior Flat Roof

Task: Service / Repair

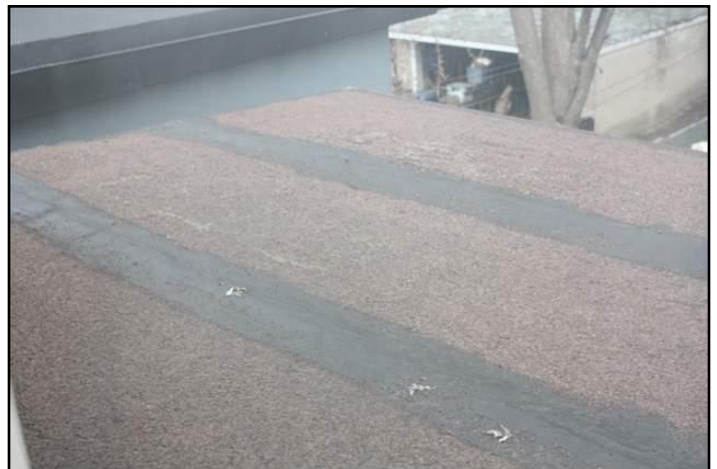
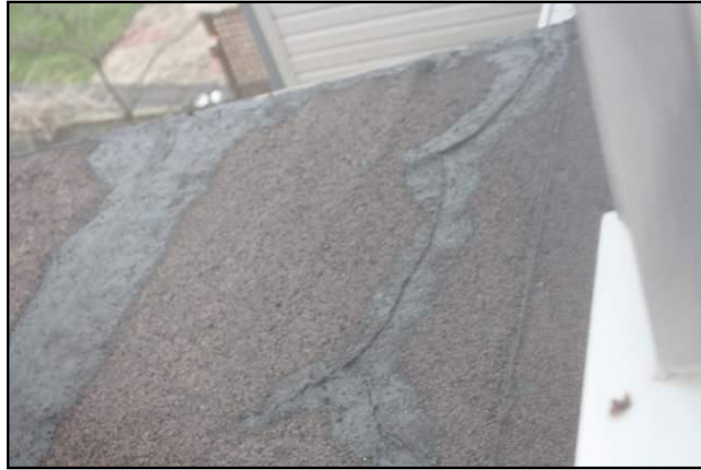
Condition: • [Loss of granules](#)

Granule loss is a normal occurrence as roof covering ages. The flat roof is reported by homeowner to be approximately 8 years old. The granule loss appears to be more than average for the age of the roof. These types of roof covering have a lifespan of 20-30 years but early failure is common.

Implication(s): Chance of water damage to contents, finishes and/or structure

Location: Rear Exterior Roof

Task: Inspect annually and repair

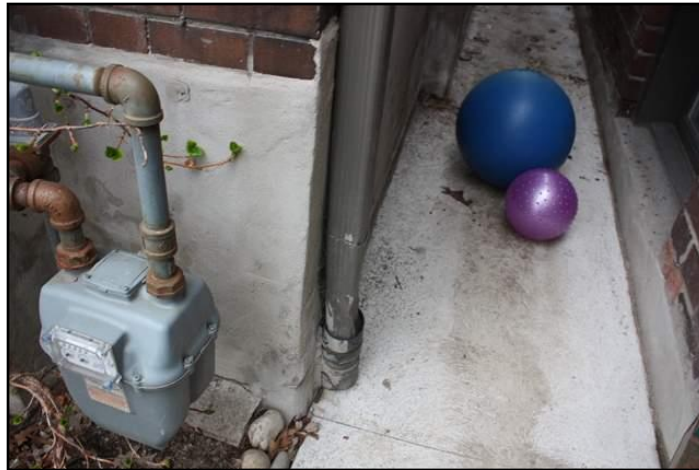
6. Discharge below grade

Condition: • [Discharge below grade](#)

Implication(s): Chance of water damage to contents, finishes and/or structure

Location: Right Exterior

Task: Monitor / Improve

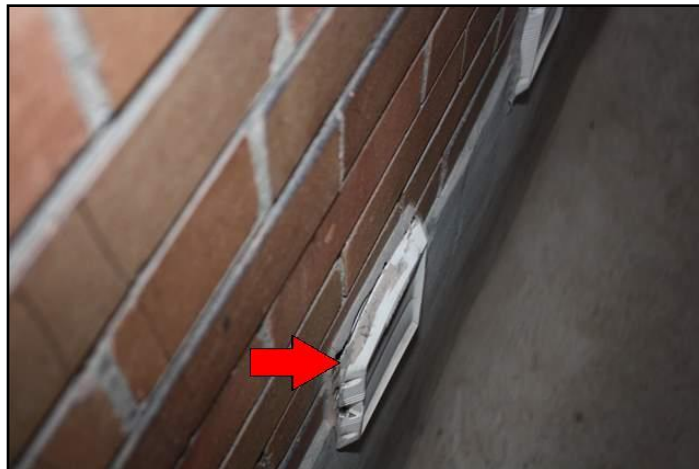
7. Caulking missing or ineffective

Condition: • [Caulking missing or ineffective](#)

Implication(s): Chance of water damage to contents, finishes and/or structure

Location: Left Side Exterior Wall

Task: Improve

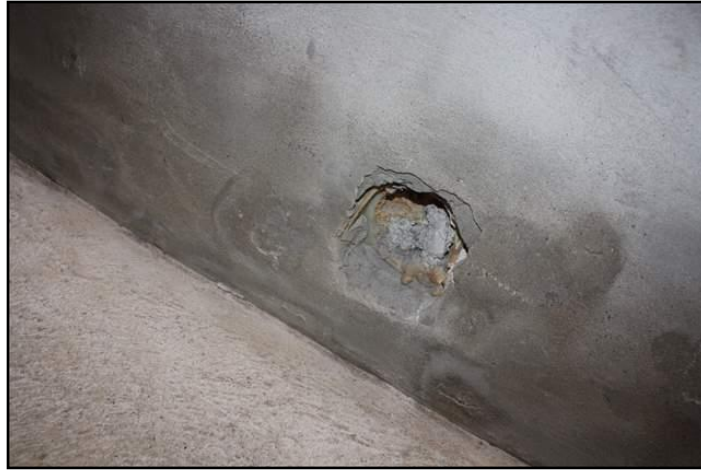
8. Gap at Wall

Condition: • Gap at Wall

Location: Left Exterior Wall

Task: Patch

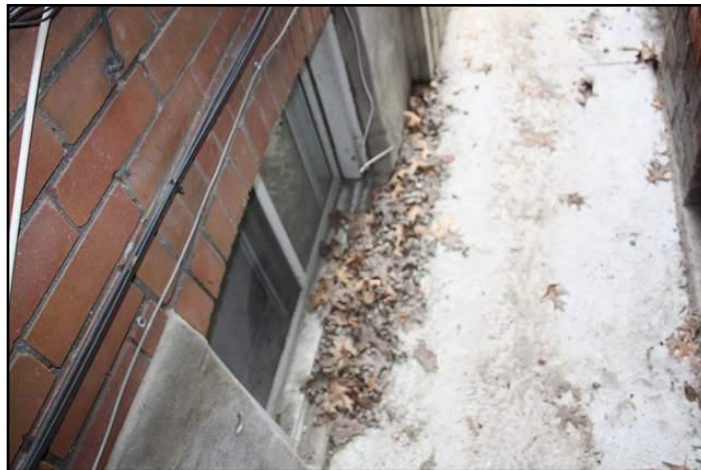
9. Sill - Near or at Grade Level

Condition: • Sill - Near or at Grade Level

Location: Right Side Exterior

Task: Monitor / Improve

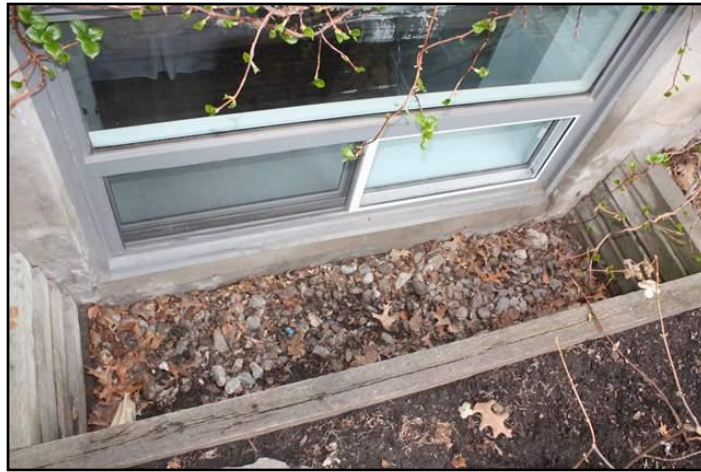
10.

Condition: • Ensure drain is present and not obstructed / clogged

Location: Front Exterior

Task: Further evaluation

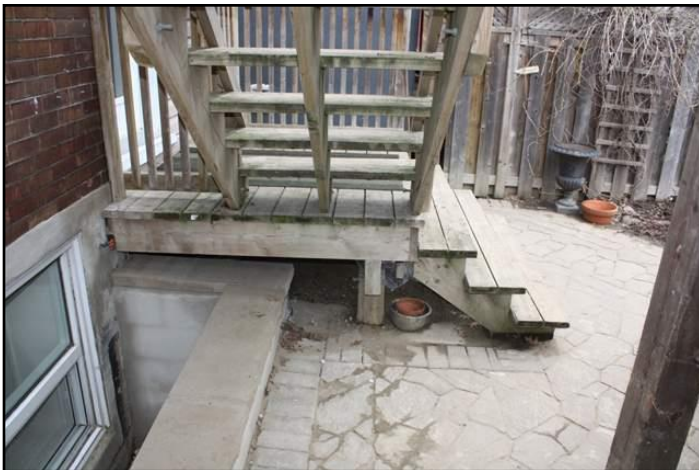
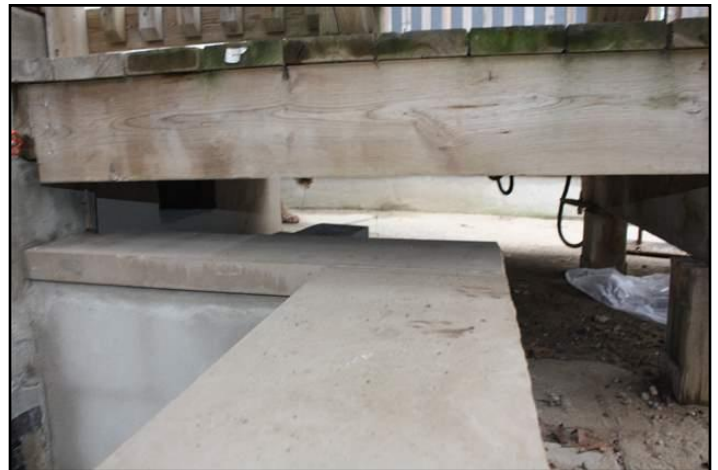
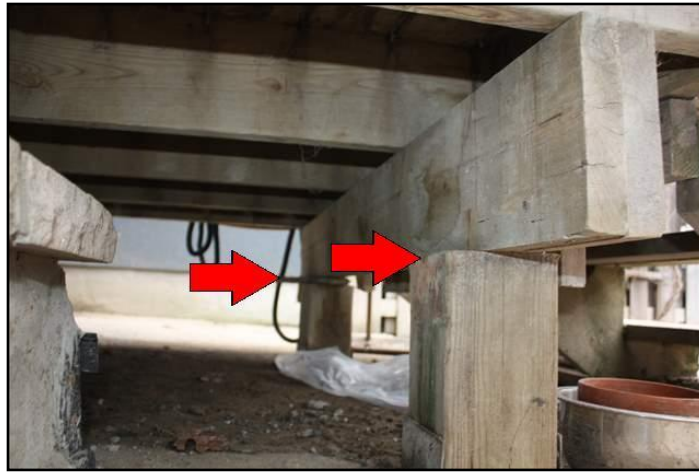
Condition: • Requires additional support posts below landing to support staircase load. Also the current posts are poorly supported at top connection

Location: Rear Exterior staircase and landing

Task: Correct / Repair

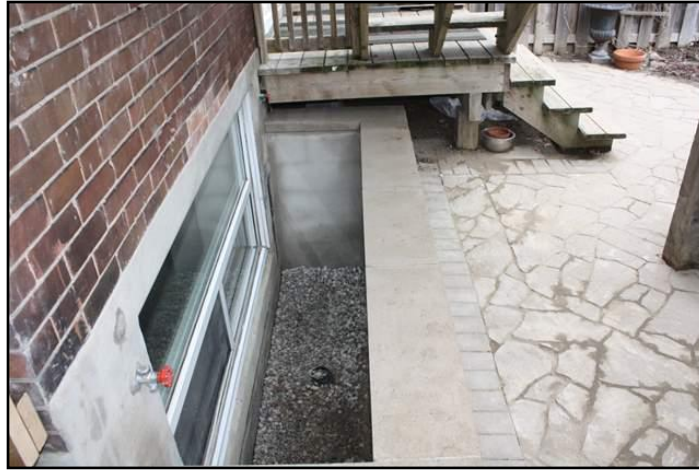
14. Missing Guardrail around window well

Condition: • [Missing](#)

Implication(s): Fall hazard

Location: Rear Exterior Window well

Task: Provide Guardrails

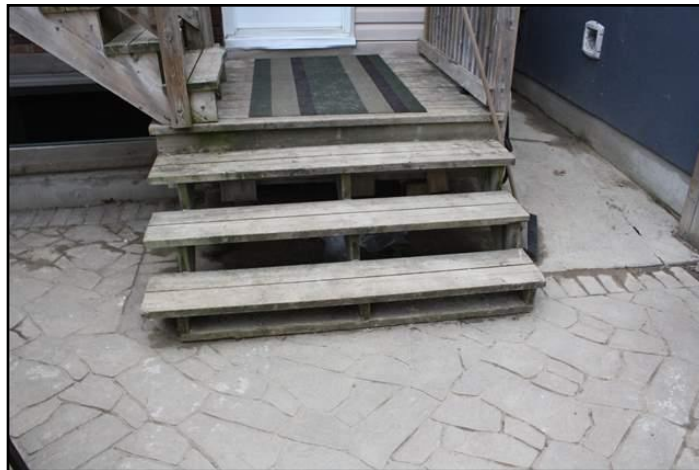
15. Missing

Condition: • [Missing](#)

Implication(s): Fall hazard

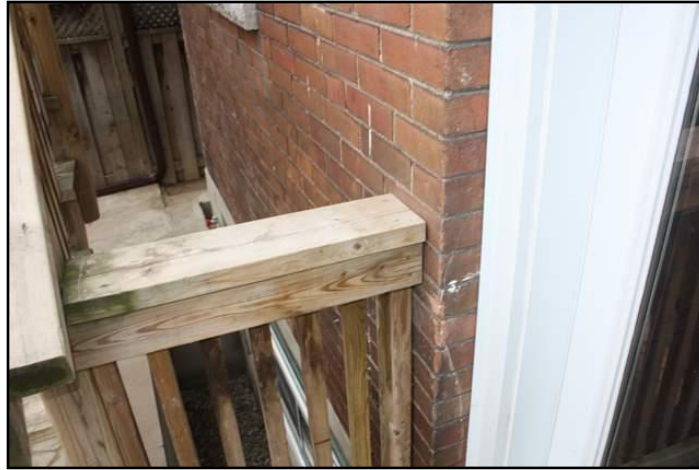
16. Weak

Condition: • [Weak](#)

Implication(s): Fall hazard

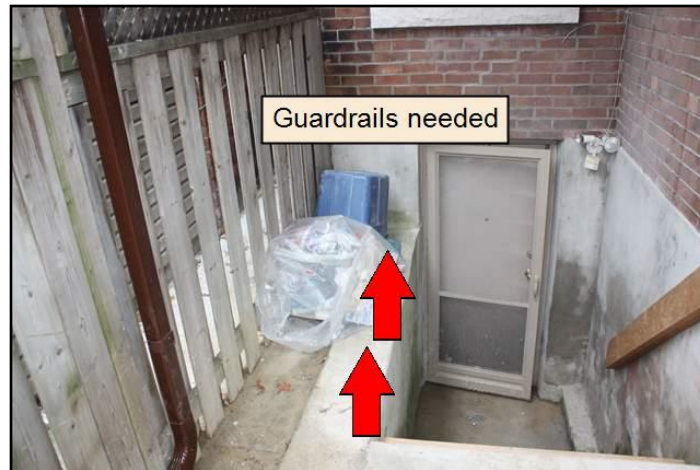
17. Guard and handrail problems

Condition: • [Guard and handrail problems](#)

Implication(s): Fall hazard

Task: Provide Guardrail at open side of walkout

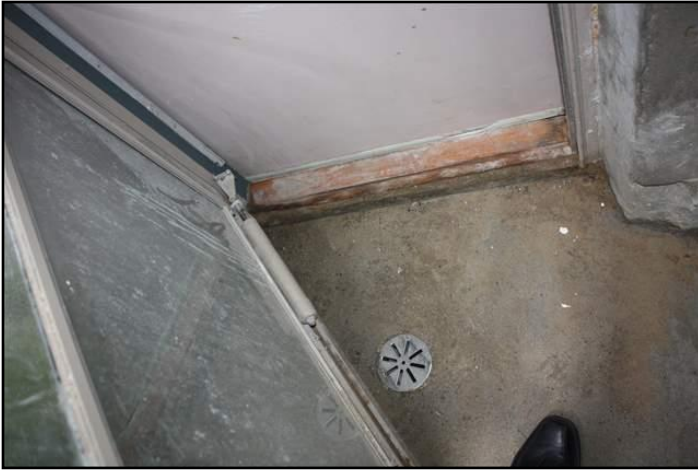
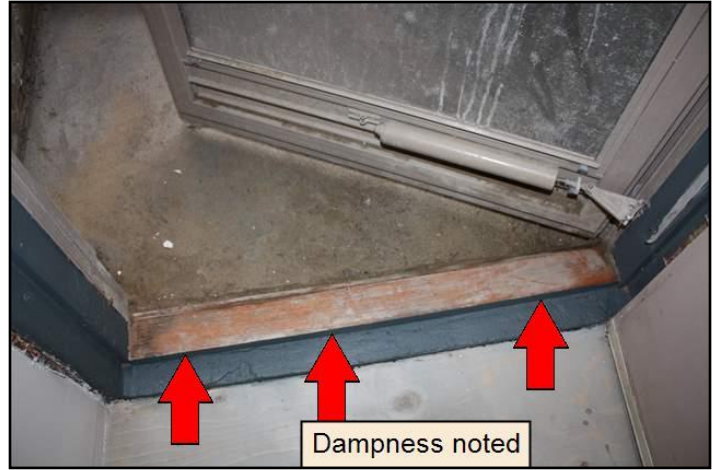
Condition: • [Door threshold missing, too low, not watertight](#)

Implication(s): Chance of water damage to contents, finishes and/or structure

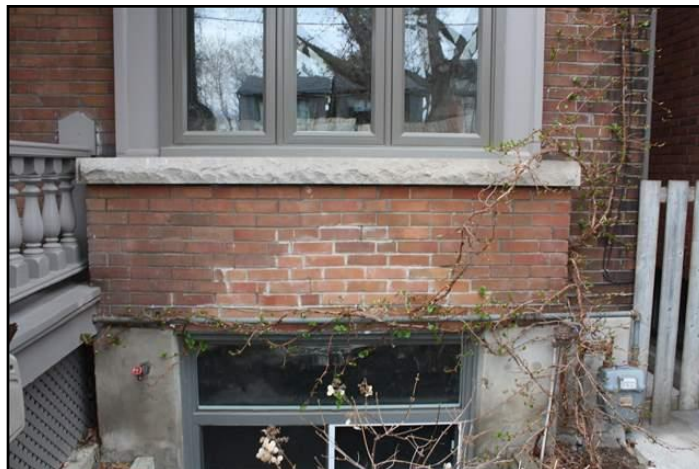
20. Prior repairs

Condition: • [Prior repairs](#)

Task: Monitor

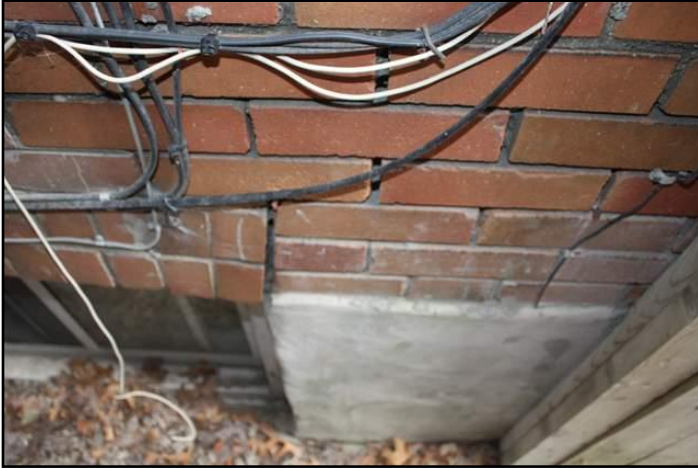
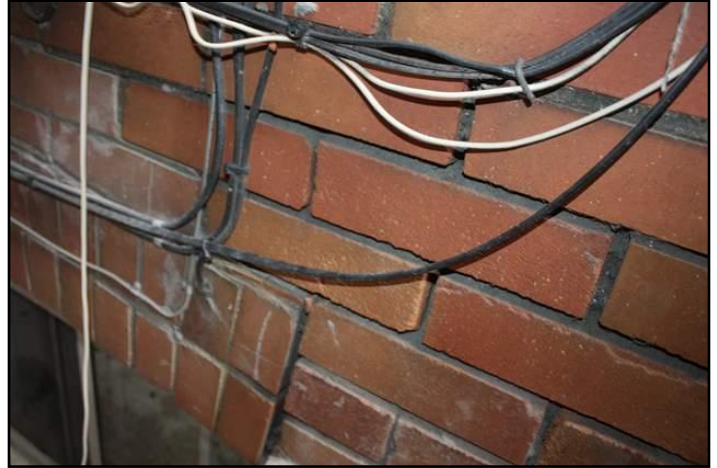
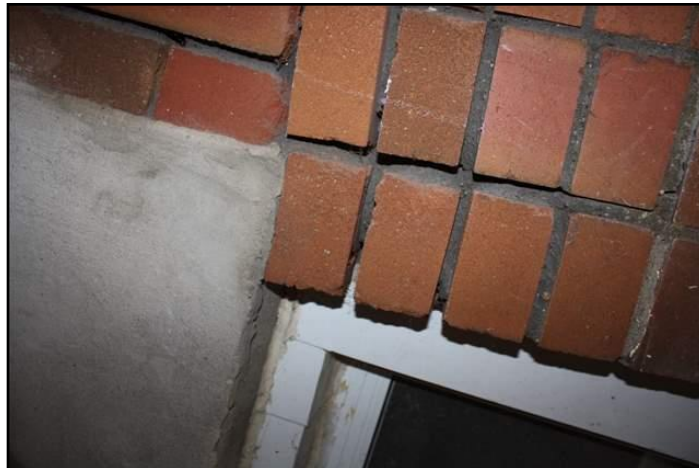
Condition: • [Mortar deteriorating](#)

Task: Repair

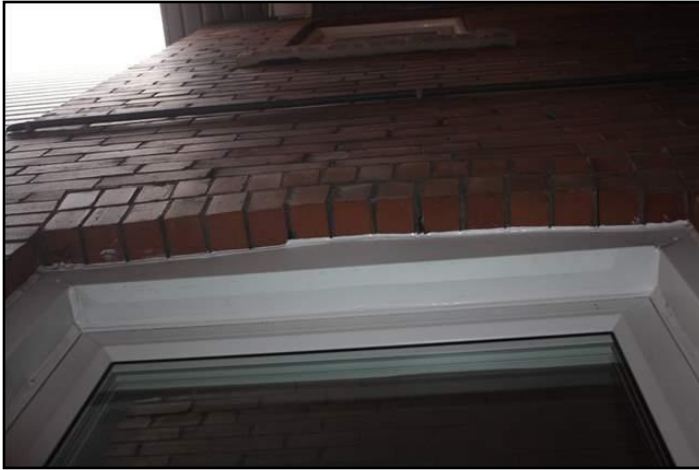
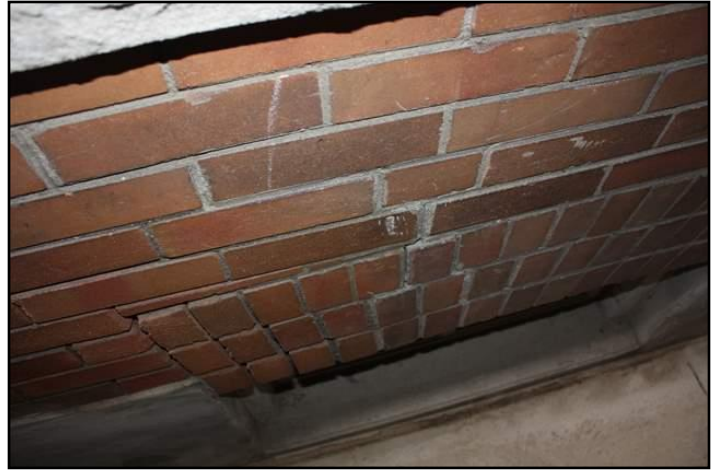
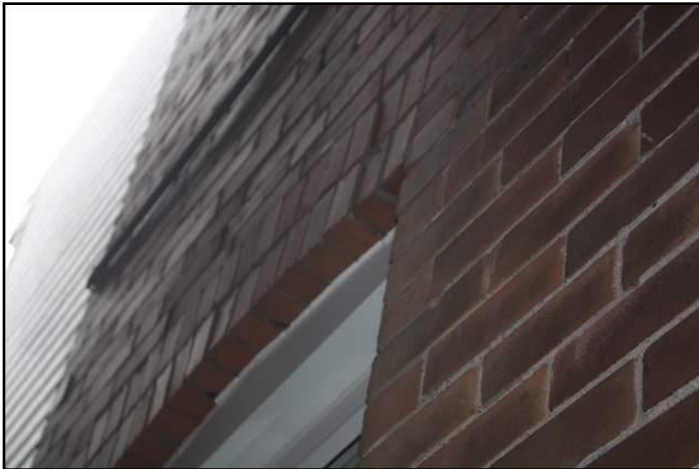
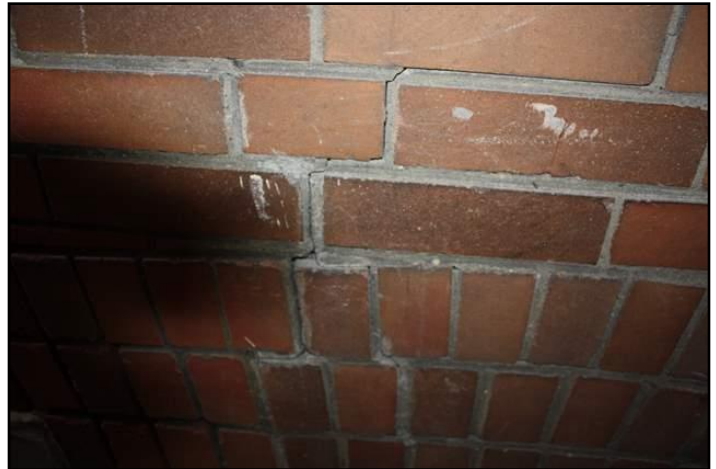
Condition: • [Dropped, rotating or leaning](#)

This is very common on arches of homes of this age. Repair cracks to prevent further movement.

Task: Repair

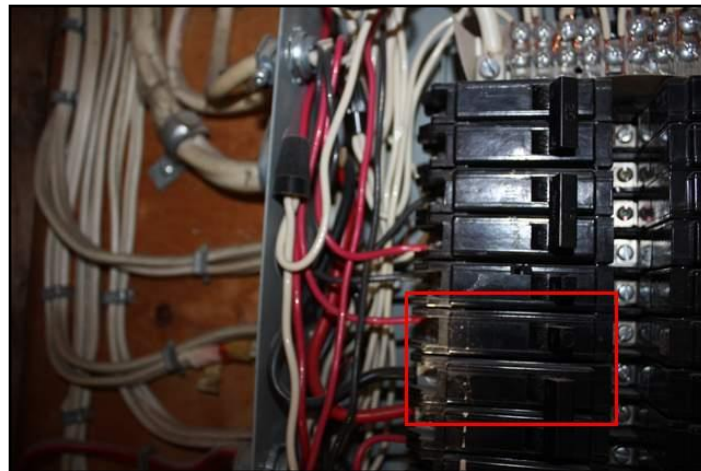
28. No links for multi-wire circuits

Condition: • [No links for multi-wire circuits](#)

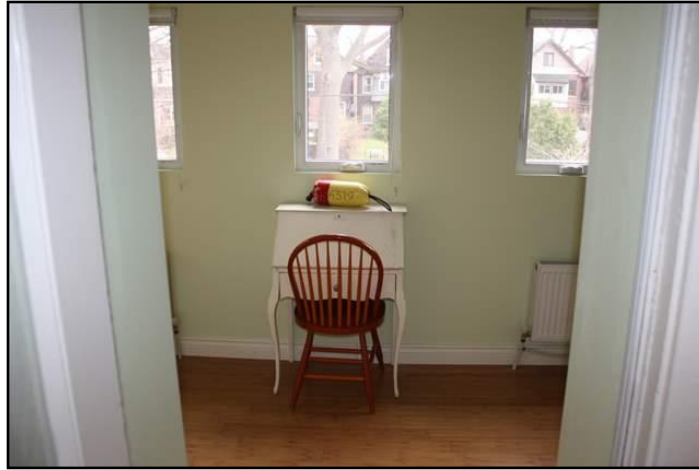
29. Ungrounded

Condition: • [Ungrounded](#)

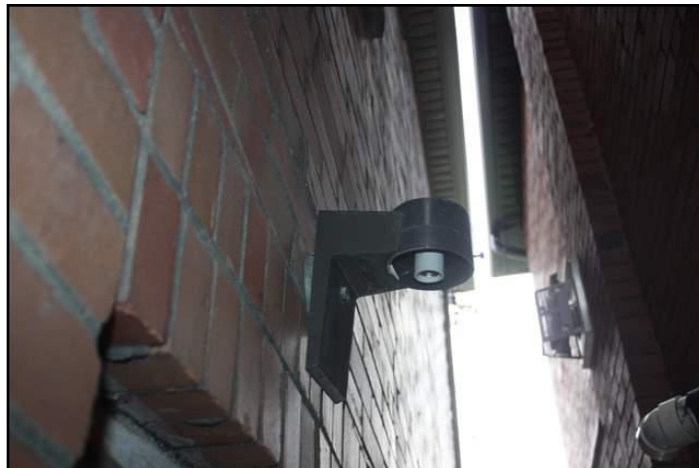
**DISTRIBUTION SYSTEM \ Lights****Condition:** • [Loose](#)**Implication(s):** Electric shock | Fire hazard**Location:** Exterior Wall**Task:** Correct**Time:** As Soon As Possible**Cost:** Regular maintenance item

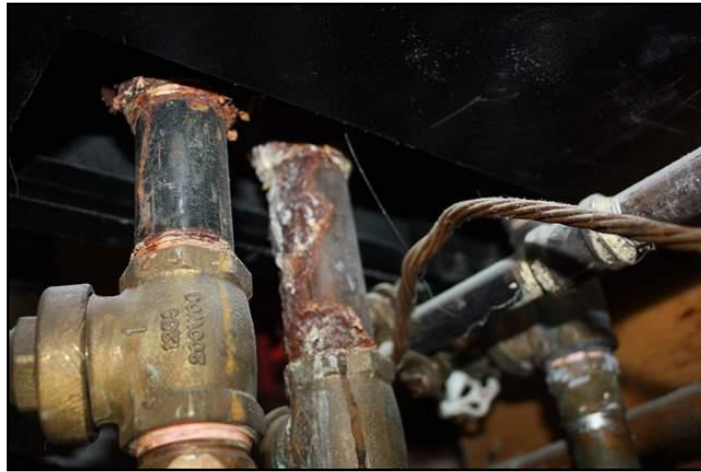
32. Rust / Corrosion

Condition: • [Rust](#)

Implication(s): Chance of water damage to contents, finishes and/or structure | Leakage | Reduced system life expectancy | Equipment failure

Location: Basement Boiler piping

Task: Service / Replace

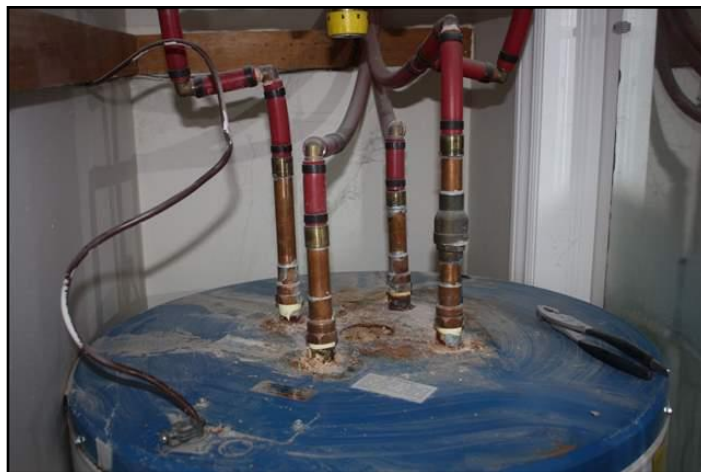
33. Rust

Condition: • [Rust](#)

Task: Service

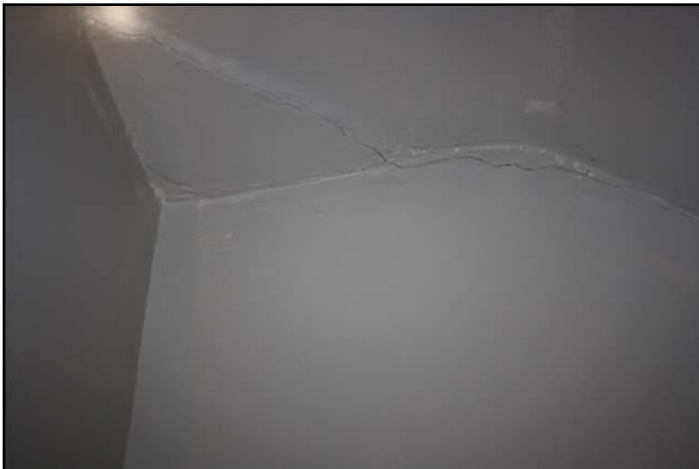
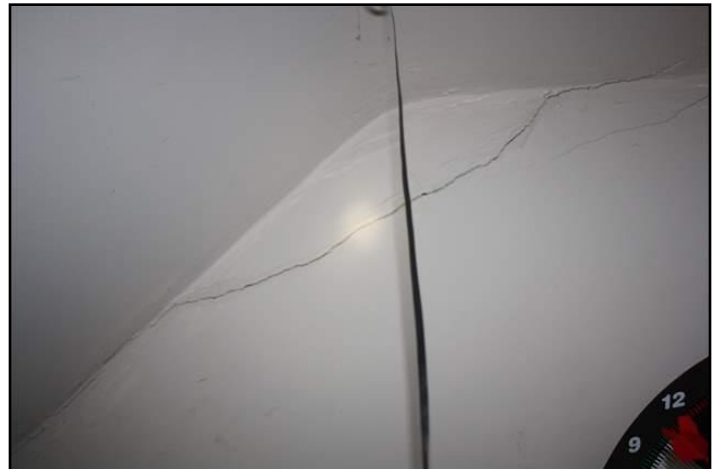
Condition: • Typical flaws

Task: Monitor

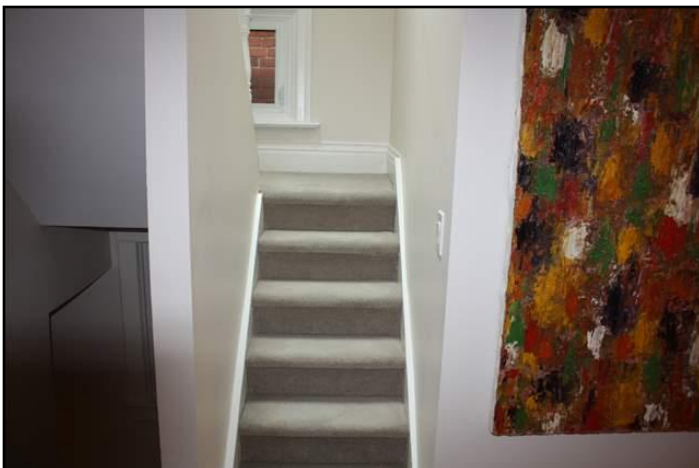
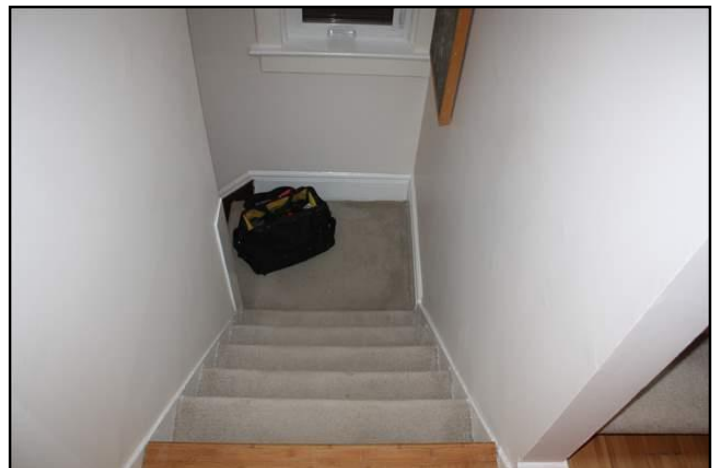
Condition: • [Missing](#)

Implication(s): Fall hazard

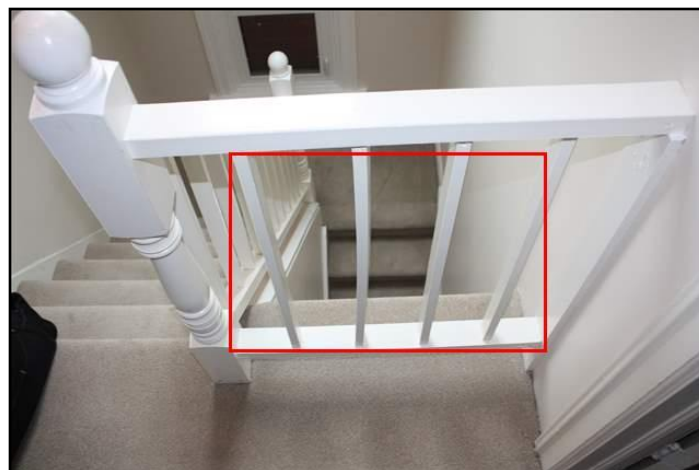
38. Damage

Condition: • [Damage](#)

Implication(s): Fall hazard

Location: Third Floor Hall

Task: Repair / Replace

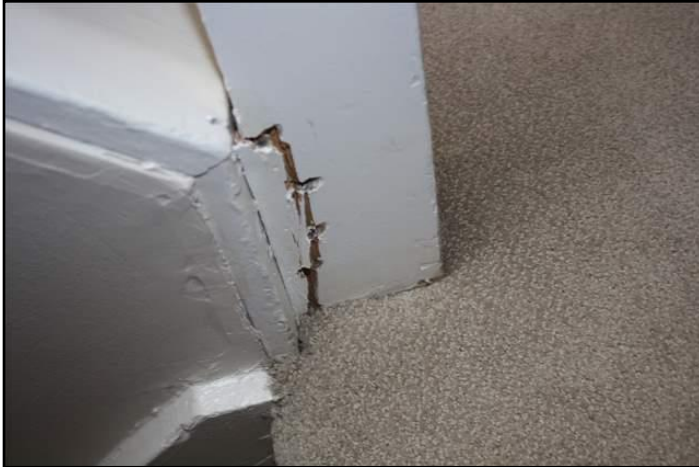
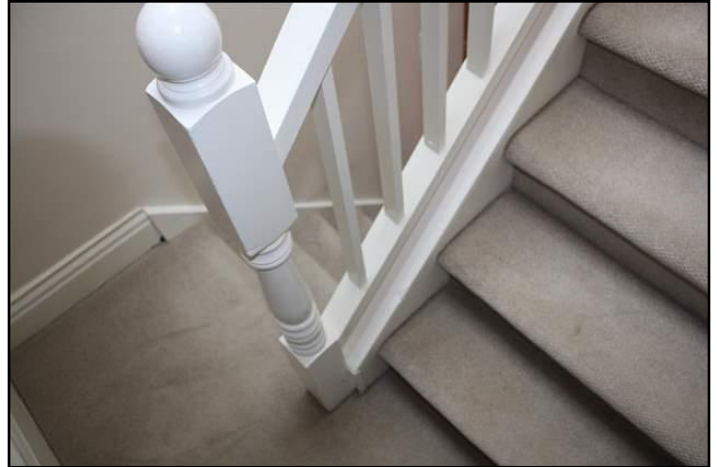
Condition: • [Damage](#)

Damage and loose

Implication(s): Fall hazard

Task: Repair / Replace

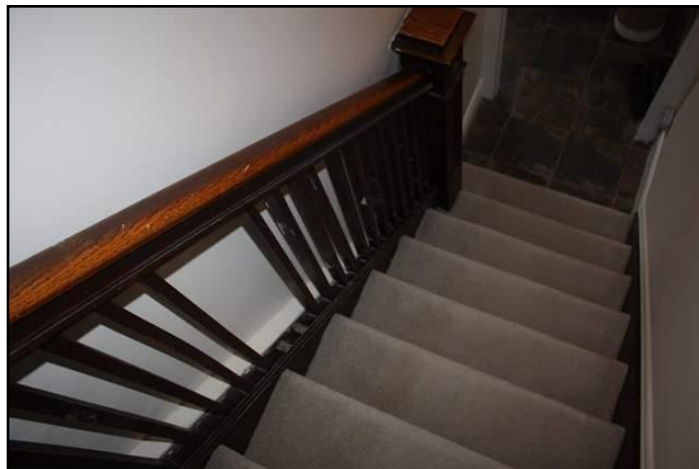
41. Damage

Condition: • [Damage](#)

Implication(s): Fall hazard

Task: Repair

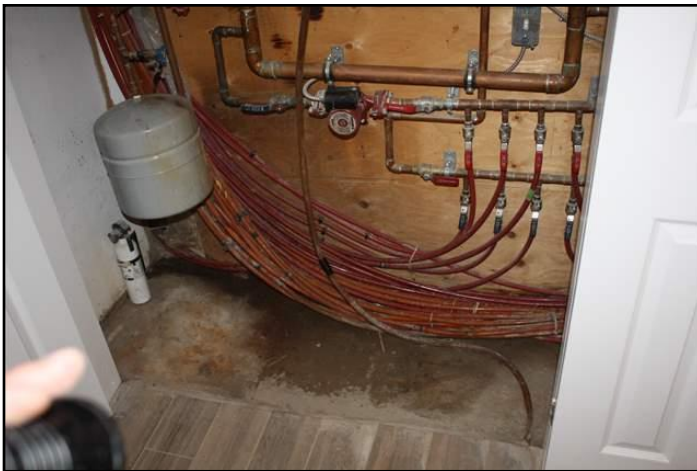
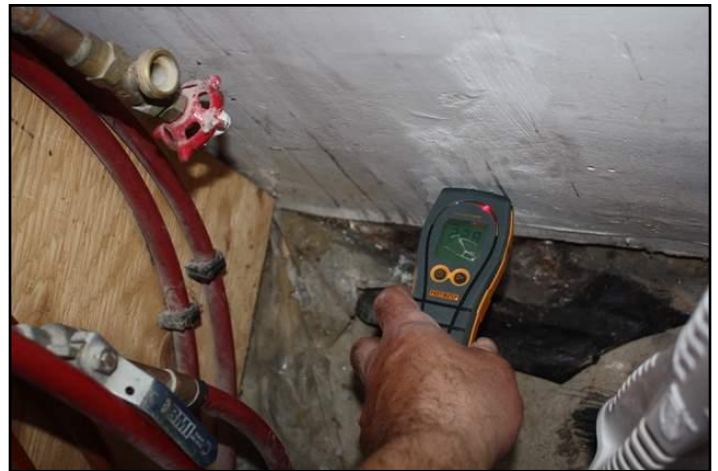
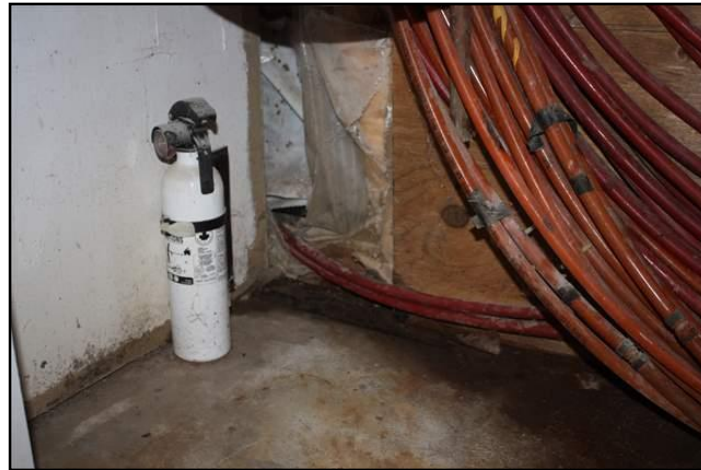
Condition: • [Dampness on floor or walls](#)

Dampness observed and confirmed using a moisture meter. We did not observe standing water in this area. Prudent to investigate and improve exterior areas to omit water/moisture entry. This area appear to be adjacent to the front porch and nearby window well. Ensure all gaps are sealed. Ensure window well is draining properly. Consider adding a window well cover to help manage water in this area. Check this basement area after rainfalls

Location: Front Basement Boiler Room

Implication(s): Chance of water damage to contents, finishes and/or structure | Material deterioration

Task: Repair / Monitor

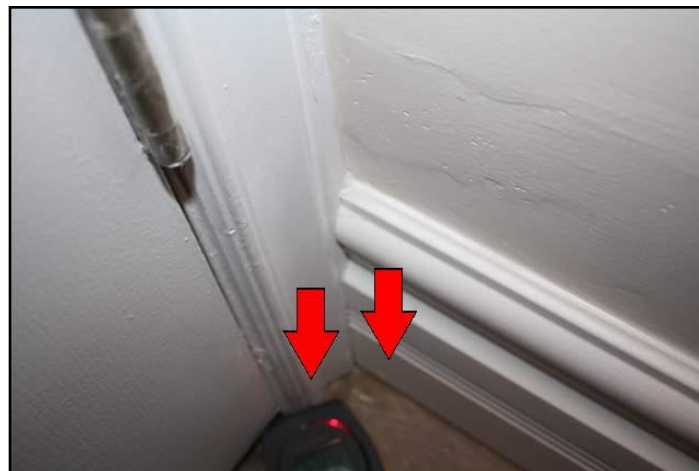
45. Water marks

Condition: • [Water marks](#)

It is common to find water marks in a basement of this age. Numerous possible causes - Condensation, leakage, plumbing leakage, installation issue, etc. There was no standing water observed during the inspection. some stains tested with moisture meter and were wet.

Location: Basement near boiler room

Implication(s): Chance of water damage to contents, finishes and/or structure

Task: Troubleshoot and repair
