INSPECTION REPORT

For the Property at:
100 ANYWHERE
AUSTIN, TX

Prepared for: JOHN DOE
Inspection Date: Wednesday, March 6, 2019
Prepared by: Chris Nowling

Report No. 3382, v.4

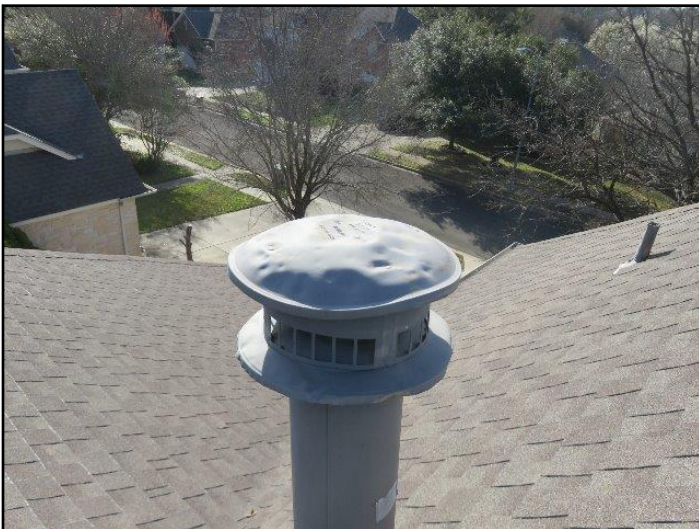
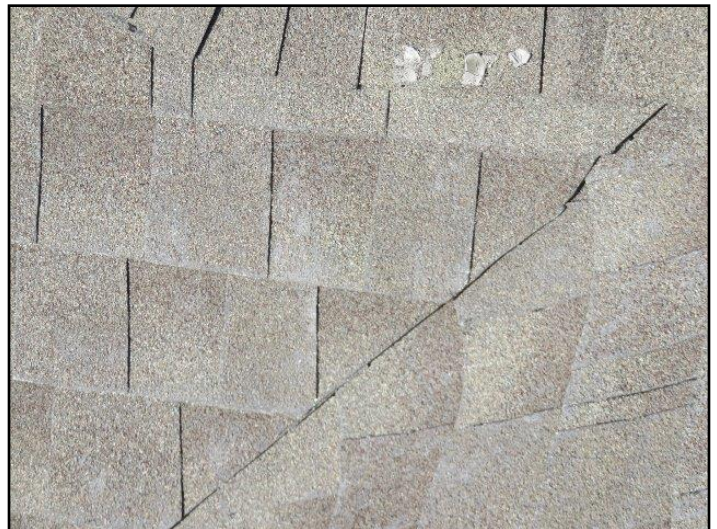
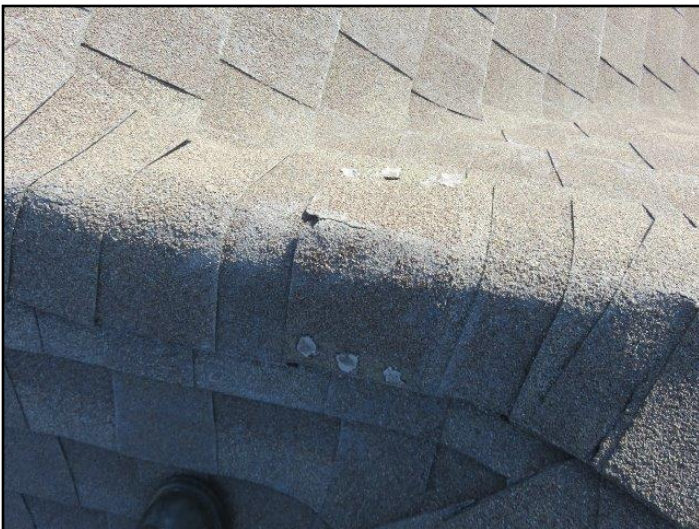
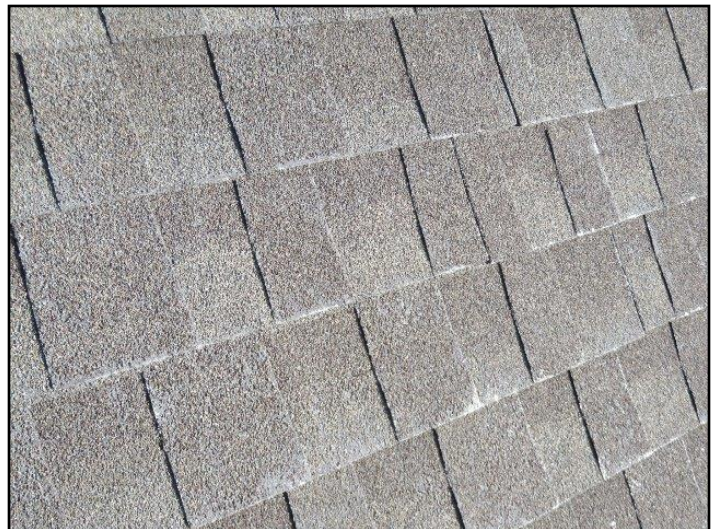
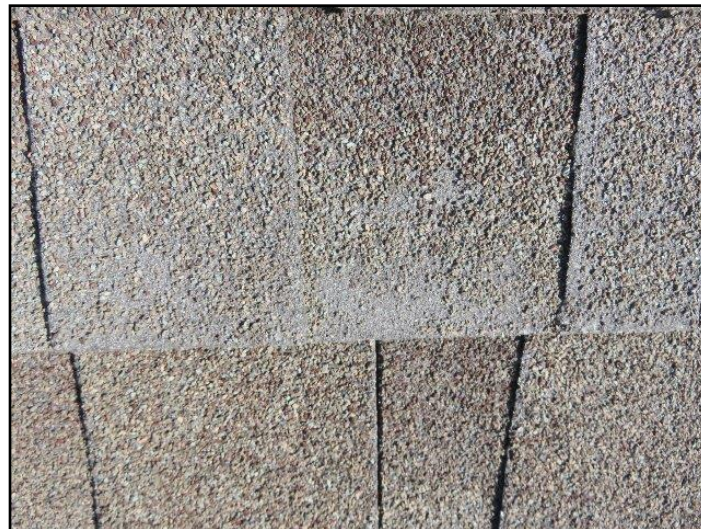
1. Condition: • [Granule loss](#)

Excessive premature granule loss at front slopes. Possibly related to an impact event such as hail.

Implication(s): Shortened life expectancy of material

Location: Southwest

1. Granule loss

2. Granule loss

3. Granule loss

4. Granule loss

5. Granule loss

Task: Deficiency- Further evaluation

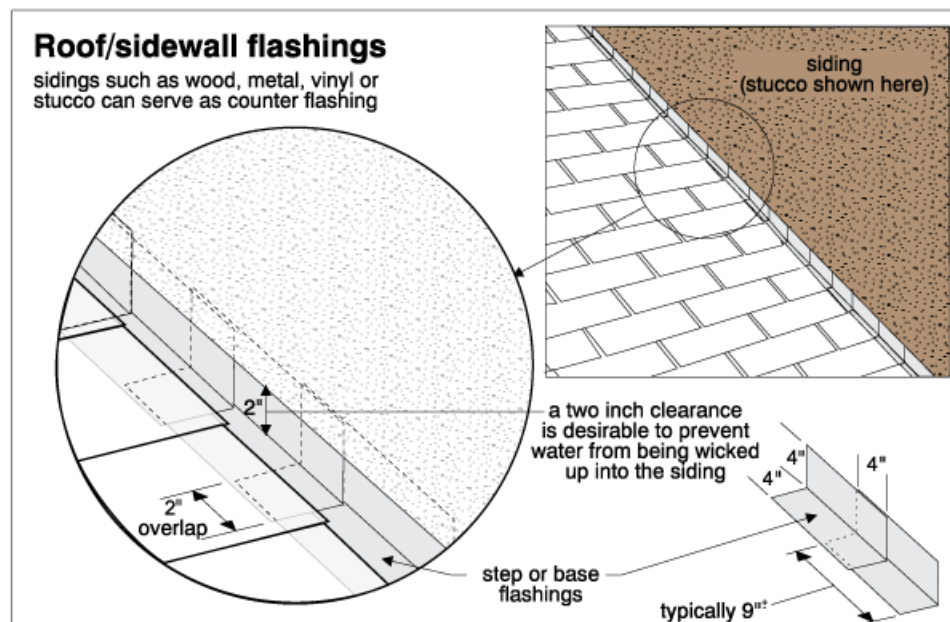
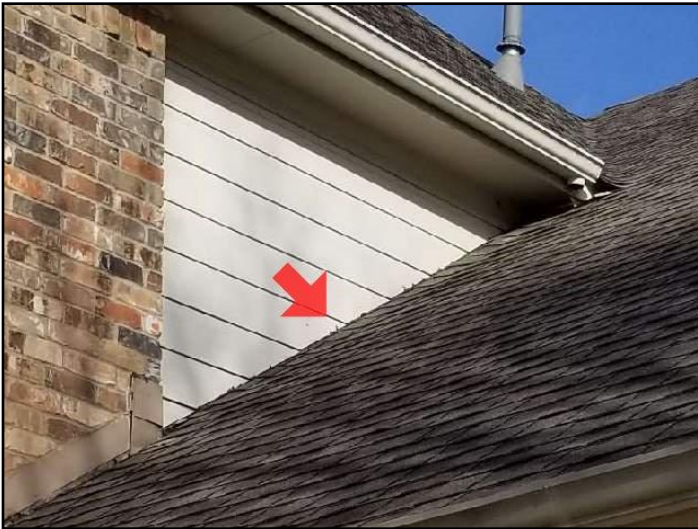
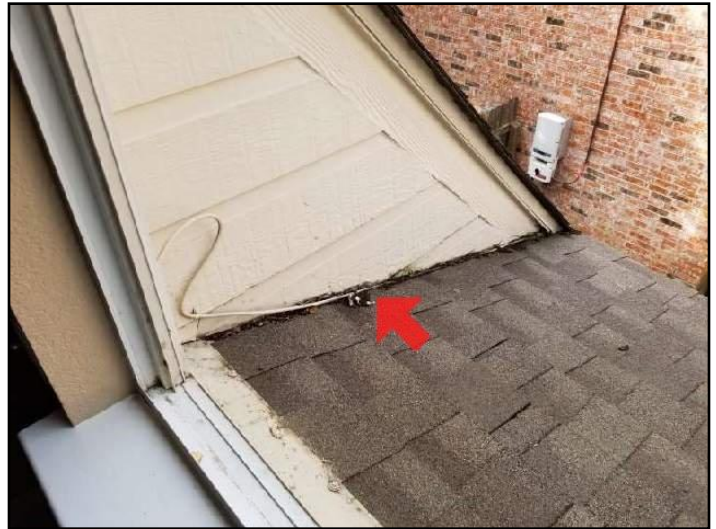
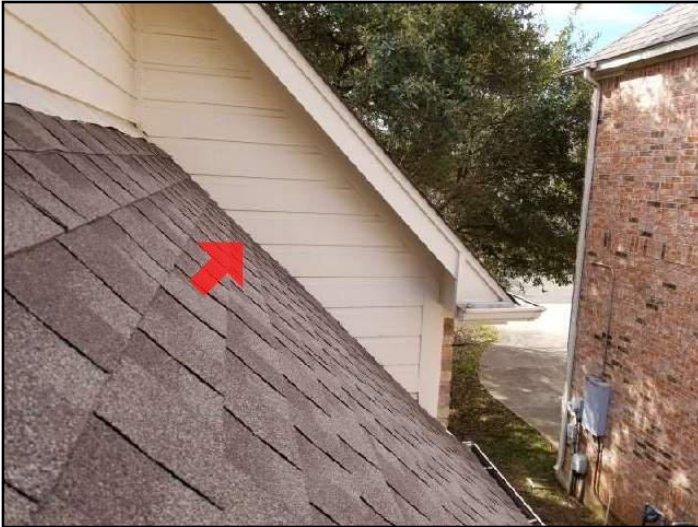
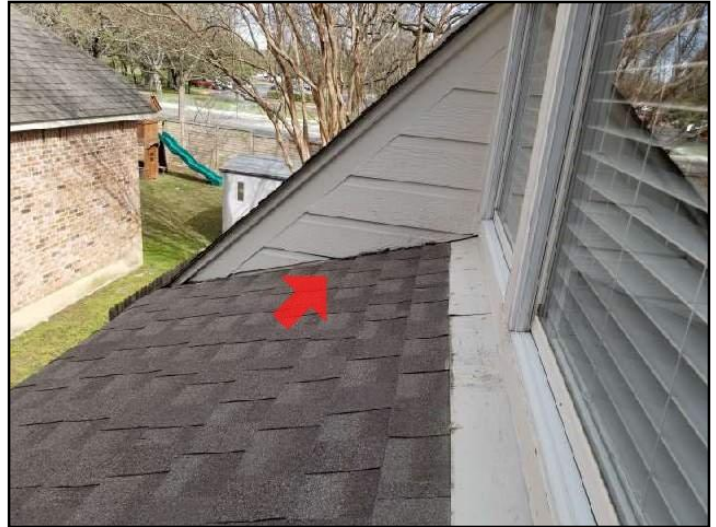
2. Condition: • [Siding not cut back](#)

Siding not trimmed away from roof properly.

Implication(s): Chance of water damage to contents, finishes and/or structure

Location: Various areas where siding is above the roof.

6. Siding not cut back

7. Siding not cut back

8. Siding not cut back

9. Siding not cut back

Task: Deficiency- Improve

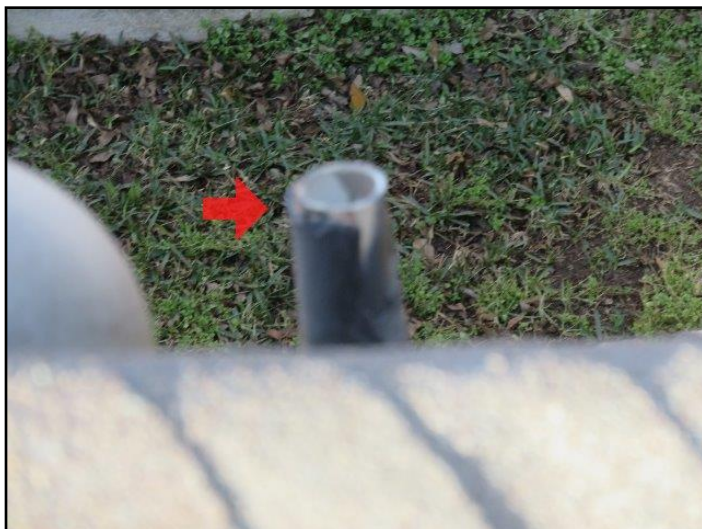
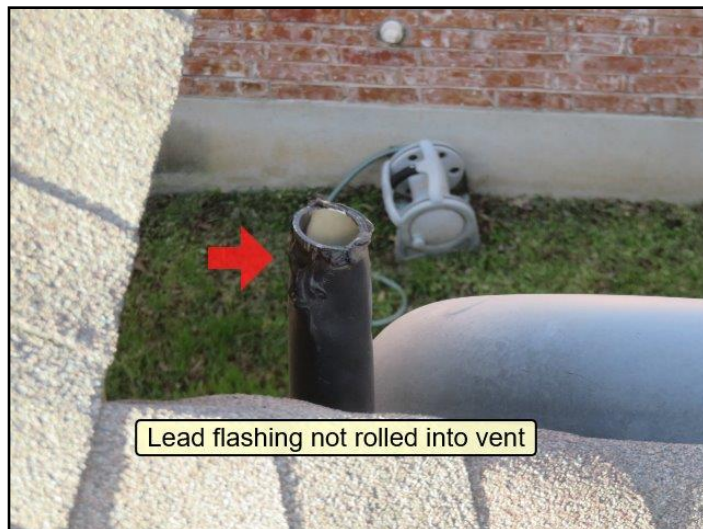
10.

3. Condition: • Lead flashing not rolled into plumbing vents

Implication(s): Leaks

Location: Left Side

Task: Deficiency- Repair

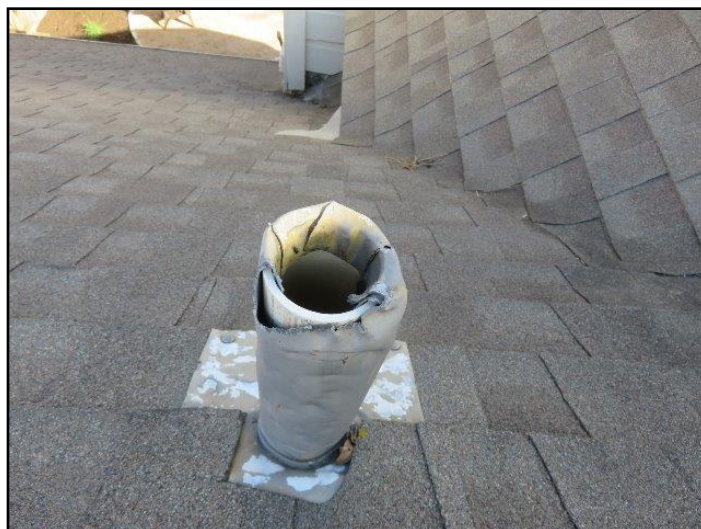
4. Condition: • [Damage](#)

Damaged lead flashing at plumbing vent.

Implication(s): Chance of water damage to contents, finishes and/or structure

Location: Rear near fireplace chimney.

12. Damage

Pipe/stack flashings: **Damage** *Notes:* **Damaged lead flashing at plumbing vent.**

Task: Deficiency- Repair

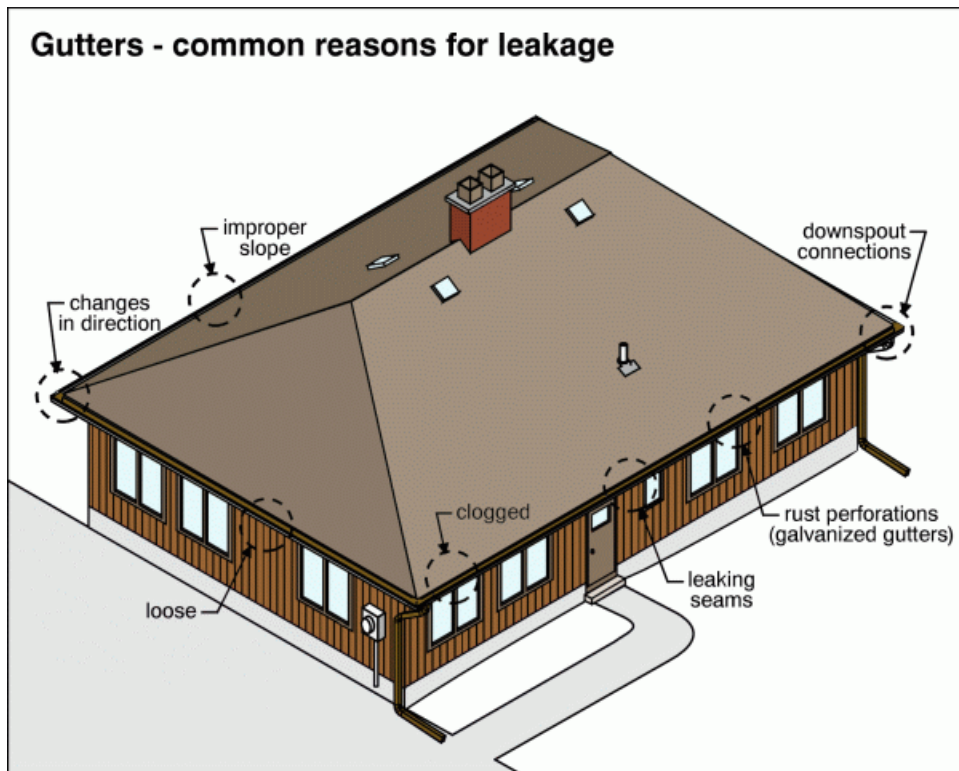
5. Condition: • [Clogged](#)

Implication(s): Chance of water damage to contents, finishes and/or structure

Location: Various

Task: Deficiency- Repair

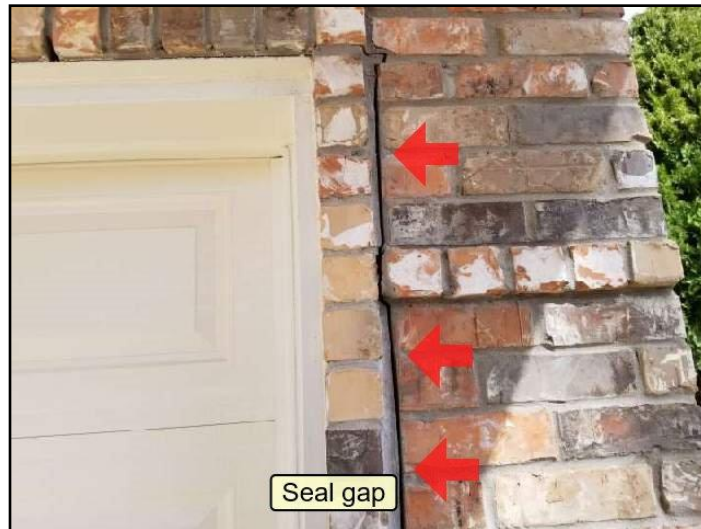
13.

6. Condition: • Gap between overhead garage door jamb and brick veneer at the right side of the garage door needs to be sealed.

Location: Garage

Task: Deficiency- Provide

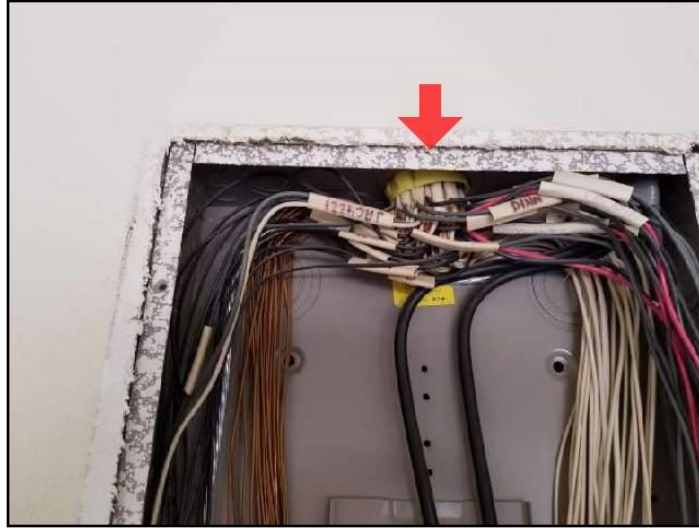
10. Condition: • The panel is flush mounted and most cables are bundled and exit the panel through a large opening or two. As per current applicable standards, the individual cables should be routed through the various small "knock-out" holes at the top, bottom and/or sides of the panel box and secured with approved cable clamps, so that any smoke or fire inside the panel is confined or at least restricted from passing through the knockout openings. What was found here today was generally the method of installation in this region at the time of this home's construction. This installation would not be allowed by current standards. NEC 312.5(C)

Location: Garage

14. The panel is flush mounted and most cables...

Task: Deficiency- Improve

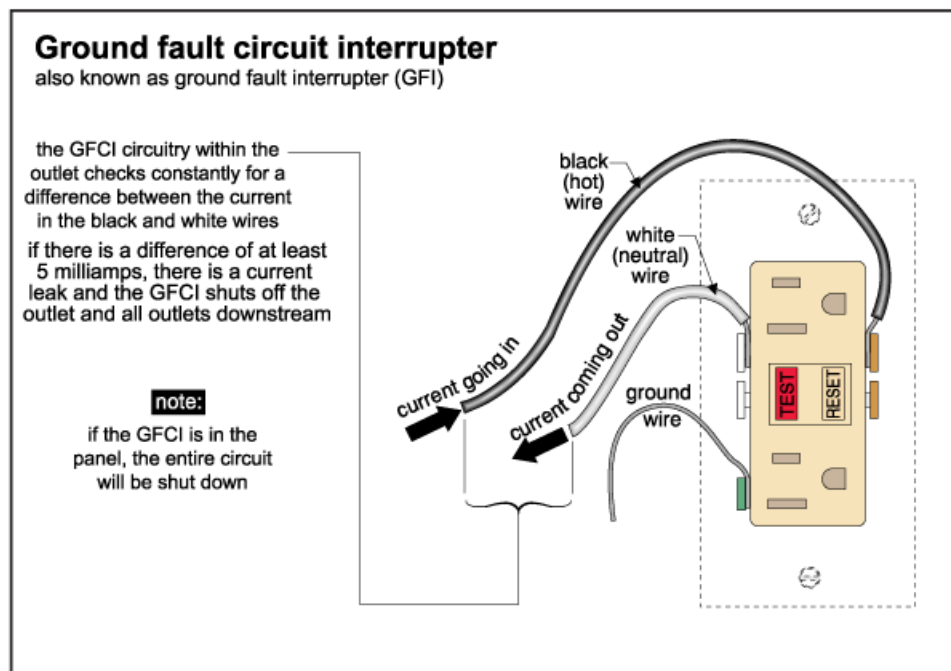
11. Condition: • [GFCI/GFI needed \(Ground Fault Circuit Interrupter\)](#)

Under current standards all garage receptacles should have GFCI protection.

Implication(s): Electric shock

Location: Garage

Task: Deficiency- Provide

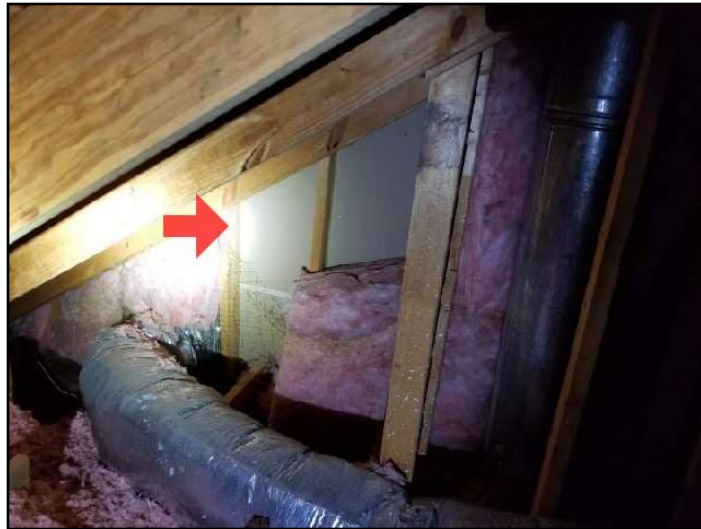
13. Condition: • [Gaps or voids](#)

Insulation batts have fallen down at living room wall exposed to attic near the fireplace.

Implication(s): Increased heating and cooling costs | Reduced comfort

15. Gaps or voids

Task: Deficiency- Correct

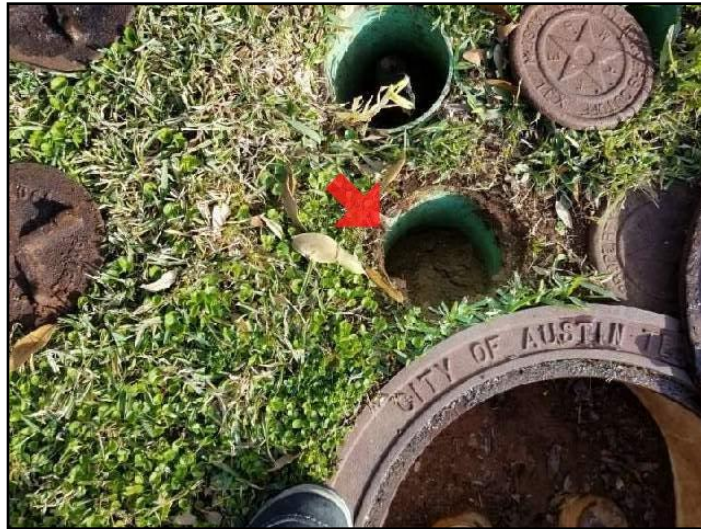
14. Condition: • [Buried](#)

Implication(s): Reduced system life expectancy | Difficult to service

16. Buried

Task: Deficiency- Further investigation and repairs recommended

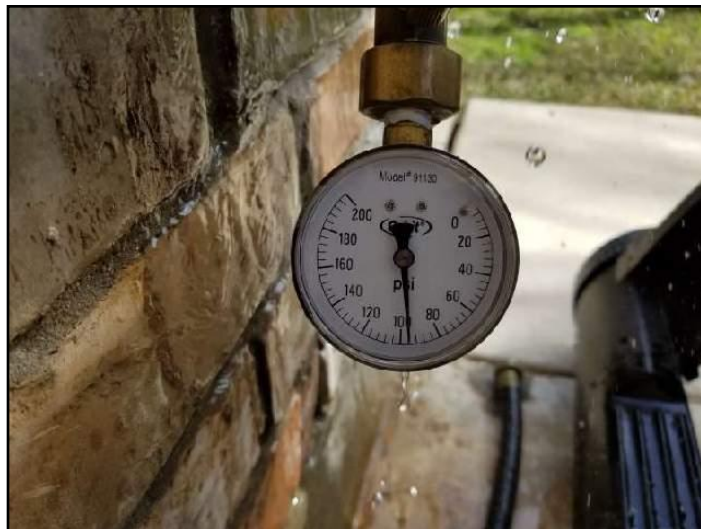
15. Condition: • As the static water pressure of the supply plumbing system exceeds 80 pounds per square inch (psi), it would be wise to install a pressure regulator; (if a pressure regulator is present have it serviced/adjusted). Otherwise, the plumbing system may be prone to leaks in piping, fittings or other equipment. Client should be aware that once a "pressure reducing valve" has been installed on the water supply, standards call for the installation of an expansion tank. Consult a licensed plumber for further evaluation and correction.

17. As the static water pressure of the supply...

Supply piping in building: **As the static water pressure of the supply plumbing system exceeds 80 pounds per square inch (psi), it would be wise to install a pressure regulator; (if a pressure regulator is present have it serviced/adjusted). Otherwise, the plumbing system may be prone to leaks in piping, fittings or other equipment. Client should be aware that once a "pressure reducing valve" has been installed on the water supply, standards call for the installation of an expansion tank. Consult a licensed plumber for further evaluation and correction.**

Task: Deficiency- Further investigation and repairs recommended

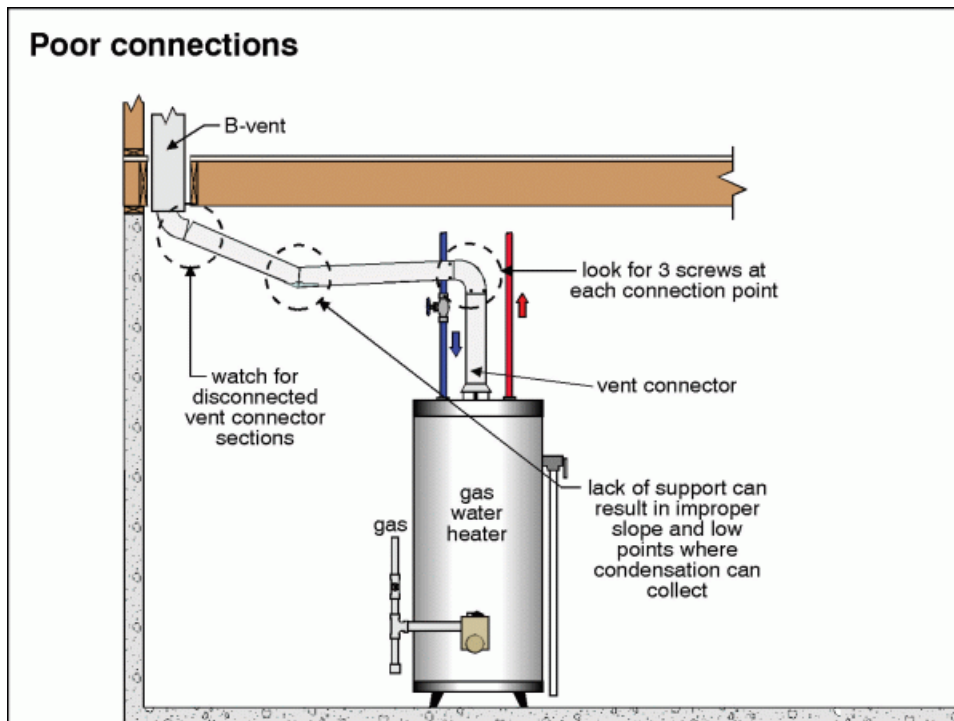
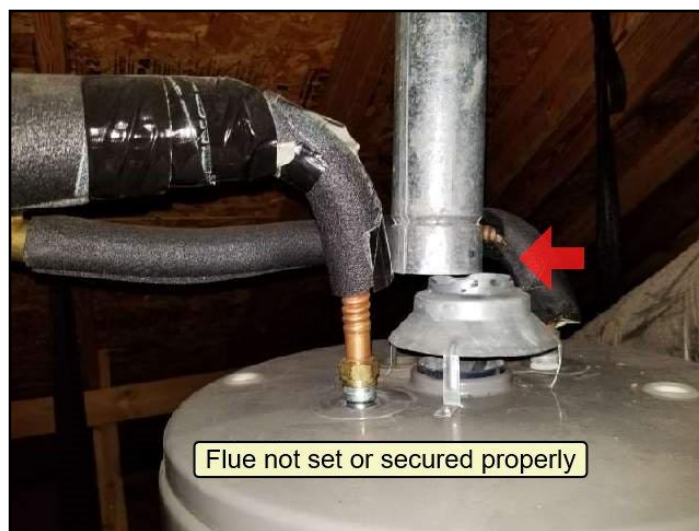
17. Condition: • [Poor connections](#)

Flue not set and secured properly on top of tank.

Implication(s): Equipment not operating properly | Hazardous combustion products entering home

Location: Attic

18. Poor connections

Task: Deficiency- Repair

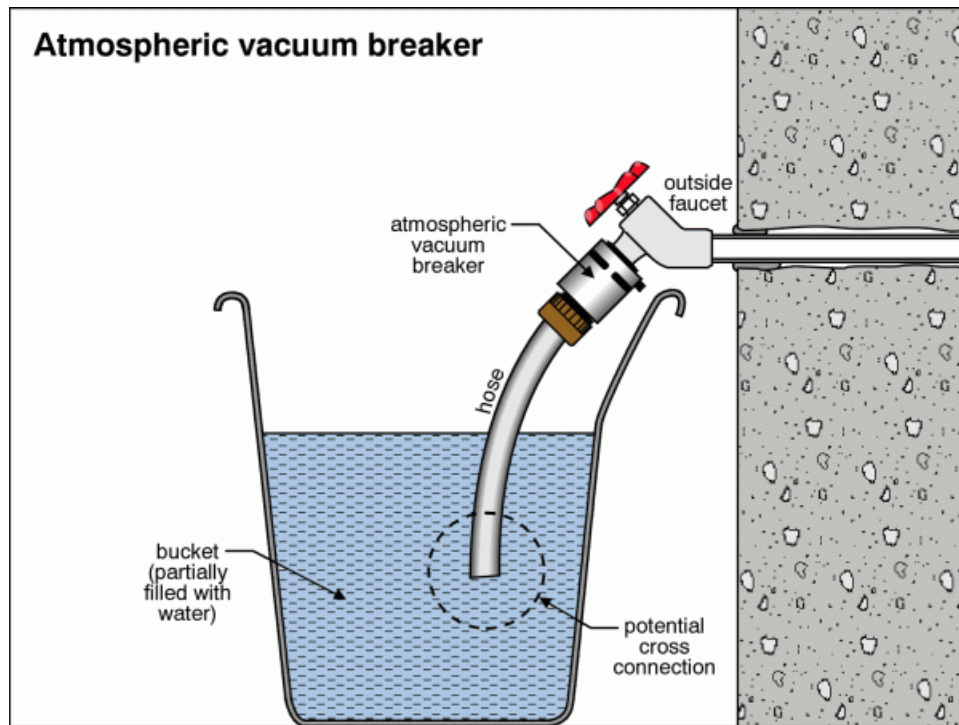
18. Condition: • [Backflow prevention missing](#)

Implication(s): Contaminated drinking water

Location: Front left of porch.

Hose bib or bibb (outdoor faucet): **Backflow prevention missing**

Task: Deficiency- Provide

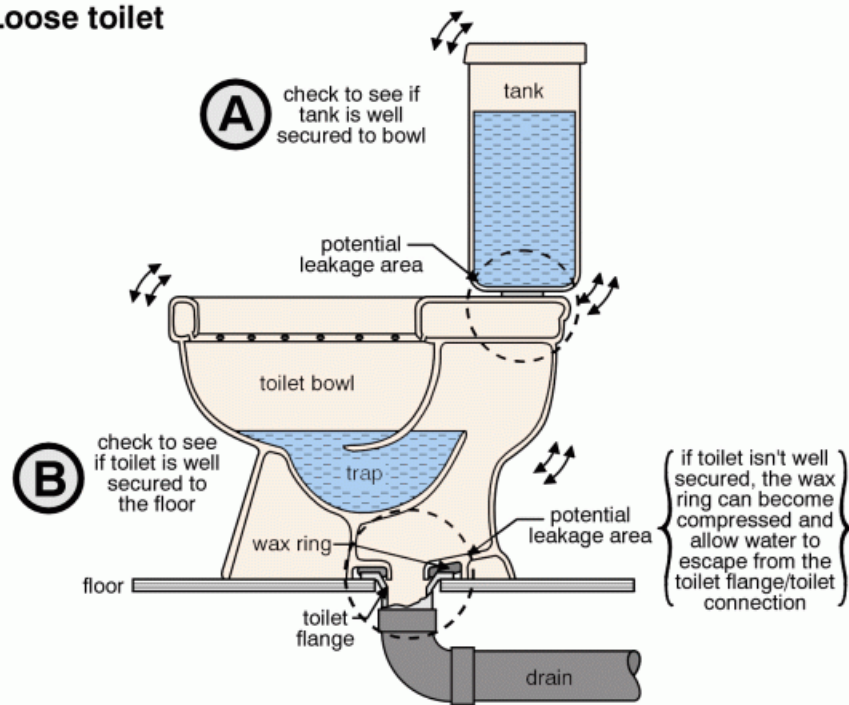
20. Condition: • [Loose](#)

Loose on floor

Implication(s): Chance of water damage to contents, finishes and/or structure | Sewage entering the building

Location: Downstairs half bath

Loose toilet

Toilet: **Loose** Notes: **Loose on floor** Location(s): **Downstairs half bath**

Task: Deficiency- Repair

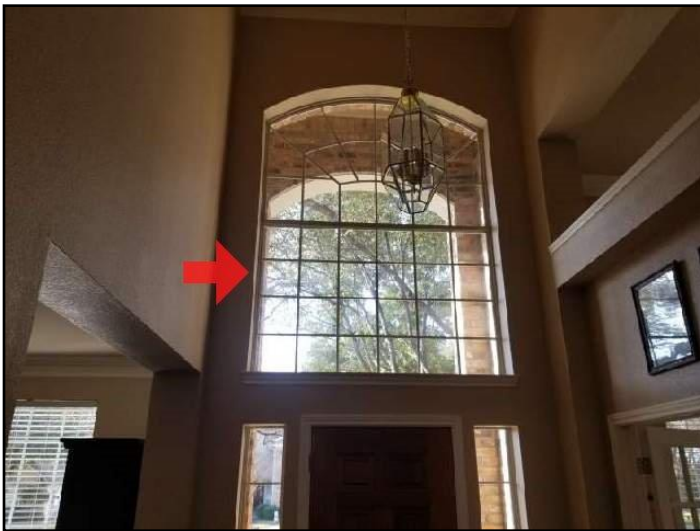
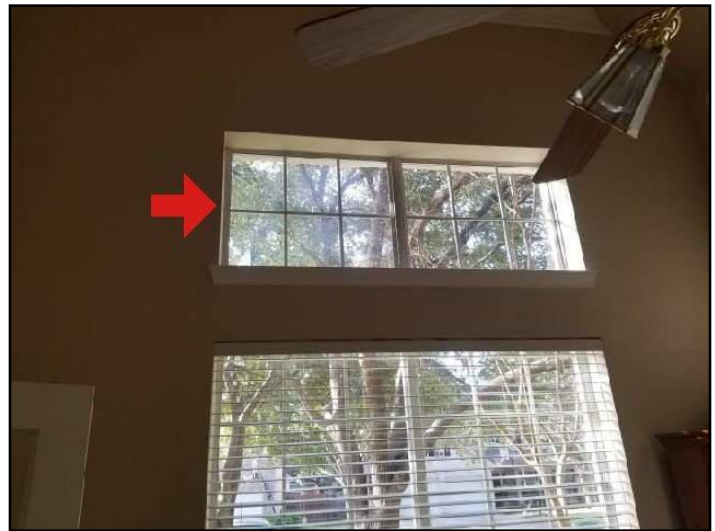
21. Condition: • [Lost seal on double or triple glazing](#)

Fogged glass.

Implication(s): Shortened life expectancy of material

Location: Front Upstairs Bedroom

22. Condition: • [Lost seal on double or triple glazing](#)

Location: Entry hall and study

19. Lost seal on double or triple glazing

20. Lost seal on double or triple glazing

Task: Deficiency- Repair

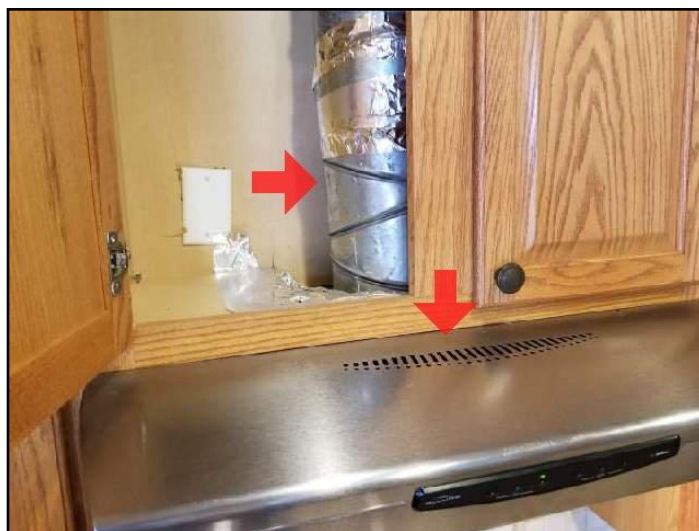
21.

24. Condition: • Range exhaust appears to be set up for exterior discharge. However much of the air is blowing inside as if it was a recirculating type and I didn't locate the exterior discharge location.

Location: Kitchen

Task: Deficiency- Further investigation and repairs recommended

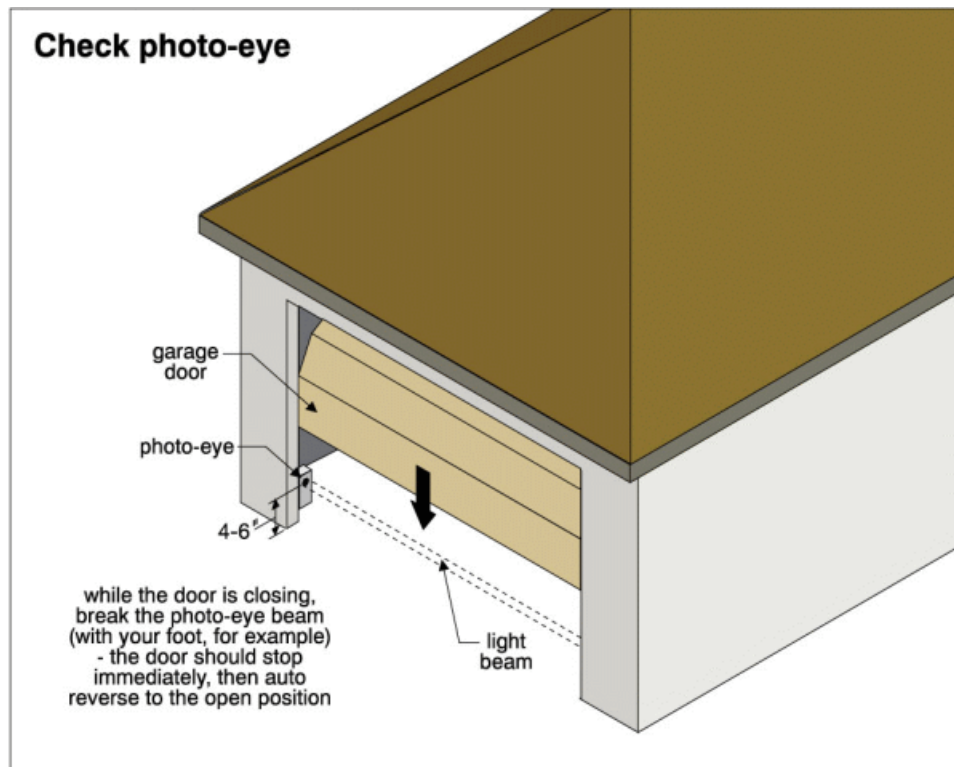
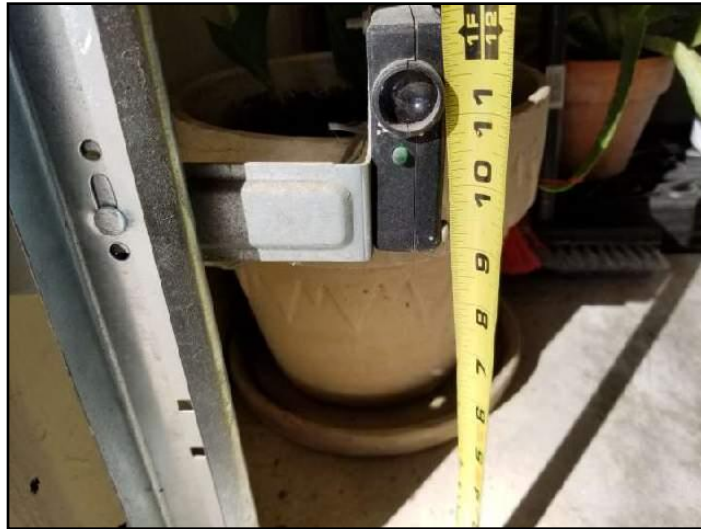
26. Condition: • Sensors poorly located

Sensors should be from 3-8" above the floor.

Implication(s): Physical injury

Location: Garage

22. Sensors poorly located

Task: Deficiency- Improve

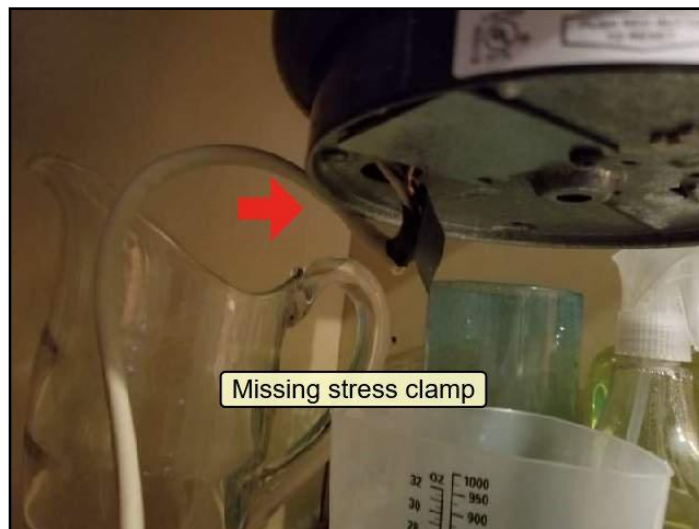
28. **Condition:** • Wiring exposed or loose

No stress clamp for electrical wiring

Implication(s): Electric shock

23. Wiring exposed or loose

Waste disposal: **Wiring exposed or loose** Notes: **No stress clamp for electrical wiring** Location(s): **Kitchen**

Task: Deficiency- Repair

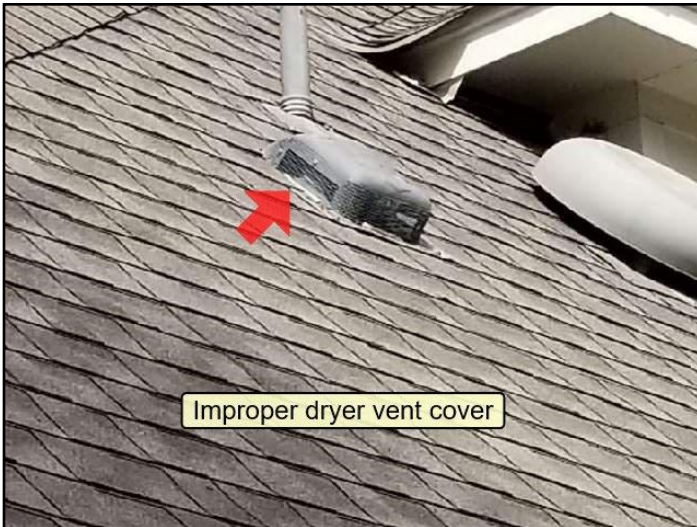
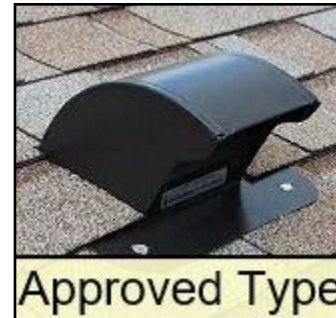
29. Condition: • Improper roof top dryer vent discharge and it is not equipped with a damper. The screening around it makes it worse.

24. Improper roof top dryer vent discharge and...

25. Improper roof top dryer vent discharge and...

Dryer: **Improper roof top dryer vent discharge and it is not equipped with a damper.**
Notes: **The screening around it makes it worse.**
Dryer: **We recommend having the dryer vent cleaned as regular maintenance.**

Task: Deficiency- Further investigation and repairs recommended
