# INSPECTION REPORT

For the Property at:  
**1234 SAMPLE ST.**  
ANNAPOLIS, MD 21401

Prepared for: REPORT SAMPLE  
Inspection Date: Wednesday, April 6, 2016  
Prepared by: Bobby Davidson

Report No. 1452, v.2

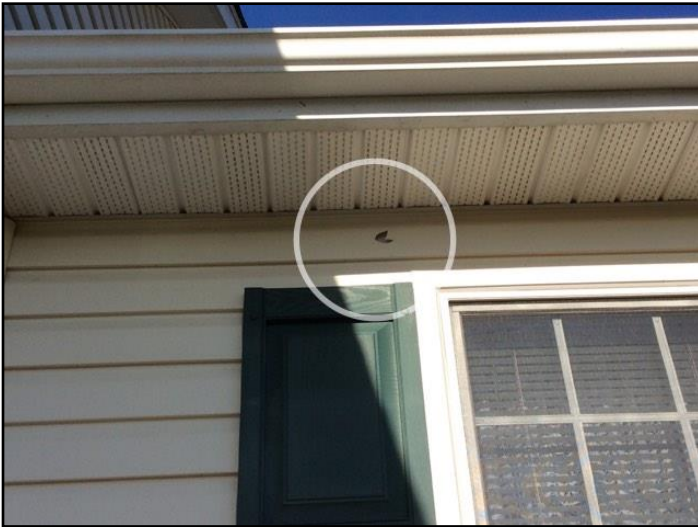
1. Condition: • [Mechanical damage](#)

There is a chip out of the siding to the right of the front porch and a small missing piece on the left rear side dormer.

1. Mechanical damage

Task: Repair

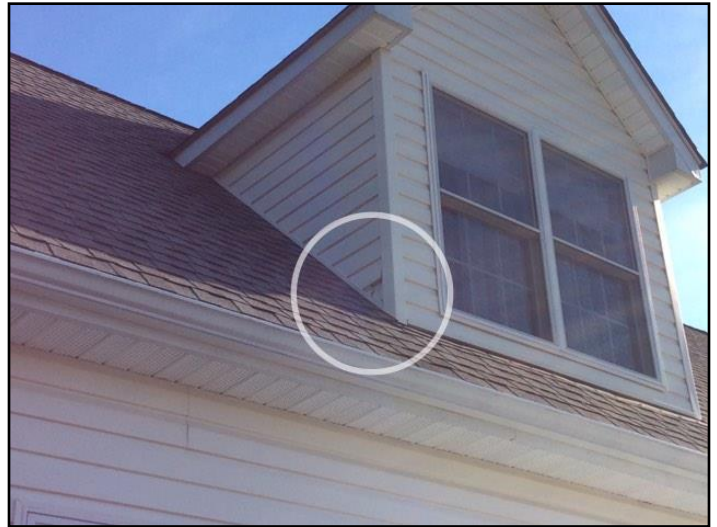
2. Mechanical damage

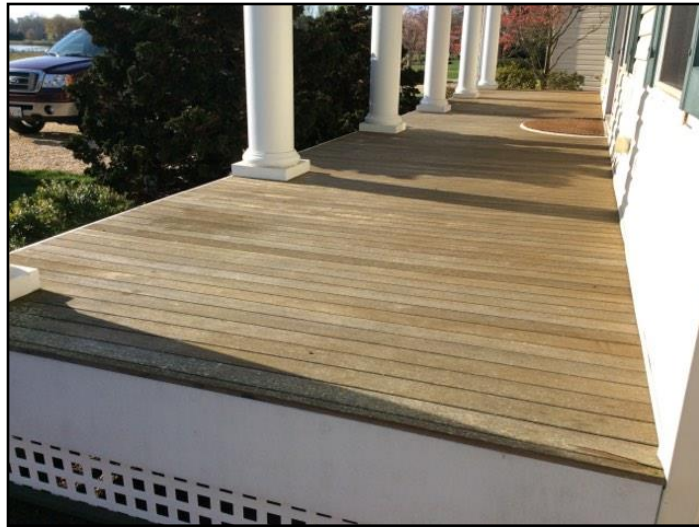
3. Condition: • [Paint or stain needed](#)

Location: Porch Front

3. *Paint or stain needed*

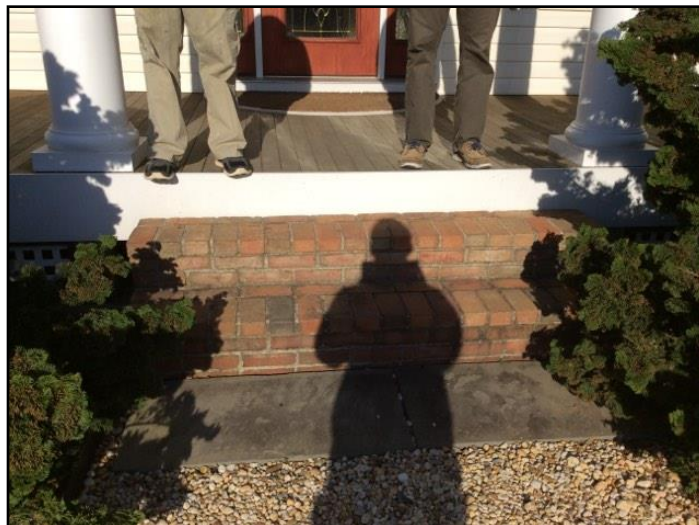
4. Condition: • [Missing](#)

Location: front porch steps

4. *Missing*

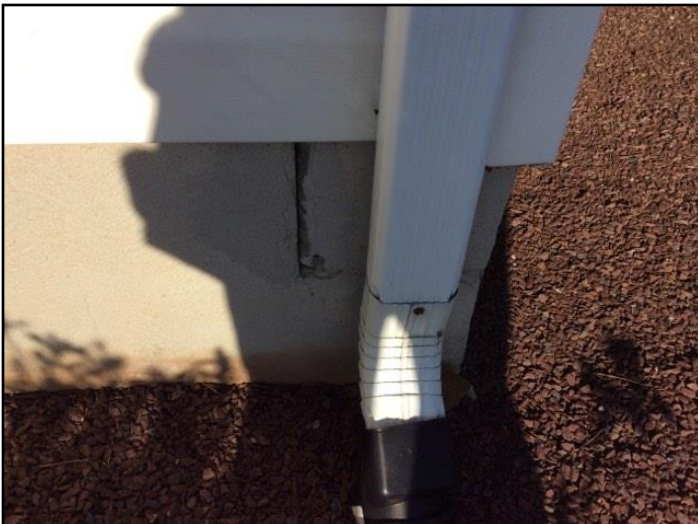
**5. Condition:** • Typical minor cracks

5. Typical minor cracks

Seal varies minor cracks.

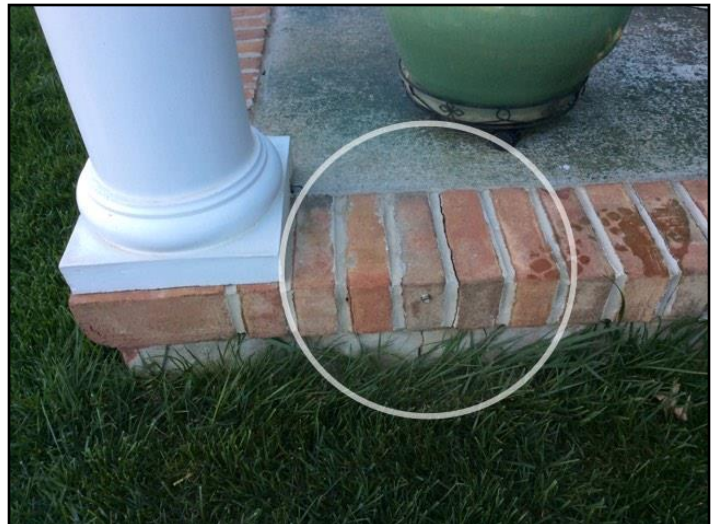
6. Typical minor cracks

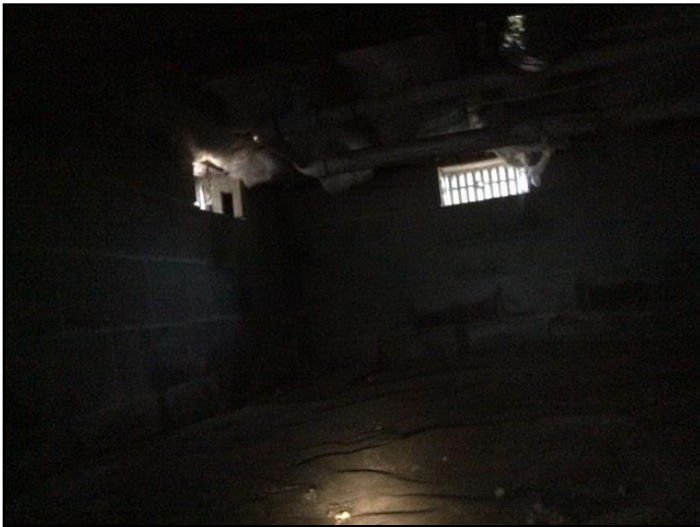
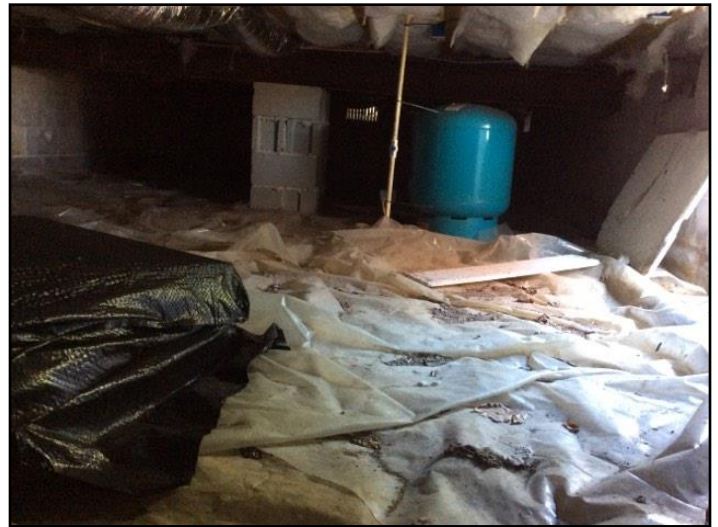
**8. Condition:** • The crawlspace is average for the age although I recommend blocking off the foundation vents and running two dehumidifiers on each end. As a long term upgrade I recommend encapsulation.

**Implication(s):** Mildew/ mold from condensation.

**Task:** Upgrade

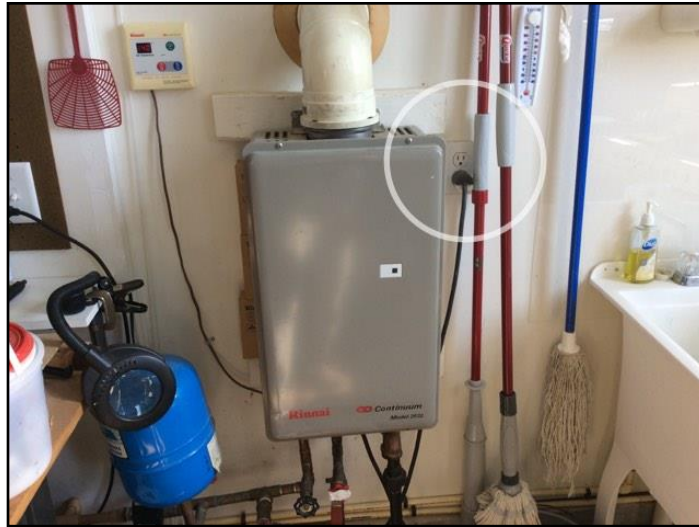
13.

**9. Condition:** • The tankless water heater in the garage is plugged into a GFI protected circuit. I recommend having it on a non-GFI outlet plugged into a dedicated outlet.

**Task:** Repair by licensed expert

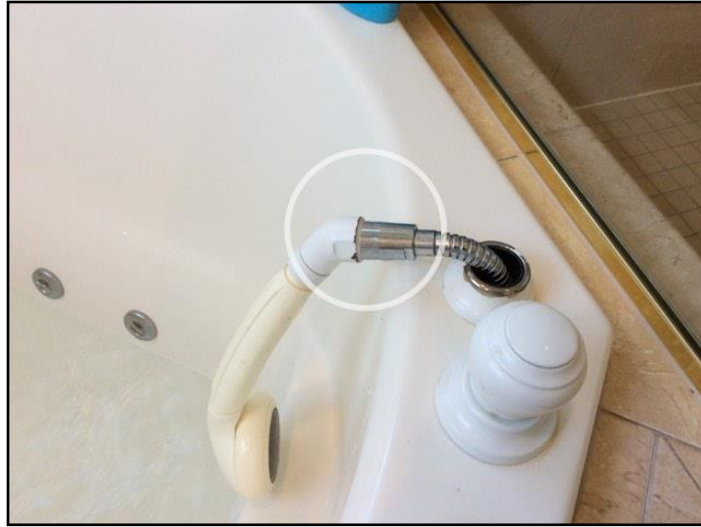
**10. Condition:** • [Drip, leak](#)

The master tub shower faucet leaks.

14. Drip, leak

**Task:** Repair

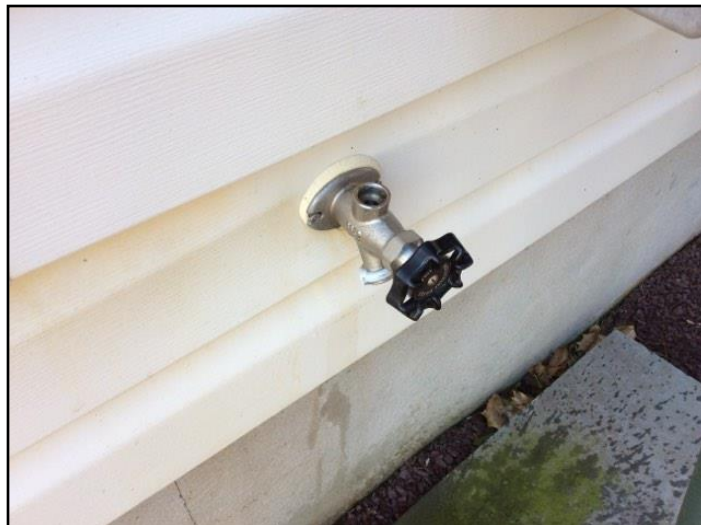
11. Condition: • [Damage](#)

The right side hose bib anti siphon is damaged.

15. Damage

**Task:** Repair by licensed expert

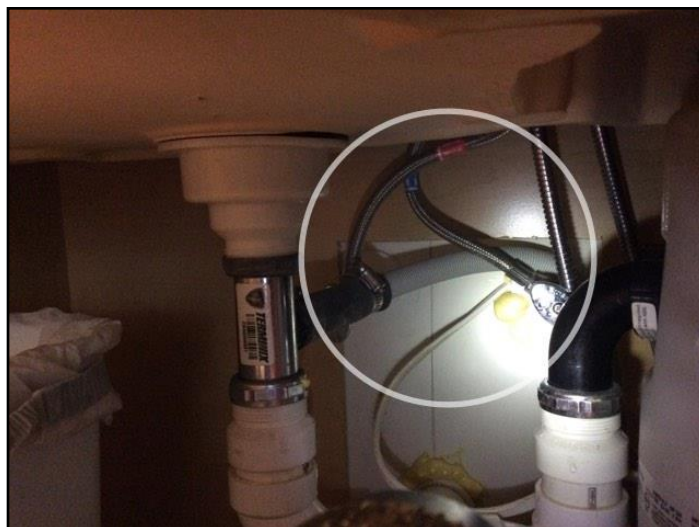
**12. Condition:** • Backflow prevention defective

The discharge hose needs to be strapped up higher to prevent back flow into the dishwasher.

**16.** *Backflow prevention defective*
