# Your Inspection Report

57 Kenneth Ave  
Toronto, ON M6P 1J1

**PREPARED BY:**  
Jim Gibson, P.Eng.

RE: Report No. 73954, v.2  
57 Kenneth Ave  
Toronto, ON  
M6P 1J1

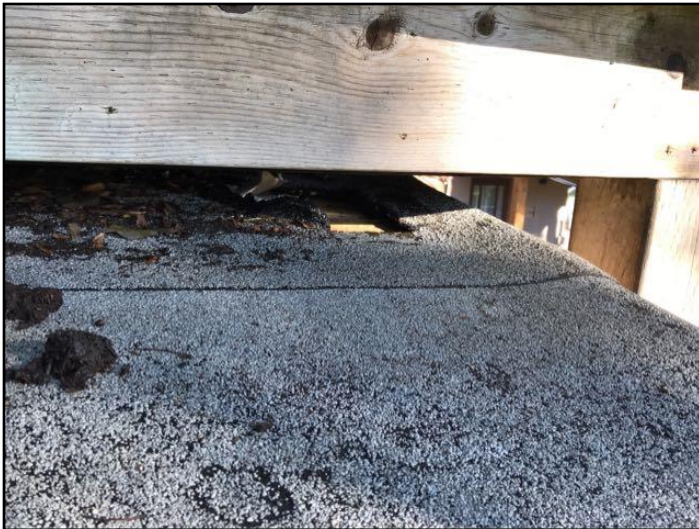
**Condition:** • [Damage, punctures, tears](#)

*Damage, punctures, tears*

**Task:** Further evaluation/repair

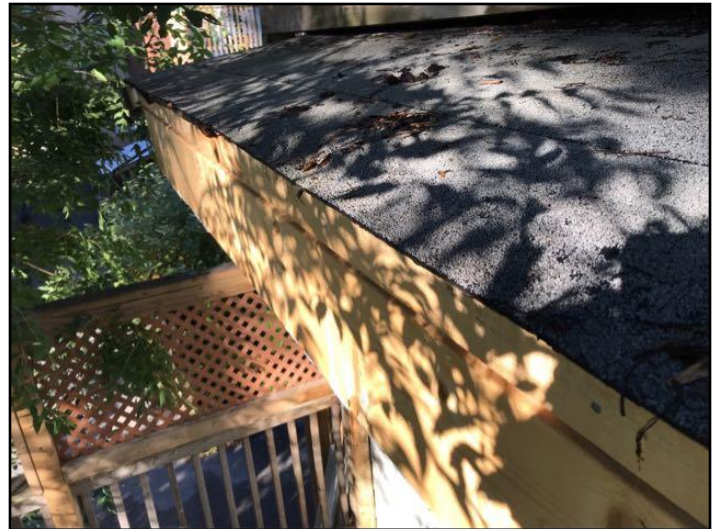
Drip edge - missing

*Drip edge - missing*

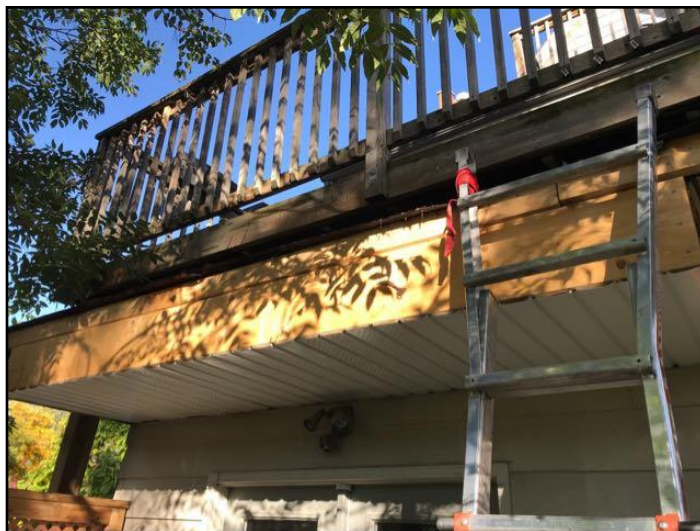
**Condition:** • Missing

*Missing*

**Task:** Provide

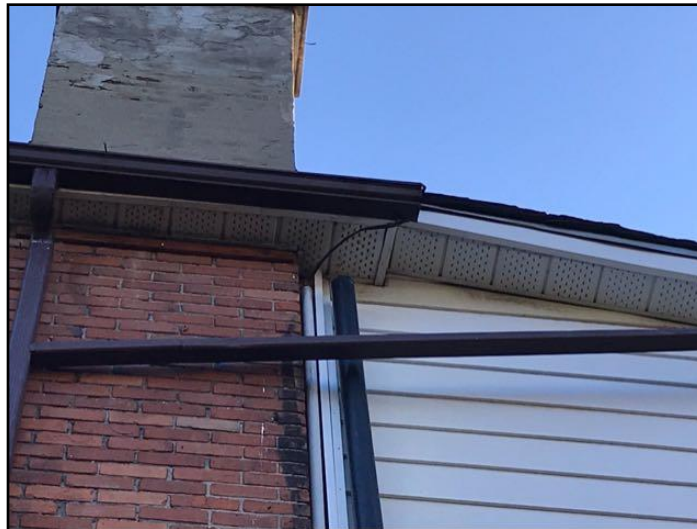
**Condition:** • [Leak](#)

*Leak*

**Task:** Repair

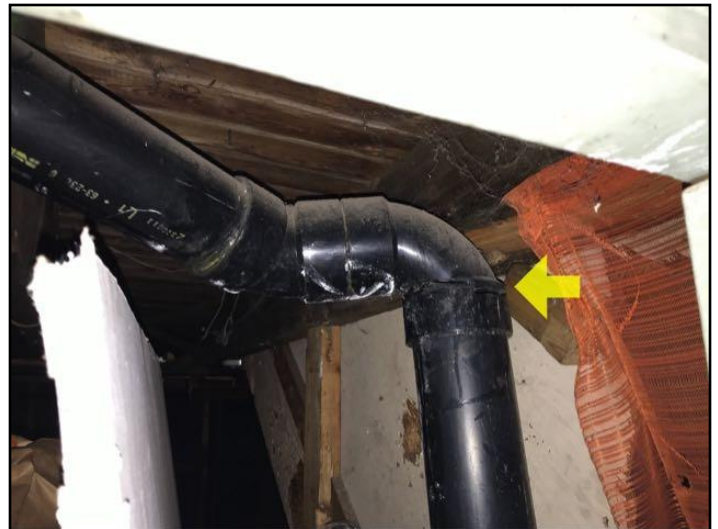
Connections poor, leak

*Damage, leak*

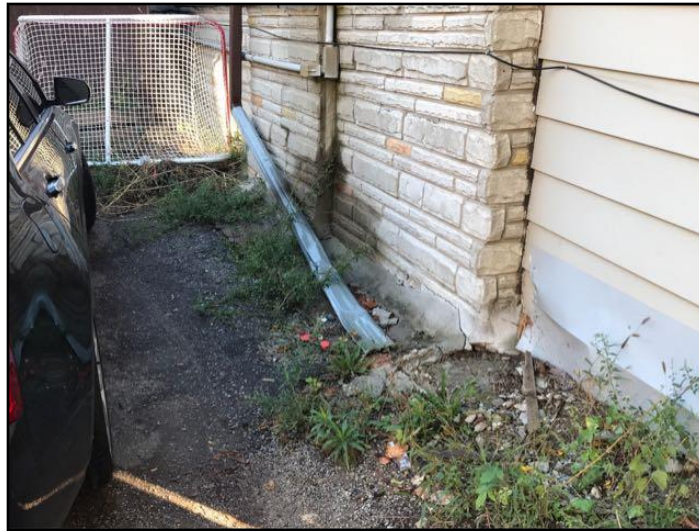
**Condition:** • [Damage](#)

*Damage*

**Task:** Replace/discharge above grade more than 2 m from building

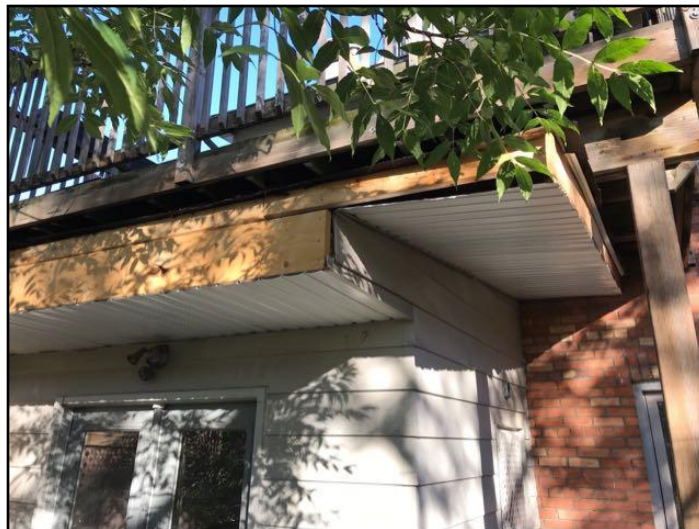
**Condition:** • Incomplete/missing, loose

*Incomplete/missing, loose*

**Task:** Repair

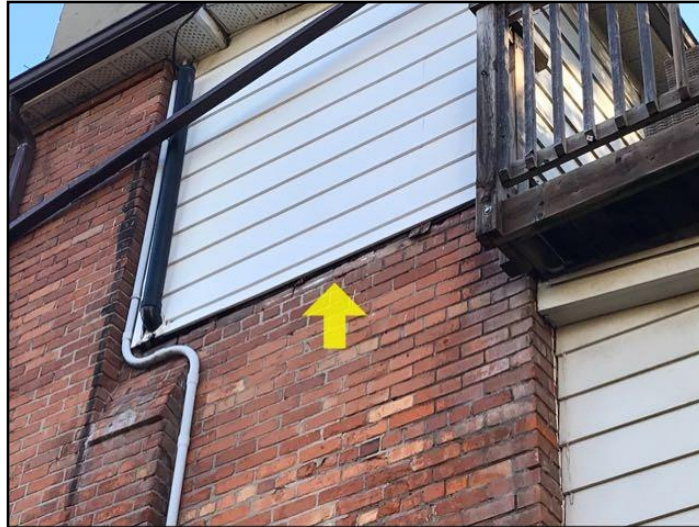
**Condition:** • Gaps/incomplete

*Gaps/incomplete*

**Task:** Further evaluation/repair

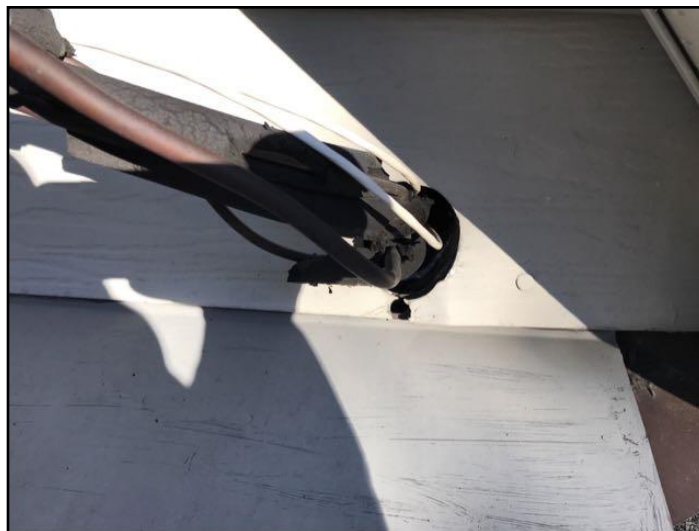
**Condition:** • Caulking - missing (around A/C lines)

*Caulking - missing*

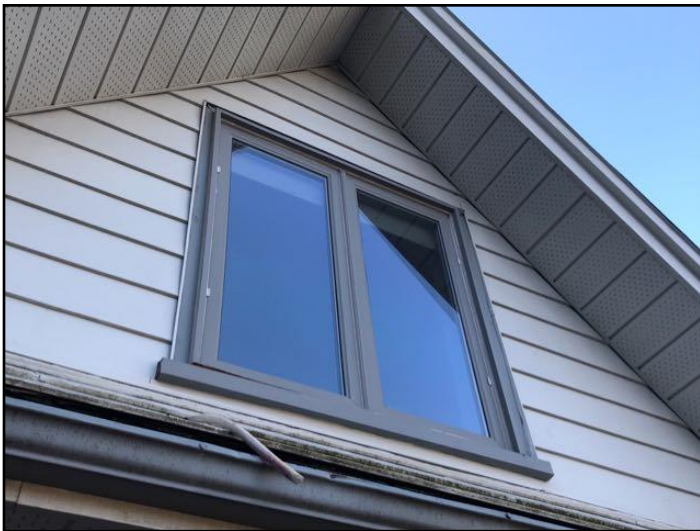
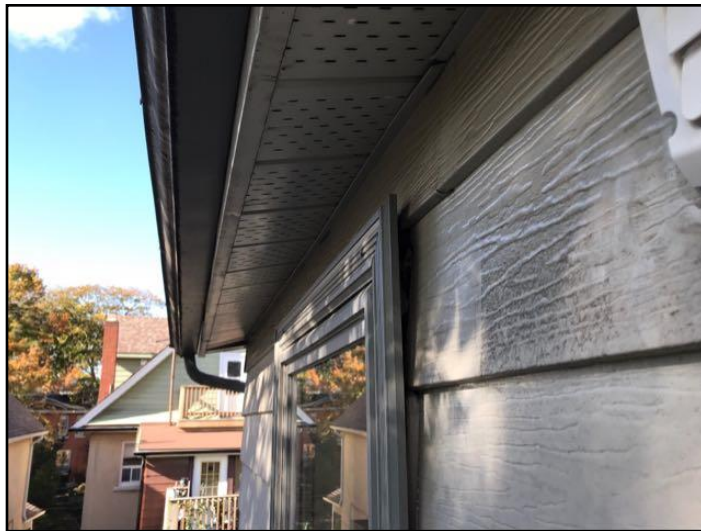
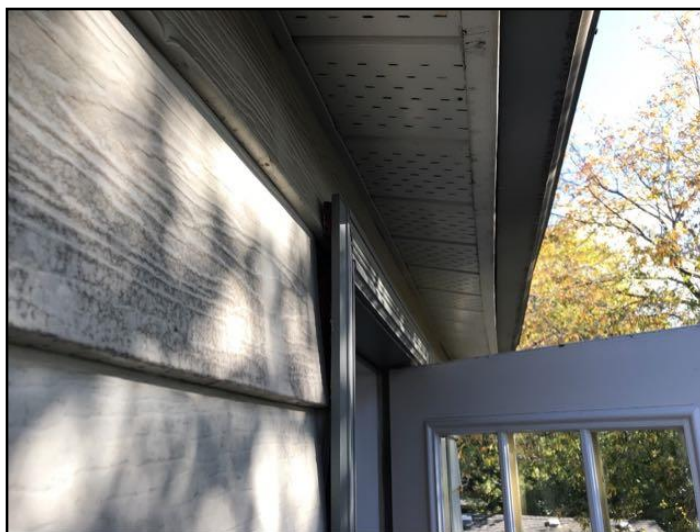
**Condition:** • Installation incorrect (project past wall openings)

Flashings - missing

Caulking - incomplete/missing

Vulnerable areas for leaks

*Installation incorrect*

**Task:** Further evaluation/repair

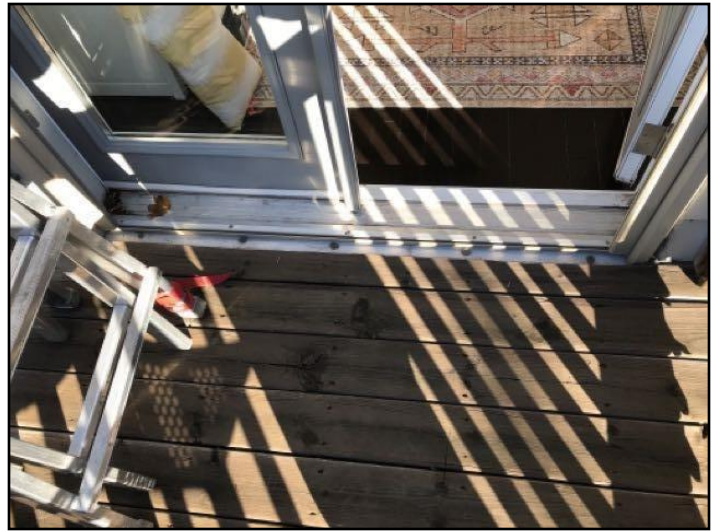
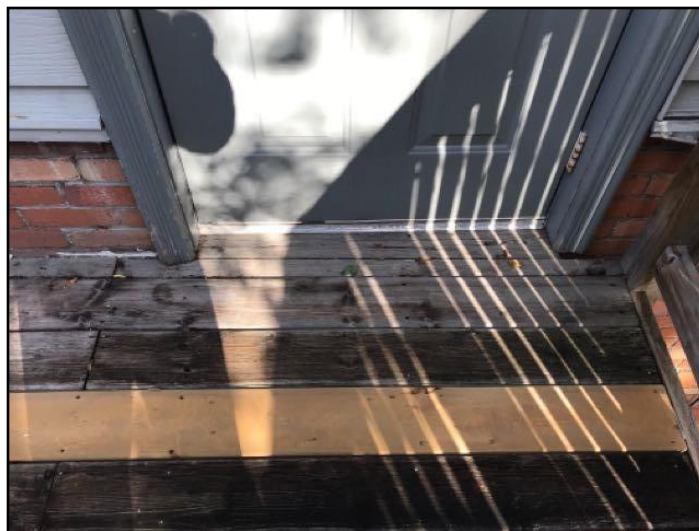
**Condition:** • Threshold too low

Vulnerable areas for leaks

*Threshold too low*

**Task:** Further evaluation/repair

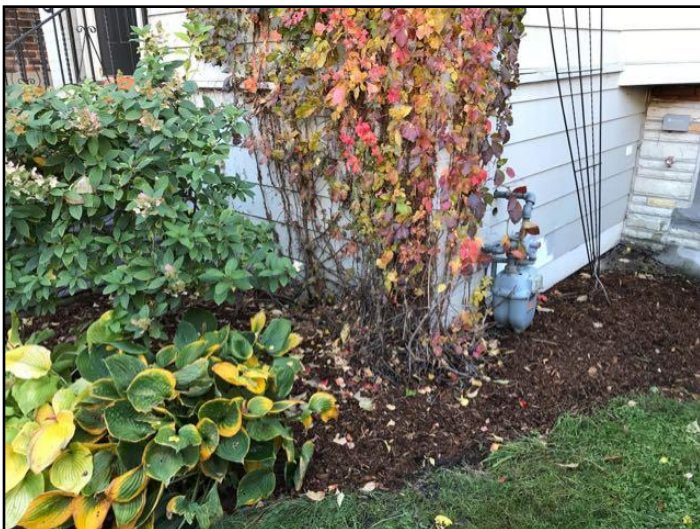
**Condition:** • Porch - wood/soil contact, water damage

Wood/soil contact, water damage

**Task:** Further evaluation/repair

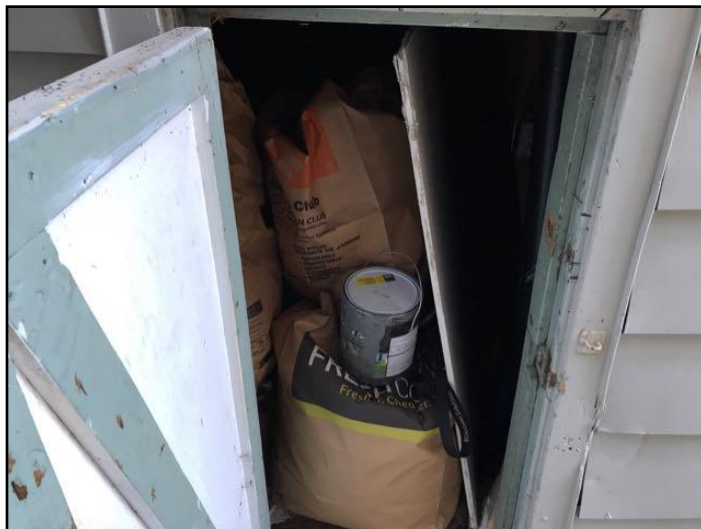
Access door - damage, loose

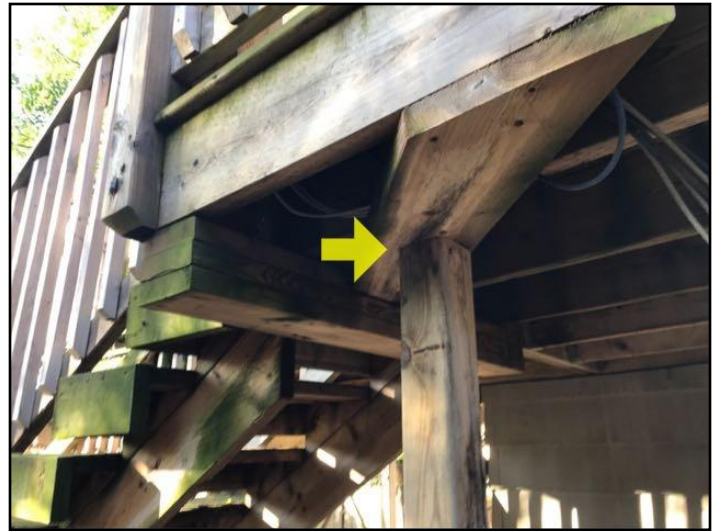
**Condition:** • [Connections weak](#)

Connections weak

**Task:** Repair

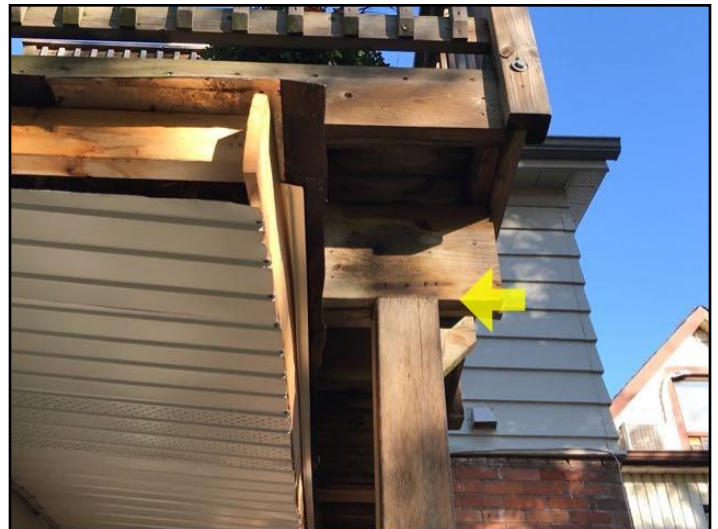
**Condition:** • [Connections weak](#)

Connections weak

**Task:** Repair

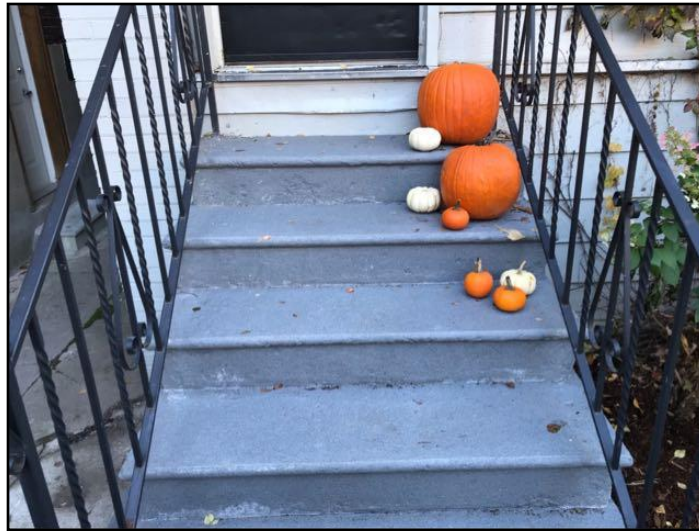
**Condition:** • Landing - too small/missing

*Landing - too small/missing*

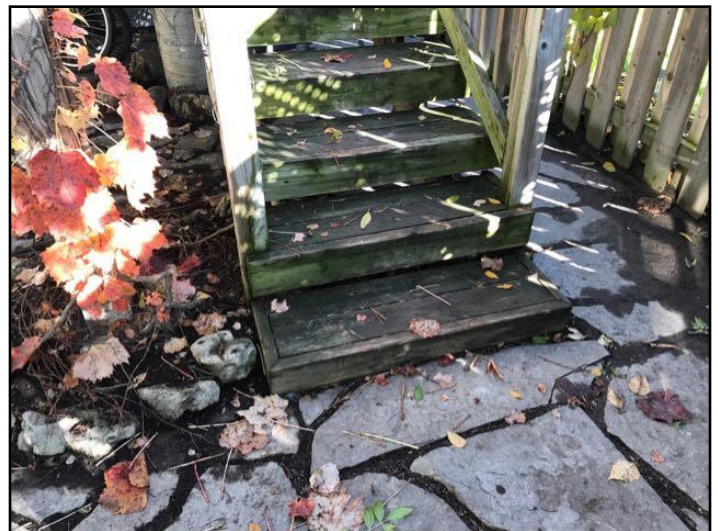
*Wood/soil contact*

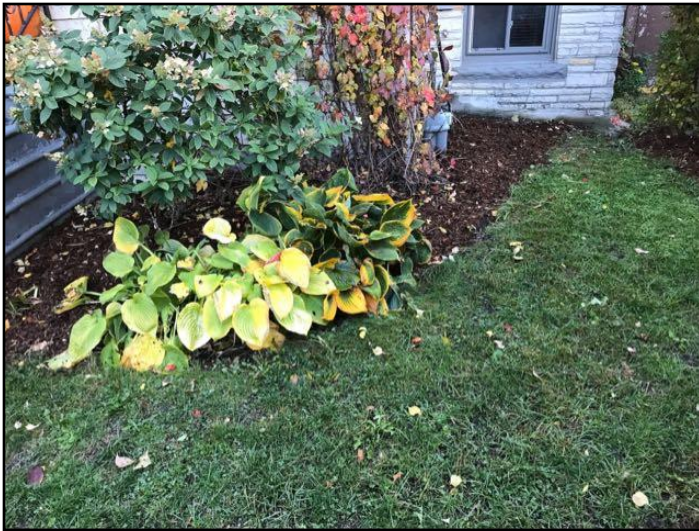
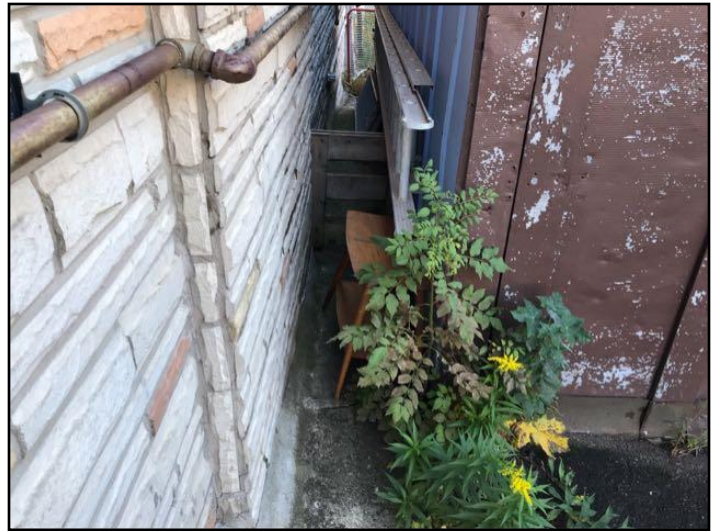
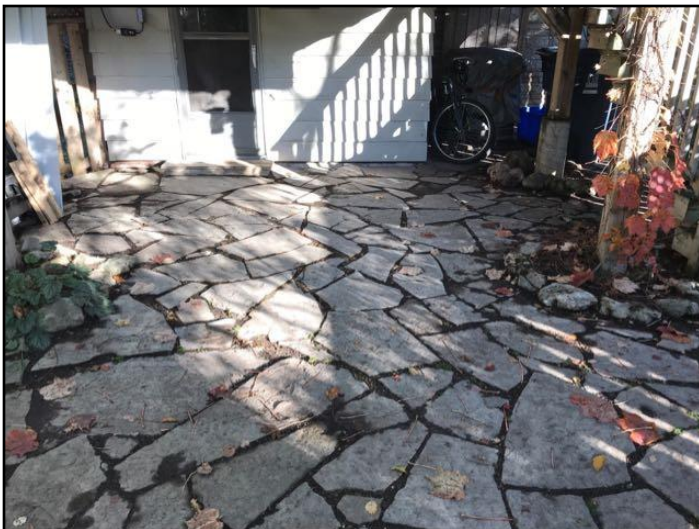
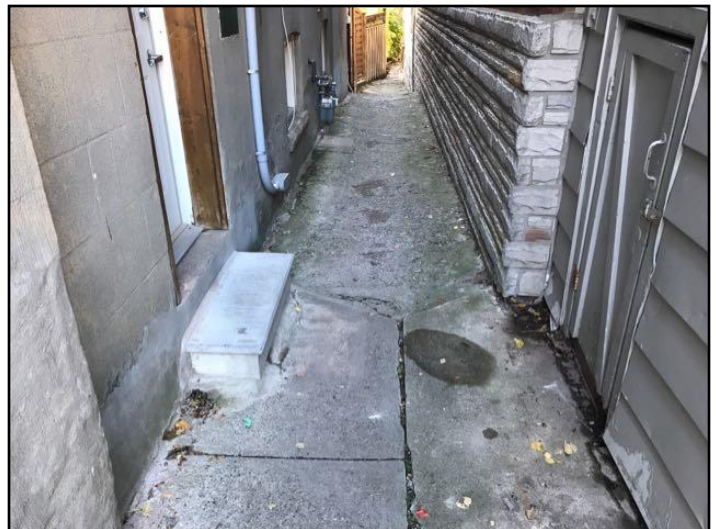
**Condition:** • [Improper slope or drainage](#)

*Improper slope or drainage*

**Task:** Repair

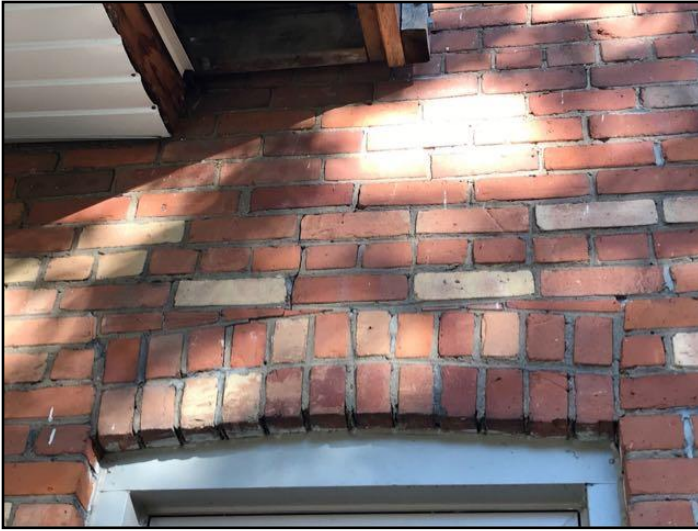
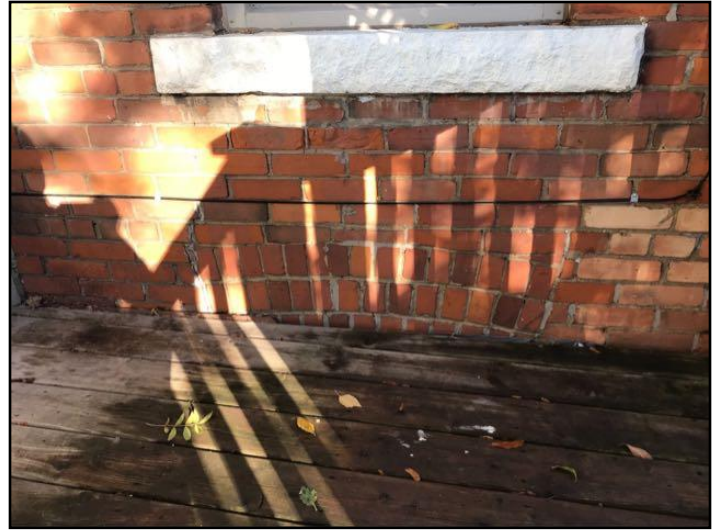
**Condition:** • Typical minor cracks

*Typical minor cracks*

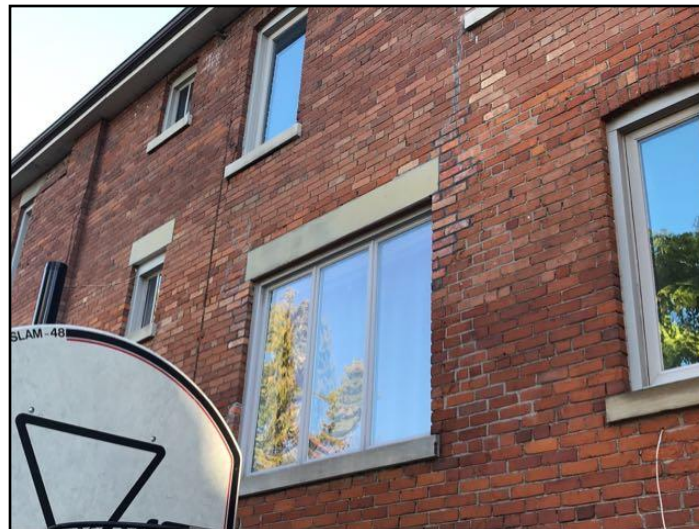
**Condition:** • Prior repairs

*Prior repairs*

**Task:** Monitor

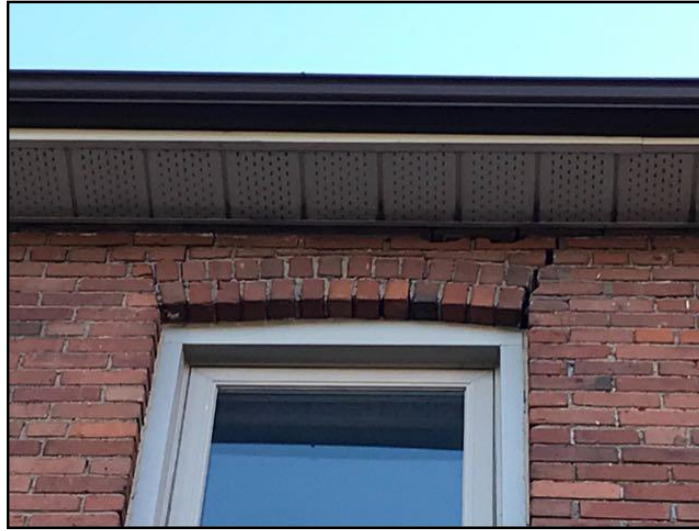
**Condition:** • Arch - movement, cracks

Mortar - deteriorated/missing

*Arch - movement, cracks*

**Task:** Repair

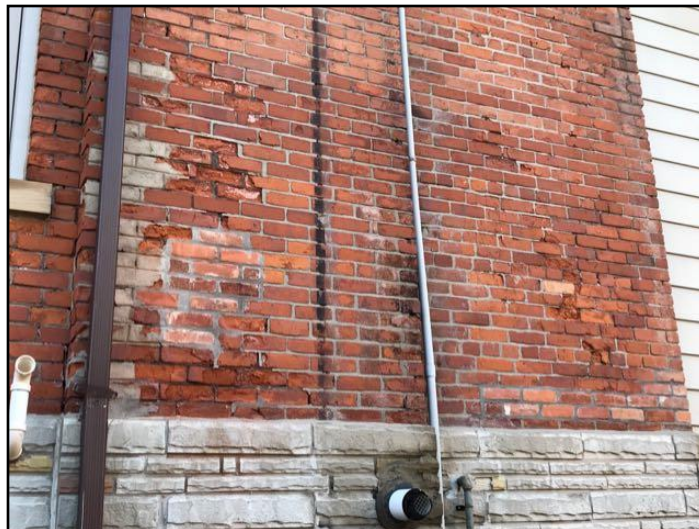
**Condition:** • Freeze/thaw damage

*Freeze/thaw damage*

**Task:** Monitor

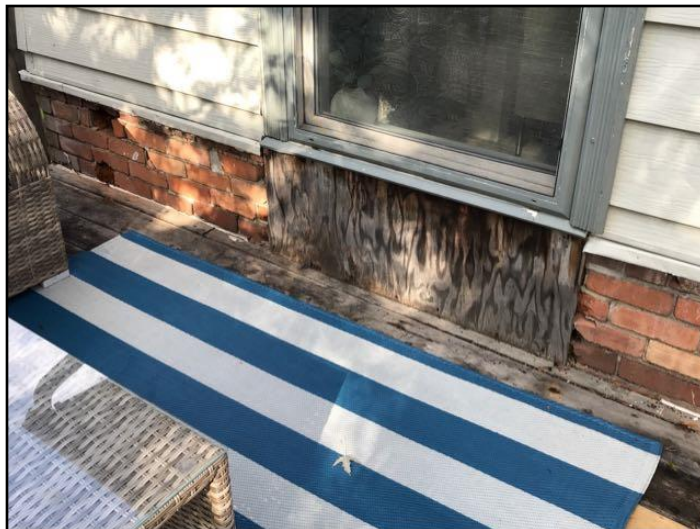
**Condition:** • Masonry and mortar - incomplete/missing, leak

Siding (plywood) - water damage

Paint and caulking - missing

*Masonry and mortar - incomplete/missing...*

**Task:** Repair

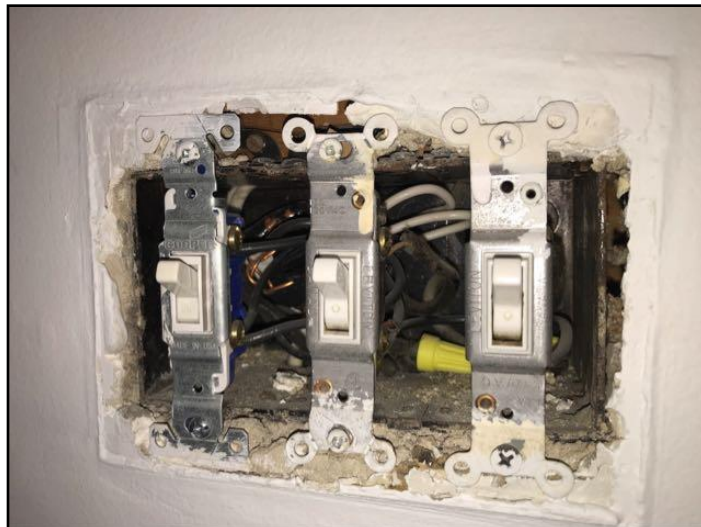
**Condition:** • Knob and Tube Wiring - in use (active/live)

*Knob and Tube Wiring - in use*

**Task:** Further evaluation/replace

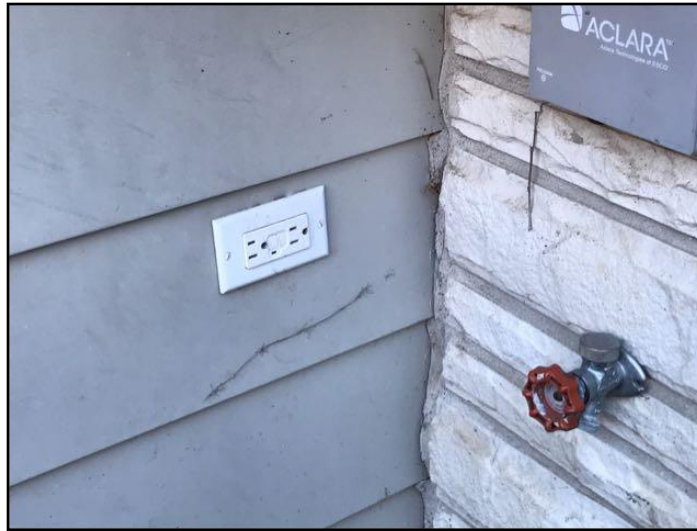
**Condition:** • GFCI outlet - wrong type (not exterior grade)

*GFCI outlet - wrong type*

**Task:** Replace/upgrade

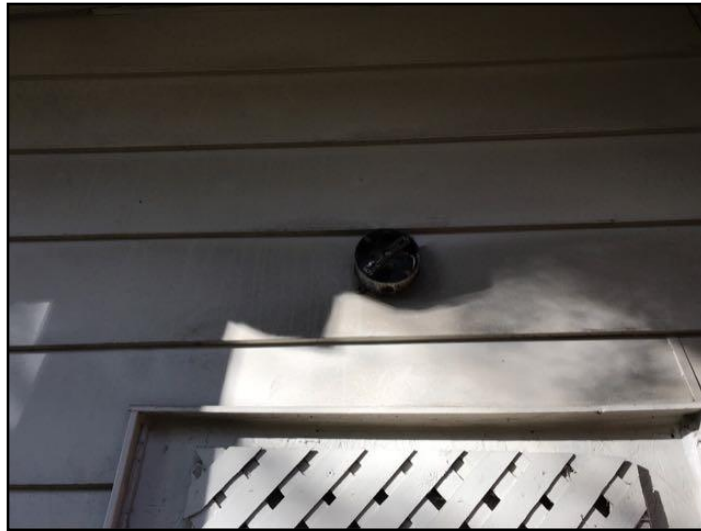
**Condition:** • [Missing](#)

*Missing*

**Task:** Provide/repair

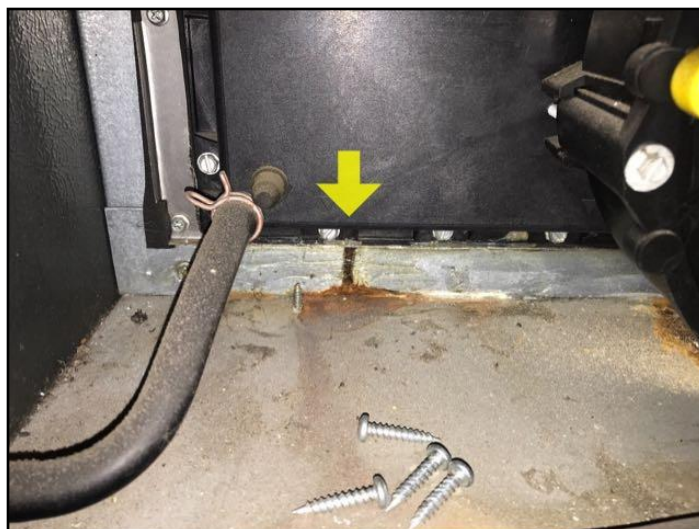
**Condition:** • Secondary heat exchanger - prior condensate leak, suspect prior repair

Prior condensate leak...

**Task:** Further evaluation/repair

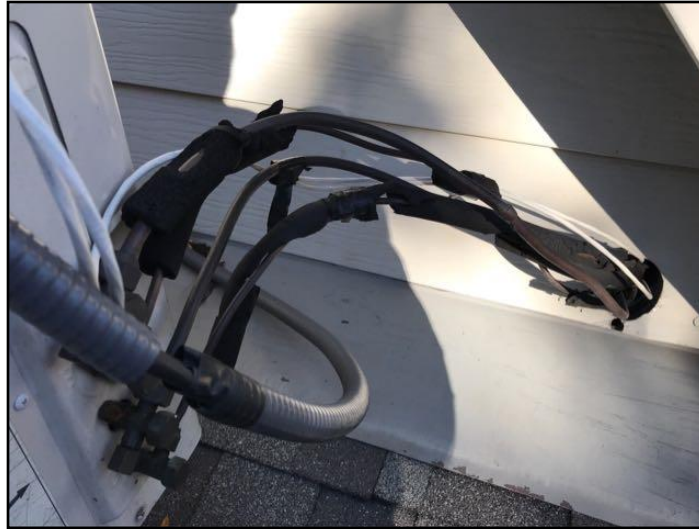
**Condition:** • Insulation - incomplete/missing

*Insulation - incomplete/missing*

**Task:** Replace

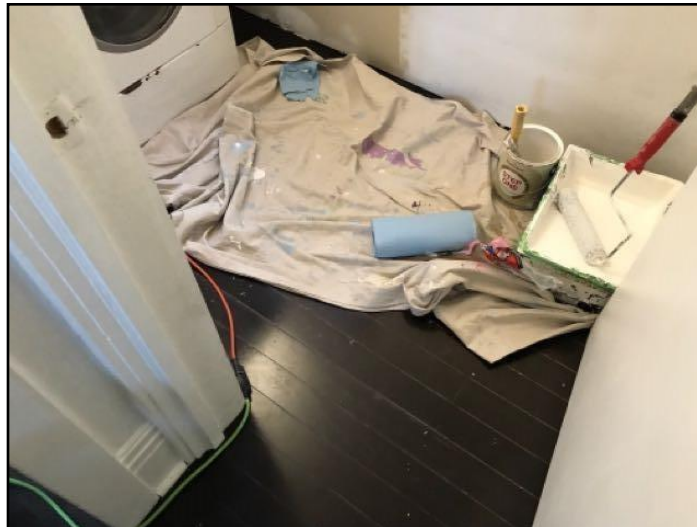
**Condition:** • Floor drains - not visible/missing

*Floor drain - not visible/missing*

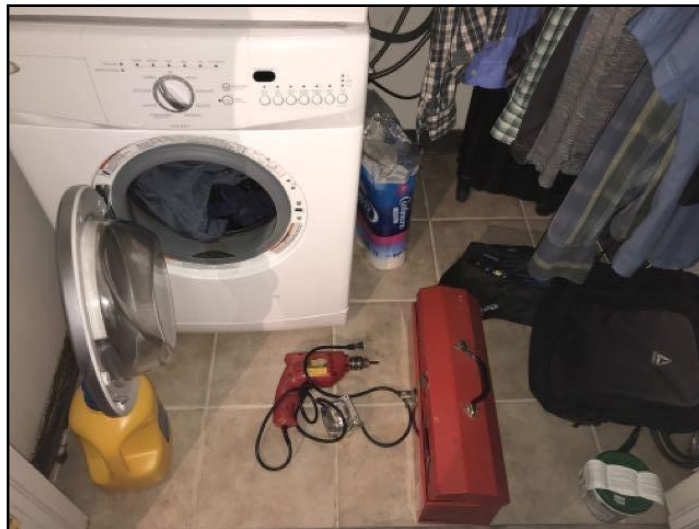
**Condition:** • Floor drain - not visible/missing

*Floor drain - not visible/missing*

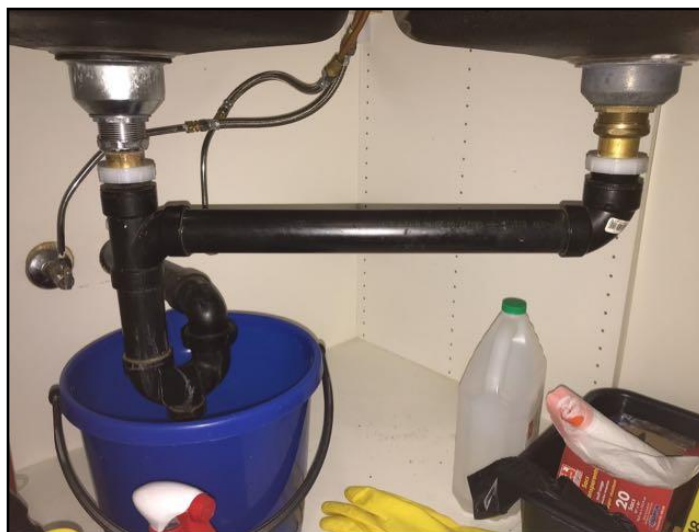
**Condition:** • [Leak](#)

*Leak*

**Task:** Repair

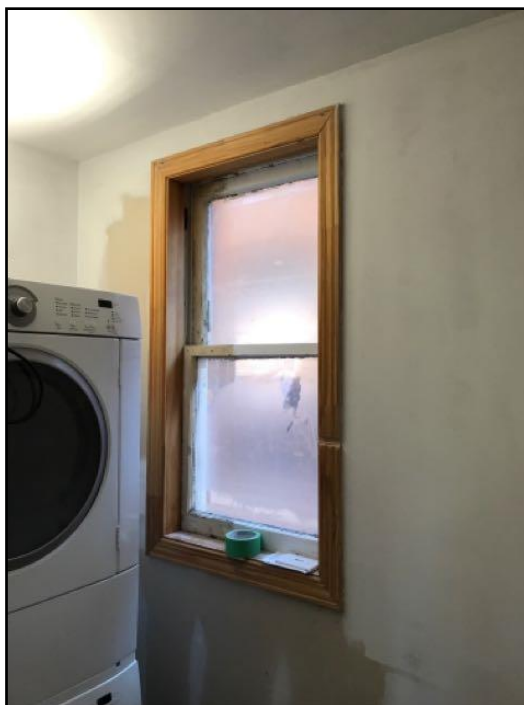
**Condition:** • Counter balance - mechanism missing

Storm window - missing

*Counter balance - mechanism missing*

**Task:** Repair/replace

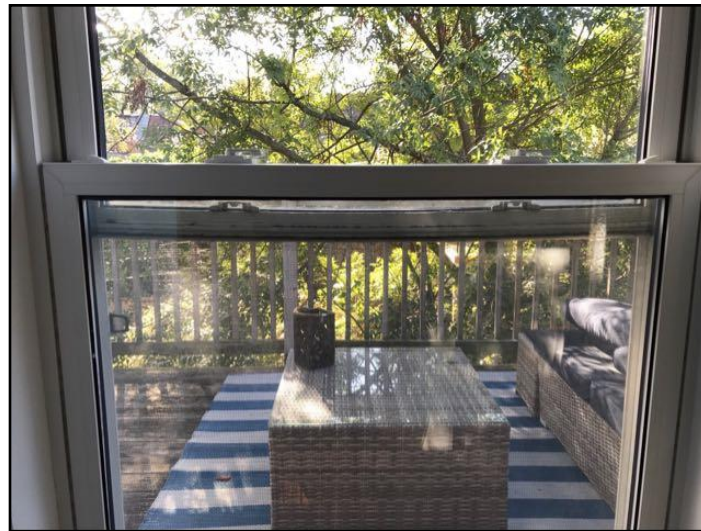
**Condition:** • Upper sash - sagging

*Upper sash - sagging*

**Task:** Repair/replace

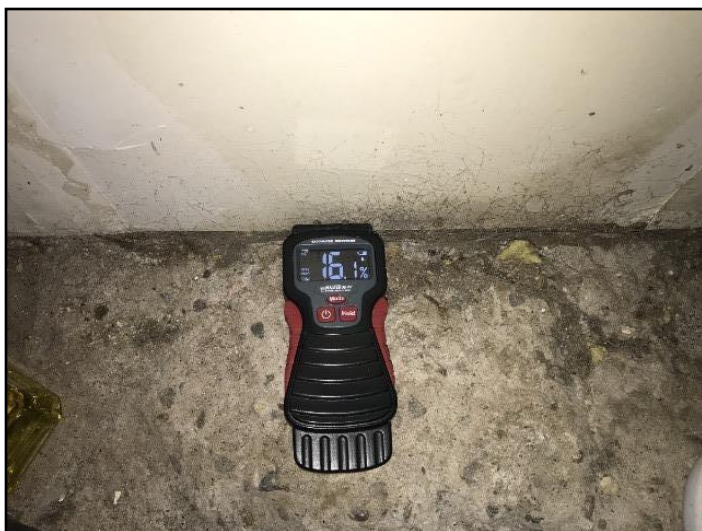
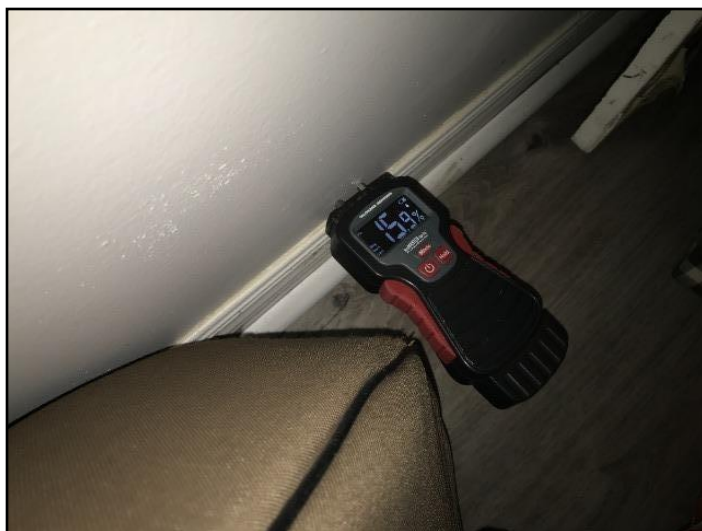
**Condition:** • Dampness

Dampness

1. First, ensure gutters and downspouts carry roof run-off away from the home. (relatively low cost)
2. If problems persist, slope the ground (including walks, patios and driveways) to direct water away from the home. (Low cost if done by homeowner. Higher cost if done by contractor or if driveways, patios and expensive landscaping are disturbed.)
3. If the problem is not resolved and the foundation is poured concrete, seal any leaking cracks and form-tie holes from the inside. (A typical cost is \$300 to \$600 per crack or hole.)
4. As a last resort, dampproof the exterior of the foundation, provide a drainage membrane and add/repair perimeter drainage tile. (High cost)
