YOUR INSPECTION REPORT

FOR THE PROPERTY AT:
48 Parkdale Rd
Toronto, ON

INSPECTION DATE:
Wednesday, May 3, 2017

RE: Report No. 2112
48 Parkdale Rd
Toronto, ON

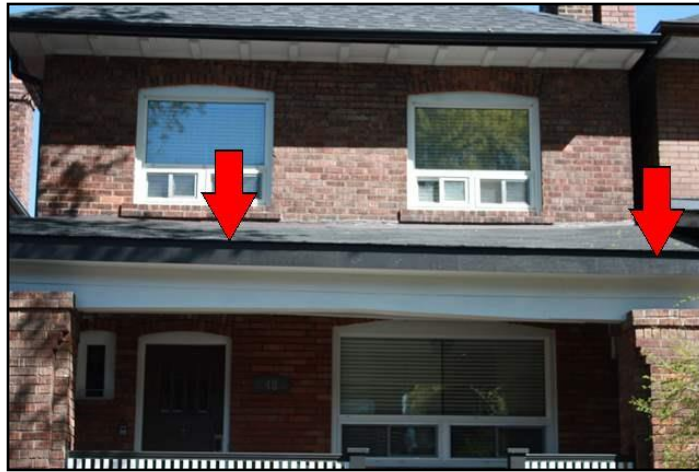
1. Missing Gutters (eavestrough)

Condition: • [Missing](#)

Implication(s): Chance of water damage to contents, finishes and/or structure

Location: Front Exterior Porch Roof

Task: Provide gutters

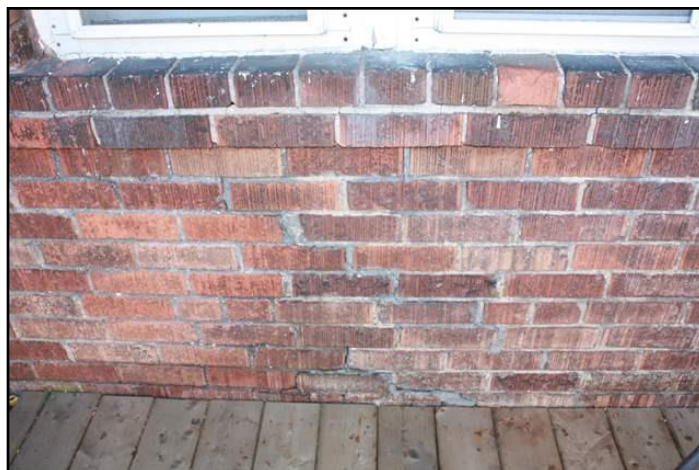
2. Cracked

Condition: • [Cracked](#)

Minor cracking / settlement noted below window. We could not see the wall below the deck so we could determine if the crack changes where not visible. These types of cracks/settlement is very common for a home of this age. Patch when performing overall masonry and chimney repairs. It's always prudent to monitor repaired areas for any activity.

Implication(s): Chance of movement | Weakened structure | Chance of water entering building

Location: Rear Exterior Wall

Task: Repair

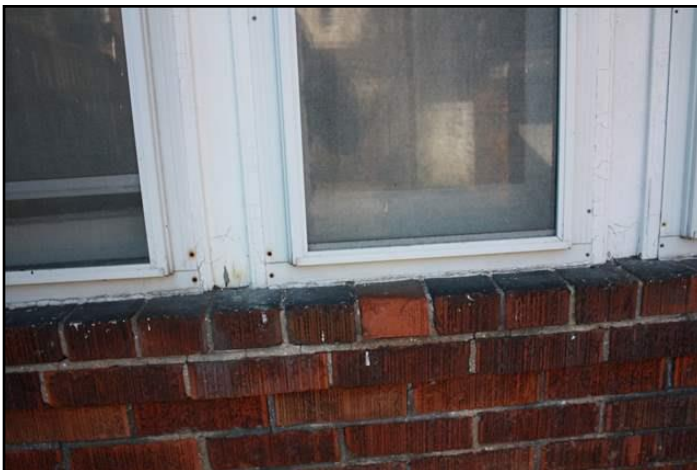
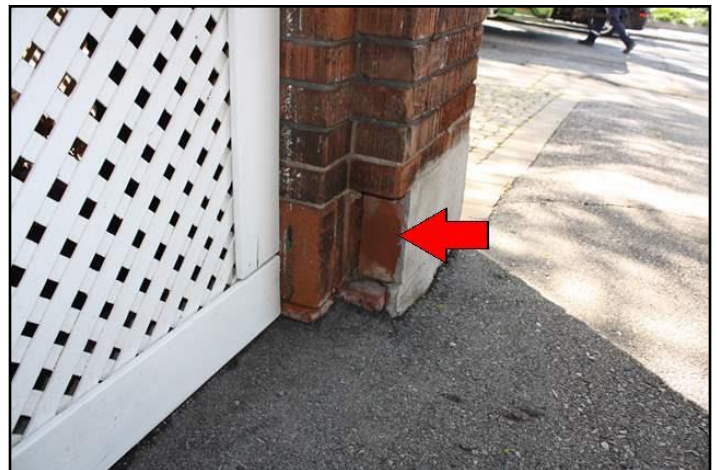
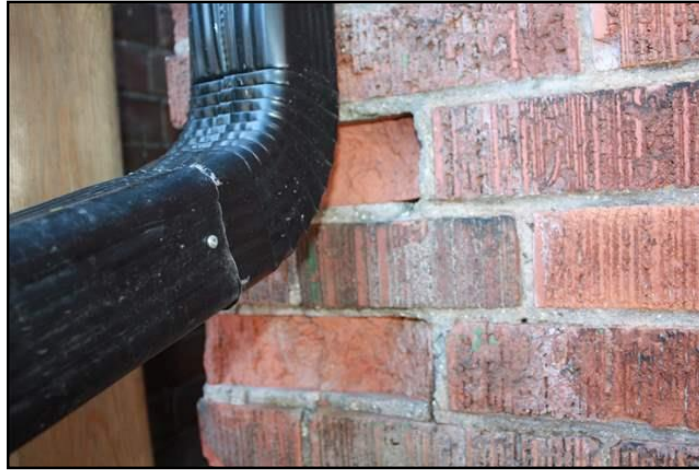
Condition: • [Spalling](#)

Spalling/ masonry deterioration noted at various areas. Repair / Replace / Tuck point masonry. This is regular maintenance for a home of this age.

Implication(s): Weakened structure | Chance of structural movement

Location: Various Exterior Wall

3. Example of spalling

4. Spalling

5. Spalling

Task: Repair

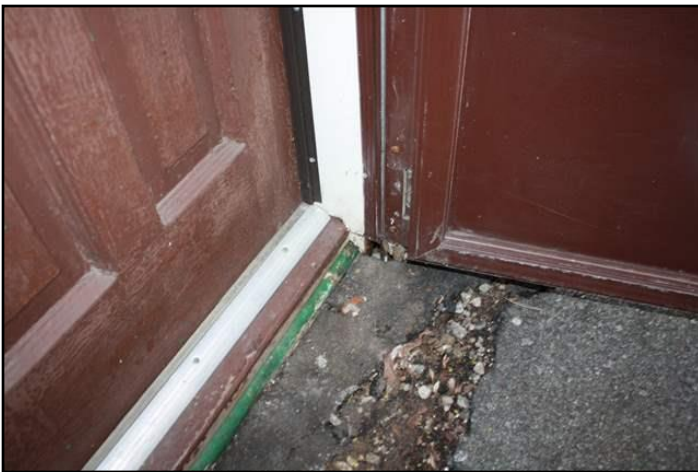
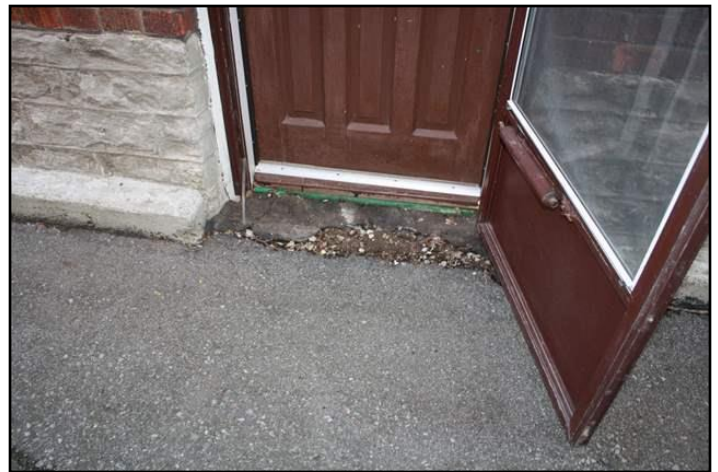
Condition: • [Sill too low](#)

Step up into house is less than 6 inches. Also gaps were noted around door. These gaps should be sealed to prevent water entry.

Implication(s): Chance of damage to finishes and structure

Location: West Exterior

6. Gaps

7. Door threshold missing, too low, not...

Task: Improve

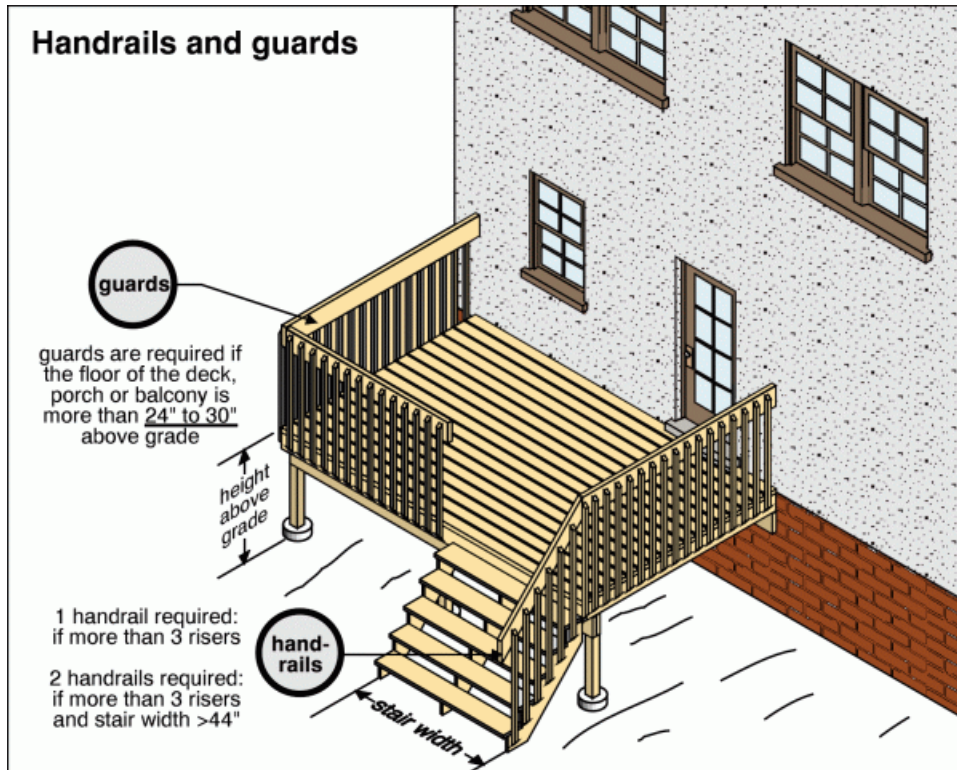
Condition: • [Missing](#)

Implication(s): Fall hazard

Location: Front Exterior Staircase

Task: Provide handrail

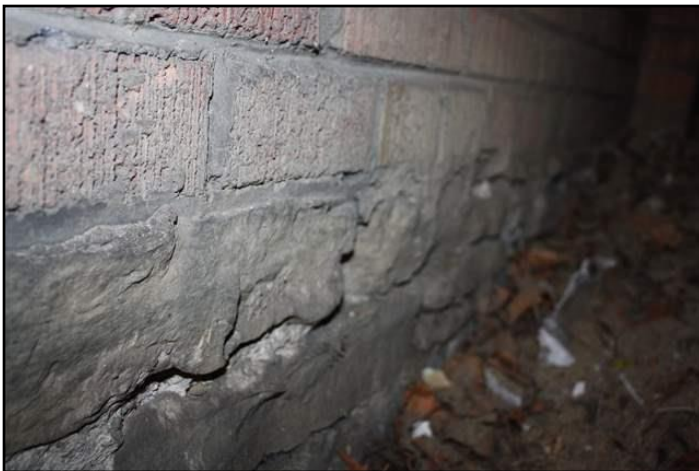
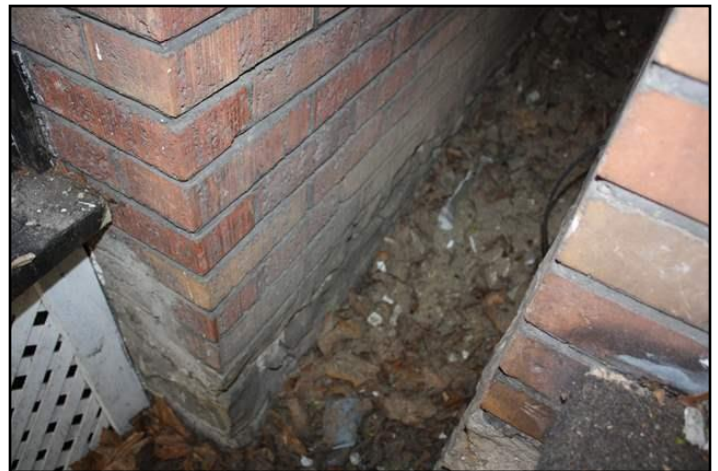
Condition: • [Mortar deteriorating or missing](#)

Due to the lack of space between the houses, only a very small portion of the East wall was observed. Stone foundations are older and usually require mortar work.

Implication(s): Chance of structural movement | Weakened structure

Location: East Exterior Wall

8. Mortar deteriorating or missing

9. Mortar deteriorating or missing

Task: Repair

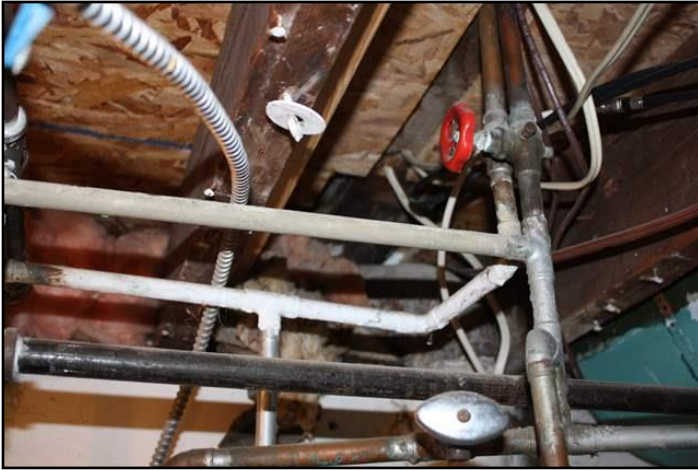
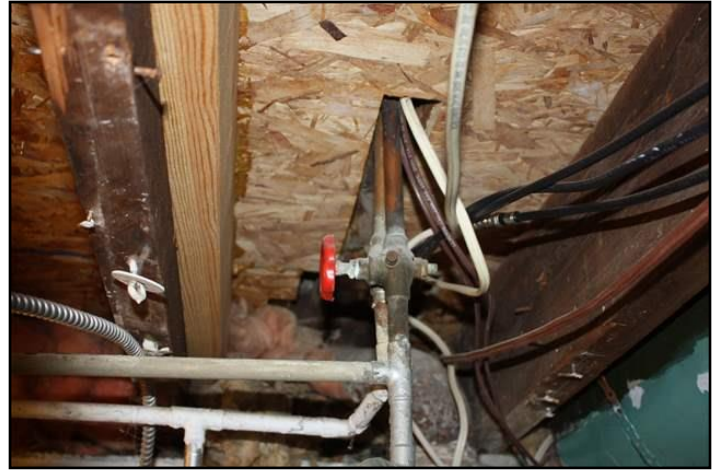
Condition: • [Prior repairs](#)

Joist repairs noted.

Implication(s): Chance of structural movement | Weakened structure

Location: Basement Boiler Room

10. Prior repairs

11. Prior repairs

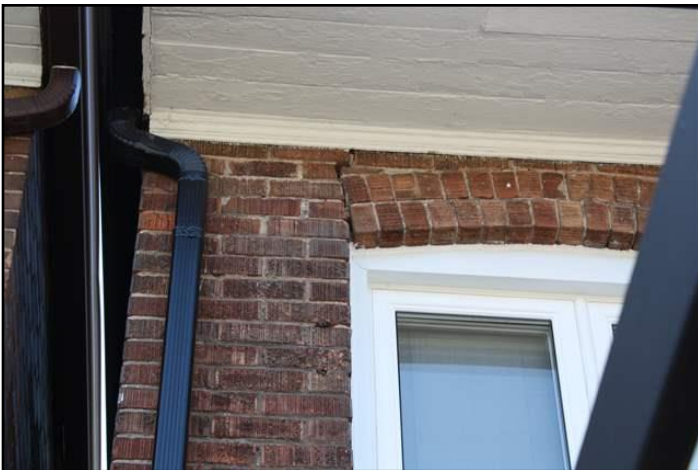
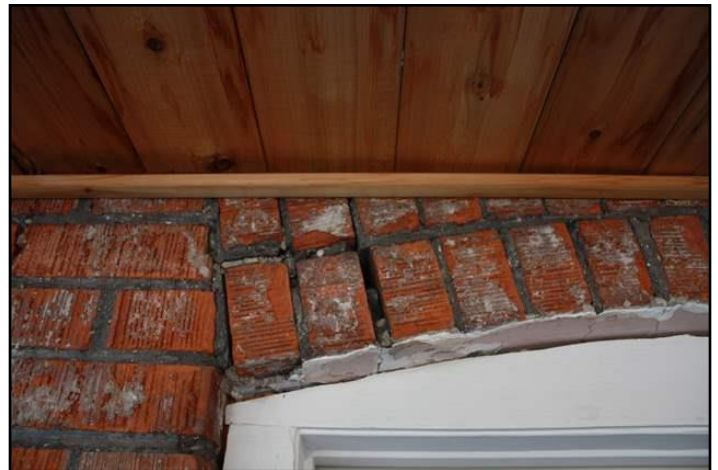
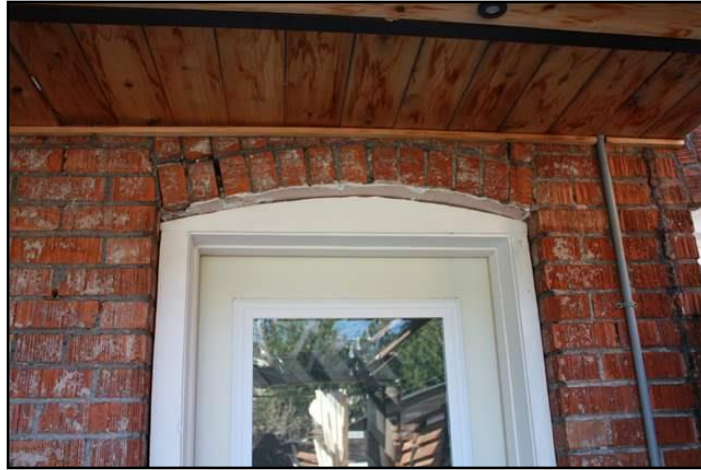
Condition: • [Mortar deteriorating](#)

Implication(s): Weakened structure | Chance of structural movement

Location: North Exterior Wall

12. Mortar deteriorating

13. Mortar deteriorating

14. Mortar deteriorating

Task: Improve

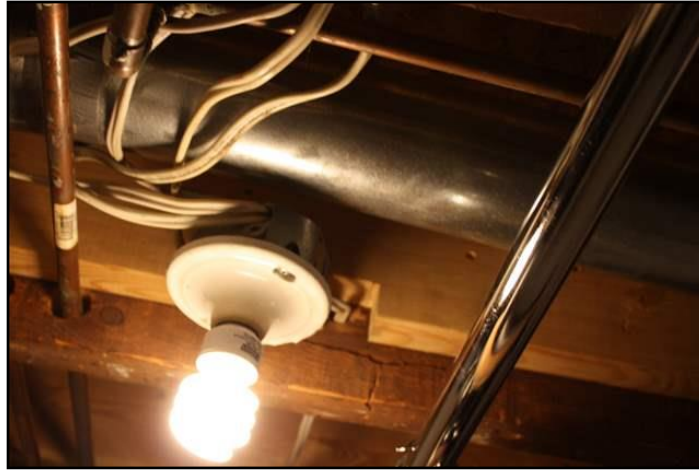
15. example

Condition: • [Too close to ducts, pipe, chimneys, etc.](#)

Problem can usually be solved by adding some insulation between the wire and ducts.

Implication(s): Fire hazard | Electric shock

Location: Basement

Task: Correct

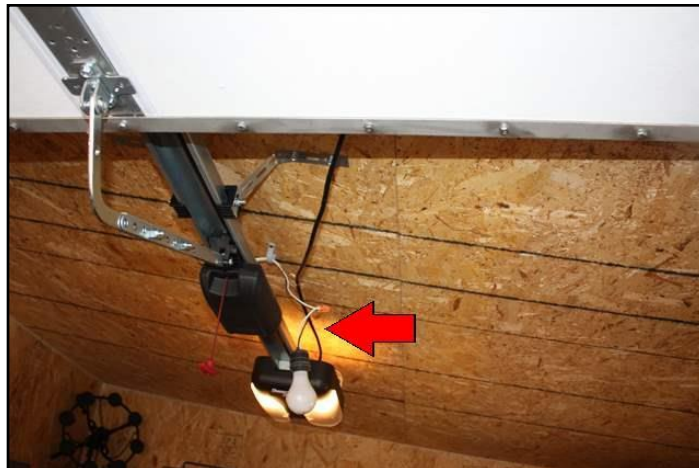
Condition: • [Loose](#)

Open splice connection. Enclose wire connection is a light fixture box.

Implication(s): Fire hazard | Electric shock

Location: Garage

16. Loose

Task: Correct

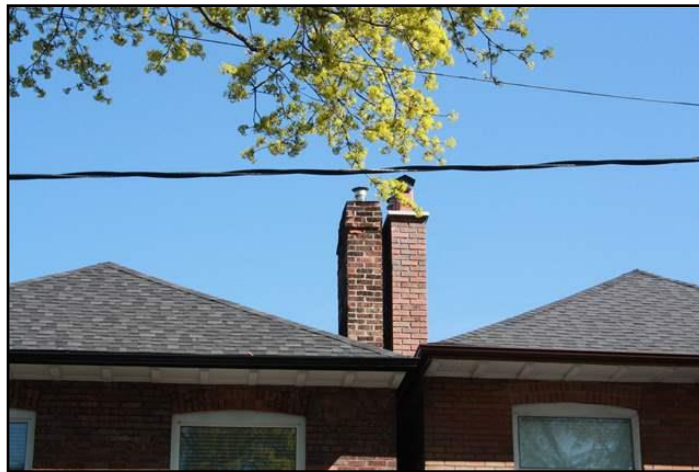
Condition: • [Loose, missing or deteriorated masonry](#)

Implication(s): Material deterioration

Location: Exterior

17. Loose, missing or deteriorated masonry

Task: Repair

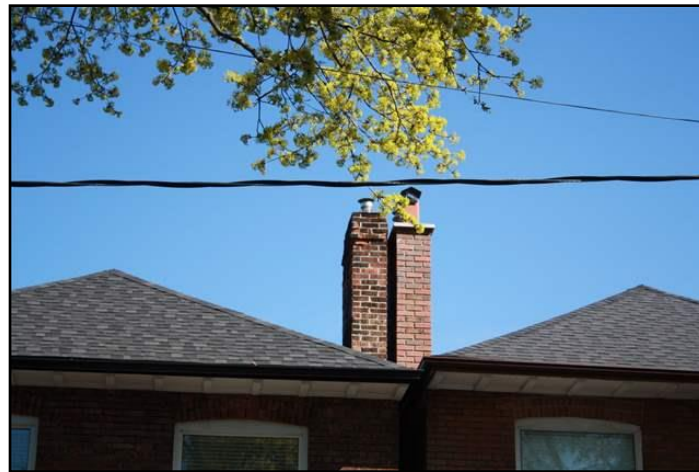
Condition: • [Missing](#)

Implication(s): Shortened life expectancy of material | Chance of water damage to contents, finishes and/or structure

Location: Exterior

18. Missing

Task: Provide

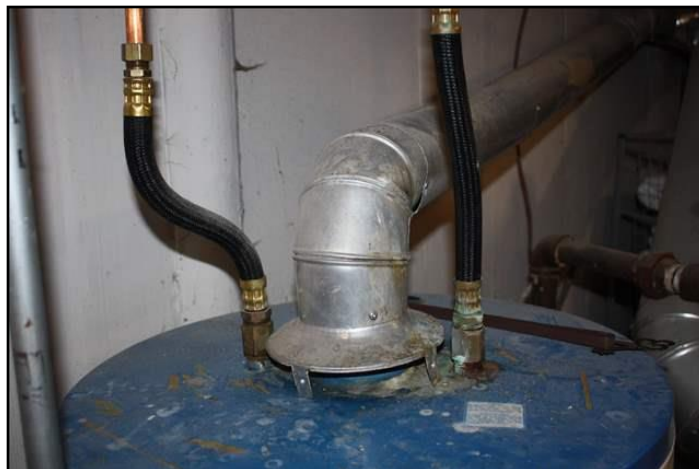
19.

Condition: • Non standard material used. (These types of hoses are usually used as piping for washing machines)

Task: Replace

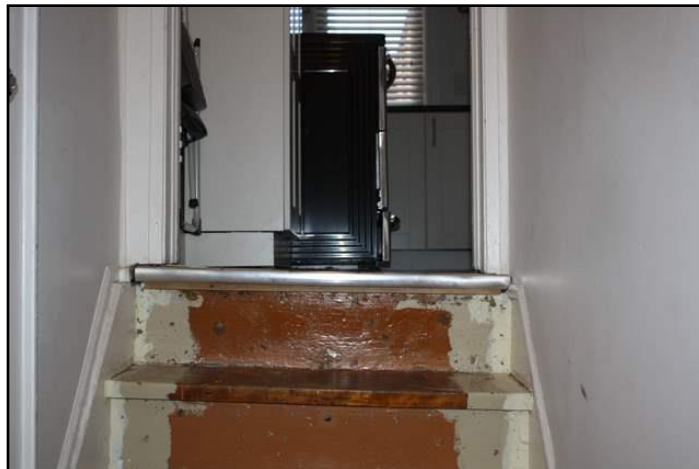
Condition: • Slope Noted. Older homes tend to have saggy, sloping floors. If you choose to make repairs to level the floors, repairs can require invasive and extensive work that can cost tens of thousands of dollars.

Photo shows an example of the sloped floors as viewed in kitchen

20. Slope Noted.

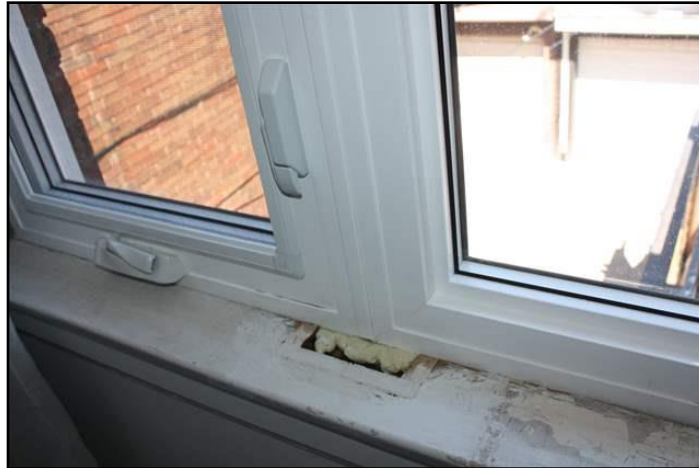
21. Example

Condition: • Damaged - Likely when windows were replaced the mid trim was removed

Task: Replace or Repair sill
