# Your Inspection Report

1234 Main Street  
Whoville, MI 98098

RE: Report No. 1810, v.2  
1234 Main Street  
Whoville, MI  
98098

# ROOFING

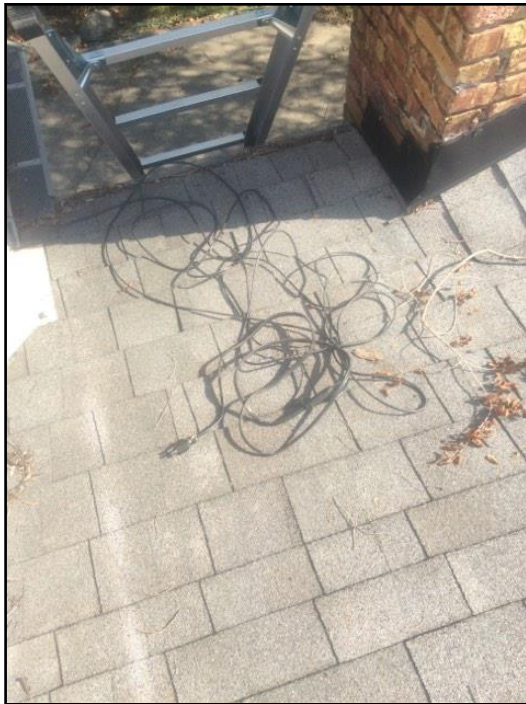
**1. Condition:** • Heat tape indicates ice damming issues. Properly install insulation is needed above rear wall. Get disclosure regarding leakage/ice dams

1. Heat tape indicates ice damming issues

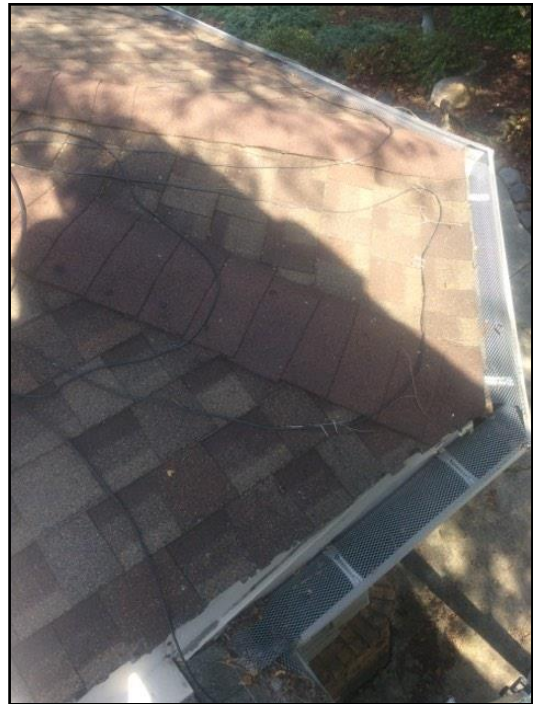
2. Heat tape indicates ice damming issues

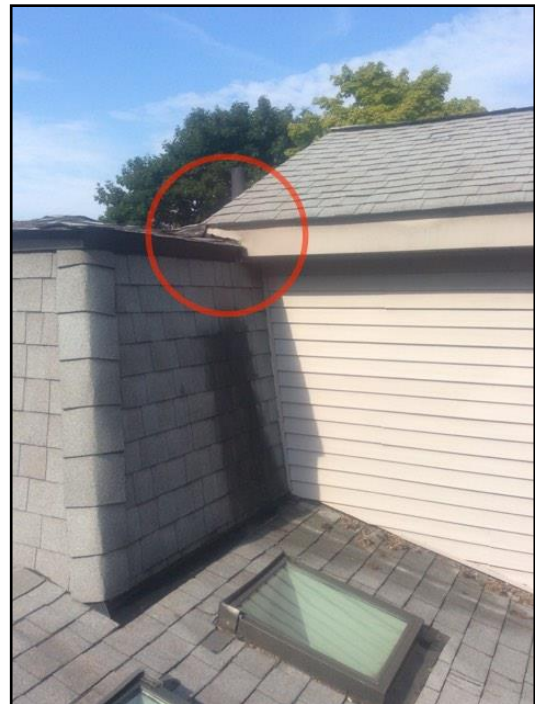
3. Condition: • Inspect & repair, as needed.

5. Inspect & repair, as needed

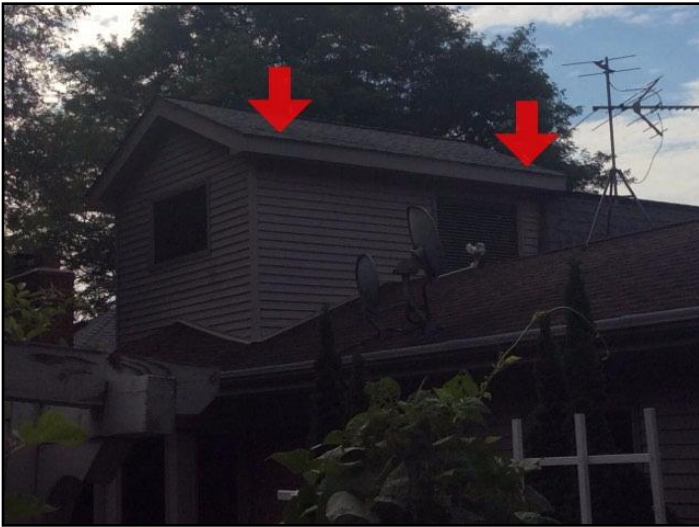
4. Condition: • [Missing](#)

Implication(s): Chance of water damage to contents, finishes and/or structure

9. Missing

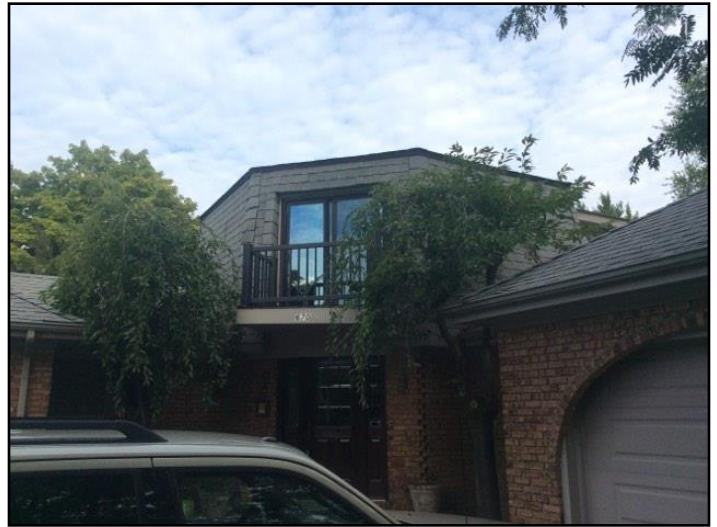
10. Missing

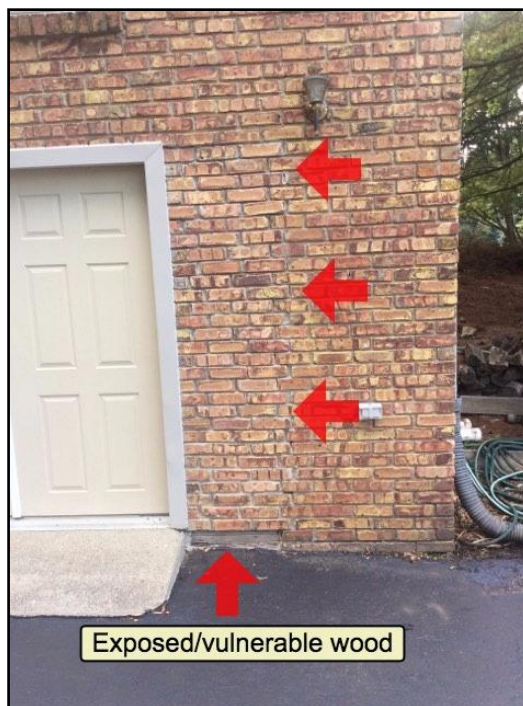
### 5. Condition: • [Cracked](#)

Wood is improperly protected in this area

**Implication(s):** Chance of water entering building | Weakened structure | Chance of movement

12. Previous patched cracked

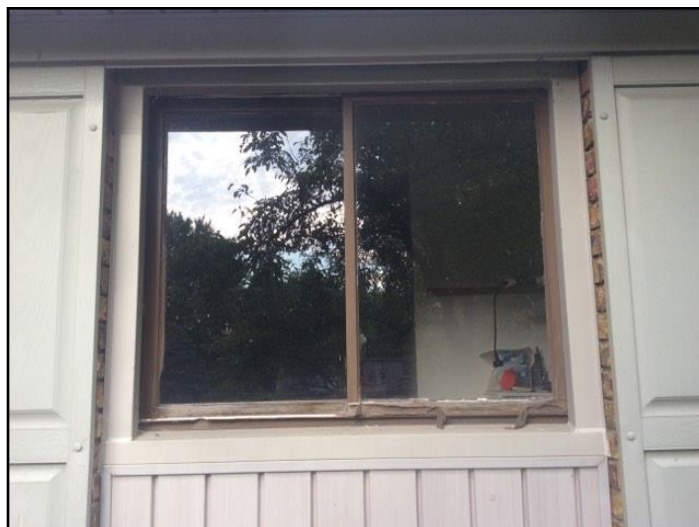
6. Condition: • Rot

Implication(s): Material deterioration

Location: Both Garage Windows

13. Rot

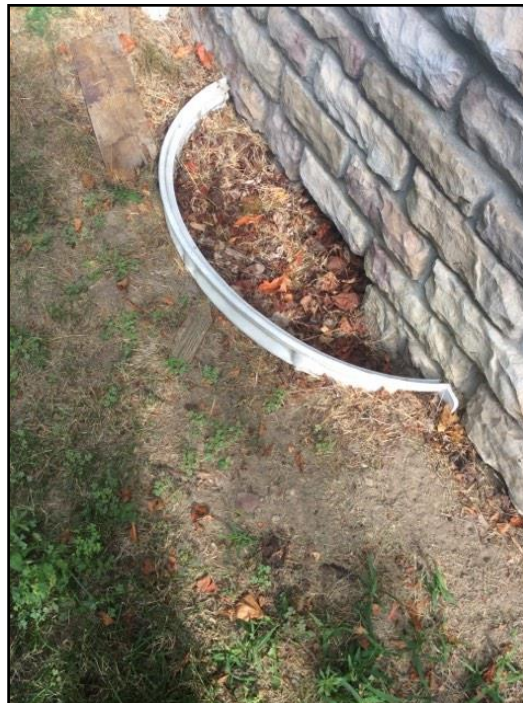
7. Condition: • [Missing](#)

Implication(s): Chance of water damage to contents, finishes and/or structure | Material deterioration

14. Missing

Install well covers

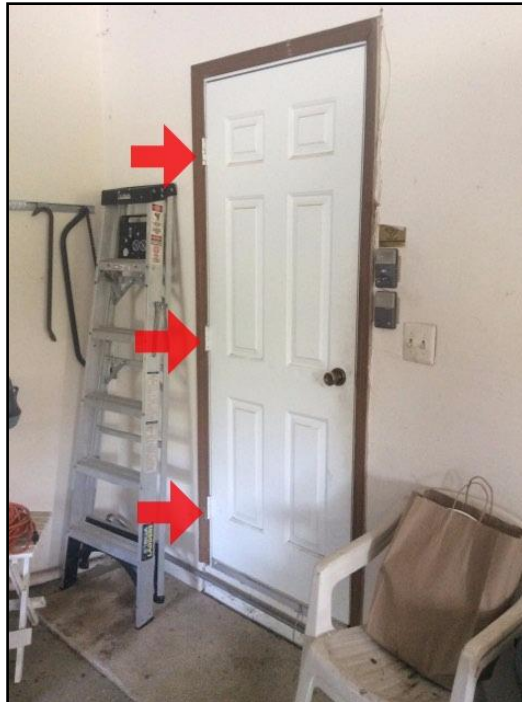
8. Condition: • [Installed backwards](#)

Implication(s): Chance of damage to finishes and structure | Reduced system life expectancy

Location: Garage

15. Installed backwards

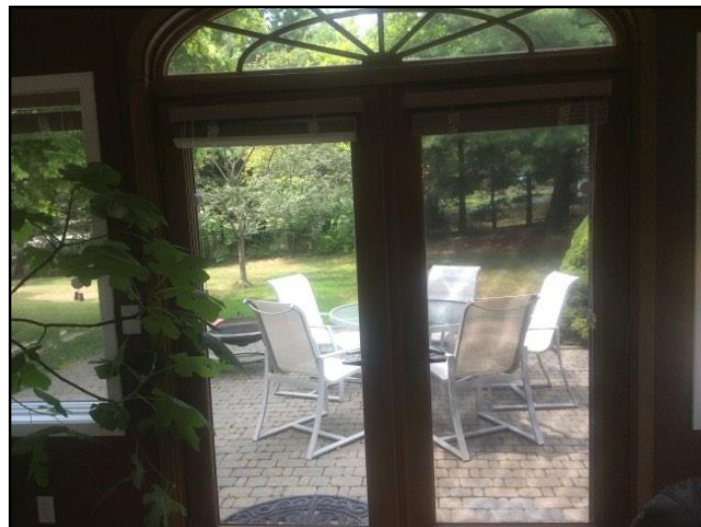
9. Condition: • [Stiff](#)

Very stiff / poor fit

Implication(s): Chance of damage to finishes

16. Stiff

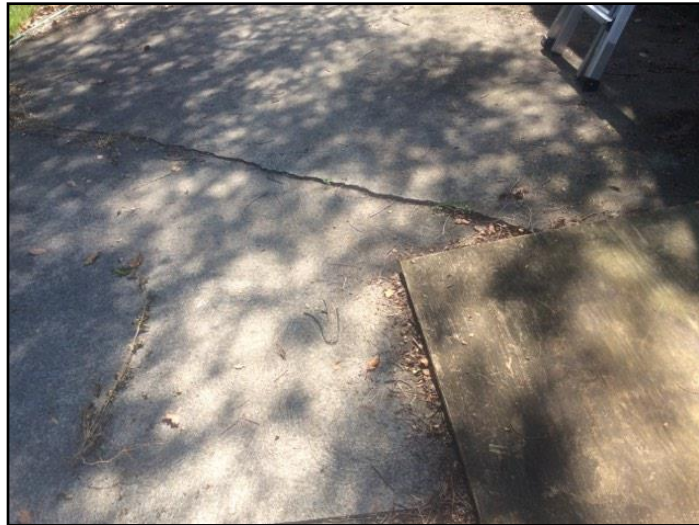
10. Condition: • [Concrete cracked](#)

Implication(s): Chance of damage to structure | Material deterioration | Trip or fall hazard

17. Concrete cracked

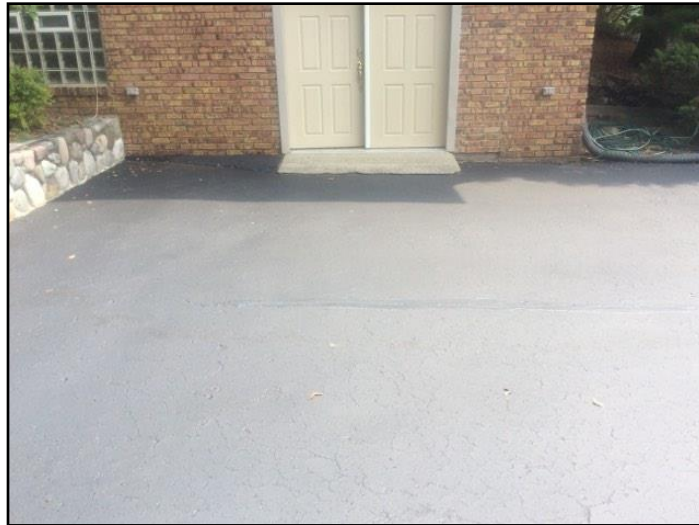
13. Condition: • [Improper slope or drainage](#)

Implication(s): Chance of water damage to contents, finishes and/or structure

18. *Improper slope or drainage*

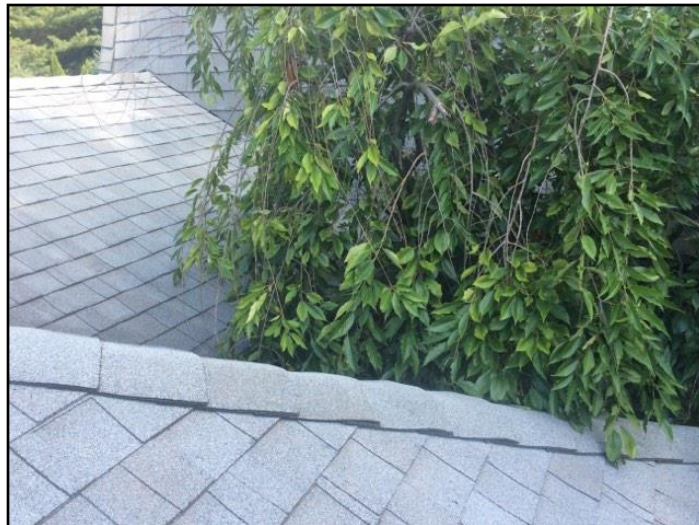
14. **Condition:** • Tree branches should not be in contact with the roof. Cut them back

19. *Cut tree branches from roof*

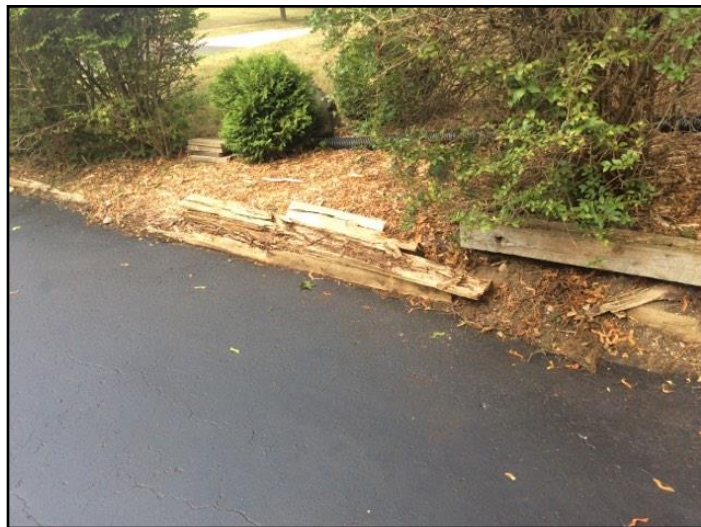
16. Condition: • [Rot or insect damage](#)

Implication(s): Weakened structure | Chance of movement

20. Rot or insect damage

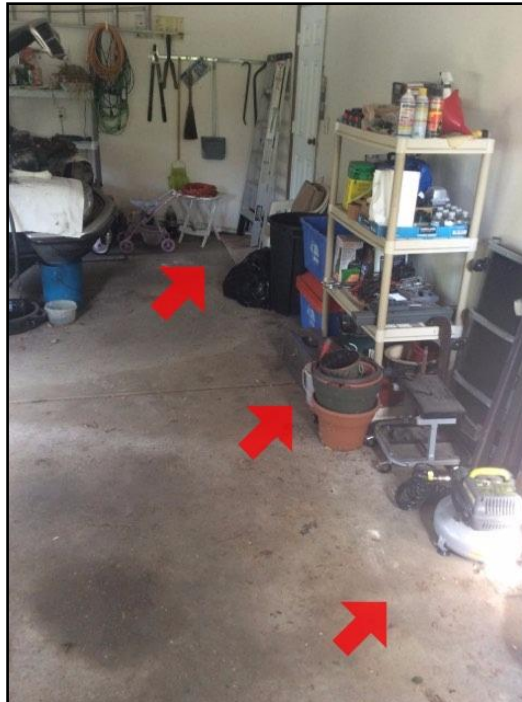
18. Condition: • Missing curb safety barrier

22. Missing curb safety barrier

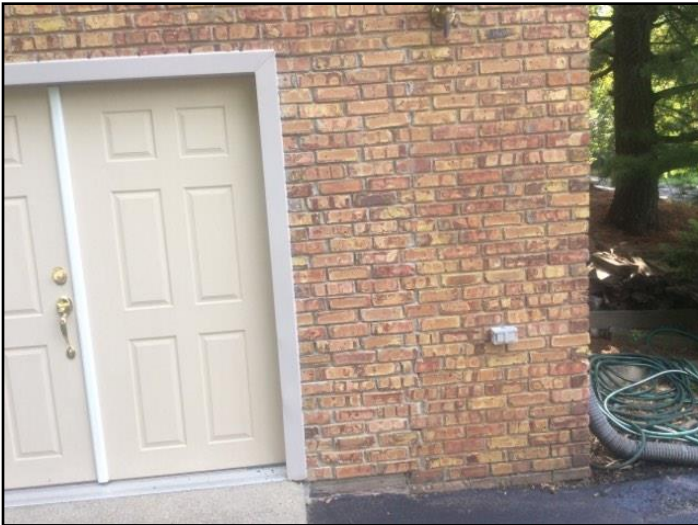
20. Condition: • [Cracked](#)

Implication(s): Weakened structure

27. Cracked

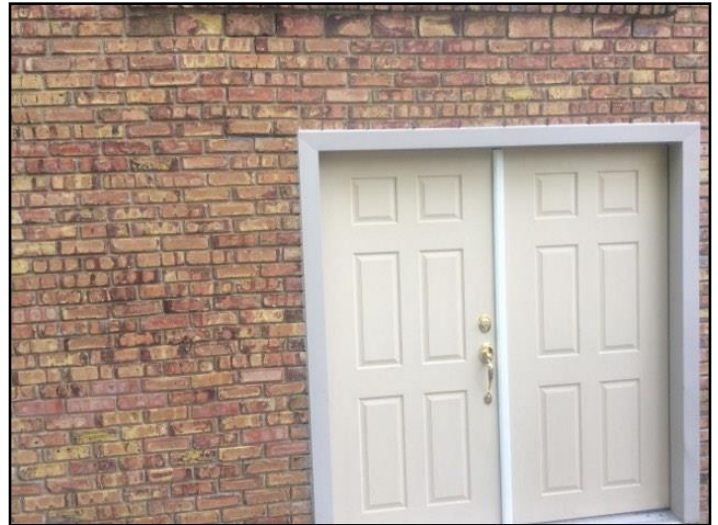
28. Cracked

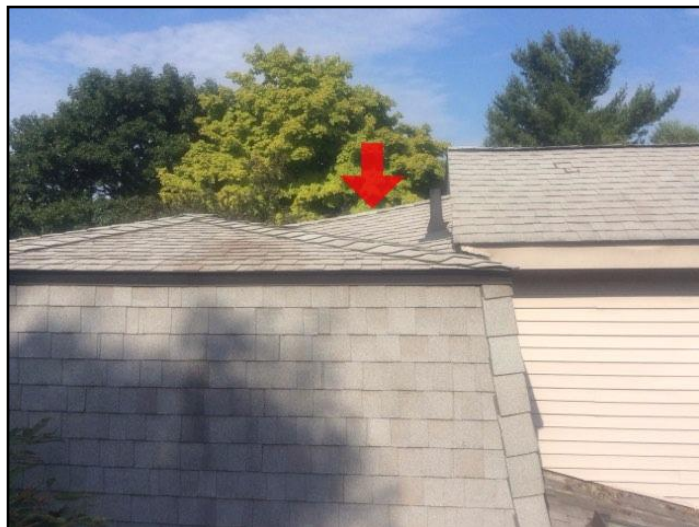
21. Condition: • Unconventional construction, ridge board should not be sloped

29. Unconventional construction

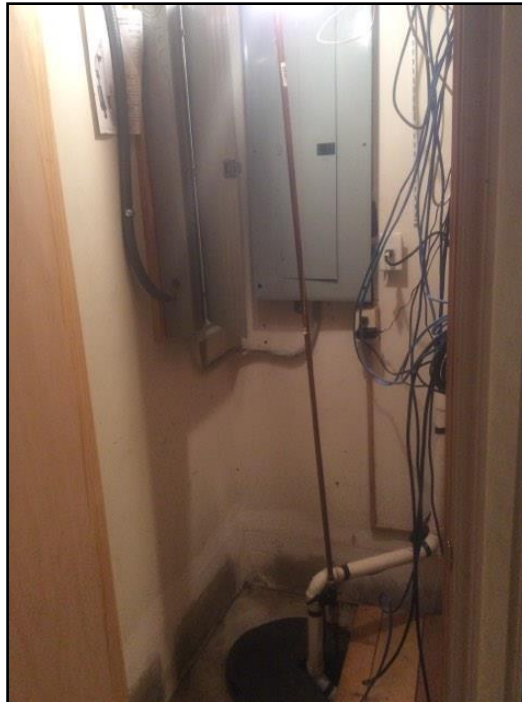
**23. Condition:** • [Poor access](#)

30. Poor access

3 feet of clearance should be provided in front of the panel

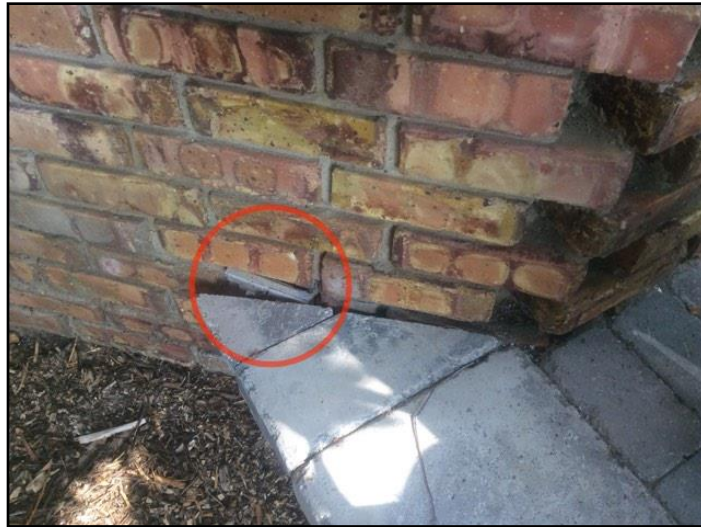
**28. Condition:** • Obstruction

31. *Obstruction*

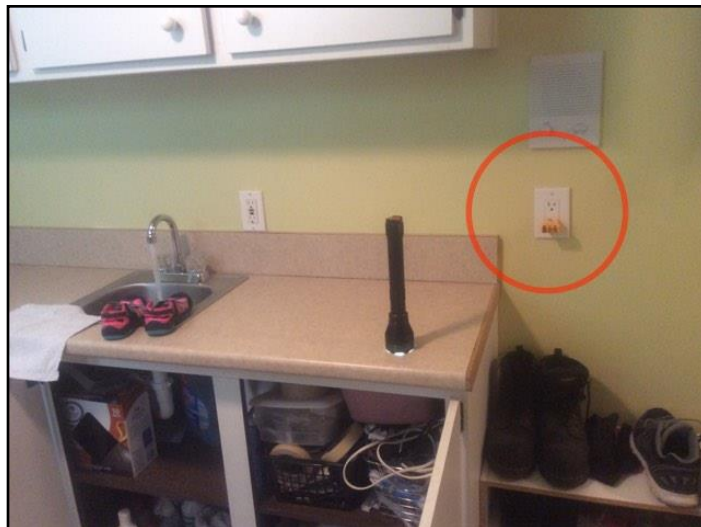
29. Condition: • [Inoperative](#)

Implication(s): Equipment inoperative

32. *Inoperative*

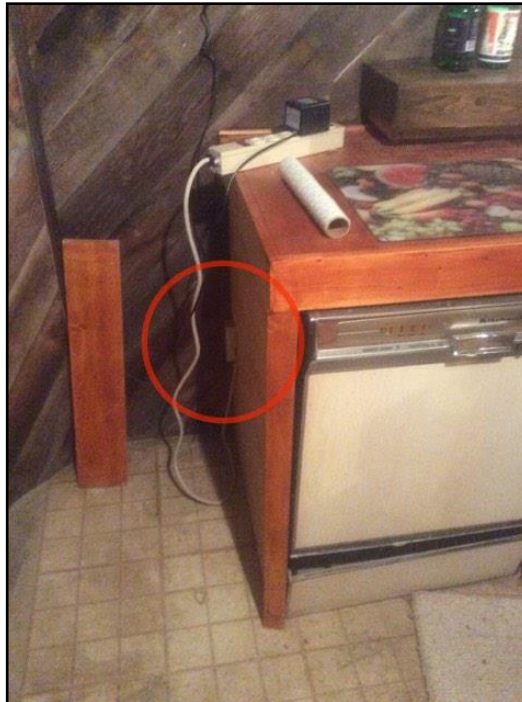
30. Condition: • [Reversed polarity](#)

33. *Reversed polarity*

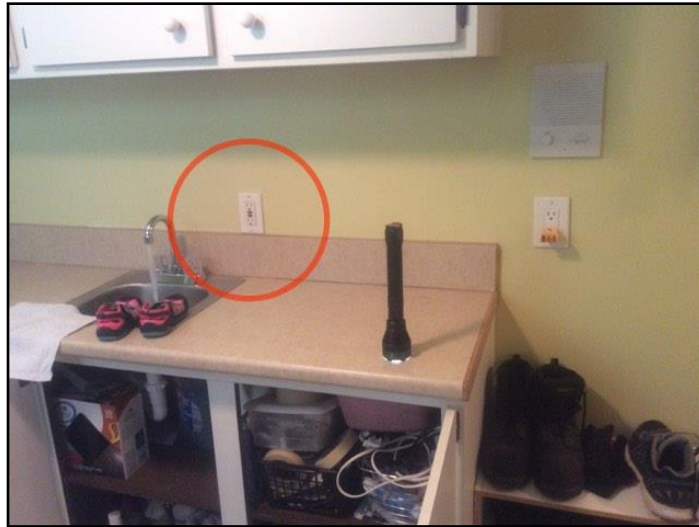
32. Condition: • [Test faulty on Ground Fault Circuit Interrupter \(GFCI\)](#)

Power cannot be interrupted; always On

Implication(s): Electric shock

35. Test faulty on Ground Fault Circuit...

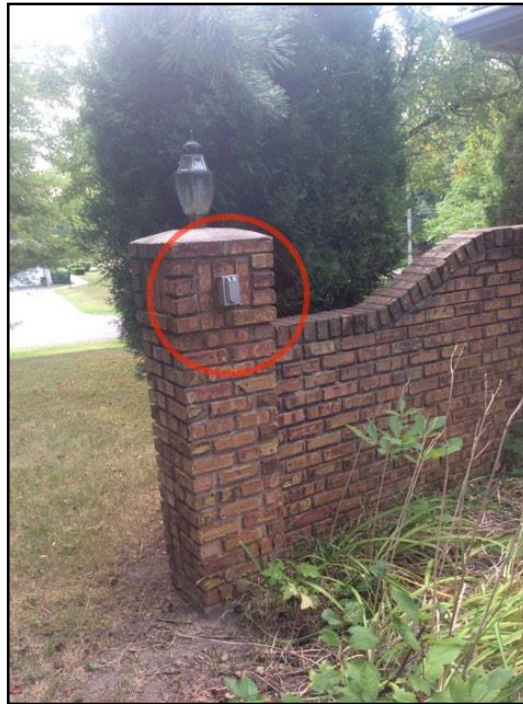
33. Condition: • [Test faulty on Ground Fault Circuit Interrupter \(GFCI\)](#)

Resetting does now power up outlet

Implication(s): Electric shock

36. Test faulty on Ground Fault Circuit...

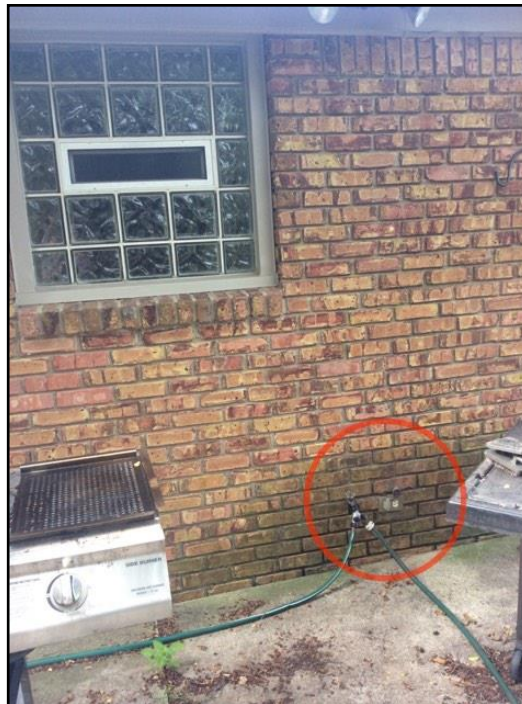
34. Condition: • [Ground Fault Circuit Interrupter \(GFCI\) needed](#)

37. GFCI needed

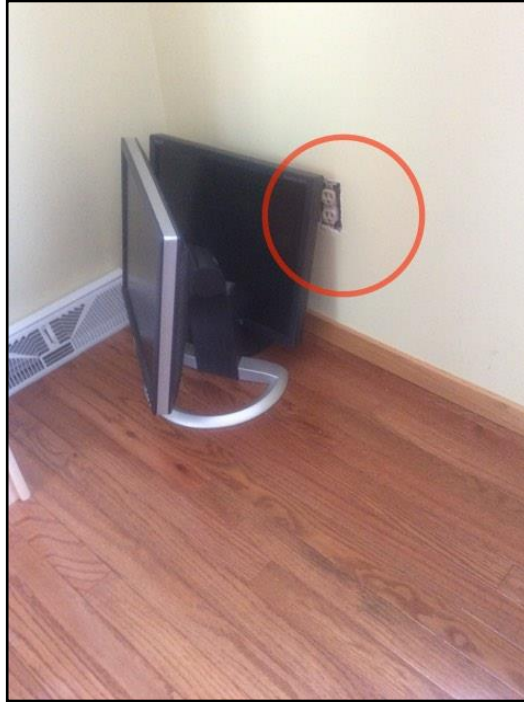
36. **Condition:** • [Missing](#)

**Location:** Second Floor

**38.** *Missing cover plate*

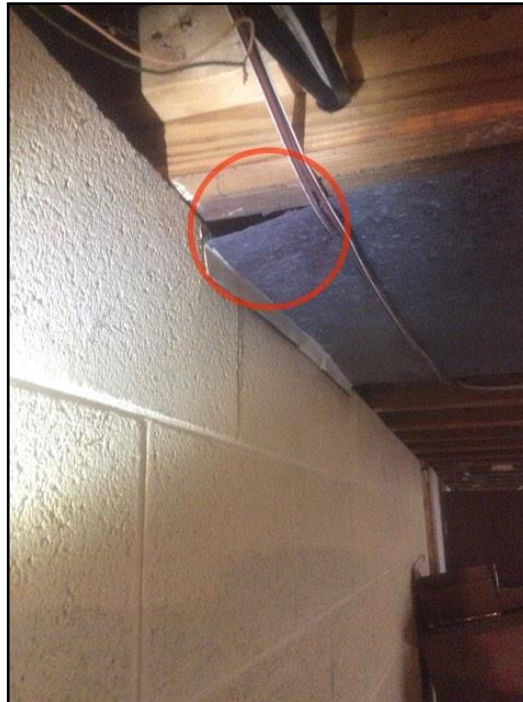
37. Condition: • [Leaky joints](#)

39. Leaky joints

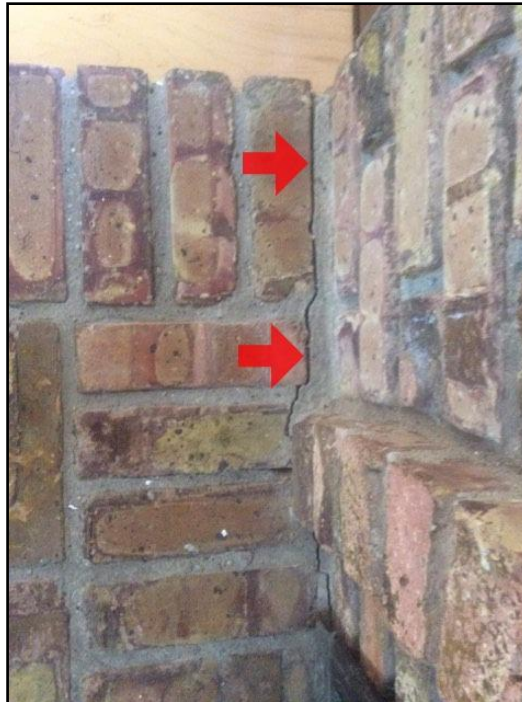
40. Condition: • [Gaps or cracks](#)

Implication(s): Fire hazard

41. Gaps or cracks

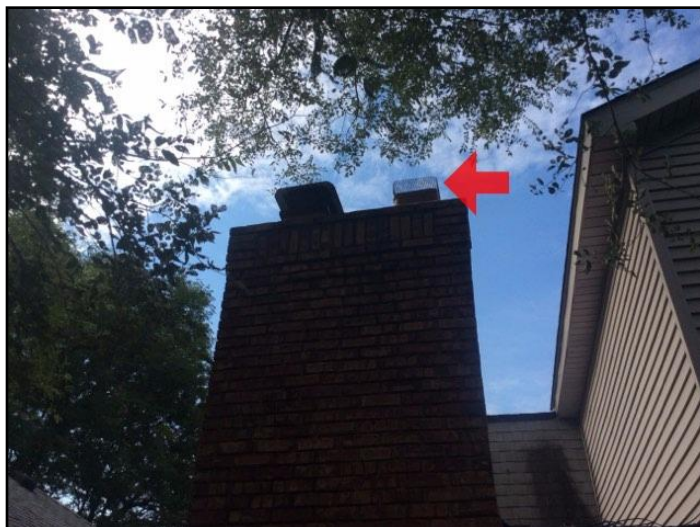
44. Condition: • [Rain cap missing or damaged](#)

**42.** *Rain cap missing*

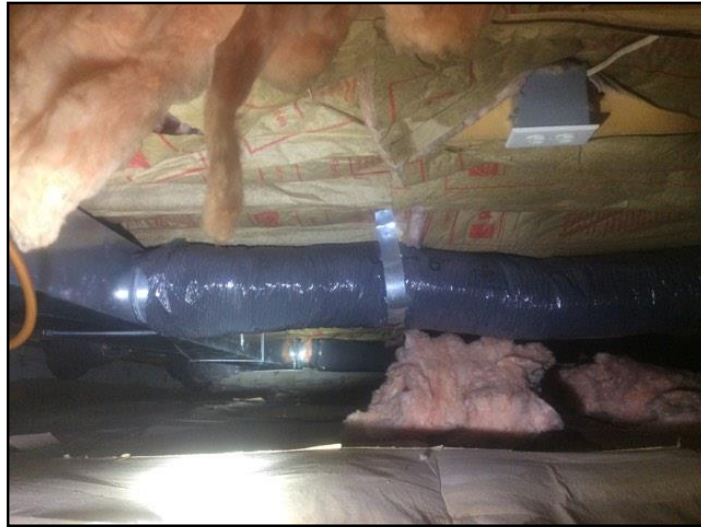
**49. Condition:** • [Wrong location](#)

**Implication(s):** Chance of condensation damage to finishes and/or structure

**Location:** Crawl Space

**45. Wrong location**

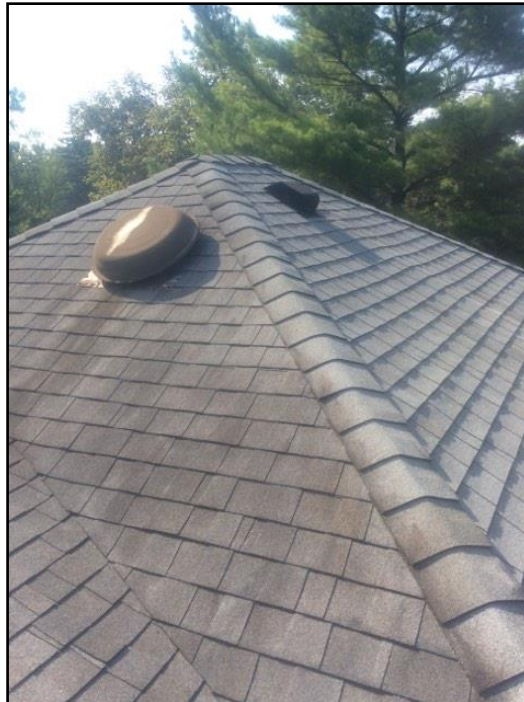
**50. Condition:** • Cannot mix different types of exhaust vents. Choose one or the other and block-off the openings for the discarded method

46. Cannot mix different types of exhaust vents

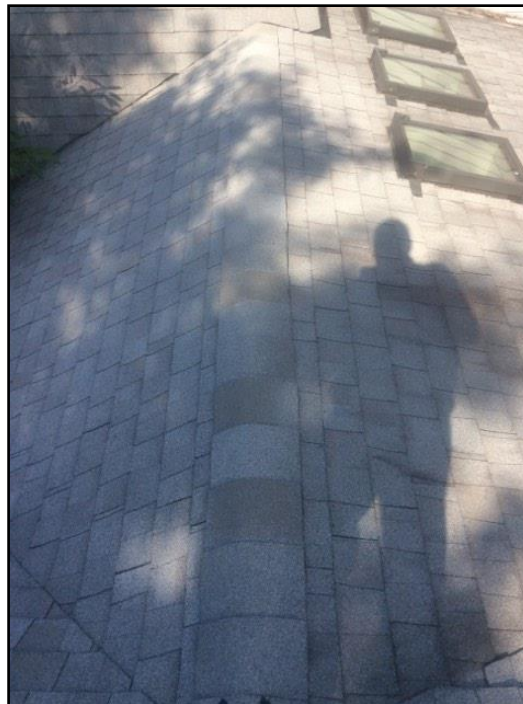
51. Condition: • [Missing](#)

Implication(s): Chance of condensation damage to finishes and/or structure

47. Missing exhaust vents

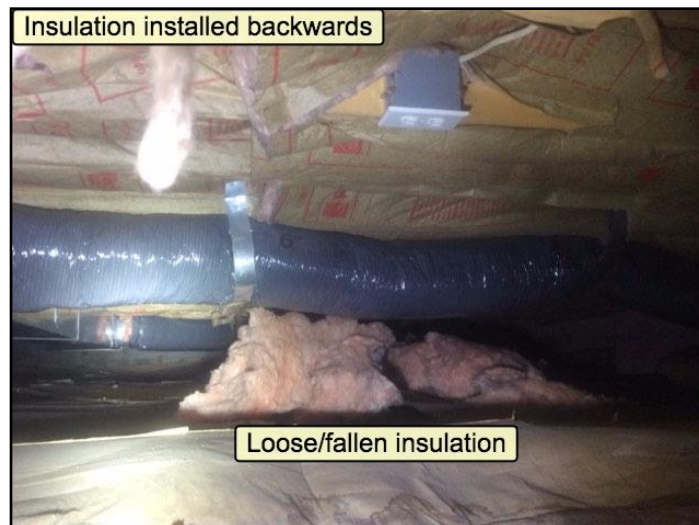
49. Exposed combustible insulation

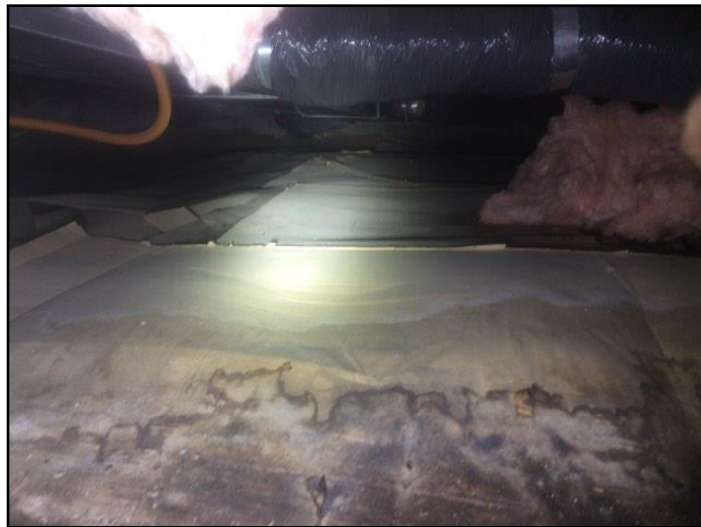
**58. Condition:** • [No vapor barrier](#)

**Implication(s):** Chance of condensation damage to finishes and/or structure

**50.** *No vapor barrier*

All debris and cardboard needs to be removed from crawl space. The vapor barrier needs to be tightly sealed at all seams and run-up the wall. Also, the exterior perimeter walls should be insulated, as well as the band joist area. The crawl needs to be treated like the other conditioned parts of the home.

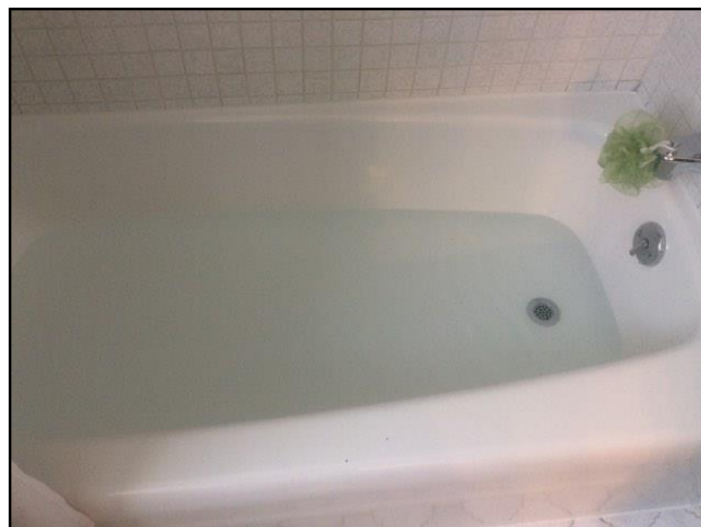
**60. Condition:** • [Slow drain](#)

**Implication(s):** Chance of water damage to contents, finishes and/or structure

51. Slow drain

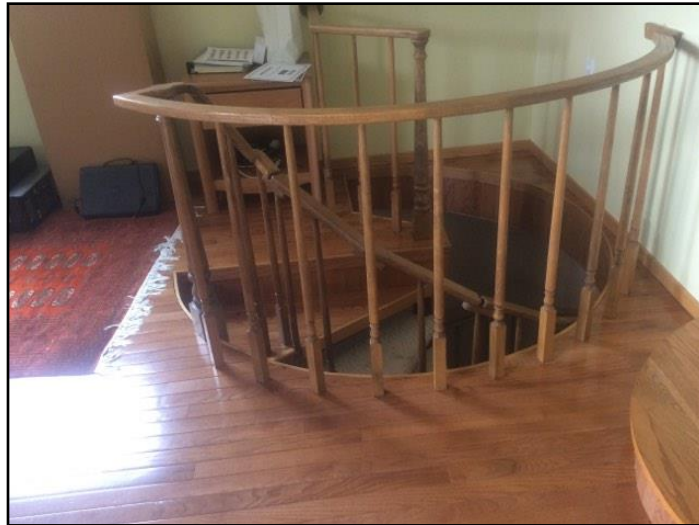
**67. Condition:** • [Too far apart](#)

**Implication(s):** Fall hazard

61. Too far apart

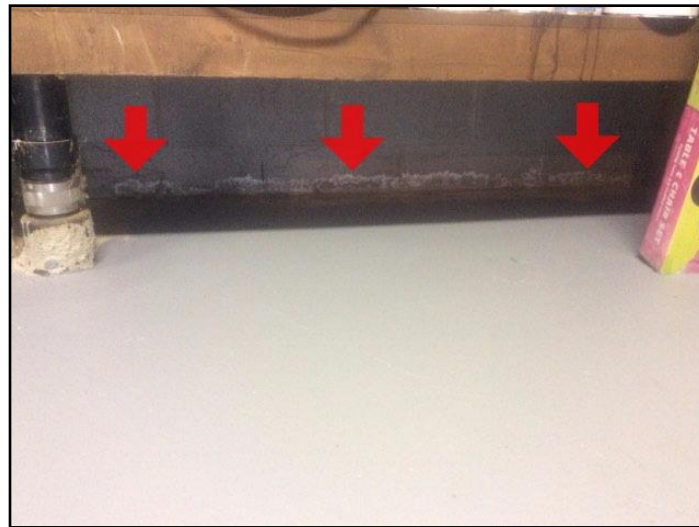
68. Condition: • [Efflorescence](#)

Implication(s): Cosmetic defects | Chance of water damage to contents, finishes and/or structure

62. Efflorescence

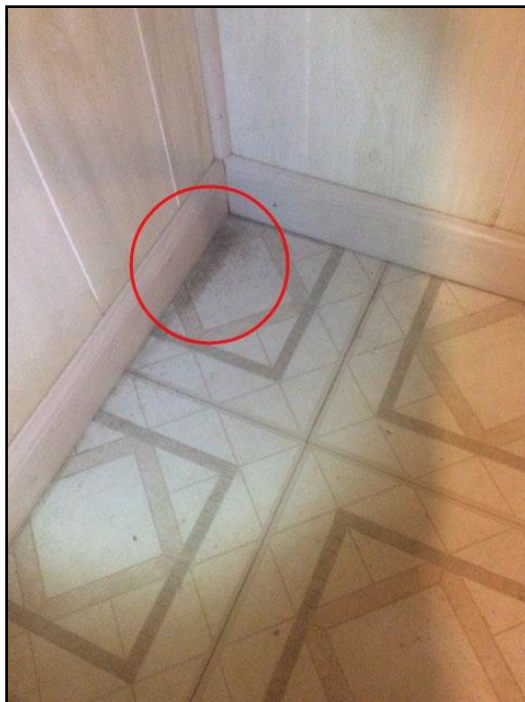
69. Condition: • [Mold](#)

**Implication(s):** Cosmetic defects | Chance of water damage to contents, finishes and/or structure | Contaminants may enter building air

63. Mold

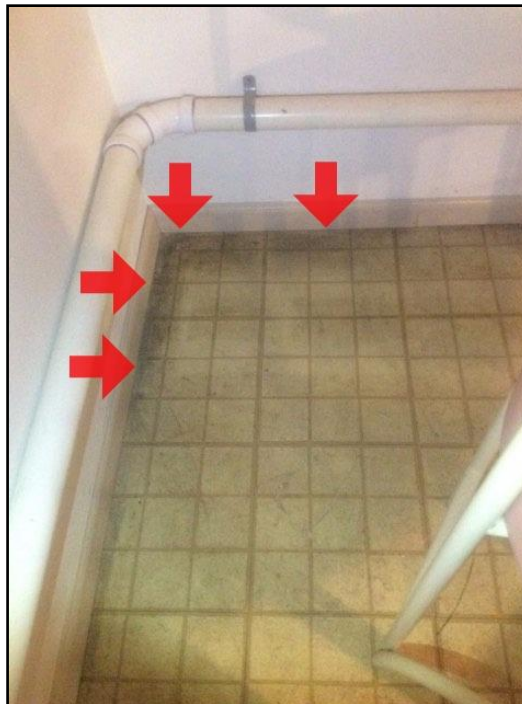
65. Mold

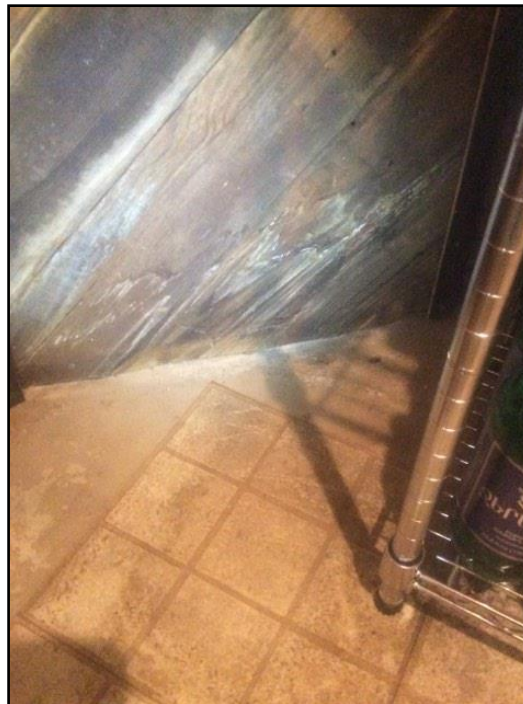
70. Condition: • [Rot](#)

Implication(s): Cosmetic defects | Chance of water damage to contents, finishes and/or structure | Material deterioration

66. Rot

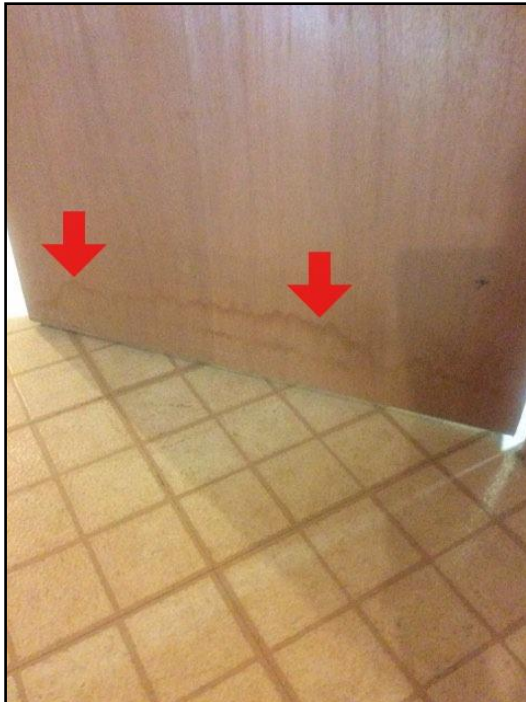
71. Condition: • [Stains](#)

Implication(s): Cosmetic defects | Chance of water damage to contents, finishes and/or structure

67. Stains

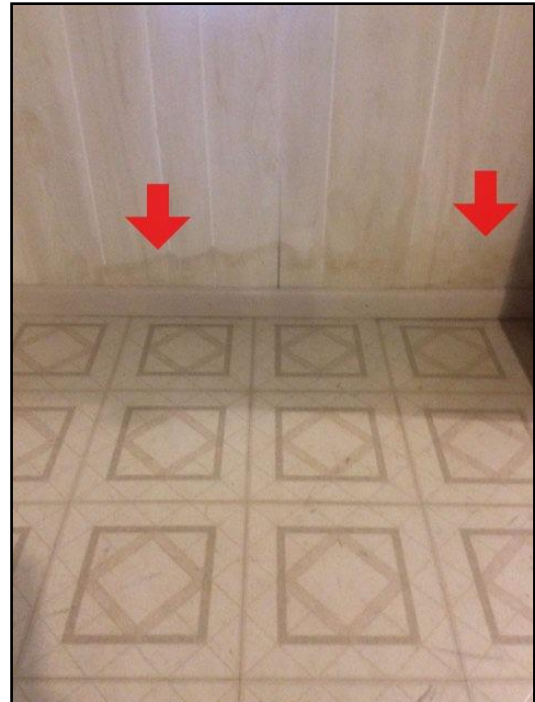
68. Stains

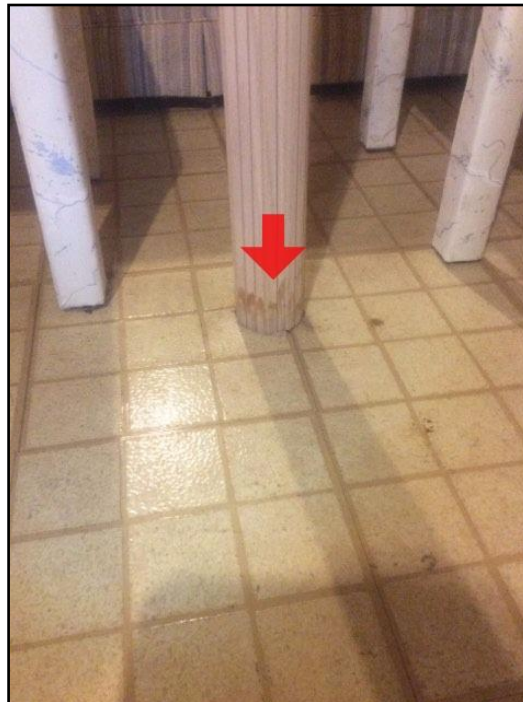
69. Stains
