INSPECTION REPORT

For the Property at:
123 ABC STREET
MEDICINE HAT, AB

Prepared for: JOHN SMITH
Inspection Date: Monday, January 4, 2021
Prepared by: Westley Franks

RE: Report No. 1097
123 ABC Street
Medicine Hat, AB

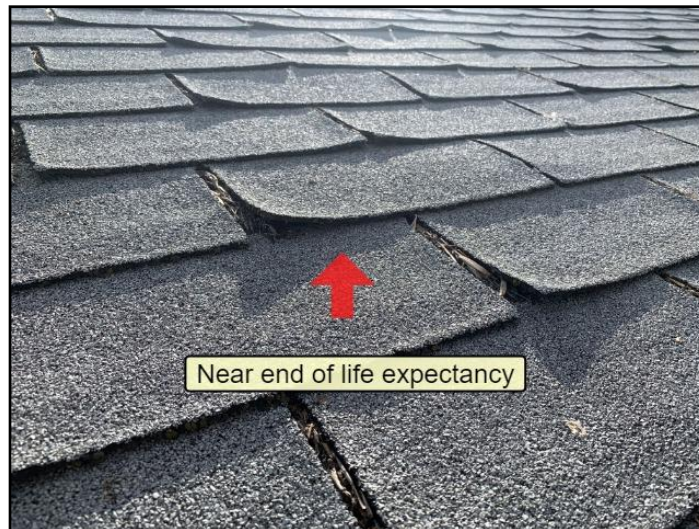
1. Condition: • [Near end of life expectancy](#)

Implication(s): Chance of water damage to structure, finishes and contents

6. *Near end of life expectancy*

Task: Get an expert opinion from a qualified contractor

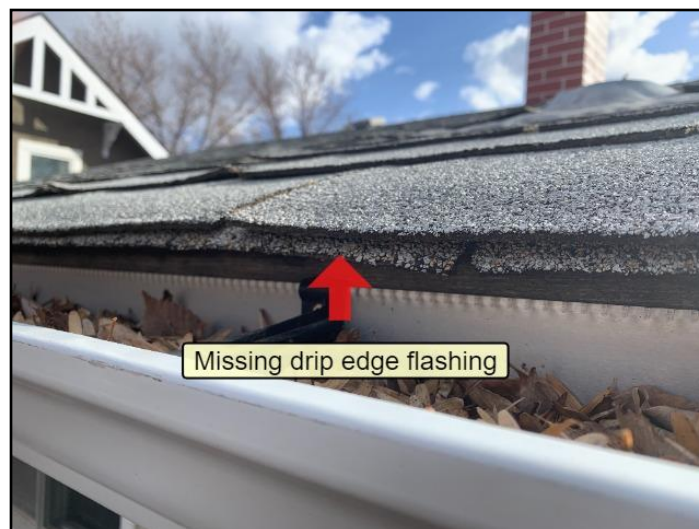
2. Condition: • Missing drip edge flashing

Implication(s): Chance of water damage to contents, finishes and/or structure

7. Missing drip edge flashing

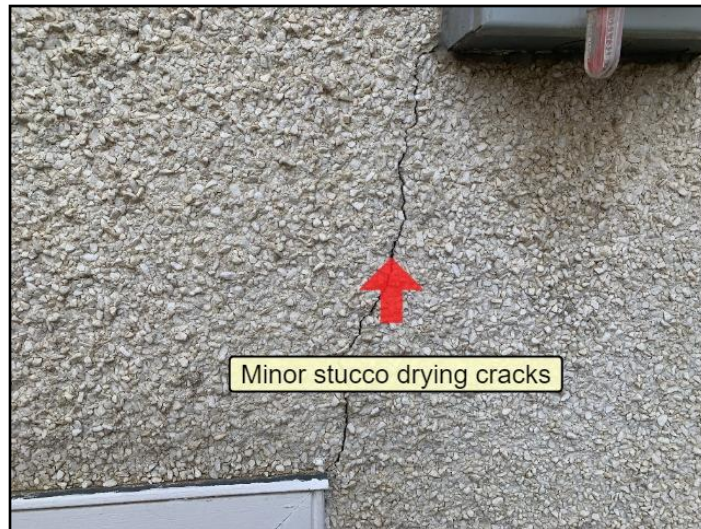
3. Condition: • Minor stucco drying cracks

10. Minor stucco drying cracks

Task: Monitor the condition

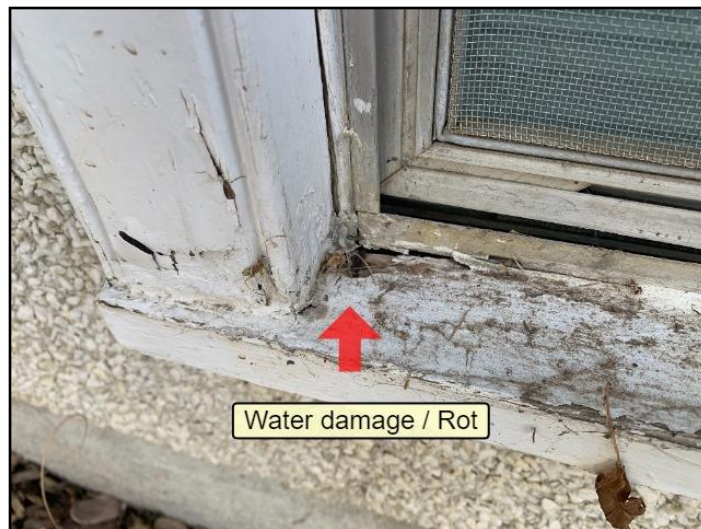
4. **Condition:** • Water damage / Rot

Implication(s): Chance of water damage to structure | Material deterioration

11. Water damage / Rot

Task: Repair by a qualified contractor,

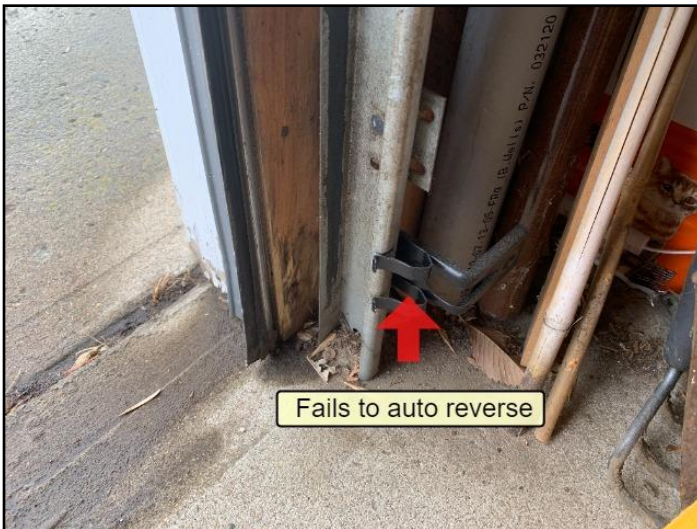
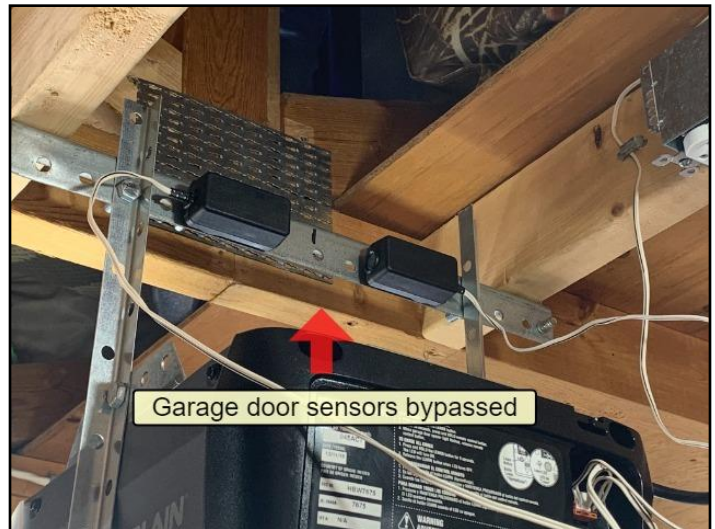
6. Condition: • [Fails to auto reverse](#)

12. Fails to auto reverse

13. Fails to auto reverse

Task: Repair by a qualified contractor,

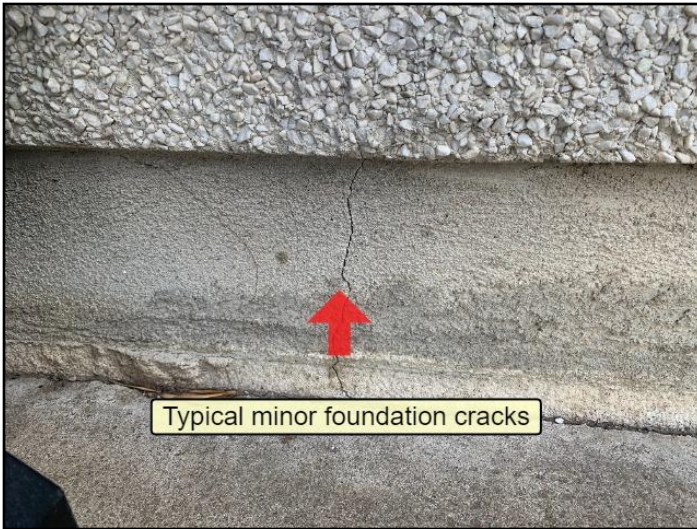
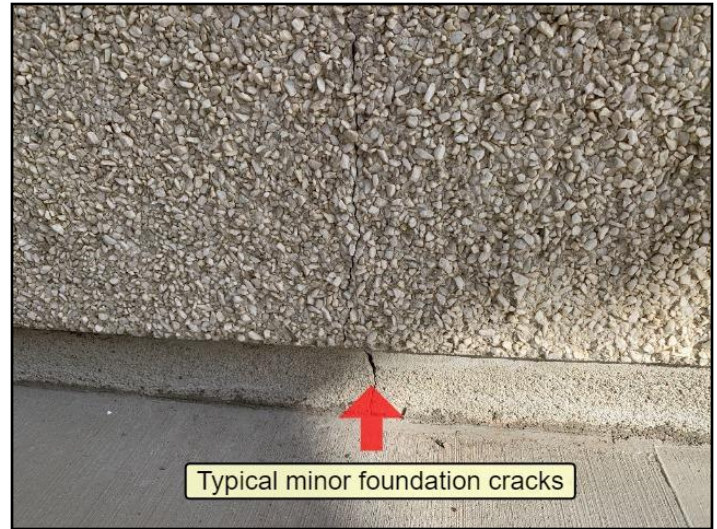
7. Condition: • Typical minor foundation cracks

This condition is typical for homes of this age

Implication(s): Chance of water entering building | Chance of damage to structure

Location: South and West Foundation wall

14. Typical minor foundation cracks

15. Typical minor foundation cracks

Task: Monitor the condition, if the condition changes, Get an expert opinion from a qualified contractor

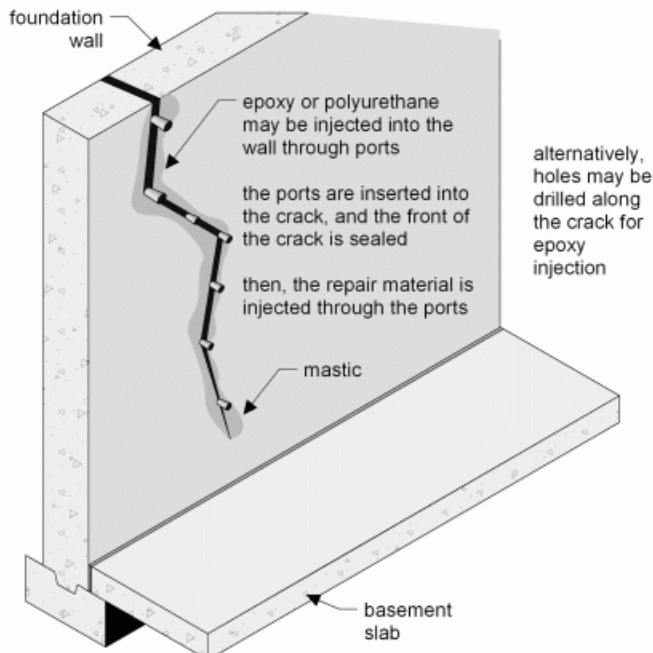
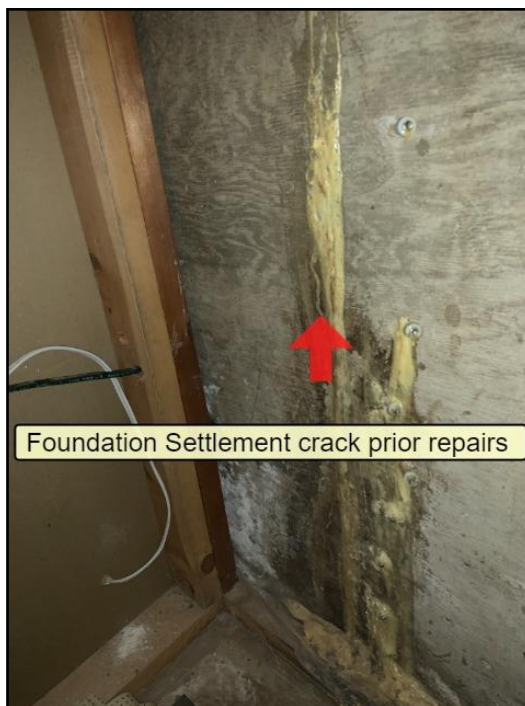
8. Condition: • Building Foundation Settlement

There is an old vertical foundation crack under the front stairs that has been repaired with polyurethan foam injection.

Implication(s): Chance of structural movement | Weakened structure | Chance of water damage to contents, finishes and/or structure

Location: North foundation wall under stairs

16. Foundation Settlement crack prior repairs

Task: Monitor the condition, if the condition changes, Get an expert opinion from a qualified contractor,

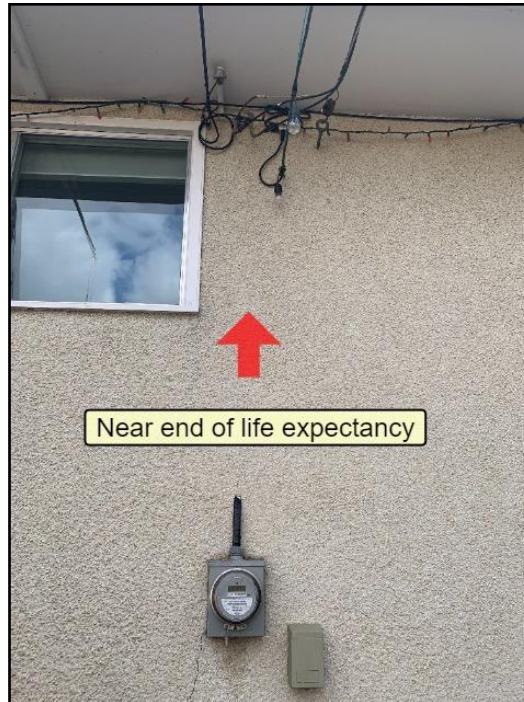
9. Condition: • Near end of life expectancy

Implication(s): Over heating wiring and equipment, Damage to conductor insulation

21. Near end of life expectancy

Task: Get an expert opinion from a qualified contractor,

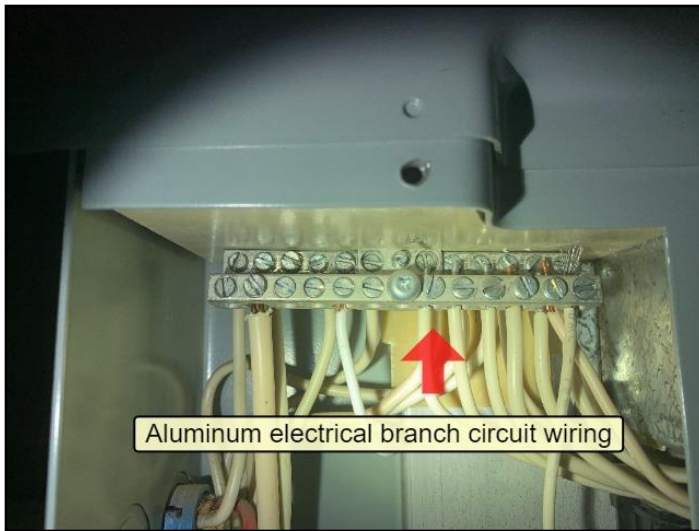
10. Condition: • [Aluminum electrical branch circuit wiring is present in the home, this wiring has a history of a](#) overheating if it was not installed and maintained properly. Over time aluminum wiring connections can become loose or rusted causing problems in the electrical circuits of the home. All aluminum wire connections in the electrical panel should be tightened, and all the receptacles, switches and lights should be "Pig Tailed" to copper wire using the proper aluminum wire connectors and de-oxidization compound. It is also recommended that the aluminum wiring branch circuits be protected with Arc-Fault protection.

Implication(s): Fire hazard | Over heating wiring | Damage to conductor insulation | Damage to equipment

22. Aluminum electrical branch circuit wiring

Task: Repair and maintain by a qualified contractor,

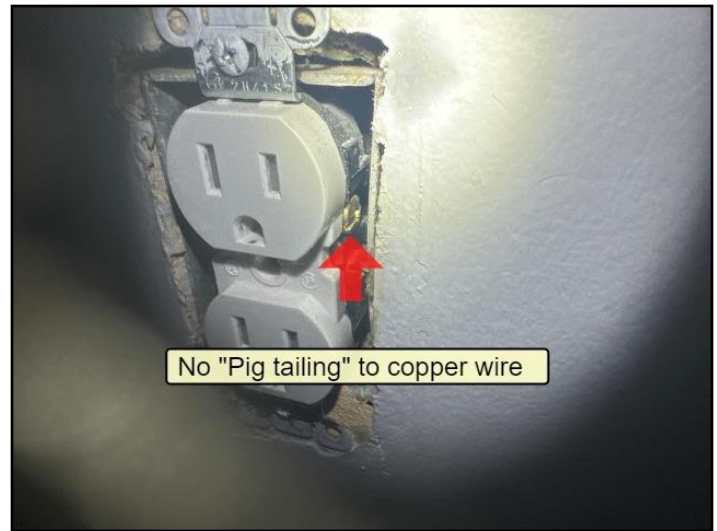
23. No "Pig tailing" to copper wire

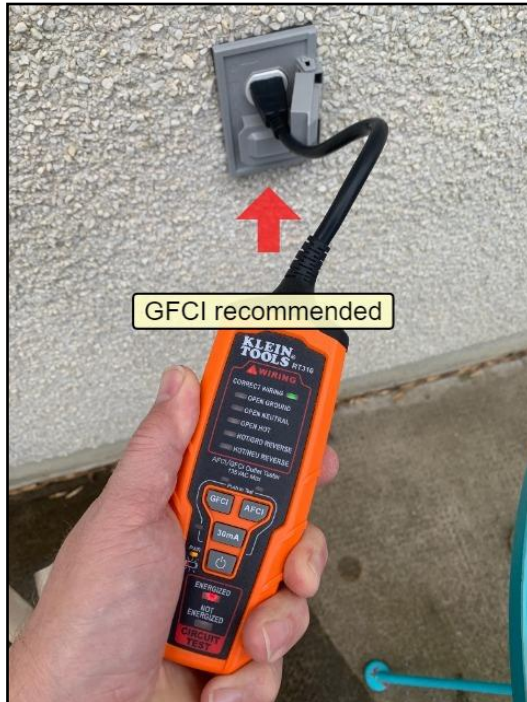
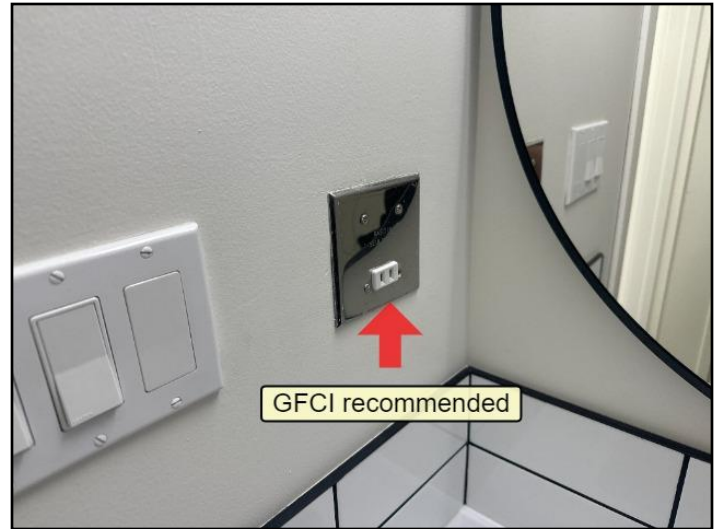
11. Condition: • [GFCI recommended \(Ground Fault Circuit Interrupter\)](#)

This is a recommended safety improvement not a deficiency. This condition is typical for homes of this age.

25. GFCI recommended

26. GFCI recommended

Task: Provide new by a qualified contractor

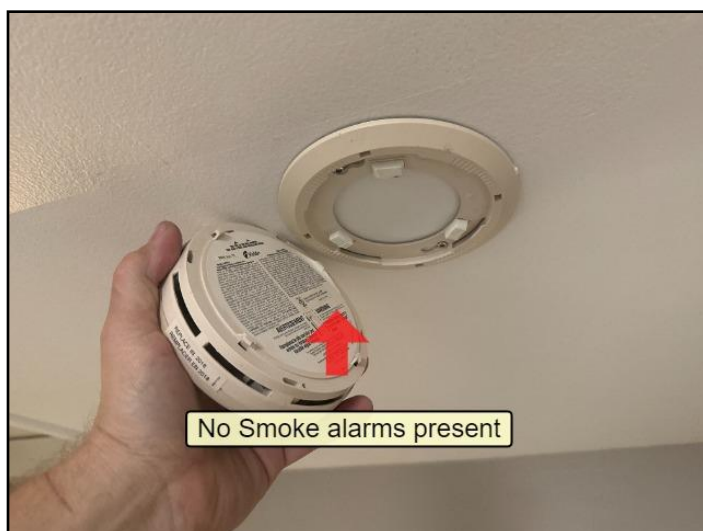
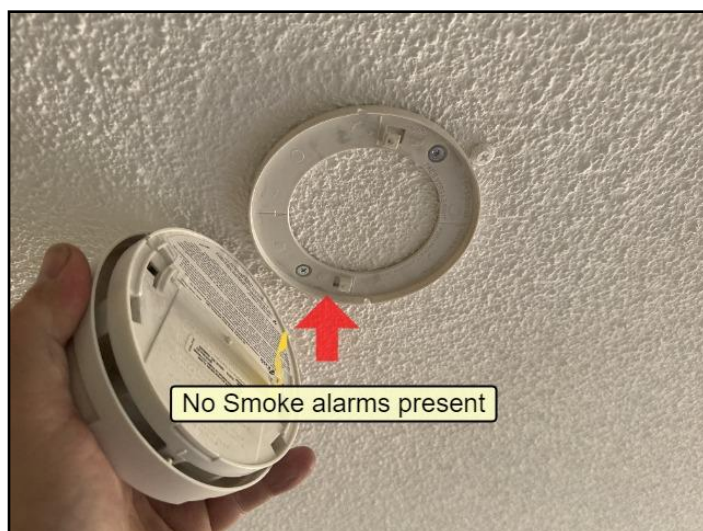
12. Condition: • There are No Smoke alarms present in the home. It is recommended that new 120 volt / battery back up CO/Smoke and Smoke alarms be installed and interconnected. This condition is typical for homes of this age.

Implication(s): Fire hazard | Life safety hazard

27. No Smoke alarms present

28. No Smoke alarms present

Task: Provide new by a qualified contractor

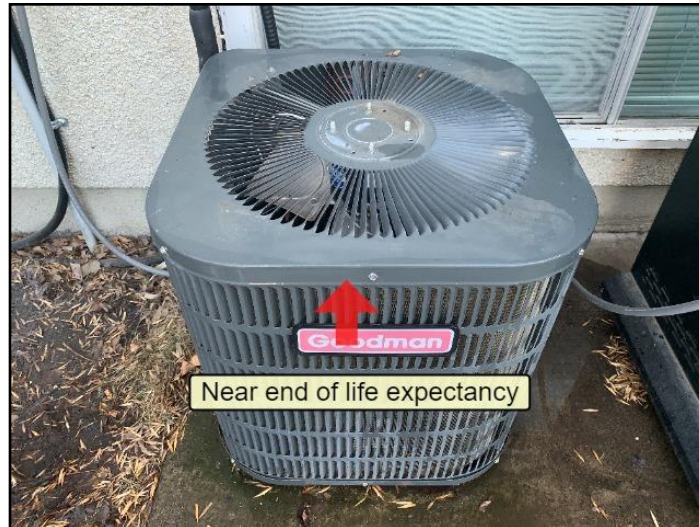
14. Condition: • [Near end of life expectancy](#)

Implication(s): Equipment failure | Reduced comfort

Location: Air Conditioner

38. *Near end of life expectancy*

Task: Get an expert opinion from a qualified and licensed contractor,

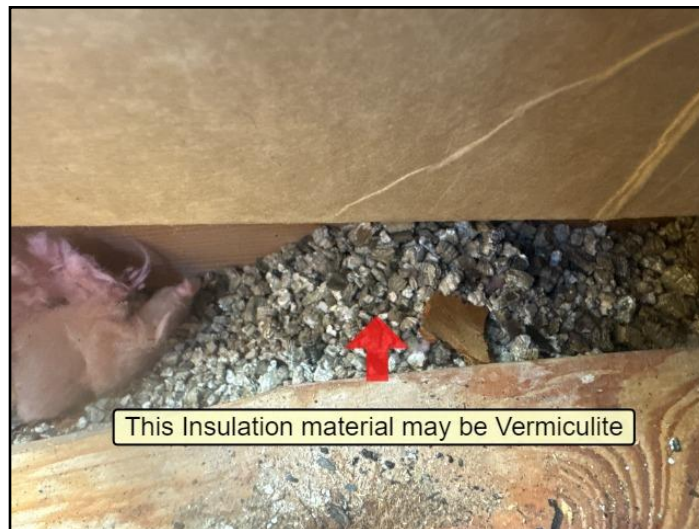
15. Condition: • [This Insulation material may be Vermiculite. It may contain Asbestos.](#)

Vermiculite insulation should not be disturbed. This is a condition that is typical for homes of this age.

43. *This Insulation material may be Vermiculite*

Task: Get a expert opinion from a qualified contractor

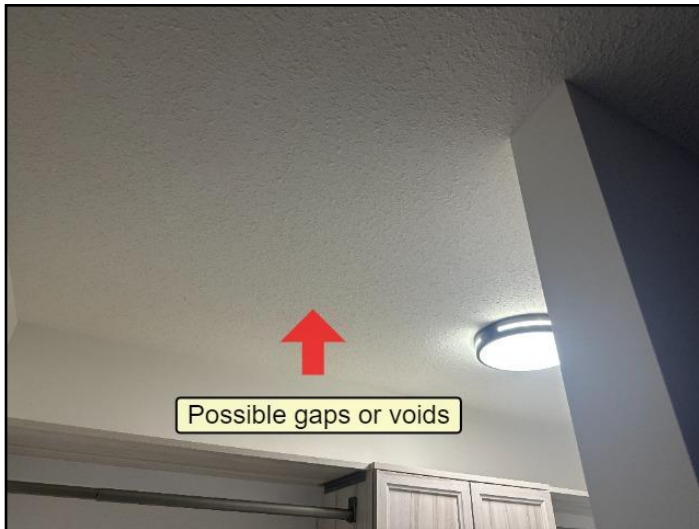
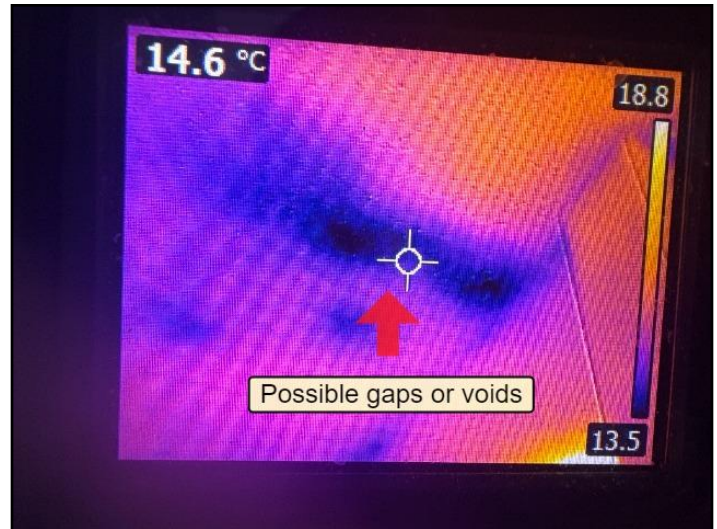
16. Condition: • Possible gaps or voids

44. Possible gaps or voids

45. Possible gaps or voids

Task: Monitor the condition

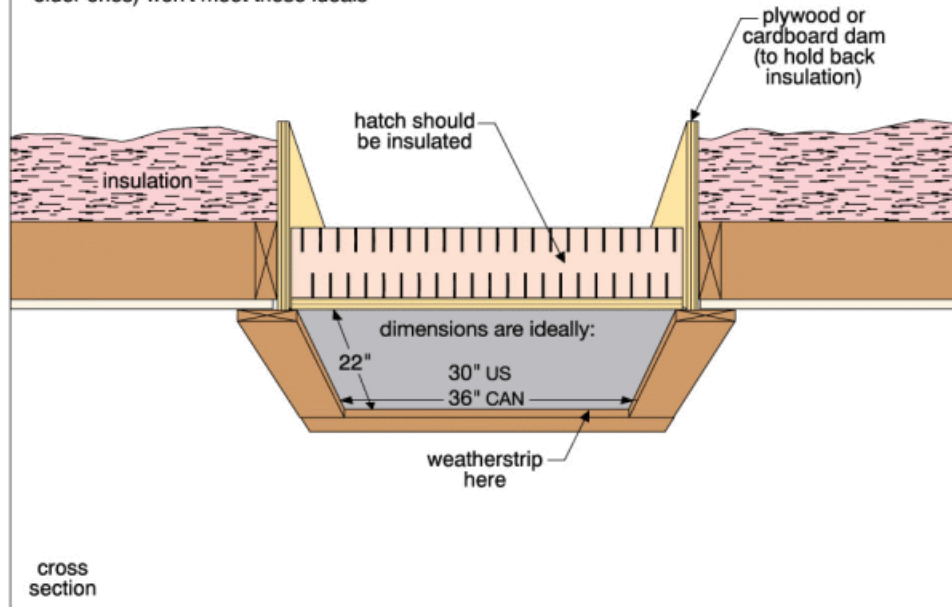
17. Condition: • Not insulated and weather stripped

Implication(s): Increased heating and cooling costs | Reduced comfort | Chance of condensation damage to finishes and/or structure

46. Not insulated and weather stripped

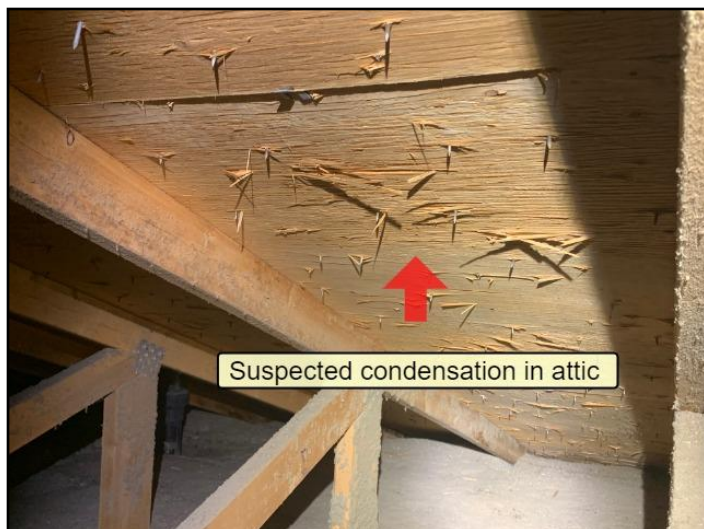
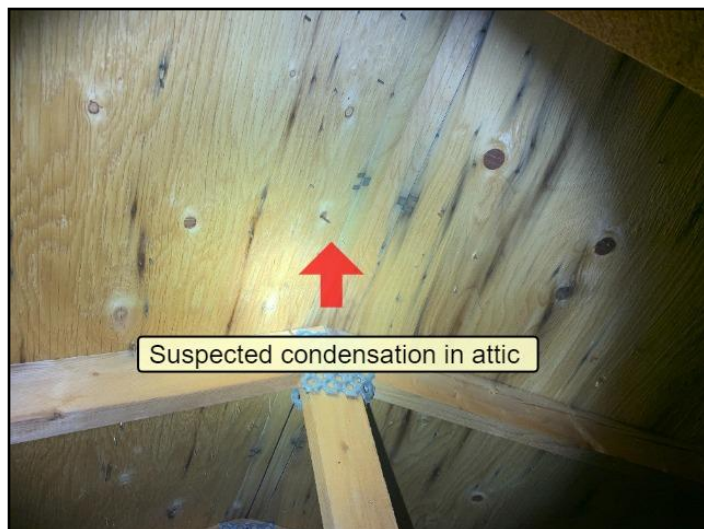
18. Condition: • Attic Insulation, vapor seal and ventilation suspect

Condensation and water stains from "Attic Rain" where found in the attic.

Implication(s): Chance of condensation damage to finishes and/or structure | Reduced life expectancy of shingles

47. Suspected condensation in attic

48. Suspected condensation in attic

Recommend improving the attic insulation and improving the ceiling vapor seal at large penetrations like the attic hatch, exhaust fans and pot lights to prevent warm air escaping from the home into the attic.

Recommend increasing the attic ventilation to quickly remove moisture from the attic.

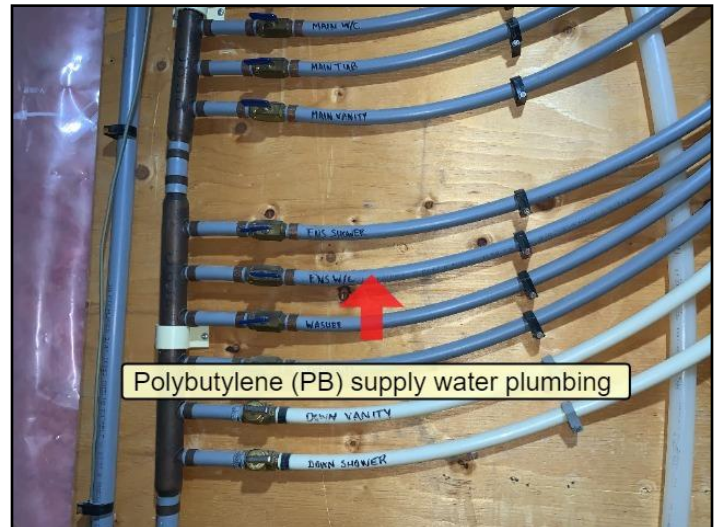
19. Condition: • Polybutylene (PB) supply water plumbing pipe has been found in the home. This piping has a history of a significantly high rate of failure. There have been instances in the past when this kind of pipe has ruptured or the connectors have failed. This pipe is no longer used in residential plumbing applications for this reason.

Implication(s): Chance of water damage to structure, finishes and contents | Leakage

54. Polybutylene (PB) supply water plumbing

55. Polybutylene (PB) supply water plumbing

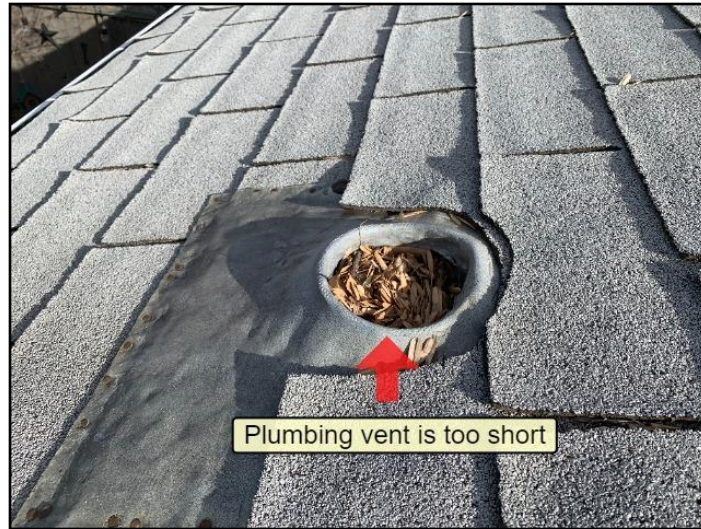
20. Condition: • Plumbing vent is too short

56. Plumbing vent is too short

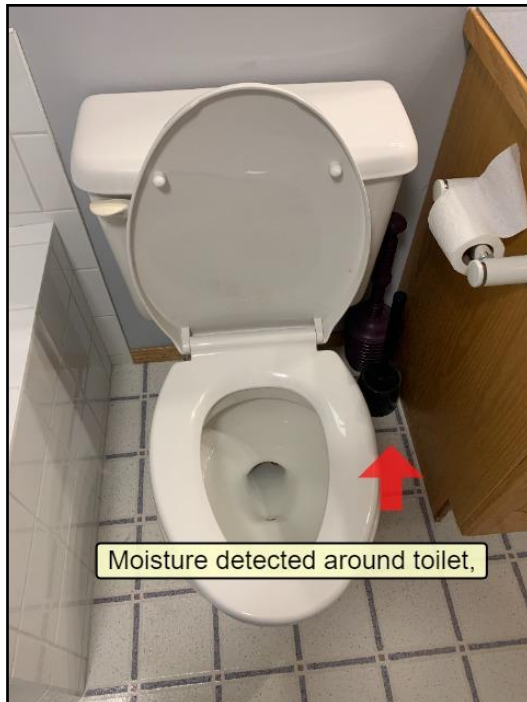
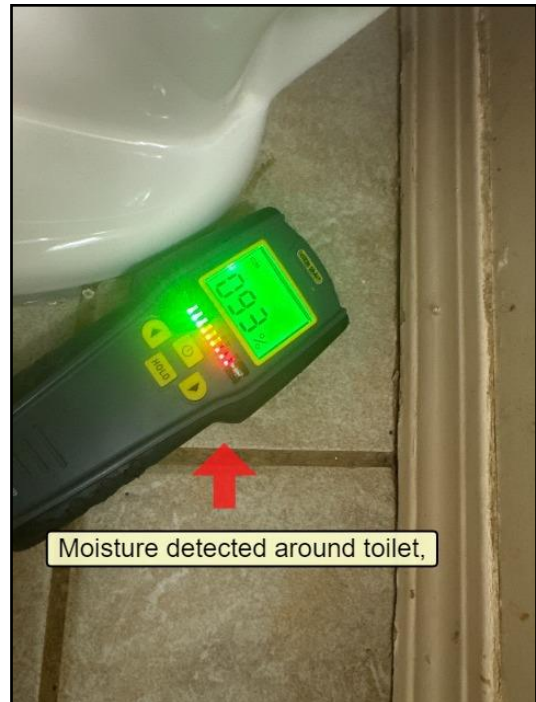
21. Condition: • Leak

57. Moisture detected around toilet,

58. Moisture detected around toilet,

Task: Repair by a qualified contractor,

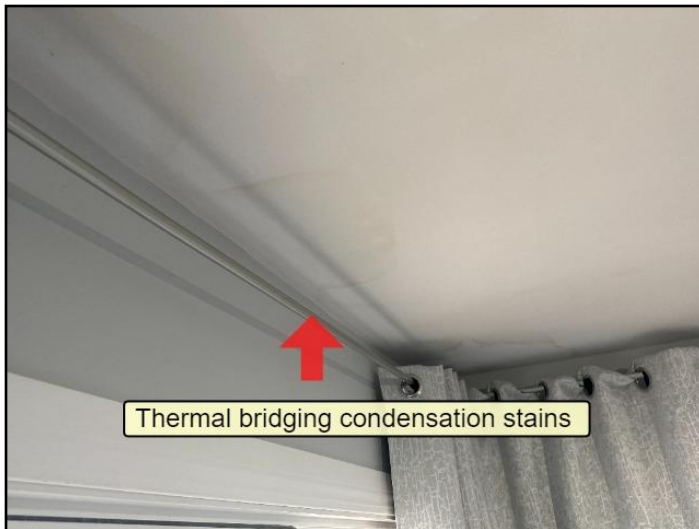
61. Thermal bridging

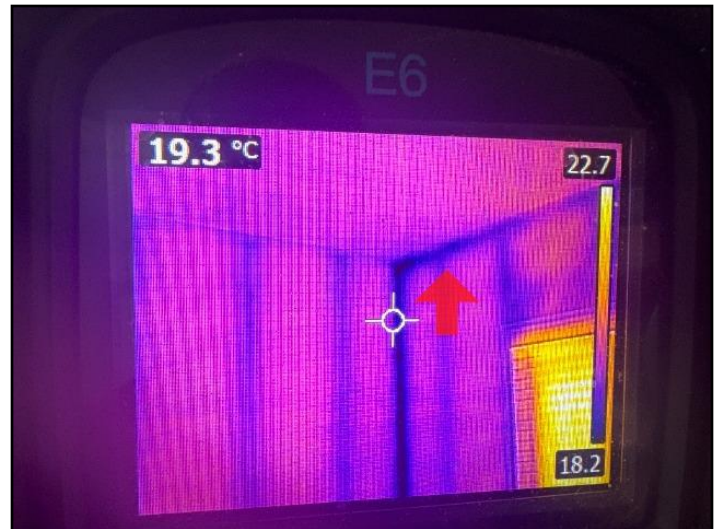
62. Thermal imaging of the area

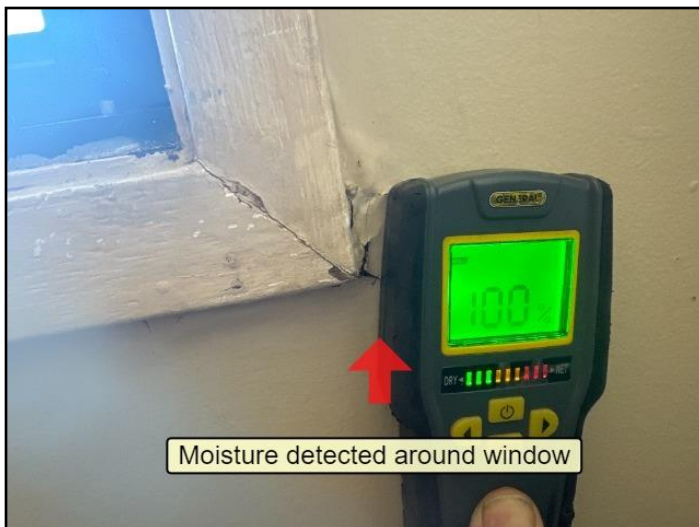
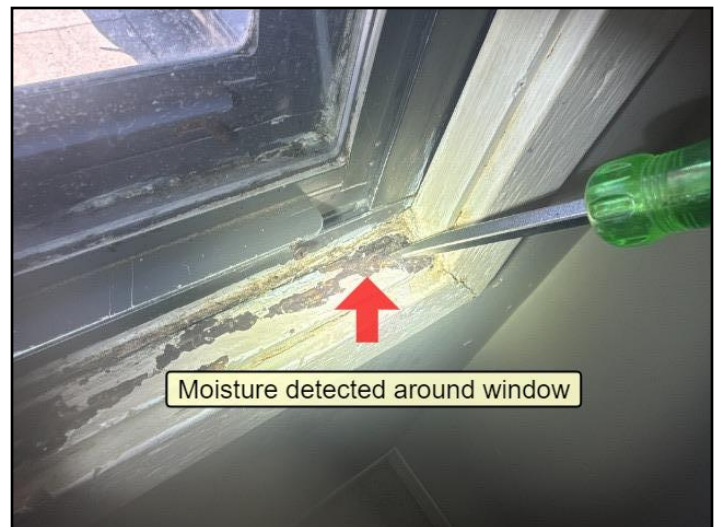
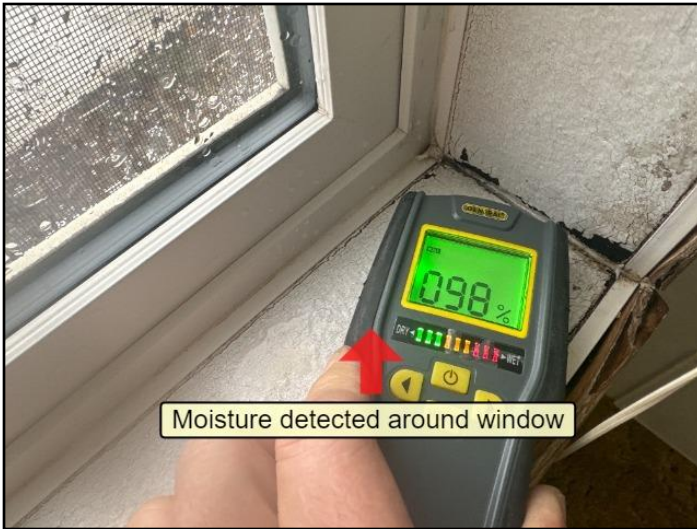
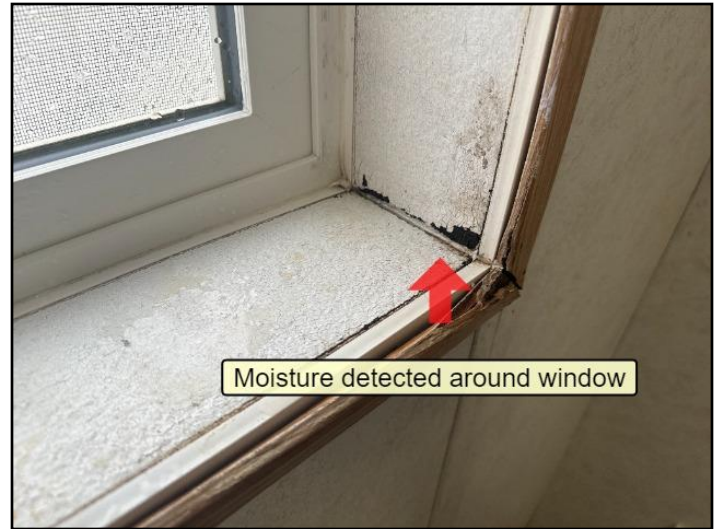
63. Moisture detected around window

64. Moisture detected around window

65. Moisture detected around window

66. Moisture detected around window

Task: Repair by a qualified contractor,

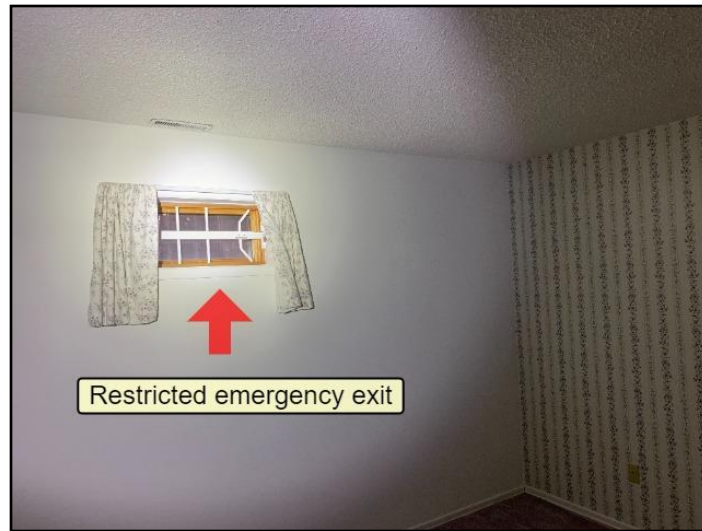
67. Restricted emergency exit

Task: Provide new by a qualified contractor

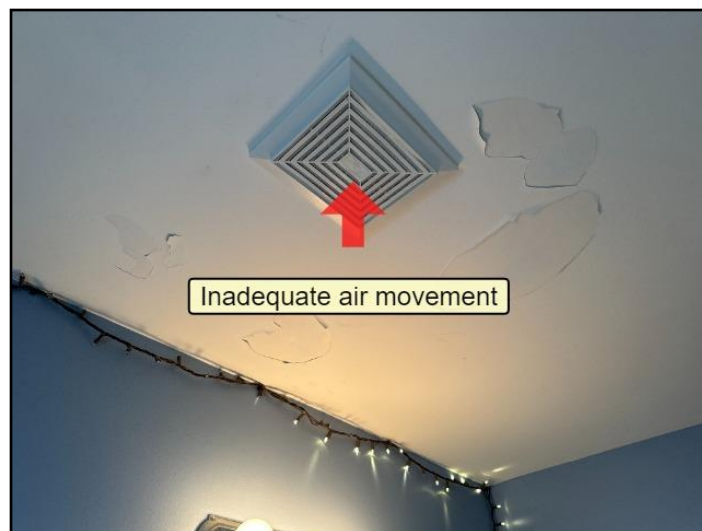
68. Inadequate air movement

Task: Replace by a qualified contractor,

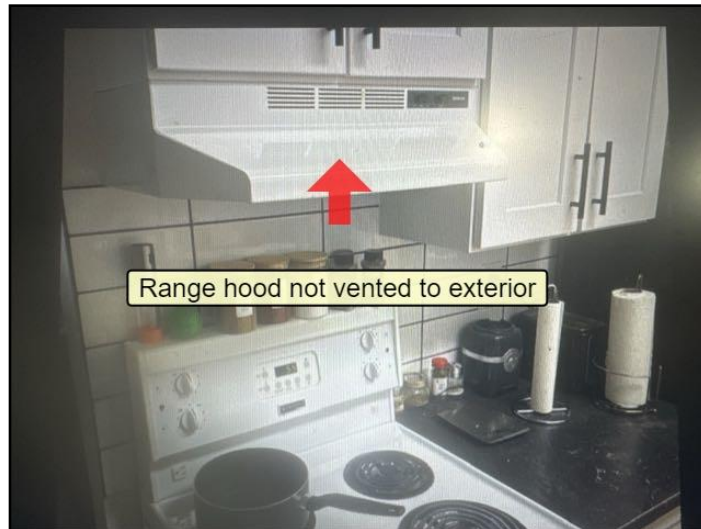
69. Range hood not vented to exterior

Task: Provide new by a qualified contractor

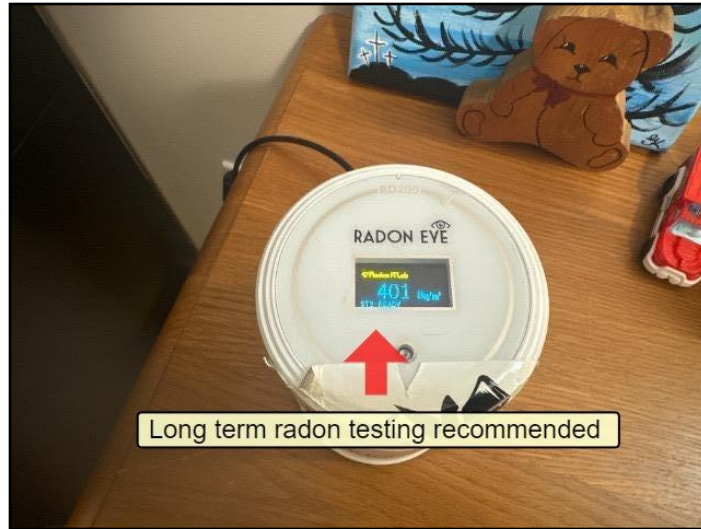
70. Long term radon testing recommended
