INSPECTION REPORT

For the Property at:
212 RIDGEMERE COURT
KITCHENER, ON N2P2V5

Prepared for: XXXXX XXXX
Inspection Date: Wednesday, March 23, 2016
Prepared by: Fermin Robles

RE: Report No. 1004, v.2
212 Ridgemere Court
Kitchener, ON
N2P2V5

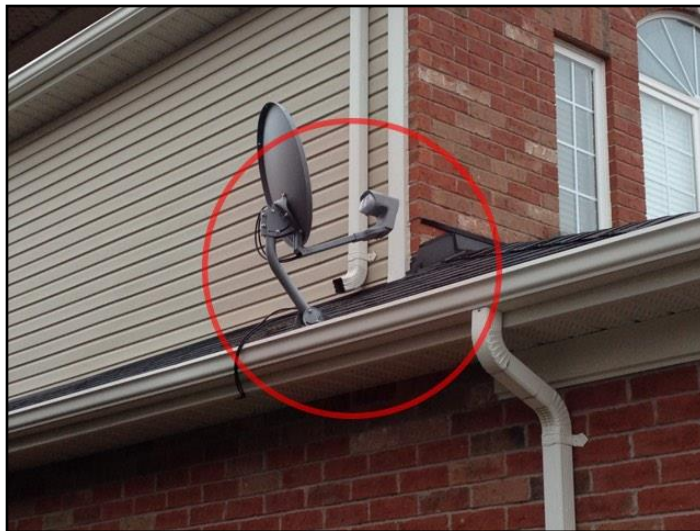
1. Condition: • [Connections loose](#)

Implication(s): Leakage

Location: Left Second Floor

Loose connections

Task: Repair

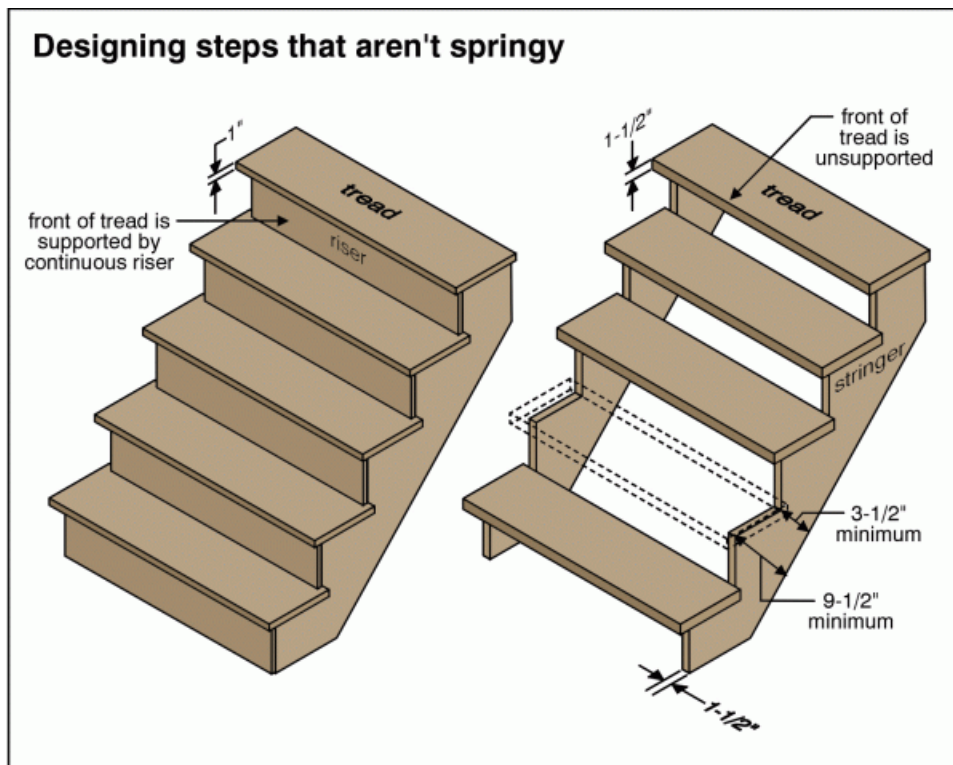
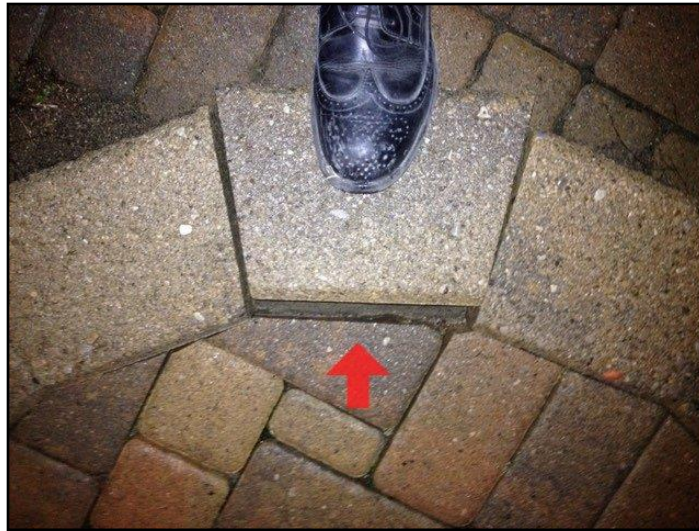
2. Condition: • [Steps springy, loose or sagging](#)

Implication(s): Trip or fall hazard

Location: Exterior Porch

Steps springy, loose or sagging

Task: Repair

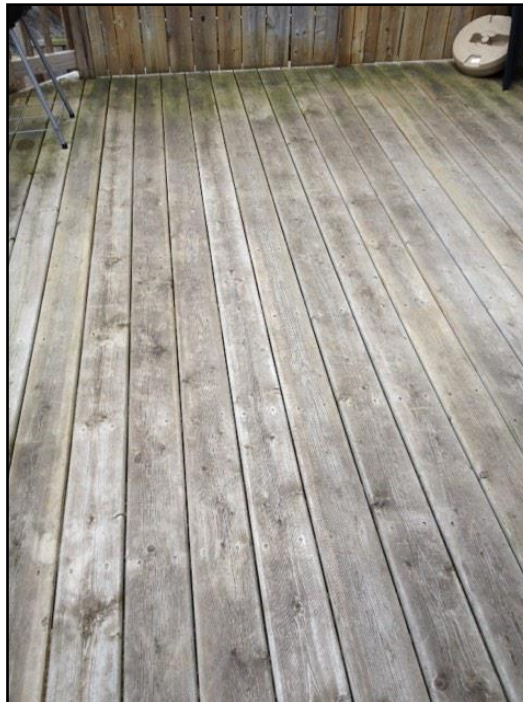
3. Condition: • [Paint or stain needed](#)

Implication(s): Material deterioration

Paint or stain needed

Task: Service

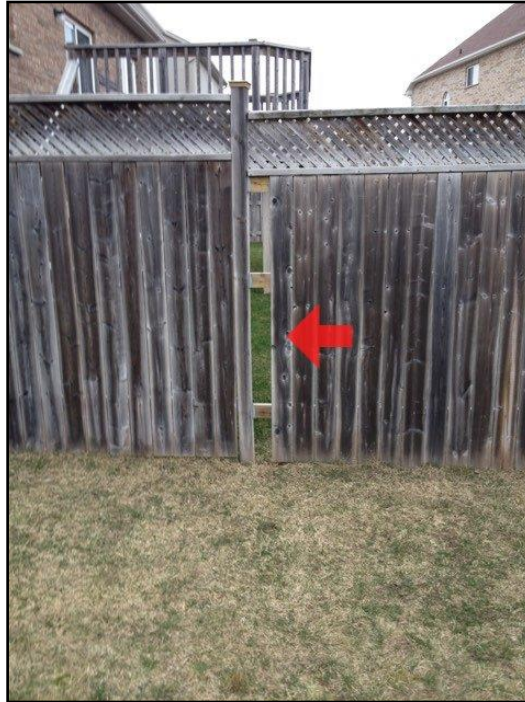
5. Condition: • Deteriorated

Implication(s): Material deterioration

Deteriorated

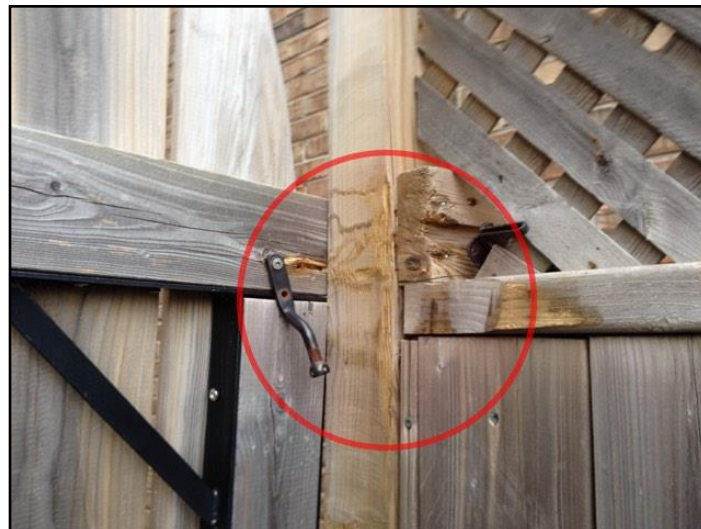
6. Condition: • Gate latch - adjustment needed

Implication(s): Reduced operability

Location: Left Side Yard

Gate latch - adjustment needed

Task: Repair

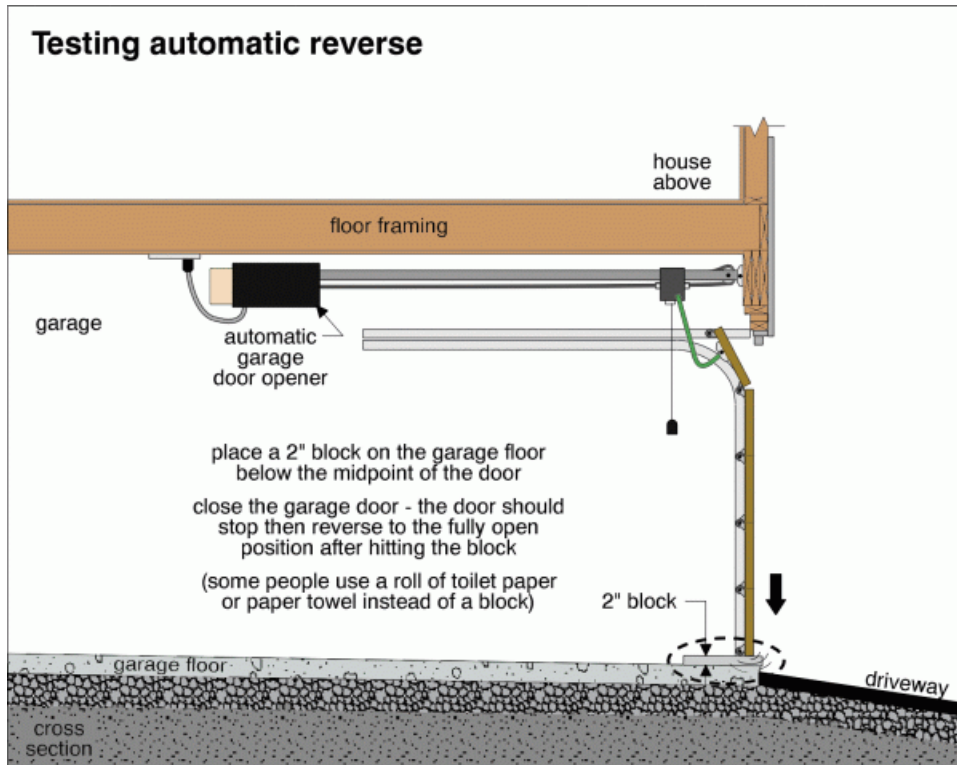
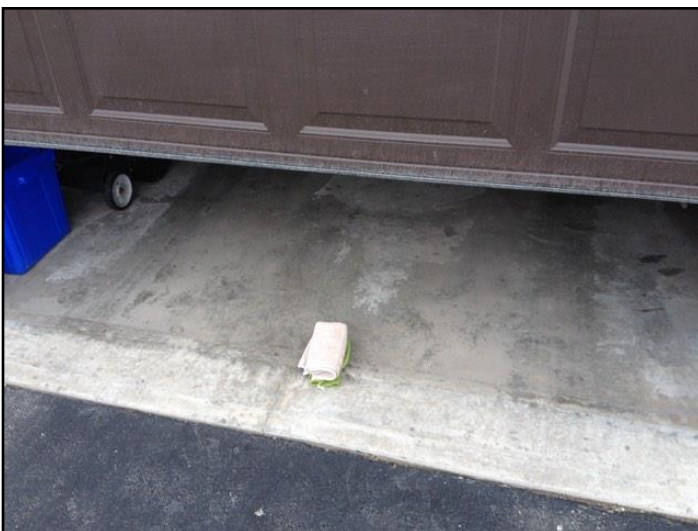
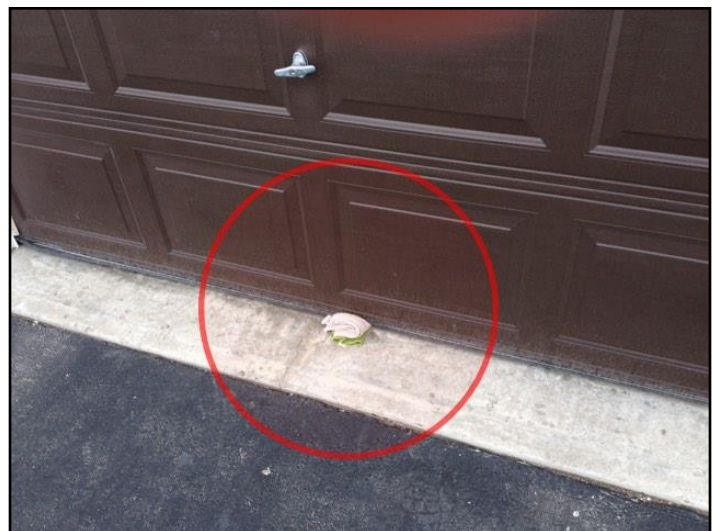
7. Condition: • [Fails to auto reverse](#)

Implication(s): Physical injury

Location: Garage

Fails to auto reverse

Task: Repair

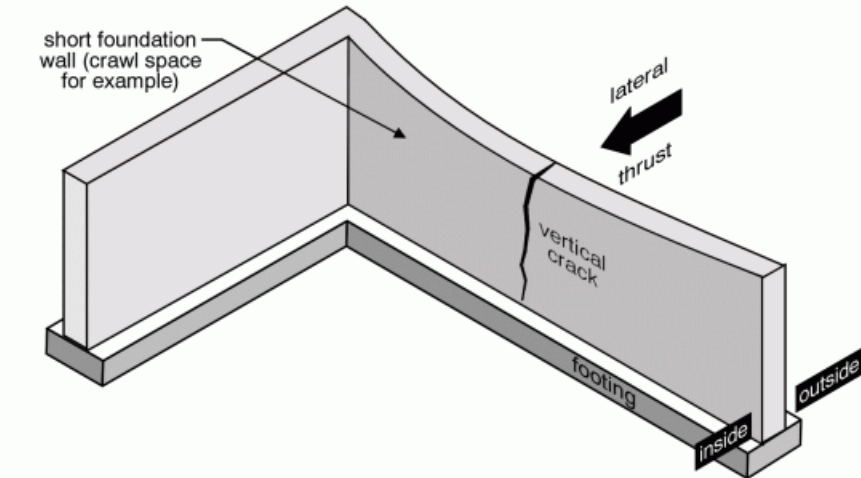
Vertical foundation cracks

in short foundation walls, horizontal forces can also cause vertical cracks (typically at the midpoint of the walls)

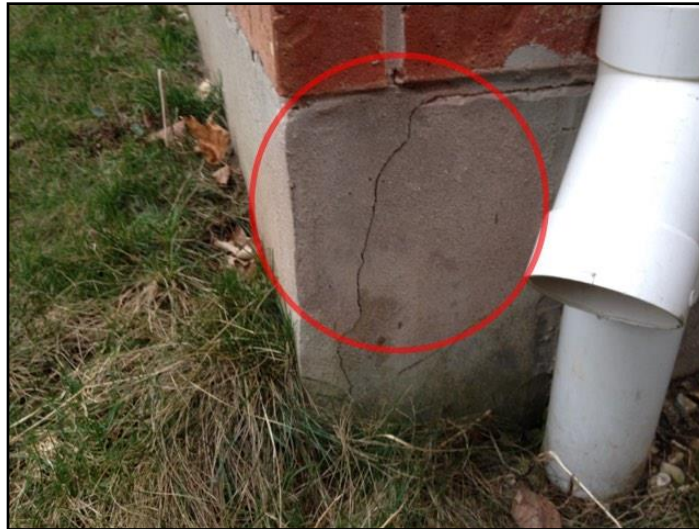
8. Condition: • [Cracked](#)

Implication(s): Chance of water damage to contents, finishes and/or structure | Weakened structure

Location: Left Side

Cracked

Task: Repair

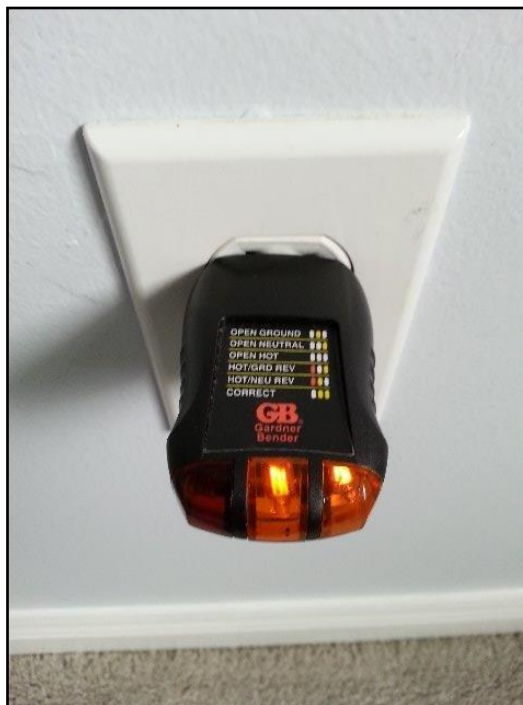
Around 20 receptacles were tested

Grounded and ungrounded - typical

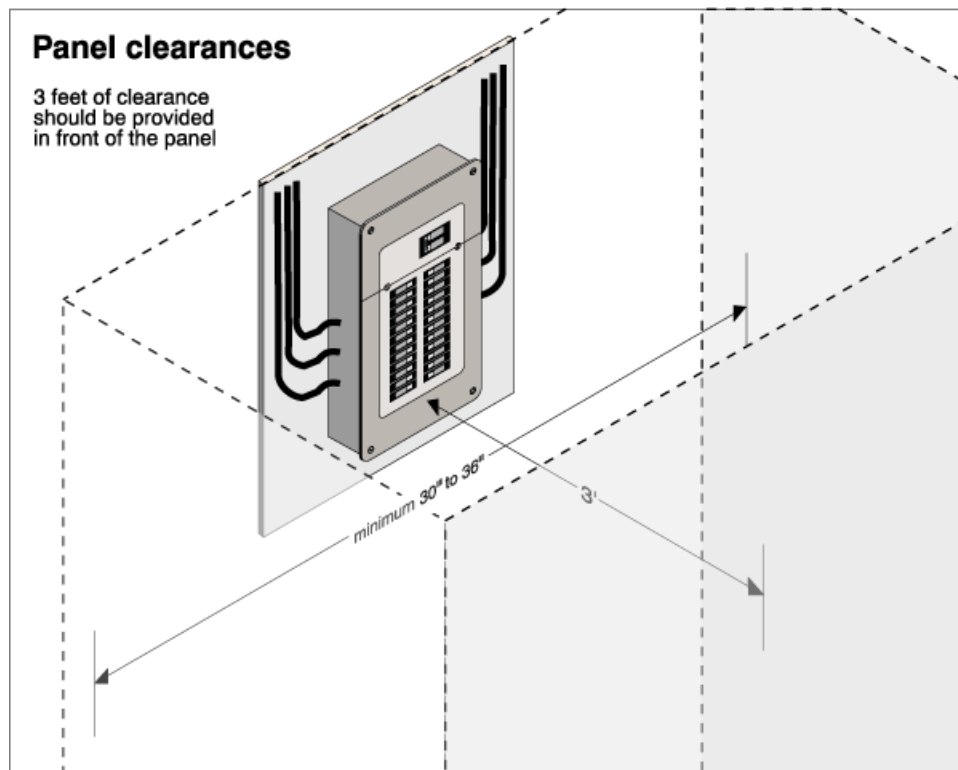
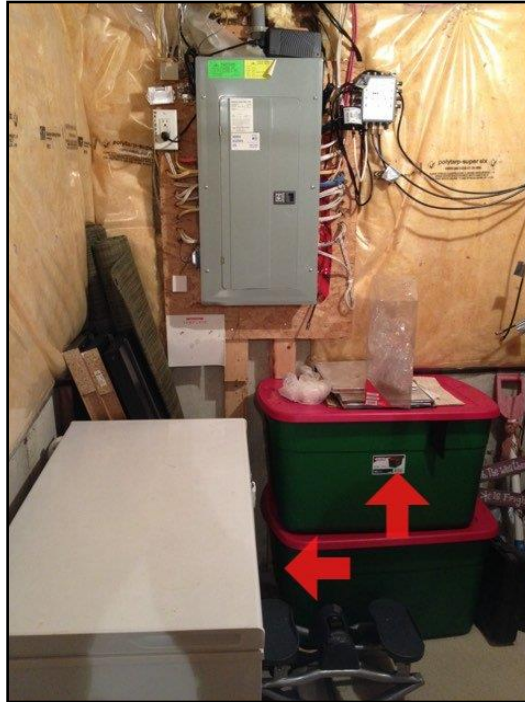
9. Condition: • No enough clearance space in front of service panel

Implication(s): Safety hazard in case of emergency

Location: Basement Utility Room

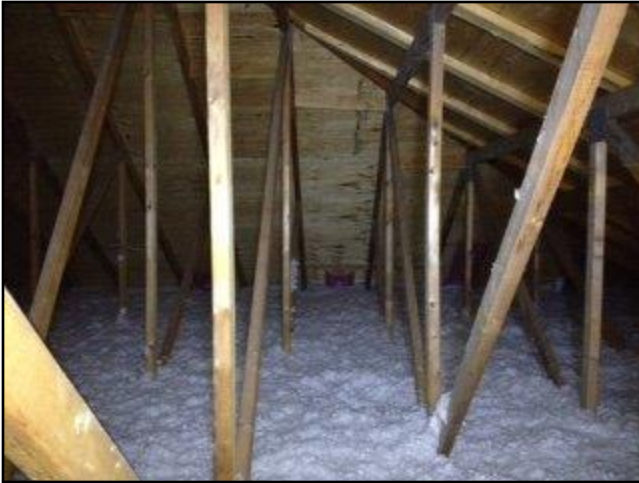
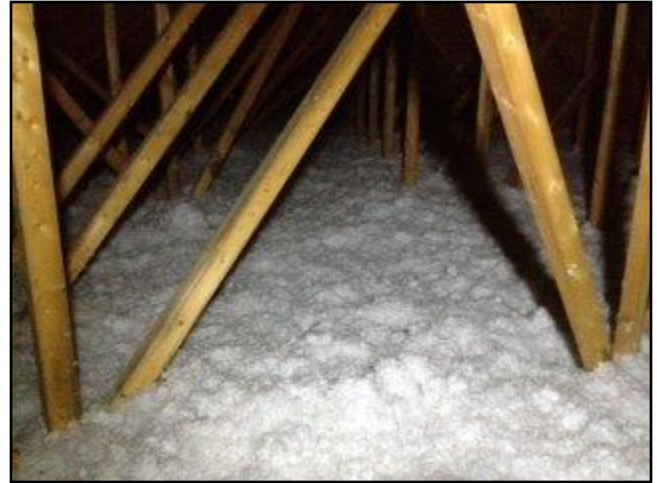
10. Condition: • [Amount less than current standards](#)

Implication(s): Increased heating and cooling costs

Location: Attic

Amount less than current standards

Task: Improve

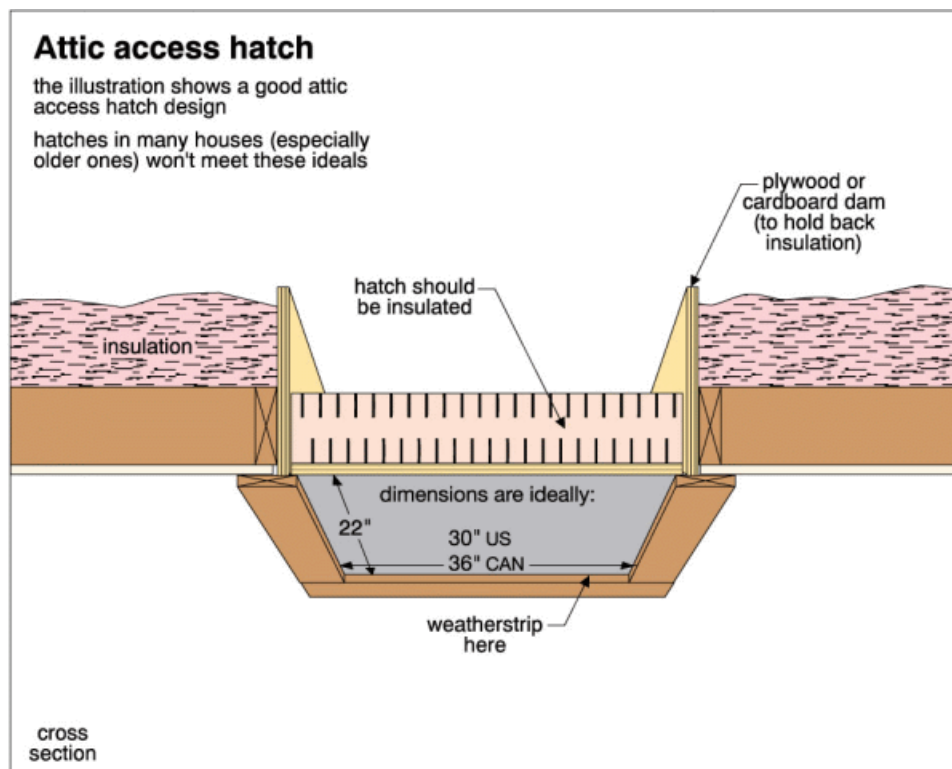
11. Condition: • [Not weatherstripped](#)

Location: Attic

Task: Repair

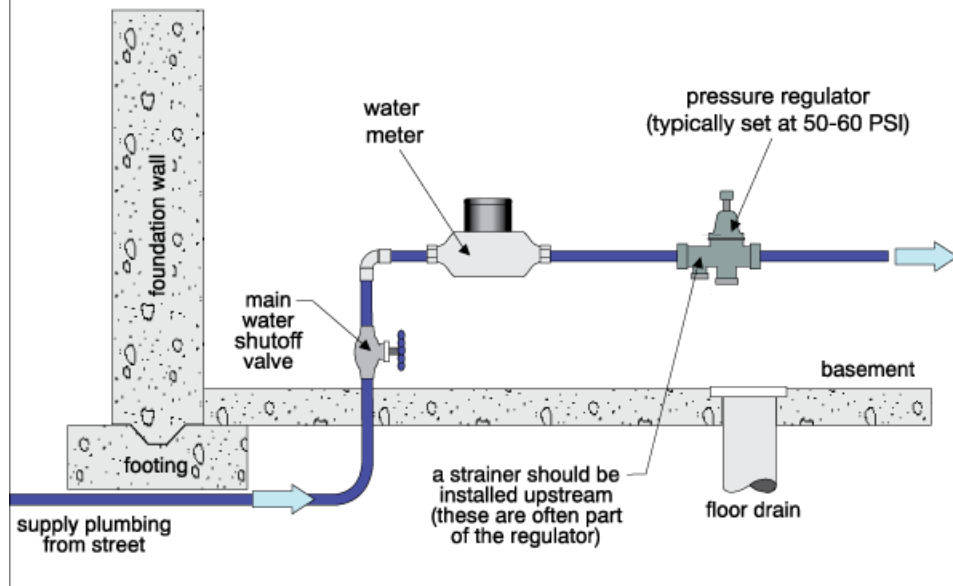
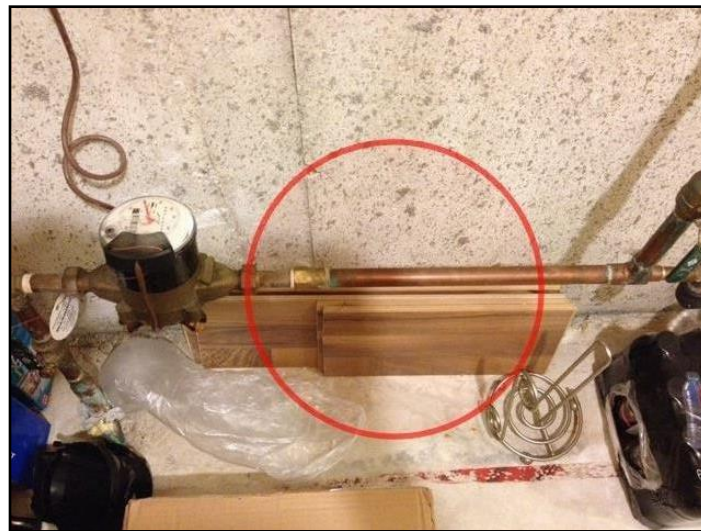
12. Condition: • [Missing](#)

Implication(s): Leakage | Damage to equipment | Chance of water damage to contents, finishes and/or structure

Location: Cold Room

Pressure regulator required

residential systems with static pressure in excess of 80 PSI usually have a pressure regulator

Missing

Task: Provide

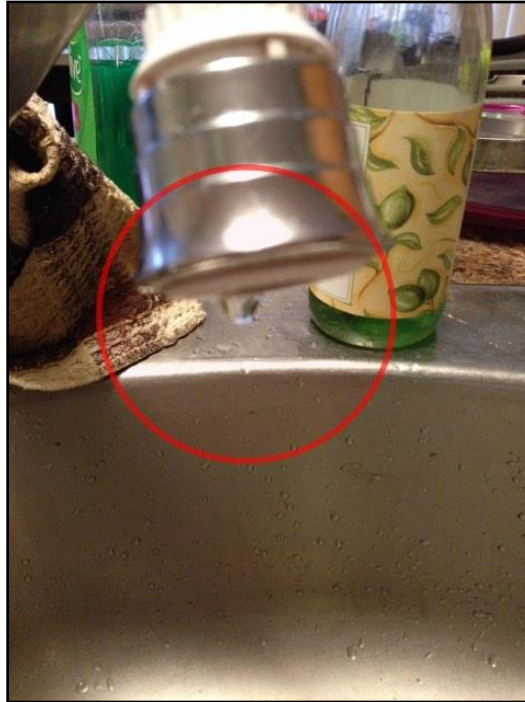
13. Condition: • [Drip, leak](#)

Implication(s): Chance of water damage to contents, finishes and/or structure

Location: Kitchen

Drip, leak

Task: Repair

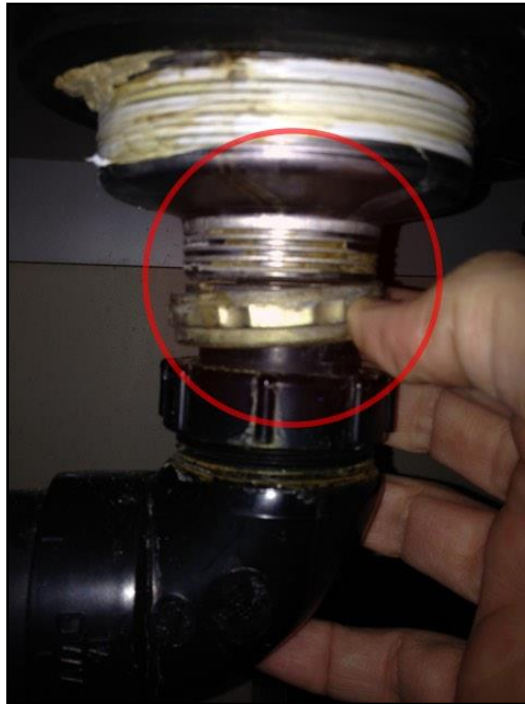
14. Condition: • [Drip, leak](#)

Implication(s): Chance of water damage to contents, finishes and/or structure

Location: Basement Dinette

Drip, leak

Task: Repair

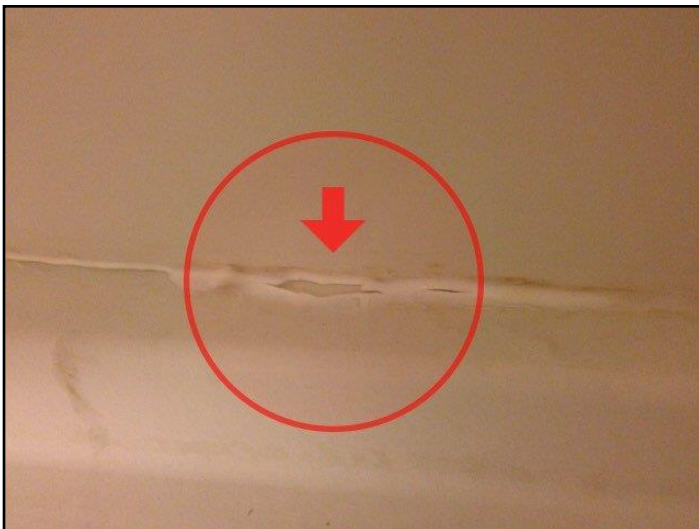
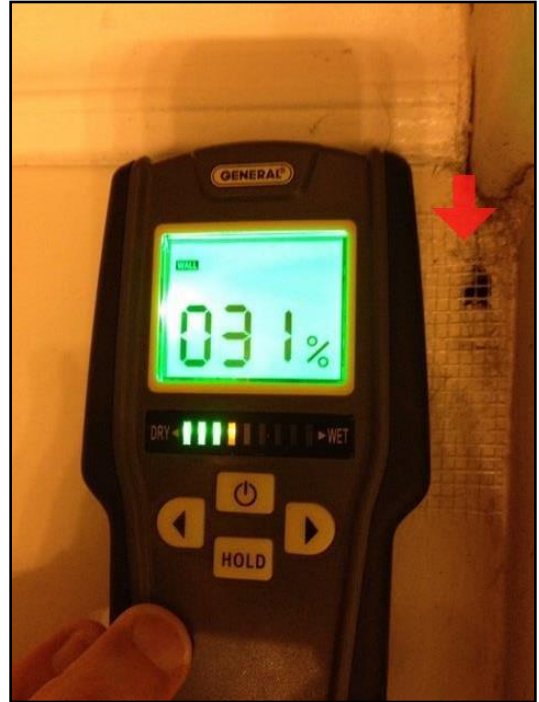
15. Condition: • [Caulking loose, missing or deteriorated](#)

Implication(s): Chance of water damage to contents, finishes and/or structure

Location: Basement Bathroom

Caulking loose, missing or deteriorated

Task: Repair

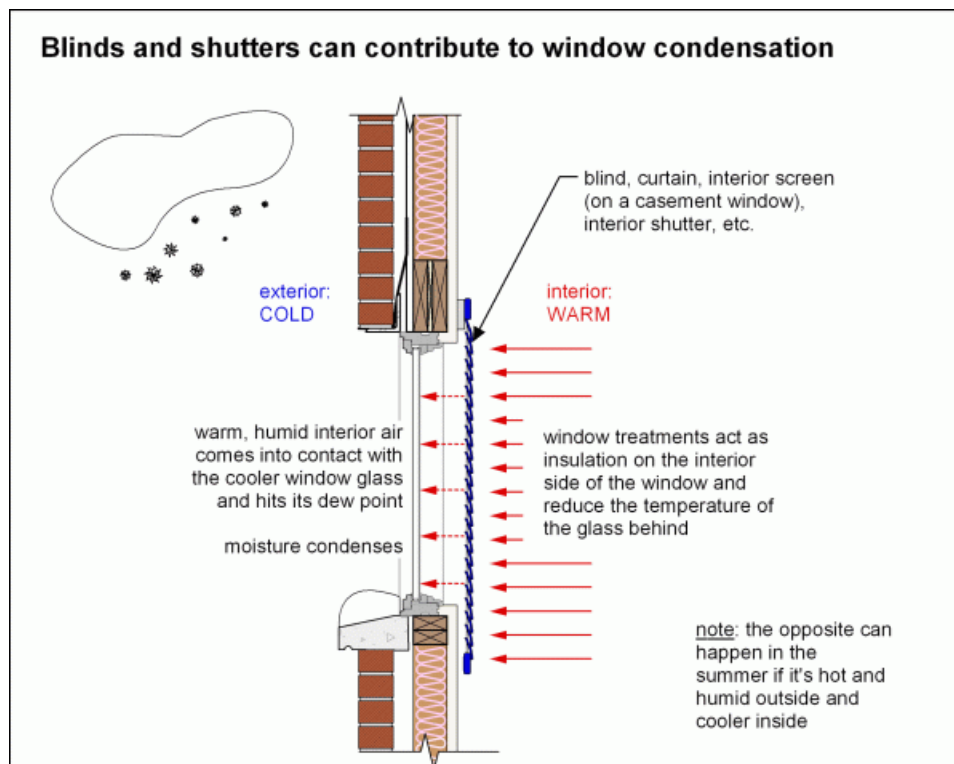
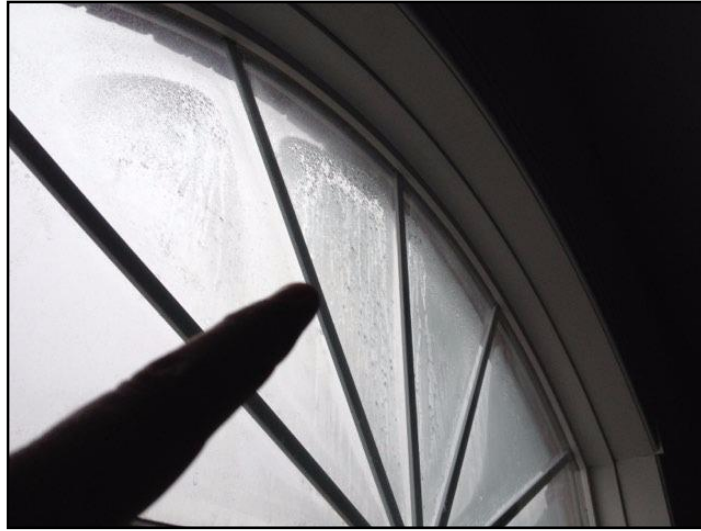
16. Condition: • [Excess condensation](#)

Implication(s): Chance of condensation damage to finishes and/or structure

Excess condensation

Task: Repair
