# YOUR INSPECTION REPORT

135 Giltspur Drive  
Toronto, ON M3L 1M4

INSPECTION DATE:  
Tuesday, October 14, 2025

RE: Report No. 8666, v.2  
135 Giltspur Drive  
Toronto, ON  
M3L 1M4

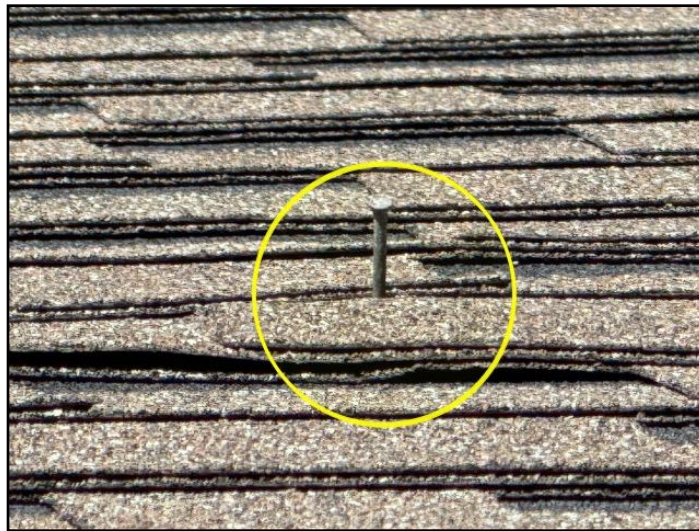
**Condition:** • [Exposed fasteners](#)

4. *Exposed fasteners*

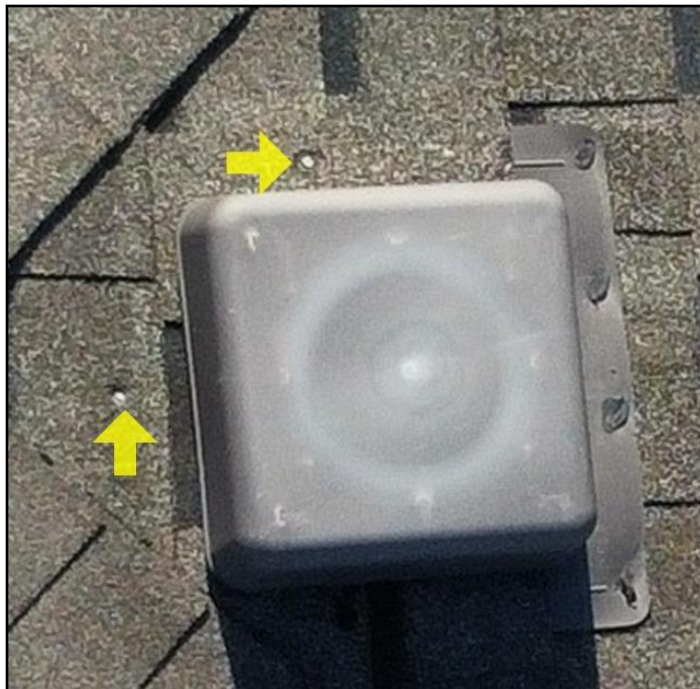
**Condition:** • [Exposed fasteners not sealed](#)

5. Exposed fasteners not sealed

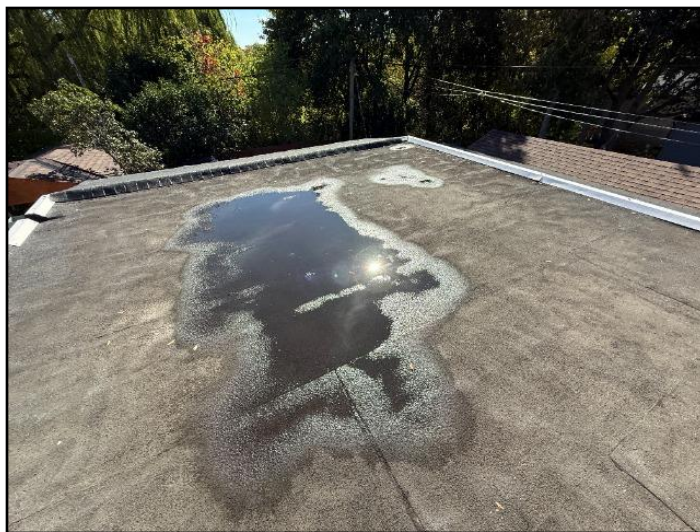
**Condition:** • Aging

6. Aging

**Task:** Inspect annually and replace when necessary

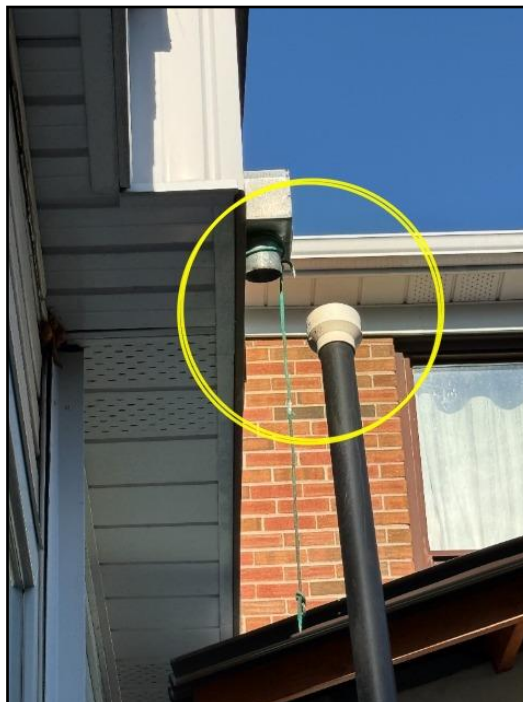
**Condition:** • [Connections loose](#)

8. Connections loose

**Task:** Repair

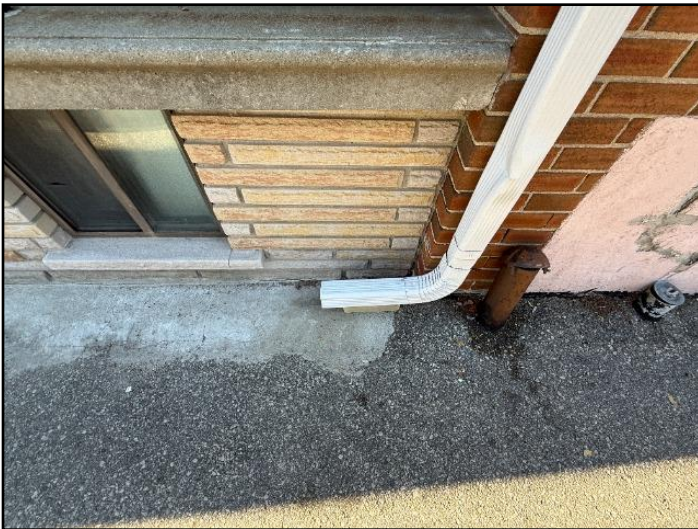
**Condition:** • [Discharge too close to building](#)

9. Discharge too close to building

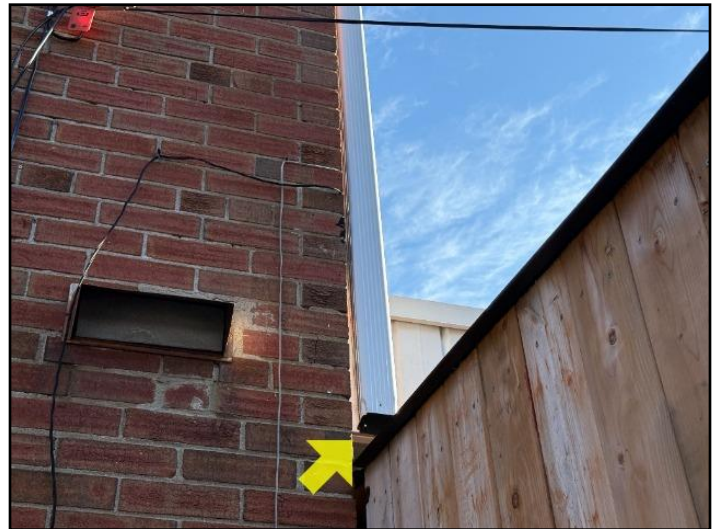
10. Discharge too close to building

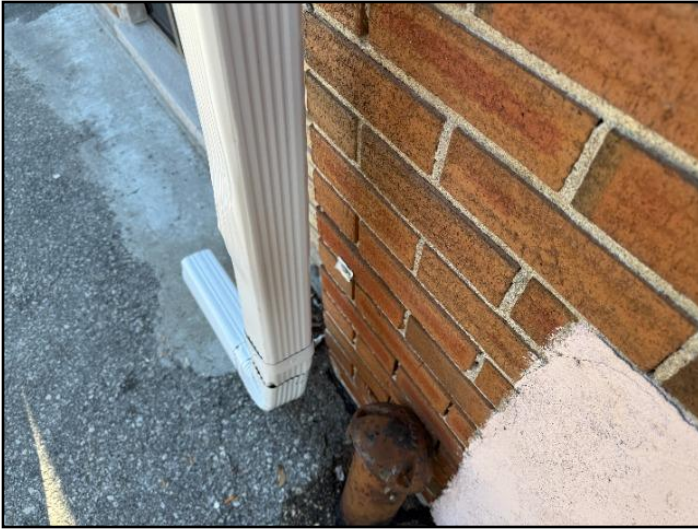
**Condition:** • [Not well secured](#)

11. Not well secured

**Task:** Repair

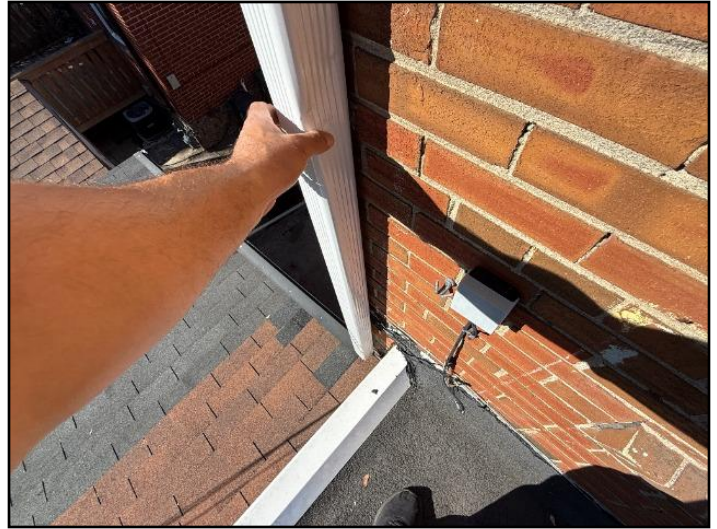
12. Not well secured

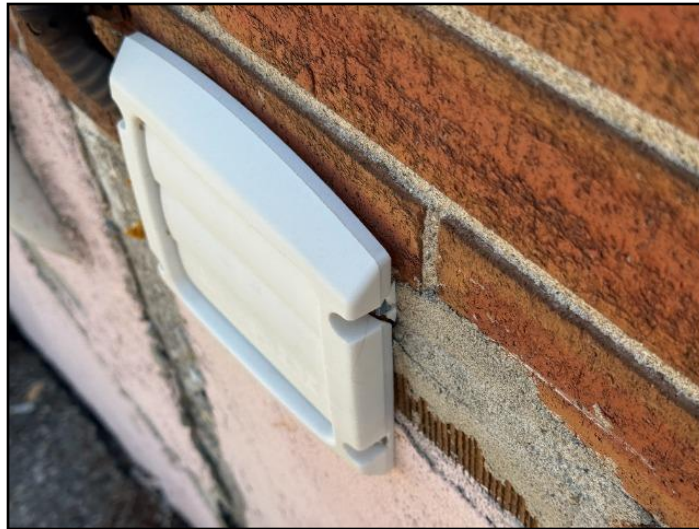
**Condition:** • FOR ALL HOMES - Caulking around windows, doors, and wall penetrations should be inspected regularly and improved as needed to prevent moisture entry and air leakage.

13. one example at vent

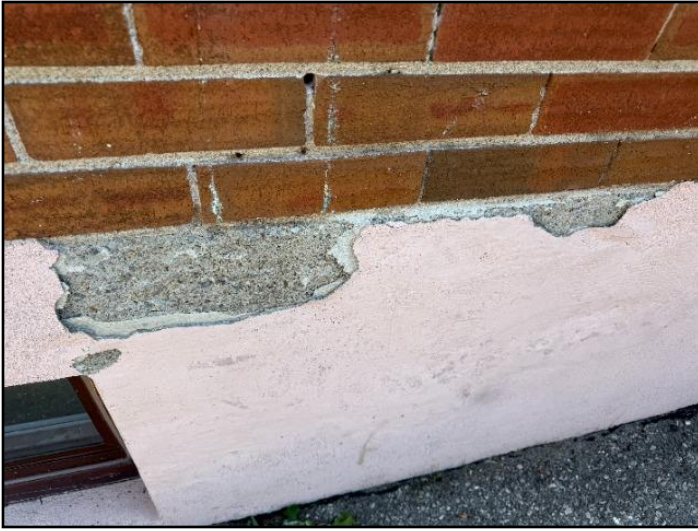
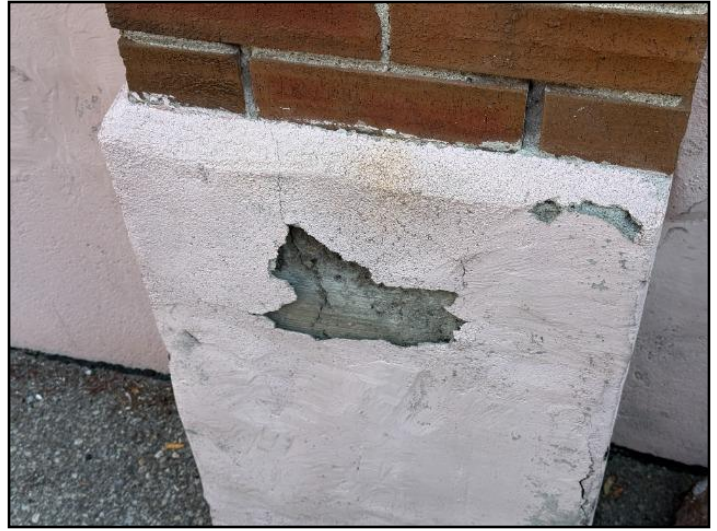
**Condition:** • [Parging damaged or missing](#)

**Implication(s):** Chance of damage to structure | Shortened life expectancy of material

**Task:** Repair

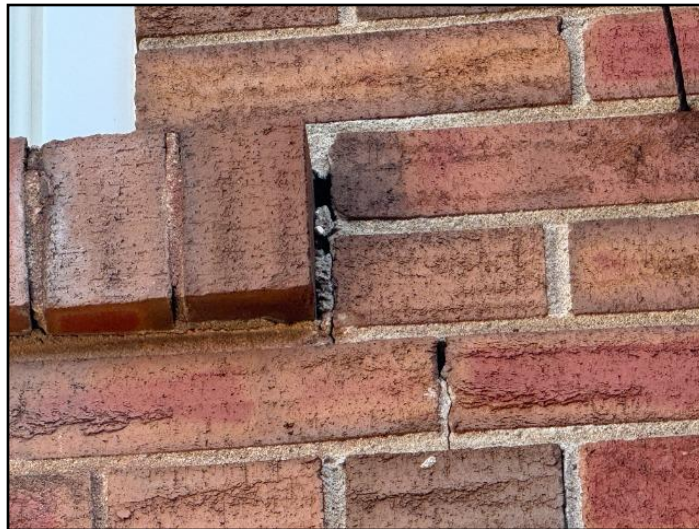
**Condition:** • Masonry and/or mortar deterioration

16. one example

Tuckpoint / Repoint mortar and patch/repair spalled masonry. This is typical maintenance for a home of this age.

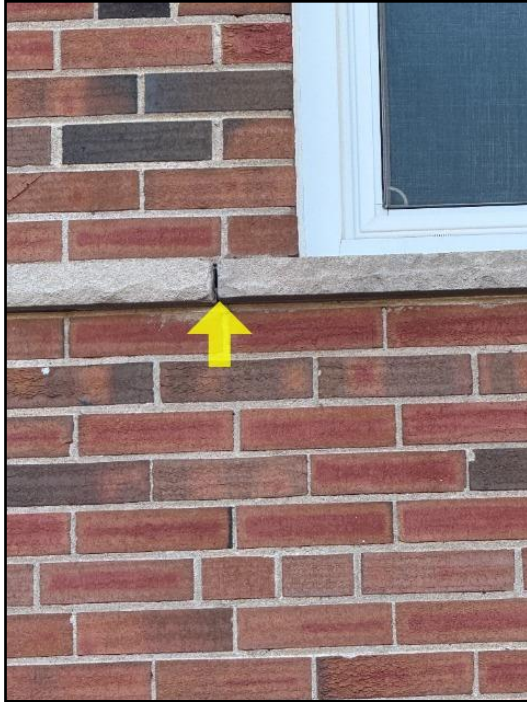
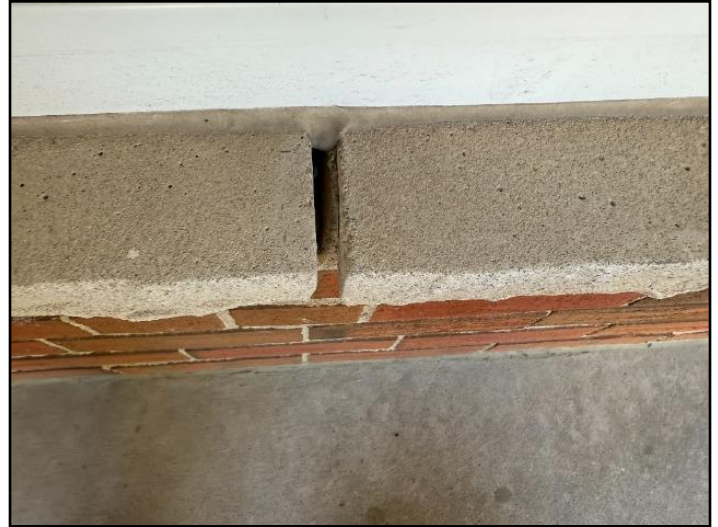
**Condition:** • Mortar deterioration at window sill control joint

17. Mortar deterioration at window sill control...

**Task:** Repair

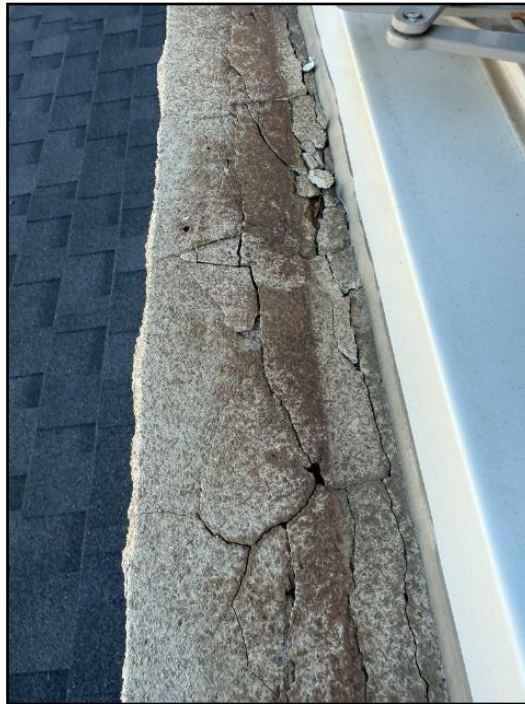
**Condition:** • [Sill deteriorated](#)

Masonry deterioration is commonly observed on exterior window sills. Sills typically deteriorate over time.

19. Sill deteriorated

**Task:** Repair / Replace

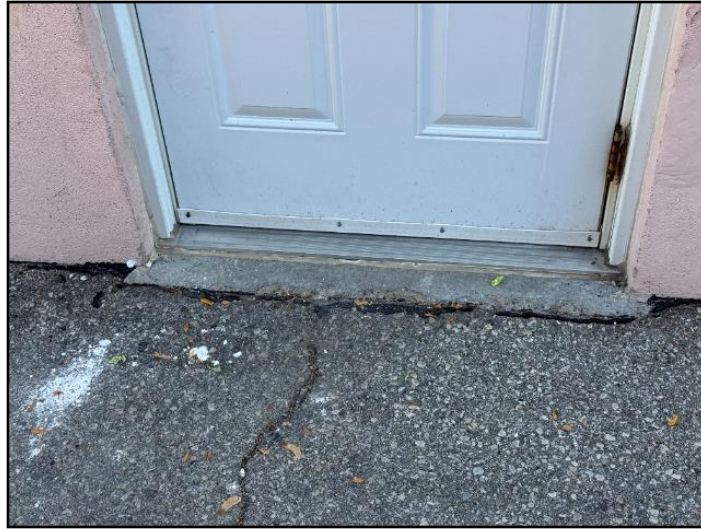
**Condition:** • Threshold too low

Having a minimal step makes the inside/outside transition easier. On the other hand, it also makes it more prone to snow buildup/leakage.

20. Threshold too low

While it is probably not practical to improve the current situation, it will be important to keep any weatherstripping/caulking in good condition.

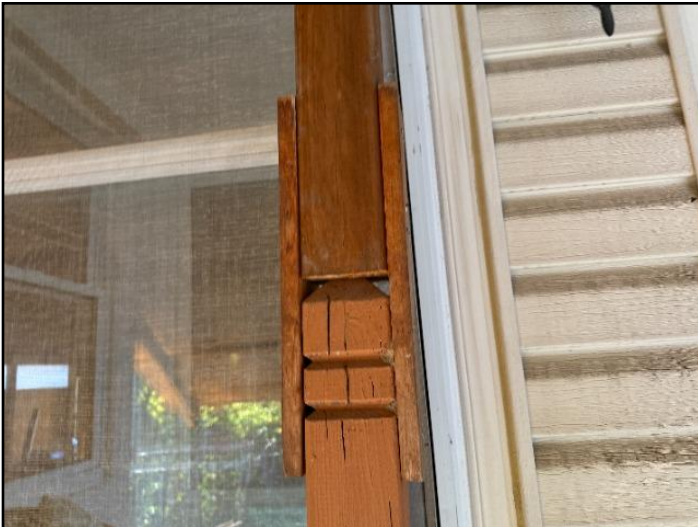
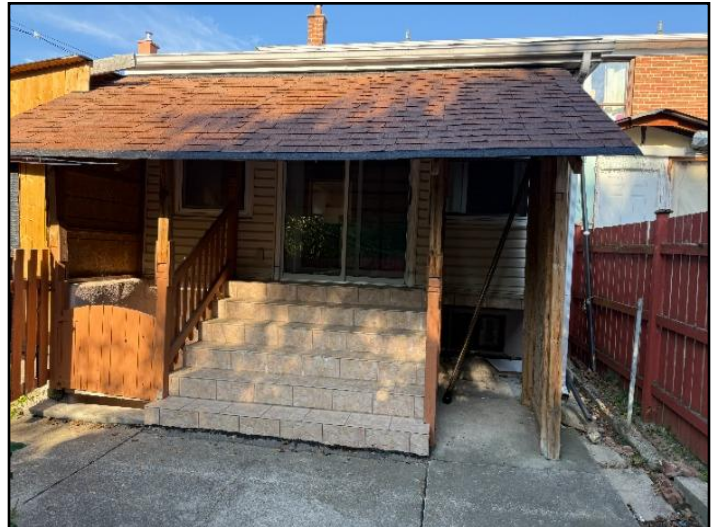
**Condition:** • A site-built awning structure has been added over the rear steps. The columns appear to be installed directly on top of existing railing balusters, which is not a proper structural support method. While this element falls outside the scope of a standard home inspection, the installation appears improvised and may not meet structural or safety standards.

**Task:** Recommend evaluation and correction by a qualified contractor if continued use is intended

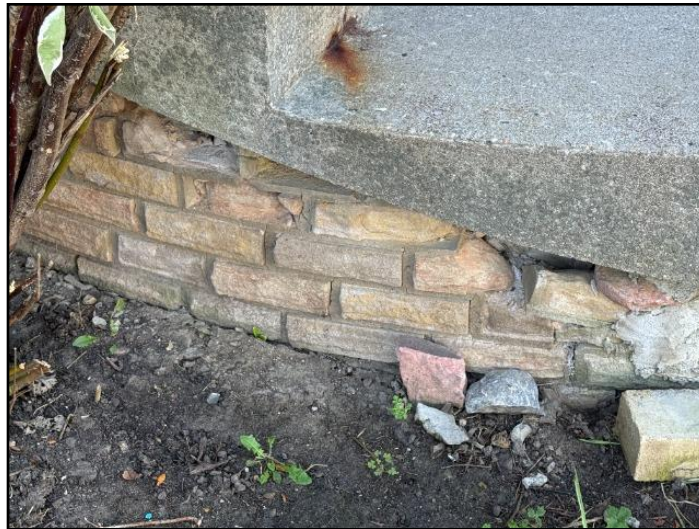
**Condition:** • [Damage](#)

**23.** *Damage*

**Task:** Repair

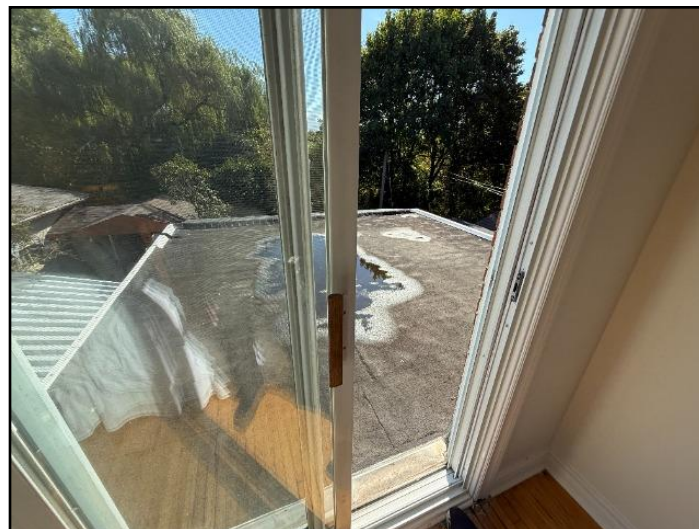
**Condition:** • [Missing](#)

A door opens directly onto a flat roof with no guardrails or protective barriers. To reduce the fall hazard, either:

24. Missing

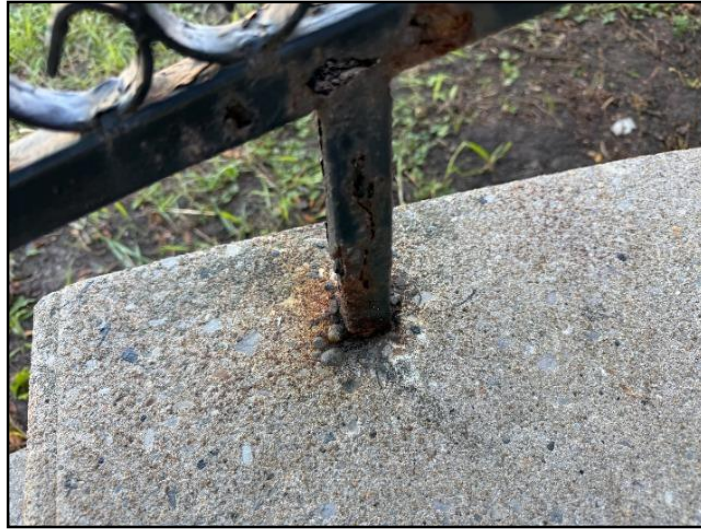
**Condition:** • [Rust](#)

25. one example

**Task:** Replace

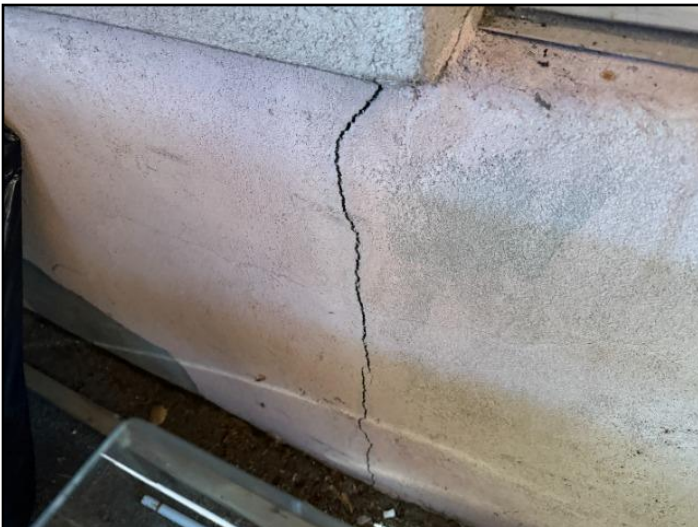
**Condition:** • [Walls cracking, leaning, bowing or spalling](#)

Cracking, damaged parging (and cracking behind parging) observed along the rear foundation wall where it extends outward to form the basement walkout sidewall. Areas of damaged parging expose underlying cracks in the wall surface. The cracking may be related to differential settlement or movement of the walkout wall.

26. Walls cracking

**Task:** Further evaluate and repair as recommended by a qualified foundation or masonry contractor.

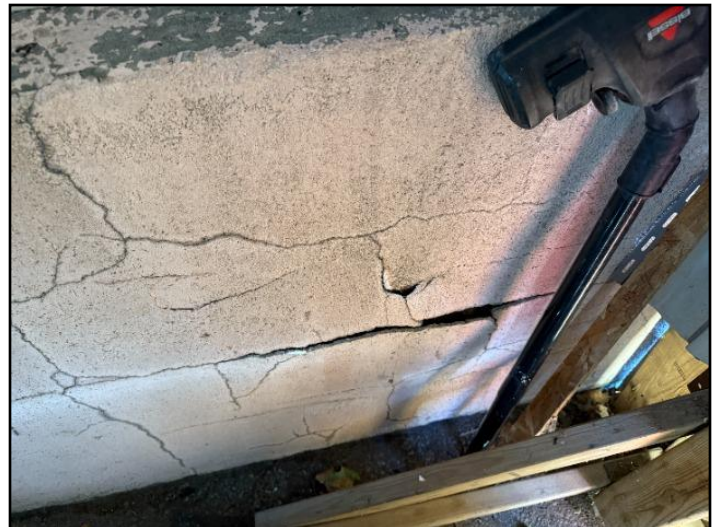
27. Cracked parging and wall behind parging

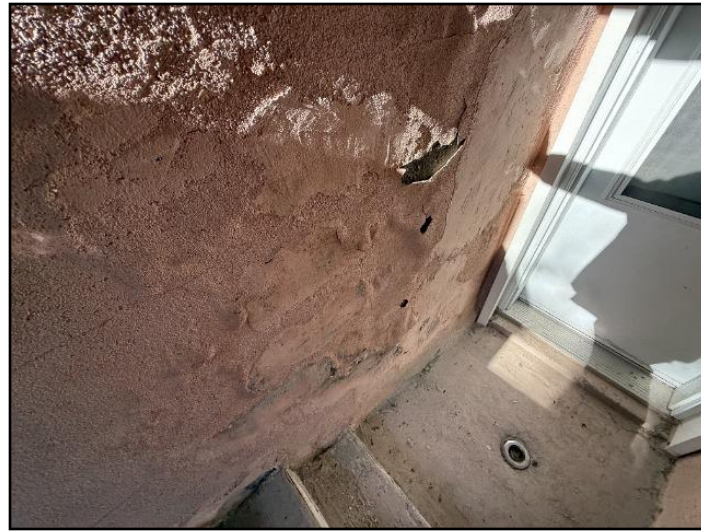
28. Spalling or damaged parging

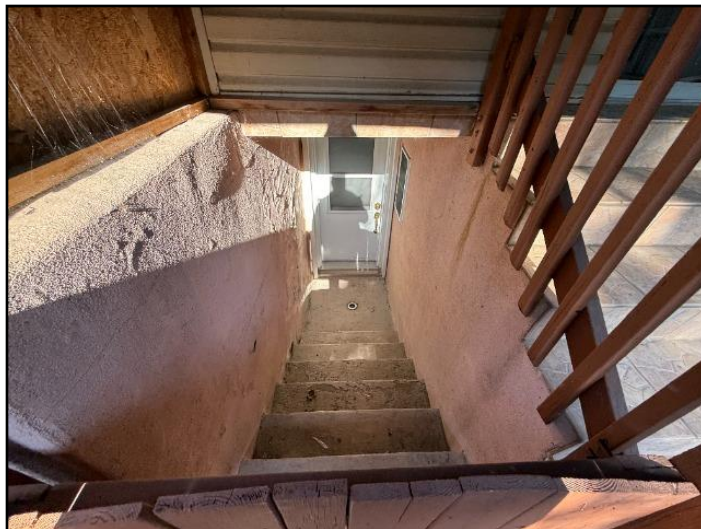
**Condition:** • [Guard and handrail problems](#)

29. Handrail missing

**Task:** Provide Handrails

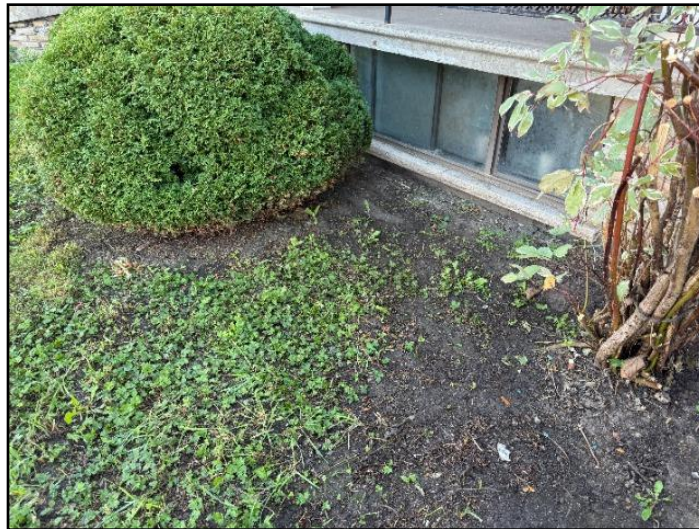
**Condition:** • Low Areas.

30. Low Areas.

Fill in low areas and ensure the ground slopes away from the home for at least 6 feet to promote proper drainage. This is a standard maintenance practice for all homes to prevent water accumulation near the foundation

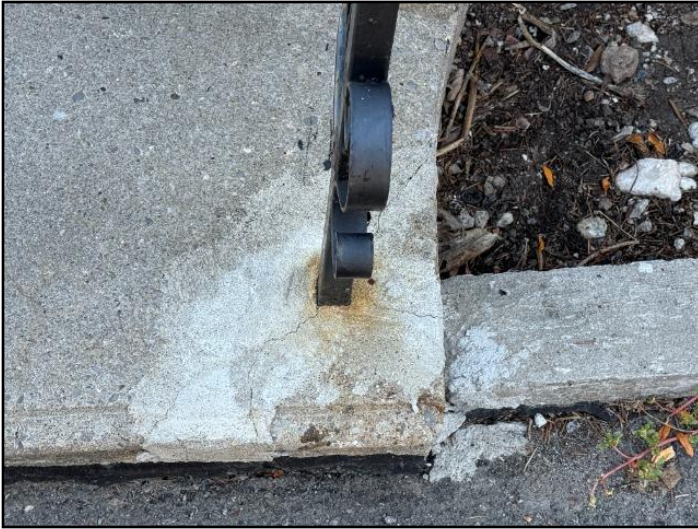
- Spalling or cracking at front steps - repair
- Minor damage at EIFS stucco - repair
- Vent loose - right side - improve seal
- Window frame at right side vestibule exhibits rot - replace or cap
- Rear second floor sliding screen difficult to operate - Adjust

31. front steps

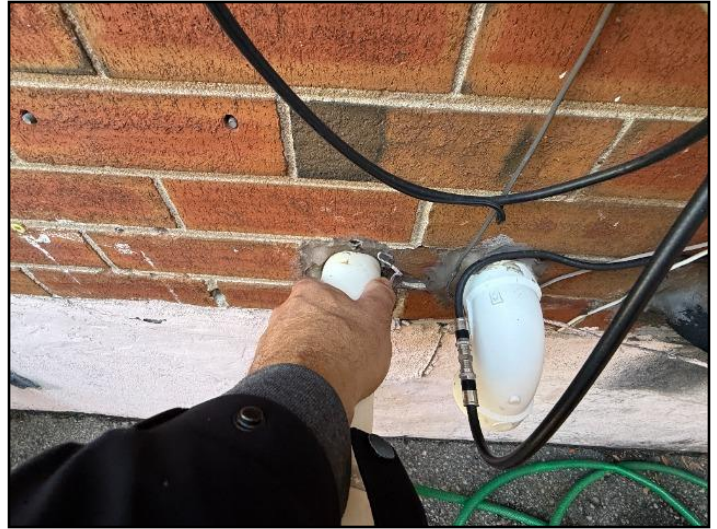
32. vent at right side

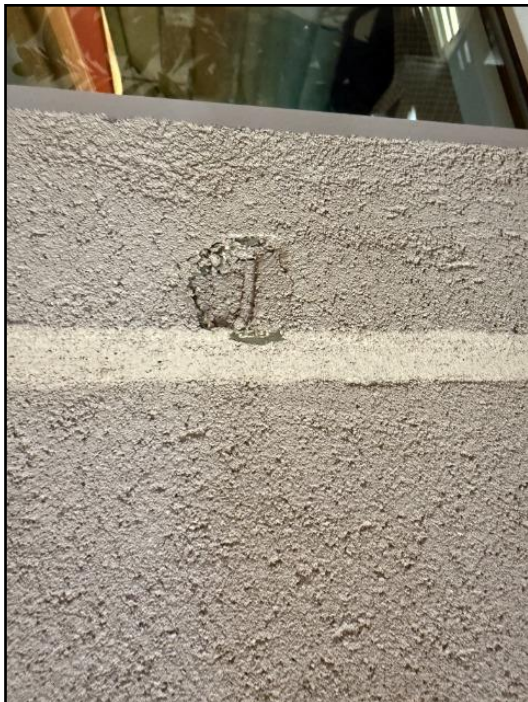
33. Minor damage at EIFS stucco

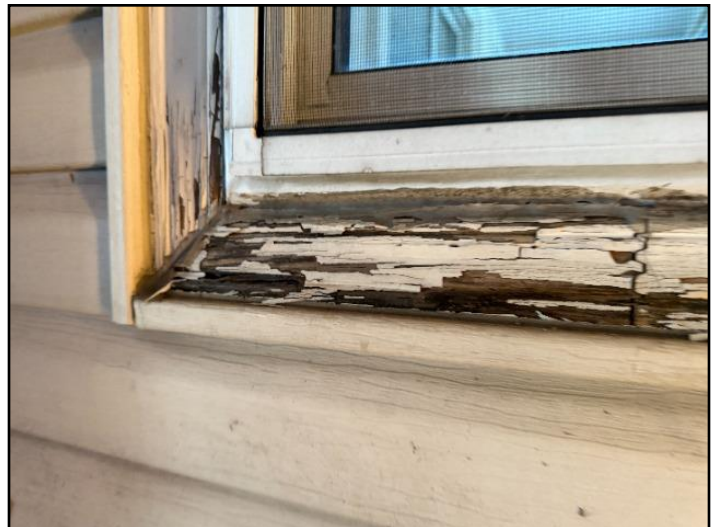
34. Right side vestibule window

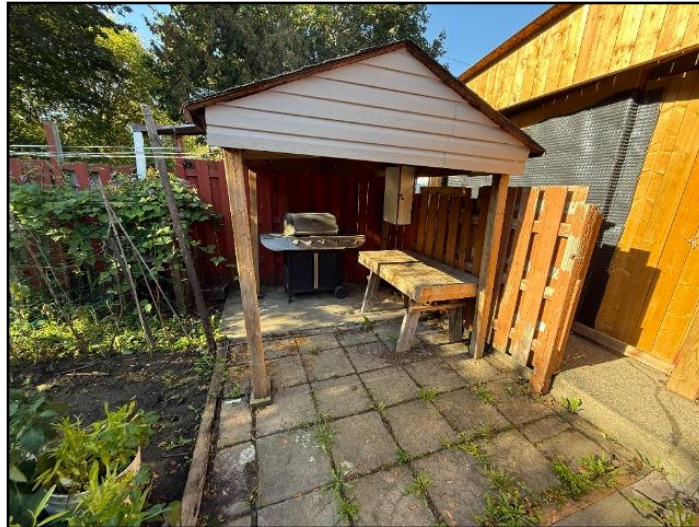
A small wood-framed shelter over the backyard barbecue area was observed to be unstable and leaning. This structure is not part of the home inspection scope; however, its instability may present a safety concern. Recommend repair or removal as needed for safety.

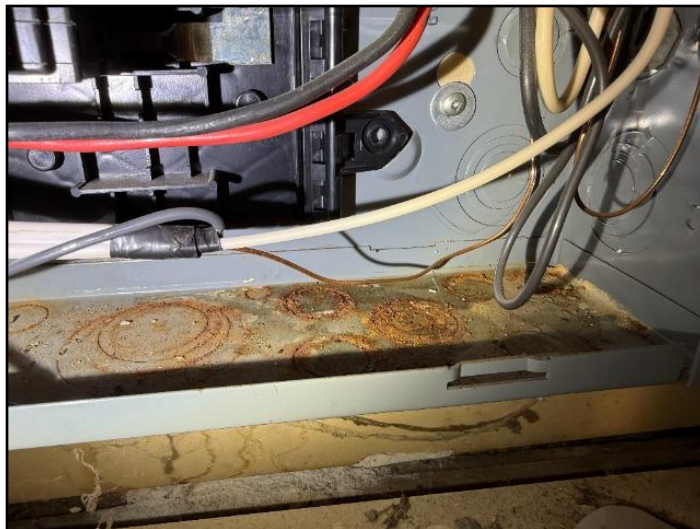
**Condition:** • [Rust or water in panel](#)

Rust was noted in panel, potentially due to the humid bathroom environment.

37. Rust or water in panel

**Task:** Further evaluation

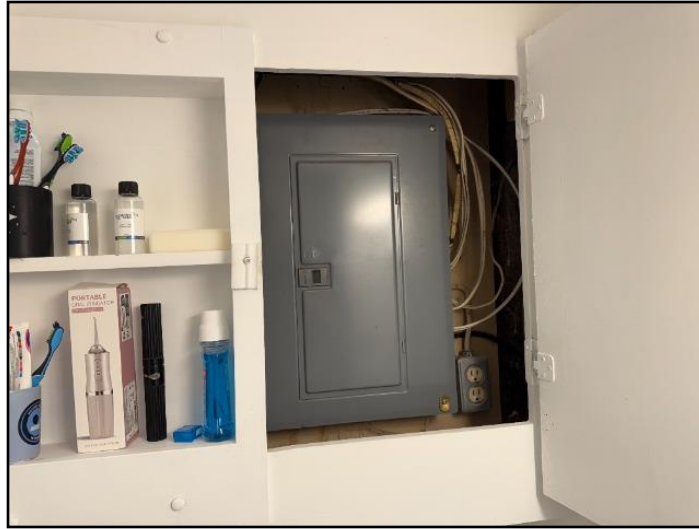
**Condition:** • [Poor access](#)

**38.** *Poor access***Condition:** • [Poor location](#)

**Task:** Further evaluation / Correct

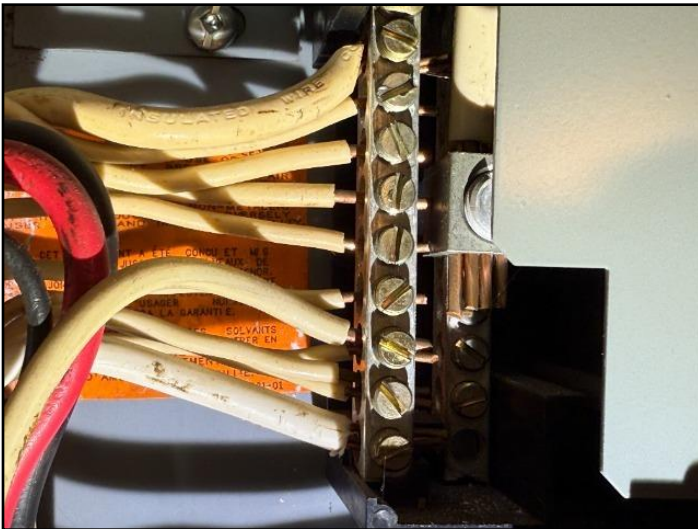
**Location:** Basement Panel bottom right**Task:** Provide proper panel fastener**Time:** When servicing panel**Cost:** Minor**SERVICE BOX, GROUNDING AND PANEL \ Panel wires****Condition:** • [Double taps](#)

39. Double taps

**Implication(s):** Fire hazard**Location:** Basement Panel**Task:** Correct**Time:** As Soon As Possible**Cost:** Minor

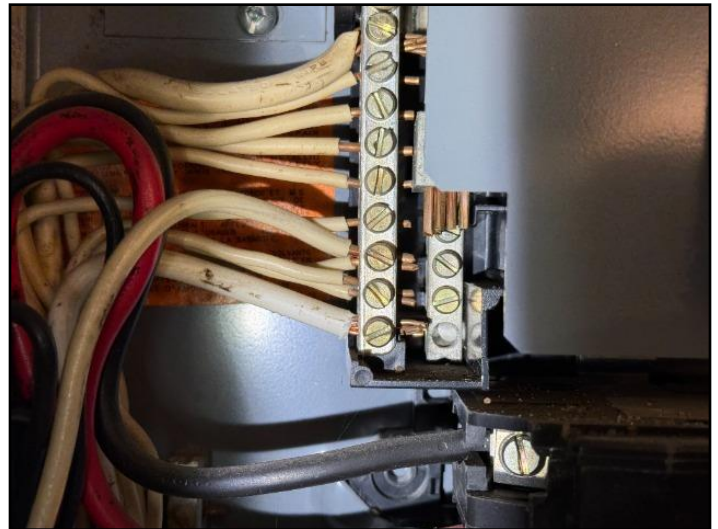
40. Double taps

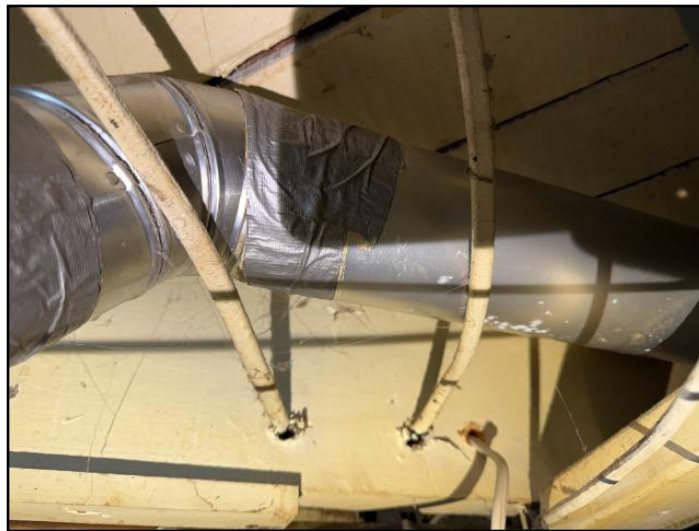
Condition: • [Too close to/touching duct, pipe, vent or chimney](#)

**41.** example**DISTRIBUTION SYSTEM \ Wiring (wires) - damaged or exposed****Condition:** • [Exposed on walls or ceilings](#)**Implication(s):** Electric shock**Location:** Basement**Task:** Correct**Time:** As Soon As Possible

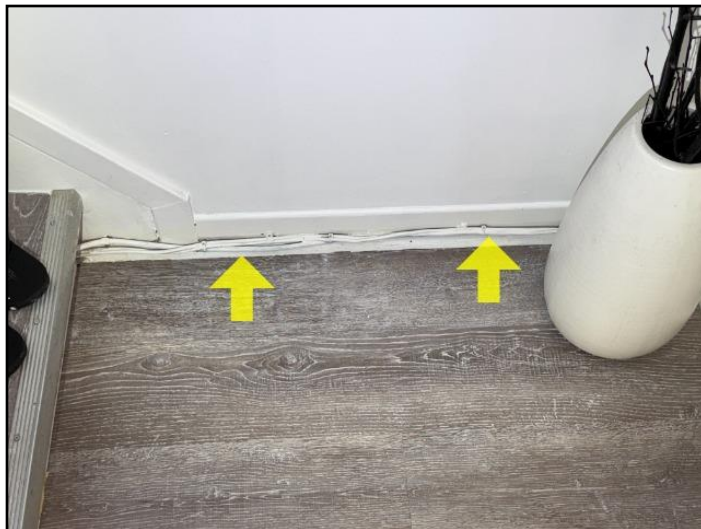
42. Exposed on walls or ceilings

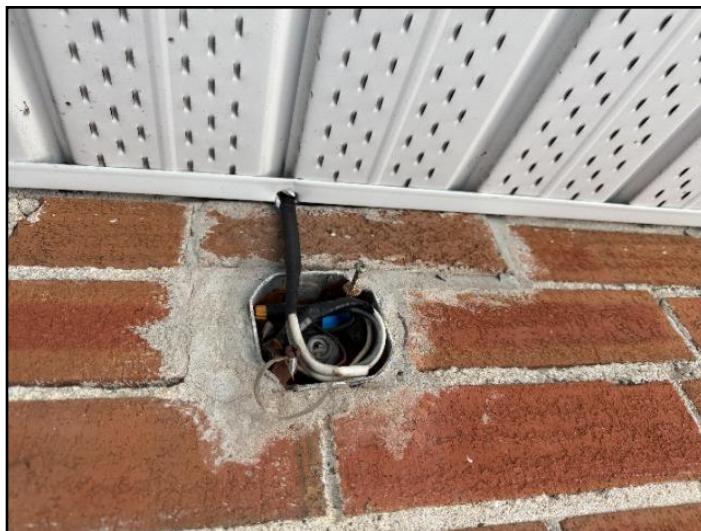
**Condition:** • Cover missing

43. Cover missing

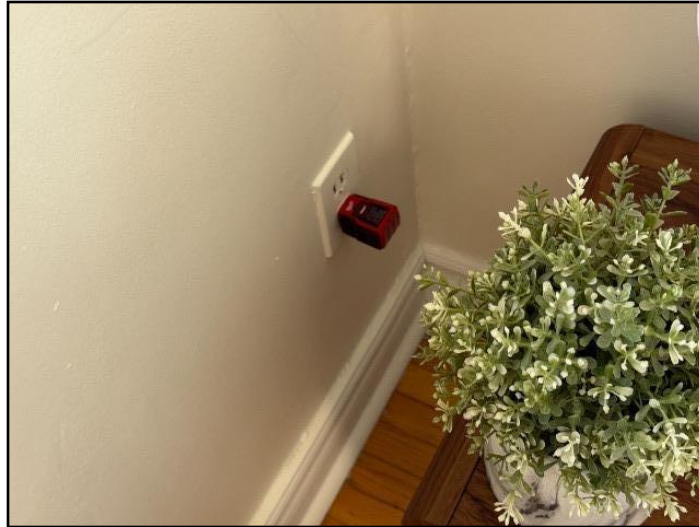
**Condition:** • [Inoperative](#)

44. Inoperative

**Task:** Repair / Replace

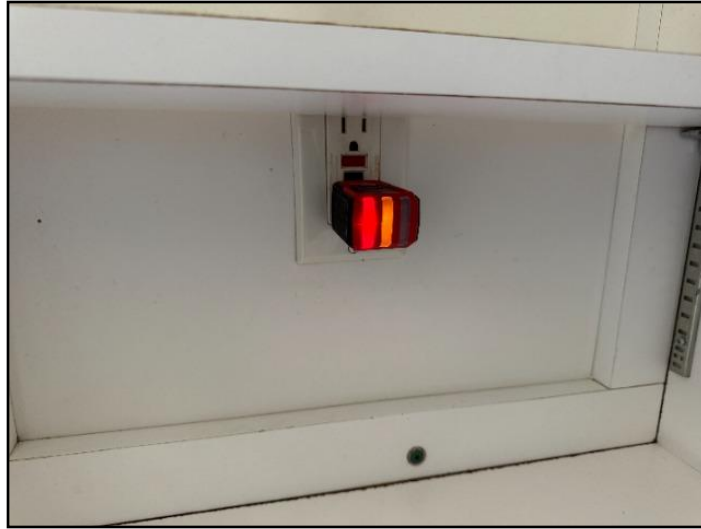
**Condition:** • [Reversed polarity](#)

**45.** *Reversed polarity*

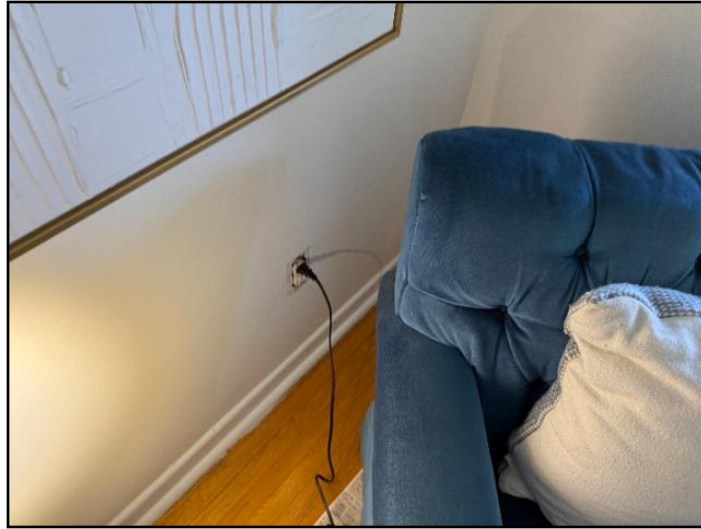
**Condition:** • For outlet (receptacle) is missing

46. For outlet (receptacle) is missing

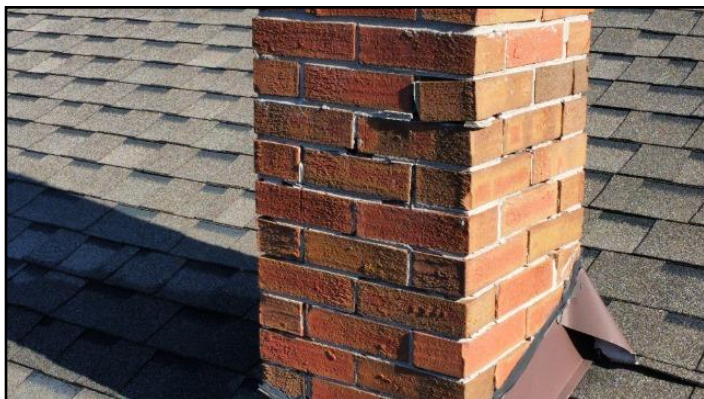
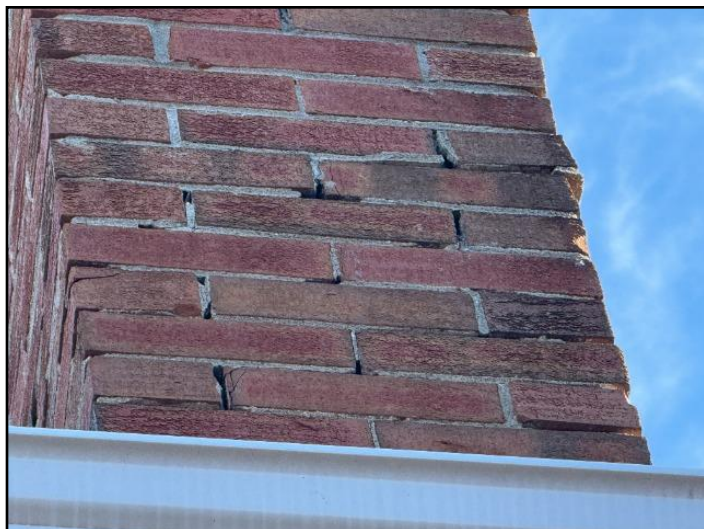
47. Loose, missing or deteriorated masonry...

48. Loose, missing or deteriorated masonry...

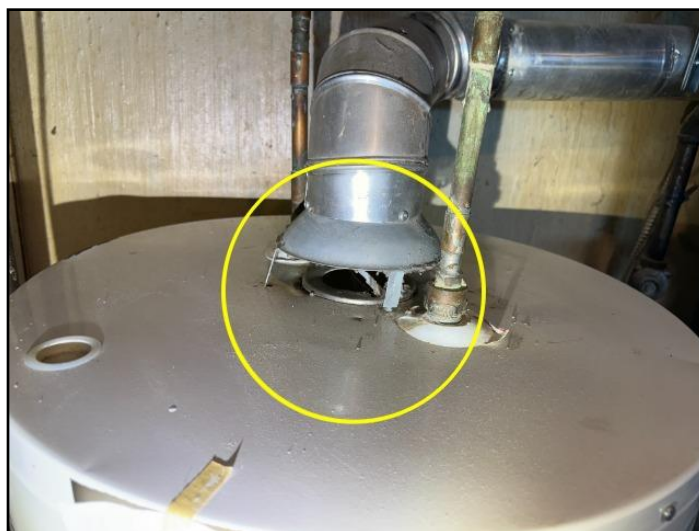
**Condition:** • [Poor connections](#)

52. vent not secured to water heater

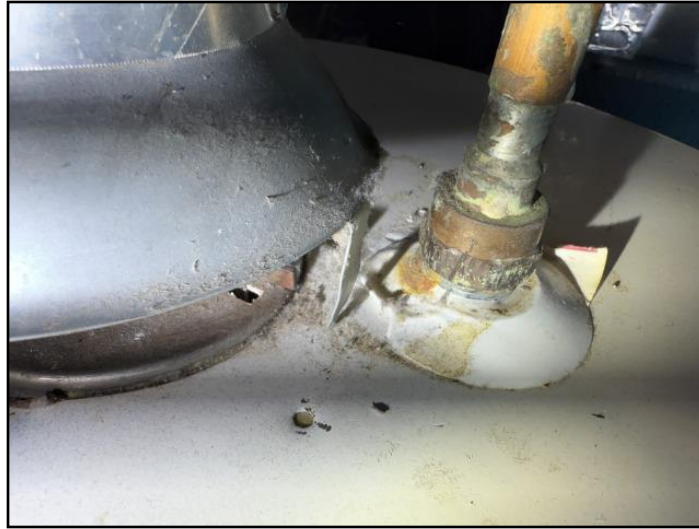
**Condition:** • [Spillage or backdraft at the draft hood](#)

53. Spillage or backdraft at the draft hood

**Task:** Further evaluation / Correct

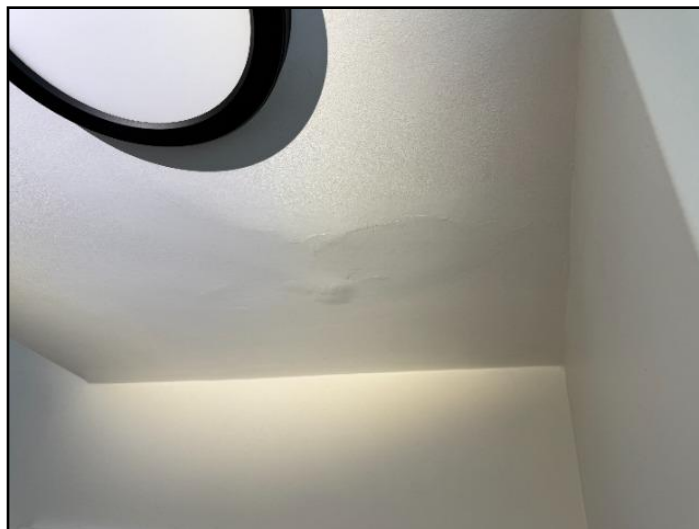
54. Patched

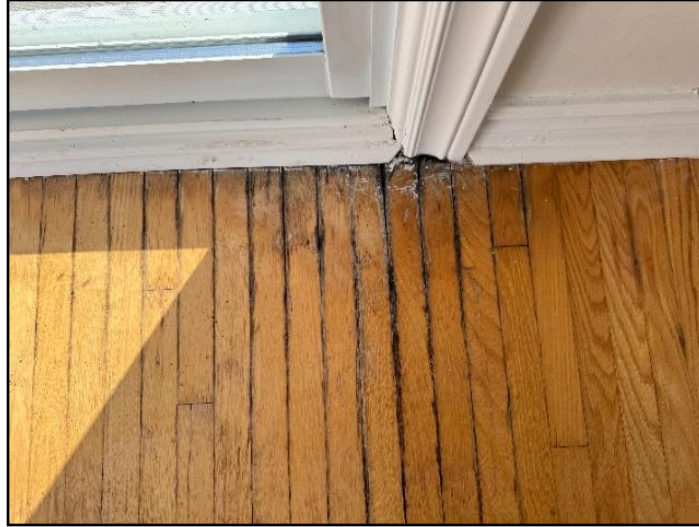
55. Stained

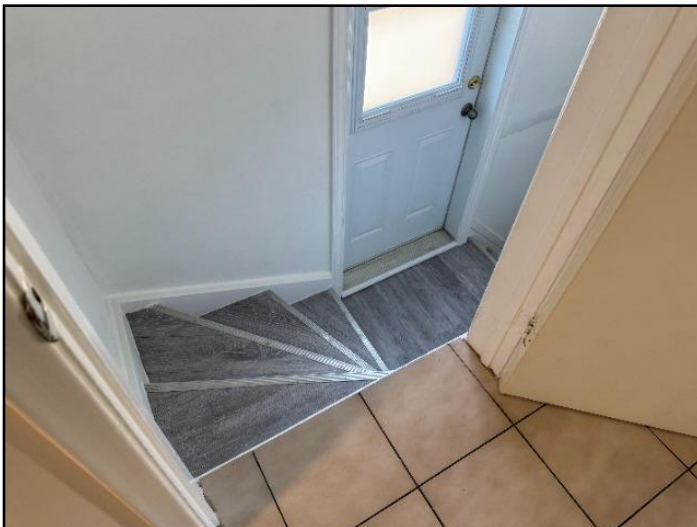
57. Missing

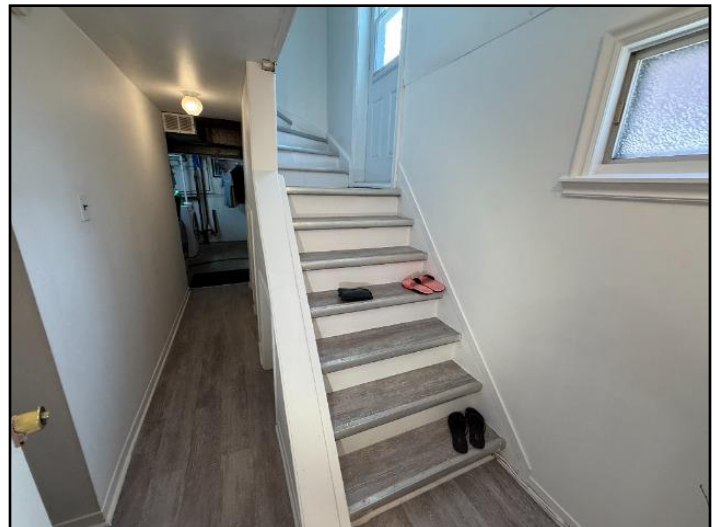
58. Missing

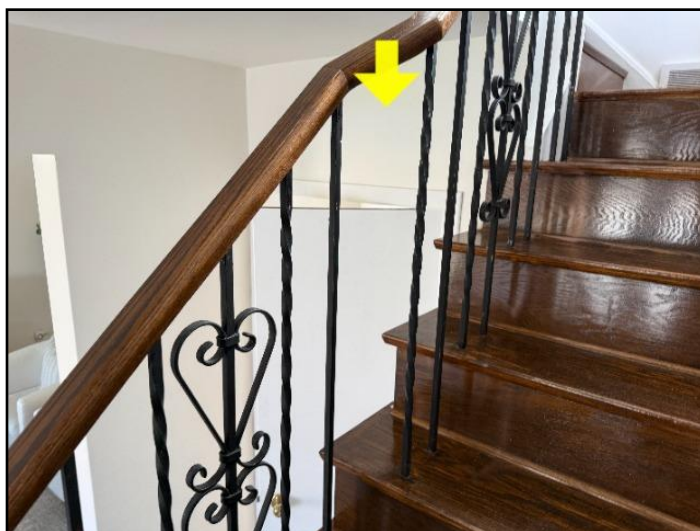
59. Too far apart

**Task:** Correct

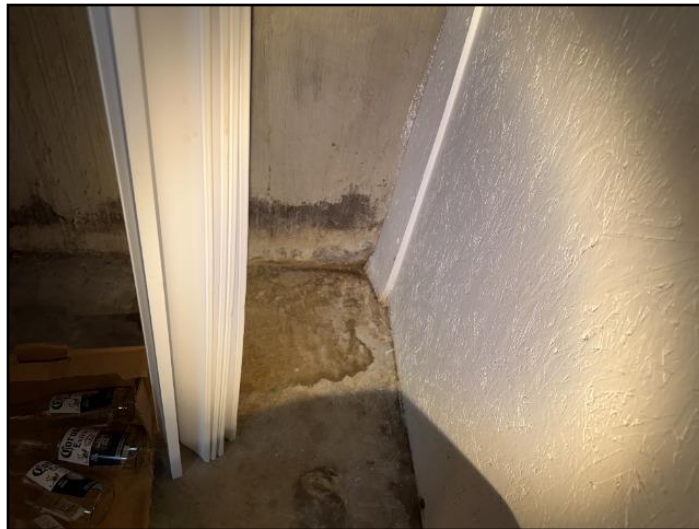
60. one example

**Task:** Monitor for moisture / water intrusion
