# INSPECTION REPORT

For the Property at:  
**123 ANY STREET**  
ANY TOWN, TN 12345

Prepared for: JOHN SMITH  
Inspection Date: Monday, February 19, 2018  
Prepared by: Melanie Moore

RE: Report No. 4176, v.5  
123 Any Street  
Any Town, TN  
12345

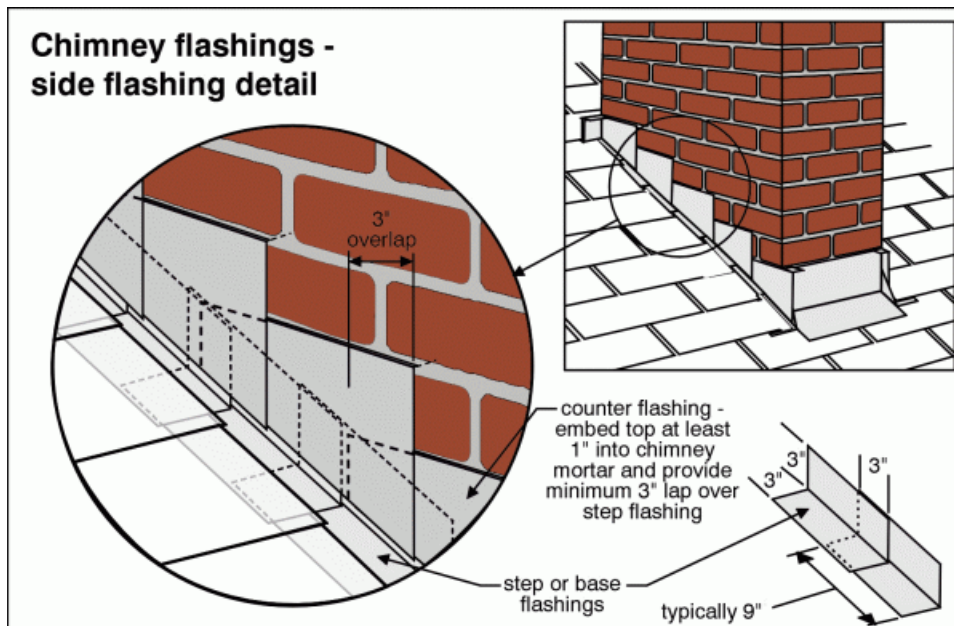
Condition: • [Not let into mortar joints](#)

Top edge of the counter flashing appears to be caulked rather than cut in

Implication(s): Chance of water damage to contents, finishes and/or structure

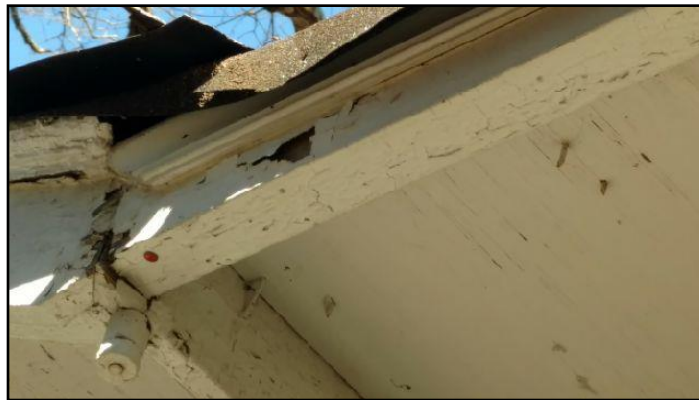
5. Water Damaged

Condition: • Water Damaged

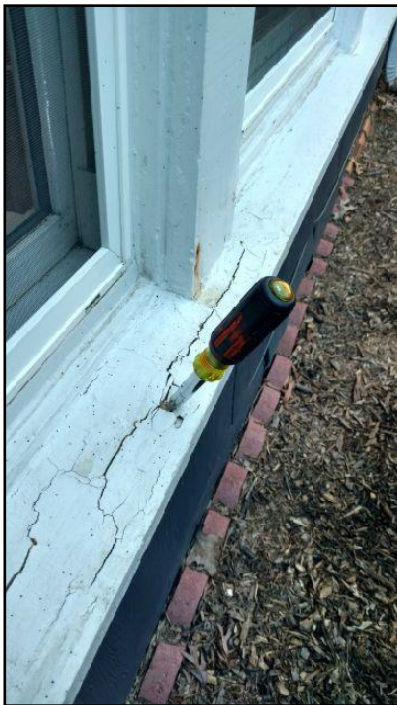
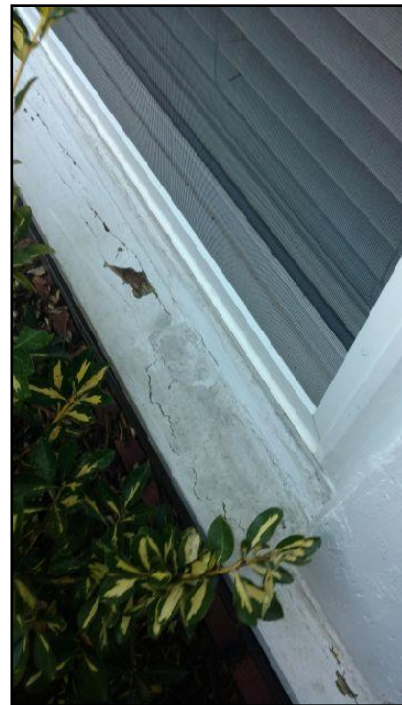
Condition: • [Rot](#)

Implication(s): Chance of water damage to contents, finishes and/or structure | Material deterioration

Location: Right Side Exterior

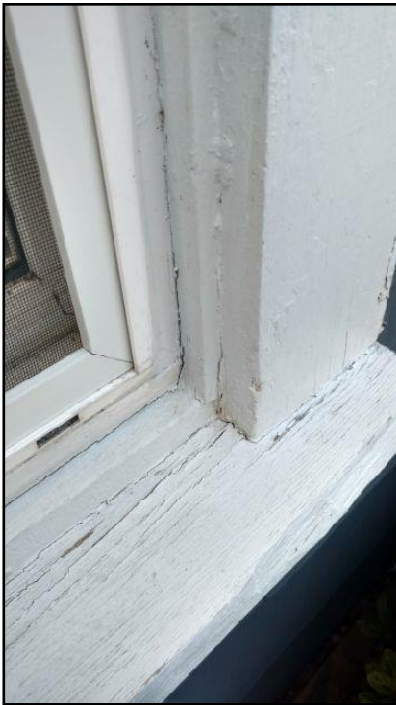
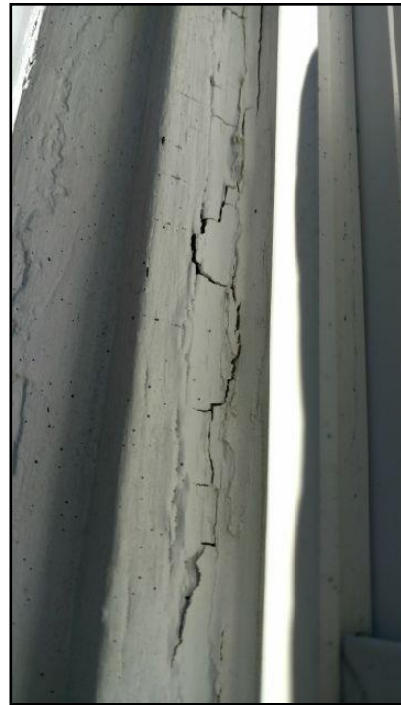
Condition: • [Paint or stain needed](#)

There is what appears to be some lead-based paint that is not secure that needs to be scraped and/or painted over. Any loose paint should be scraped loose. Anything that is well attached can be painted over and sealed and become a non issue.

Implication(s): Chance of water damage to contents, finishes and/or structure | Material deterioration

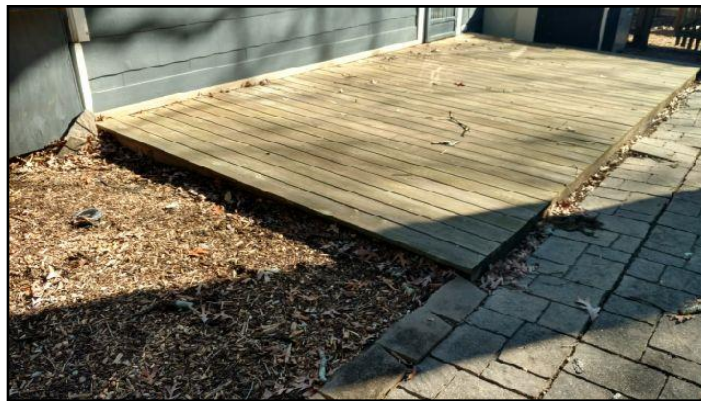
12. Wood/soil contact

**Condition:** • [Wood/soil contact](#)

**Implication(s):** Rot | Insect damage

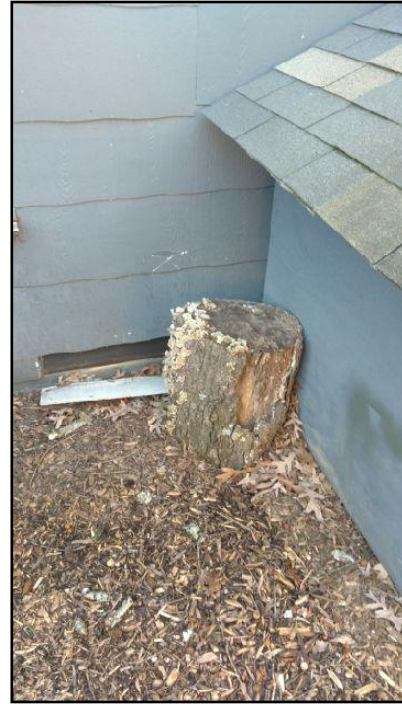
14. Debris encourages rodents.

**Condition:** • Debris encourages rodents.

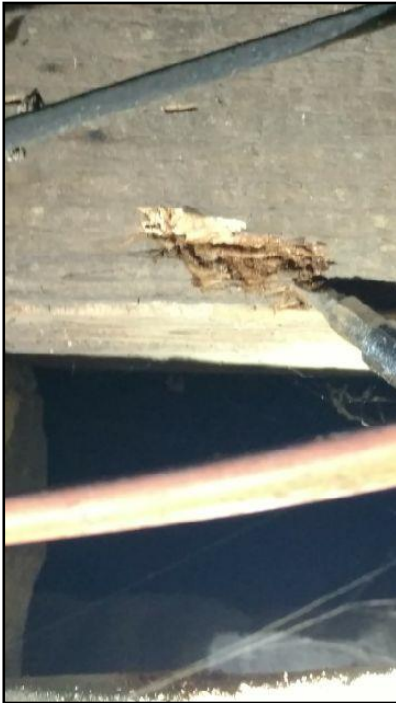
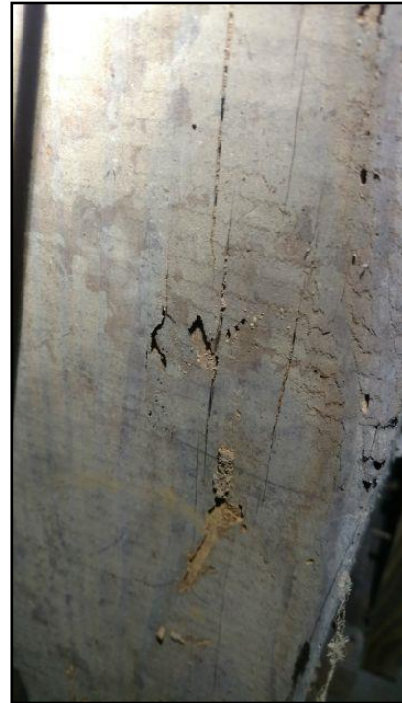
**Condition:** • recommend termite inspector

Possible signs of wood-boring insect activity on Main beam. I highly recommend that there are termite inspection and any areas they find current or past activity and having a structural inspection.

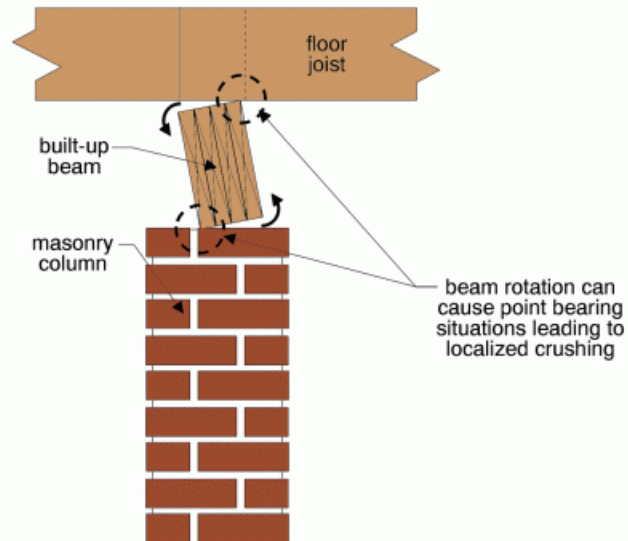
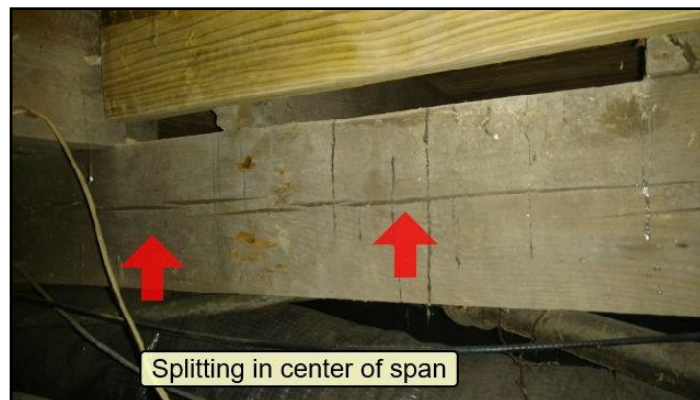
21. Rotated or twisted beams

**Condition:** • [Rotated or twisted beams](#)

The band that has possible wood-boring insect damage also seems to be splitting down the center where it is spanning between columns. I recommend this be checked for structural integrity

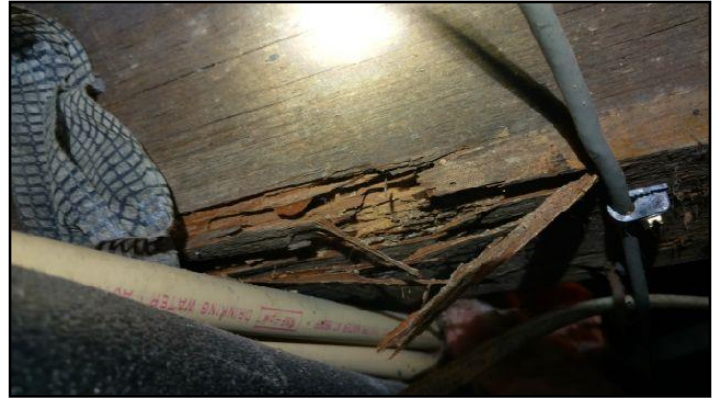
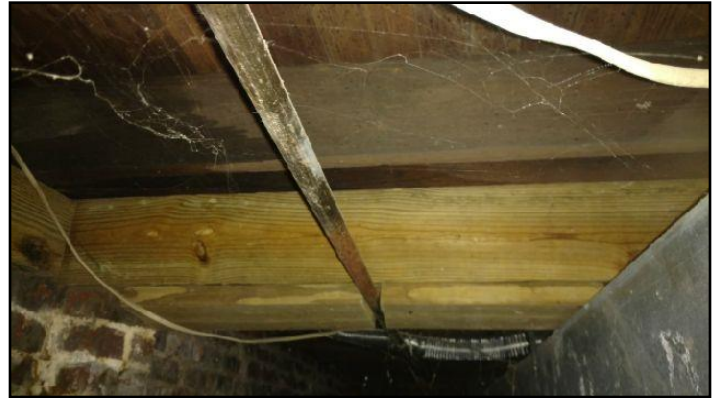
### Condition: • [Prior repairs](#)

While a 2x8 has been scammed to a property of what appears to be a wood boring insect damaged beam, the board does not real a load bearing point not reach the full length plus some of the damaged beam.

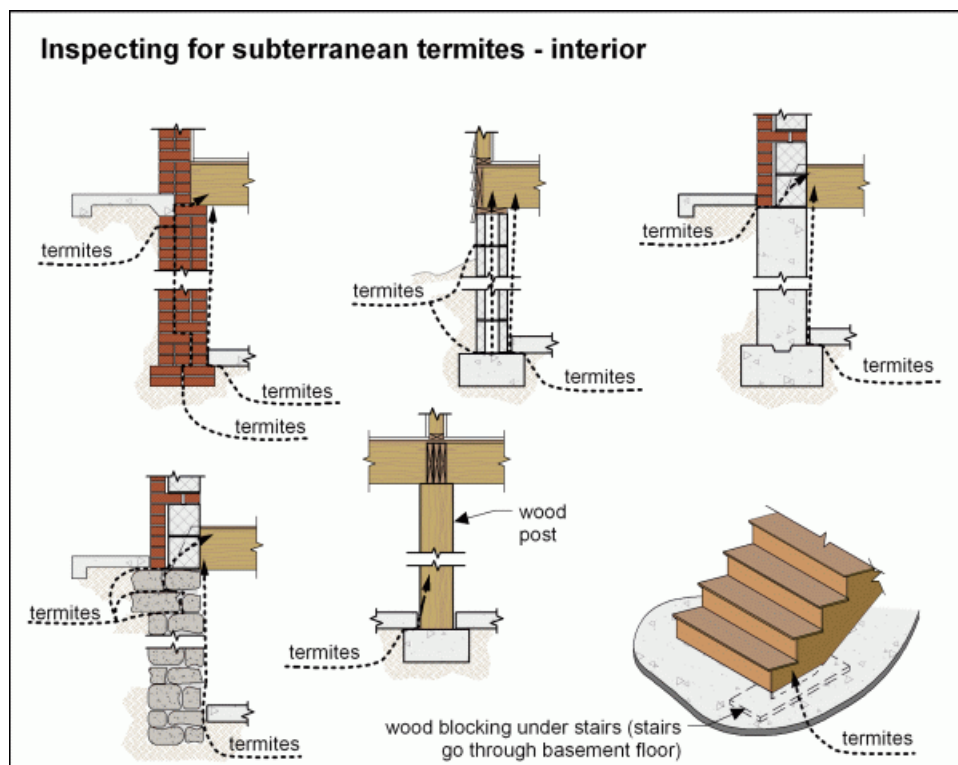
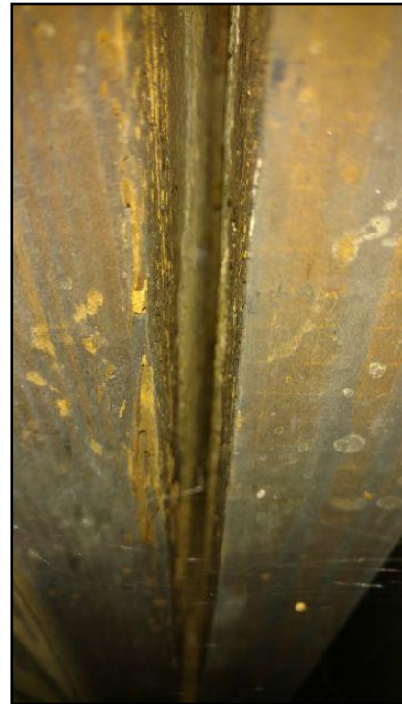
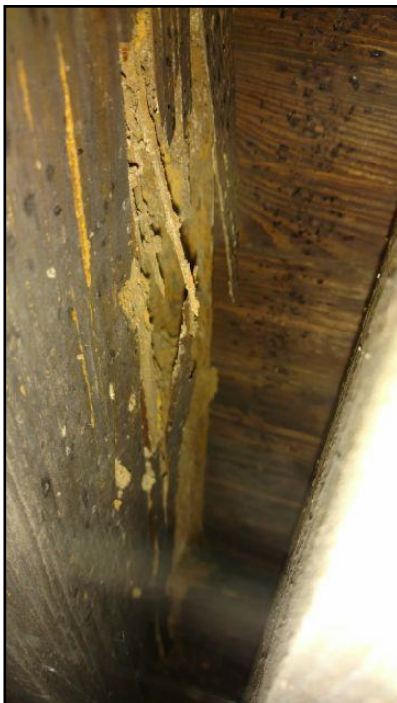
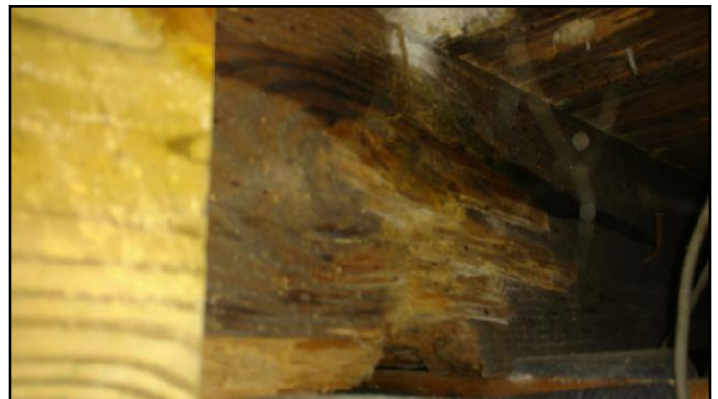
**Condition:** • [Rot, insect or fire damage](#)

A short area of insect damaged joist does have a repair board but here again it does not reach the length of the damage in to undamage material. This board serves no purpose as it is installed

**Implication(s):** Weakened structure

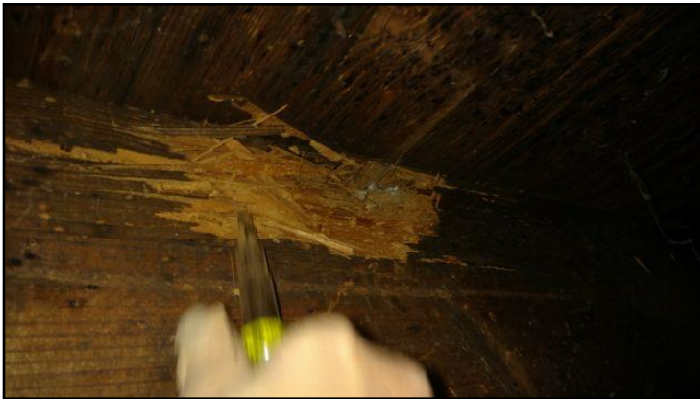
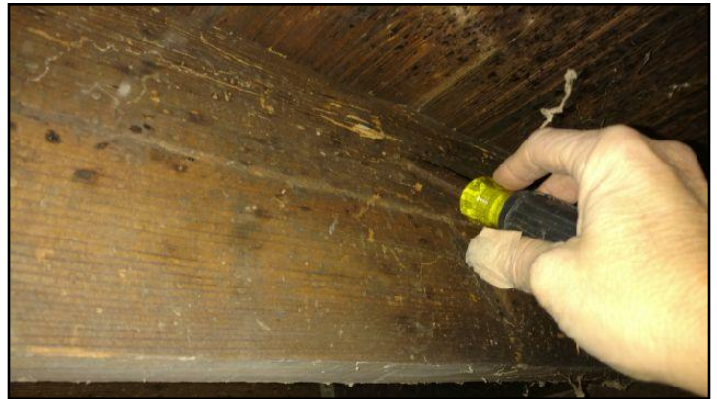
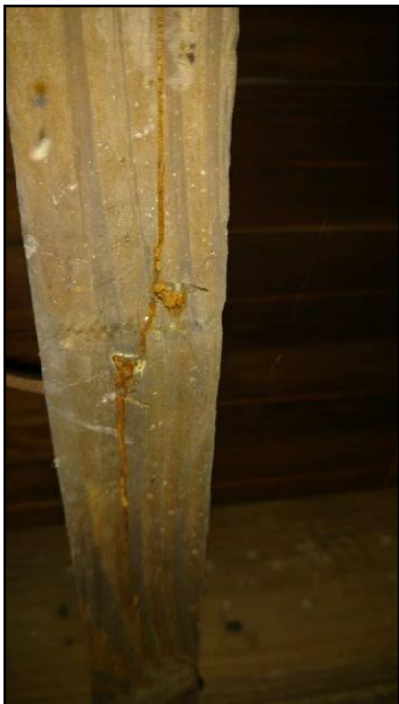
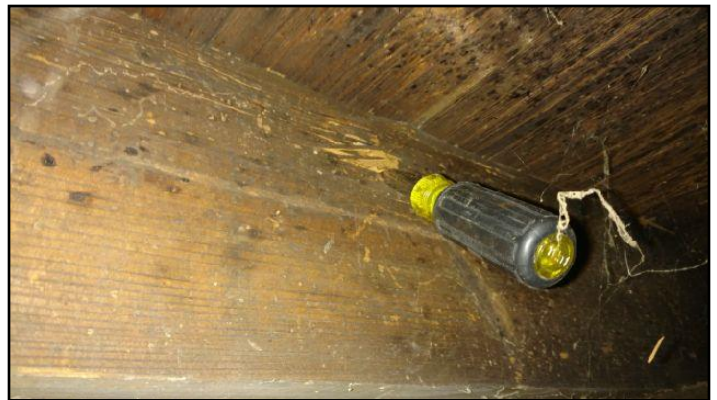
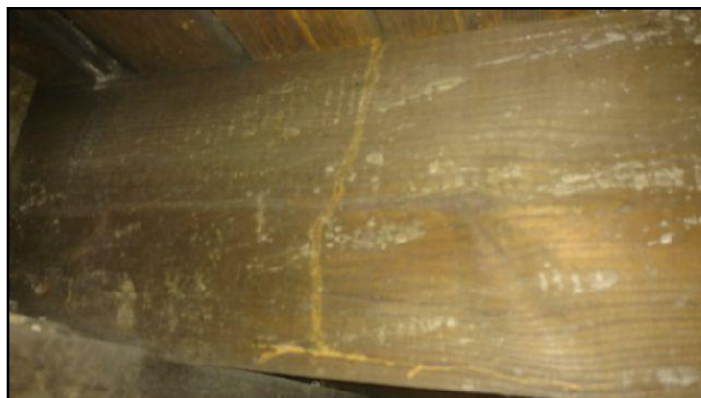
**Condition:** • [Rot, insect or fire damage](#)

Several Joists have no repairs made to them with signs of insect damage. I highly recommend a thorough termite and individual joist structural inspection

**Implication(s):** Weakened structure

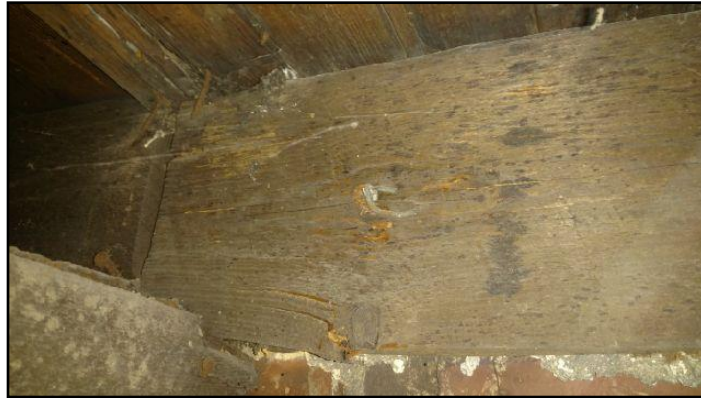
39. Rot, insect or fire damage

**Condition:** • [Rot, insect or fire damage](#)

**Implication(s):** Weakened structure

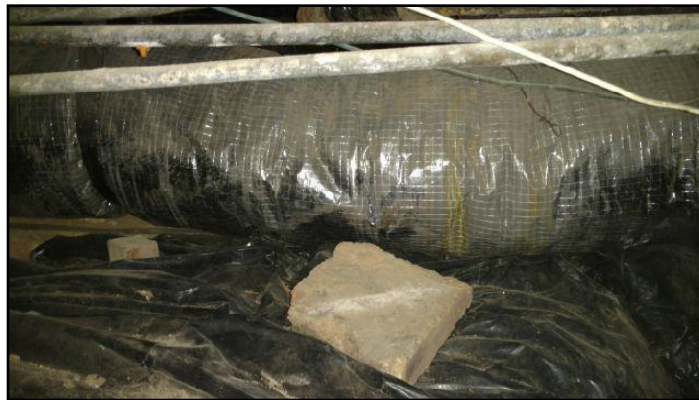
47. Ductwork is laying on the ground. This will...

**Condition:** • Ductwork is laying on the ground. This will deteriorate the protective coating causing leaks.

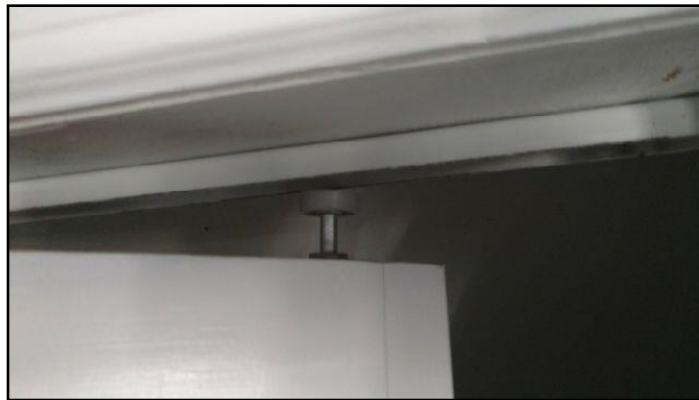
63. Ineffective

Condition: • [Ineffective](#)

Implication(s): Equipment ineffective

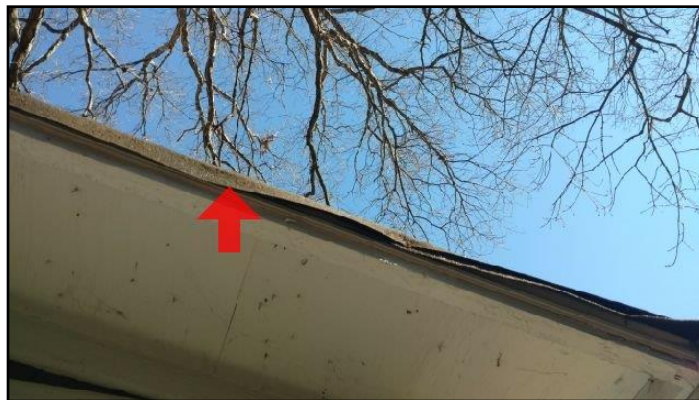
**69.** Overhangs too big or small Asphalt roofing...

### **4. Condition:** • Overhangs too big or small

Asphalt roofing is designed to overhang the edge of the roof from 1-1 ½" without breaking when installed properly with starter strip and drip edge. This length allows the roofing to propel the water well over the edge of the structure preventing water damage. Overhangs that are left too short fail to do this. Just as bad however is leaving the overhang weighty and, when the tar based material heats and softens, allow it to bend under the weight and break where it folds and the roofline.

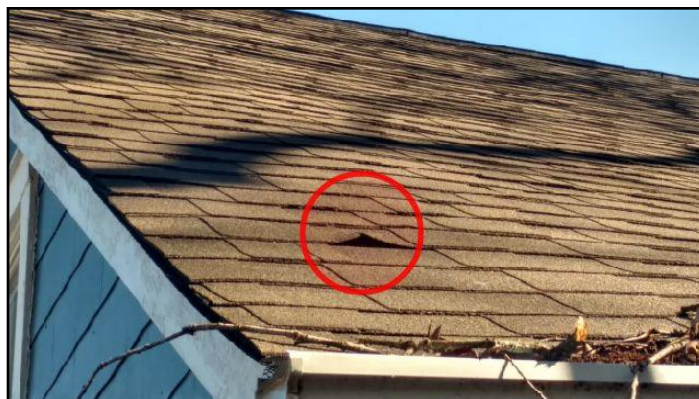
**70.** Raised fasteners under roofing - When you...

**5. Condition:** • Raised fasteners under roofing - When you see shingle humped up, usually that means a nail/fastener has backed out under it. This can cause a leak to form on top of the nail head due to weather deteriorating the high point faster than surrounding material. To correct this, you can use a flat wide piece of thin metal, like a flat bar. Gently lift the shingle only as high as necessary to see to place the metal on top of the head, then lay the shingle on the metal. Take a small bloc of wood and lay it on top of the shingle sandwiching the roofing between the metal and wood, then strike the wood with a hammer reseating the nail. This will spread the blow and lessen damage to the shingle we are trying to protect.

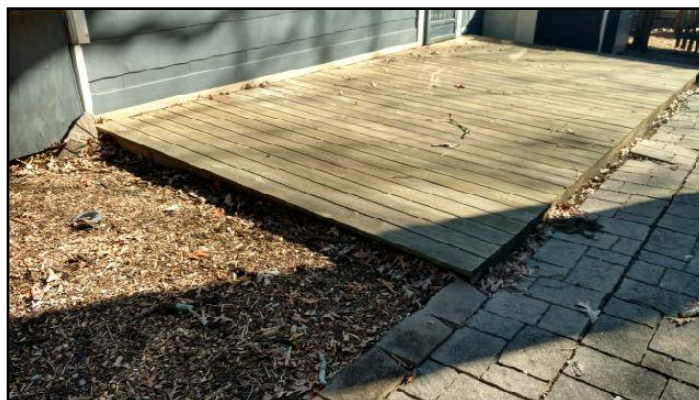
80. Wood/soil contact

**16. Condition:** • [Wood/soil contact](#)

**Implication(s):** Rot | Insect damage

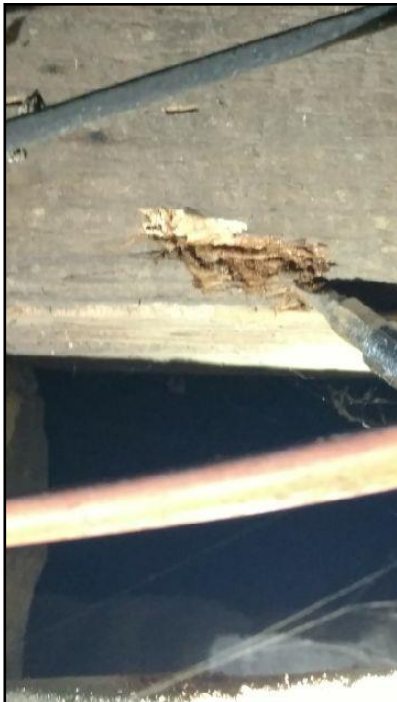
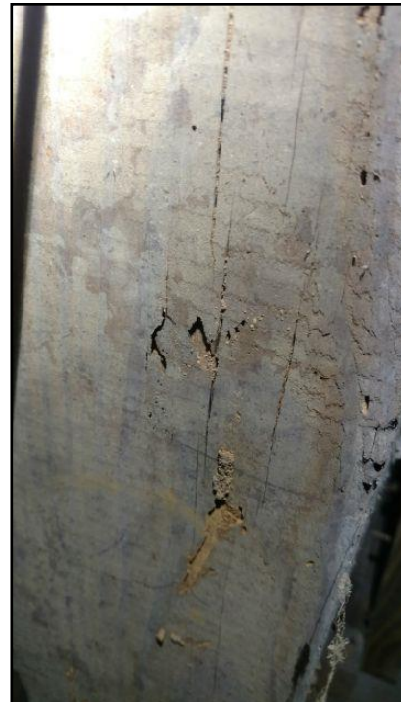
**25. Condition:** • recommend termite inspector

Possible signs of wood-boring insect activity on Main beam. I highly recommend that there are termite inspection and any areas they find current or past activity and having a structural inspection.

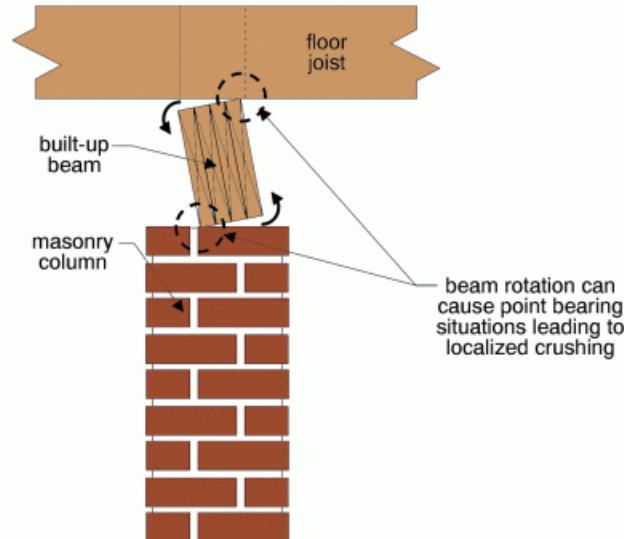
89. Rotated or twisted beams

**Implication(s):** Weakened structure | Chance of structural movement

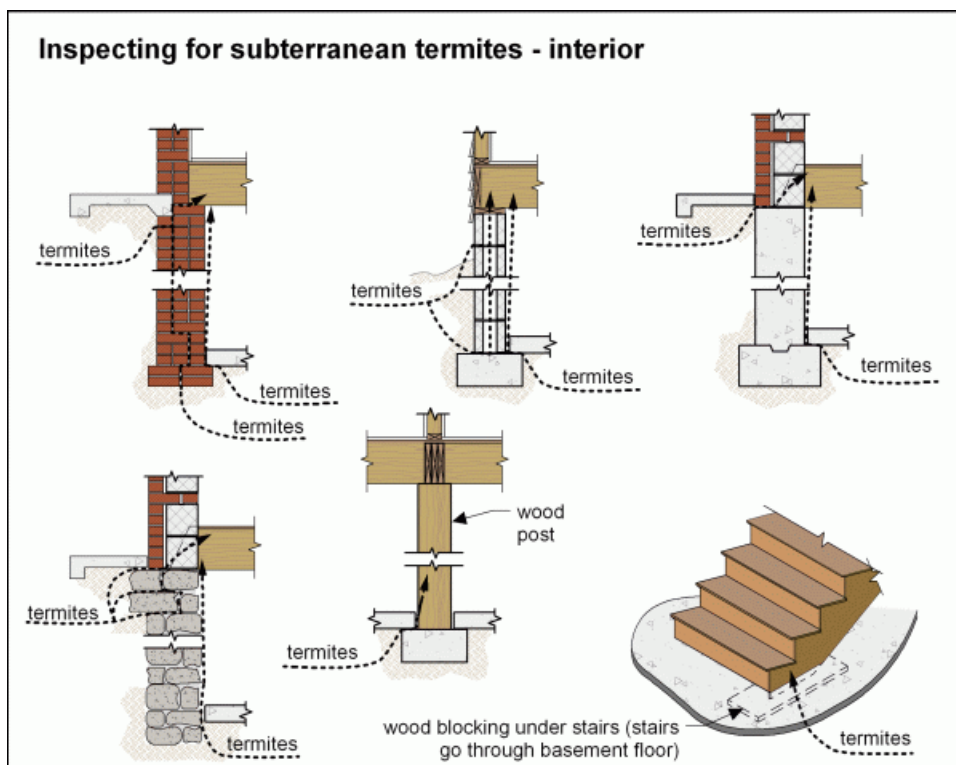
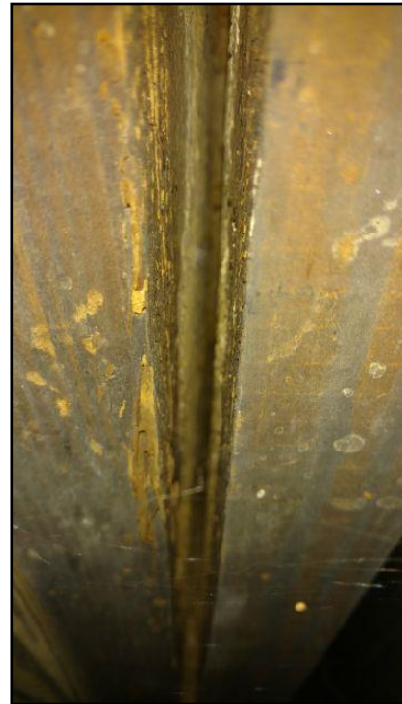
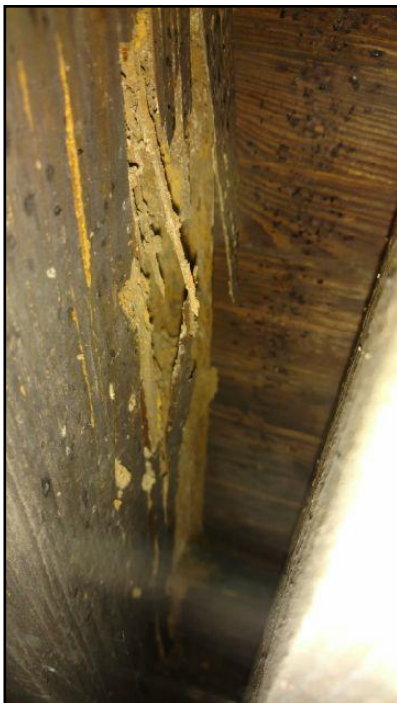
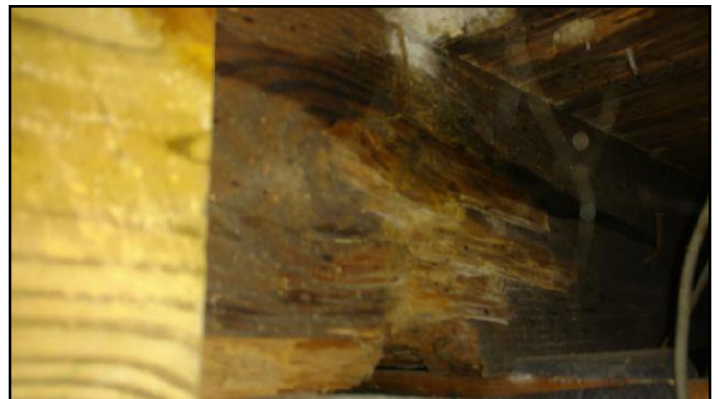
A short area of insect damaged joist does have a repair board but here again it does not reach the length of the damage in to undamage material. This board serves no purpose as it is installed

**Implication(s):** Weakened structure

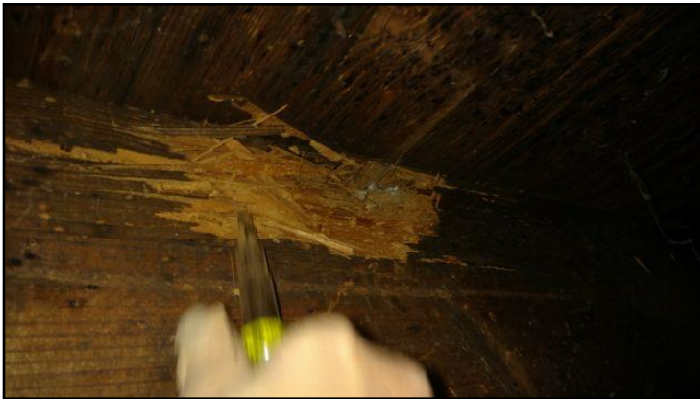
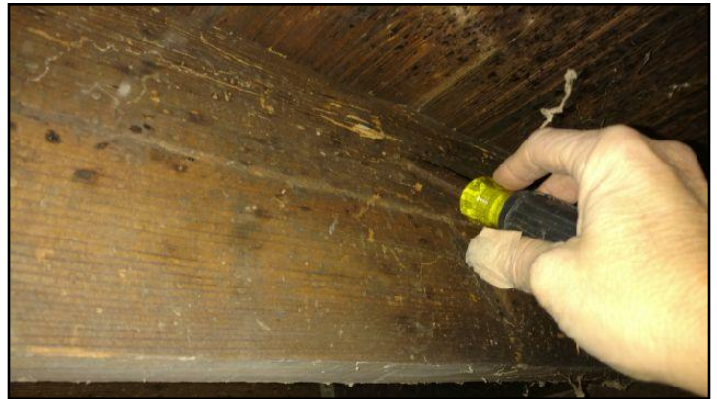
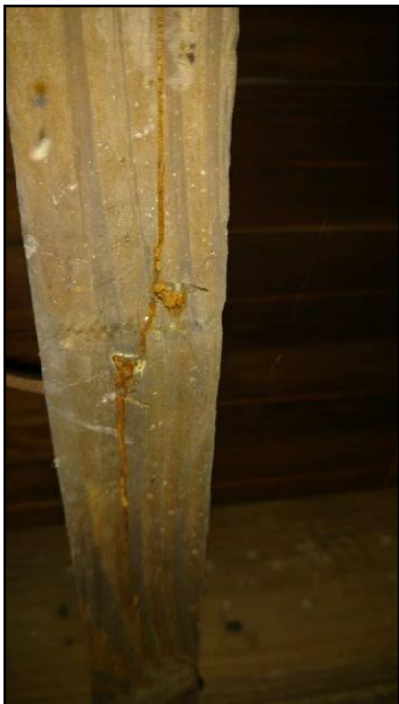
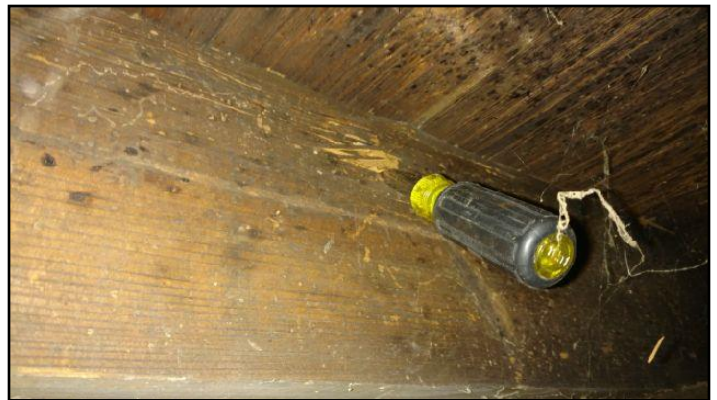
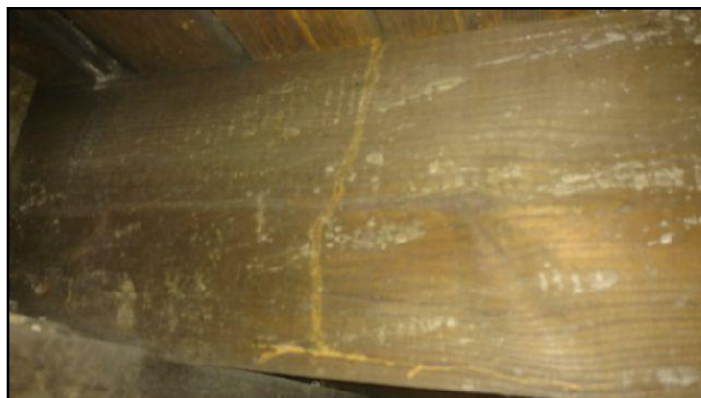
## 32. Condition: • [Rot, insect or fire damage](#)

Several Joists have no repairs made to them with signs of insect damage. I highly recommend a thorough termite and individual joist structural inspection

## Implication(s): Weakened structure

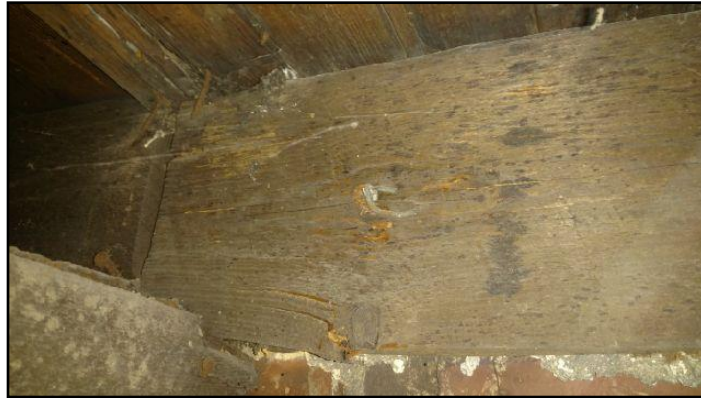
**107.** *Rot, insect or fire damage*

**33. Condition:** • [Rot, insect or fire damage](#)

**Implication(s):** Weakened structure

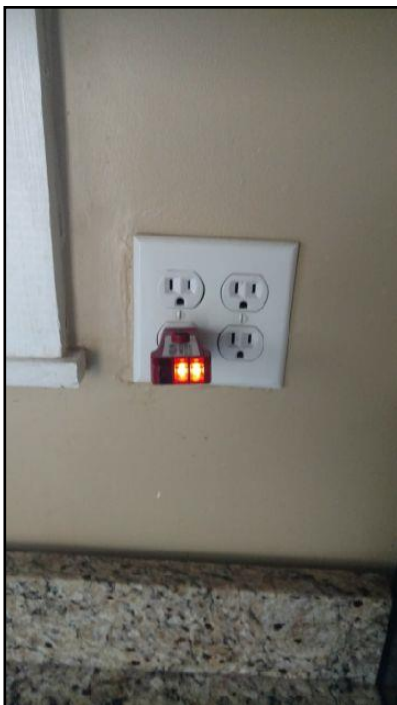
110. Open Ground

37. Condition: • Open Ground

Only the right Outlet in the double Outlet panel beside the kitchen sink is open ground.

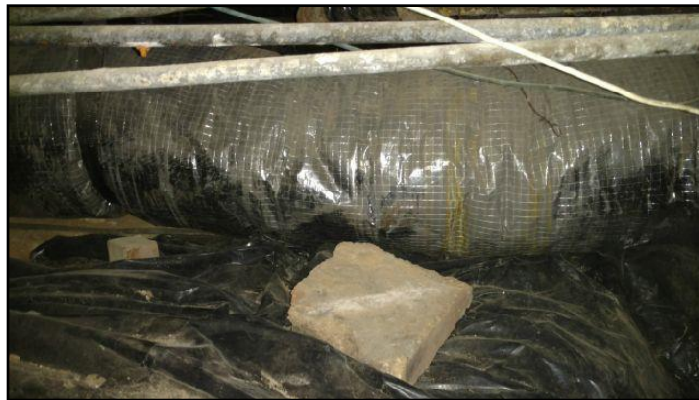
119. Ductwork is laying on the ground. This will...

43. Condition: • Ductwork is laying on the ground. This will deteriorate the protective coating causing leaks.

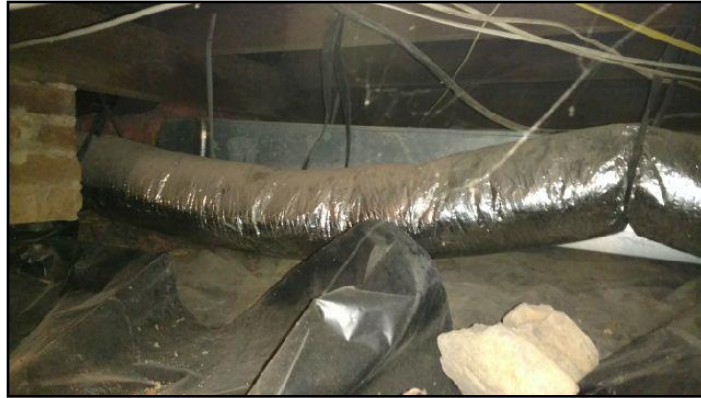
121. *Poor support*

45. Condition: • [Poor support](#)

Implication(s): Increased cooling costs | Reduced comfort

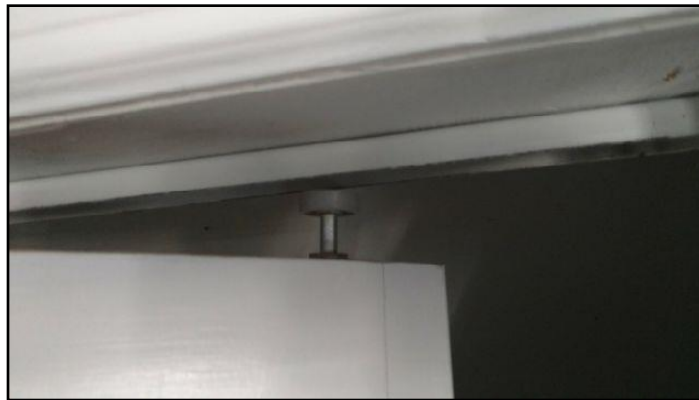
139. Ineffective

70. Condition: • [Ineffective](#)

Implication(s): Equipment ineffective
