YOUR Inspection Report

123 Main Street
Louisville, KY 40204

Friday, April 5, 2019

RE: Report No. 1145
123 Main Street
Louisville, KY
40204

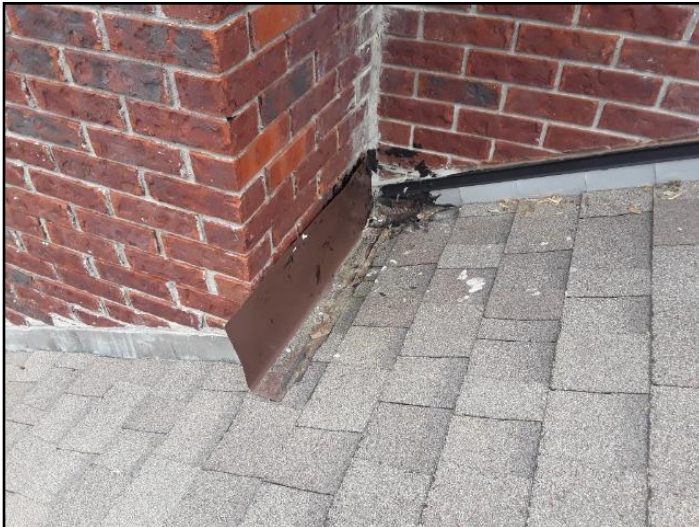
Evidence of past leak noted on the high side of the chimney over the garage area. It appeared the roof can trap water during a rain event. The leak has also damaged the garage ceiling (see Interior Recommendations section).

Implication(s): Chance of water damage to contents, finishes and/or structure

5. Evidence of trapped water

Task: Have evaluated by a qualified roofing contractor

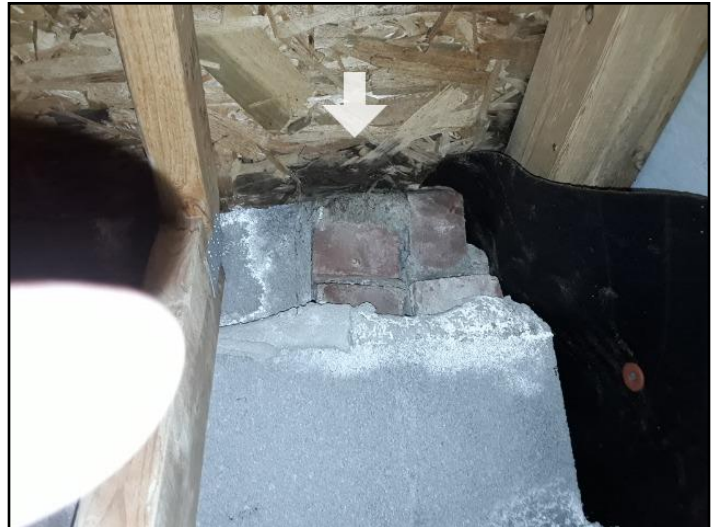
6. Signs of past leak (view from attic)

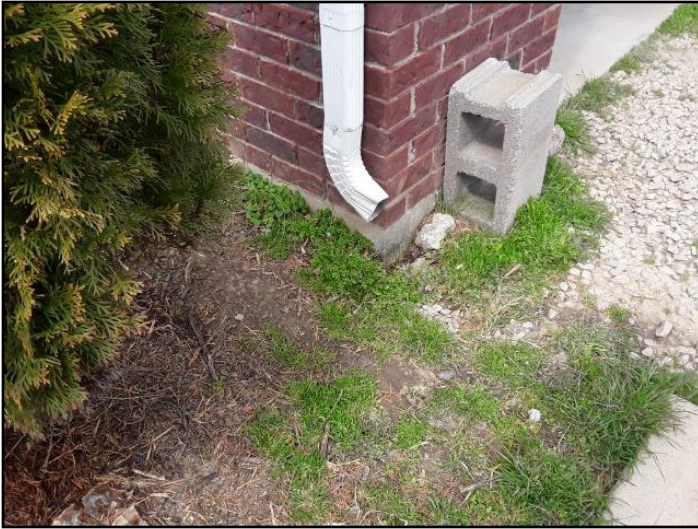
2. Condition: • Missing splash block

Location: Front and rear right side of the house

7. Missing splash block

Task: Furnish and install missing items

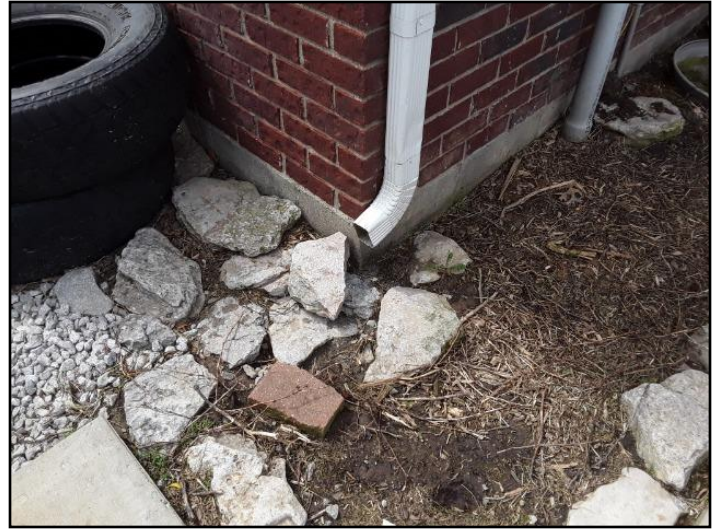
8. Missing splash block

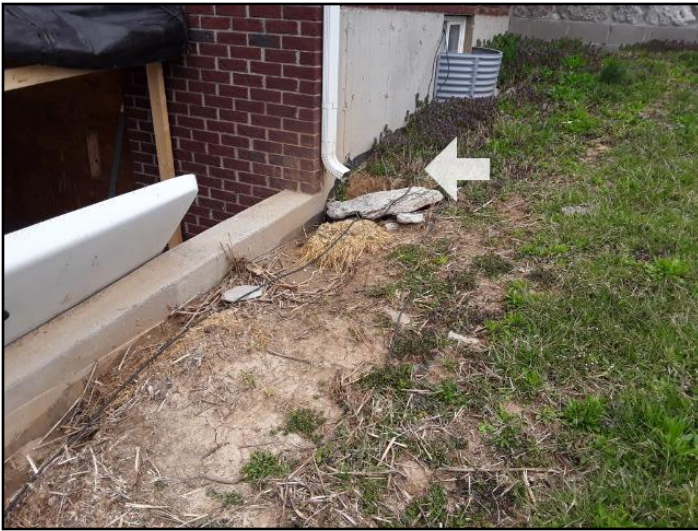
Implication(s): Chance of water damage to contents, finishes and/or structure

Location: Both front and rear left corner of house

9. Discharge too close to building

Recommend routing downspout discharge via drain tile to past the ends of the retaining walls.

Task: Have evaluated by qualified contractor

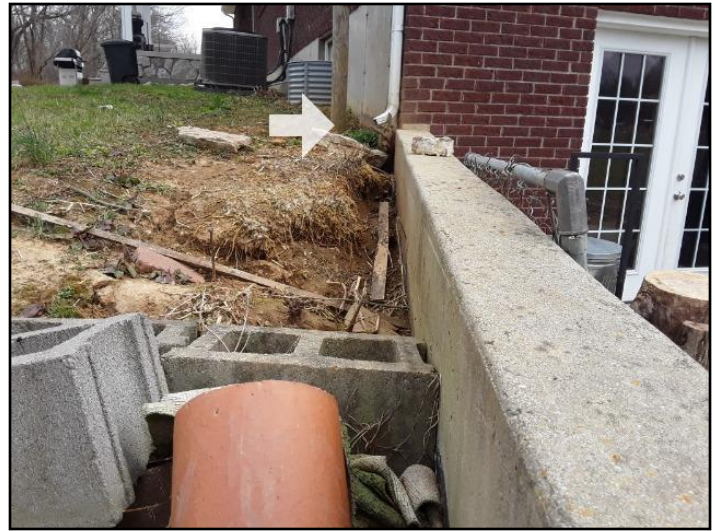
10. Discharge too close to building

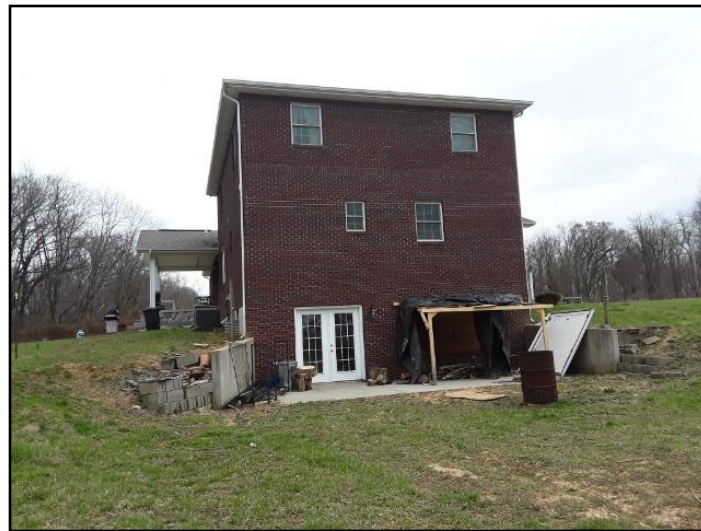
Evidence of basement water intrusion was noted near the side patio and the basement sliding doors.

Location: Left side of house

11. Improper slope - swale needed

Task: Improve drainage by creating a small swale to direct water flow to the creek from the house faster

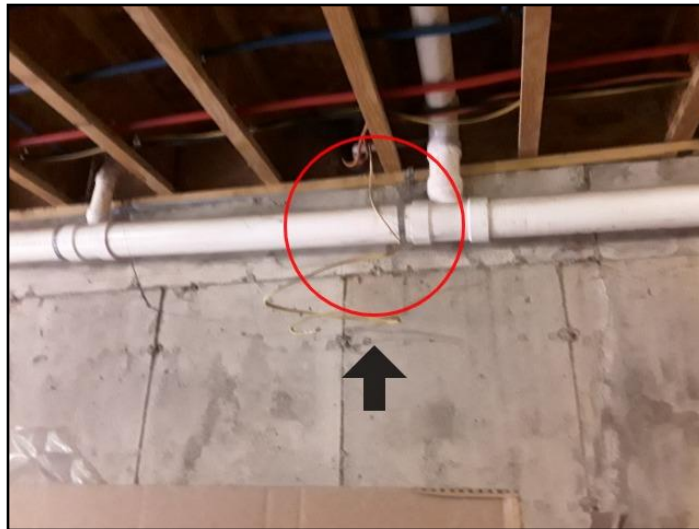
A "hot" electrical wire was hanging from the basement ceiling joist. The wire should terminate inside a covered junction box secured to a ceiling joist or the wall.

Implication(s): Electric shock | Fire hazard

14. Exposed "hot" wire

Task: Have evaluated by a qualified contractor

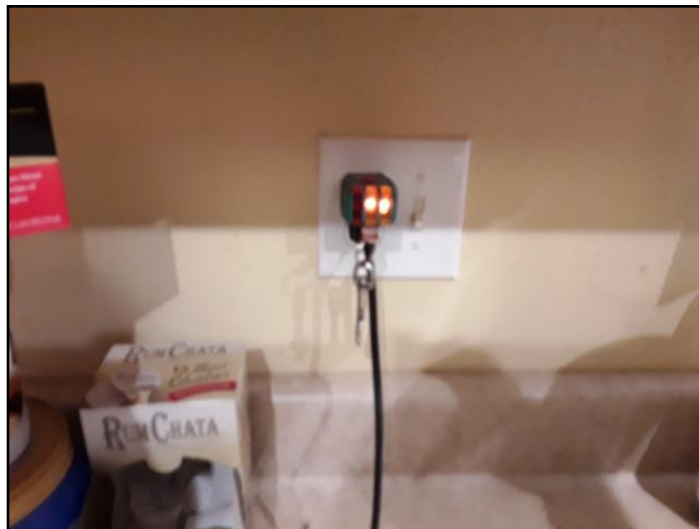
Outlet on the left side of the kitchen sink should be the GFCI type.

Implication(s): Electric shock

15. GFCI needed

Task: Replace outlet with GFCI

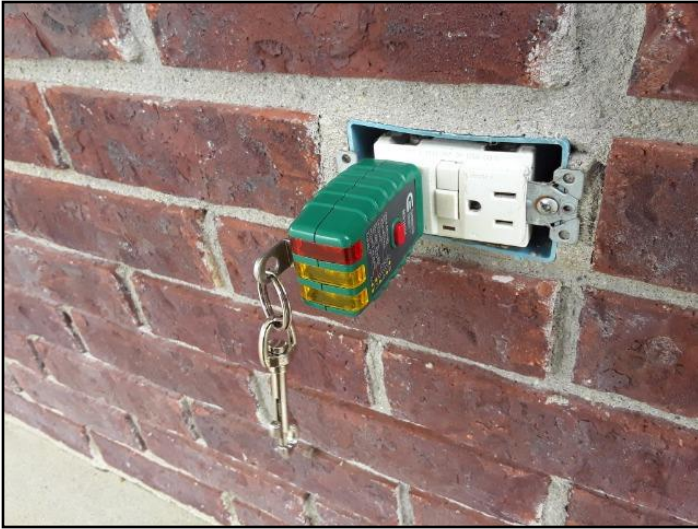
16. Front porch

Three GFCI outlets on the front (2) and rear (1) porches did not work.

Implication(s): Electric shock

Task: Have evaluated by a qualified electrician

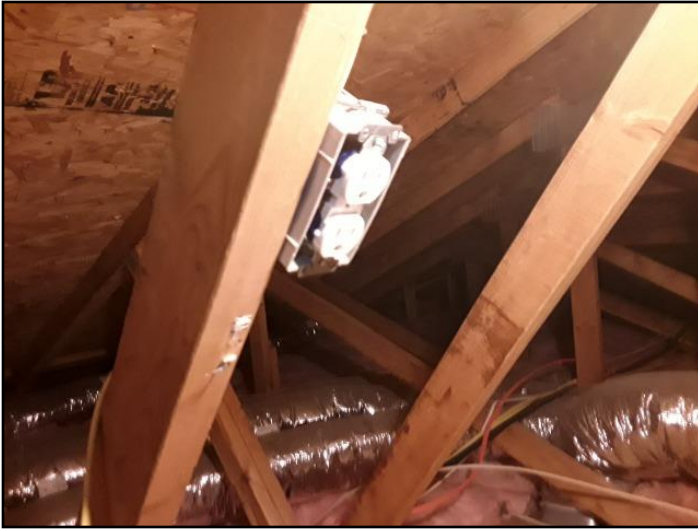
Multiple wall switches, outlets and electrical junction boxes did not have covers on them. (not all missing covers shown)

Implication(s): Electric shock

19. Missing cover - attic

Task: Furnish and install missing items.

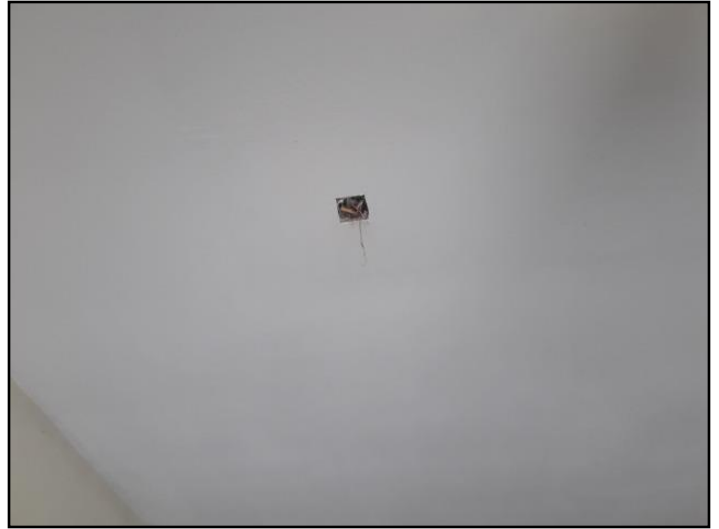
20. Missing cover - garage ceiling

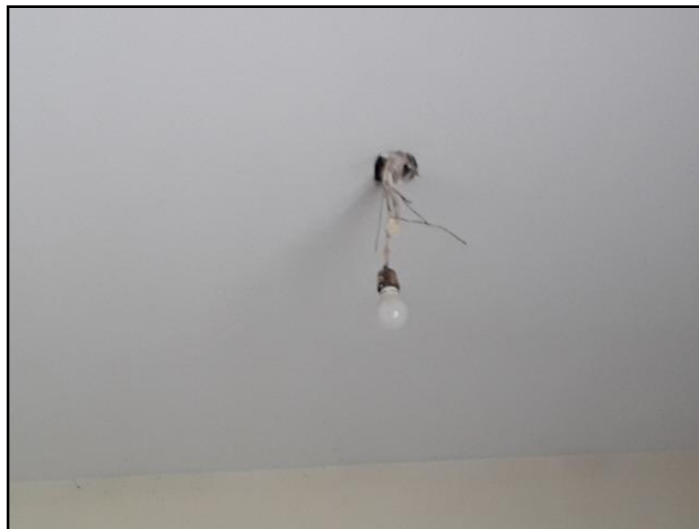
9. Condition: • [Damage](#)

Implication(s): Electric shock | Fire hazard

Location: Garage - near the water heater

21. Damage

Task: Repair or replace as needed

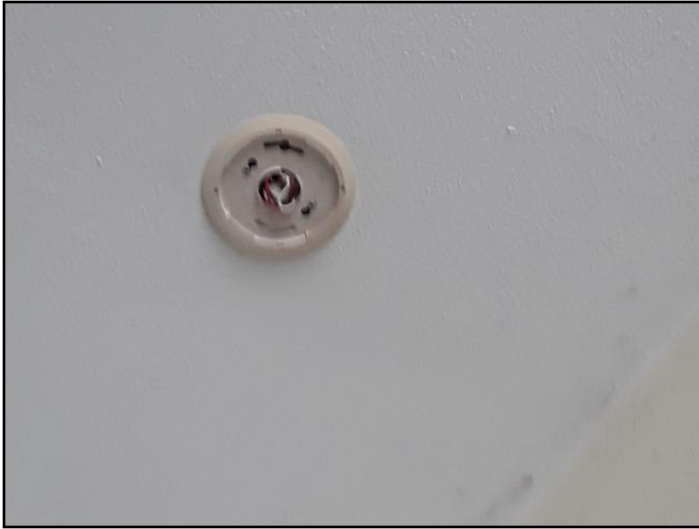
Current standards require smoke detector in each bedroom, one in each hallway outside the bedrooms. A minimum of one is required on each level including basements and habitable attics. Smoke detectors are not required in kitchens. This house did not appear to have all the recommended smoke detectors.

Implication(s): Fire hazard

22. *Missing - garage*

Task: Furnish and install missing items

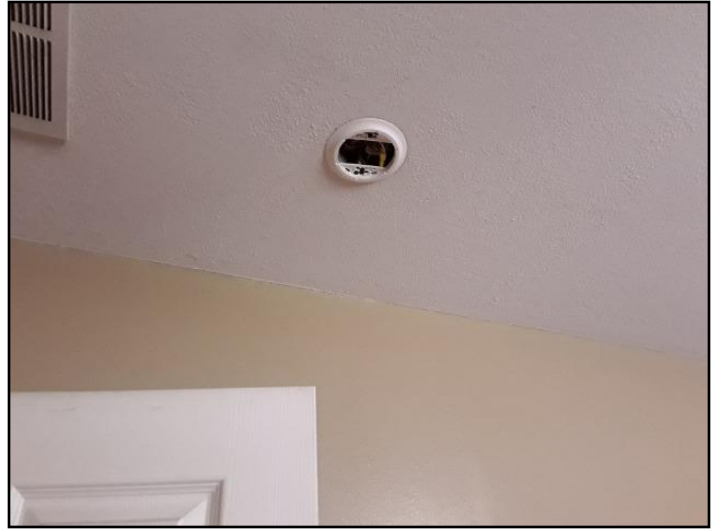
23. *Missing - bedroom*

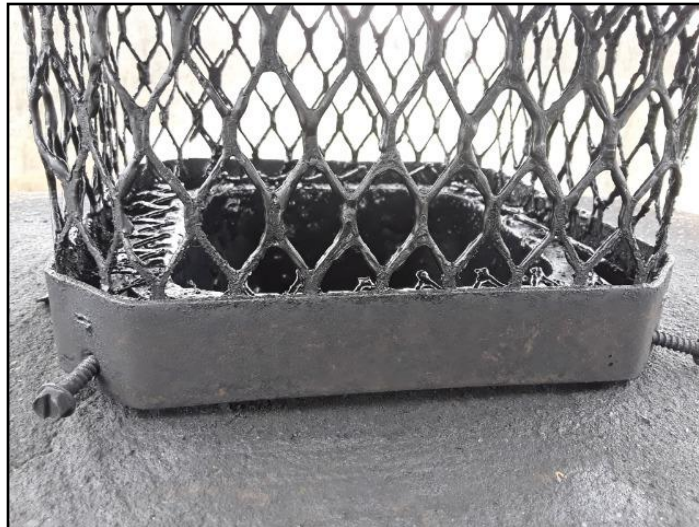
Heavy creosote build-up on the chimney flue connected to the basement wood stove (front flue in chimney)

Implication(s): Fire hazard

30. *Creosote build-up (front flue)*

Task: Have chimney and fire place evaluated by a chimney sweep

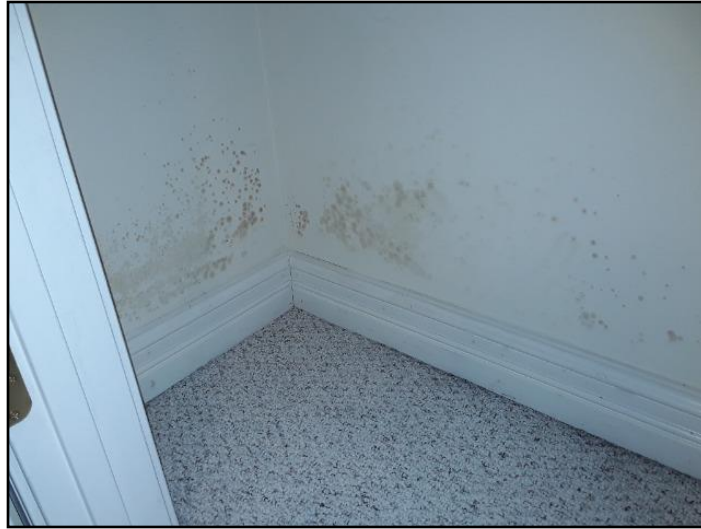
12. Condition: • Bio-growth like substance noted on closet wall

Implication(s): Health hazard

38. Bio-growth substance

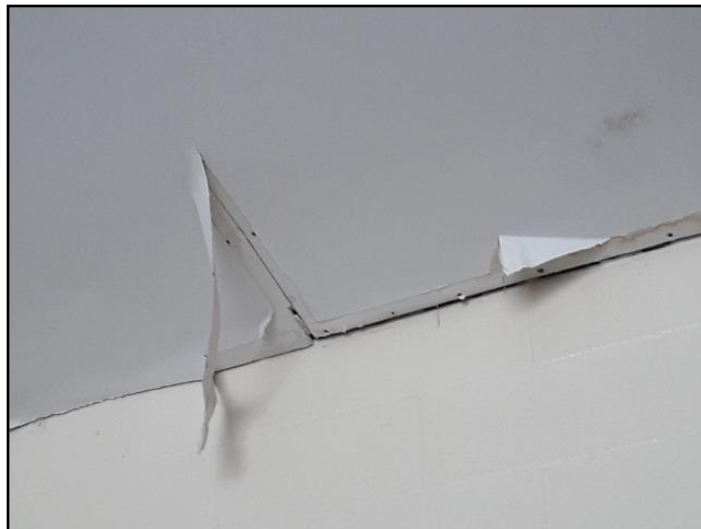
Roof leak (see Roofing Recommendation section) has caused ceiling damage. Once the roof is fixed, recommend fixing the drywall.

Implication(s): Chance of water damage to contents, finishes and/or structure

Location: Garage ceiling

39. Water damage

Task: Have evaluated by a qualified contractor

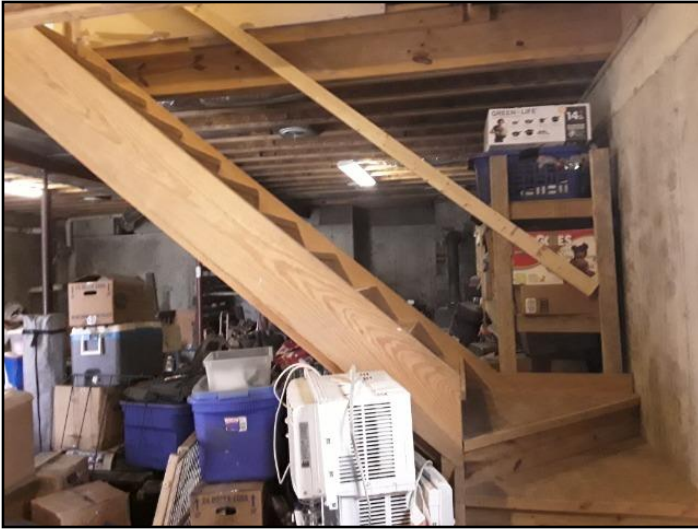
Missing or sub-standard handrails on steps leading to the basement.

Implication(s): Fall hazard

40. Missing handrails

Task: Recommend installing handrails on stairs (both sides)

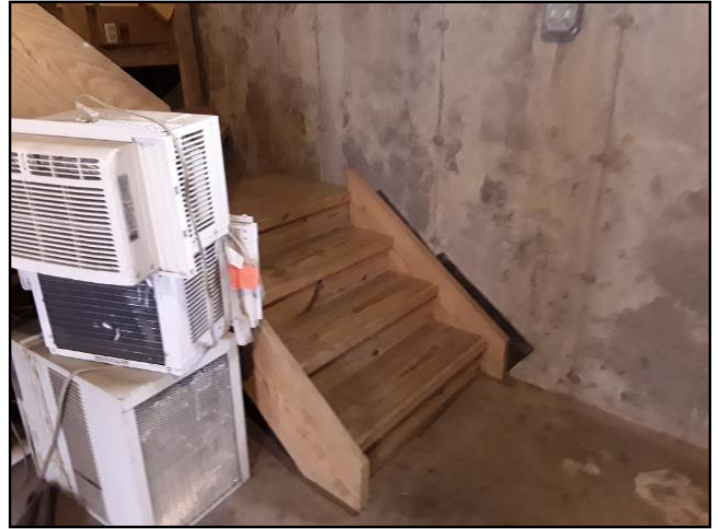
41. Missing handrails

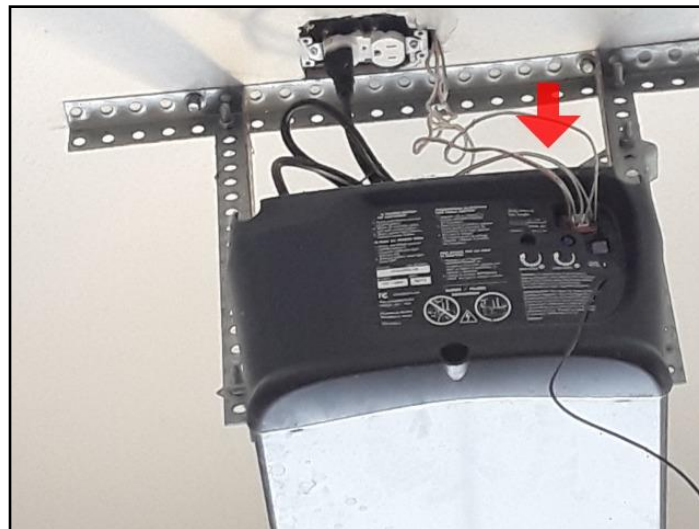
15. Condition: • [Adjustment needed to open or close limits](#)

Implication(s): Equipment not operating properly

42. Adjustment needed to open or close limits

Task: Adjust screws on back of the operator do desired pressure

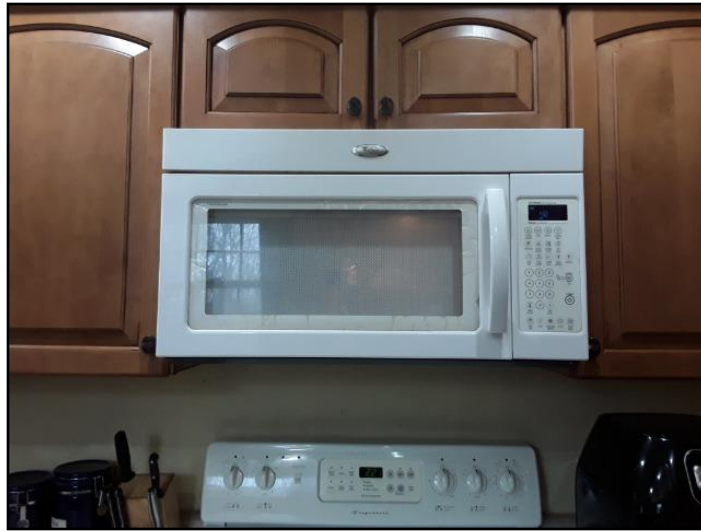
16. Condition: • Inoperative

Implication(s): Equipment inoperative

43. *Inoperative*

Task: Repair or replace as needed

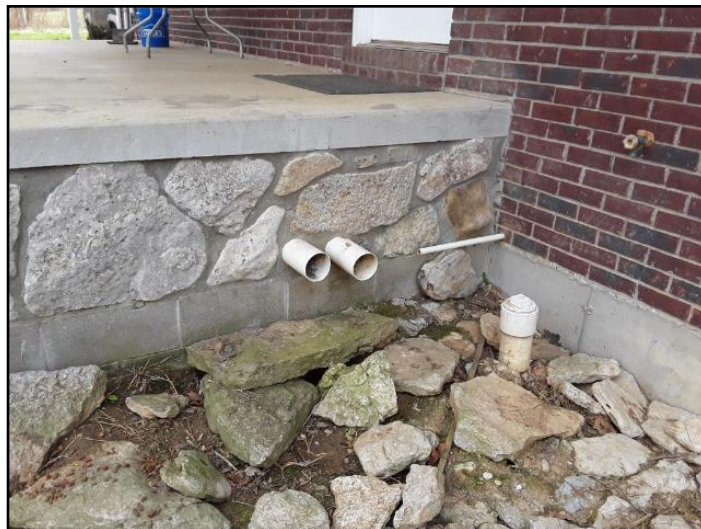
17. Condition: • Screen on vent termination

No covers on both dryer vents (2). Cold air and vermin may enter.

44. *No covers on dryer vents*

Task: Install flap door style vent caps
