Your Inspection Report

14 Briarcroft Rd
Toronto, ON

INSPECTION DATE:
Wednesday, February 1, 2017

RE: Report No. 56706
14 Briarcroft Rd
Toronto, ON

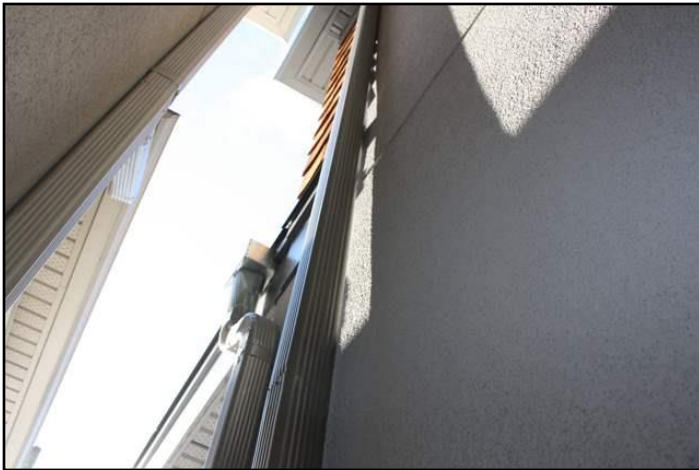
Condition: • [Loose](#)

Loose

Time: Less than 1 year

Cost: Minor

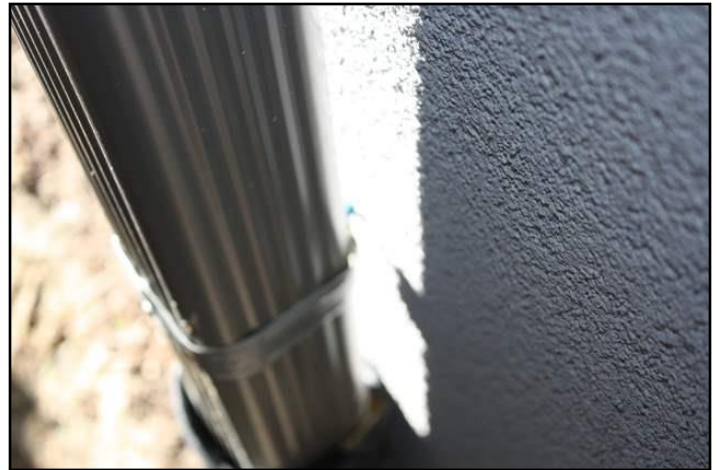
Loose

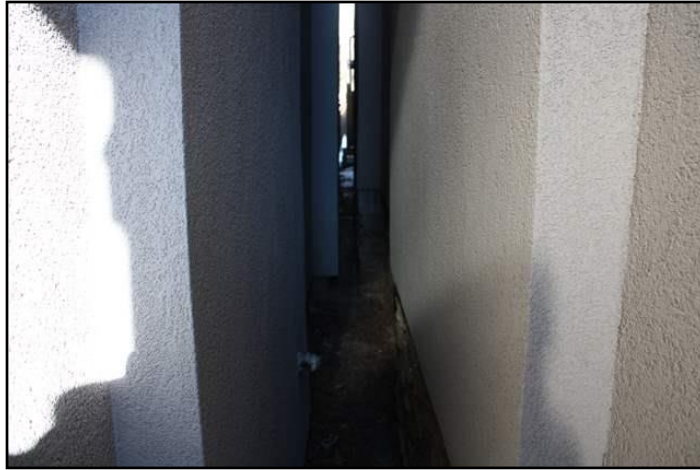
Wall - access restricted

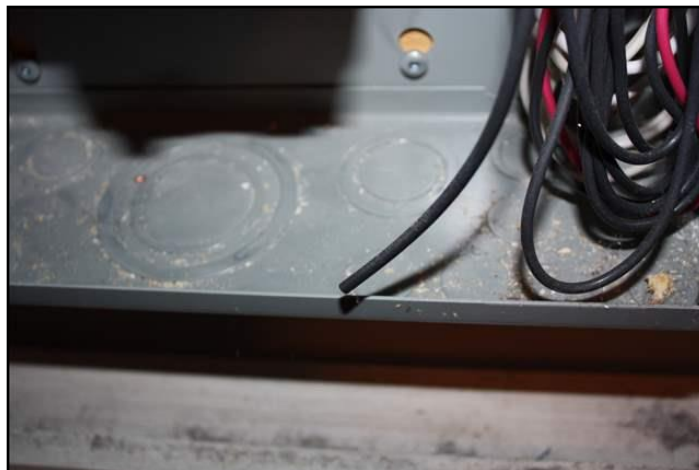
Condition: • [Abandoned](#)

Abandoned

Time: Immediate

Cost: Minor

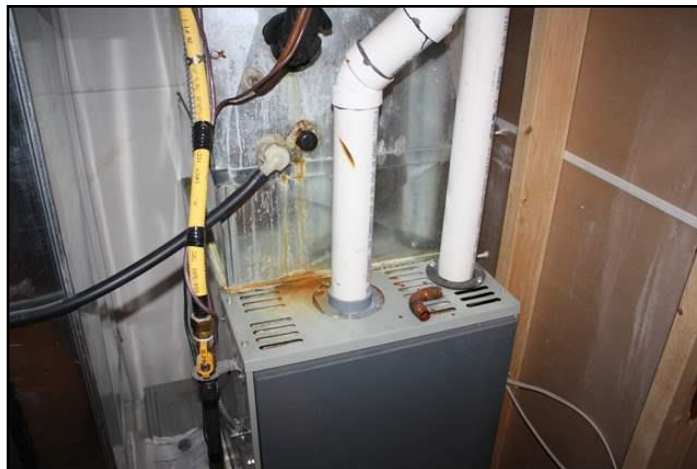
Condition: • [Condensate Line - leak](#)

Prior condensate leak noted. Was dry at time of inspection. Monitor when in cooling mode.

Prior leak.

Task: Monitor

Time: Unknown

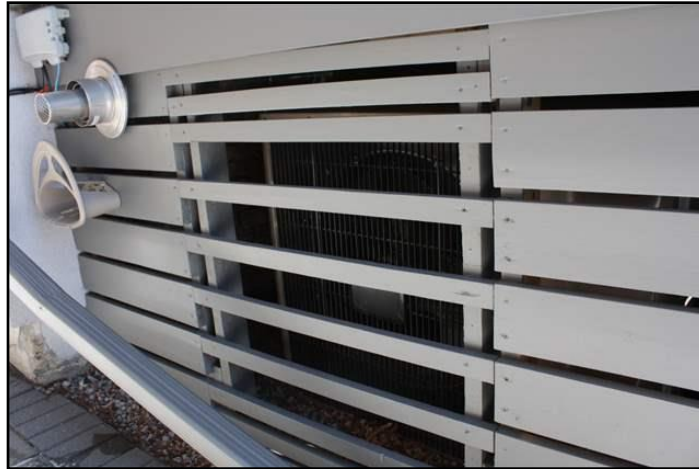
- Low outdoor temperatures prevented operational testing of the air conditioner. The unit should be inspected by a qualified service technician prior to operation.
- Restricted access

Restricted access

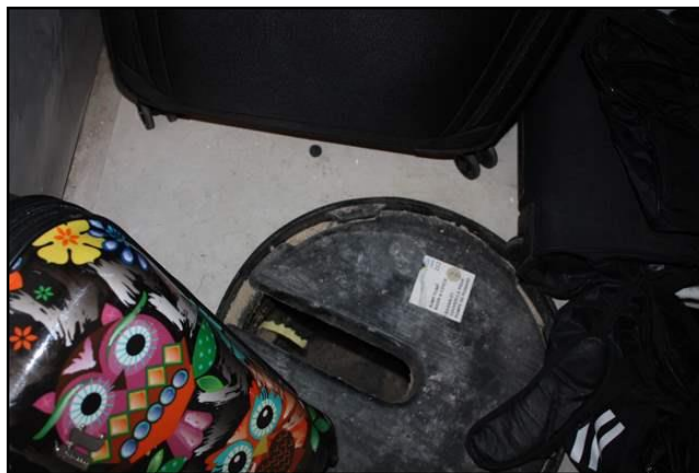
Condition: • Sump Pit in basement. No sump pump and pit is dry. Does not appear to be active

Task: Monitor

Time: Ongoing
