YOUR INSPECTION REPORT

168 Sixth Street
Toronto, ON M8V 3A5

INSPECTION DATE:
Monday, August 27, 2018

RE: Report No. 2317, v.2
168 Sixth Street
Toronto, ON
M8V 3A5

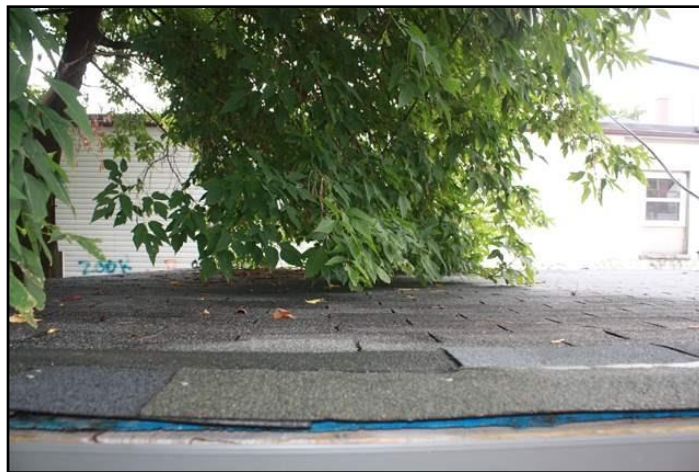
1.

Condition: • Wrong type of roof covering for flat roof. Sloped roof shingles used on garage.

Location: Exterior Garage Roof

Task: Correct / Replace

Time: Discretionary

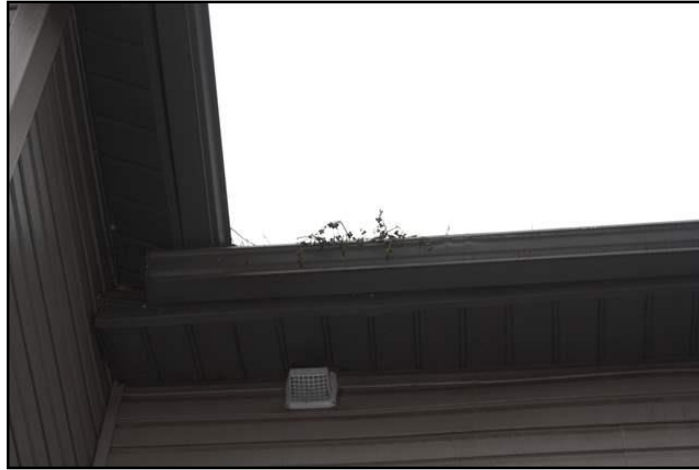
Condition: • [Clogged](#)

Implication(s): Chance of water damage to contents, finishes and/or structure

Location: Various Exterior

2. Clogged

Task: Clean

Time: Regular maintenance

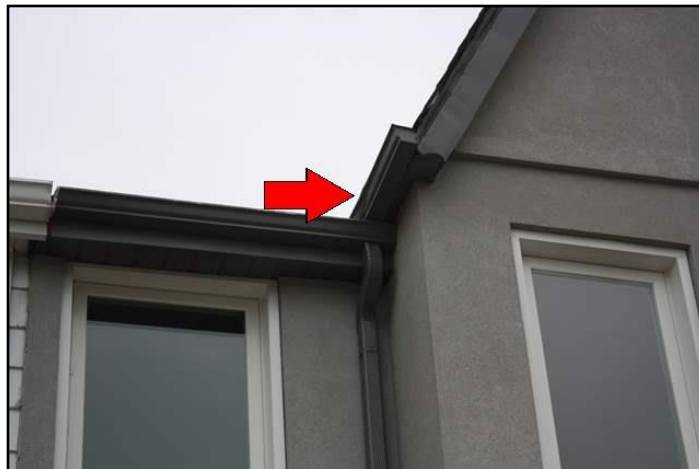
Condition: • Damage

Location: Front Exterior

3. Damage

Task: Repair / Replace

Time: Regular maintenance

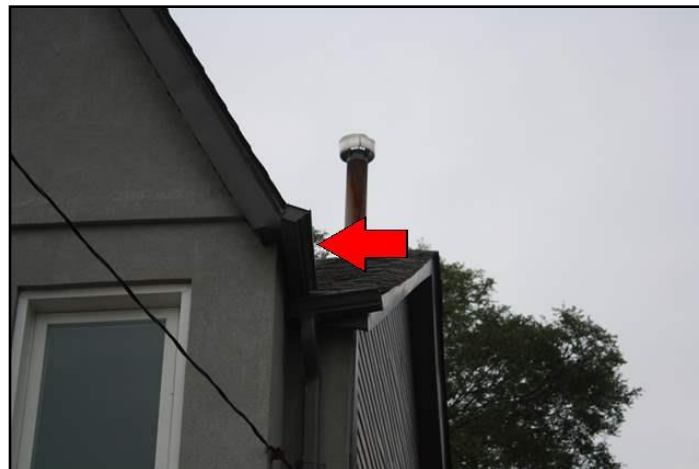
Condition: • [Improper slope, ponding](#)

Implication(s): Chance of water damage to contents, finishes and/or structure

Location: Front Exterior gutter

4. Improper slope, ponding

Task: Improve gutter

Time: Less than 1 year

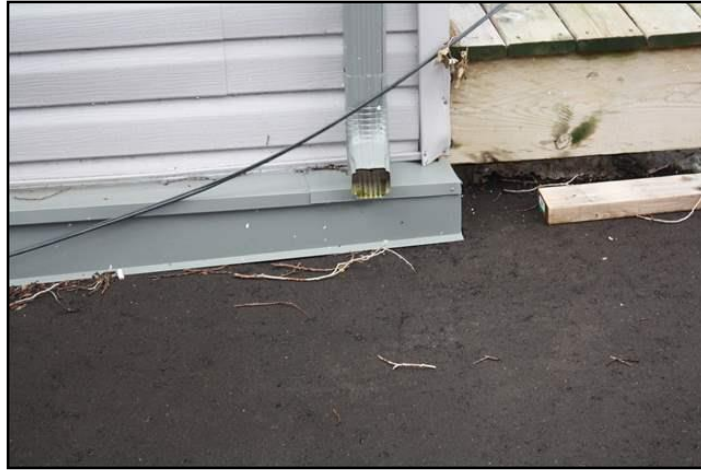
Condition: • [Discharge too close to building](#)

Implication(s): Chance of water damage to contents, finishes and/or structure

Location: Exterior

5. Discharge too close to building

Task: Monitor / Improve

Time: If necessary

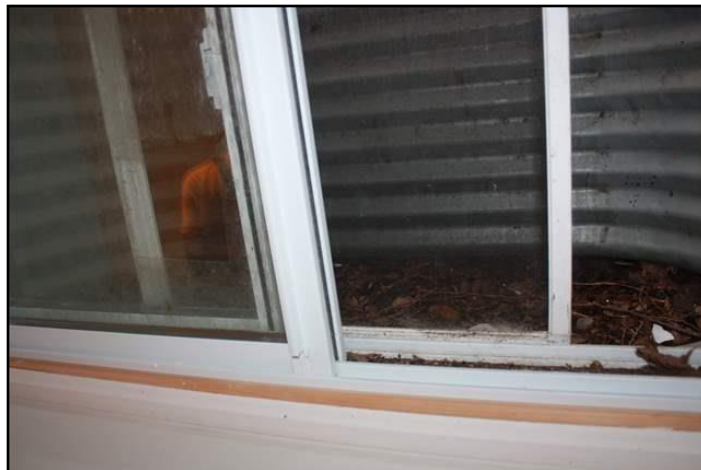
Condition: • Window sill is at or below grade.

Location: Rear Exterior

6. Window sill is at or below grade.

Task: Improve

Time: Less than 1 year

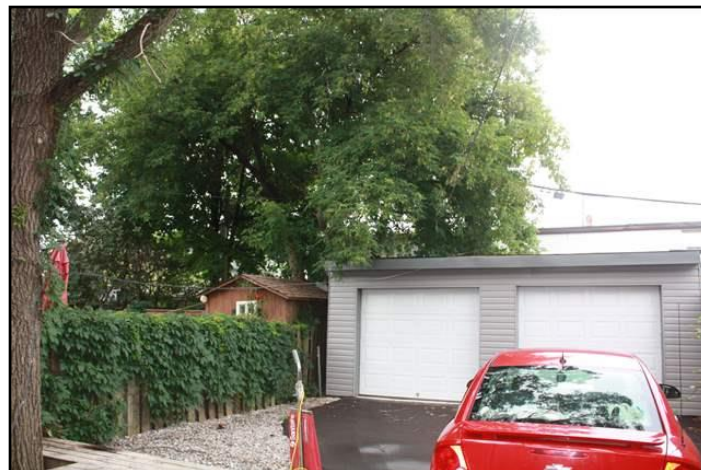
Condition: • [Trees or shrubs too close to building](#)

Implication(s): Chance of water damage to contents, finishes and/or structure | Chance of pests entering building | Material deterioration

Location: Exterior Garage

7. Trees or shrubs too close to building

Keep tree branches trimmed back 3 feet from roof line.

Task: Improve

Time: Ongoing

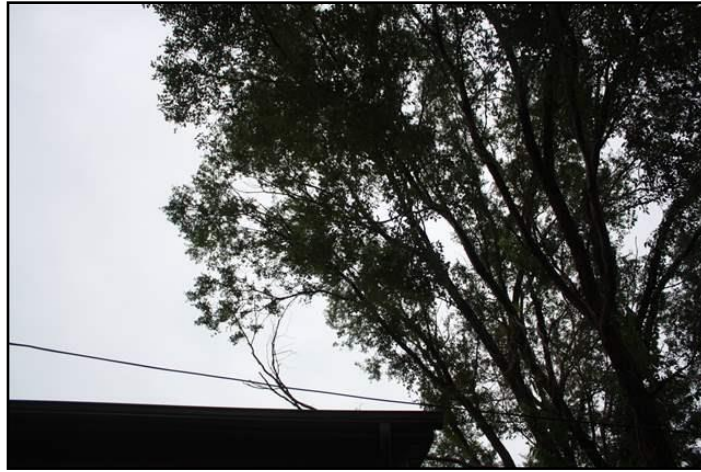
Condition: • [Trees or shrubs too close to building](#)

Implication(s): Chance of water damage to contents, finishes and/or structure | Chance of pests entering building | Material deterioration

Location: Rear Exterior

8. Trees or shrubs too close to building

Keep tree branches trimmed back 3 feet from roof line.

Task: Improve

Time: Ongoing / Regular maintenance

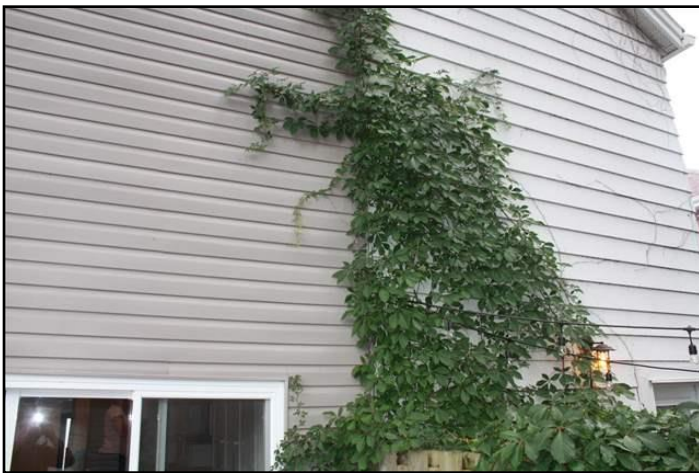
Condition: • Vines on building

Vines may damage the home over time. If vines are to remain, and we understand the aesthetic reasons for leaving them, we recommend controlling the growth so vines do not attach to wood surfaces or roofs, and do not clog gutters and downspouts and soffit vents.

Implication(s): Chance of damage to finishes | Chance of pests entering building

Location: Rear Exterior

9. Vines on building

Task: Remove

Time: Less than 1 year

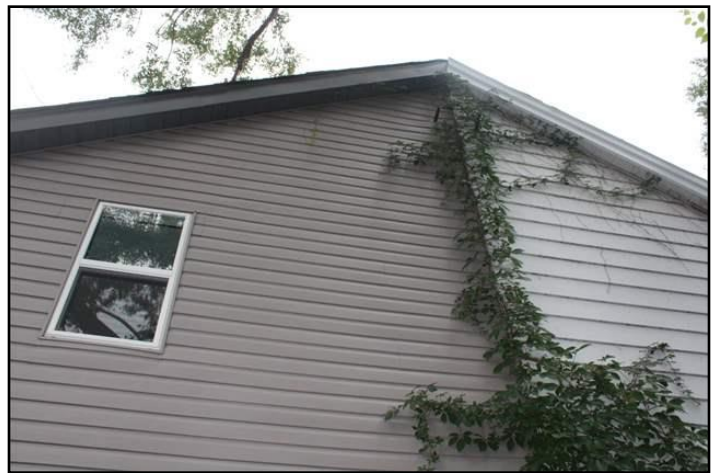
10. Vines on building

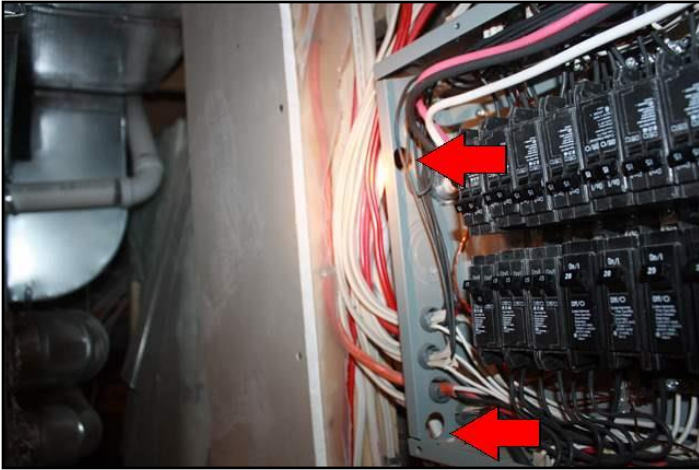
Condition: • [Openings in panel](#)

Implication(s): Electric shock | Fire hazard

Location: Basement Panel

11. Openings in panel

Task: Correct

Time: Immediate

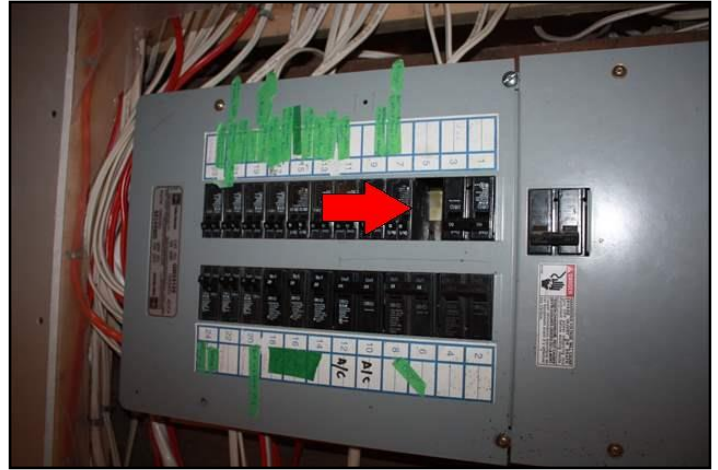
12. Openings in panel

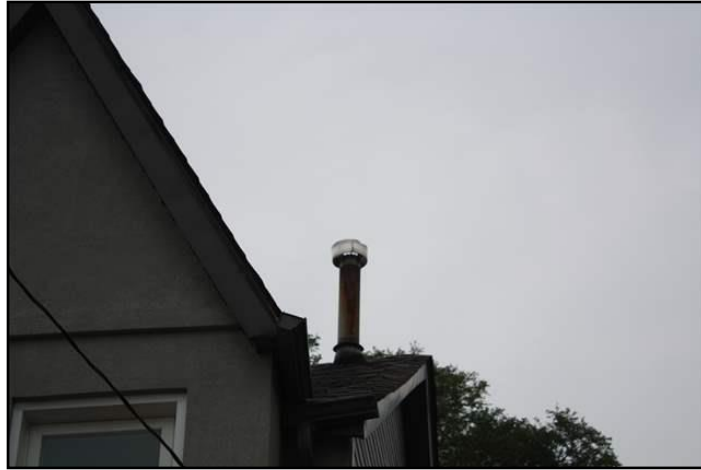
Condition: • [Chimney walls rusting or pitting](#)

Metal chimney no longer in use. Remove if desired.

Implication(s): Chance of movement | Hazardous combustion products entering home

Location: Exterior Roof

13. Chimney walls rusting or pitting

Task: Remove

Time: Less than 2 years

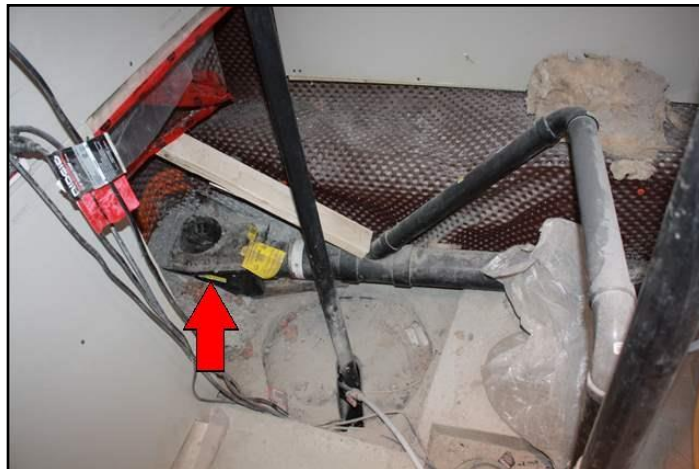
- Present. These valves help prevent sewer backup. Many insurance companies insist these be installed before they will offer a sewer backup endorsement, which we strongly recommend you obtain.

14. Present. These valves help prevent sewer...

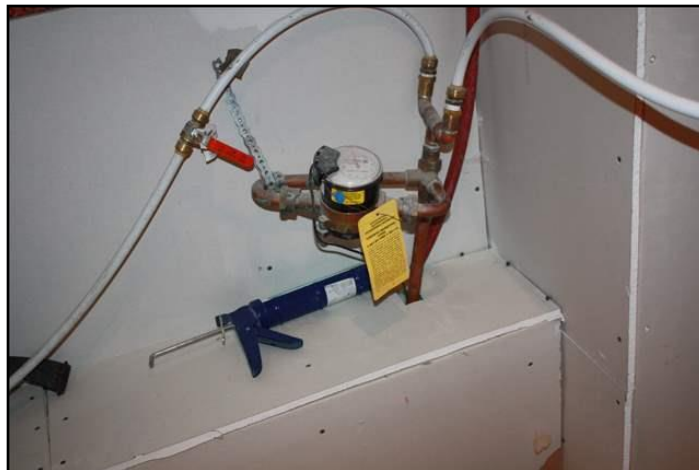
Condition: • [Missing or cannot be located](#)

main shut off valve is required prior to meter.

Implication(s): Chance of water damage to contents, finishes and/or structure | Difficult to service

Location: Basement Furnace Room

15. Missing

Task: Provide shut off valve

Time: As Soon As Possible

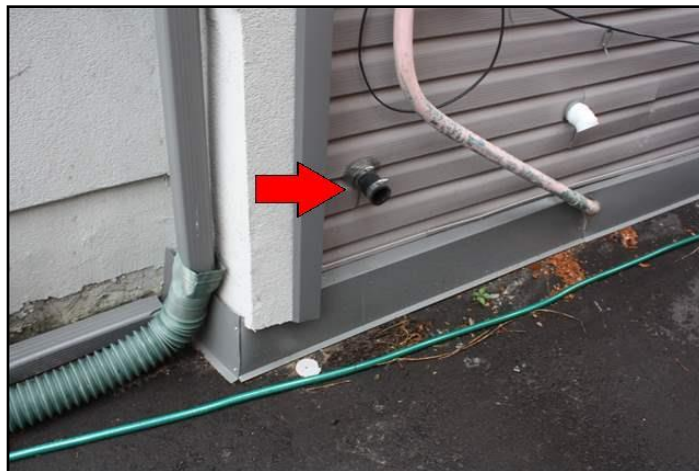
Condition: • [Discharge pipe problems](#)

Implication(s): Chance of water damage to contents, finishes and/or structure

Location: Right Side Exterior

16. Discharge pipe

Ideally, the discharge of the sump should drain to the exterior of the home extended to 12 feet away.

Task: Monitor / Improve

Time: If necessary

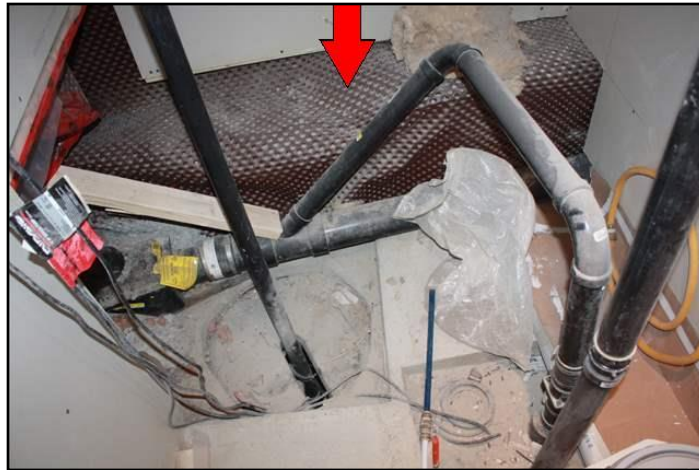
Condition: • [Drainage membrane](#)

For Your Information - Homeowner noted that a drainage membrane was added to the foundation wall. This is a common method used to help manage moisture on stone foundations.

Location: Throughout Basement

17. Drainage membrane
