# YOUR INSPECTION REPORT

331 Windermere Avenue  
Toronto, ON M6S 3K9

INSPECTION DATE:  
Monday, May 3, 2021

RE: Report No. 2882  
331 Windermere Avenue  
Toronto, ON  
M6S 3K9

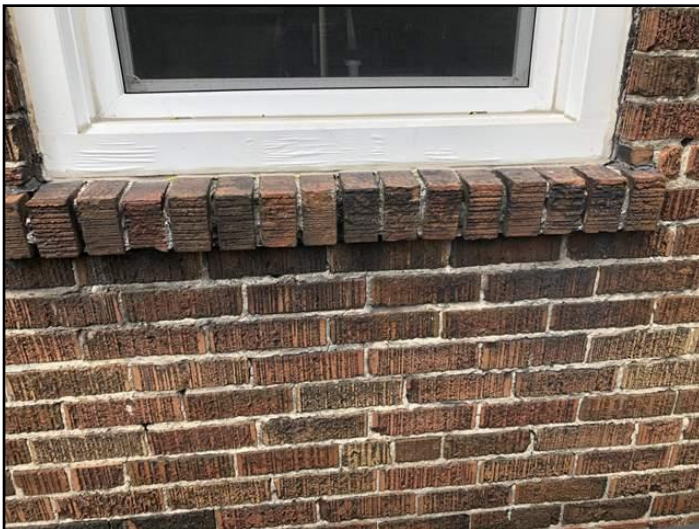
1. example

**Condition:** • [Mortar deterioration](#)

Provide mortar (Repointing, Tuck pointing) at various areas of the exterior brick and sills. This is routine maintenance for homes of this age. Overall the brick and mortar is in good condition. photos show sampling.

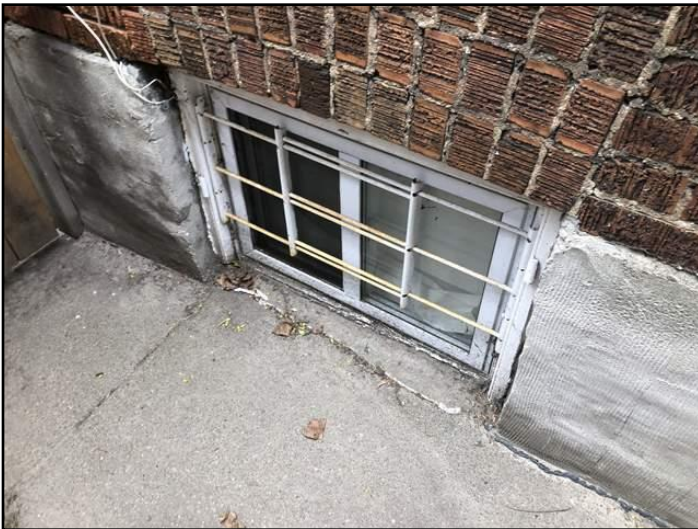
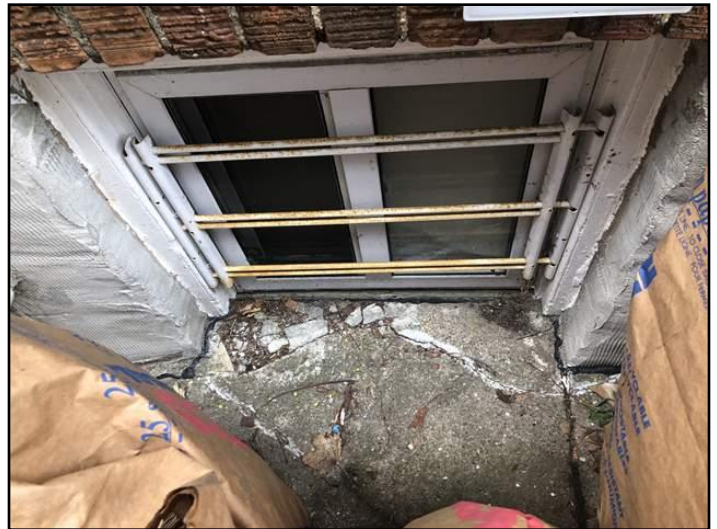
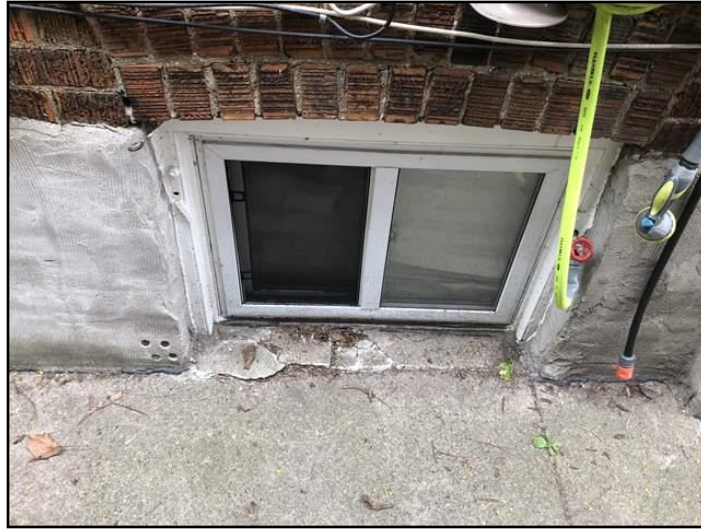
**Condition:** • Sill - Near or at Grade Level

This was common on older construction. Modern standards require that bottom of window be above grade by 6-inches or a window well be provided. Window sills at grade are vulnerable to damage and water leakage

4. Sill - Near or at Grade Level

**Task:** Monitor / Improve

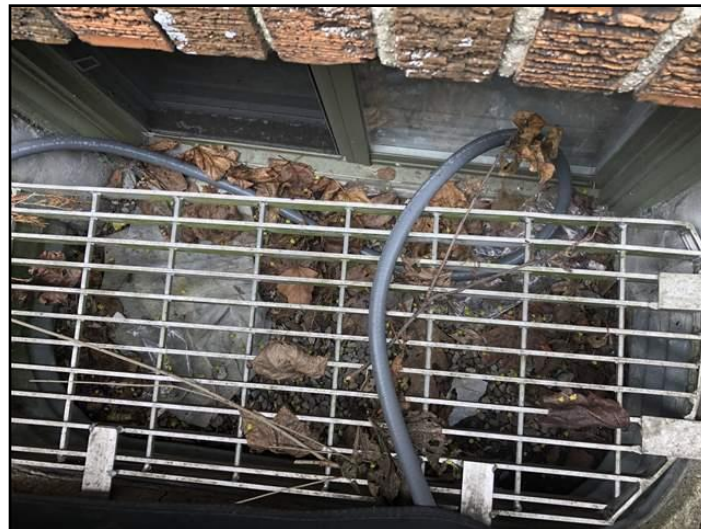
**Condition:** • [Less than 6 inches below window](#)

7. Less than 6 inches below window

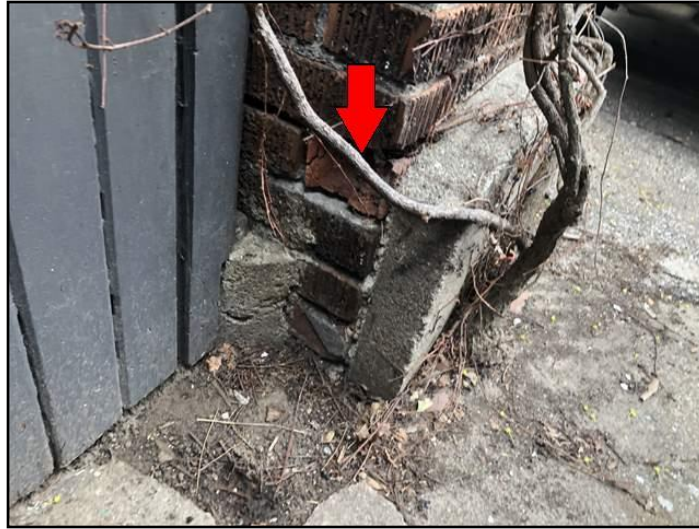
**Condition:** • [Spalling](#)

8. Minor spalling

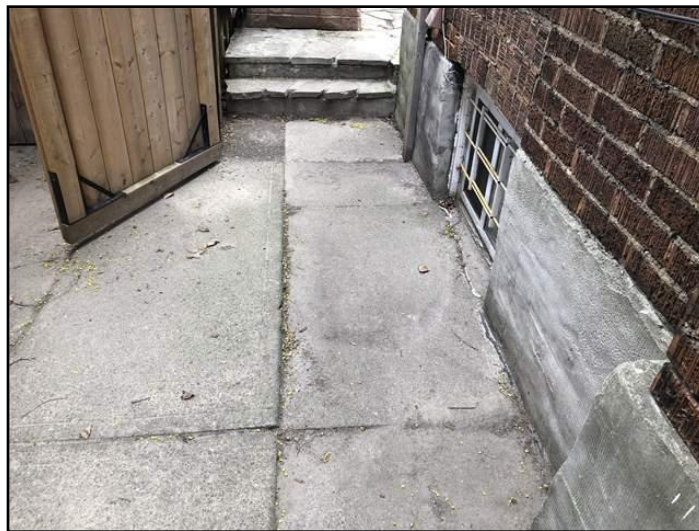
**Condition:** • Low Areas.

### 9. Low Areas

**Condition:** • During rainfall, walk the exterior to view if any water is draining towards the home. Improve these areas as needed

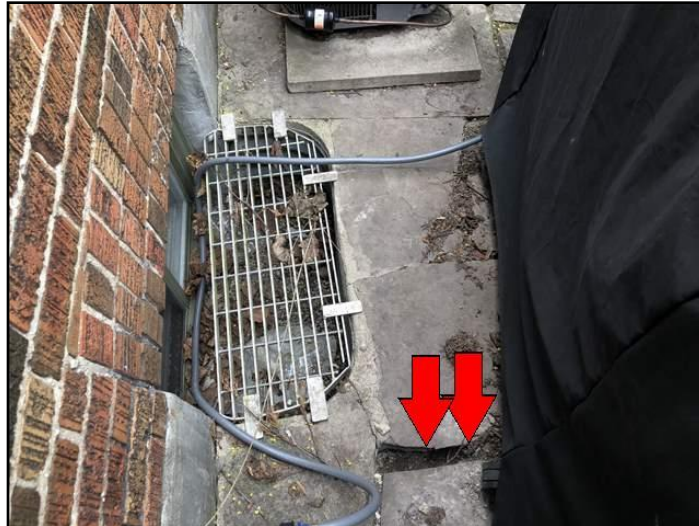
10.

**Condition:** • Gap in walkway or patio.

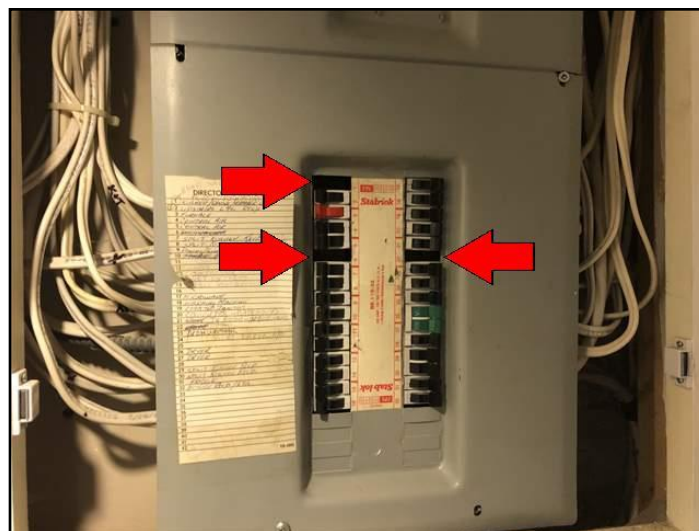
**Condition:** • [Openings in panel](#)

12. Openings in panel

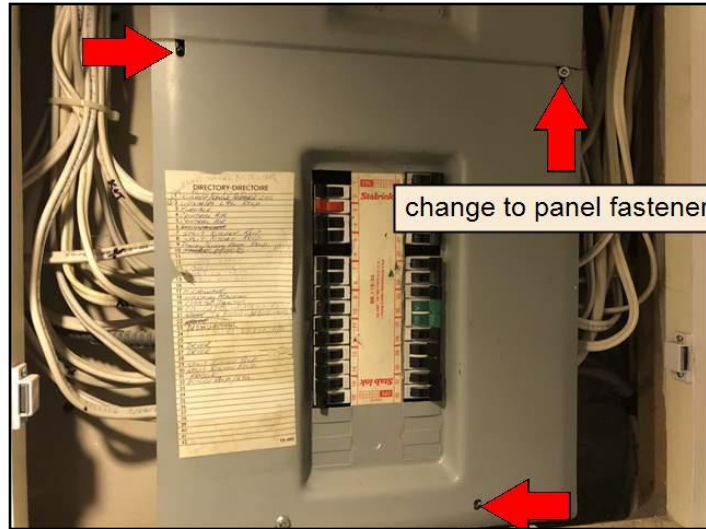
**Condition:** • Missing or Improper Panel Cover Fasteners

13. Missing or Improper Panel Cover Fasteners

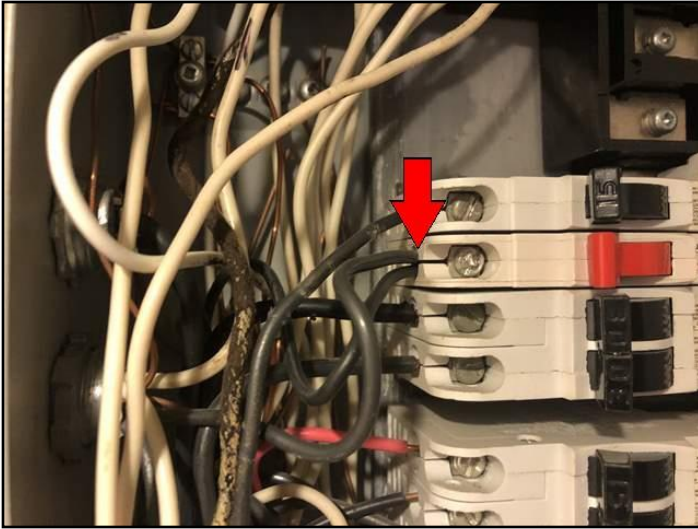
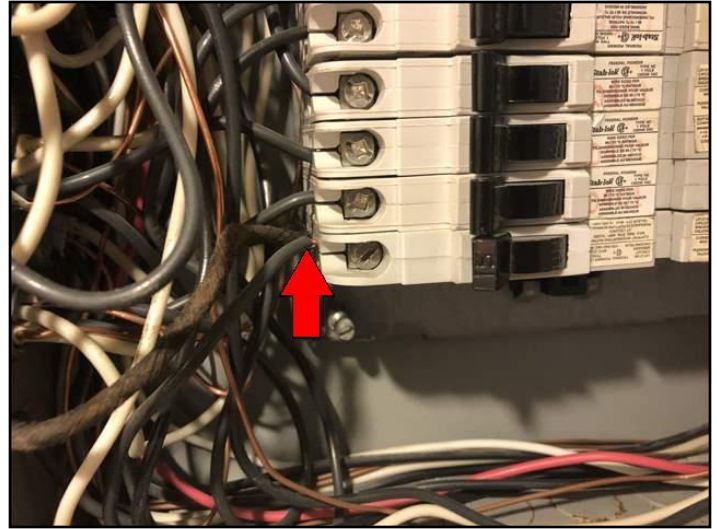
Condition: • [Double taps](#)

14. Double taps

15. Double taps

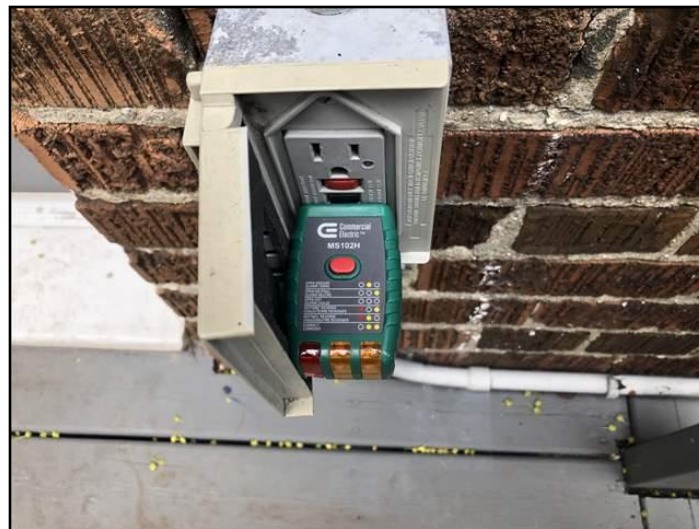
**Condition:** • [Test faulty on GFCI/GFI \(Ground Fault Circuit Interrupter\)](#)

**Location:** Rear Exterior

16. Test faulty on GFCI/GFI (Ground Fault...

**Task:** Replace

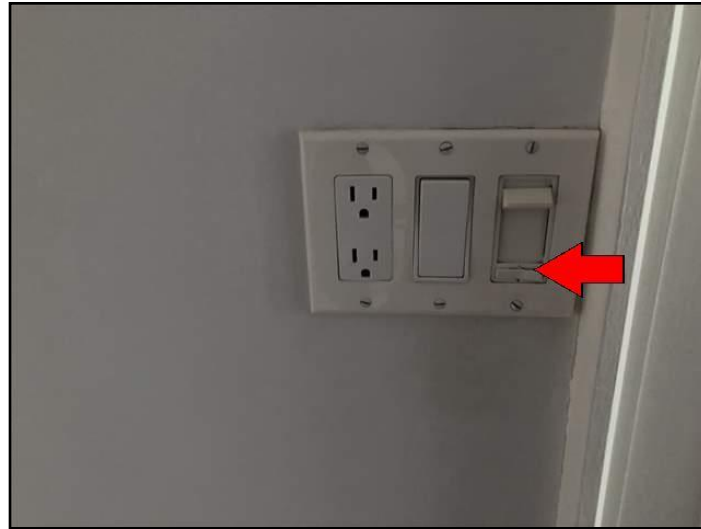
**Condition:** • [Faulty](#)

17. Faulty

**Task:** Repair / Replace

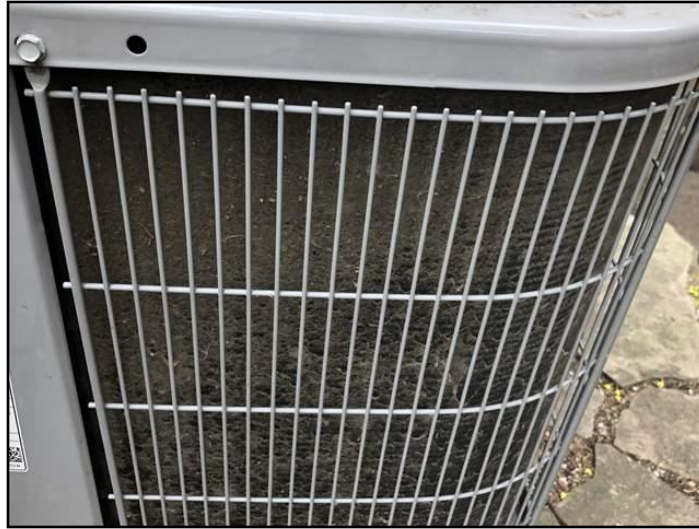
**Condition:** • [Dirty](#)

18. *Dirty*

**Task:** Clean

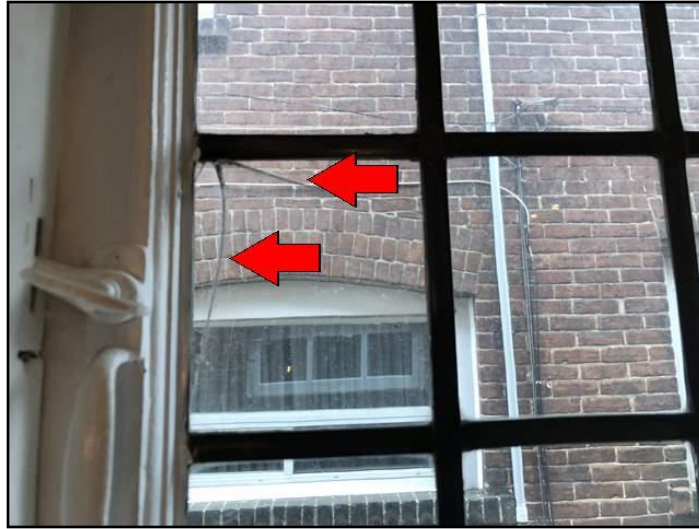
**Condition:** • [Cracked](#)

19. Cracked

**Task:** Replace

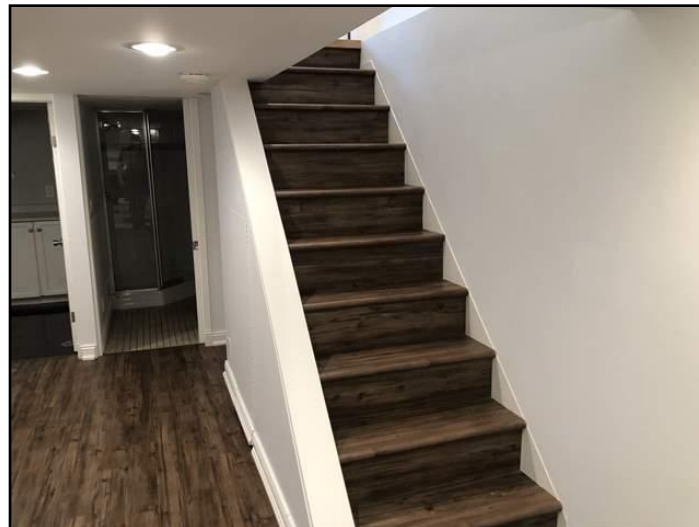
**Condition:** • [Missing](#)

20. Missing

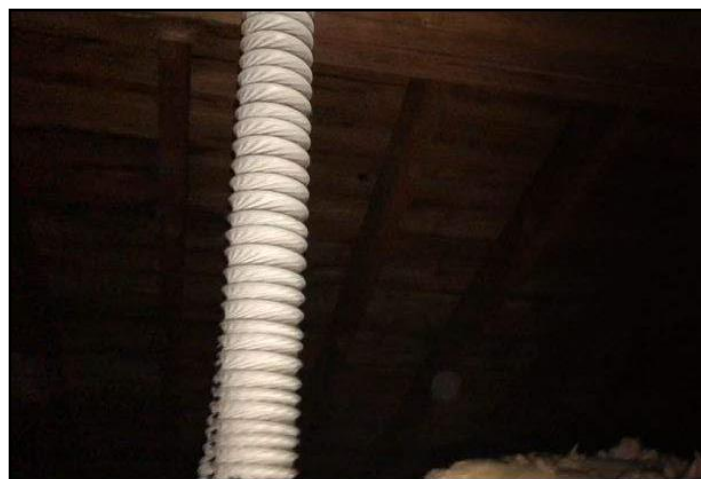
**Condition:** • [Not insulated in unconditioned space](#)

21. Not insulated in unconditioned space
