Your Inspection Report

222 Sample Road, Suite B214
Tampa, FL 33619

INSPECTION DATE:
Friday, February 16, 2018

PREPARED BY:
Tom Frey

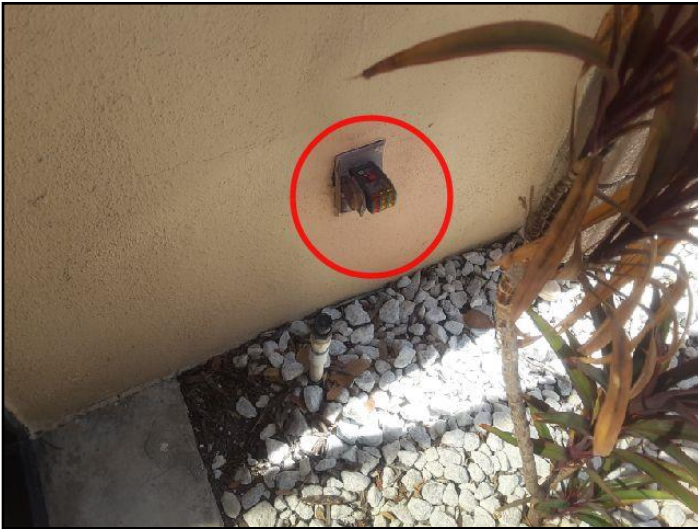
Condition: • Ungrounded three-prong receptacles

Several ungrounded exterior outlets noted

1. Ungrounded three-prong receptacles

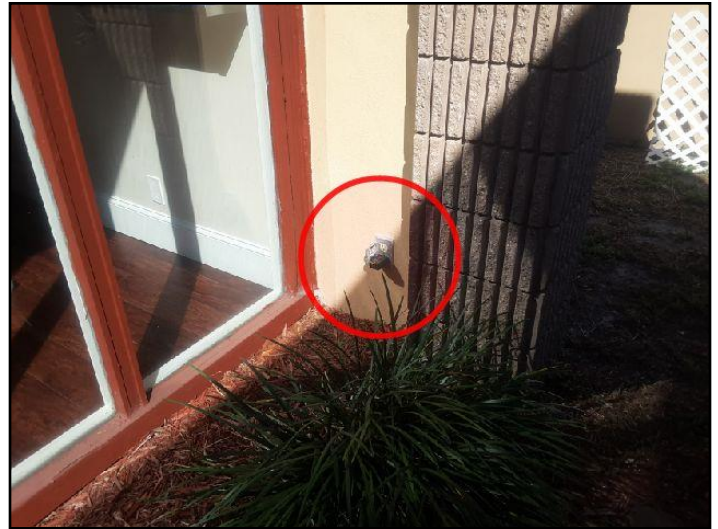
2. Ungrounded three-prong receptacles

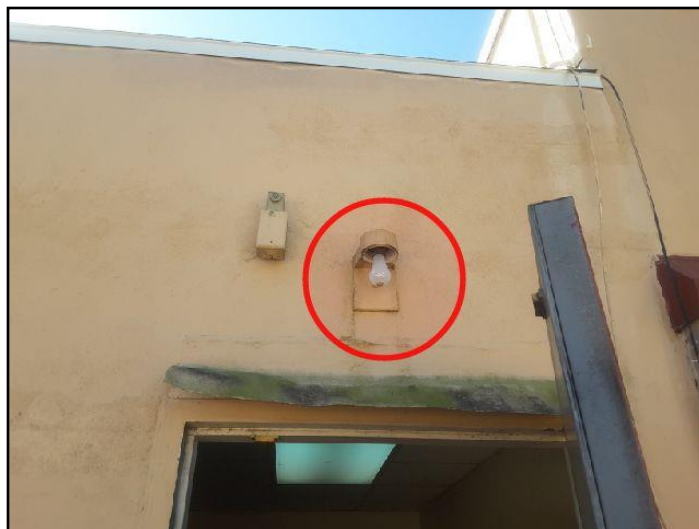
3.

Condition: • Light cover missing

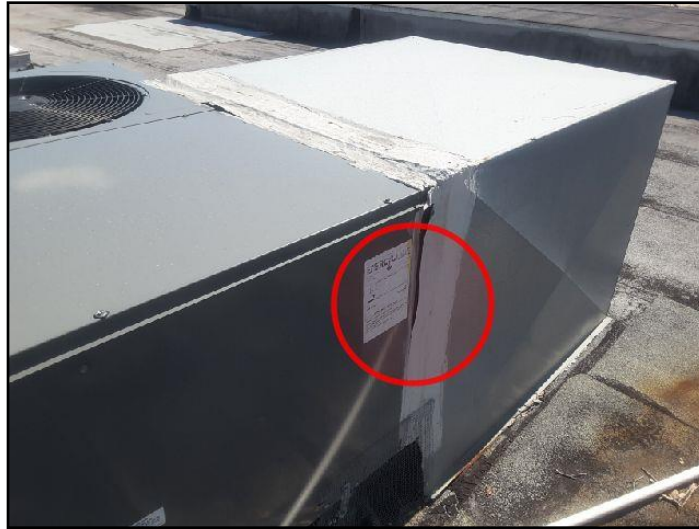
Condition: • Exterior ductwork poor / damaged
Leaky joints

4. Exterior ductwork poor / damaged

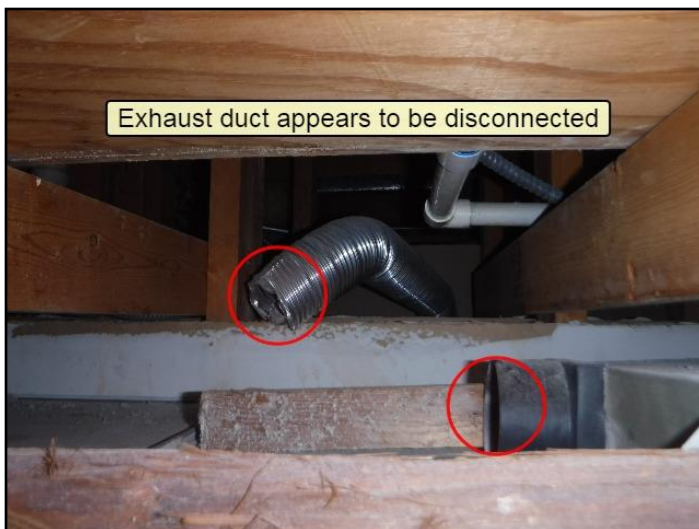
Condition: • Discharging into the attic / ceiling space
Suite 100

5. Discharging into the attic / ceiling space

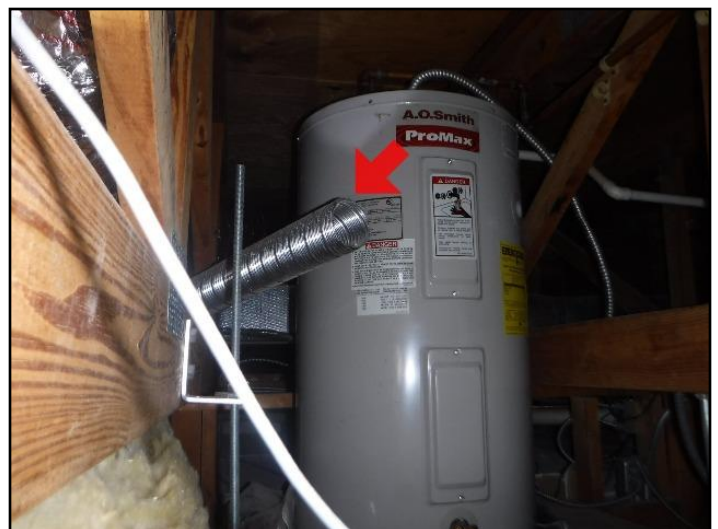
6. Discharging into the attic / ceiling space

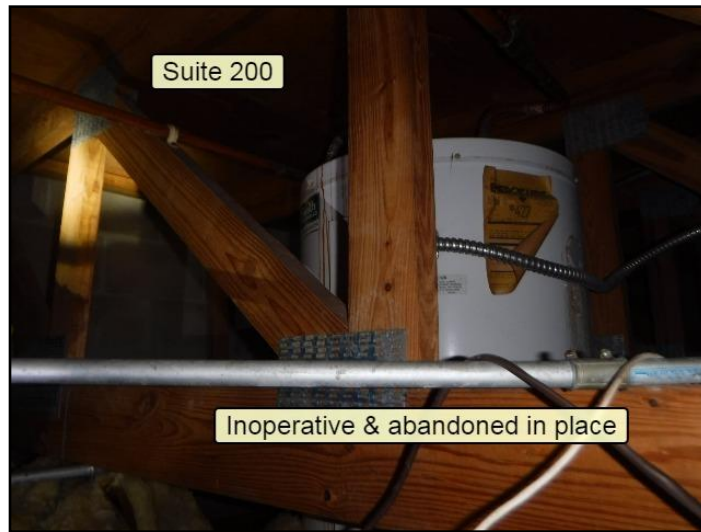
7.

Condition: • Suite 200 HWT damaged & not operating . Appears to be abandoned in place

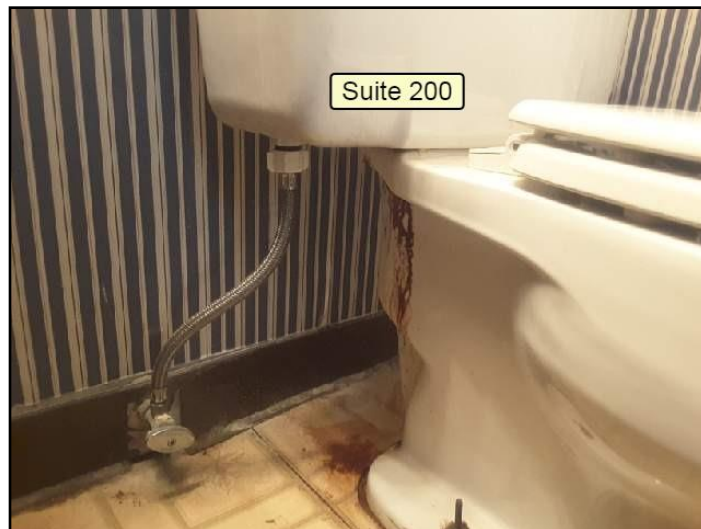
Condition: • Leak

Suite 200

8. Some deferred maintenance was noted.

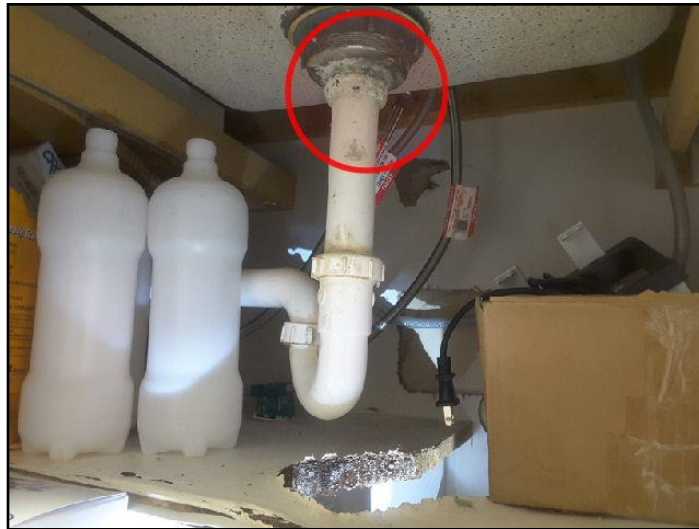
Condition: • Leaking faucet(s)

Suite 100

9. Leaking faucet(s)

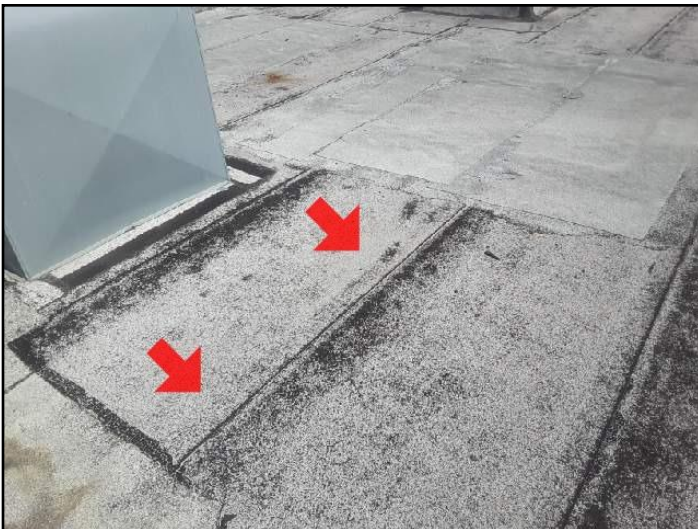
Condition: • Blistering

Blistering noted in numerous locations throughout the roof

10. Blistering

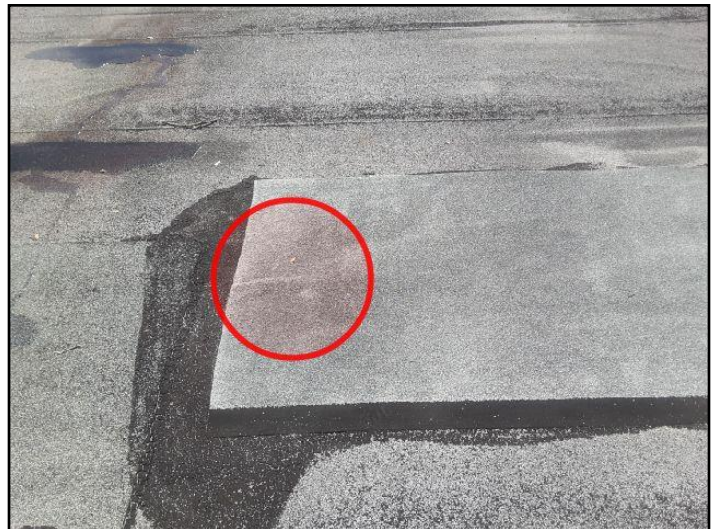
11. Blistering

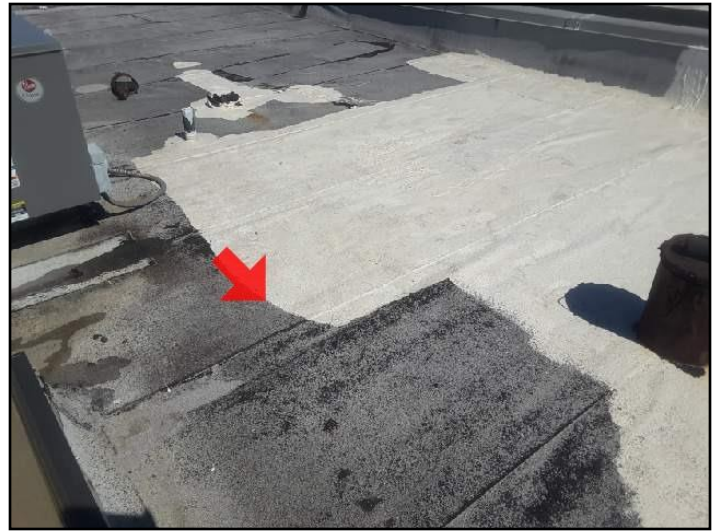
13. Blistering

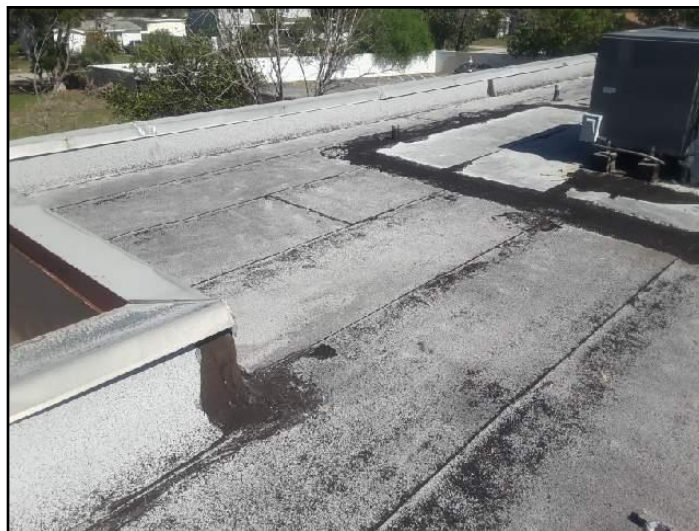
14. Blistering

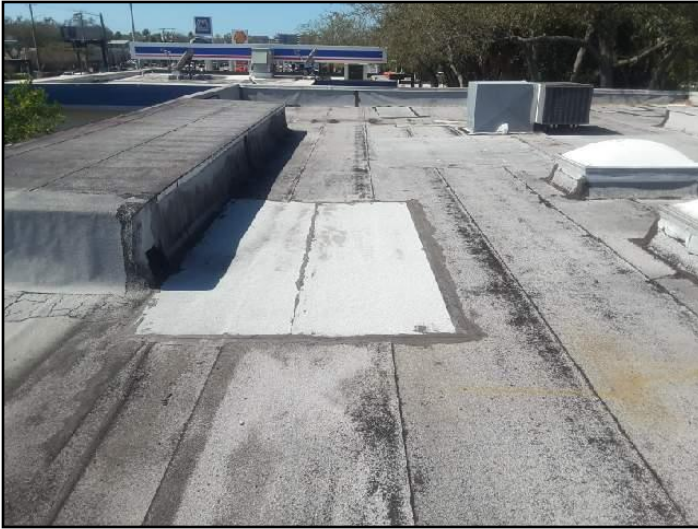
Condition: • Previous repairs noted
Numerous patched noted

15. Previous repairs noted

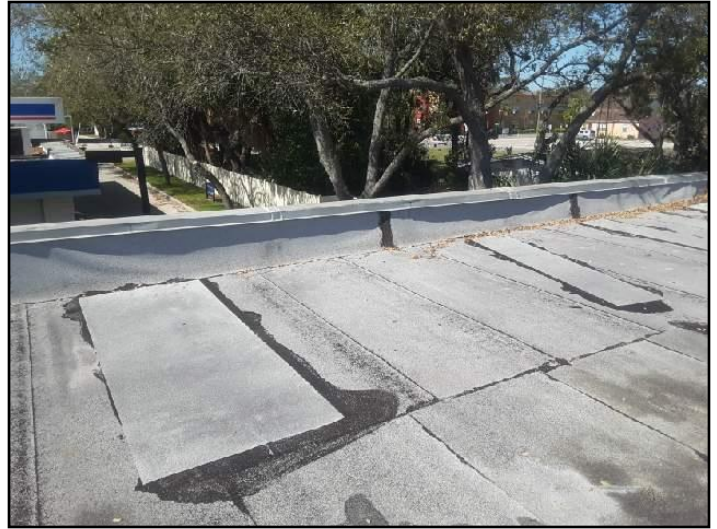
16. Previous repairs noted

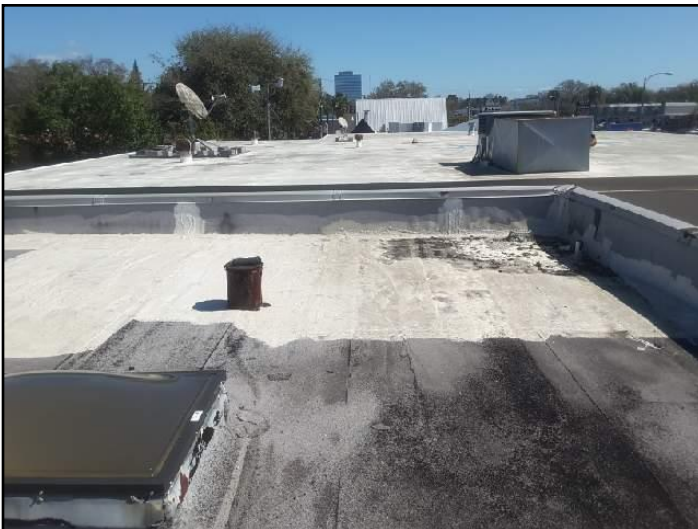
17. Previous repairs noted

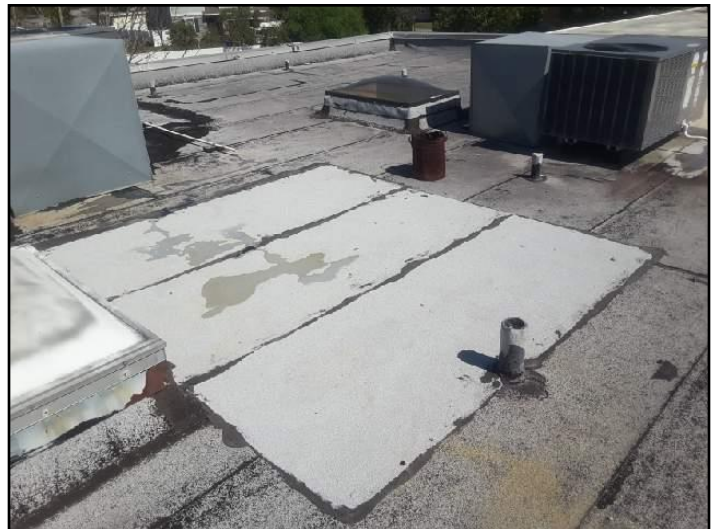
18. Previous repairs noted

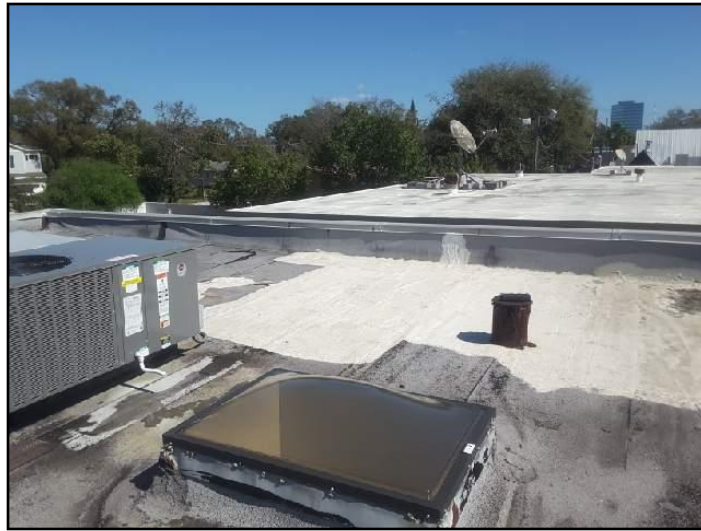
19. Previous repairs noted

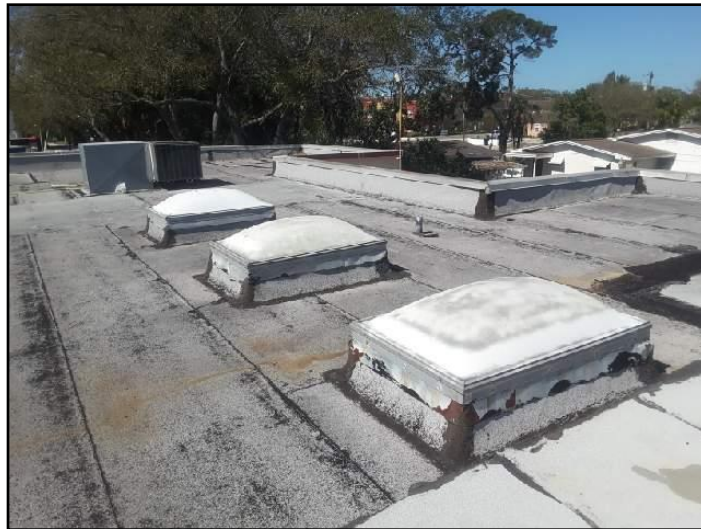
20.

Condition: • Old and worn

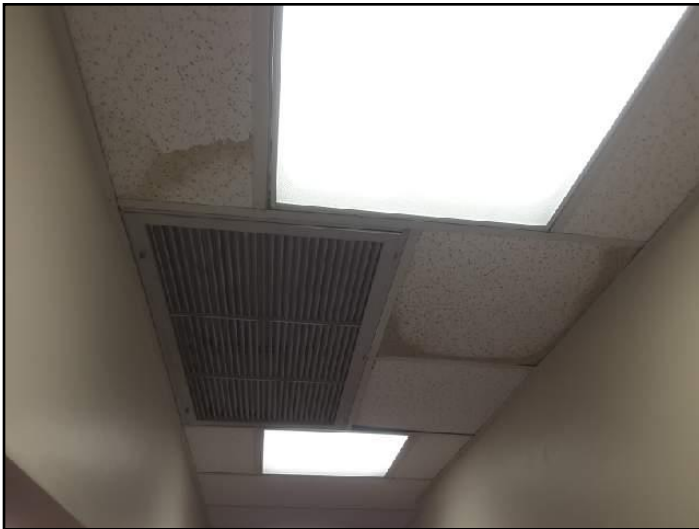
Condition: • Water stain

21. Water stain

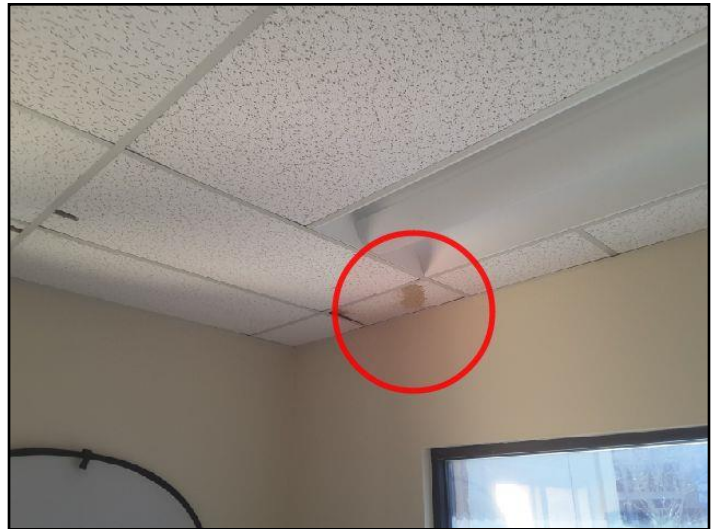
22. Water stain

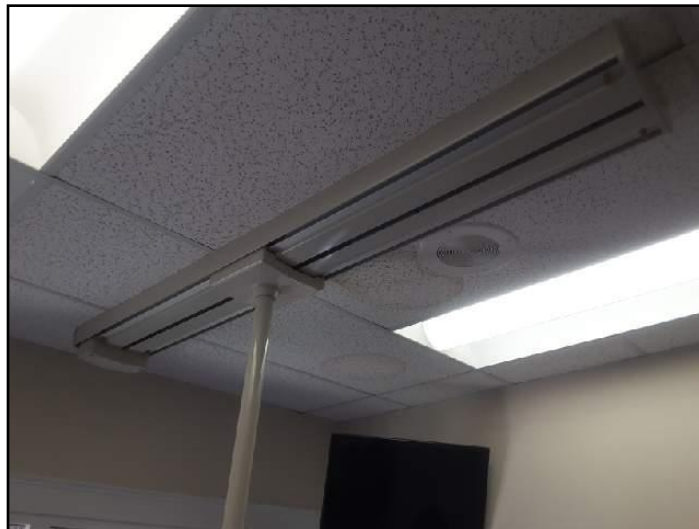
23. Water stain

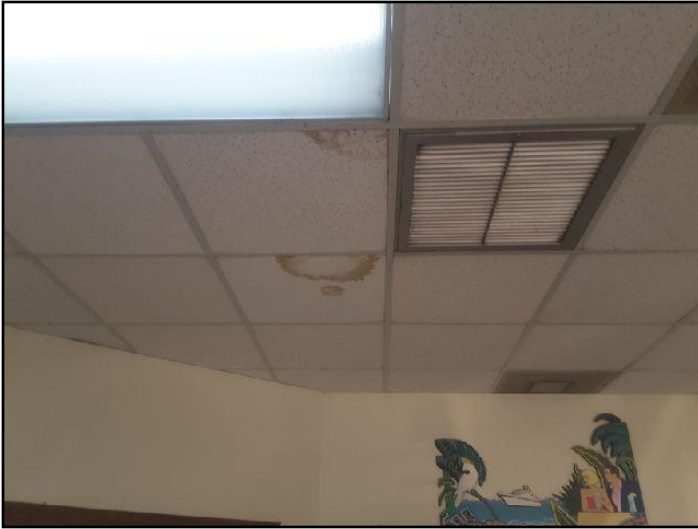
Condition: • Water stain

24. Water stain

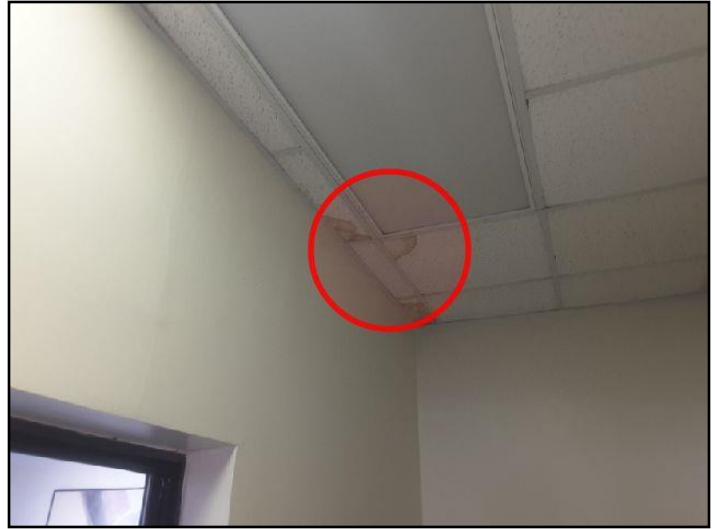
25. Water stain

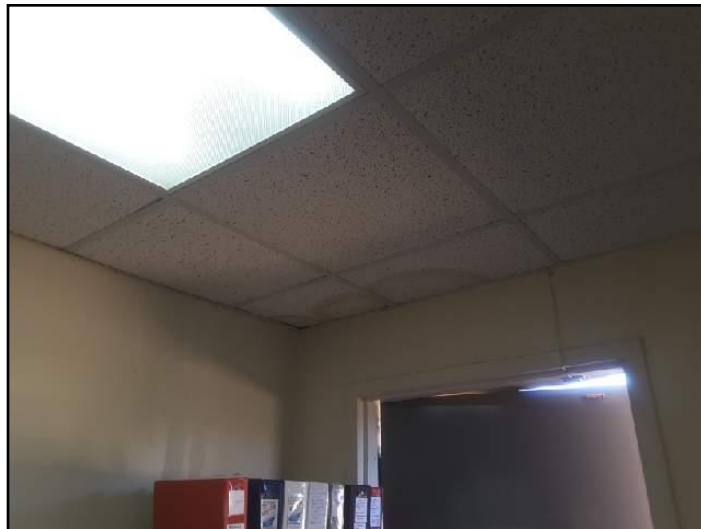
26. Water stain

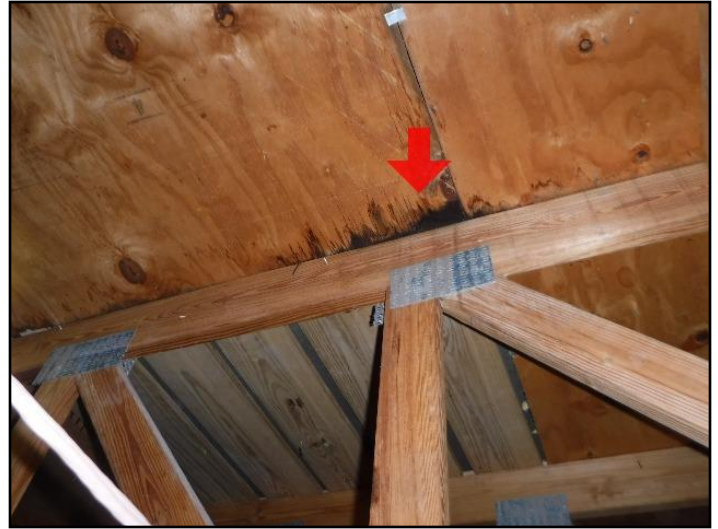
28.

Condition: • Water stains noted in several areas.

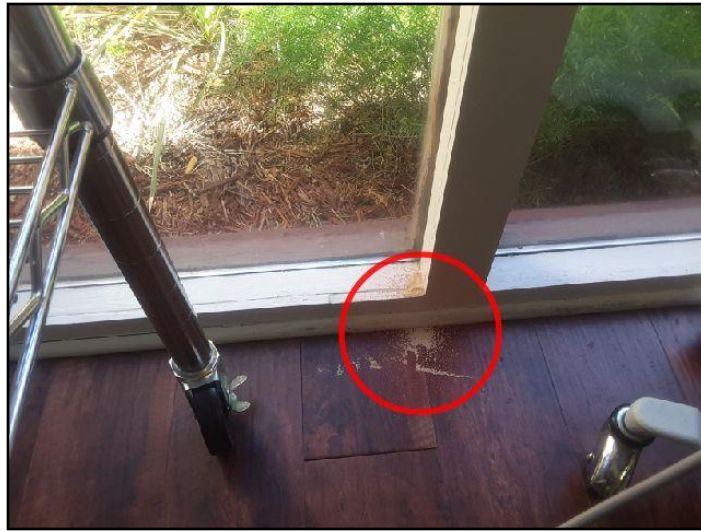
Condition: • Evidence of damage noted

Termite frass noted

31. Evidence of damage noted

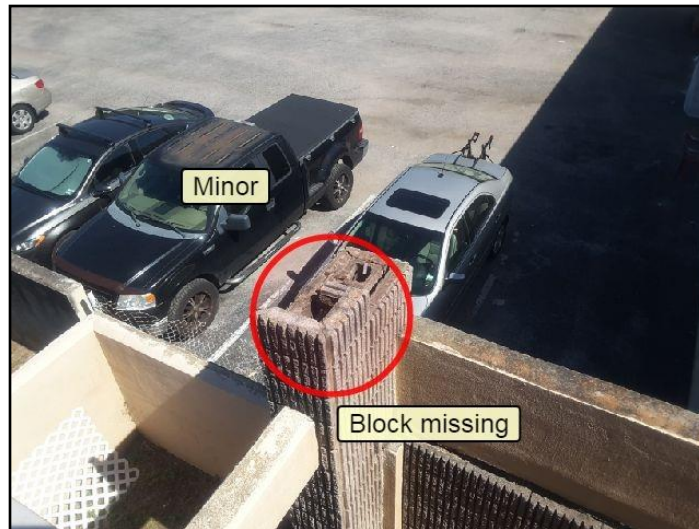
Condition: • Damage

32. Damage

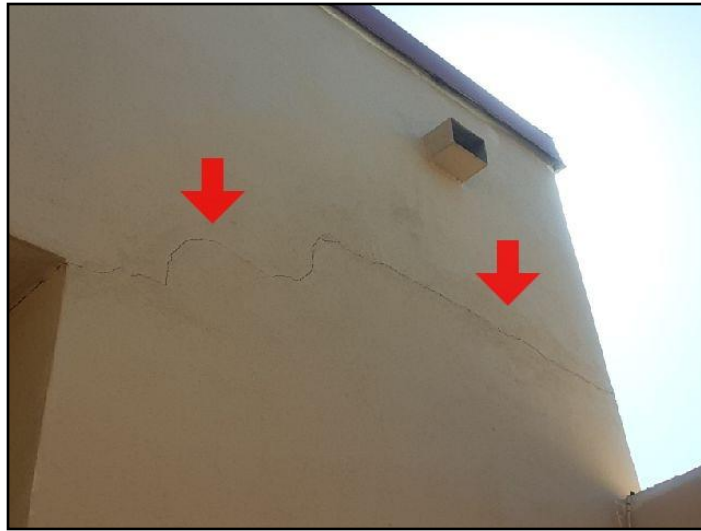
Condition: • Minor cracking

33. *Minor cracking*

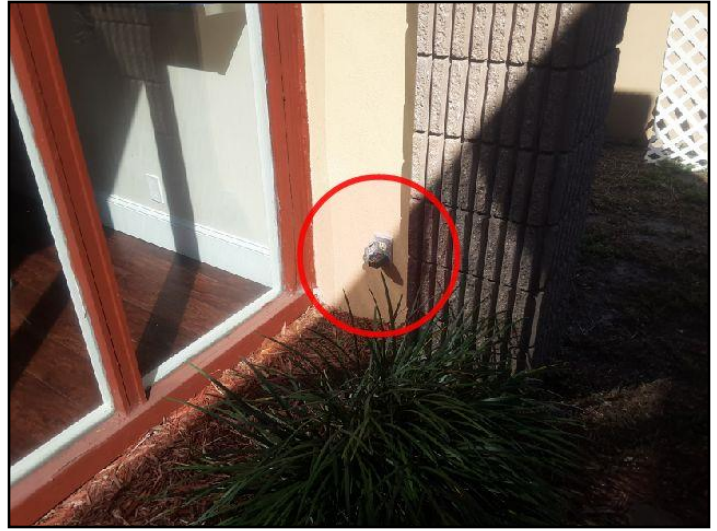
4. **Condition:** • Ungrounded three-prong receptacles
Several ungrounded exterior outlets noted

47. Ungrounded three-prong receptacles

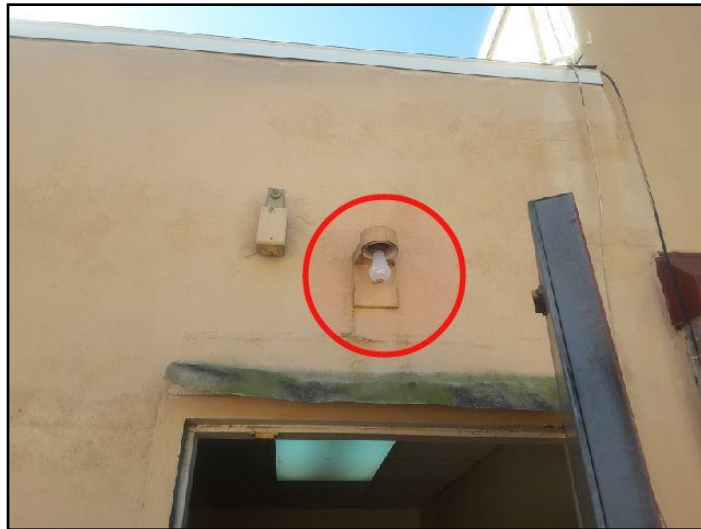
48.

5. Condition: • Light cover missing

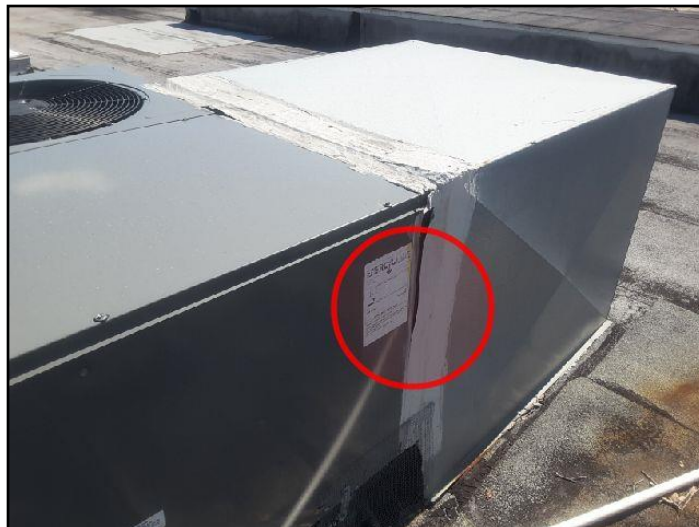
6. Condition: • Exterior ductwork poor / damaged

Leaky joints

55. Exterior ductwork poor / damaged

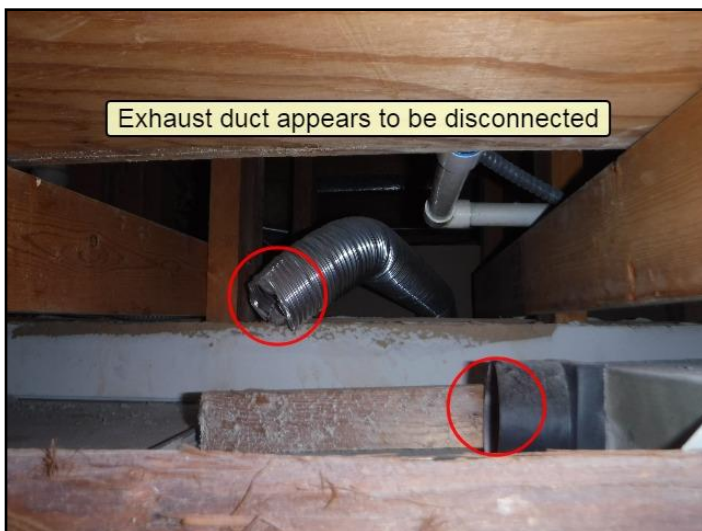
7. Condition: • Discharging into the attic / ceiling space

Suite 100

58. Discharging into the attic / ceiling space

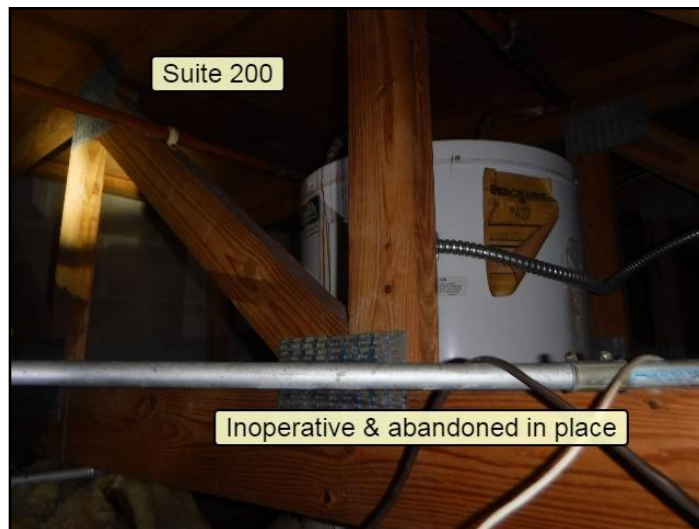
70.

11. Condition: • Suite 200 HWT damaged & not operating . Appears to be abandoned in place

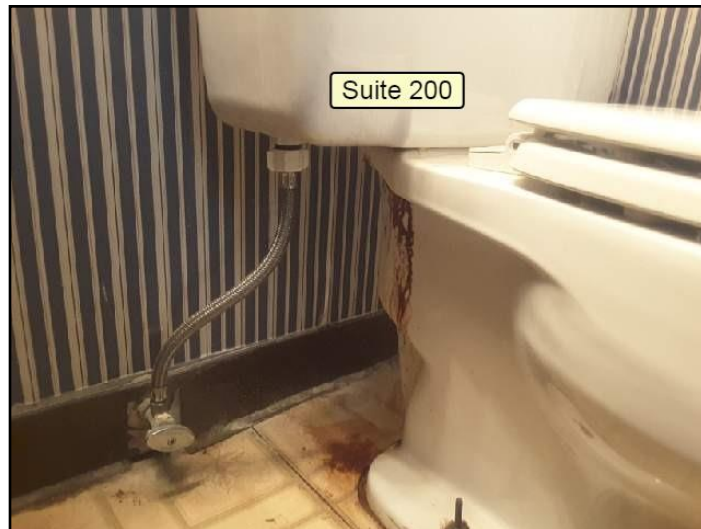
13. Condition: • Leak

Suite 200

71. Some deferred maintenance was noted.

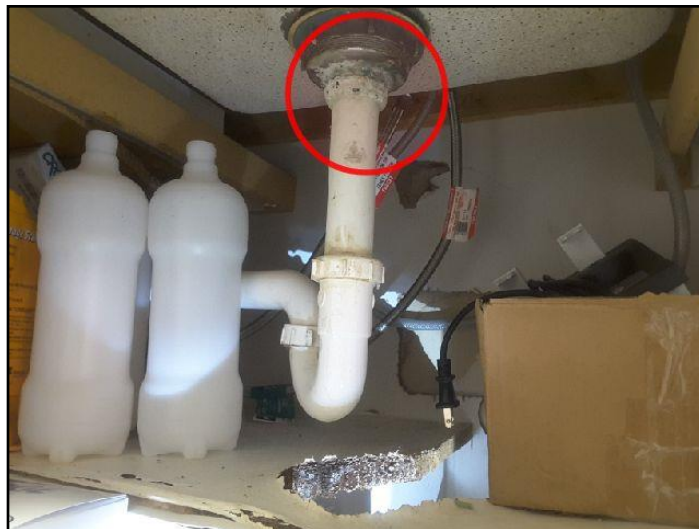
14. Condition: • Leaking faucet(s)

Suite 100

72. Leaking faucet(s)

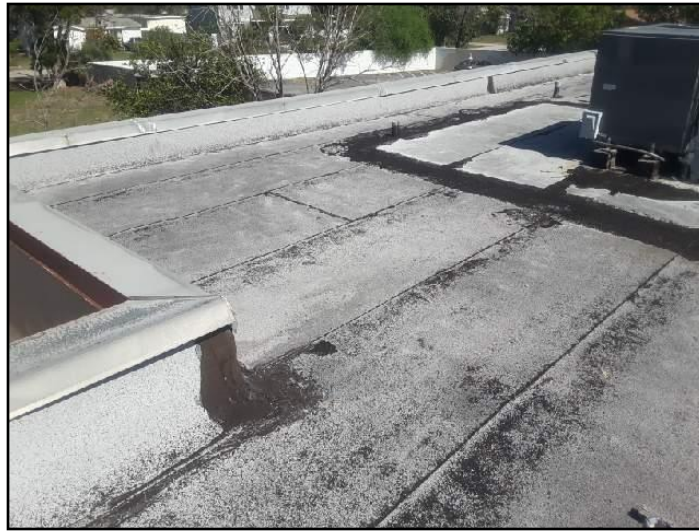
18. Condition: • Blistering

Blistering noted in numerous locations throughout the roof

86. *Blistering*

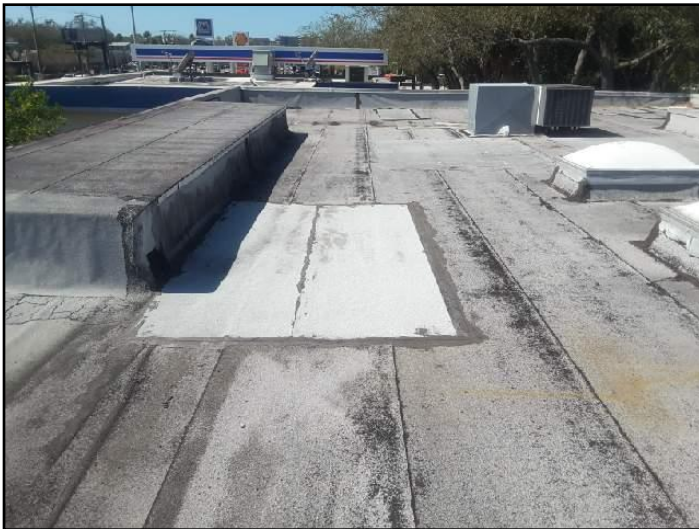
19. Condition: • Previous repairs noted
Numerous patched noted

87. *Previous repairs noted*

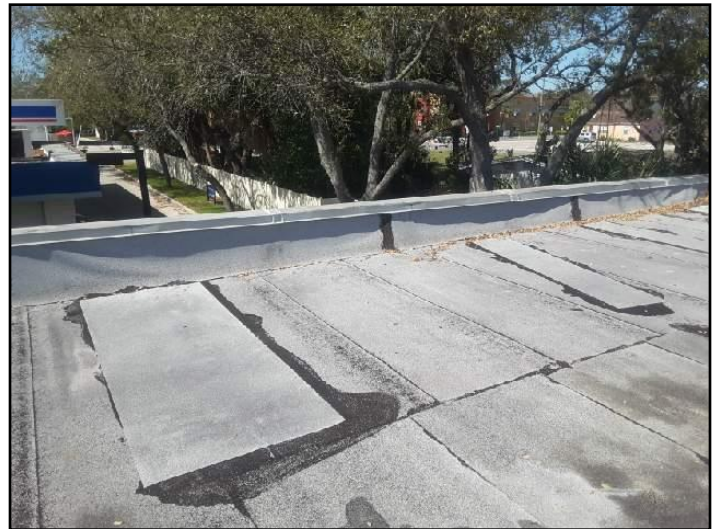
88. *Previous repairs noted*

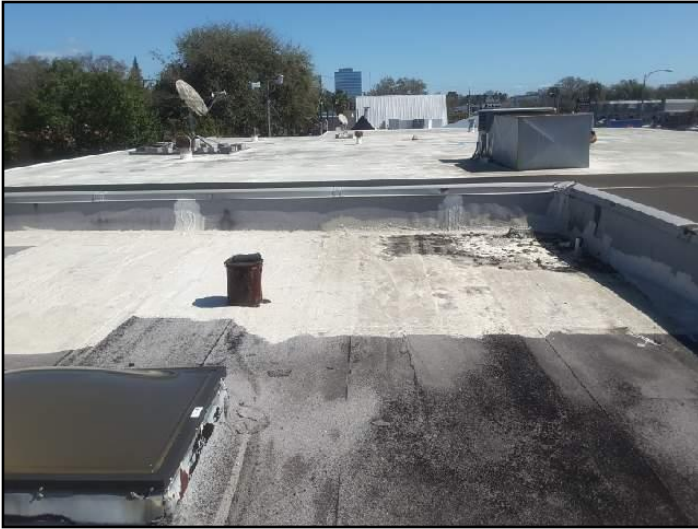
89. Previous repairs noted

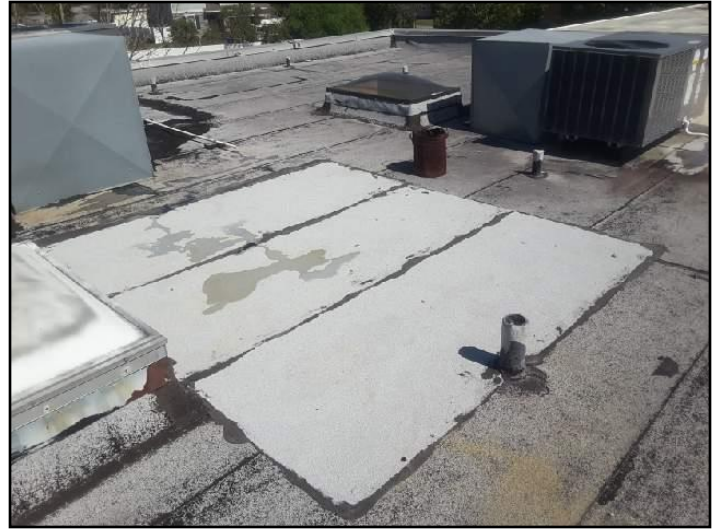
90. Previous repairs noted

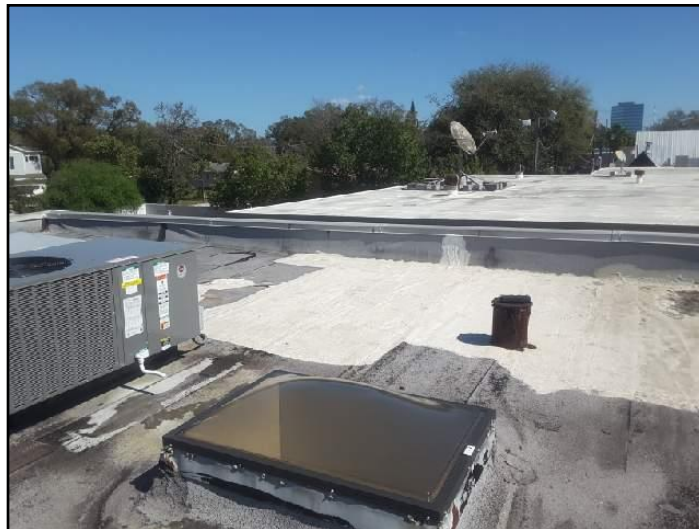
91. Previous repairs noted

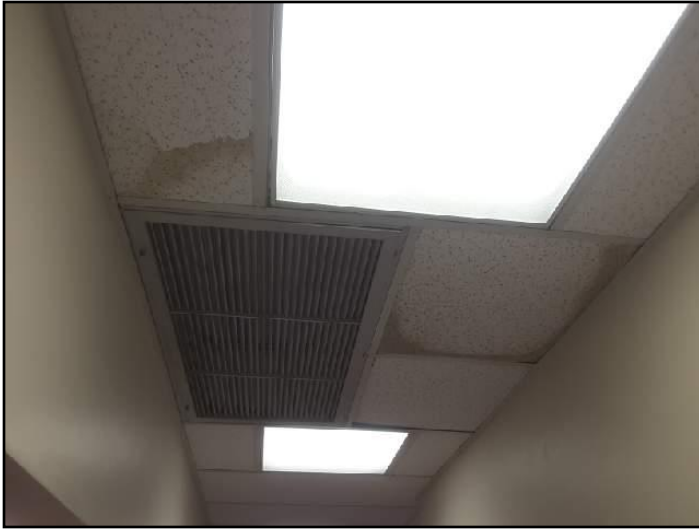
26. Condition: • Water stain

114. Water stain

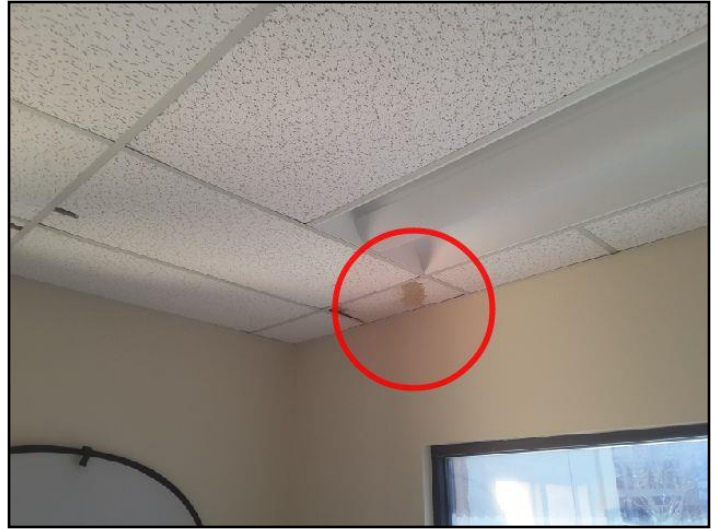
115. Water stain

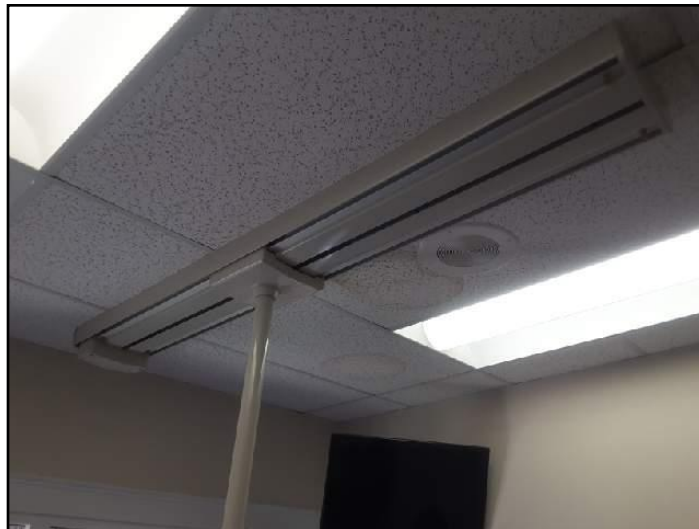
116. Water stain

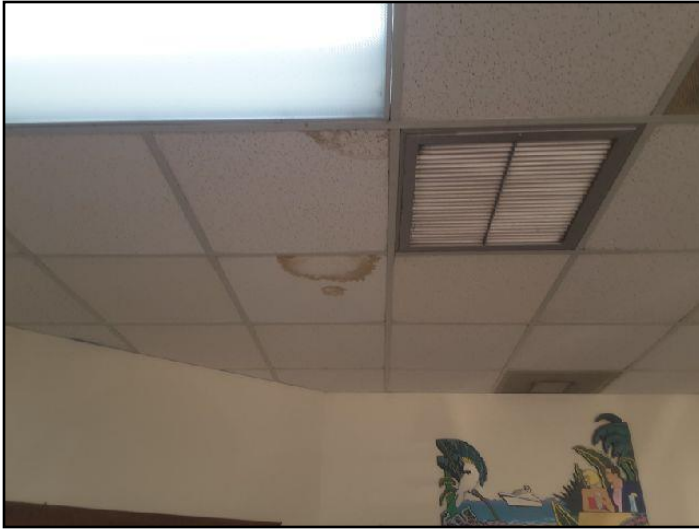
27. Condition: • Water stain

117. Water stain

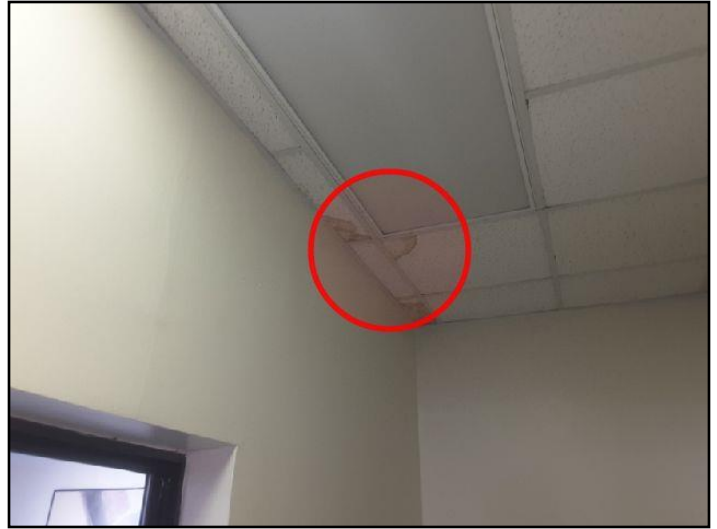
118. Water stain

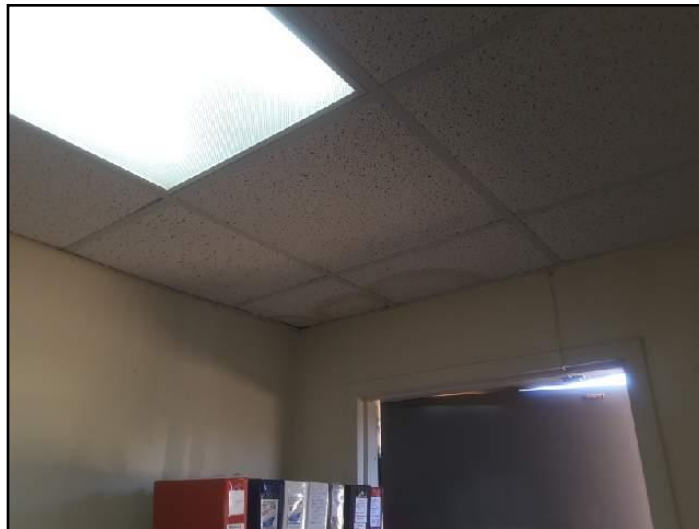
119. Water stain

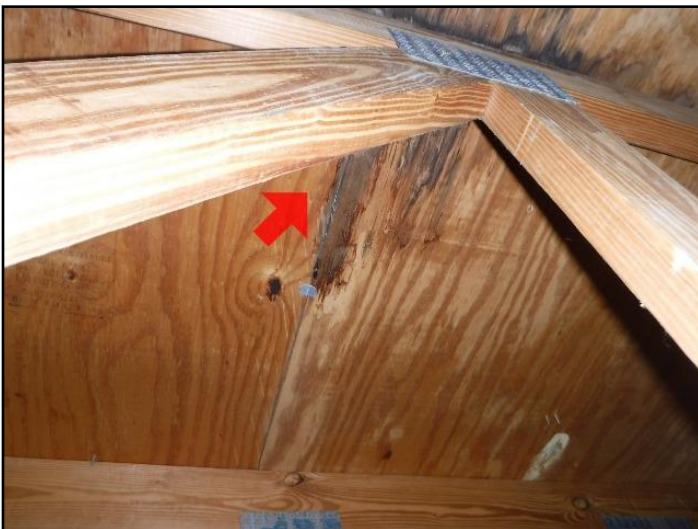
127.

34. Condition: • Water stains noted in several areas.

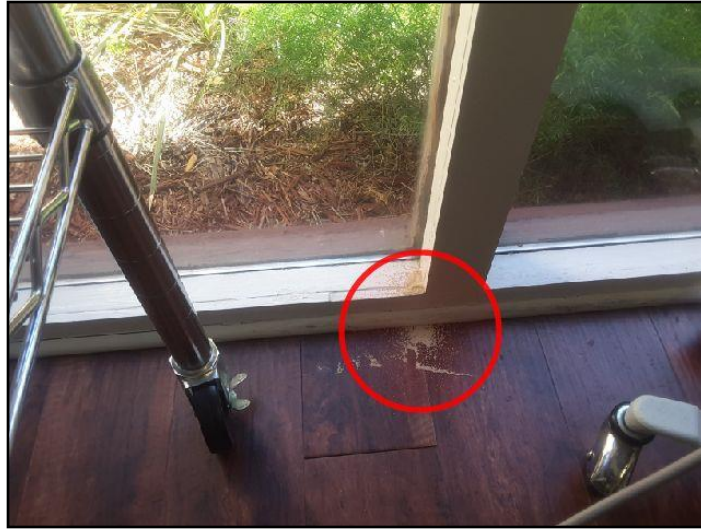
**131.** No signs of damage noted**36. Condition:** • Evidence of damage noted

Termite frass noted

132. *Evidence of damage noted*

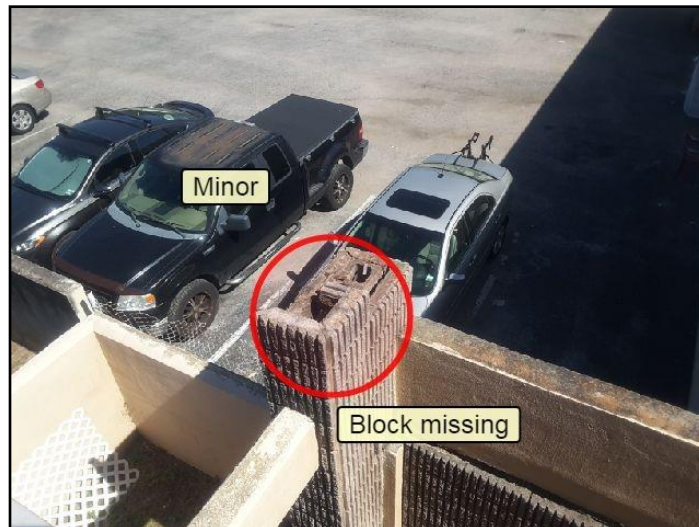
41. Condition: • Damage

145. Damage

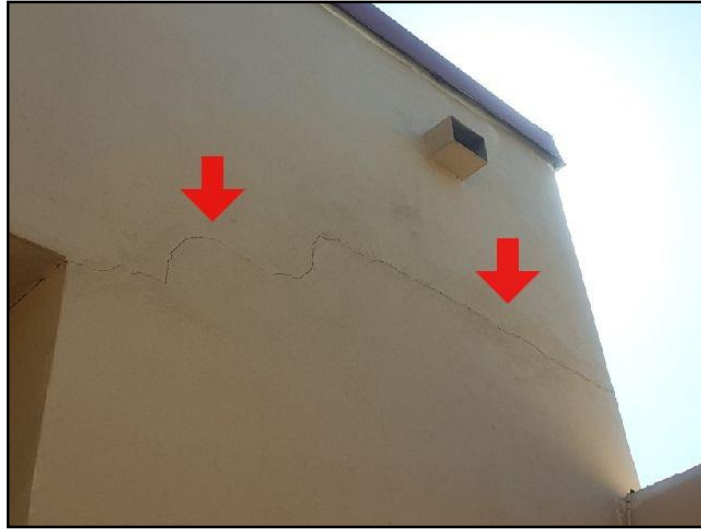
42. Condition: • Minor cracking

146. *Minor cracking*
