Your Inspection Report

121 Eighth Street
Toronto, ON

INSPECTION DATE:
Monday, May 7, 2012

RE: Report No. 31601
121 Eighth Street
Toronto, ON

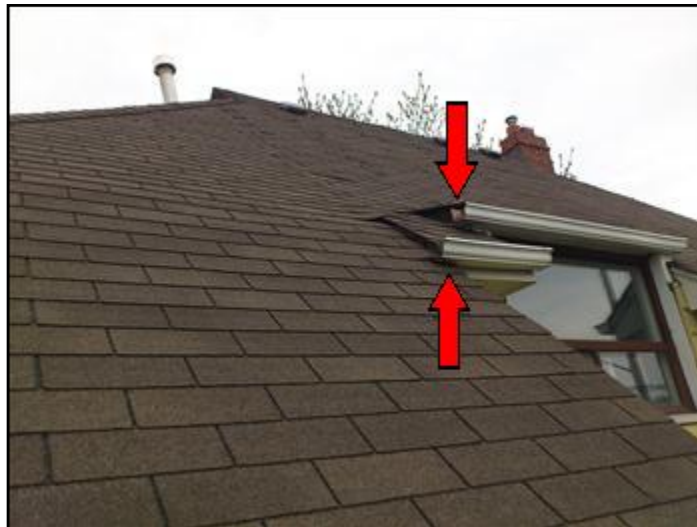
Condition: • [Upper roof draining onto lower roof causes wear](#)

Ex: Upper roof draining onto lower roof

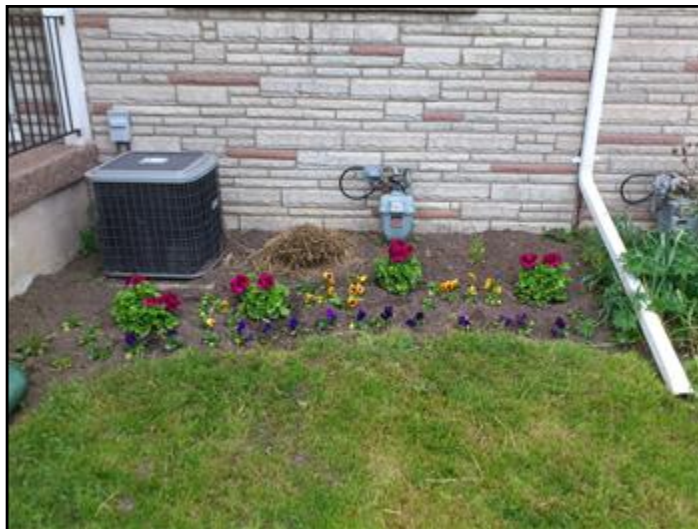
Condition: • [Garden against wall](#)

Garden against wall

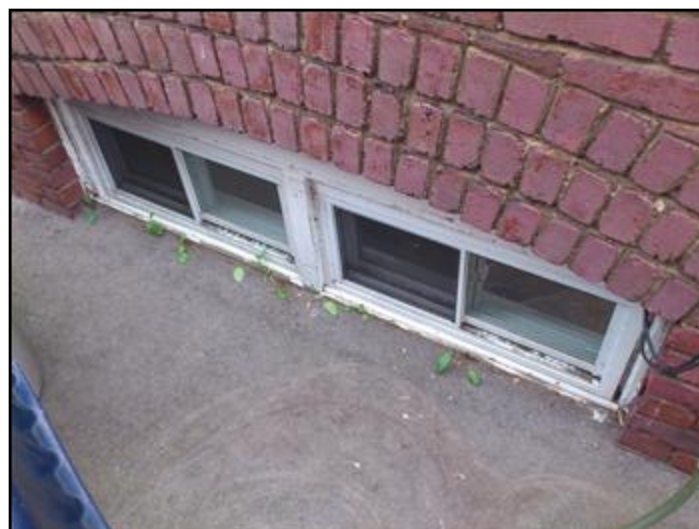
Condition: • [Window well - missing](#)

Window well - desirable

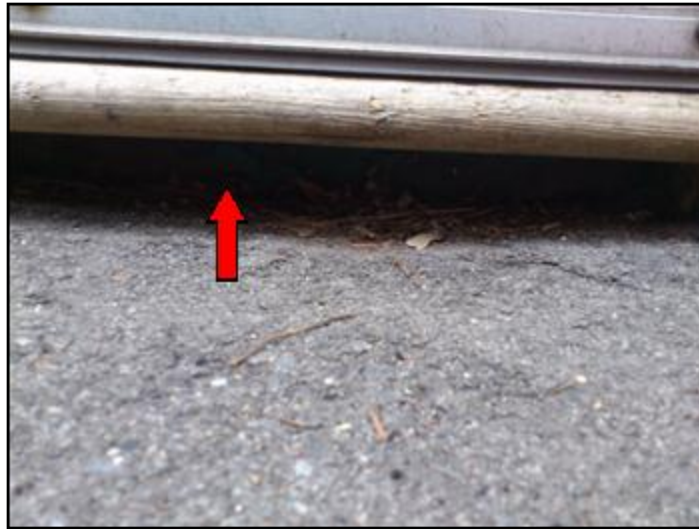
Condition: • Gap under side door may allow water/moisture into basement

Gap under door

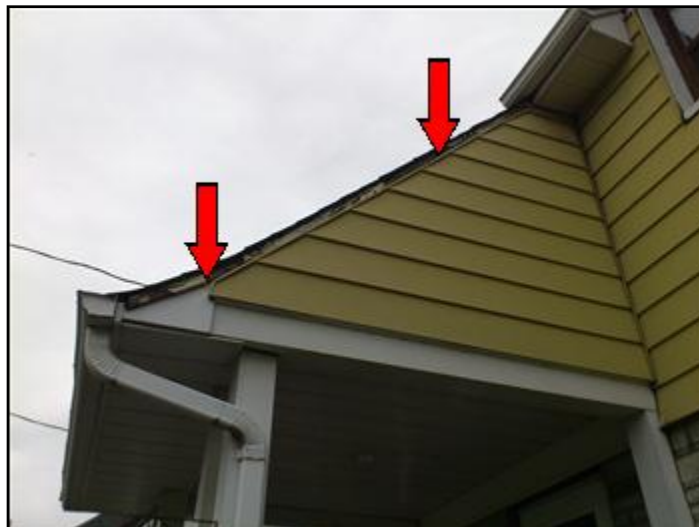
Condition: • [Paint/stain](#)

Paint/stain

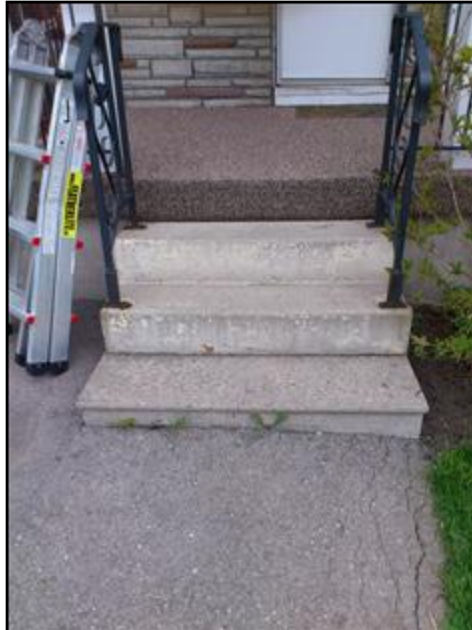
Condition: • [Trip hazard](#)

Non-uniform steps create a trip hazard

Trip hazard

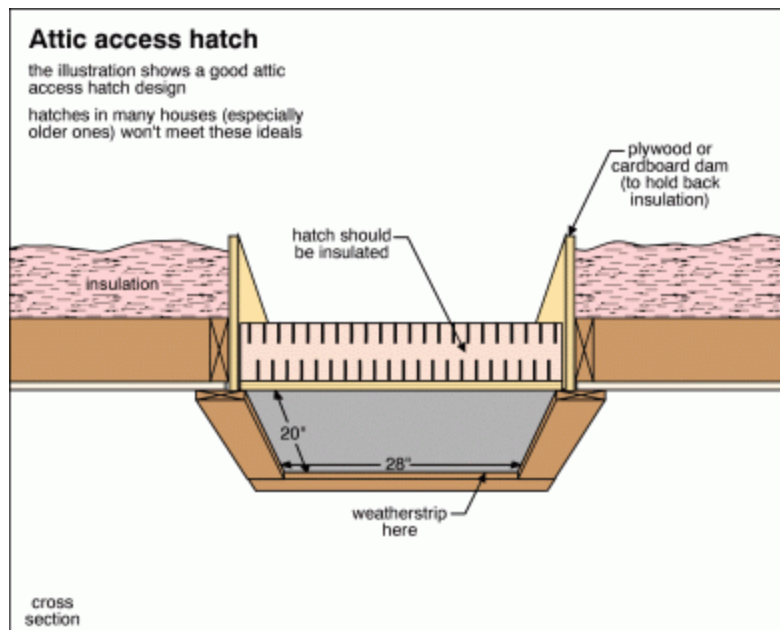
Condition: • Access hatch weatherstripping/fit less than ideal

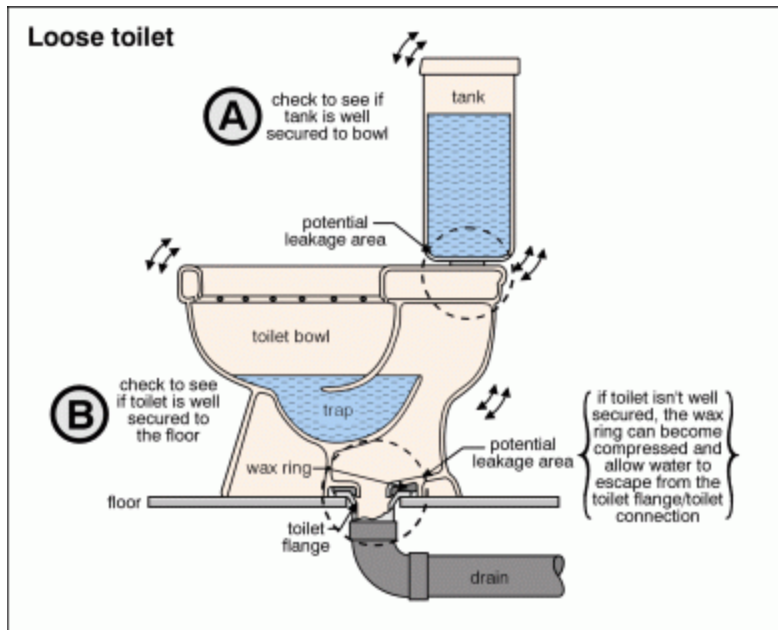
Condition: • [Loose](#)

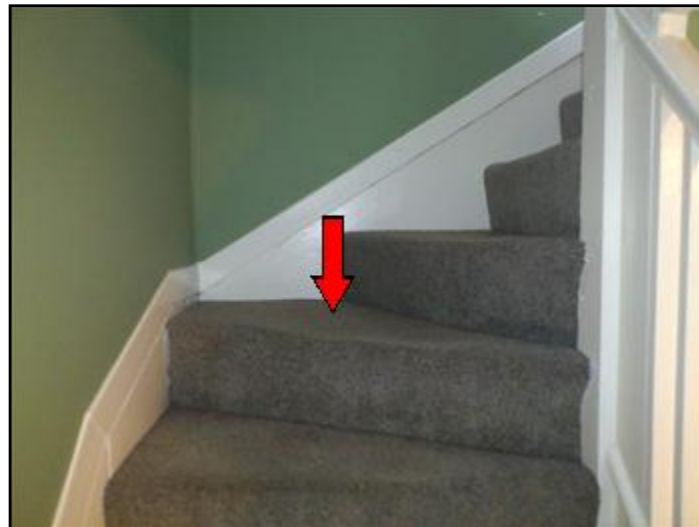
Condition: • One step is starting to sag

Sagging step

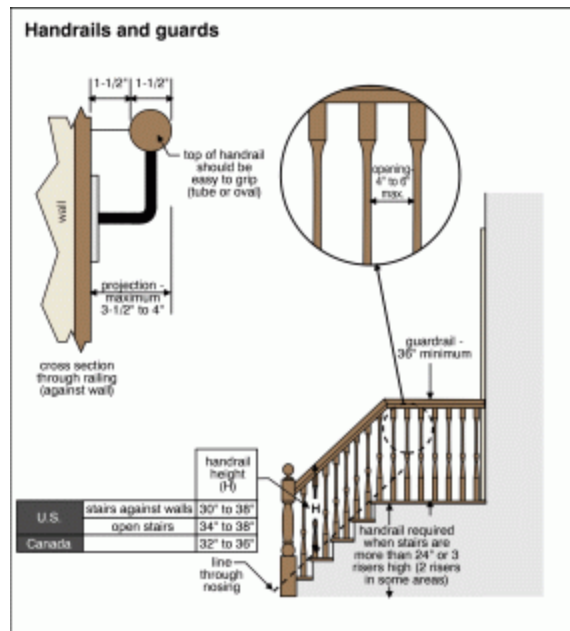
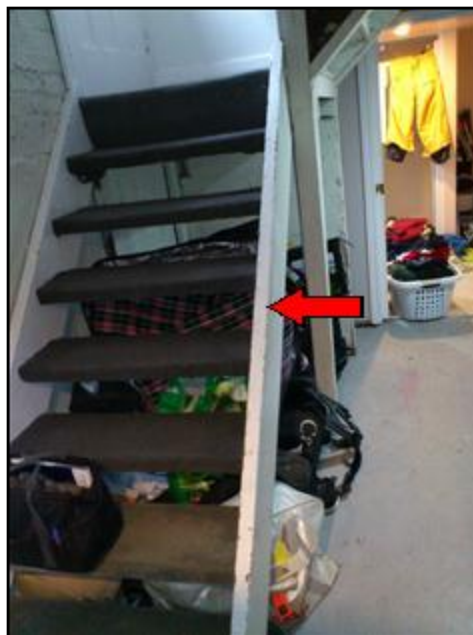
Condition: • [Railing missing](#)

Guard needed on open side of stairs to eliminate fall hazard for children and pets

Railing missing
