YOUR INSPECTION REPORT

4400 Bouldercrest Road
Ellenwood, GA 30294

INSPECTION DATE:

Wednesday, August 13, 2025

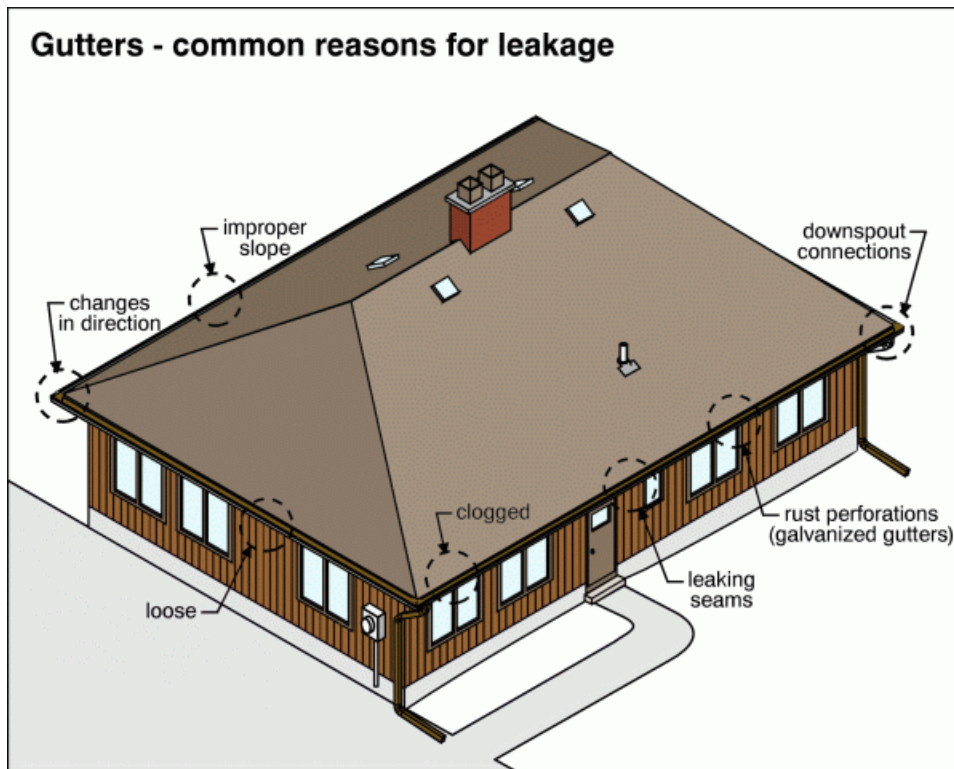
3. Condition: • [Clogged](#)

The home's gutters were found to be clogged with debris, which prevents proper drainage of rainwater from the roof and can lead to water overflow onto fascia boards, siding, and the foundation. Prolonged clogging can cause water to back up under the roofing materials, potentially leading to roof leaks, wood rot, and damage to structural components. Additionally, poor drainage near the foundation increases the risk of basement or crawlspace moisture intrusion. Recommend immediate cleaning of the gutter system and installation of gutter guards or a regular maintenance schedule to ensure consistent water flow and protect the home from water-related damage.

Task: Clean Gutters/Add Gutter Guards

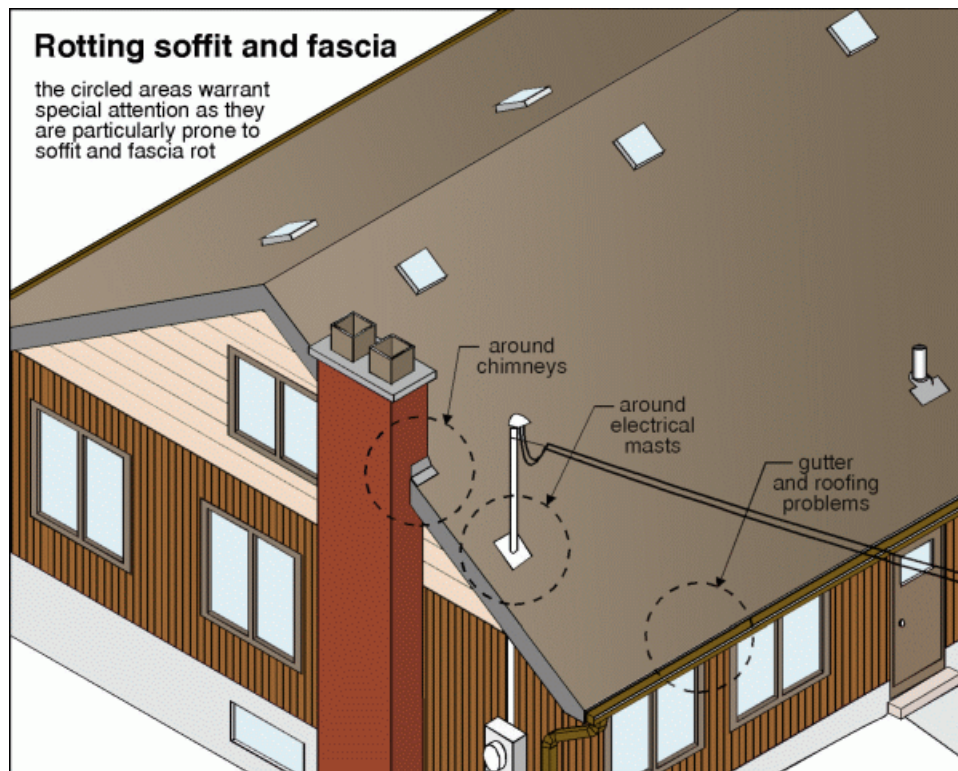
7. Condition: • [Damage](#)

Soffit and fascia boards in multiple areas of the property. This damage may include rot, warping, or missing sections, which can expose the roof structure and attic to moisture, pests, and further deterioration. Left unaddressed, this issue could lead to more extensive damage to the roof and surrounding structures. It is recommended to have a qualified contractor perform necessary repairs or replacements to restore the soffit and fascia to proper condition.

Task: Repair

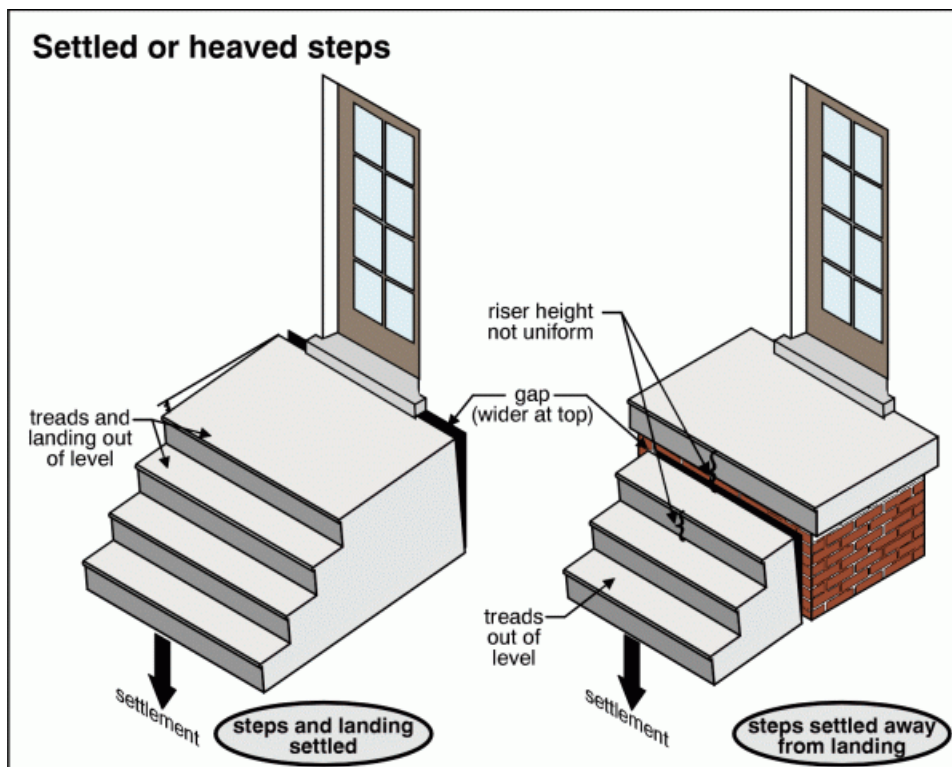
12. Condition: • [Steps or landings settling or heaving](#)

During the inspection, steps and/or landings were observed to have settled or heaved, creating uneven surfaces. This condition can present a tripping hazard and may indicate underlying soil movement or drainage issues. It is recommended that a qualified contractor evaluate the affected areas and perform necessary repairs to restore safe and stable surfaces.

Task: Consult Licensed Contractor
