YOUR INSPECTION REPORT

Hou Dat Inspects
New Orleans, TX

Saturday, August 31, 2024

PROPERTY INSPECTION REPORT FORM

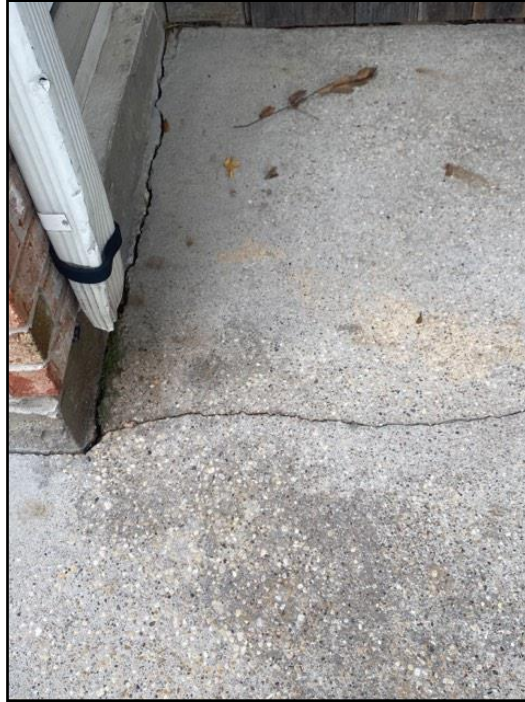
8.

General: • Crack by garage

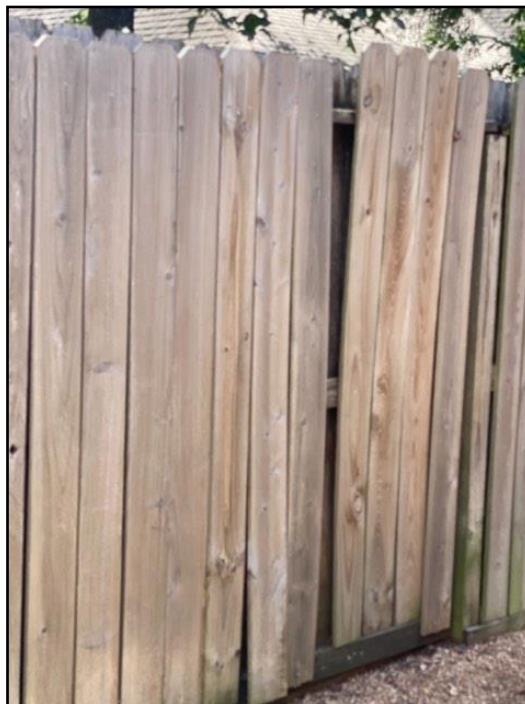
15. Wood

- Wood
- Missing board

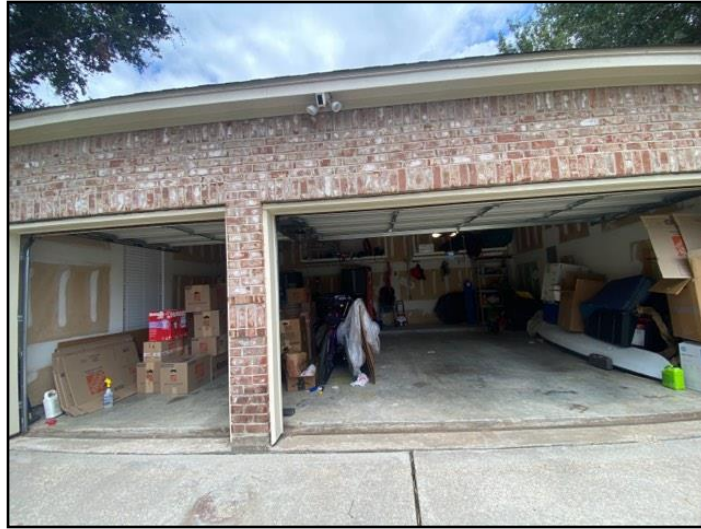
16. Attached

- Attached
Water leak

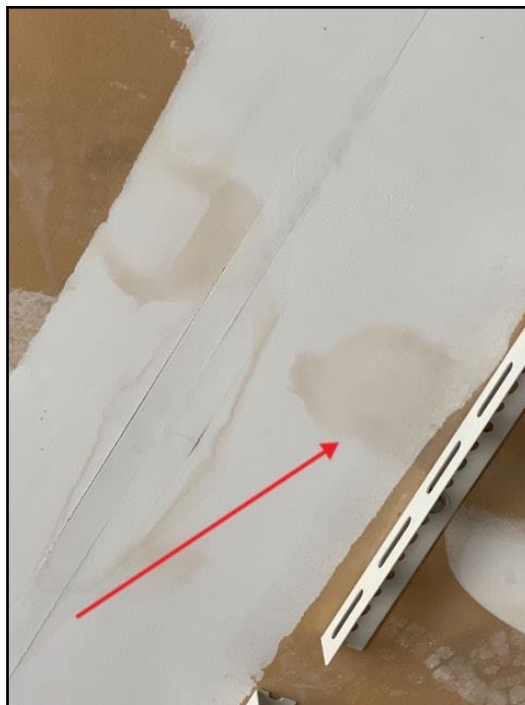
17. Attached

- Attached
Leak

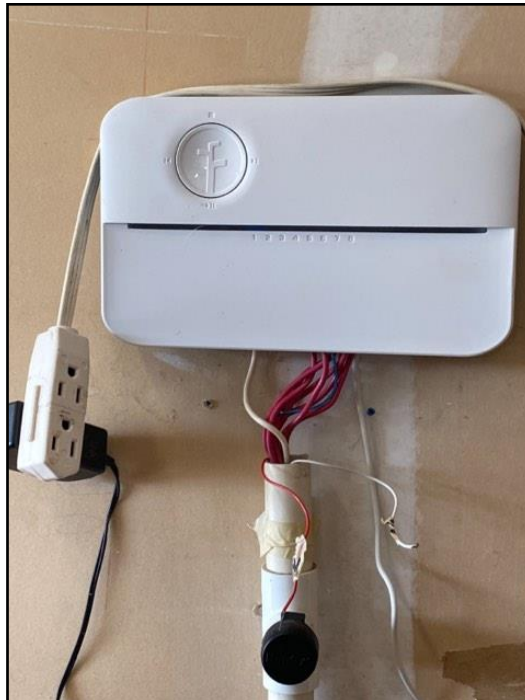
21. Automatic

Inoperable Loose wires Recommend irrigation specialist evaluate

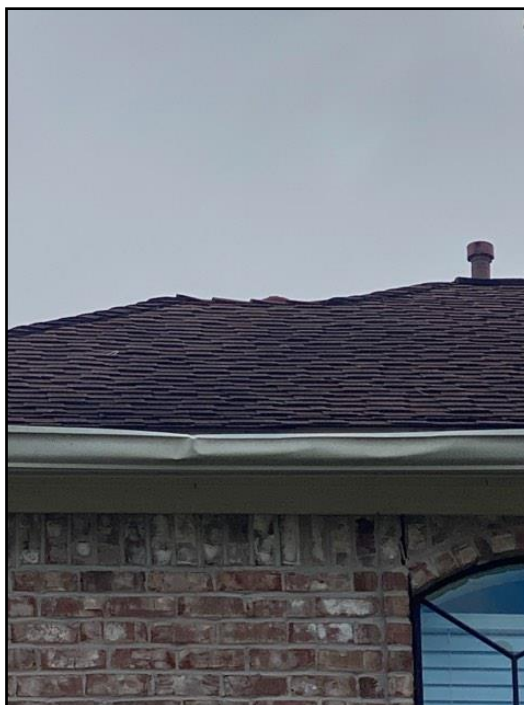
22. Damage

- 3. Condition:** • Damage

Front left

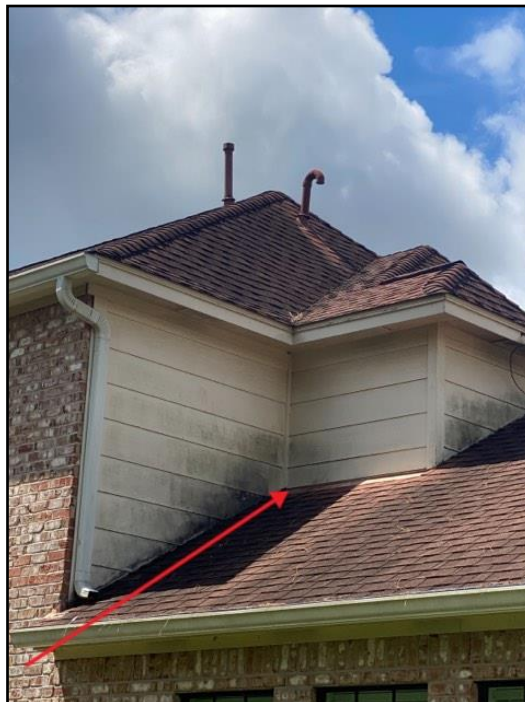
23. Missing

- 4. Condition:** • Missing

Fungal growth and recommend gutters to redirect water drainage from roof

Implication(s): Chance of water damage to structure, finishes and contents

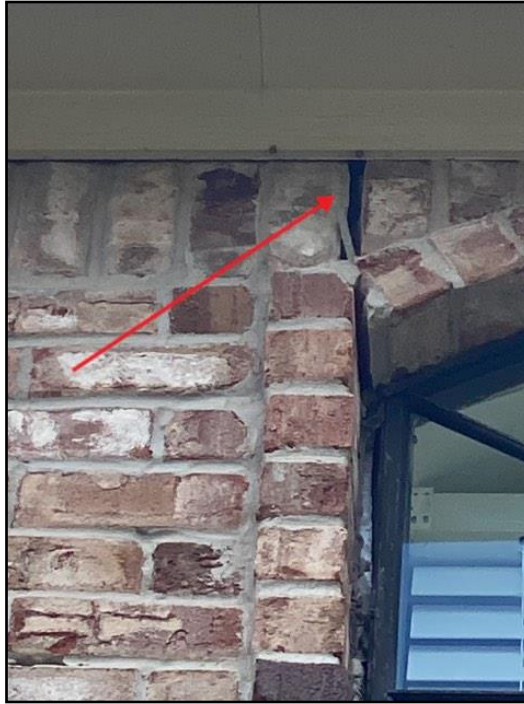
24. Cracked

6. Condition: • [Cracked](#)

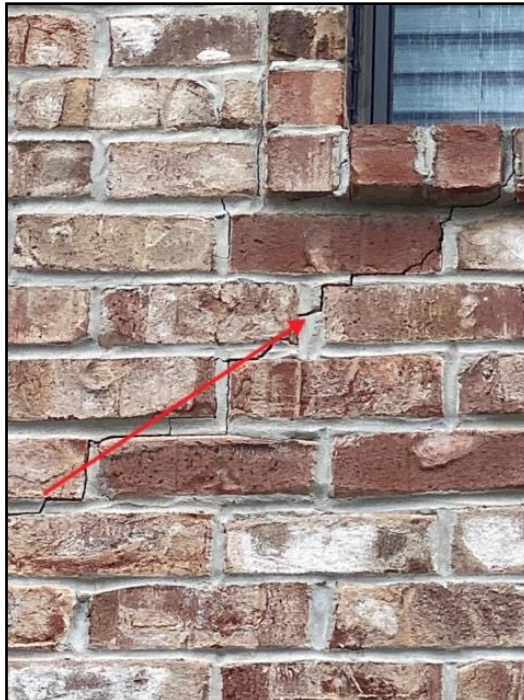
25. Cracked

7. Condition: • [Cracked](#)

Implication(s): Chance of water entering building | Weakened structure | Chance of movement

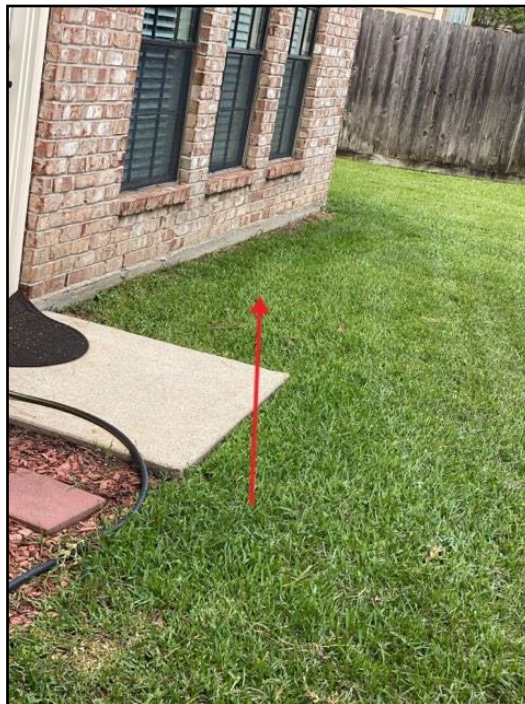
26. Improper slope or drainage

8. Condition: • [Improper slope or drainage](#)

Negative slope

Implication(s): Chance of water damage to structure, finishes and contents

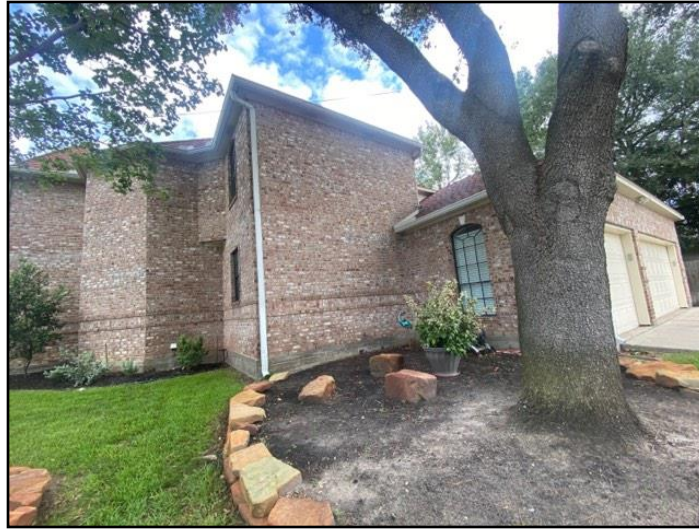
29. Large trees close to building

13. Condition: • [Large trees close to building](#)

Implication(s): Weakened structure | Chance of structural movement

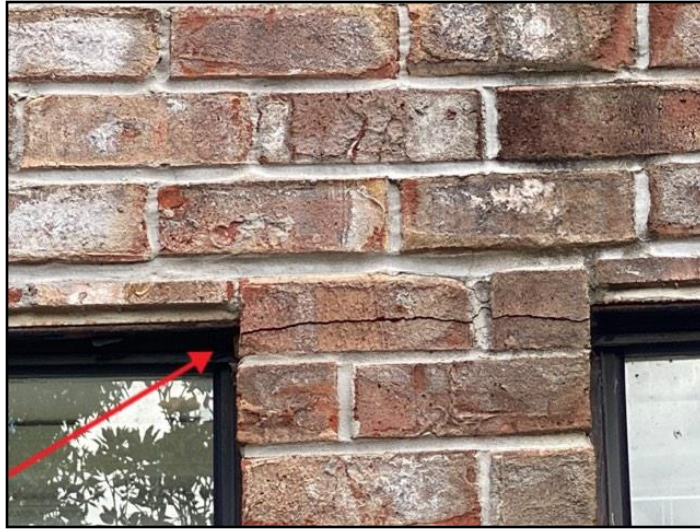
30. *Lintel rusting*

14. Condition: • [Lintel rusting](#)

Implication(s): Weakened structure | Chance of structural movement

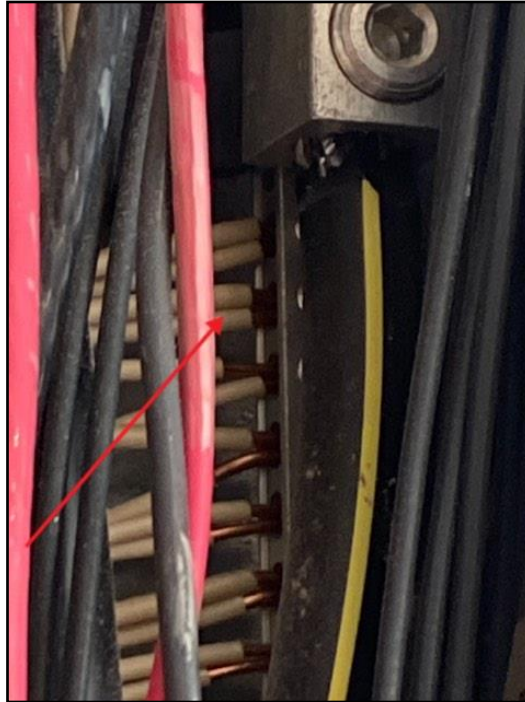
35. Double taps

17. Condition: • [Double taps](#)

Implication(s): Fire hazard

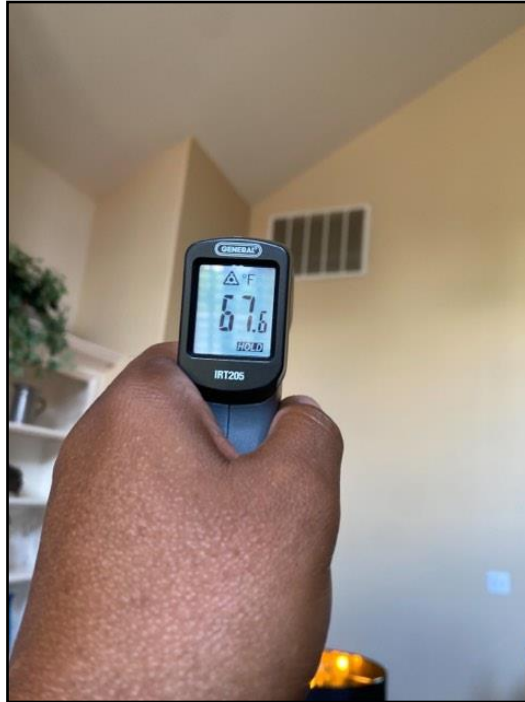
51. Temperature split across cooling coil less...

25. Condition: • Temperature split across cooling coil less than 15 degrees Fahrenheit

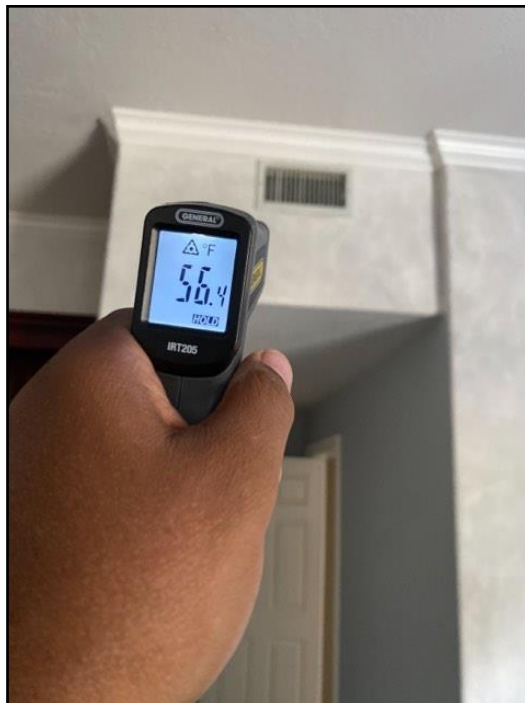
52. Temperature split across cooling coil less...

26. Condition: • Temperature split across cooling coil less than 15 degrees Fahrenheit

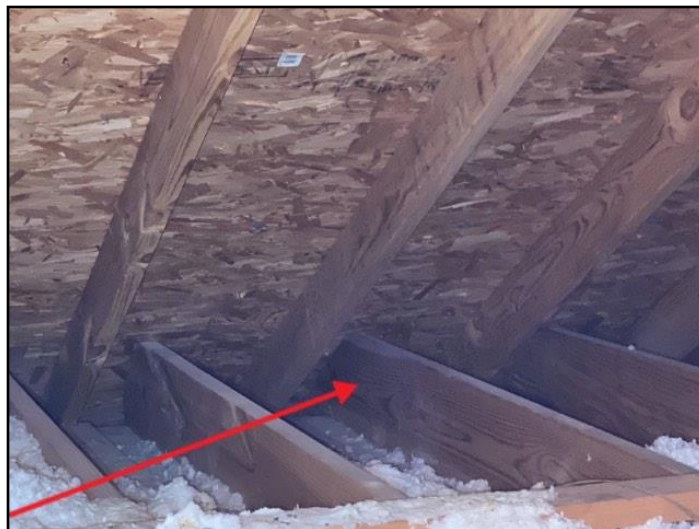
54.

General: • Gaps and voids in attic

General: • Recommend insulation contractor evaluate

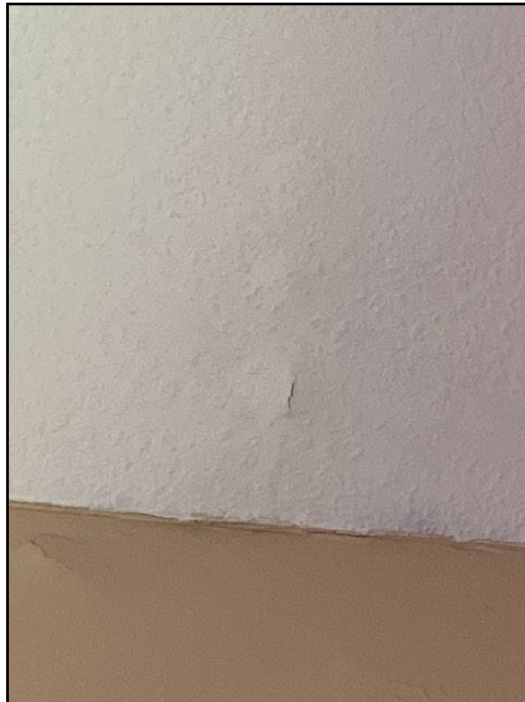
91. *Water stains*

30. Condition: • Water stains

Over fireplace

Implication(s): Chance of water damage to structure, finishes and contents

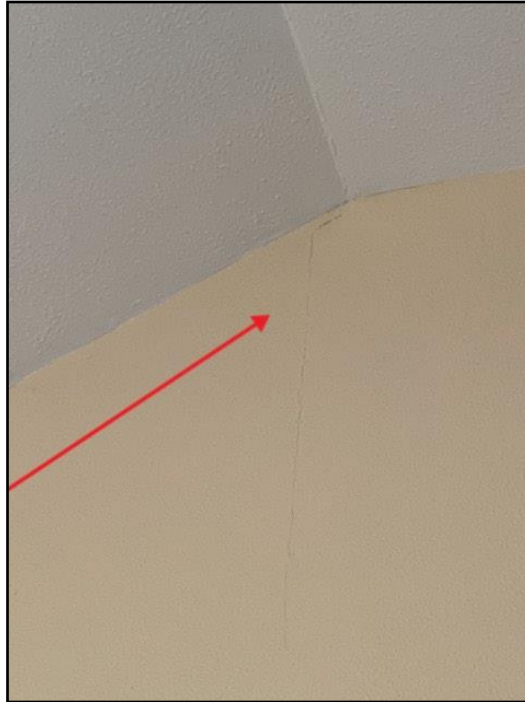
92. Cracks

31. Condition: • Cracks

Implication(s): Chance of structural movement | Damage or physical injury due to falling materials

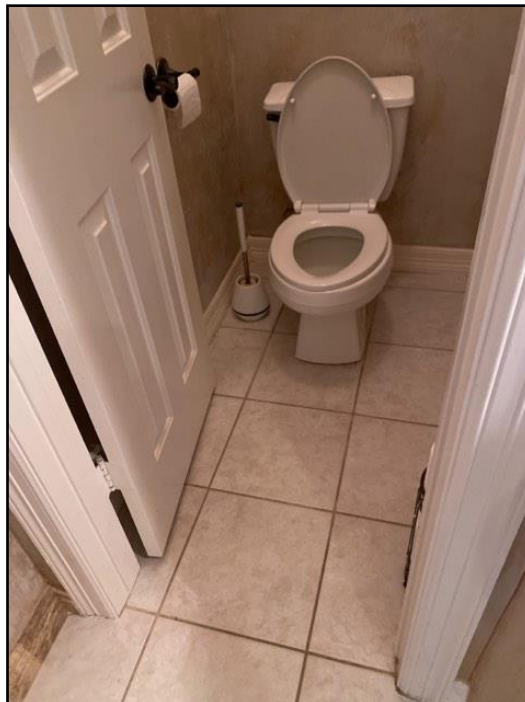
93.

32. Condition: • Slight slope in master bathroom

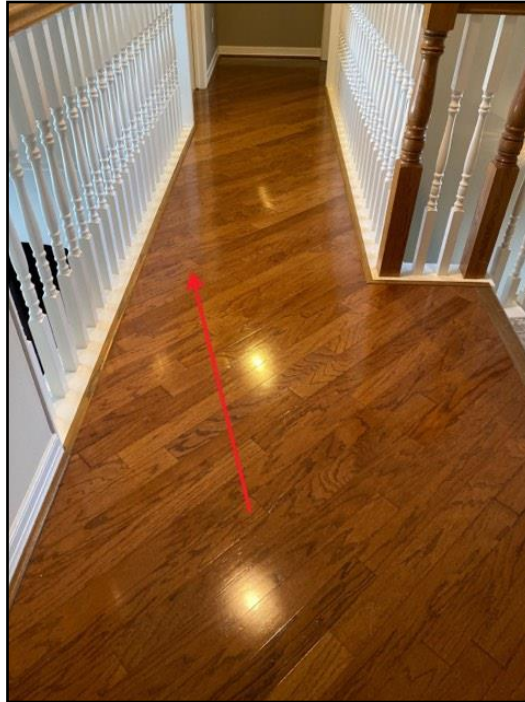
94. Slopes

33. Condition: • Slopes

Upstairs
