YOUR INSPECTION REPORT

34 Coe Hill Drive
Toronto, ON M6S 3C8

INSPECTION DATE:
Tuesday, August 27, 2019

RE: Report No. 2524, v.2
34 Coe Hill Drive
Toronto, ON
M6S 3C8

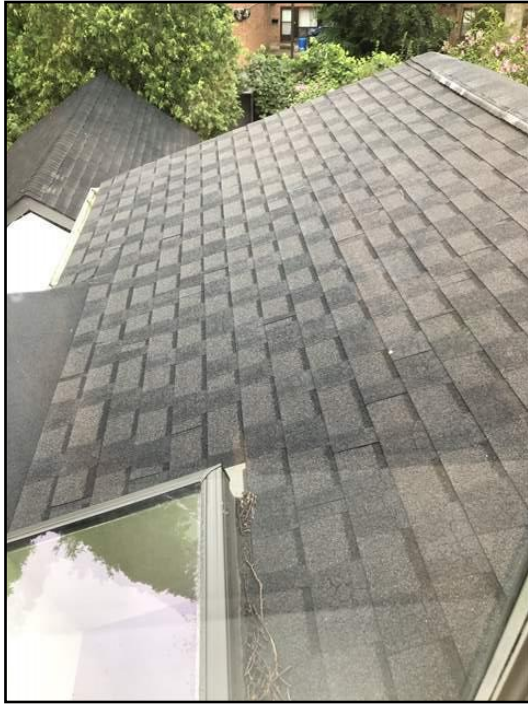
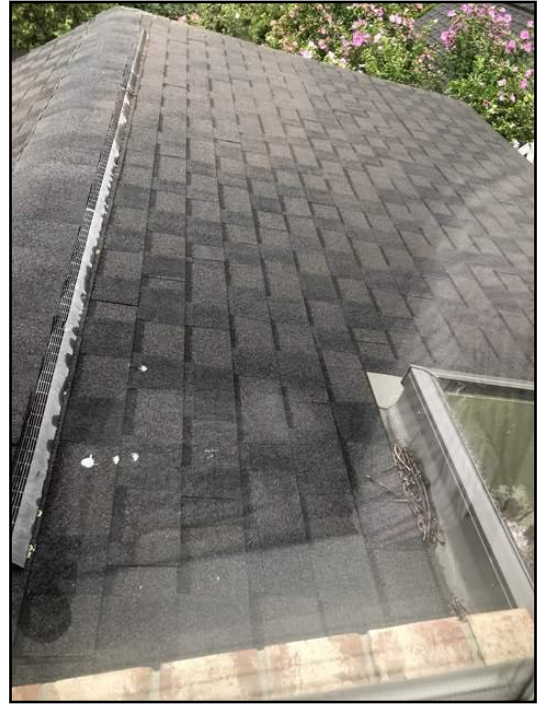
Condition: • [Cracks](#)

The roof covering on the addition is reported to be 14 years old. Typical lifespan is 20 years. Surface cracking noted on shingles. (craze-cracking).

Typically craze-cracking starts around the 10-12 year mark but there are many factors that can affect this. This type of cracking is typical with some types of shingles and by itself is not a major concern.

1. rear addition

2. Rear addition

Task: Inspect annually

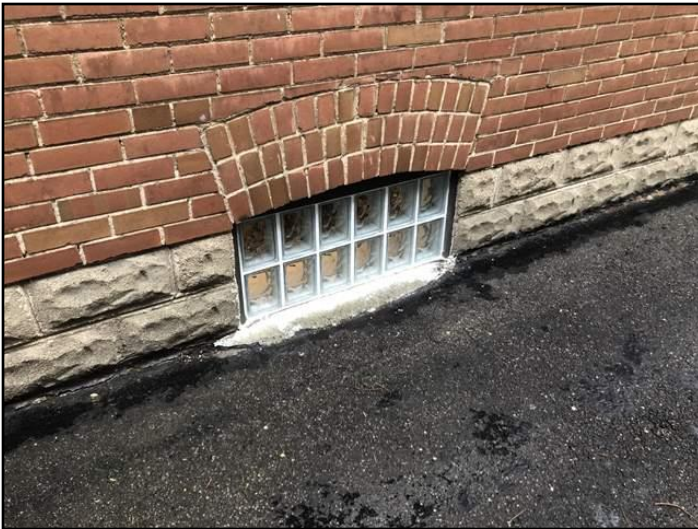
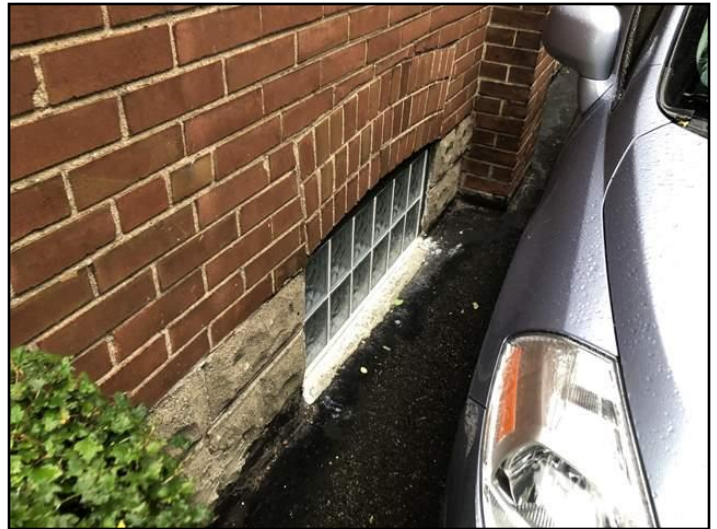
Condition: • Sill - Near or at Grade Level

This is typical for homes of this age. Modern standards require that sill be 6-inches above grade

3. Sill - Near or at Grade Level

4. Sill - Near or at Grade Level

Task: Monitor / Improve

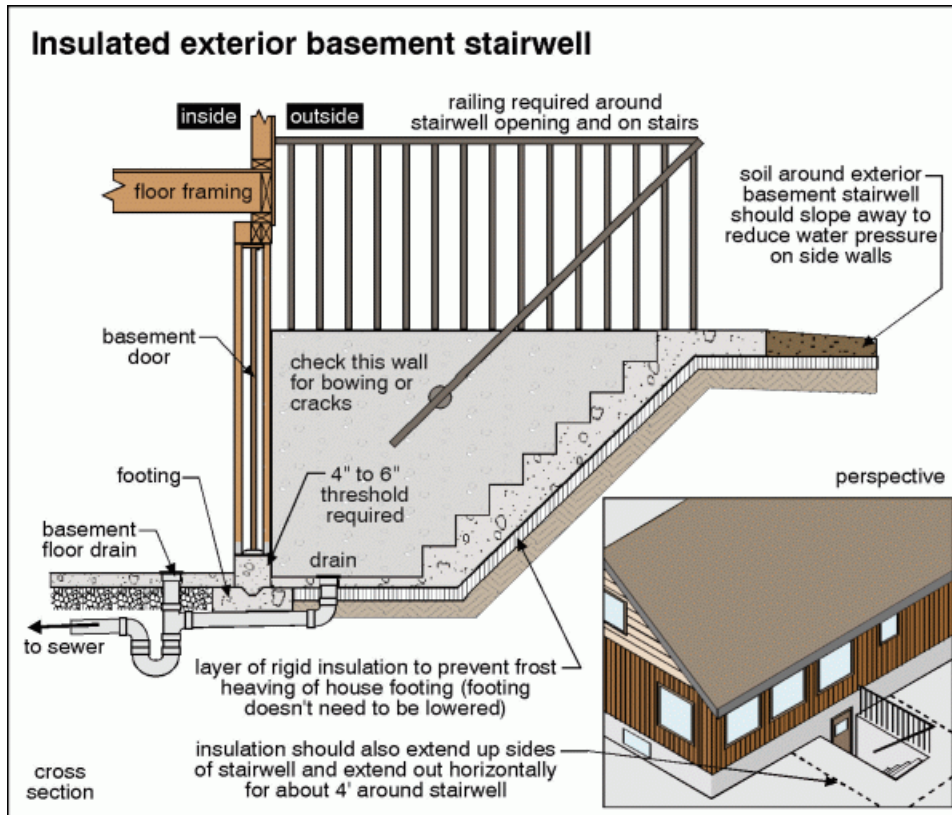
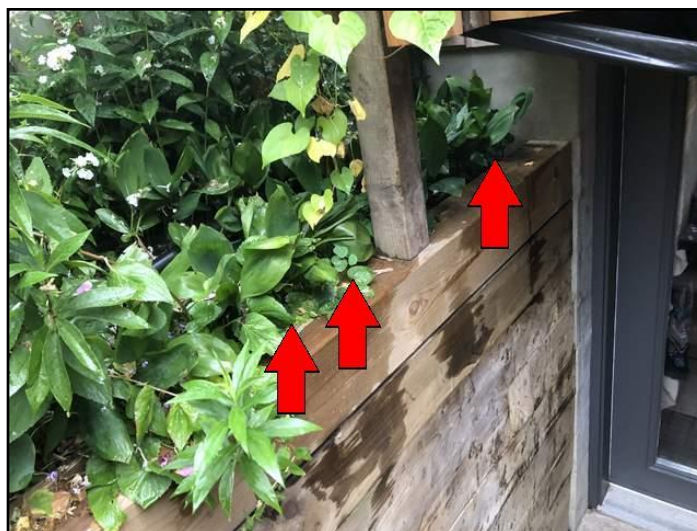
Condition: • [Guard and handrail problems](#)

Implication(s): Fall hazard

5. Guard and handrail problems

Task: Provide Guardrails on open side

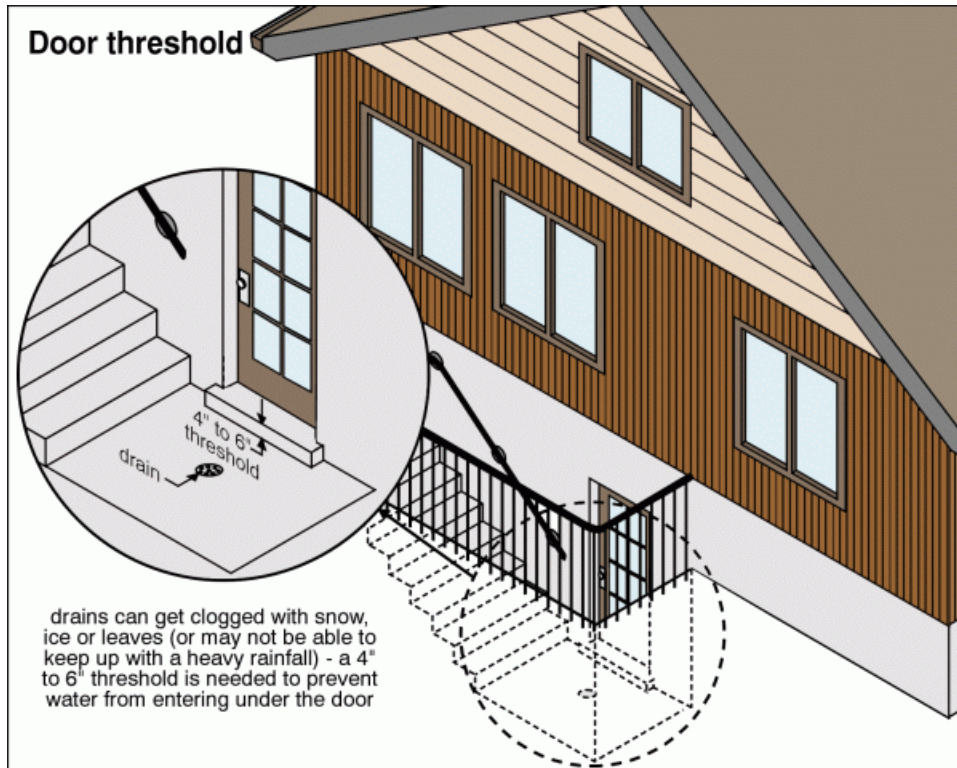
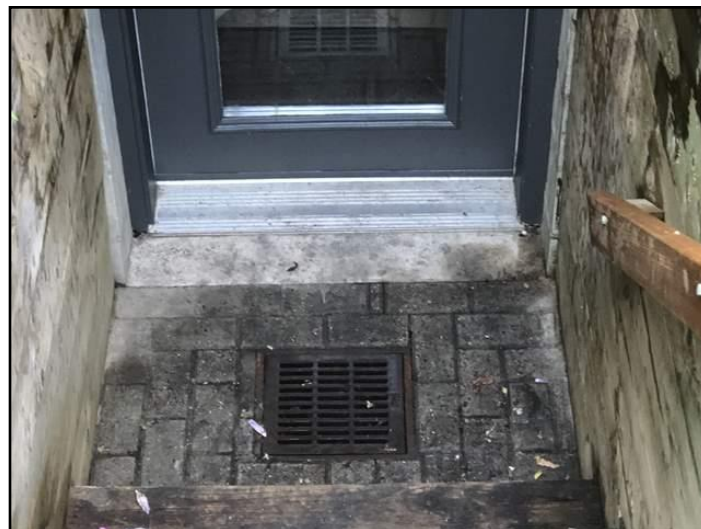
Condition: • [Door threshold missing, too low, not watertight](#)

Implication(s): Chance of water damage to contents, finishes and/or structure

6. Door threshold missing, too low, not...

Task: Improve

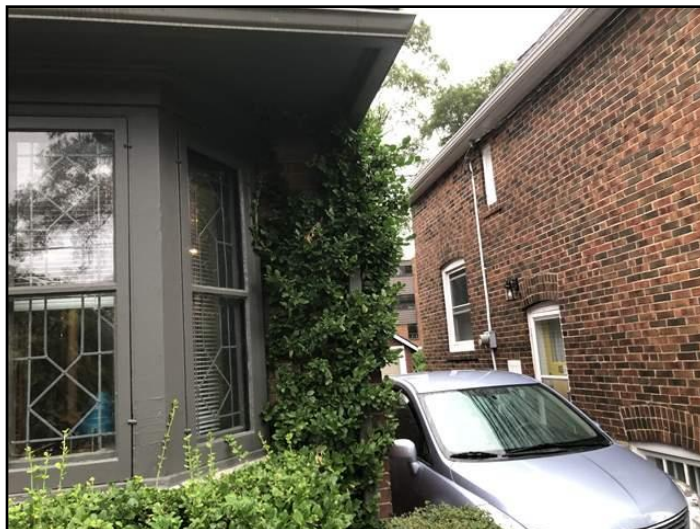
Condition: • Vines on building

Vines may damage the home over time. If vines are to remain, and we understand the aesthetic reasons for leaving them, we recommend controlling the growth so vines do not attach to wood surfaces or roofs, and do not clog gutters and downspouts and soffit vents.

7. Vines on building

Task: Remove

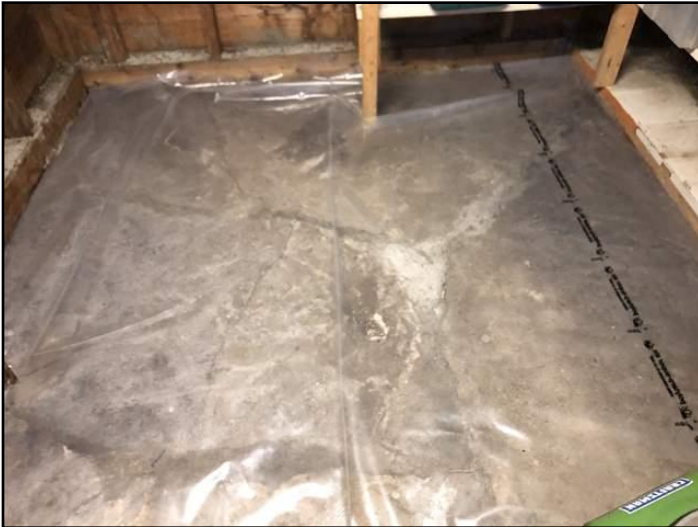
8.

Condition: • This is a typical very old shed style garage commonly found in Toronto. The concrete floor is cracked. The garage door is not perfectly sized for the opening.

Repair ongoing as needed

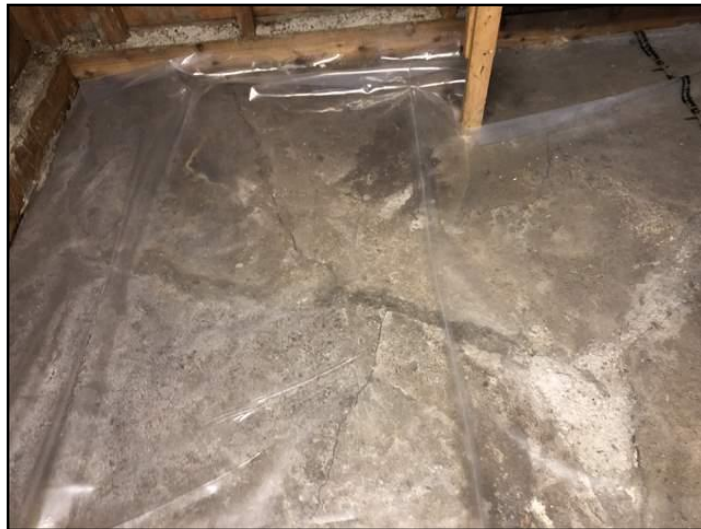
Condition: • [Cracked](#)

Cracking and Settlement or Heaving Observed. It is common for a concrete garage floor of this age to contain cracks. This is not part of the structure. Repair/replace as needed.

10. Cracked

Task: Repair / Replace

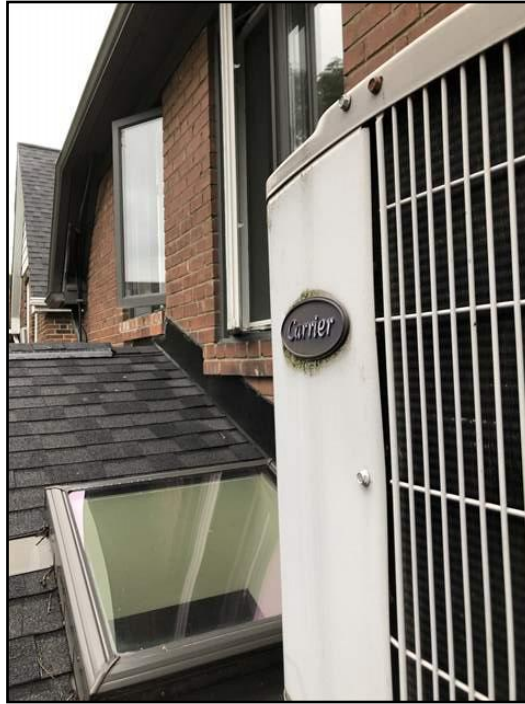
Condition: • [Near end of life expectancy](#)

Typical Life Expectancy for this type of unit is 10-15 years. The current unit is 14 years old. (as per seller) Service annually and continue to use until replacement is needed.

Implication(s): Equipment failure | Reduced comfort

13. Near end of life expectancy

Task: Replace

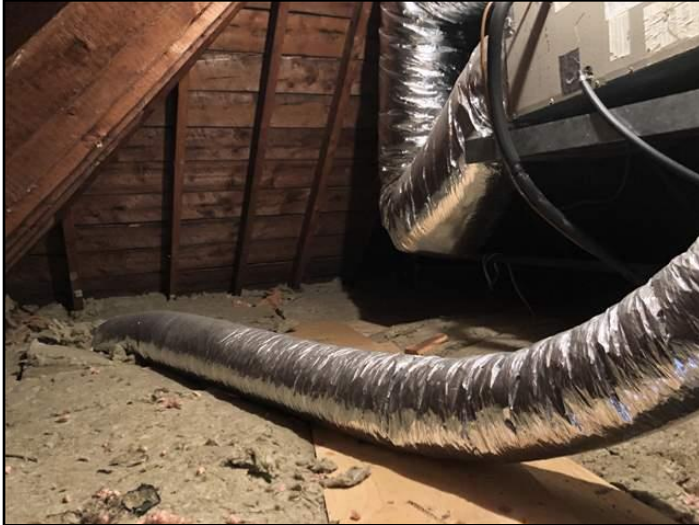
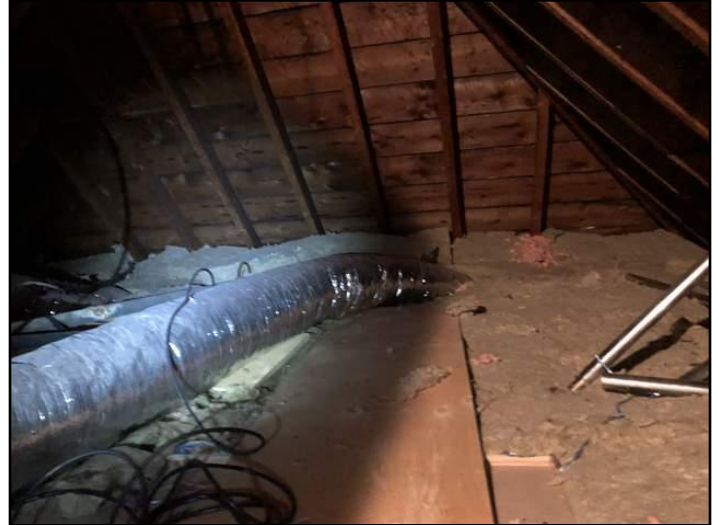
14. Glass fiber

15. Glass fiber

Condition: • [Amount less than current standards](#)

Below current standards of R-50 (as of 2012) . Also gaps or voids in insulation observed
