Your Inspection Report

62 Lynd Ave
Toronto, ON M6R 1T9

INSPECTION DATE:
Monday, March 26, 2018

RE: Report No. 61646
62 Lynd Ave
Toronto, ON
M6R 1T9

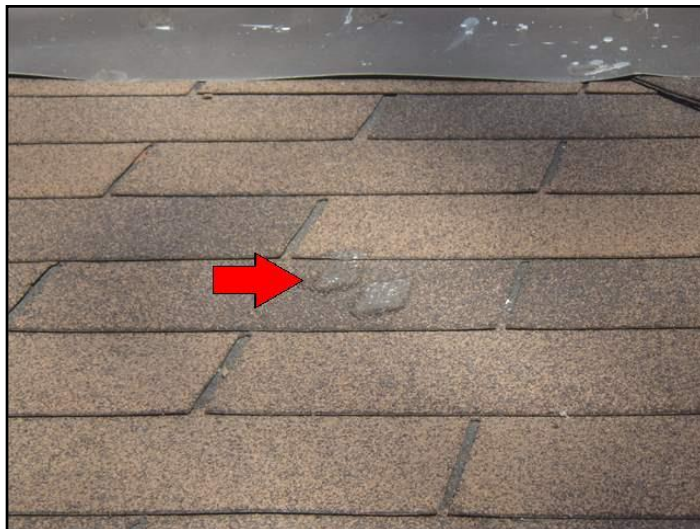
Granule loss

Condition: • [Granule loss](#)

Task: Repair

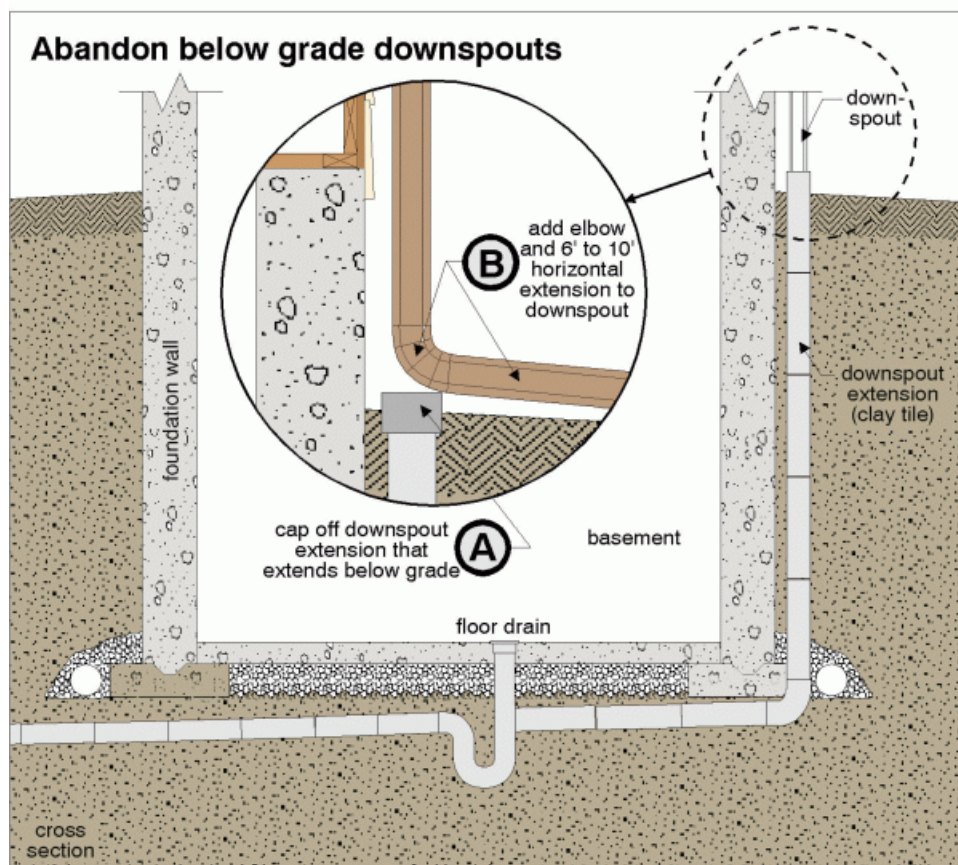
Condition: • Downspouts in Toronto should be disconnected from the city sewers.

Task: Improve

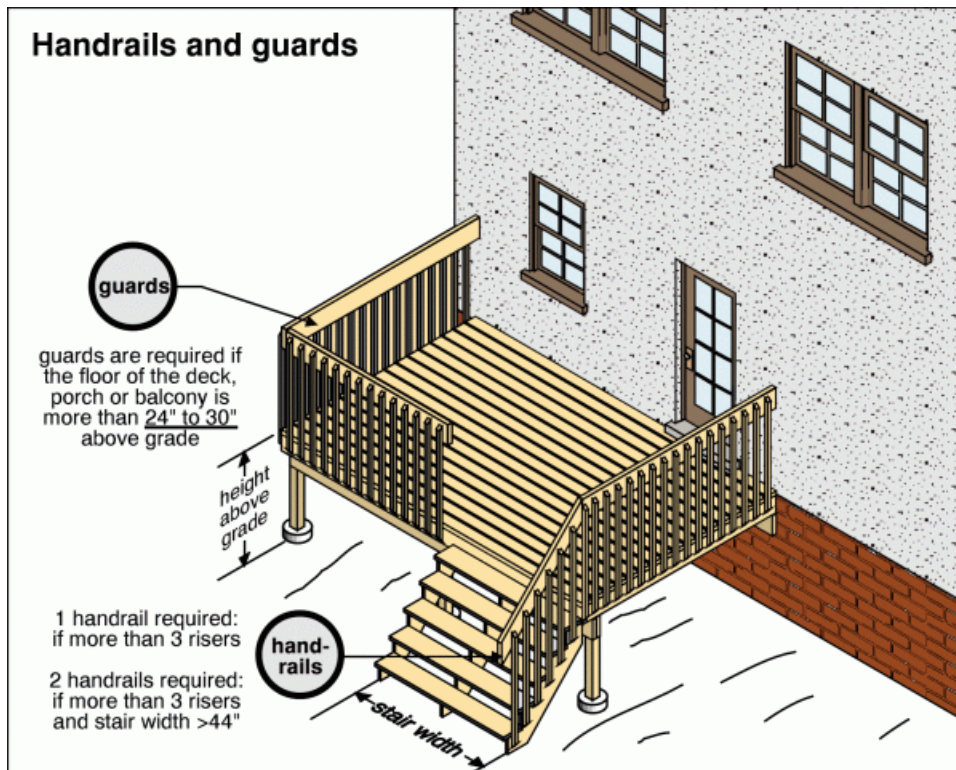
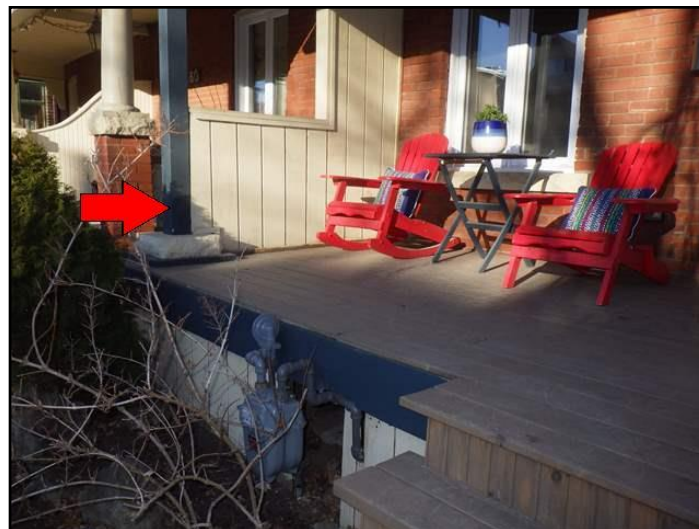
Missing

PORCHES, DECKS, STAIRS, PATIOS AND BALCONIES \ Handrails and guards

Condition: • [Missing](#)

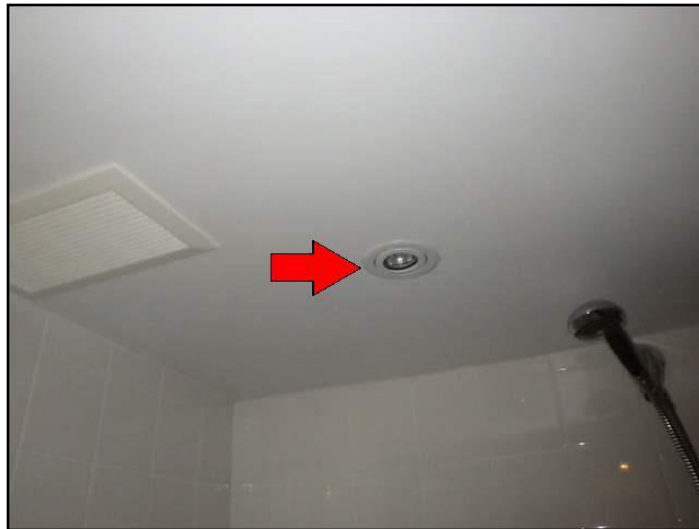
Conventional lights in wet areas

Condition: • [Conventional lights in wet areas](#)

Replace bezel with one meant for wet locations.
