YOUR INSPECTION REPORT

FOR THE PROPERTY AT:
688 Beresford Avenue
Toronto, ON M6S 3C5

INSPECTION DATE:
Thursday, January 28, 2021

RE: Report No. 2811
688 Beresford Avenue
Toronto, ON
M6S 3C5

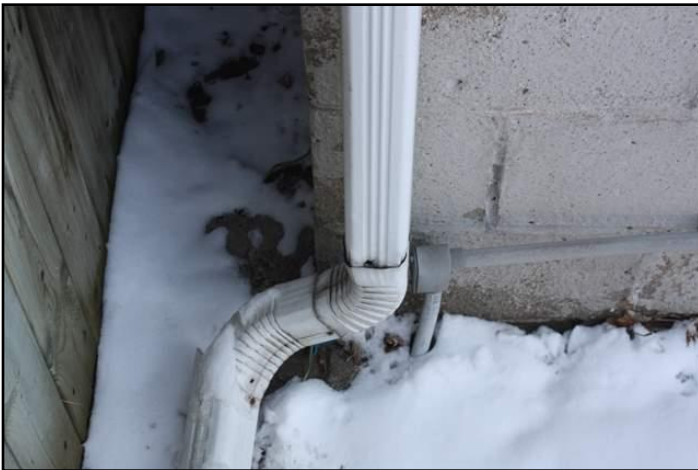
1. Connections loose

Condition: • [Connections loose](#)

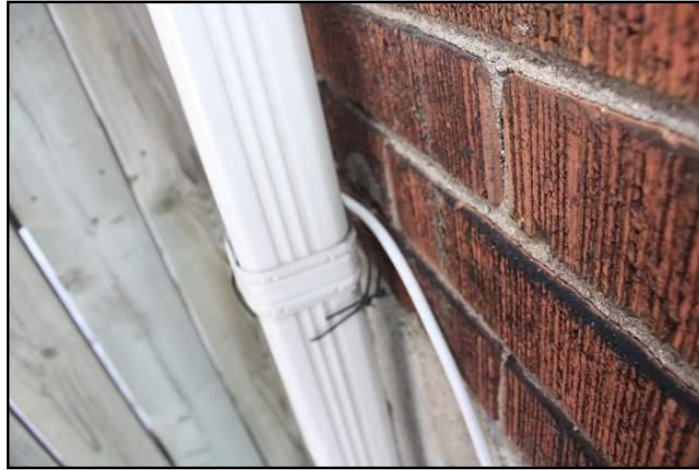
3. not secured to wall

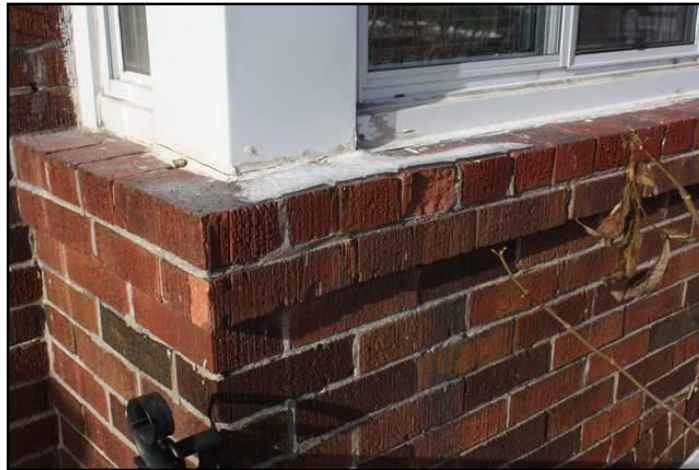
Condition: • [Spalling](#)

Spalling at various areas. Repair / Replace / Tuck point masonry and mortar. Most homes of this age will require routine masonry repairs. Photos show a sampling.

4. Spalling

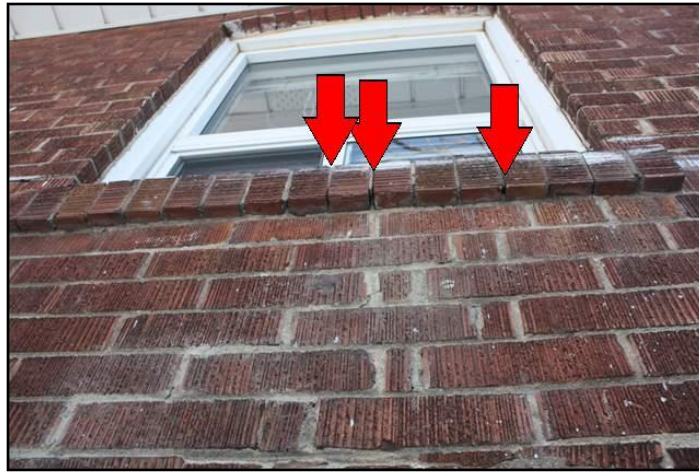
5. example

Condition: • [Mortar deterioration](#)

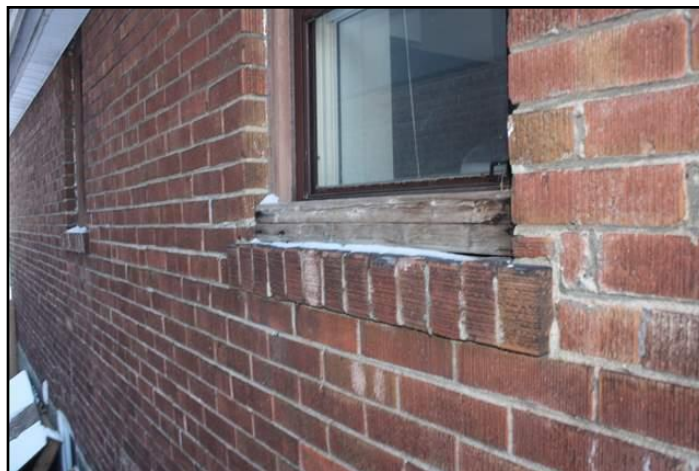
6. example

Condition: • [Paint or stain needed](#)

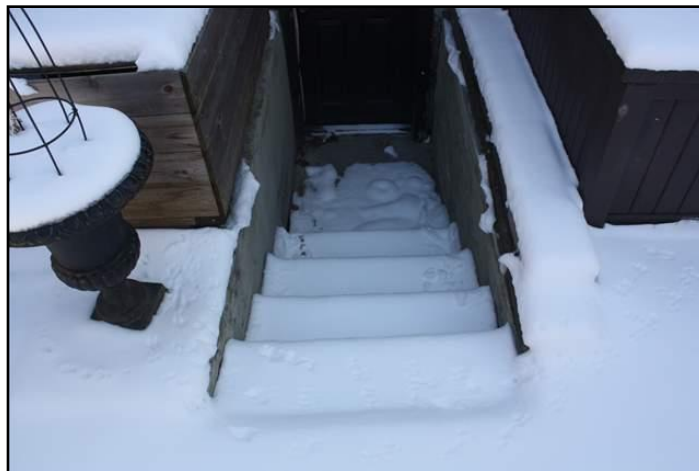
Condition: • [Guard and handrail problems](#)

7. Guard and handrail problems

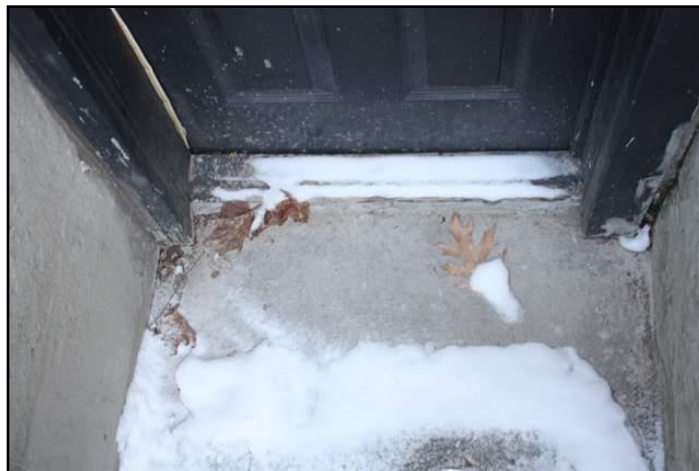
Condition: • [Door threshold missing, too low, not watertight](#)

8. Door threshold missing, too low, not...

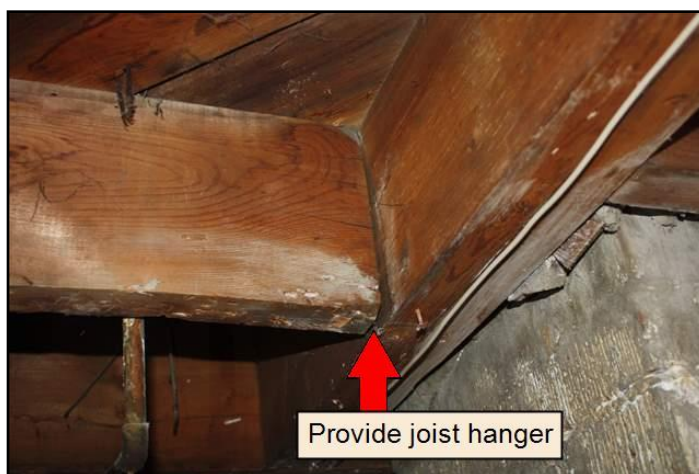
Condition: • [Poor end bearing, joist hanger connections](#)

9. joist above boiler

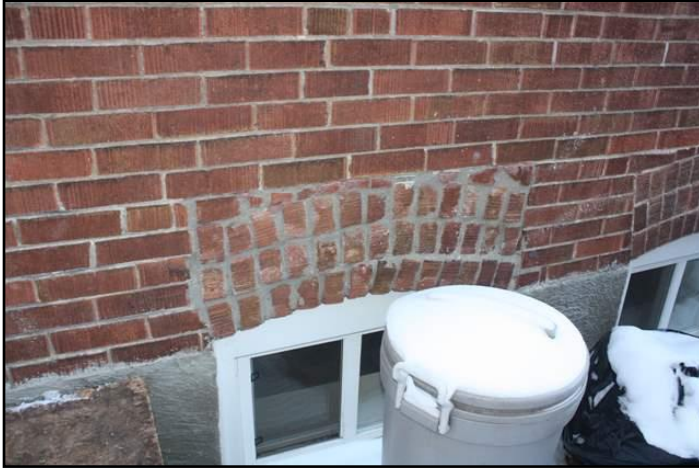
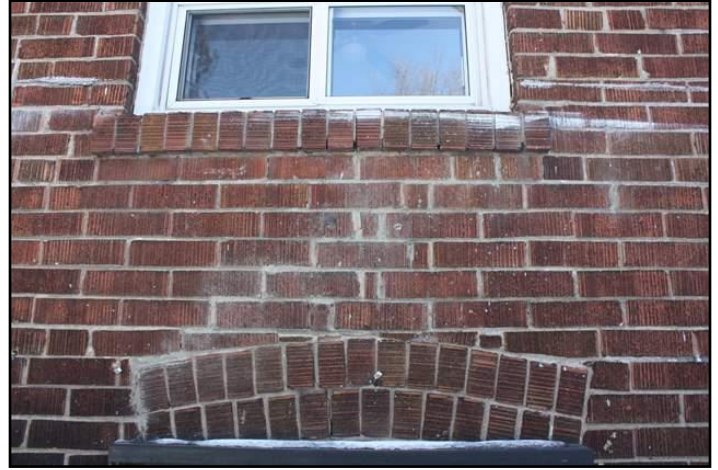
Condition: • [Prior repairs](#)

It is common to find a multitude of wall repairs on homes of this age. Photos show sampling

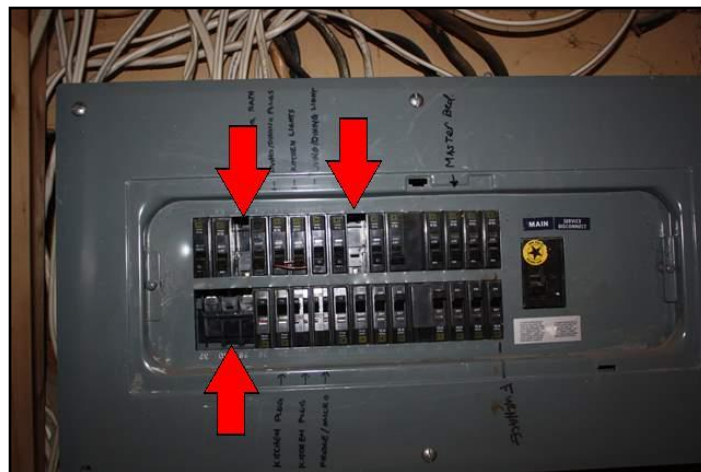
Condition: • [Openings in panel](#)

12. Openings in panel

any exposed panel openings (that would allow access to the inside of the panel) should be fitted with secure covers

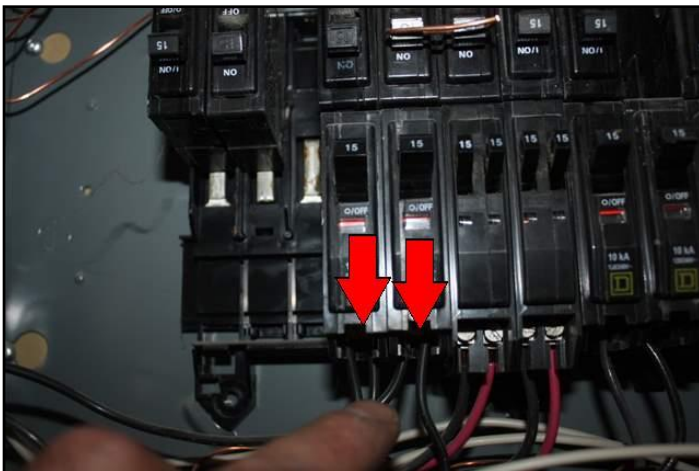
Condition: • [Double taps](#)

13. Double taps

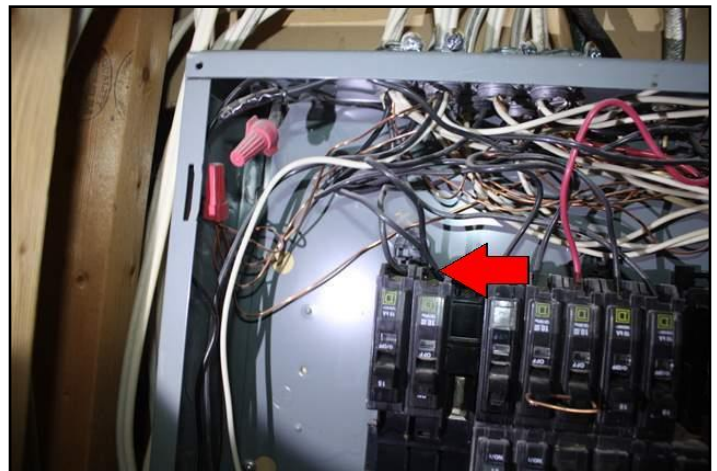
14. Double taps

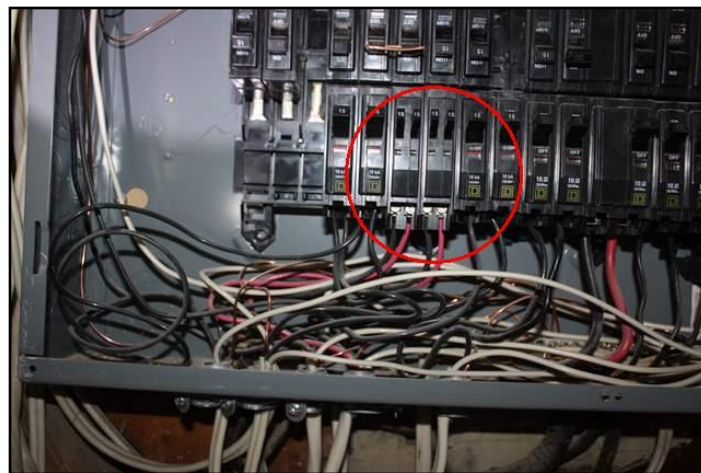
Condition: • [Breaker bridge missing](#)

15. Breaker bridge missing

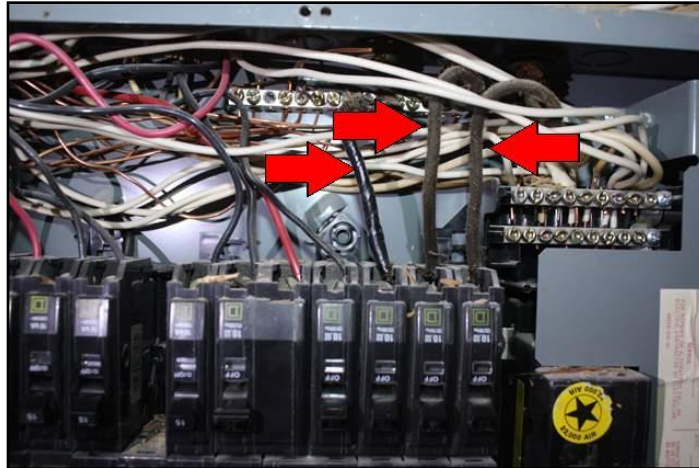
Condition: • Minor amount of Knob and Tube wiring live/active/in-use.

We noted three distribution lines of knob and tube wiring in the panel. These are likely distribution lines to various outlets/switches in the home. Knob and tube wiring was installed pre-1950 in all homes. The MAJORITY of wiring we observed at the panels contained modern updated wiring. Most of the wiring in the home is behind walls and ceilings and not observed.

16. Minor amount of Knob and Tube wiring...

The ESA authority does not consider this wiring unsafe if found in good condition, however, some insurers require this wiring be upgraded. Consult with your insurance company for their requirements and/or acceptable limits. You may also contact David Slack Insurers regarding homes with knob and tube wiring. In various cases, they will insure if found in

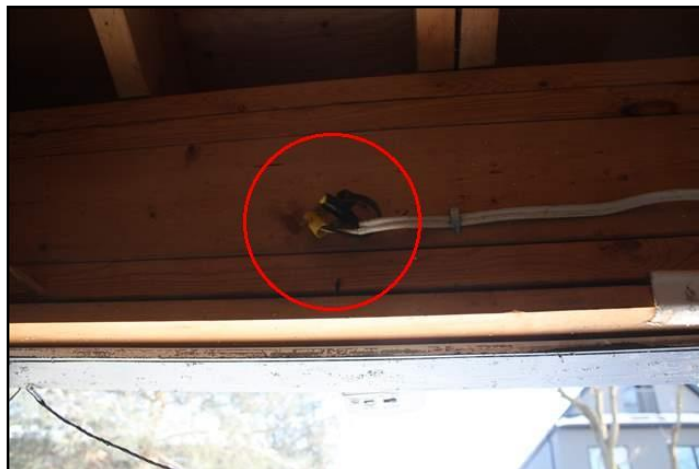
Condition: • [Abandoned wire](#)

17. Abandoned wire

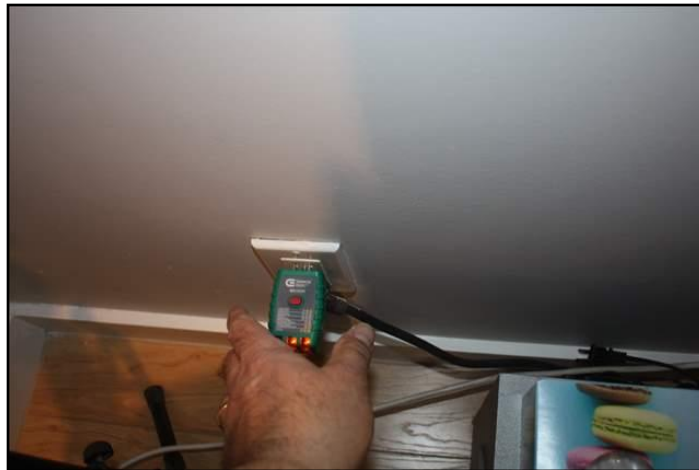
Condition: • [Loose](#)

18. Loose

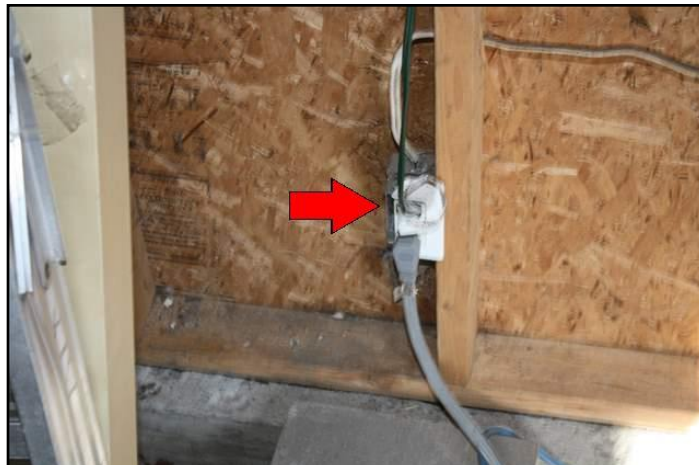
Condition: • For outlet (receptacle) is damaged

19. For outlet (receptacle) is damaged

Task: Replace

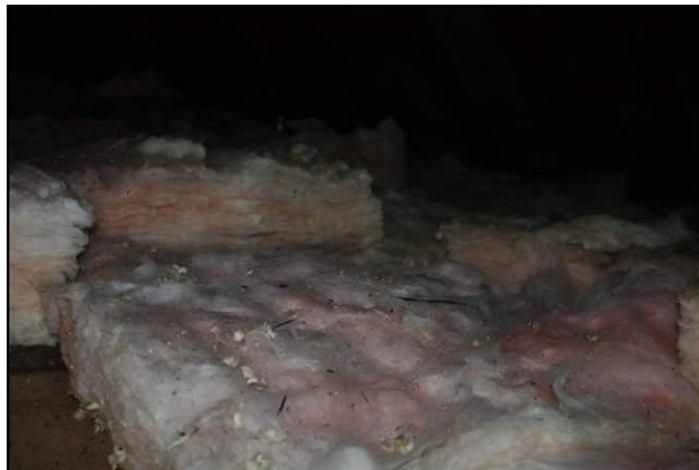
Condition: • [Amount less than current standards](#)

20. Amount less than current standards

Task: Upgrade

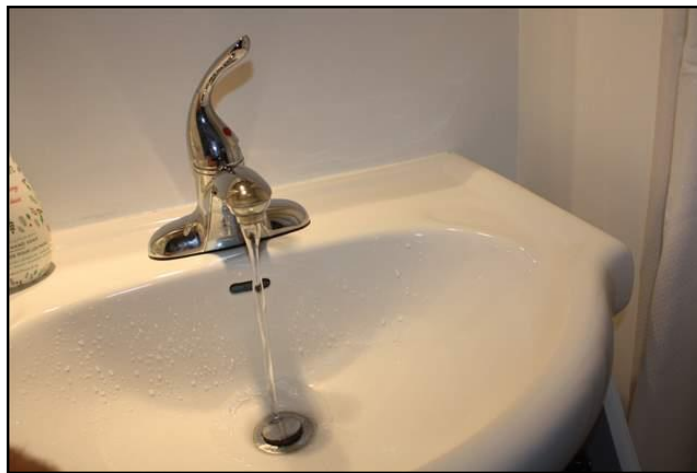
Condition: • [Poor pressure or flow](#)

22. Poor pressure or flow

Task: Improve

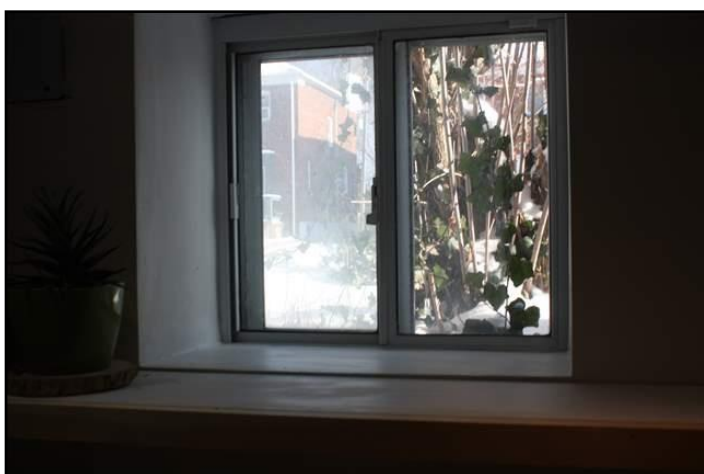
23. basement window

Condition: • Inoperative

Task: Correct/Repair

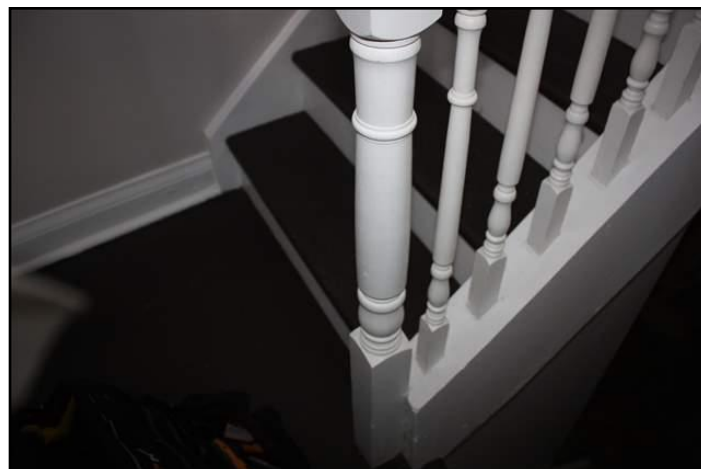
Condition: • [Loose](#)

25. Loose baluster

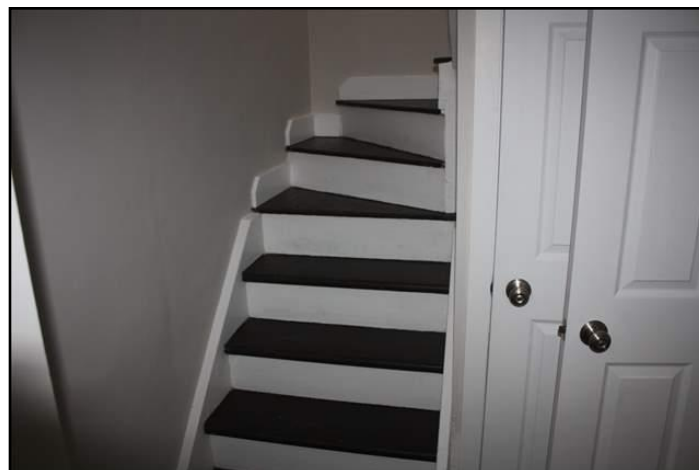
Condition: • [Missing](#)

26. Missing
