YOUR INSPECTION REPORT

FOR THE PROPERTY AT:
326 Indian Grove
Toronto, ON M6P 2H5

INSPECTION DATE:
Thursday, March 26, 2026

RE: Report No. 9139, v.2
326 Indian Grove
Toronto, ON
M6P 2H5

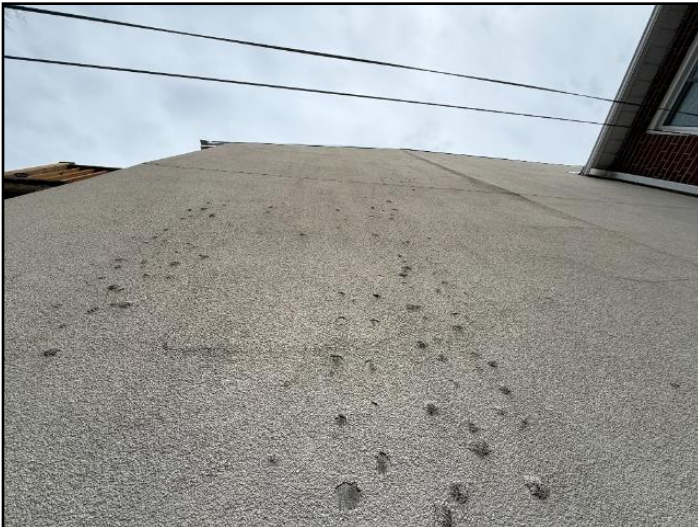
5. minor surface damage examples

Condition: • [Minor cracks](#)

Minor surface cracking was noted at the wall finish. Localized surface damage was also noted in areas, reportedly from prior vine growth/removal.

Task: Repair and seal as needed

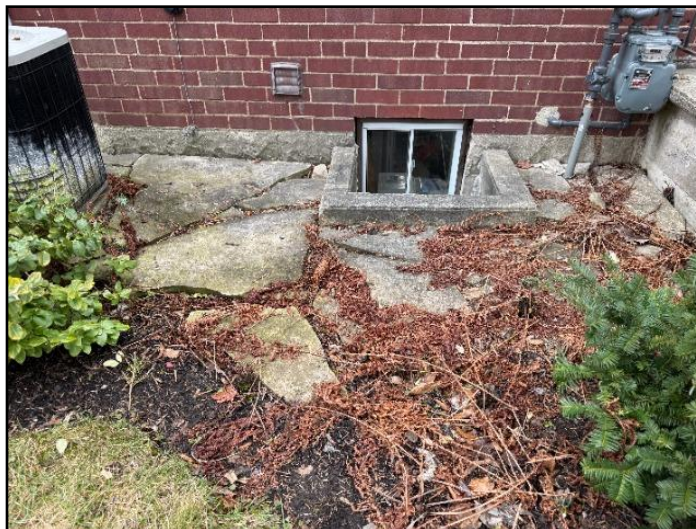
7. Improper slope or drainage

Condition: • [Improper slope or drainage](#)

Areas of grading near the front of the home were sloping toward the foundation. Improve low areas so water drains away from the home.

Task: Correct

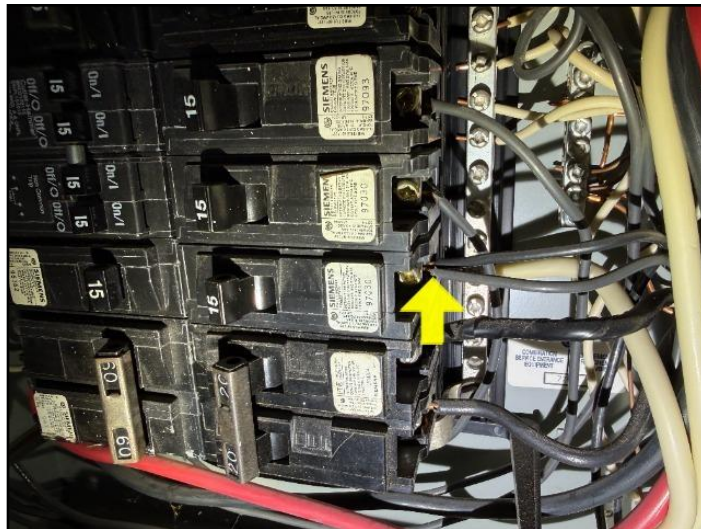
10. Double taps

Condition: • [Double taps](#)

Time: As Soon As Possible

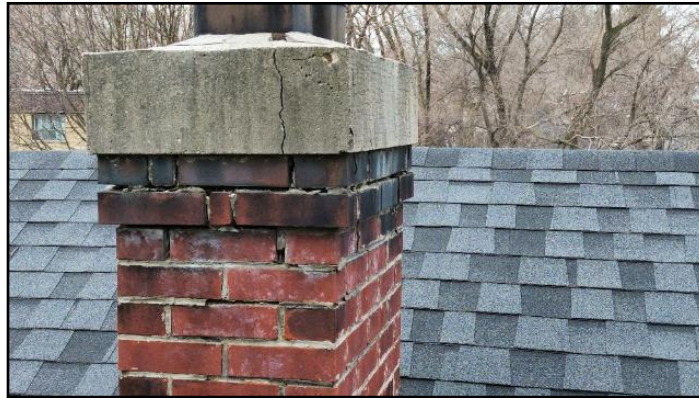
11. Loose, missing or deteriorated masonry...

Condition: • Loose, missing or deteriorated masonry and/or mortar

Additionally, chimney cap (crown) exhibits cracks.

Task: Repair

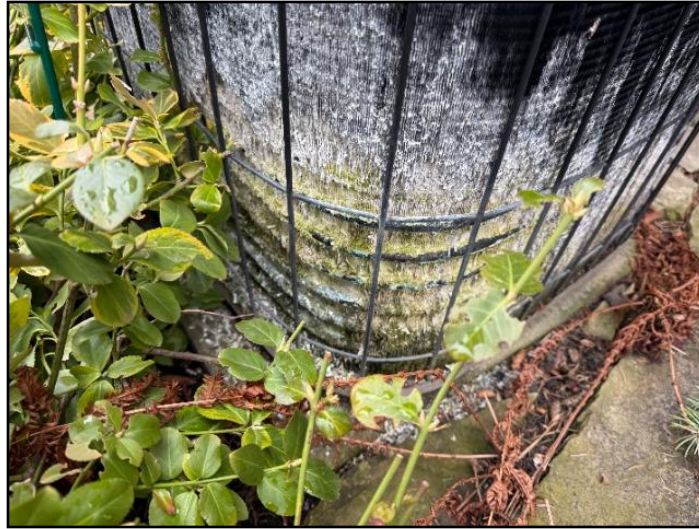
12. Corrosion

Condition: • [Corrosion](#)

Task: Service / Replace

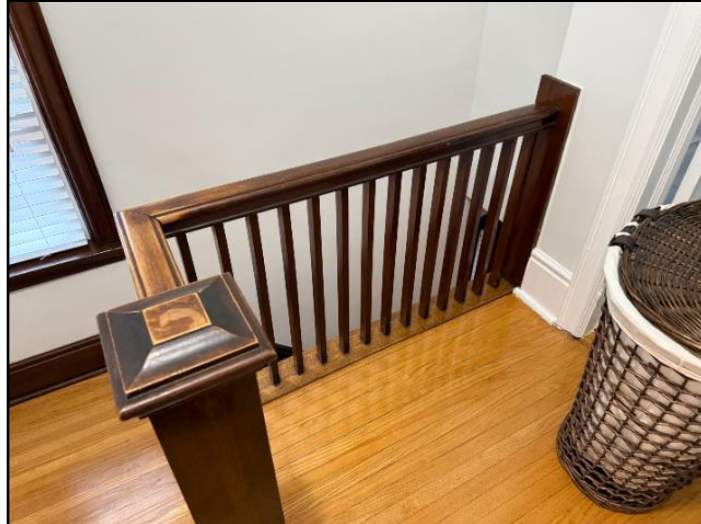
14. Too low

Condition: • [Too low](#)

Additionally guard is slightly loose.

Task: Upgrade

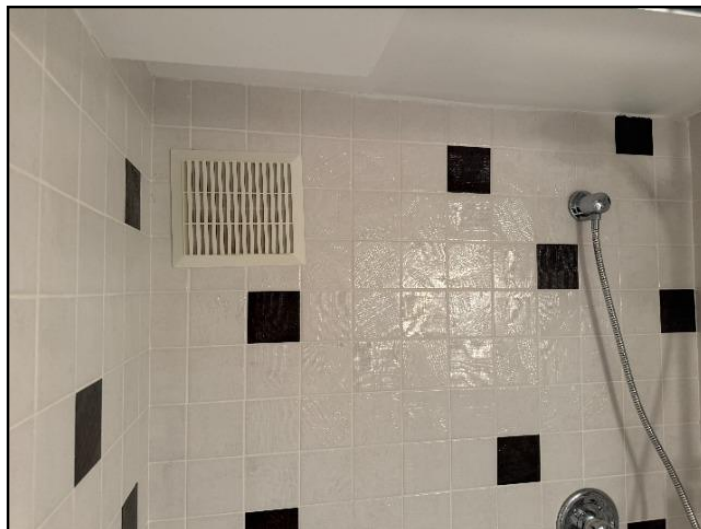
15. Bathroom exhaust fan installed within the...

Condition: • Bathroom exhaust fan installed within the shower or bathtub area
Verify that the current fan is rated for wet areas and installed appropriately.

Implication(s): Potential electrical safety hazard or premature failure of the fan

Task: Further evaluation
