# Your Inspection Report

84 Lavinia Ave  
Toronto, ON

**INSPECTION DATE:**  
Tuesday, September 27, 2016

RE: Report No. 55437  
84 Lavinia Ave  
Toronto, ON

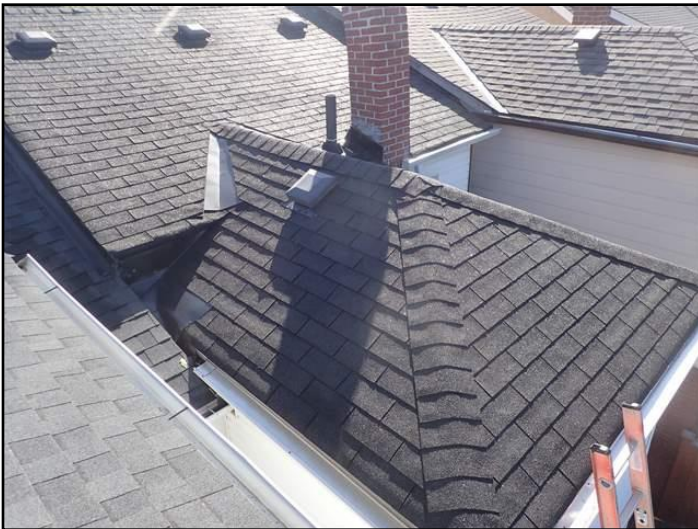
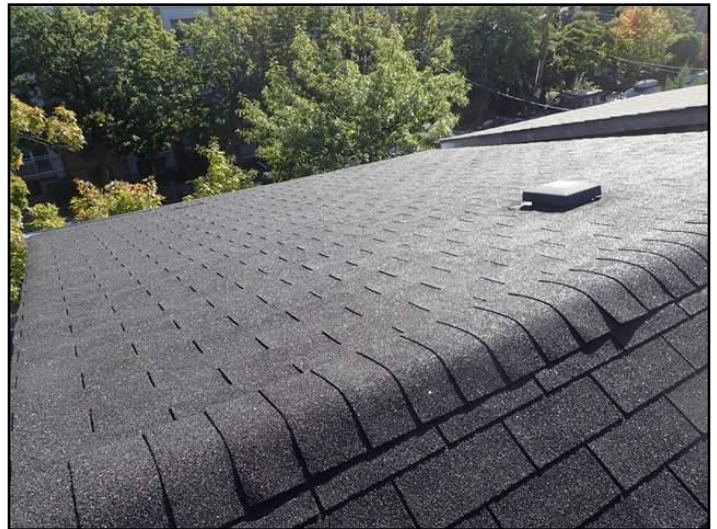
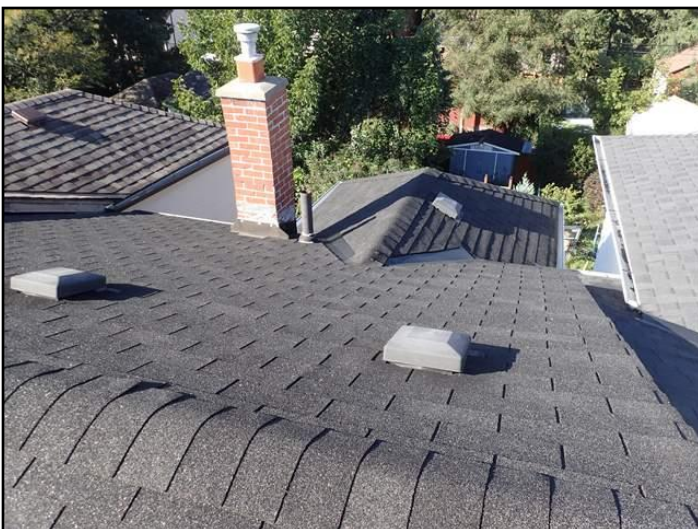
**Condition:** • The roof shingles are in good overall condition with a few prior repairs noted.

*Shingles are in good condition*

Annual inspections are recommended (on any roof) to take care of any roof damage and/or regular maintenance items (flashings/caulking).

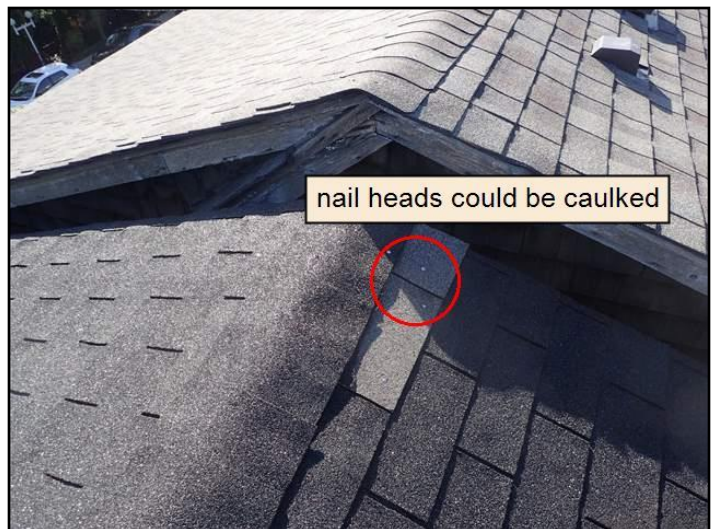
*Prior repair noted*

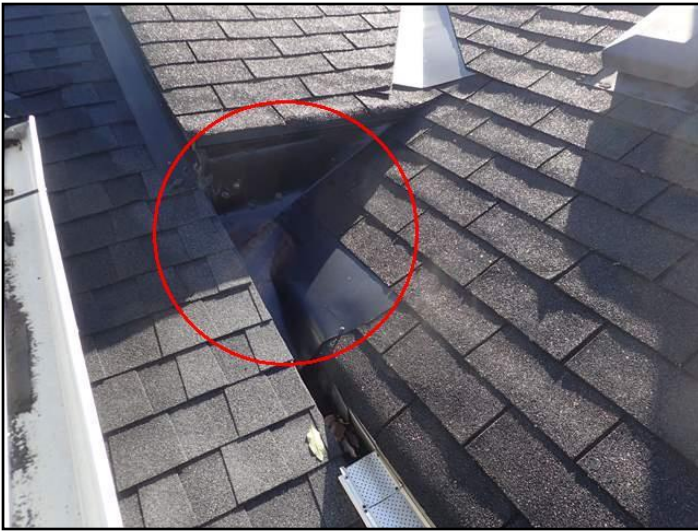
*Prior repairs noted*

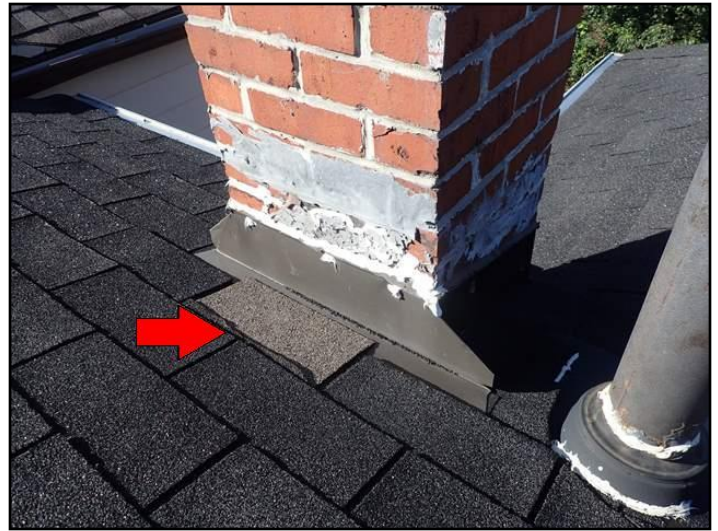
*Prior repair noted*

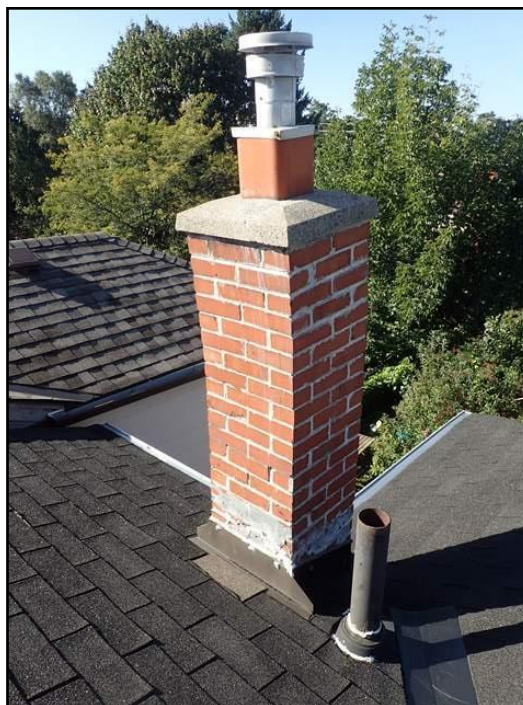
**Condition:** • The chimney is in good condition

The masonry looks sound, the cap and liner are good and the flashing looks intact.

*The chimney is in good condition*

From time to time re-pointing may be in order to replace any loose or missing mortar.

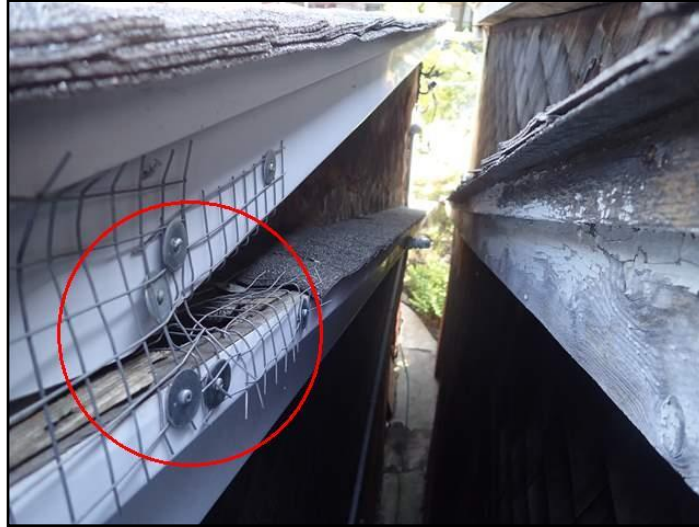
**Condition:** • Prior repairs / animal damage noted

*This area could be improved*

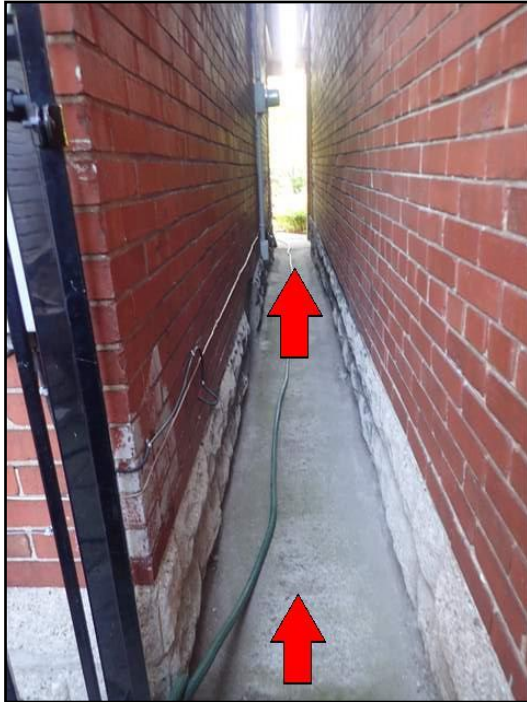
**Condition:** • The grading generally runs from the back to the front of the property.

**Implication(s):** When trying to minimize basement leakage, it is always best to be proactive and slope the grading away from the house.

*Maintain positive slope away from house*

**Task:** Monitor/Improve

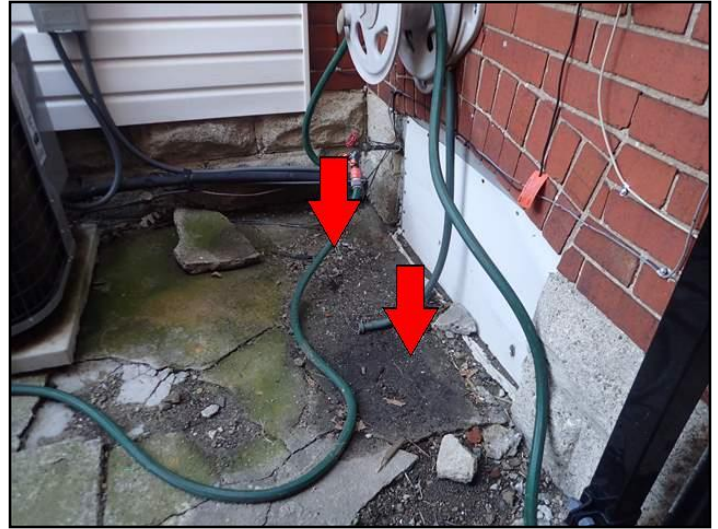
*Watch for low areas*

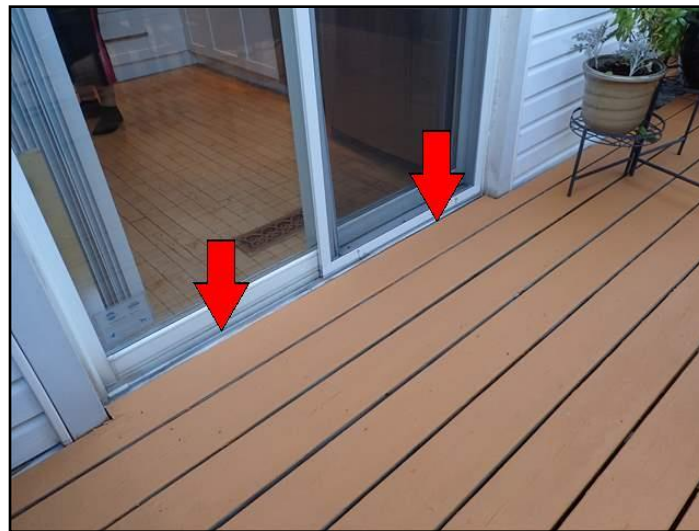
**Condition:** • Threshold height marginal

**Implication(s):** Having a minimal step makes the inside/outside transition easier. On the other hand, it also makes it more prone to snow buildup/leakage. While it is probably not practical to improve the current situation, it will be important to keep any weatherstripping/doorsill in good condition.

*Threshold height marginal*

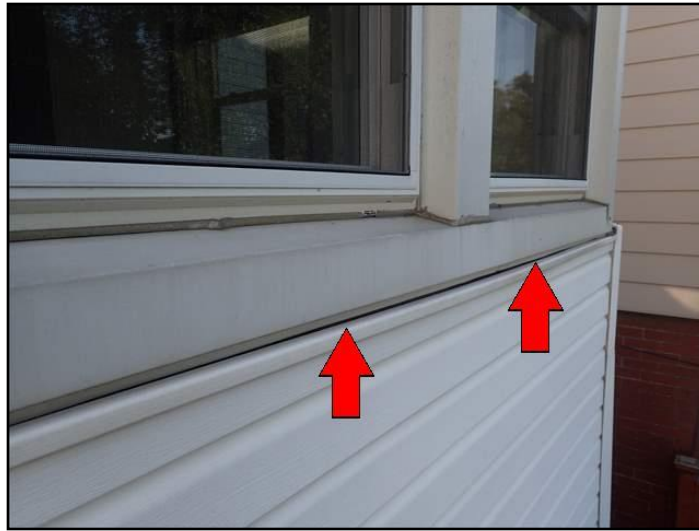
**Condition:** • [Caulking - deteriorated / missing](#)

*Seal gap between window trim & siding*

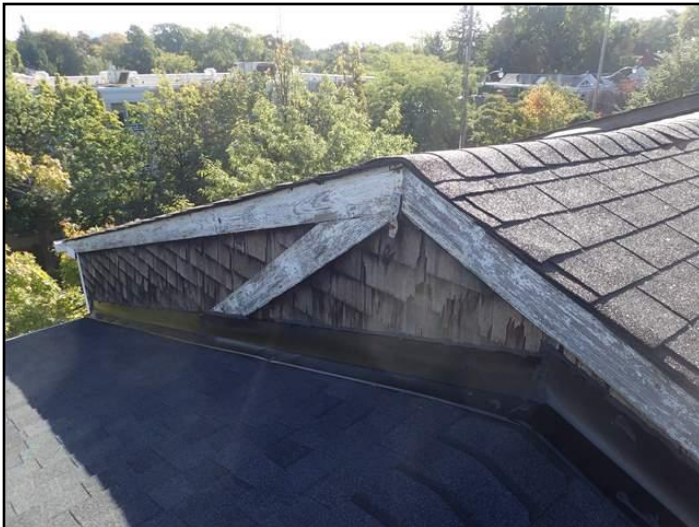
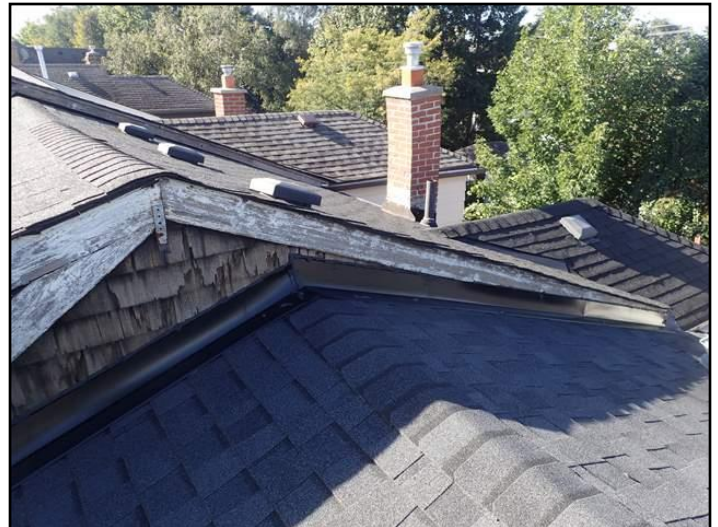
**Condition:** • [Deteriorated](#)

*Deteriorated shingle siding*

**Task:** Replace

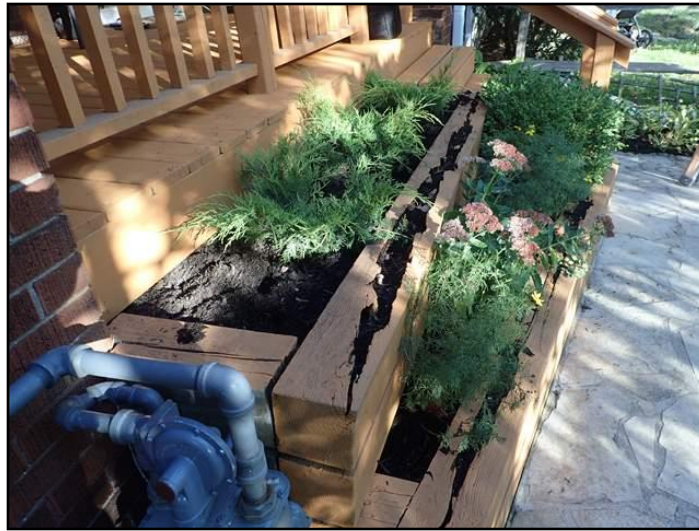
**Condition:** • Rotted planter

*Rotted planter*

**Task:** Replace / Remove

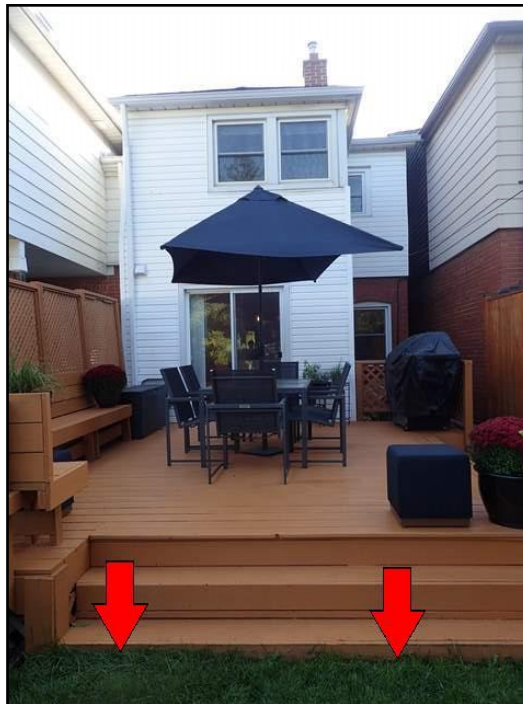
**Condition:** • [Wood / soil contact](#)

Any wood that is buried or in contact with the ground is more prone to rot/insect damage.

*Wood / soil contact*

The deck should be maintained (paint/stain/replace damaged wood) like any exterior wood until it becomes more cost effective to replace it altogether.

**Task:** Repair / Replace

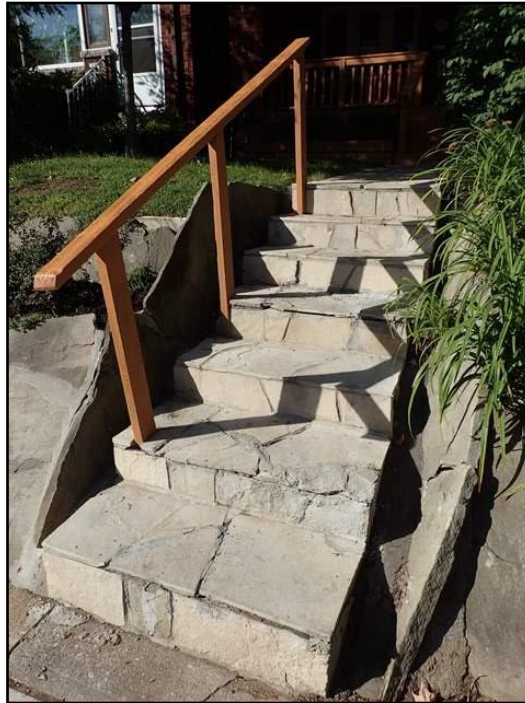
**Condition:** • Low quality repairs

The railing is rudimentary and the stone repairs are not professionally done.

*Low quality repairs to stairs*

**Task:** Repair / Replace

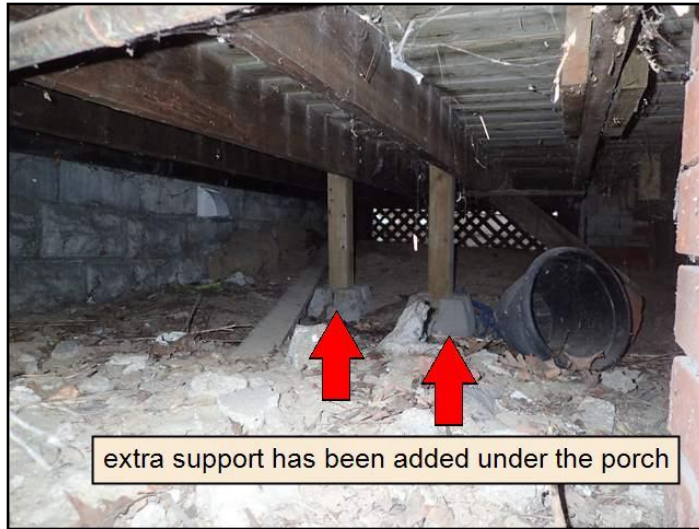
**Condition:** • Long spans are prone to sagging

*Long spans are prone to sagging*

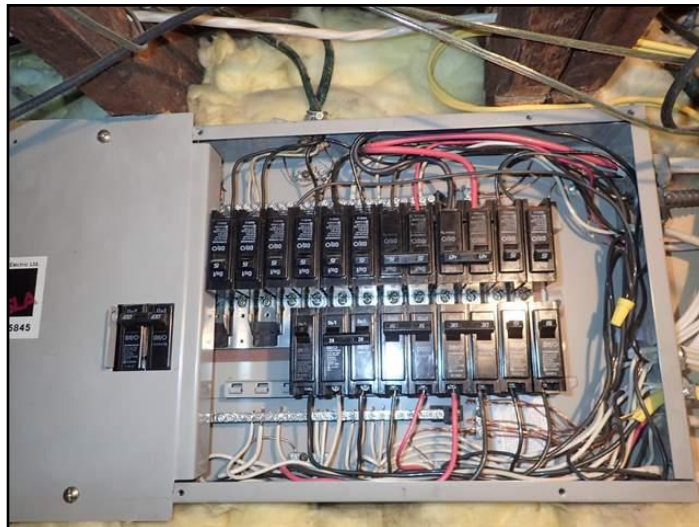
- The panel and the panel wires look professionally organized and well put together. Any other visible work looks well installed.

*Panel and wiring professionally installed*

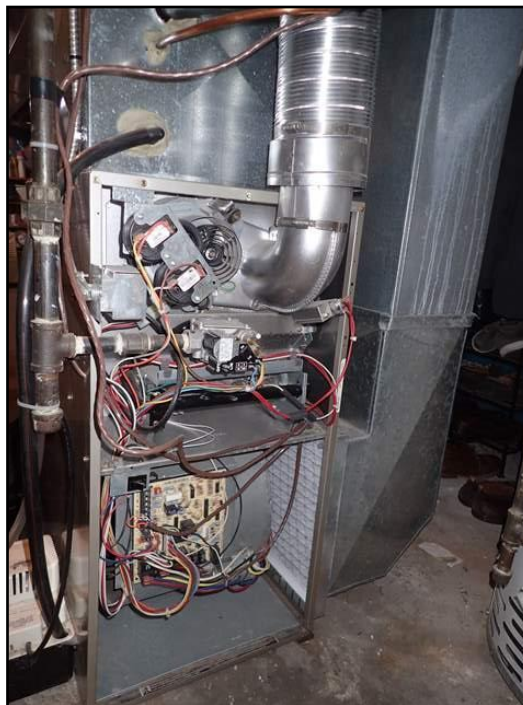
- The furnace is working properly and airflow was noted at all registers. It is common to feel the airflow stronger at some registers, depending on the length of the ductwork and the number of turns required to get there. Different preferences and seasons often necessitate different setups (balancing).

*Furnace cabinet in good, clean condition*

A service agreement that covers parts and labour (for heating and cooling equipment) is typically advised.

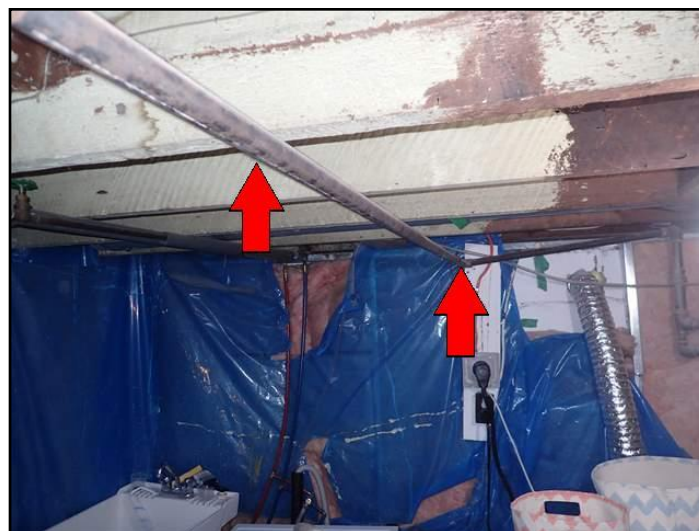
**Condition:** • [Piping support inadequate](#)

*Piping support inadequate*

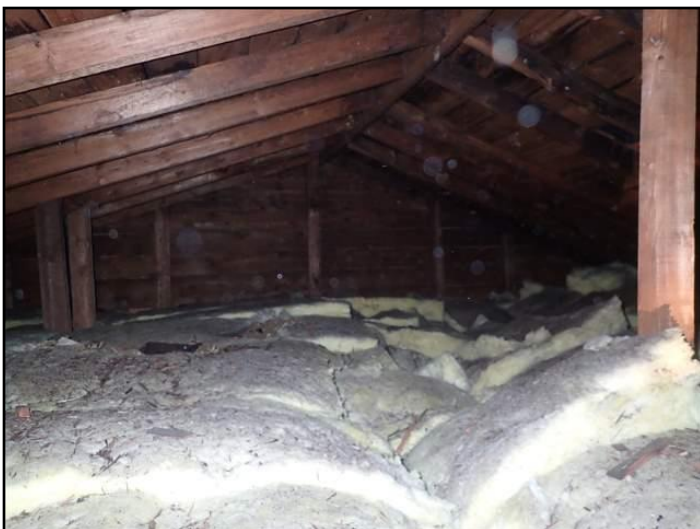
**Condition:** • [Insulation level below modern standards](#)

*Insulation is relatively even*

**Task:** Upgrade

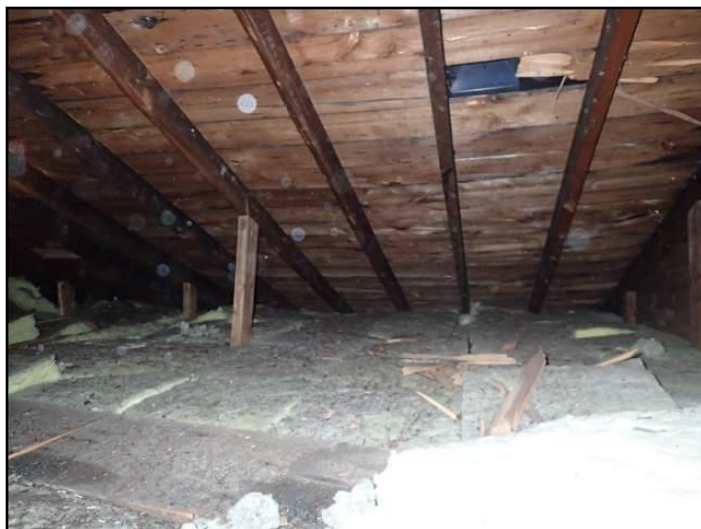
*Roof sheathing is clean*

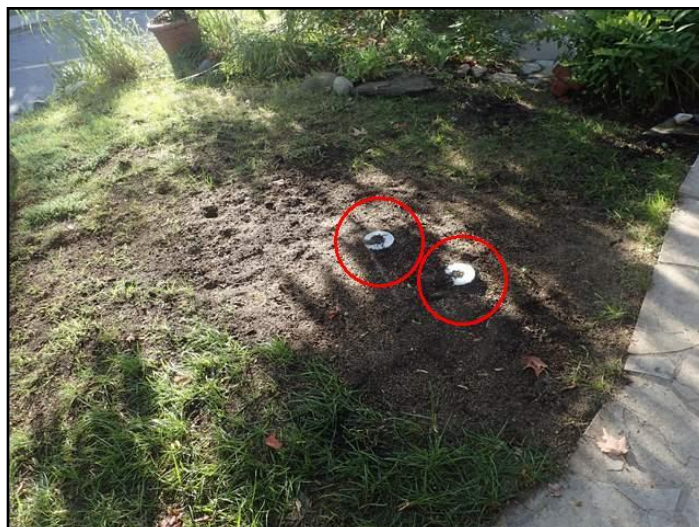
**Condition:** • A video inspection of the waste plumbing is recommended to determine whether there are tree roots, other obstructions, or damaged pipe. This is common on older properties, especially when mature trees are nearby. This is a great precautionary measure and can help prevent a sewage backup, although many homeowners wait until there are problems with the drains. This Specialty Service can be booked through Carson Dunlop at 1-800-268-7070.

Plastic cleanout at the front garden usually indicates that some kind of work has been done.)

*Cleanouts may indicate drain improvements*

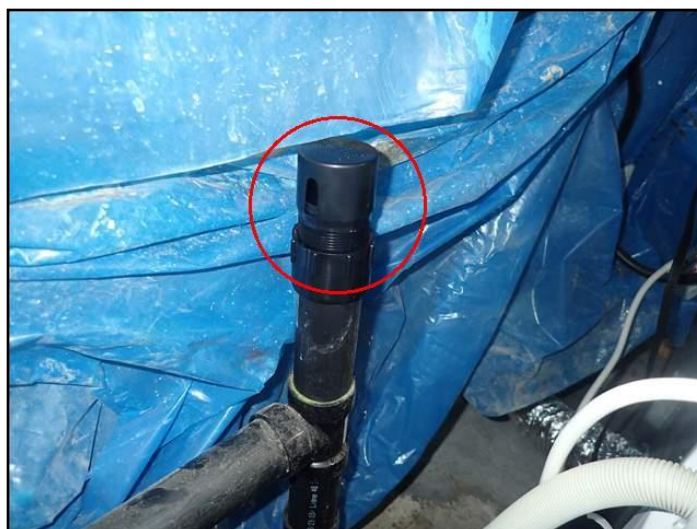
**Condition:** • [Auto-vent not recommended](#)

If they are defective, there is a risk of sewer gases entering the house.

*Auto-vent not recommended*

**Task:** Monitor / Improve

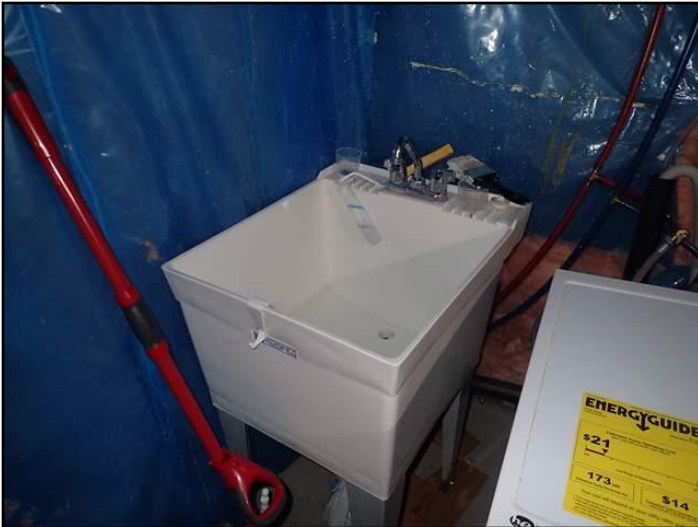
**Condition:** • Loose

*Loose laundry tub*

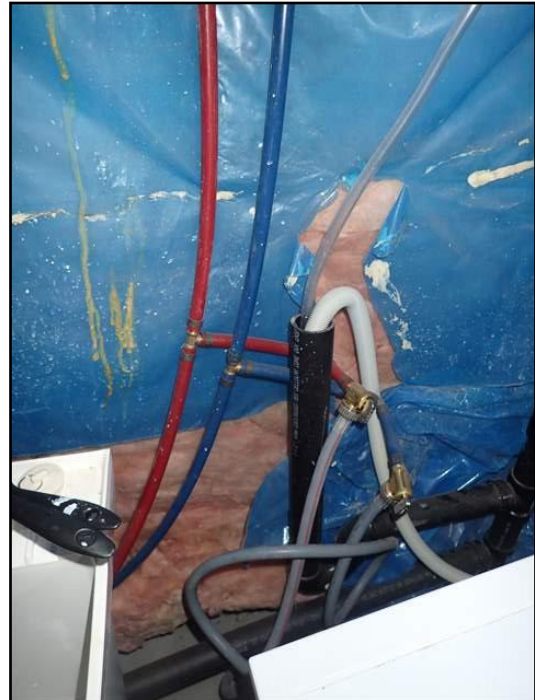
*Loose supply and drain piping*
