# Your Inspection Report

346 Indian Road Crescent  
Toronto, ON M6P 2H1

**INSPECTION DATE:**  
Monday, August 24, 2026

RE: Report No. 9748  
346 Indian Road Crescent  
Toronto, ON  
M6P 2H1

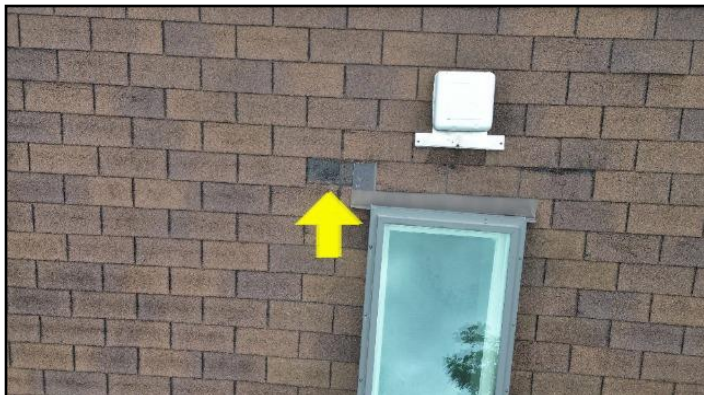
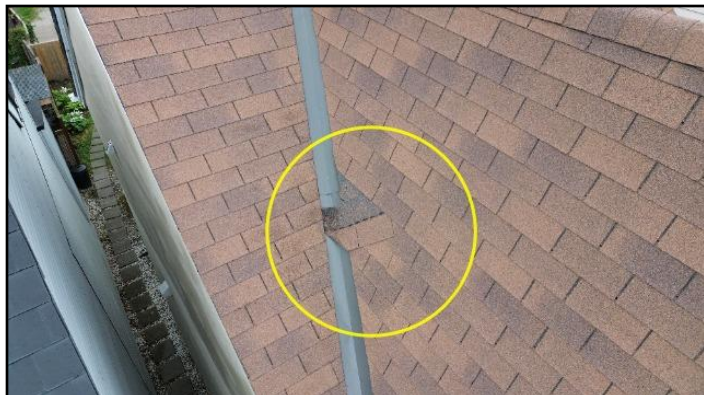
**Condition:** • [Missing, loose or torn](#)

2. Missing, loose or torn

3. Missing, loose or torn

**Task:** Repair

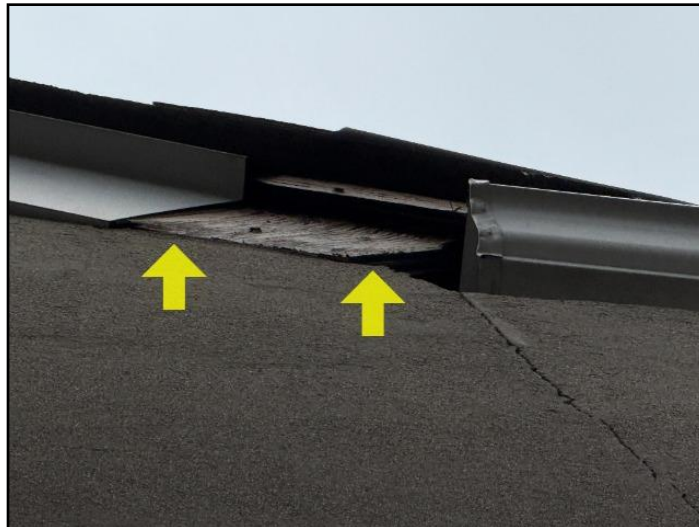
**Condition:** • [Loose or missing pieces](#)

4. Loose or missing pieces

**Task:** Repair

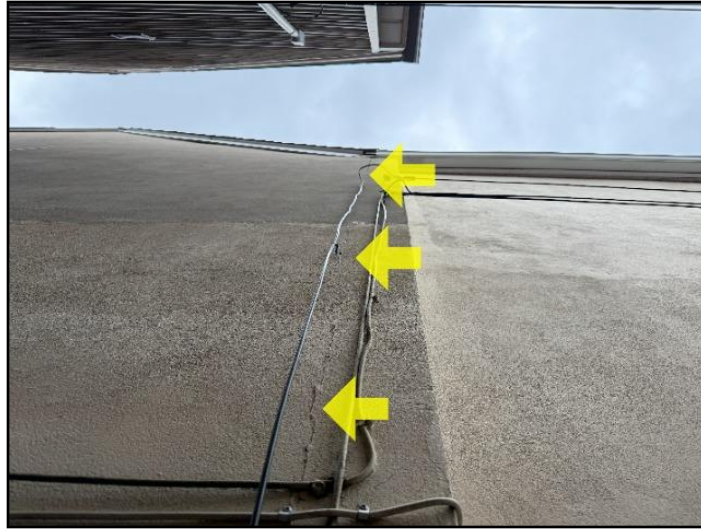
5.

**Condition:** • [Cracked](#)

A vertical crack was noted at the right exterior wall near the addition. No significant displacement was observed.

**Task:** Seal / Repair and monitor for movement or recurrence

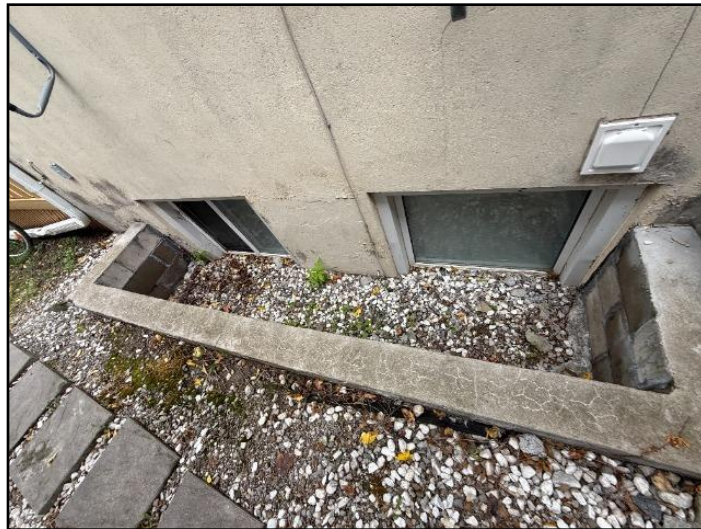
**Condition:** • [Less than 6 inches below window](#)

6. *Less than 6 inches below window*

**Task:** Improve

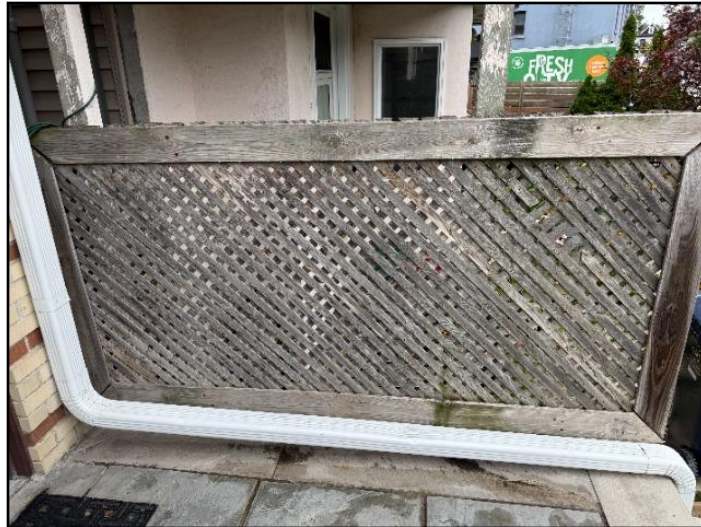
**Condition:** • [Ineffective](#)

Wood lattice guard was loose/poorly secured.

7. Ineffective

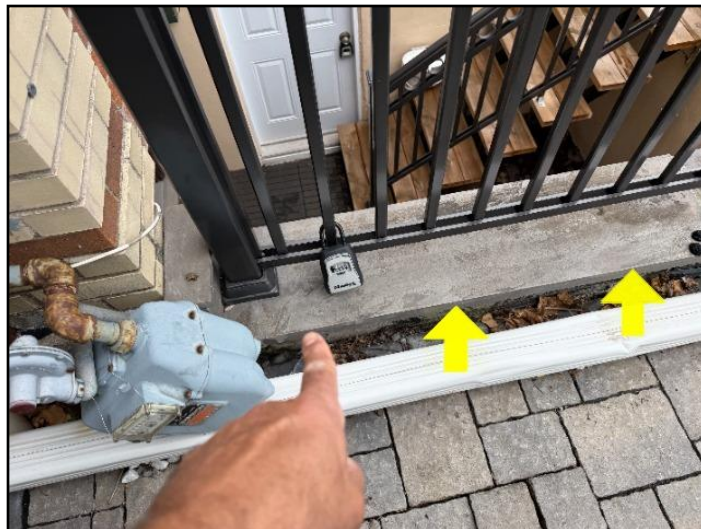
**Condition:** • [Guard and handrail problems](#)

Guardrail was secured to loose/moving pavers, allowing movement of the guard when pushed.

8. Guard and handrail problems

**Task:** Secure

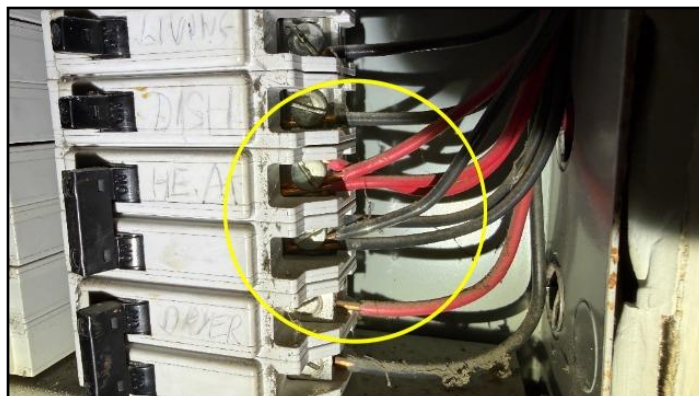
**Condition:** • [Double taps](#)

13. Double taps

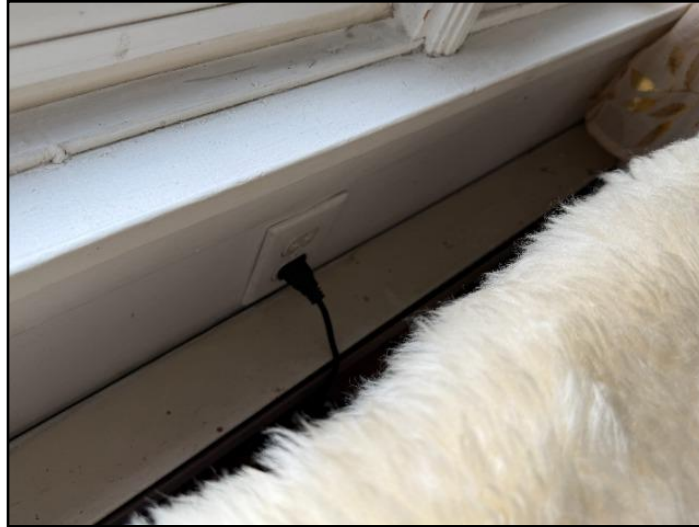
**DISTRIBUTION SYSTEM \ Outlets (receptacles) - number or location****Condition:** • [Above electric baseboard heaters](#)

One receptacle was observed above an electric baseboard heater. Additional locations may be concealed by furnishings.

**14.** Above electric baseboard heaters

**Location:** Upper unit bedroom**Task:** Remove / Relocate**Time:** Prior to use**Cost:** minor

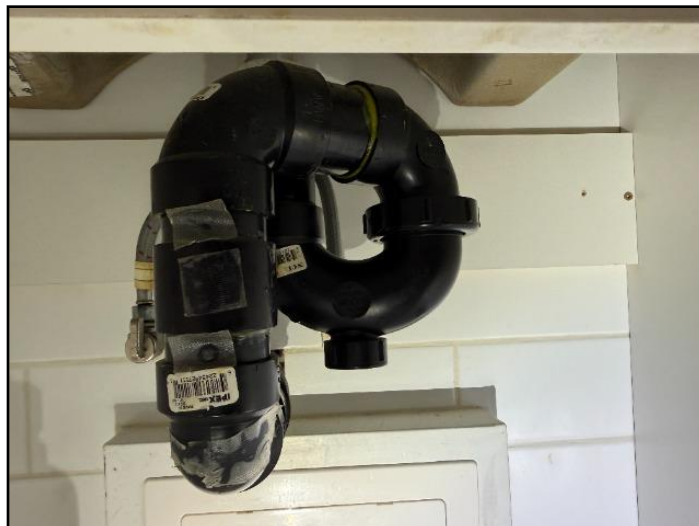
**Condition:** • Nonstandard shape or material

15. Nonstandard shape or material

**Task:** Monitor for siphoning or clogging and improve if necessary

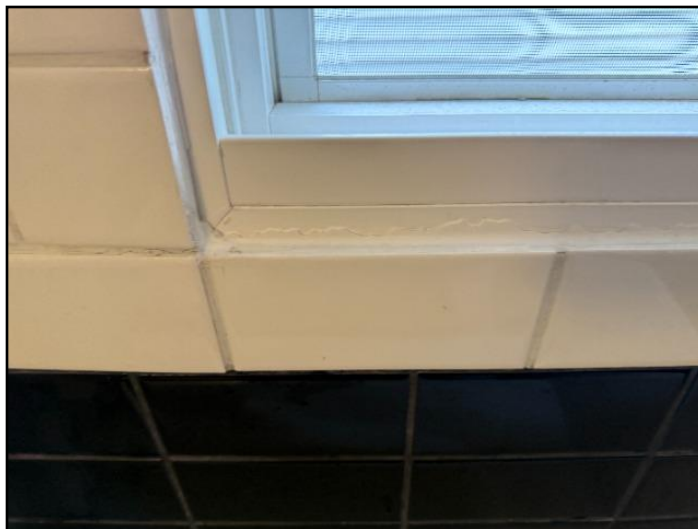
**Condition:** • [Tile loose, broken or missing](#)

Tiles in a localized area below the window were loose/moving. Caulking at the area was deteriorated.

**16.** Tiles loose

**Task:** Secure/Repair and recaulk

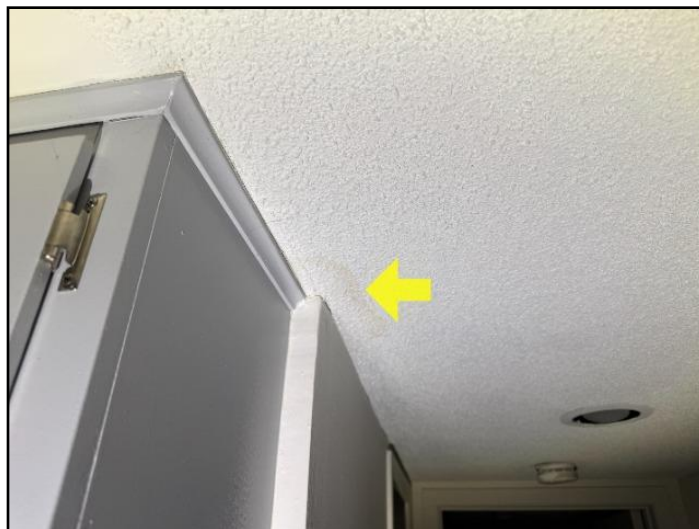
**Condition:** • Water stains - Dry at time of inspection

Tested with moisture meter.

17. Water stains - Dry at time of inspection

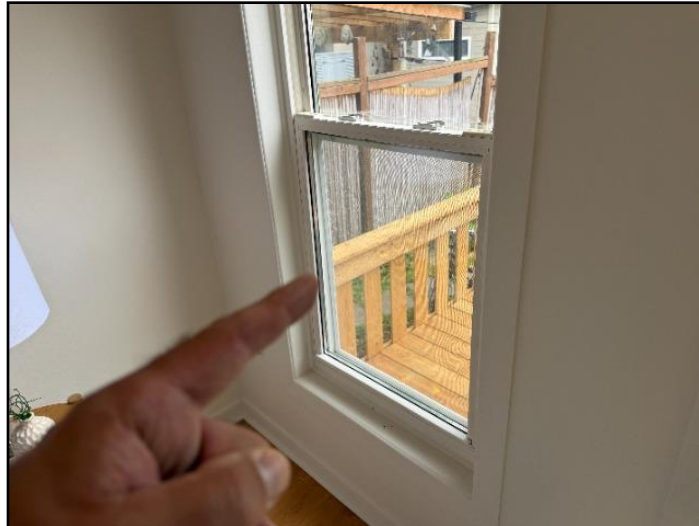
**Condition:** • [Won't stay open](#)

18. Won't stay open

**Task:** Repair
