# YOUR INSPECTION REPORT

FOR THE PROPERTY AT:  
466 Beresford Avenue  
Toronto, ON M6S 3B7

INSPECTION DATE:  
Tuesday, October 21, 2025

RE: Report No. 8716, v.2  
466 Beresford Avenue  
Toronto, ON  
M6S 3B7

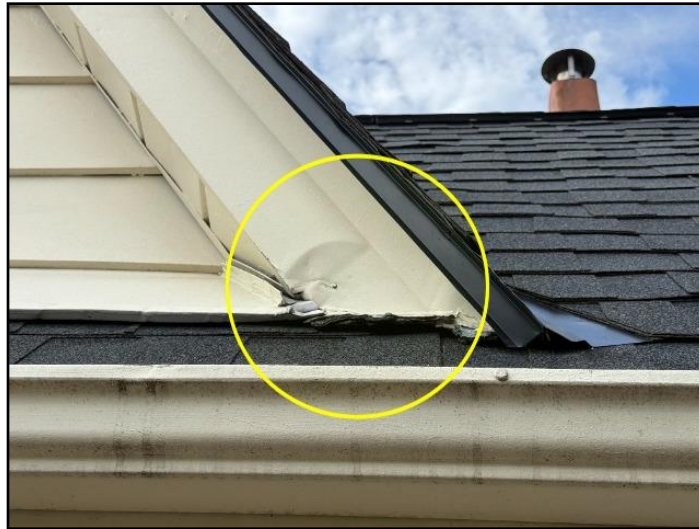
**Condition:** • [Damage, loose, open seams, patched](#)

5. Damage, loose, open seams, patched

**Task:** Repair

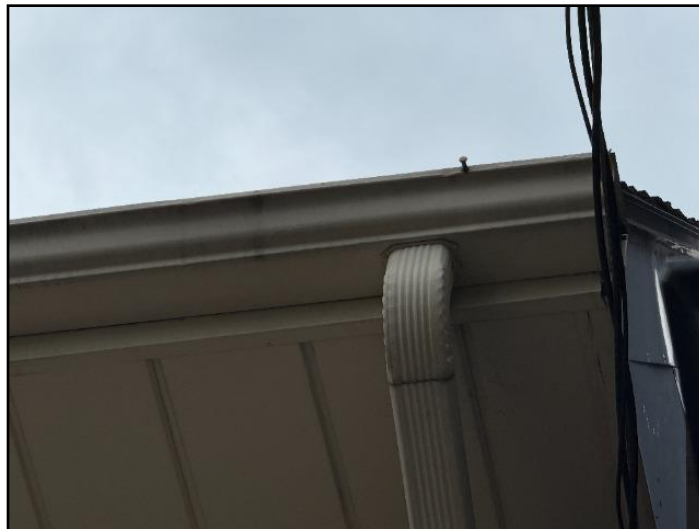
**Condition:** • Loose

Fasteners loose in some areas

7. one example

**Task:** Improve

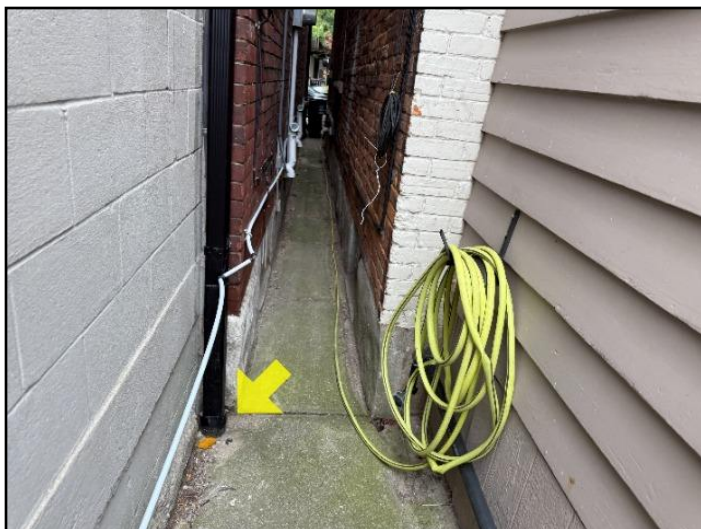
**Condition:** • Discharge below grade

8. Discharge below grade

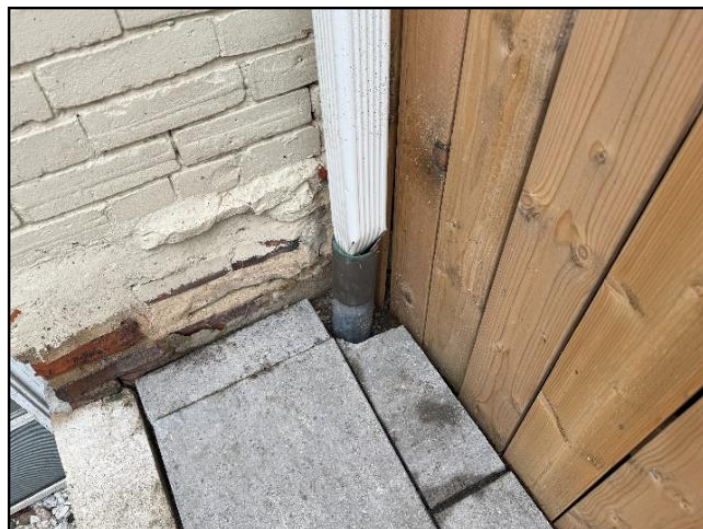
9. Discharge below grade

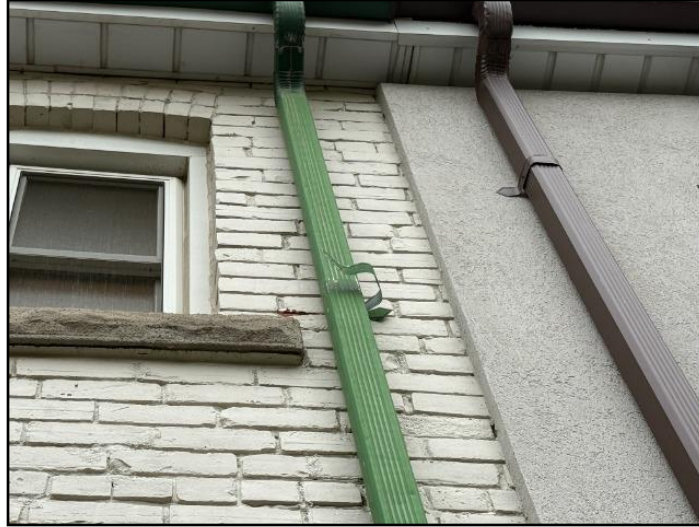
**Condition:** • [Not well secured](#)

10. Not well secured

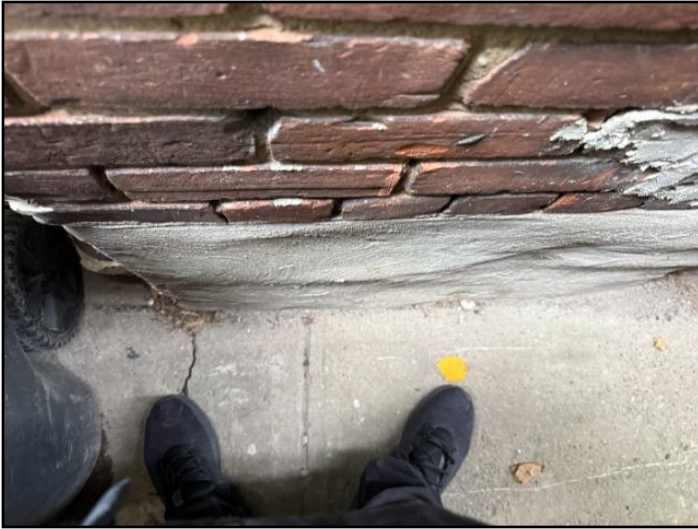
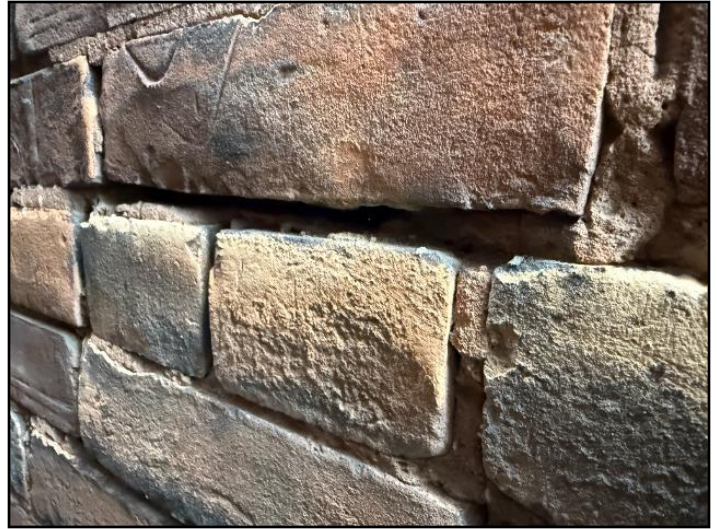
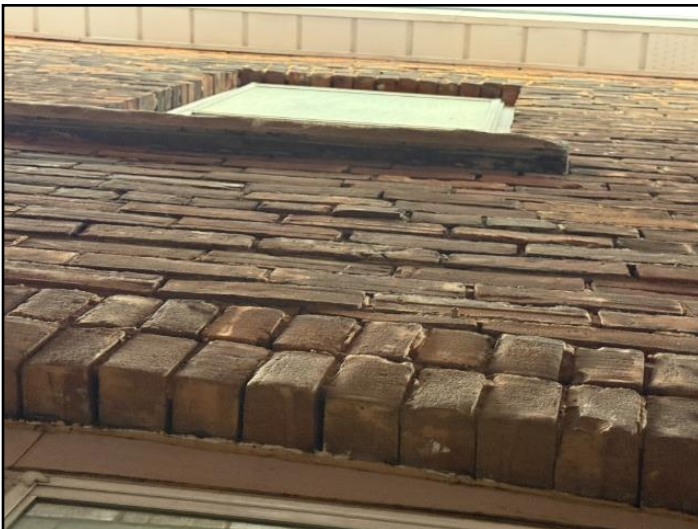
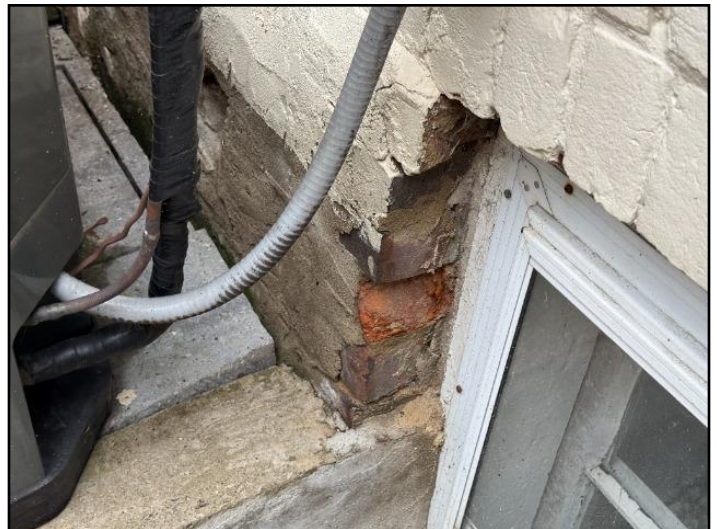
**Condition:** • Masonry and/or mortar deterioration

11. Masonry and/or mortar deterioration

Tuckpoint / Repoint mortar and patch/repair spalled masonry. This is typical maintenance for a home of this age.  
photos show a sampling

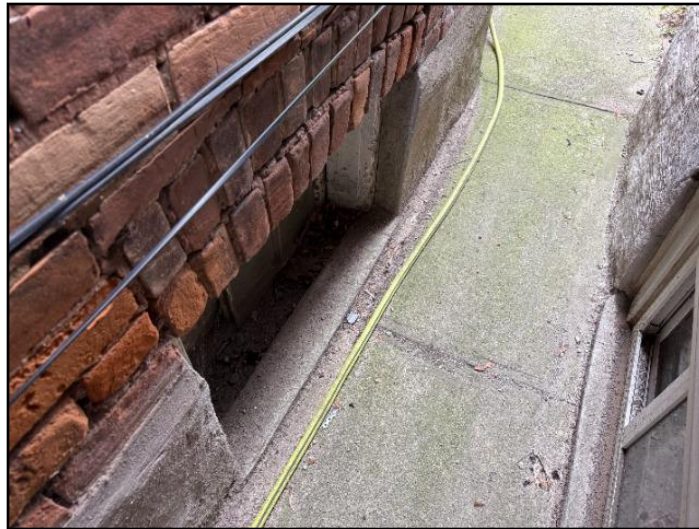
**Condition:** • Sill - Near or at Grade Level

Basement window at or near grade level. Modern standards recommend that the bottom of the window be at least 6 inches above grade or have a window well installed. Consider adding window well if regrading or when necessary. In the meantime, ensure windows remain well-sealed to prevent water intrusion.

15. Sill - Near or at Grade Level

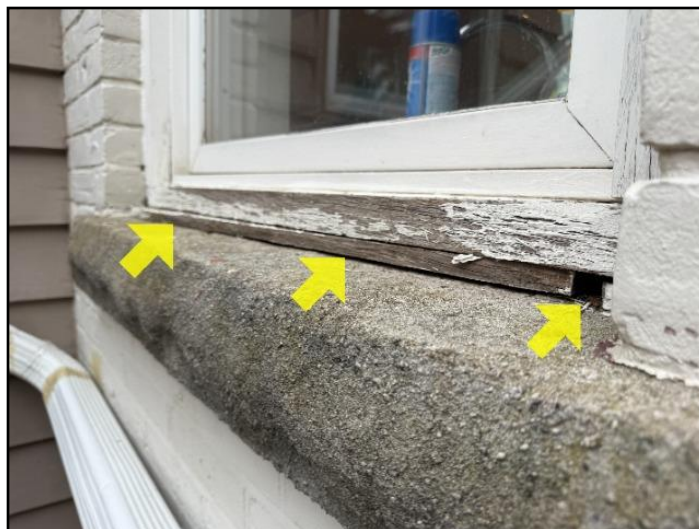
Condition: • [Missing or loose pieces](#)

16. Missing or loose pieces

Task: Repair or cap

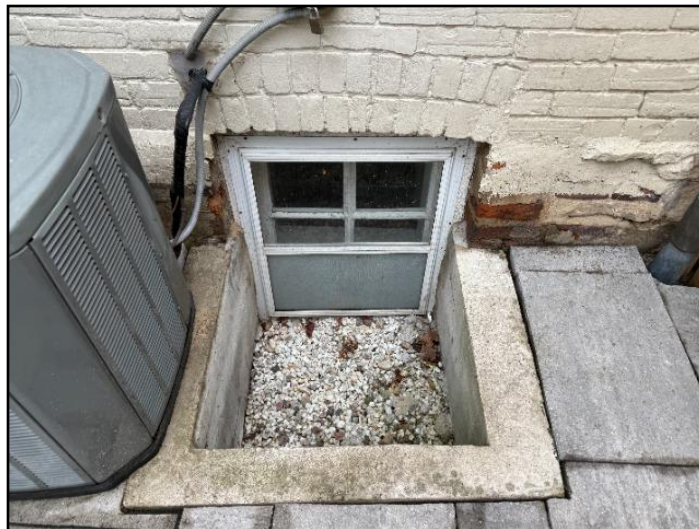
Condition: • [Less than 6 inches below window](#)

**17.** Less than 6 inches below window

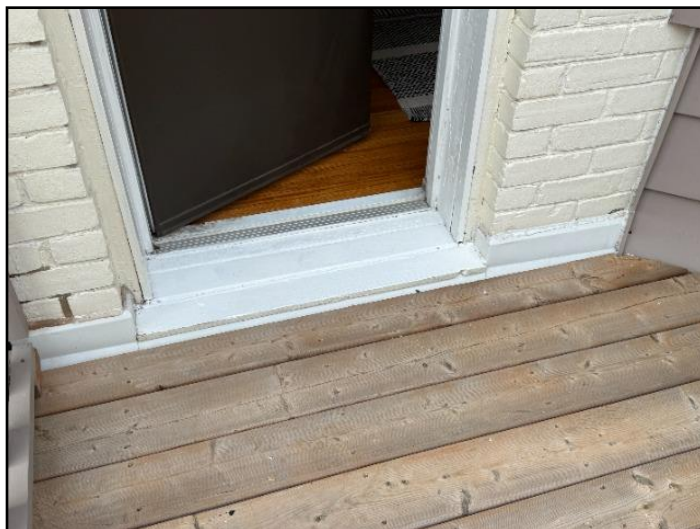
**Condition:** • Threshold too low

Having a minimal step makes the inside/outside transition easier. On the other hand, it also makes it more prone to snow buildup/leakage.

18. Threshold too low

While it is probably not practical to improve the current situation, it will be important to keep any weatherstripping/caulking in good condition.

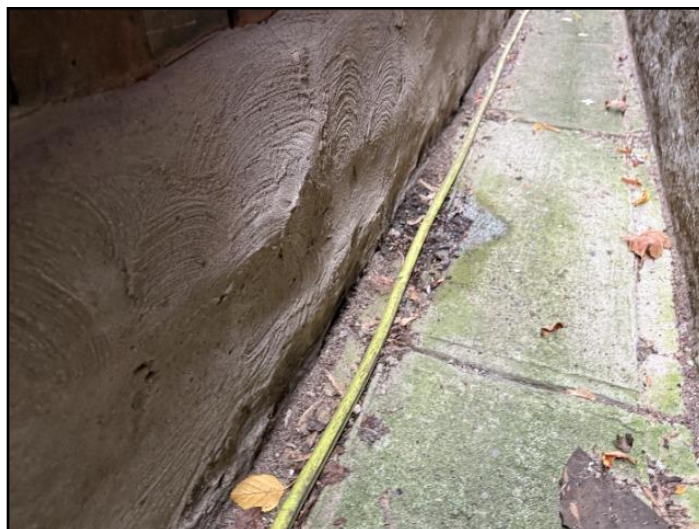
**Condition:** • The foundation has been parged over original stone. The irregular or uneven appearance reflects the shape of the underlying stonework and is typical for older foundations. The parging conceals the original stone surface.

19. Example

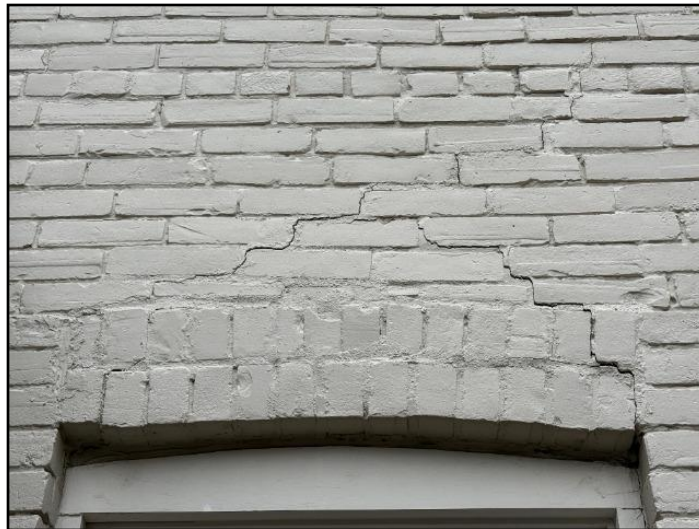
**Location:** Various Basement Furnace Room**Task:** For Your Information**WALLS \ Arches****Condition:** • [Cracked](#)

It is very common for masonry to develop settlement cracks, particularly at arches above windows and doors.

20. Cracked

Repointing/tuckpointing the mortar and repairing cracks helps prevent further damage or movement. These repairs also serve as a reference point to monitor for any future activity.

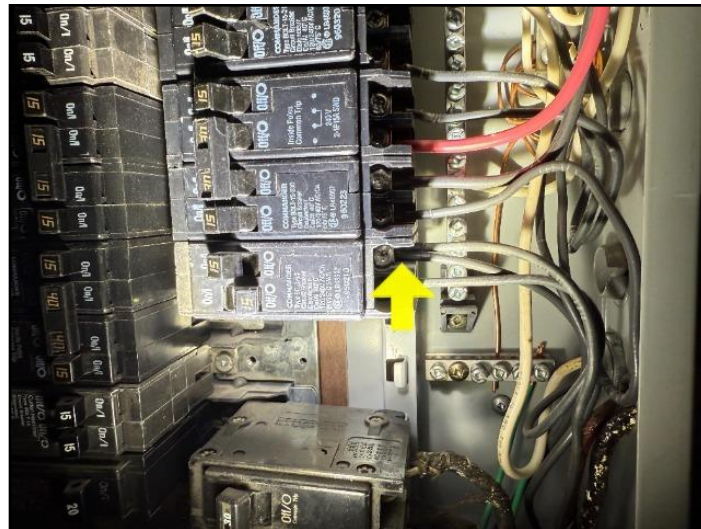
**Condition:** • [Double taps](#)

22. Double taps

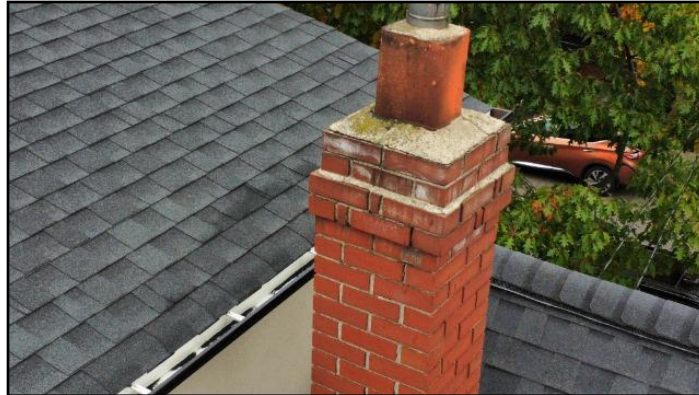
**Condition:** • [No drip edge on cap \(crown\)](#)

Additionally, minor cracks noted

**23.** *No drip edge on cap (crown)*

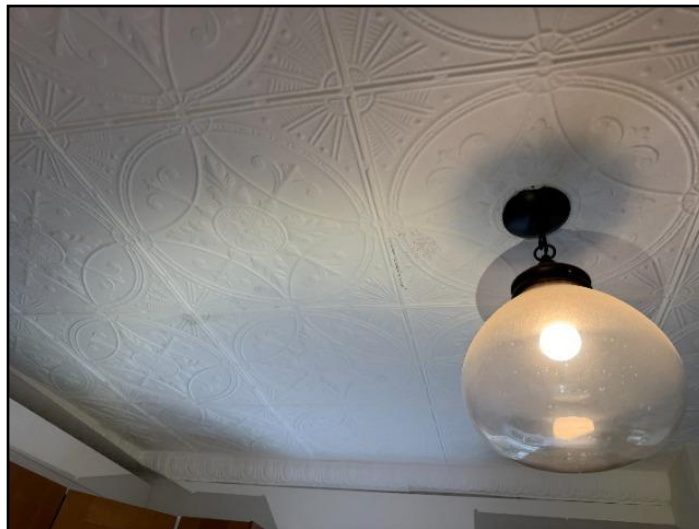
**Condition:** • Typical flaws

All blemishes tested with moisture meter and were dry at time of inspection

25. Typical flaws

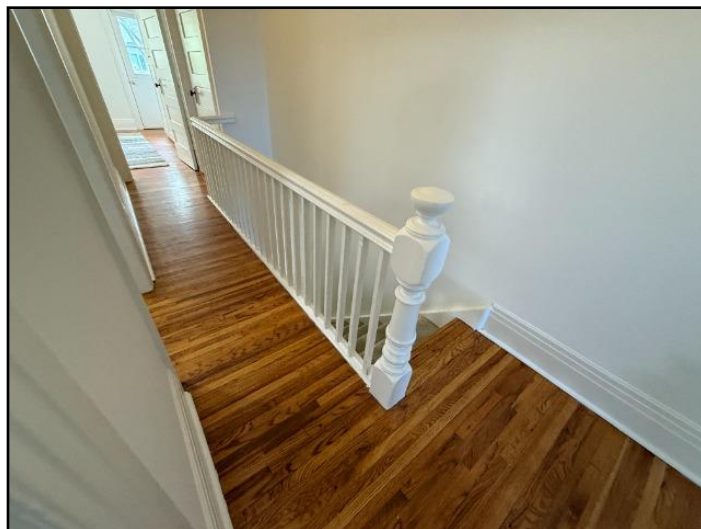
**Condition:** • [Too low](#)

26. Too low

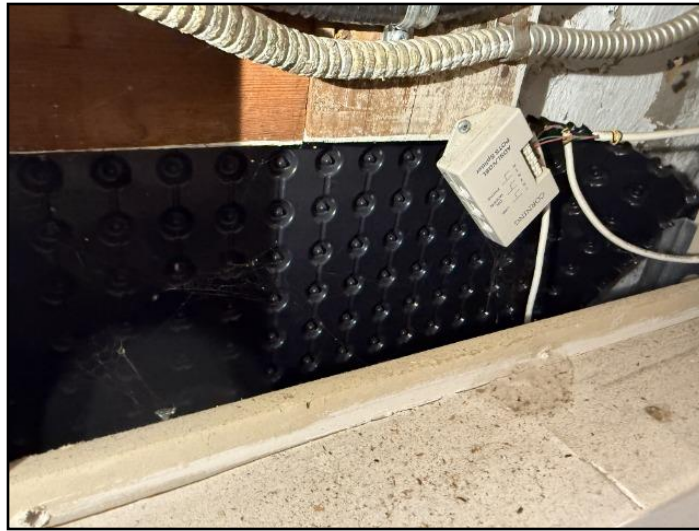
**Condition:** • [Interior drainage system](#)

A dimple membrane and sump pump were observed, indicating an interior drainage system has been installed to manage foundation moisture. These systems are designed to collect and redirect water that seeps through the foundation walls rather than prevent it from entering.

27. Interior drainage system example

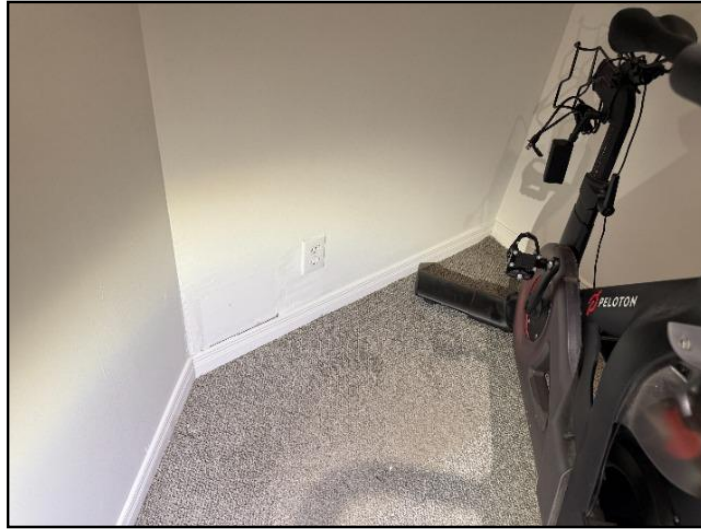
**Condition:** • [Dampness on floor or walls](#)

Localized patching was observed, and elevated moisture was detected along the lower front basement wall using a moisture meter. The wall surface has been recently patched and painted, which may affect readings and limit visual confirmation. No visible staining or active leakage was observed, and the carpet was dry at the time of inspection. The area should be monitored for recurring dampness once the paint has fully cured.

28. General area

**Task:** Monitor for dampness/leakage
