Your Inspection Report

13 Bradley Ave
Toronto, ON

INSPECTION DATE:
Thursday, March 9, 2017

RE: Report No. 57110
13 Bradley Ave
Toronto, ON

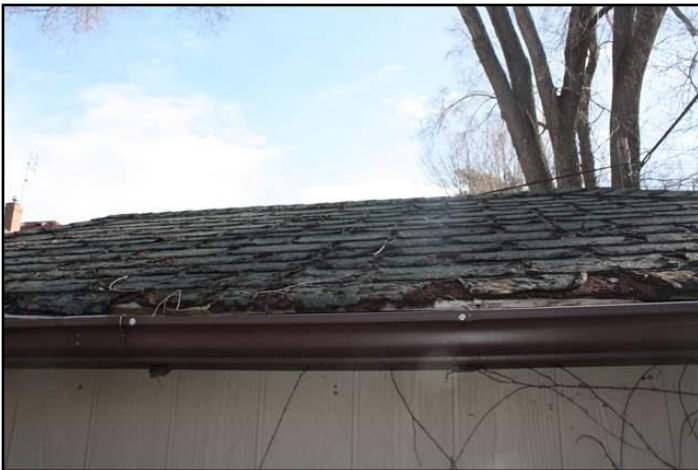
Condition: • [Old, worn out](#)

Old, worn out

Task: Replace

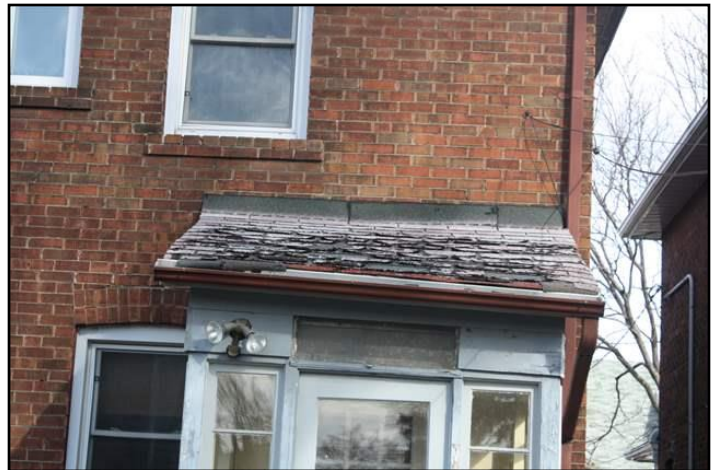
Old, worn out

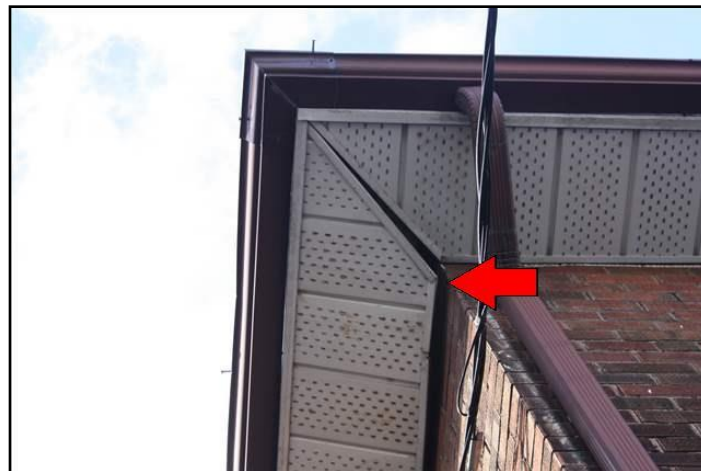
Condition: • [Loose or missing pieces](#)

Loose or missing pieces

Task: Repair

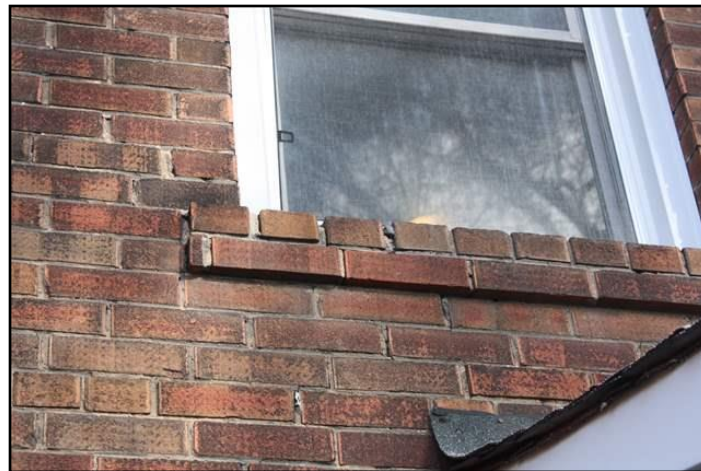
Condition: • [Mortar deterioration](#)

Example of sill needing tuckpointing

Task: Repair - tuckpointing (repointing)

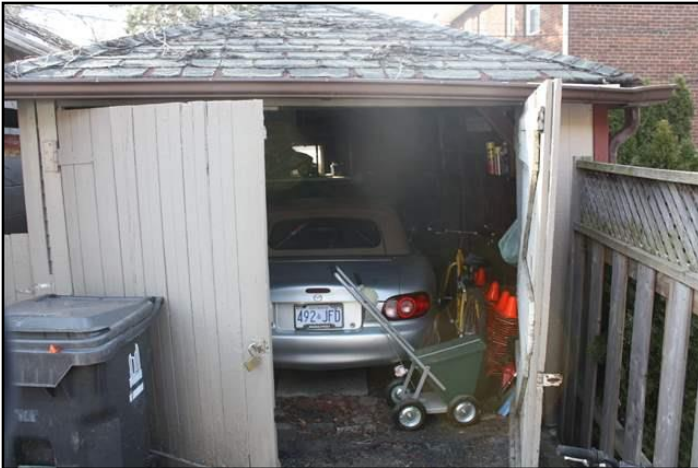
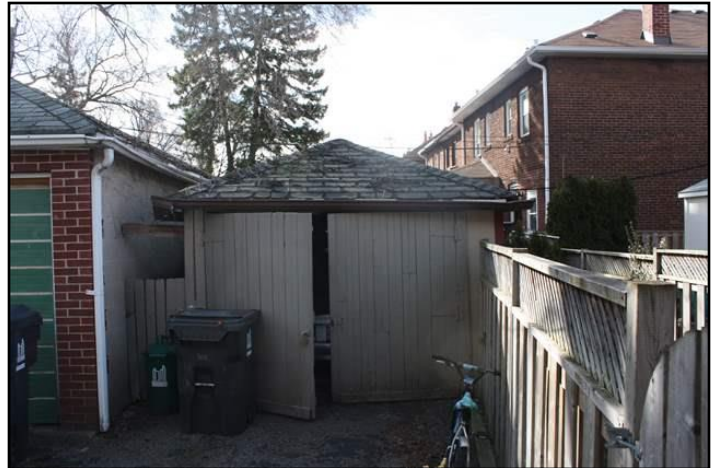
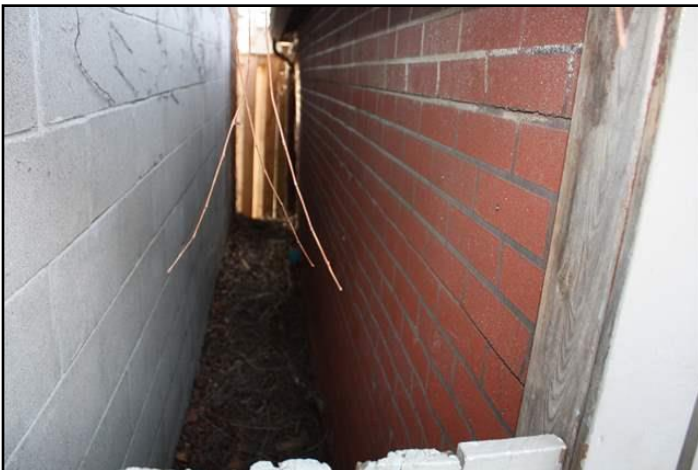
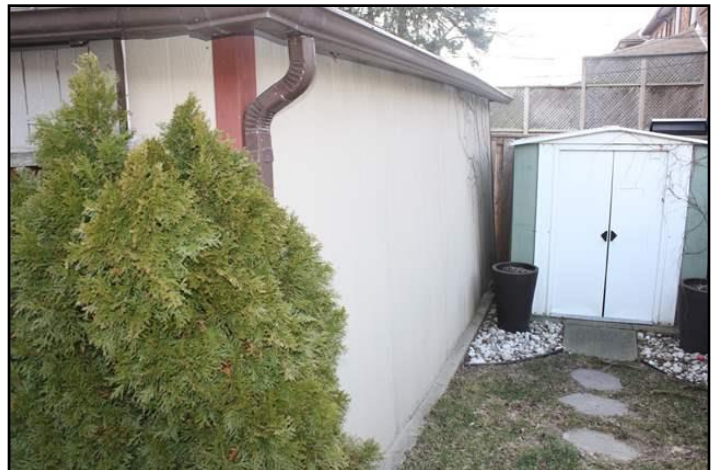
Condition: • Typical low quality structure

Garage / Shed is very old and is leaning. Walls are bowing. Insulbrick siding noted.

Typical low quality structure

Task: Repair / Replace / Demolish

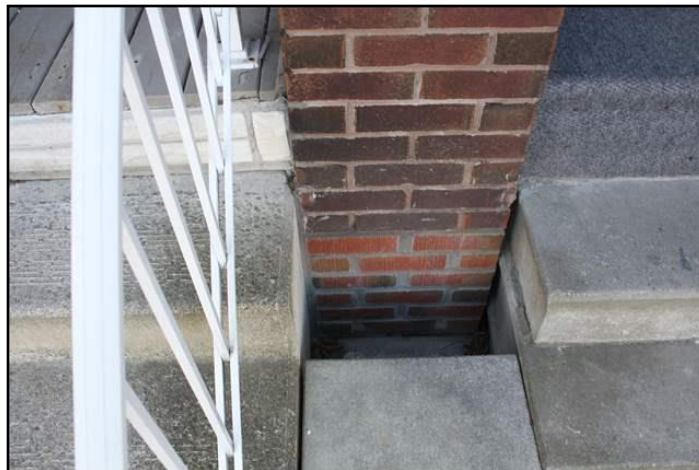
Condition: • [Prior repairs](#)

example of Prior repairs

Task: Monitor

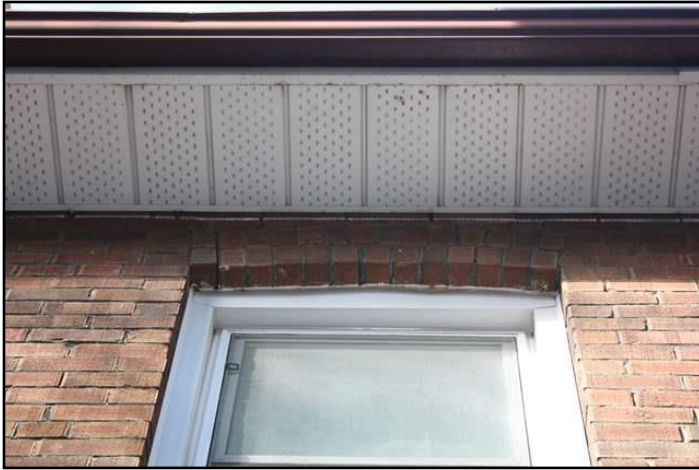
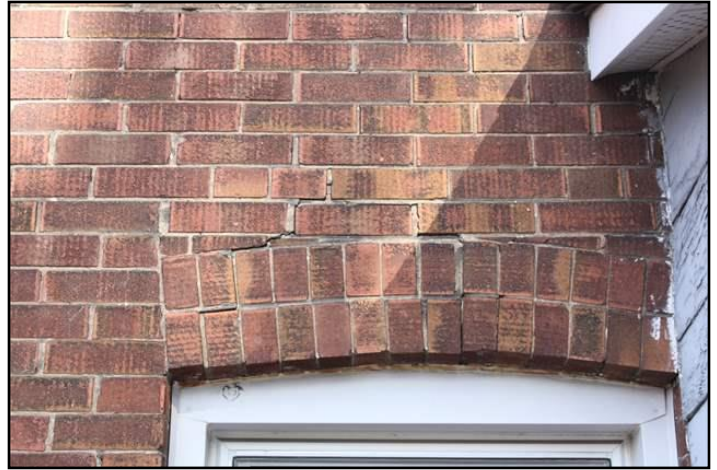
Condition: • [Cracked](#)

Cracked

Task: Repair

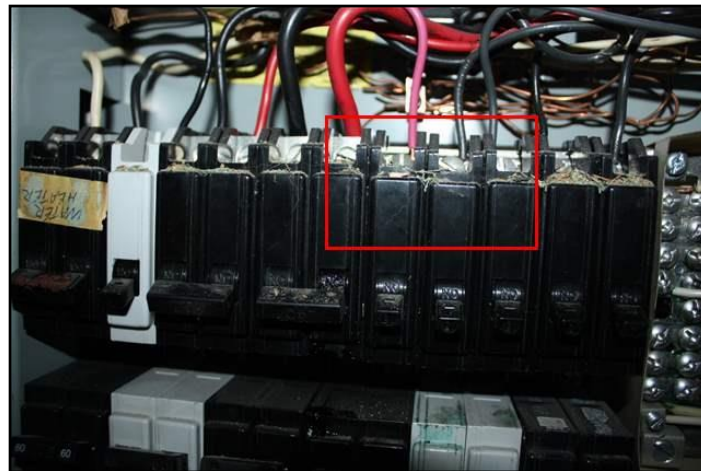
Condition: • [No links for multi-wire circuits](#)

No links for multi-wire circuits

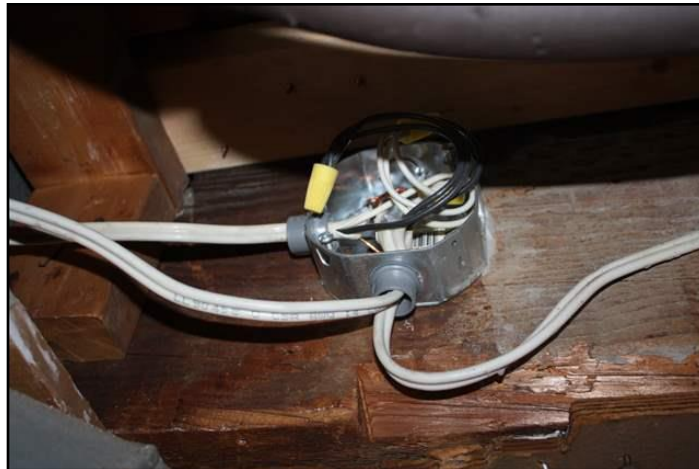
Condition: • [Cover loose or missing](#)

Cover loose or missing

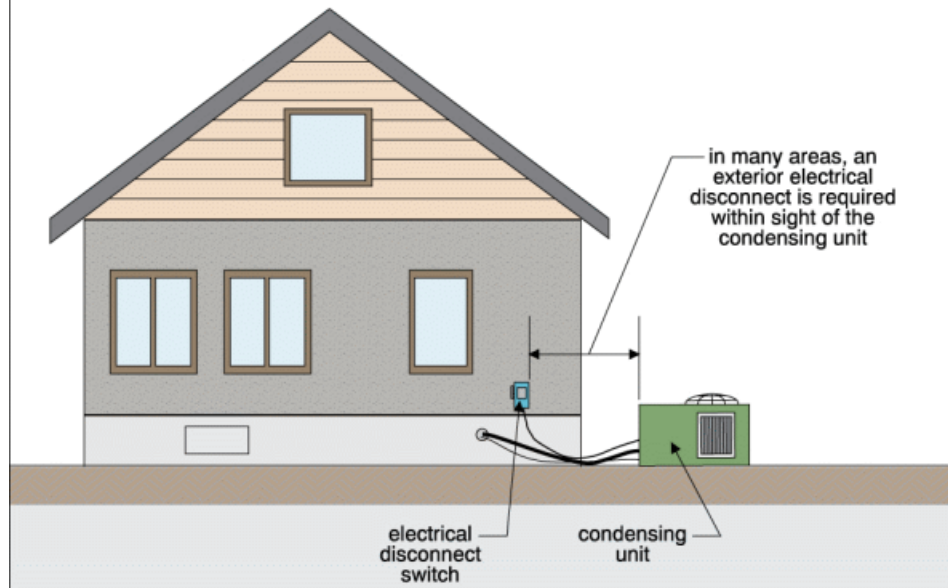
Condition: • [Missing electrical shutoff](#)

Missing electrical shutoff

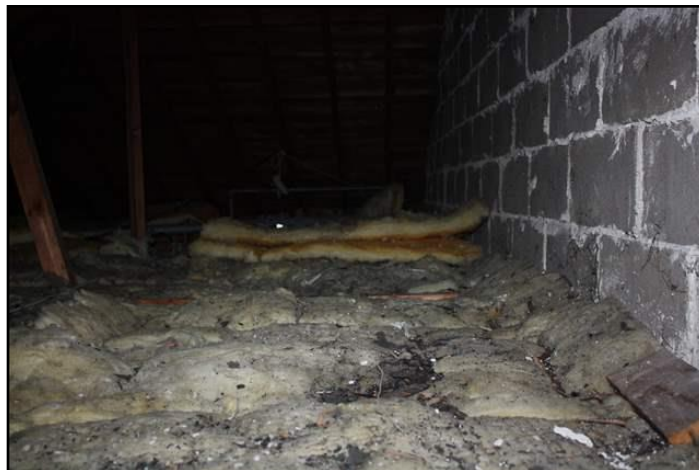
Condition: • [Amount less than current standards](#)

Amount less than current standards

Task: Upgrade

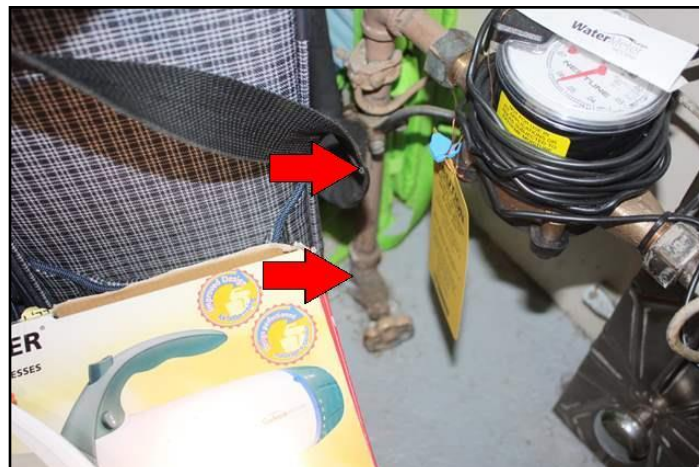
Condition: • Galvanized steel supply pipe should be replaced

Galvanized steel supply pipe should be...

Task: Further evaluation

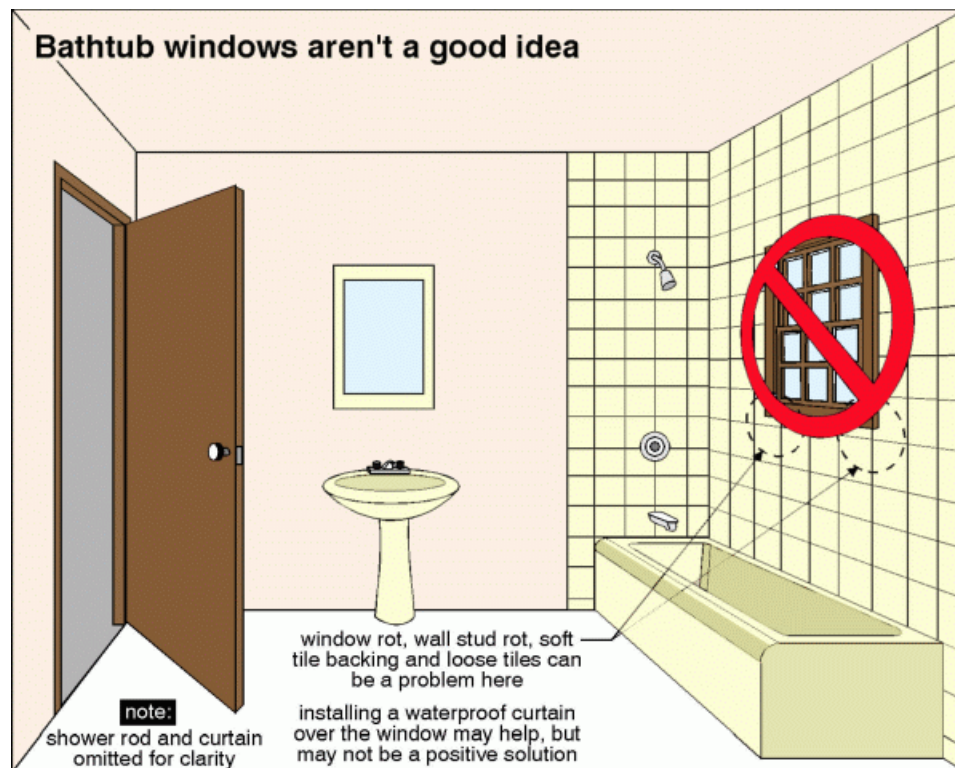
Condition: • Window in a bathtub enclosure.

Implication(s): Windows in tub enclosures are more prone to water damage. Extra attention should be paid to ensure the area is well sealed and efforts should be made to minimize the amount of water directed at the window.

Task: Monitor/Improve

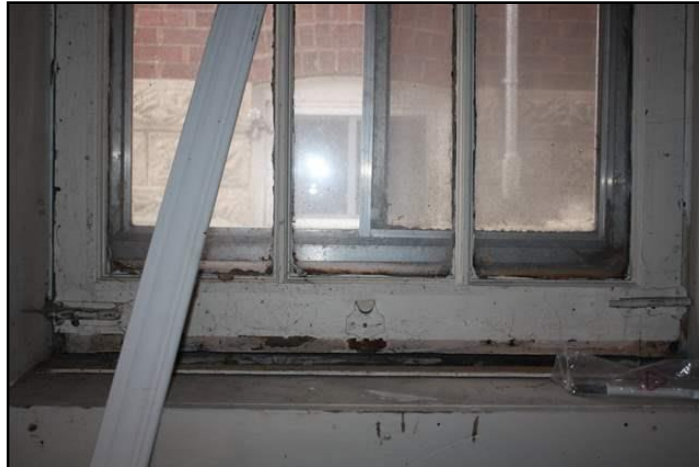
Condition: • [Original lower quality units](#)

Example

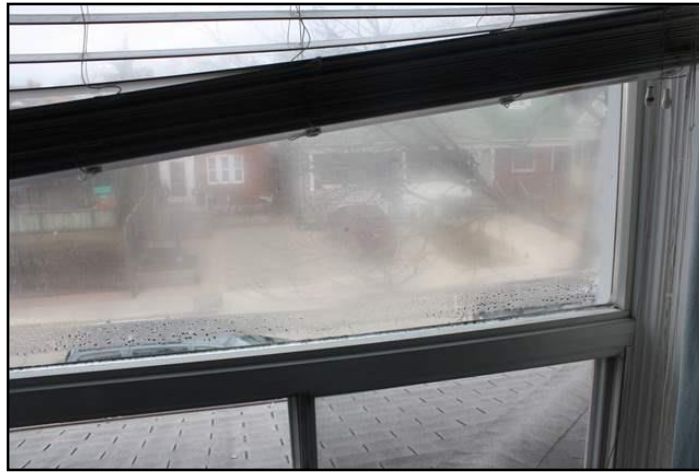
Condition: • [Lost seal on double or triple glazing](#)

Lost seal on double or triple glazing

Task: Replace

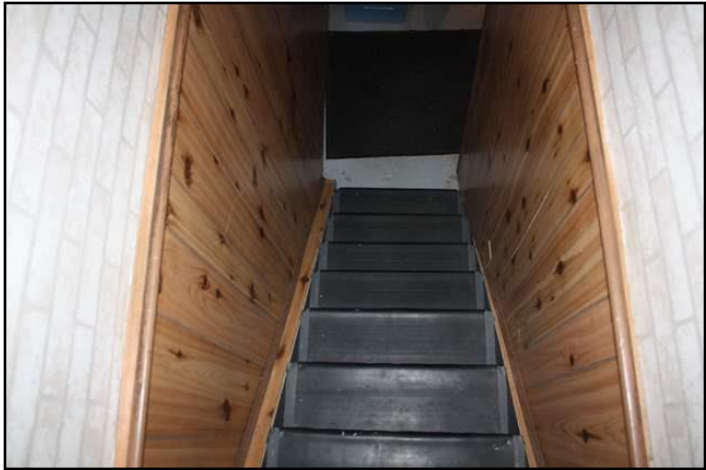
Condition: • [Missing](#)

Missing handrails
