Your Inspection Report

268 Montrose Avenue
Toronto, ON M6G 3G8

Michael Turney, Certification #33304

RE: Report No. 1019, v.4
268 Montrose Avenue
Toronto, ON
M6G 3G8

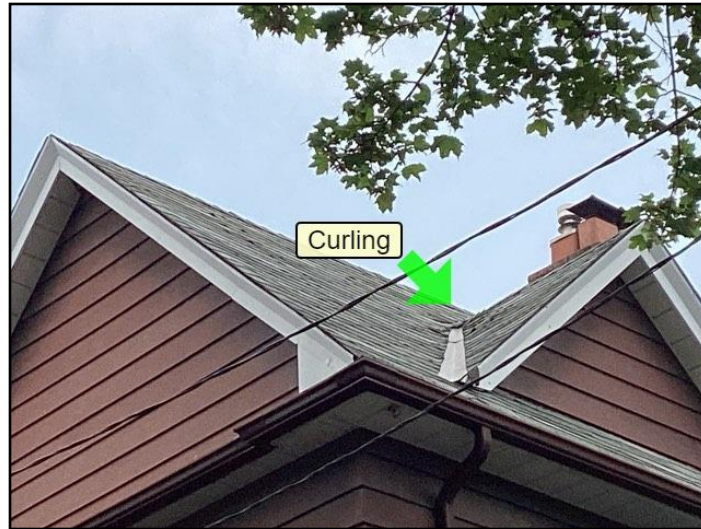
1. Condition: • Aging

Asphalt shingles and roof valleys showing signs of aging, including curling of the shingles, loss of granules, and general breakdown.

Curling, deteriorating shingles

Task: Replace - and consider replacing roll roofing at the same time.

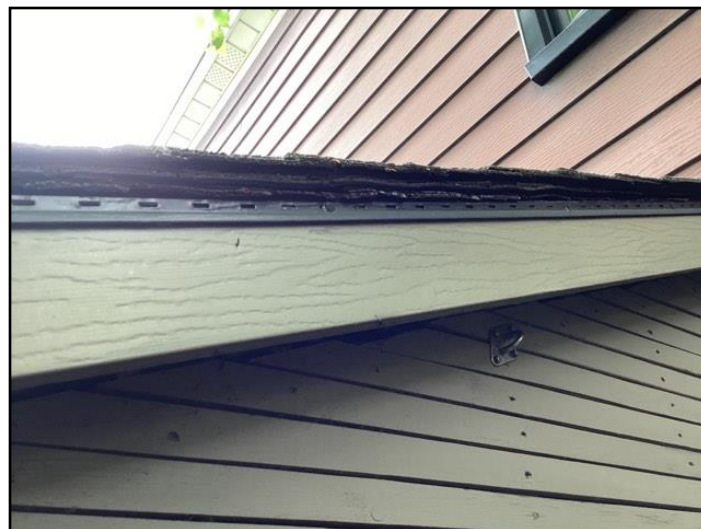
2. Condition: • [Multiple layers](#)

Shed attached to house has multiple layers of shingles. Consider replacing when updating the roof of the house.

Implication(s): Shortened life expectancy of material

Asphalt shingles

Task: Replace

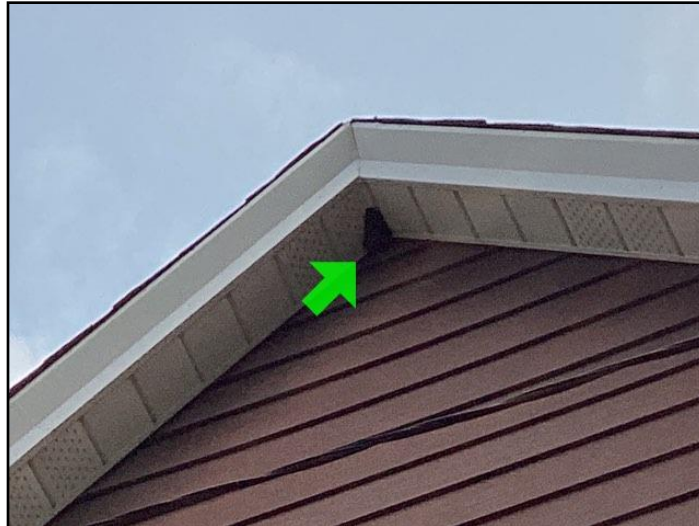
3. Condition: • [Insect damage](#)

Unable to determine whether the nest is active at the time of the inspection.

Implication(s): Material deterioration

Insect nest

Task: Remove

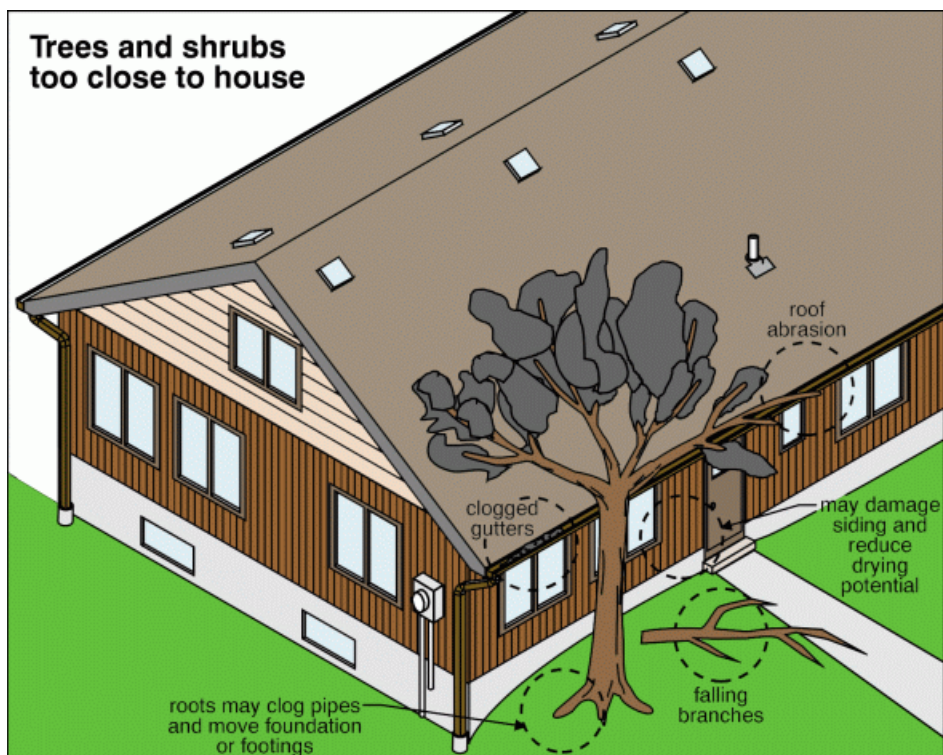
5. Condition: • [Trees or shrubs too close to building](#)

Consider trimming and or removing some of the foliage in front of the house to improve access to gas meter, water main valve, as well as garden drainage and overall aesthetic.

Implication(s): Chance of water damage to structure, finishes and contents | Chance of pests entering building | Material deterioration

Task: Correct

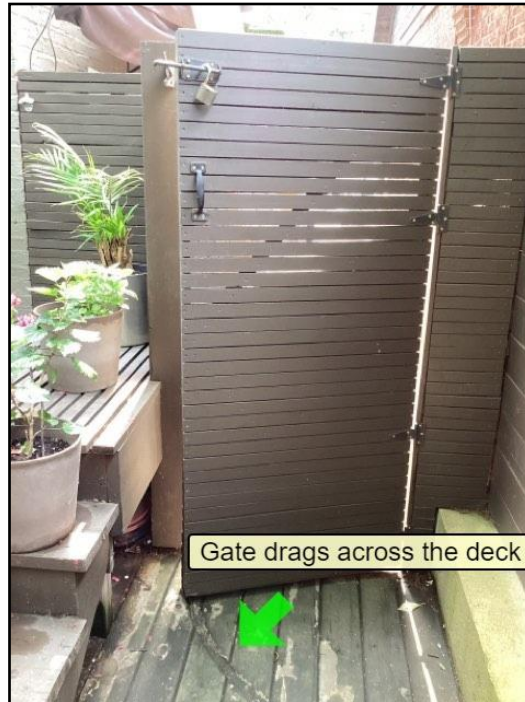
6. Condition: • Gate - adjustment needed

Gate does not open and close smoothly -- needs to be adjusted for resistance free motion.

Side gate

Task: Repair

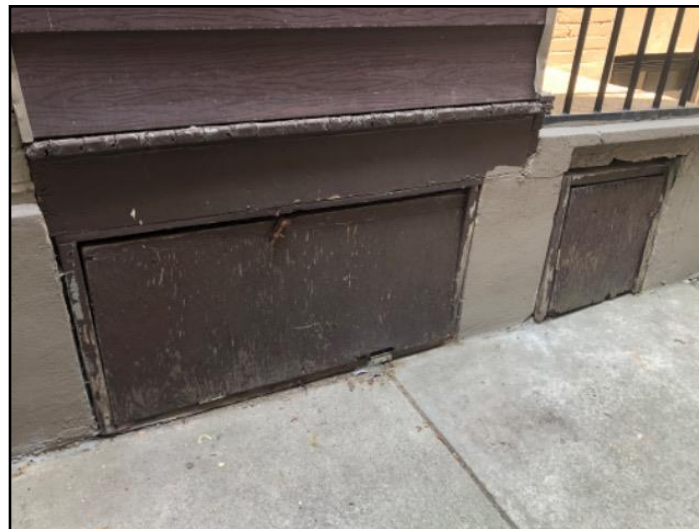
7. Condition: • Both access doors under the porch are deteriorating and need to be replaced or repaired to improve their open and close function.

Access hatch/doors

Task: Repair or replace

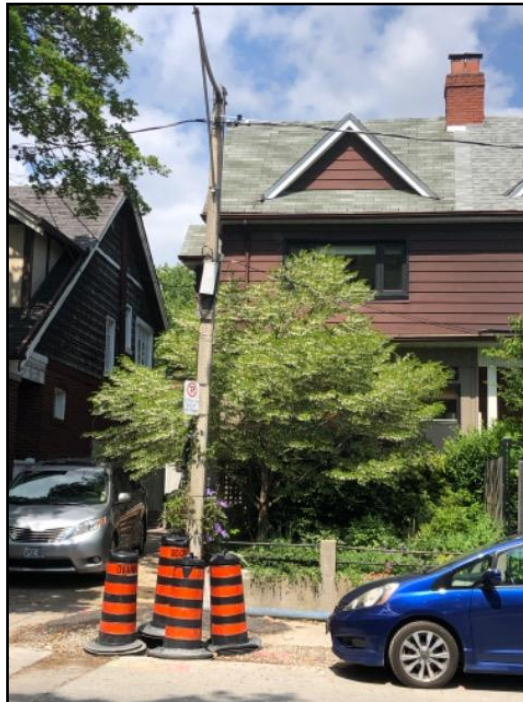
Thick bush in the front garden made the visual inspection of the front of the house difficult. Access was also somewhat hindered due to City of Toronto water works activity at the time of the inspection.

Vines/shrubs/trees

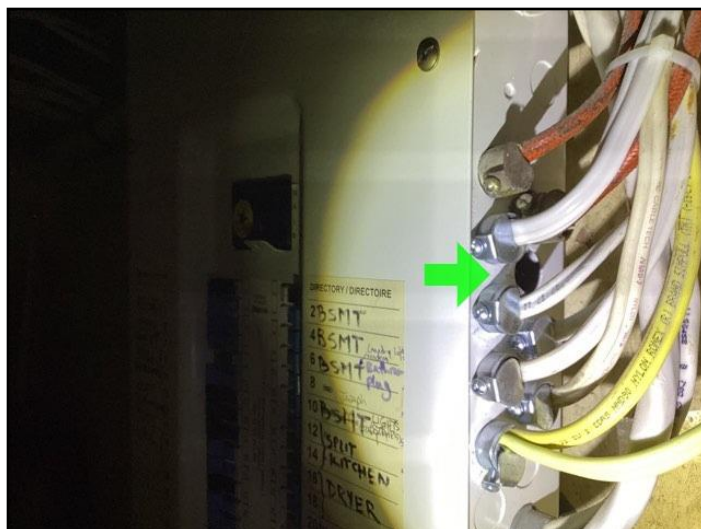
9. Condition: • Missing knock-out from right side of panel.

Electrical panel

Task: Correct

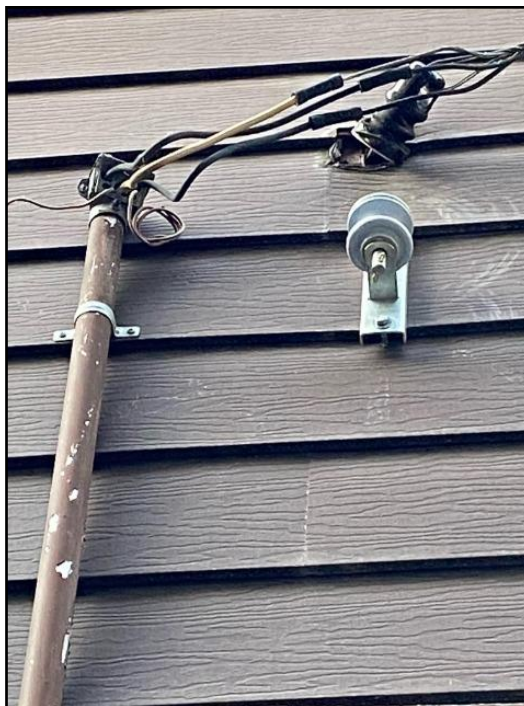
10. Condition: • Work-in-progress -- a new clevis has been affixed to the house but the hydro support wire still needs to be attached. Recommend an electrician complete this task.

Task: Complete the task as per above

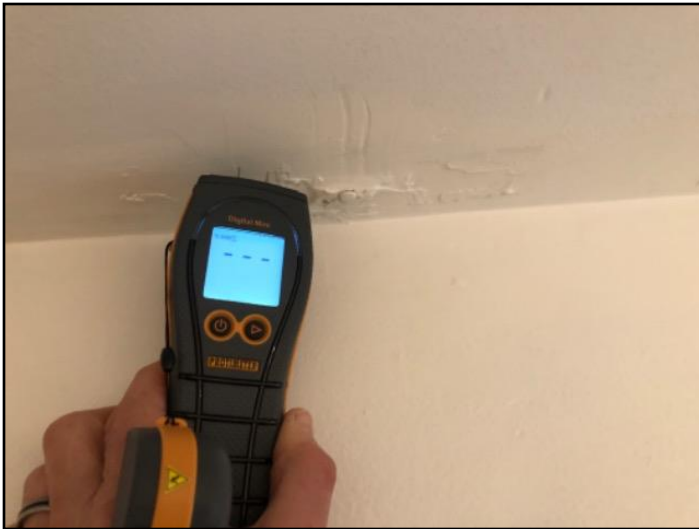
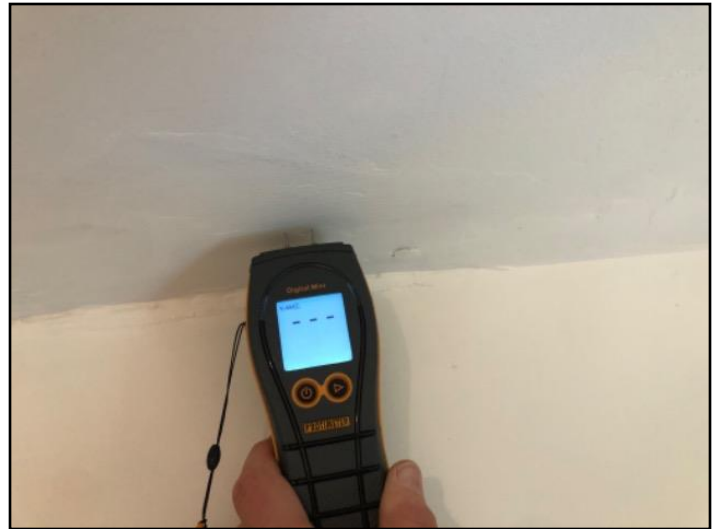
16. Condition: • [Nail pops](#)

Ceiling nail pops in second floor bedroom #2. In older homes the framing can move slightly from its original position or shrink away from walls and ceilings. This drying and shrinkage leaves the nails to loosen in their locations. Make sure to correct using proper screw length. For ¼-inch drywall, use 1-inch to 1 ¼-inch sheetrock screws. For ½-inch drywall, use 1 ¼-inch to 1 ½-inch sheetrock screws. For ¾-inch drywall, use 1 ½-inch to 2-inch sheetrock screws. The area was tested and no moisture was detected at the time of the inspection.

Nail pops

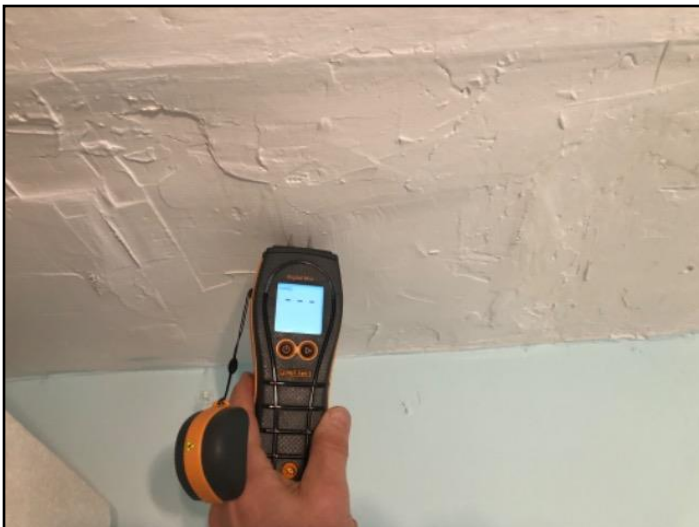
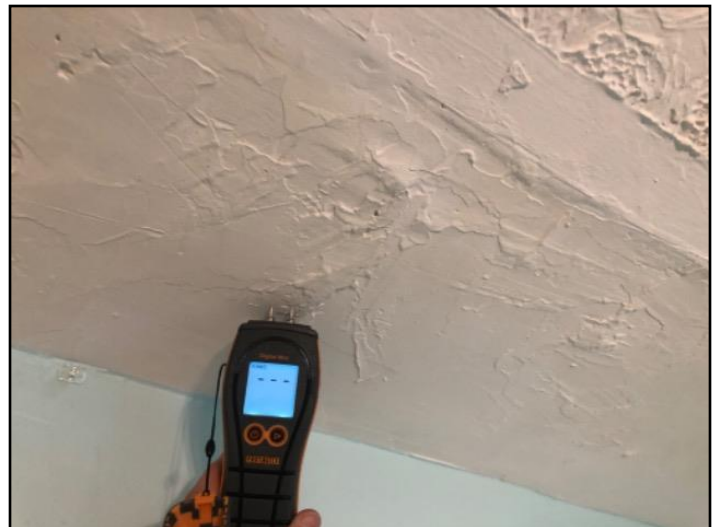
17. Condition: • [Patched](#)

Patched area of ceiling in second floor bedroom #1. Appears to be patchwork following the removal of pre-existing cabinets. The area was tested and no moisture was detected at the time of the inspection.

Patched area

Task: Correct
