# YOUR INSPECTION REPORT

FOR THE PROPERTY AT:  
22 Ostend Avenue  
Toronto, ON M6S 1L4

PREPARED FOR:  
ALEX PORRITT  
GILLIAN RITCHIE  
INSPECTION DATE:  
Monday, February 28, 2022

RE: Report No. 7023  
22 Ostend Avenue  
Toronto, ON  
M6S 1L4

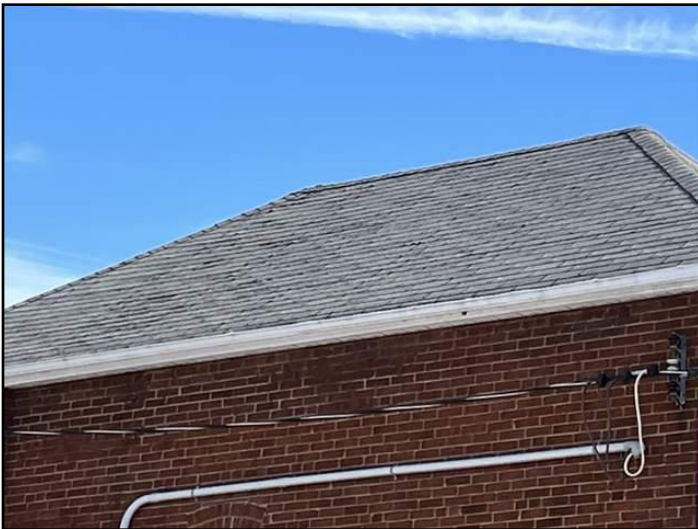
The current roof covering is old /worn and is at the end of its lifespan. Due to sun exposure, the South / West sides of roofs typically wear out faster. We recommend full replacement.

1. Old, worn out

**Task:** Replace

**Time:** This Spring

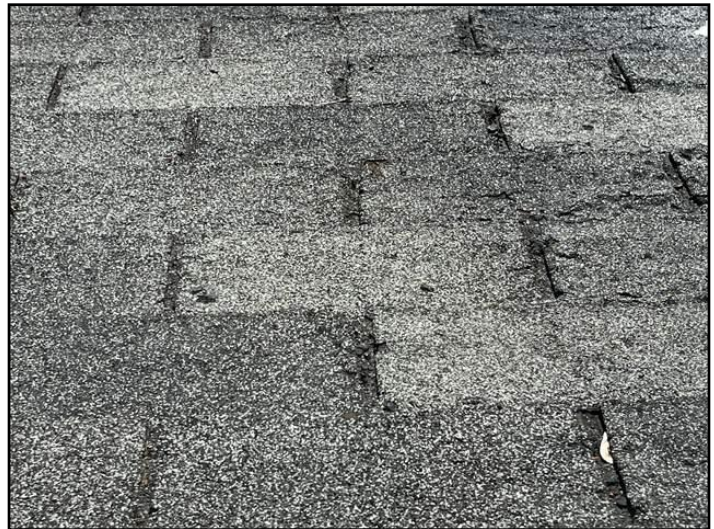
2. Old, worn out

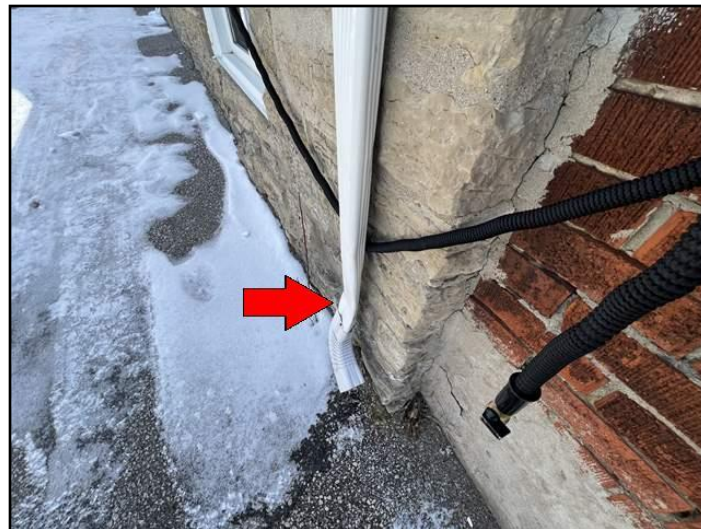
**Condition:** • [Damage](#)

3. Damage

**Task:** Repair / Replace

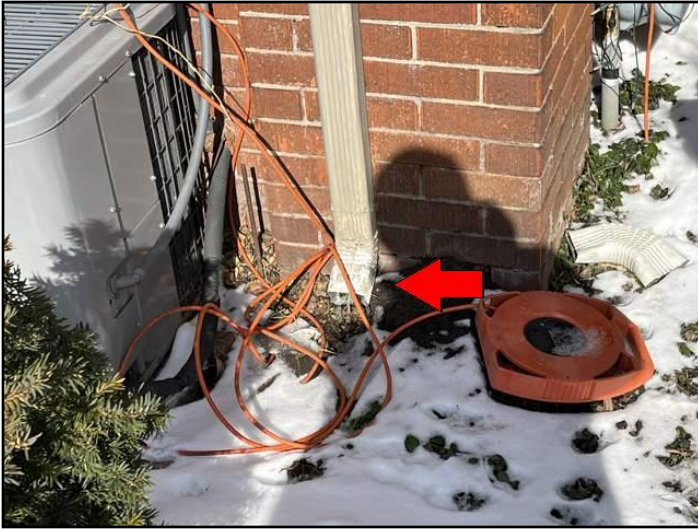
**Condition:** • [Discharge too close to building](#)

4. Discharge too close to building

**Time:** Less than 1 year

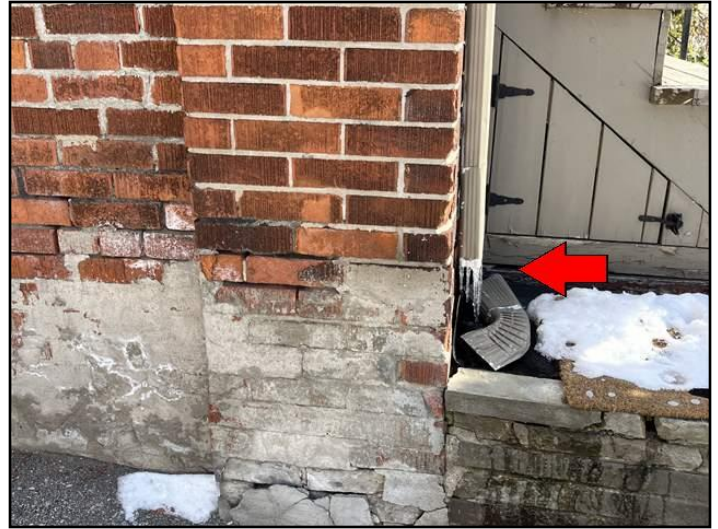
5. Discharge too close to building

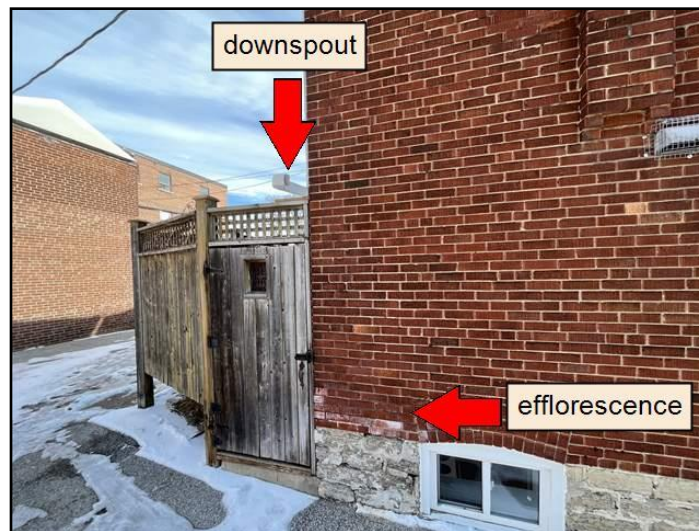
**Condition:** • [Should discharge 6 feet from building](#)

Likely contributing to why efflorescence is noted at wall.

6. Should discharge 6 feet from building

**Task:** Extend downspout to ground

**Time:** Less than 1 year

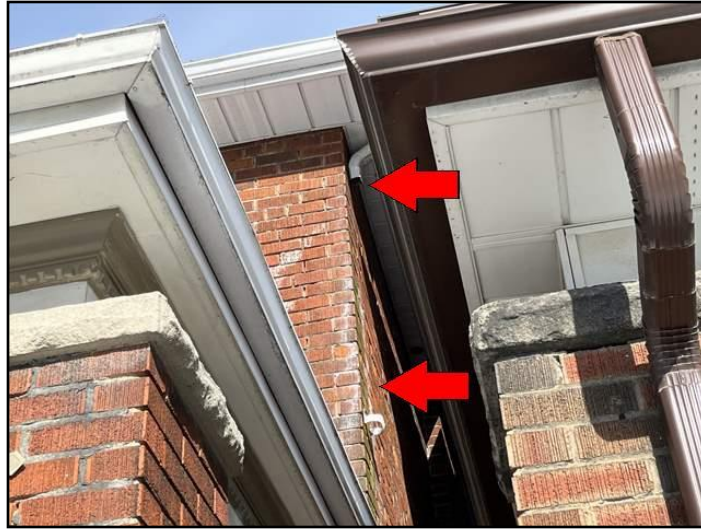
**Condition:** • [Missing](#)

7. Missing

**Task:** Replace

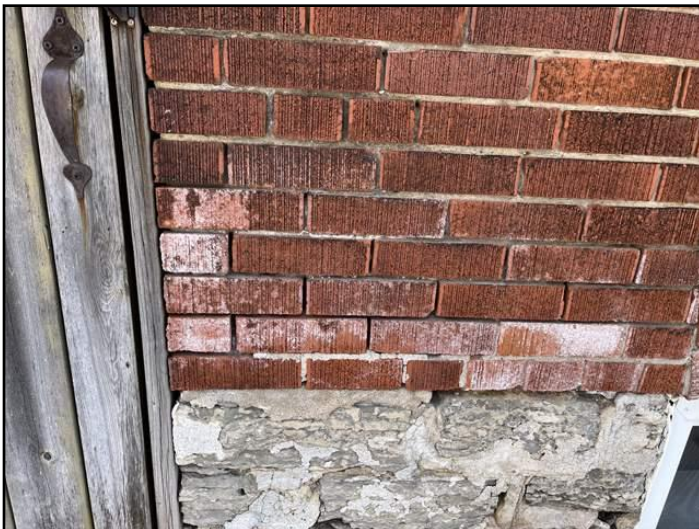
**Condition:** • [Mortar deterioration](#)

8. Mortar deterioration

**Task:** Repair

**Cost:** Consult masonry specialist

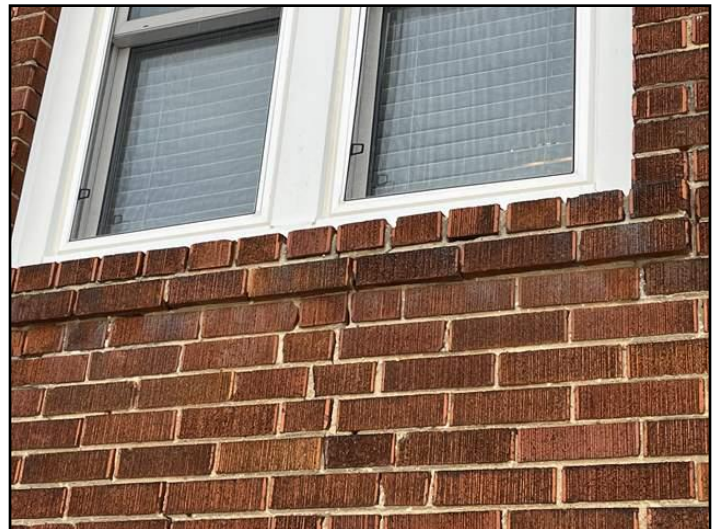
9. Mortar deterioration

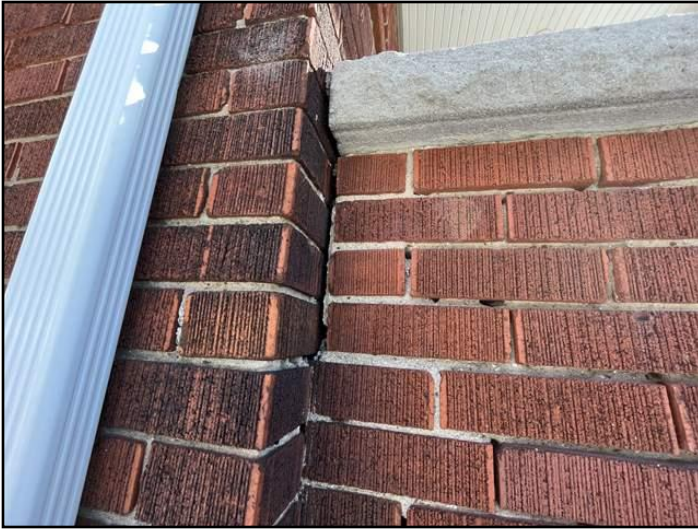
10. Mortar deterioration

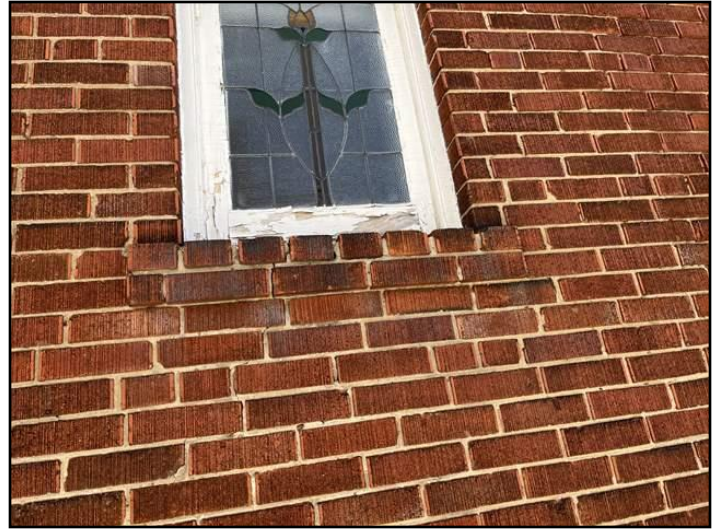
11. Mortar deterioration

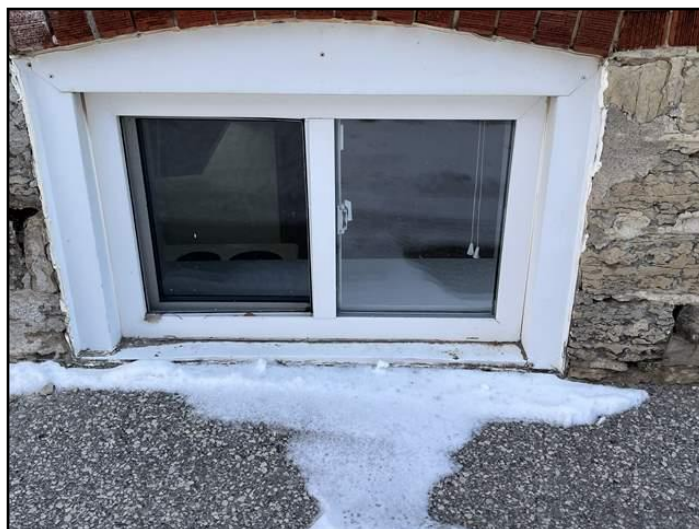
**Condition:** • Sill - Near or at Grade Level

12. Sill - Near or at Grade Level

**Task:** Monitor / Improve

**Time:** As Required

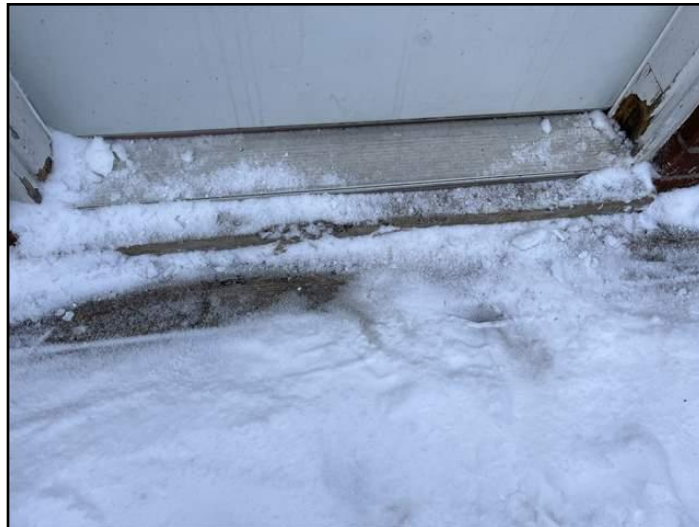
**Condition:** • Threshold too low

On the other hand, it also makes it more prone to snow buildup/leakage.

13. Threshold too low

While it is probably not practical to improve the current situation (unless rebuilding the deck), it will be important to keep any weatherstripping/caulking in good condition.

**Task:** Monitor / Improve

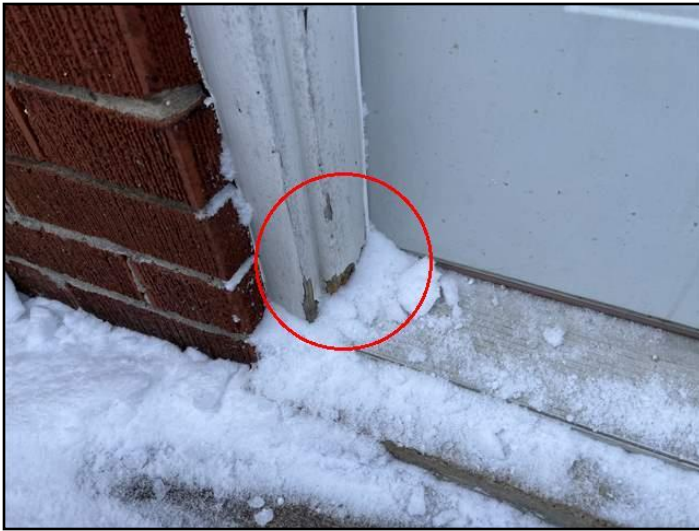
14. example

**Condition:** • [Rot](#)

**Task:** Repair / Replace

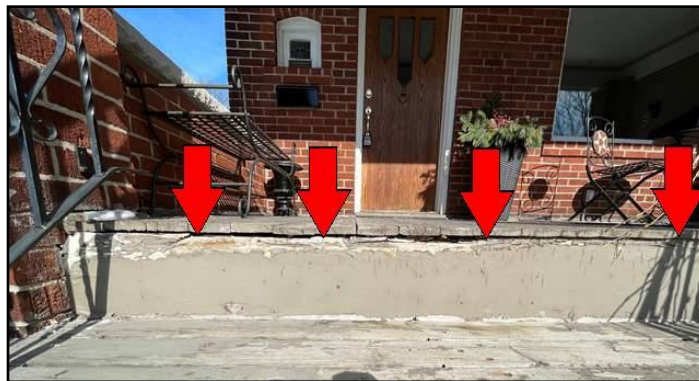
**Condition:** • [Steps springy, loose or sagging](#)

16. Riser old/worn

**Task:** Improve / Repair riser floor board support

**Time:** Less than 1 year

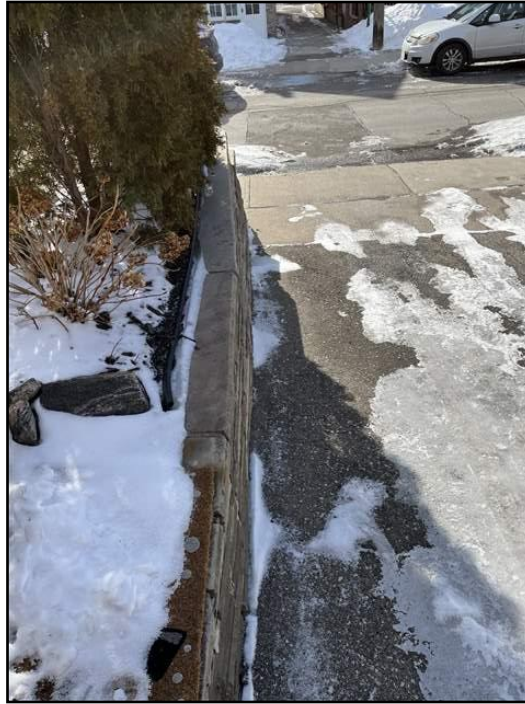
**Condition:** • [Bowing or bulging](#)

Uncertain if wall was installed with curve or bowing over time. Does not appear to be an imminent issue. Monitor activity and make improvements/repairs only if movement noted.

17. soil retaining wall

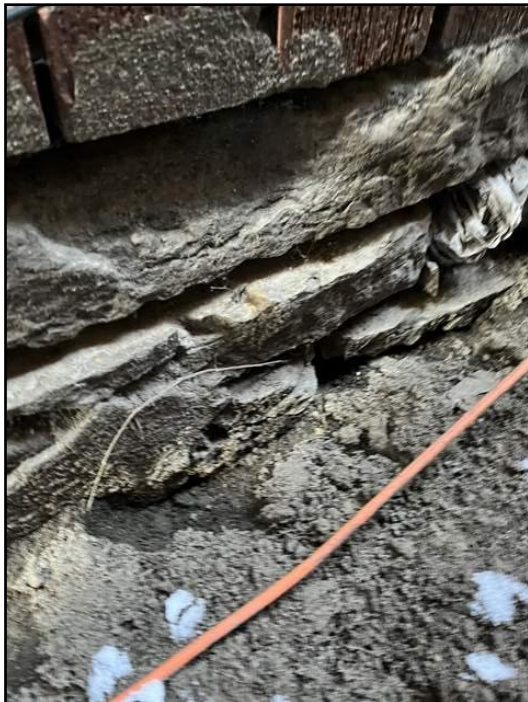
**Condition:** • [Mortar deteriorated or missing](#)

Older Stone foundations typically require masonry and mortar work.. Recommendation is to provide mortar and masonry at stone foundations where required and then parge foundations (parging also noted in report) photos show small sampling

18. Mortar deteriorated or missing

**Task:** Repair

**Time:** Less than 1 year

**Cost:** Consult masonry specialist

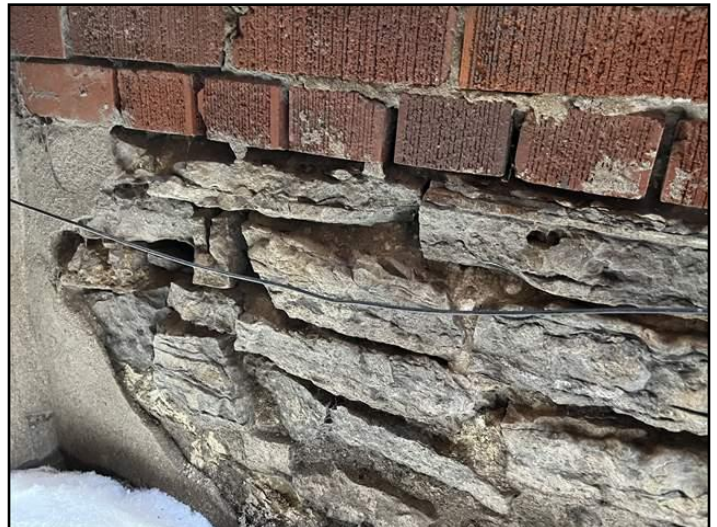
19. Mortar deteriorated or missing

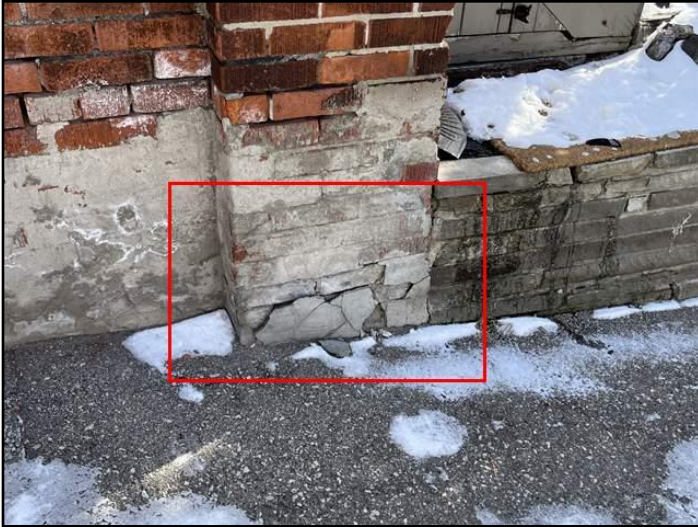
## Condition: • [Parging damaged or missing](#)

It is common to provide parging on older stone foundations. The parging will break down over time and crack/crumble. photos show a sampling

20. Parging damaged or missing

**Time:** Less than 1 year

**Cost:** Typically \$5-\$7 per square foot

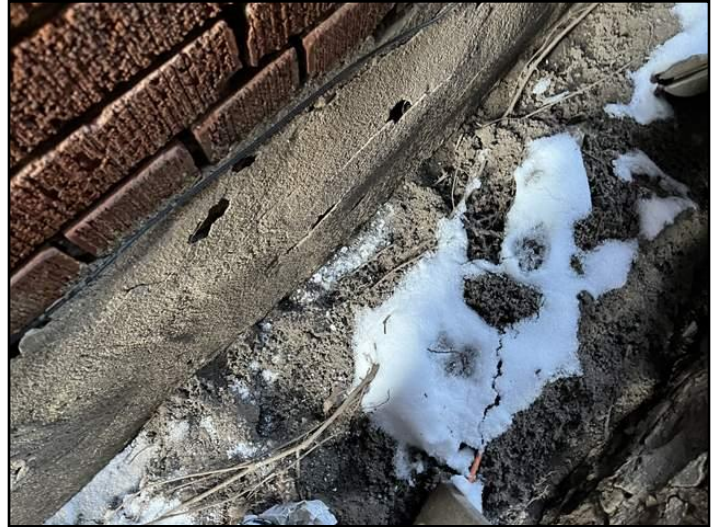
21. Parging damaged or missing

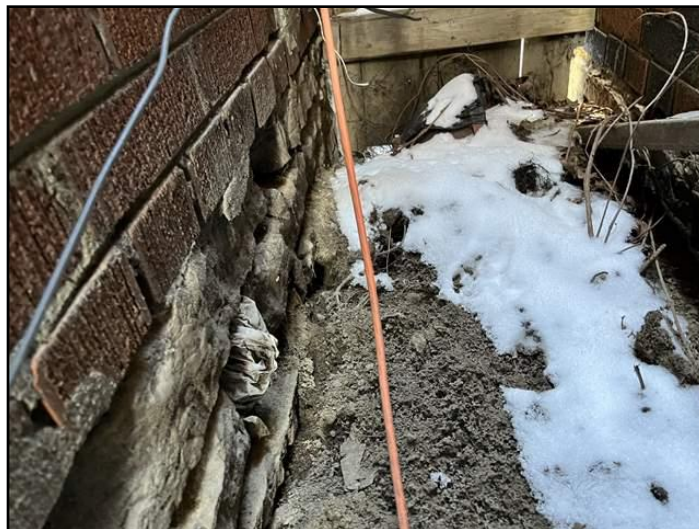
22. Parging damaged or missing

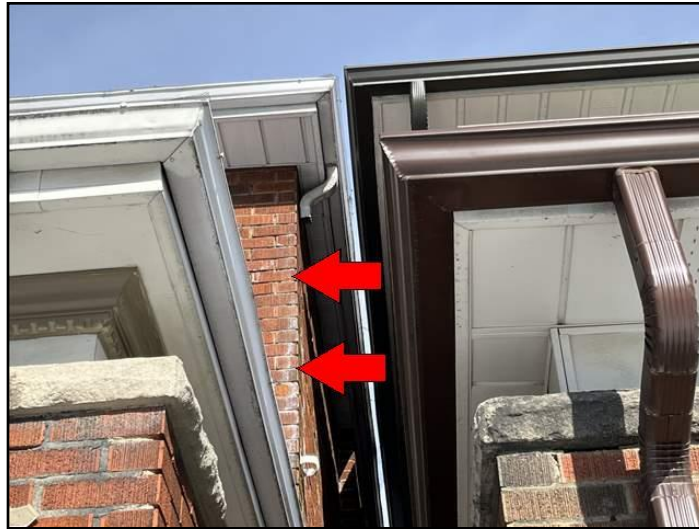
## Condition: • [Efflorescence](#)

efflorescence noted at right and left side. Both areas appear to be caused by deficiencies with lack of downspouts.

23. Efflorescence

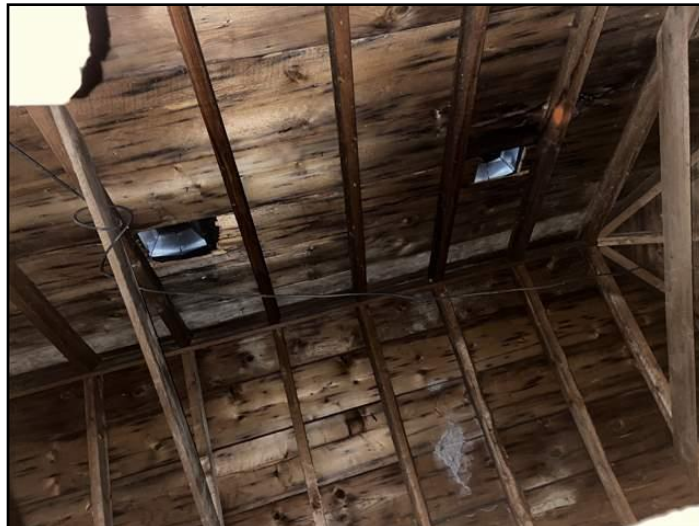
### Condition: • [Water stains](#)

Evidence of prior leakage. See roofing note

24. Water stains

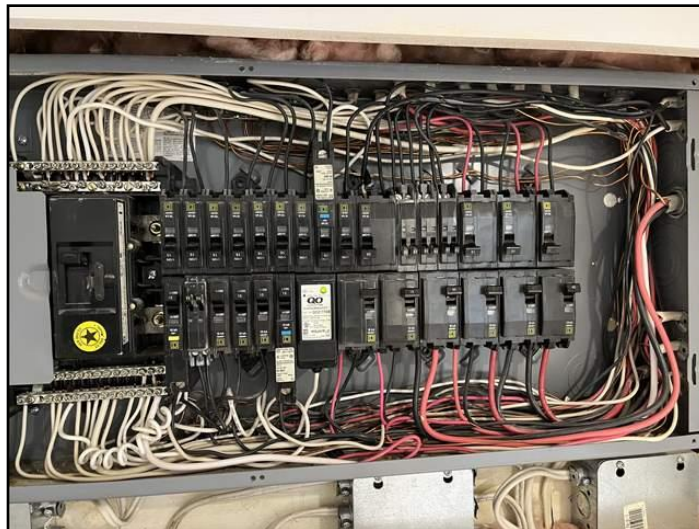
Good condition

25. Breakers - basement

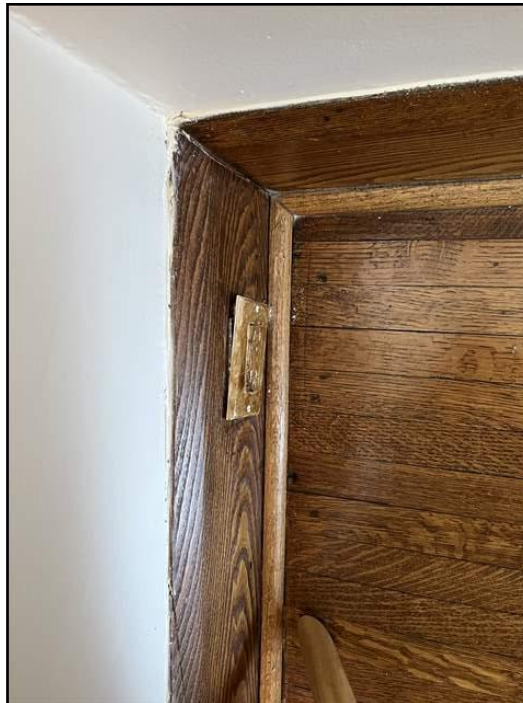
**Condition:** • [Loose](#)

26. Loose

**Task:** Correct

**Time:** As Soon As Possible

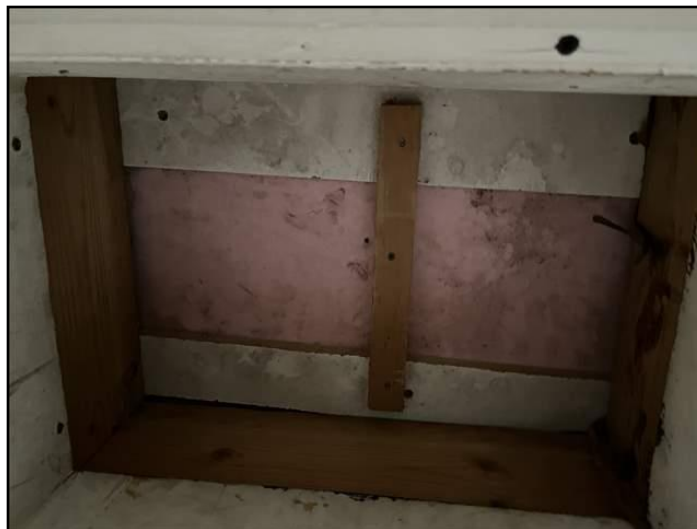
27.

**Condition:** • Attic hatch is less than ideal. Improve hatch and weather strip to prevent air loss into attic

**Task:** Replace

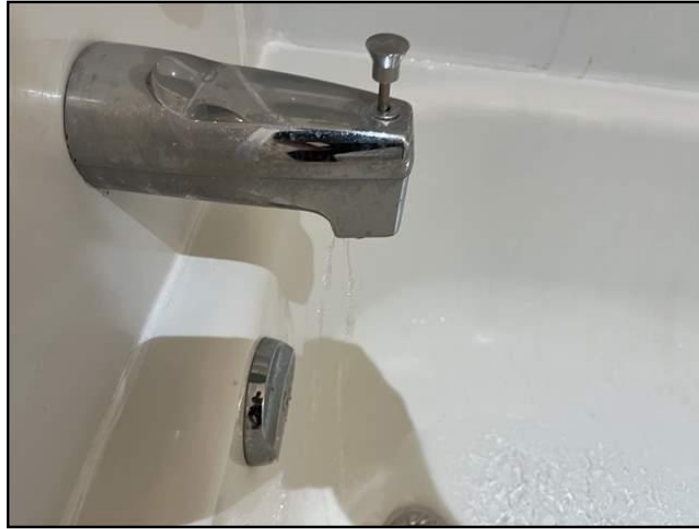
**Condition:** • [Shower diverter inoperative or defective](#)

28. Shower diverter

**Task:** Clean or Replace

**Time:** Regular maintenance

**Cost:** Minor

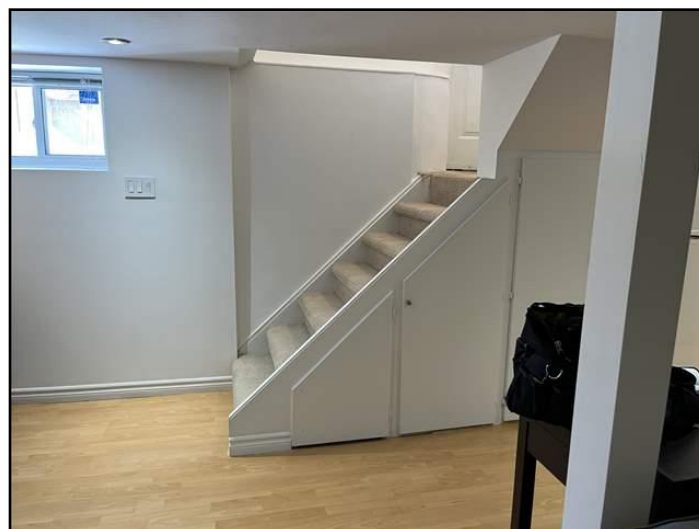
**Condition:** • [Missing](#)

29. Missing

**Task:** Provide

**Time:** Less than 1 year

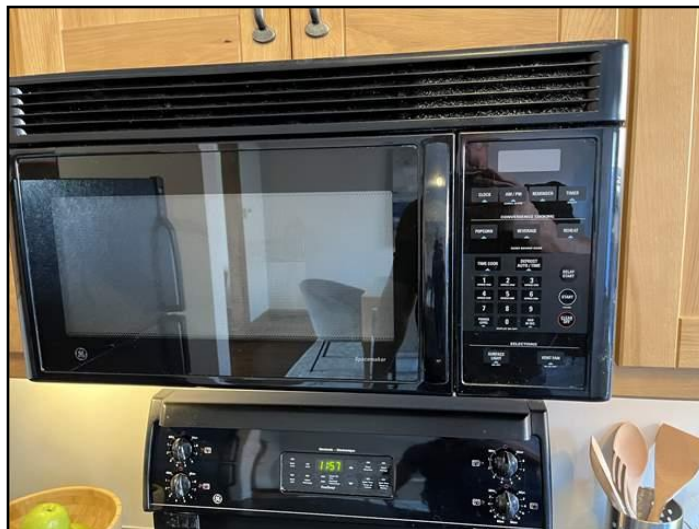
**Condition:** • Inoperative

30. Inoperative

**Task:** Repair or Replace

**Time:** As Soon As Possible
