YOUR Inspection Report

75 York View Dr
Toronto, ON M8Z 2G3

Sunday, August 18, 2019

Report No. 5700, v.2

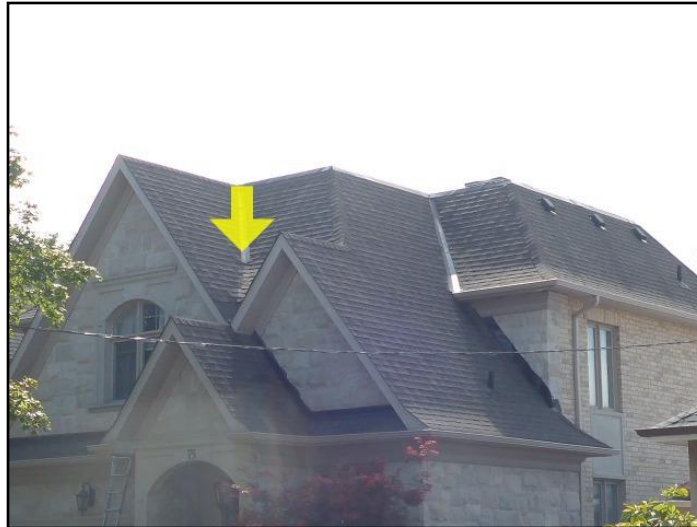
Condition: • 'Log jam' roof design will be more prone to water issues.

Note: No evidence of problem was noted at the time of inspection.

Converging roof lines

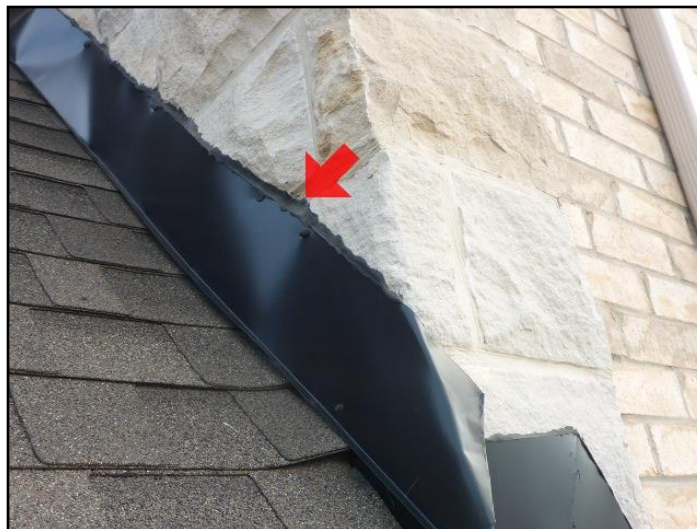
Condition: • Flashings are vulnerable areas

Some flashings are relying on caulking to remain water tight. Caulking is prone to cracking over time. All flashings should be monitored annually.

Regular maintenance is important

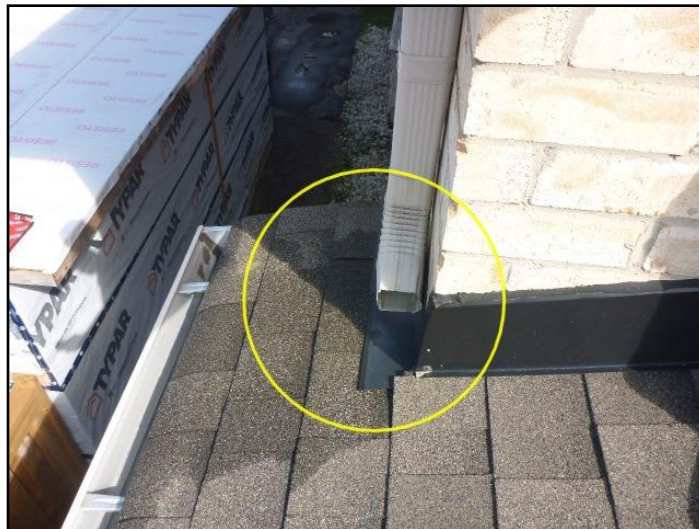
Condition: • [Drain onto lower roof - causes premature roof wear](#)

Extend to gutter below

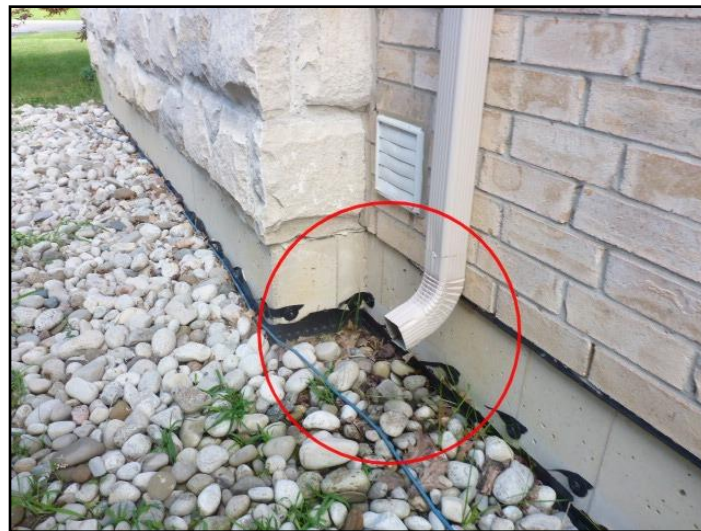
Condition: • [Downspout ends too close to home. It should direct water at least 6 feet from building.](#)

Extend all downspouts away from foundation

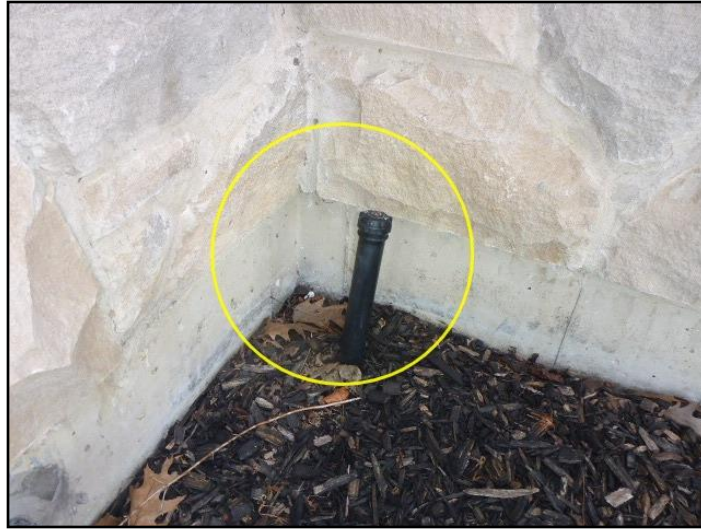
Condition: • Care should be taken with lawn sprinkler systems (irrigation systems). These can wet and damage exterior walls and cause leakage problems into basements and crawlspaces. Water should not be directed against or adjacent to the building.

Reconsider irrigation up against foundation

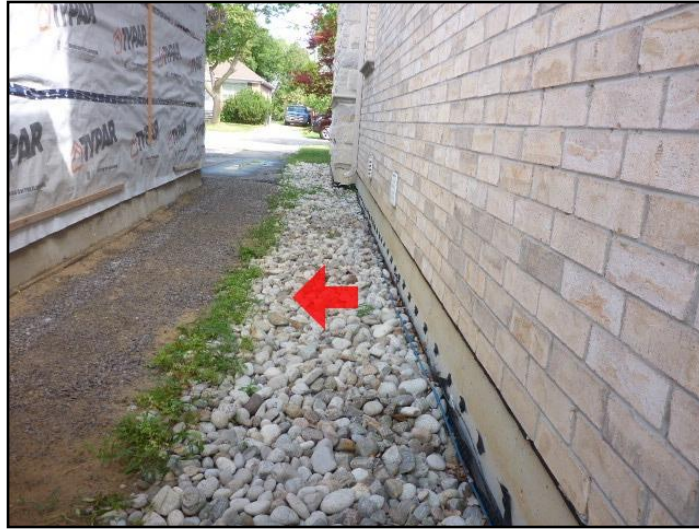
Condition: • As discussed, try and create a 'dry moat' in the form of proper lot grading topped with heavy plastic and gravel. Patio slabs, interlock stones or poured concrete is also a solution but considerably more expensive. The goal is to move water at least 3 feet away from the home before it can enter the soil. This task should be completed as soon as possible. See comments at the Interior section of the report for other information regarding basement leakage.

Move water away from foundation

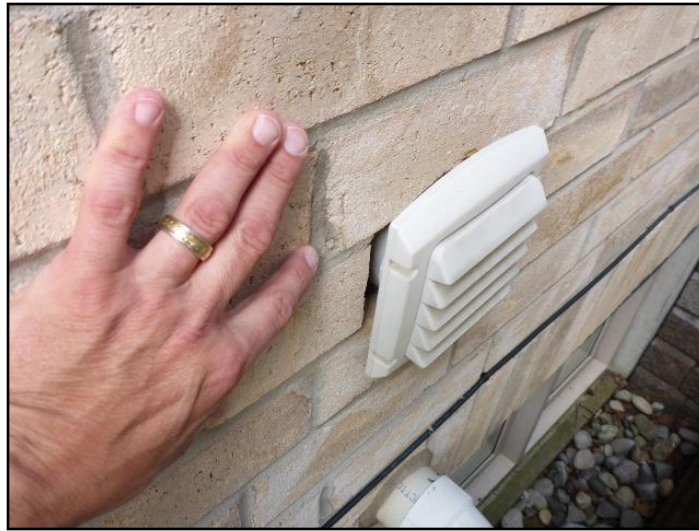
Condition: • [Vent not well sealed](#)

Seal vent

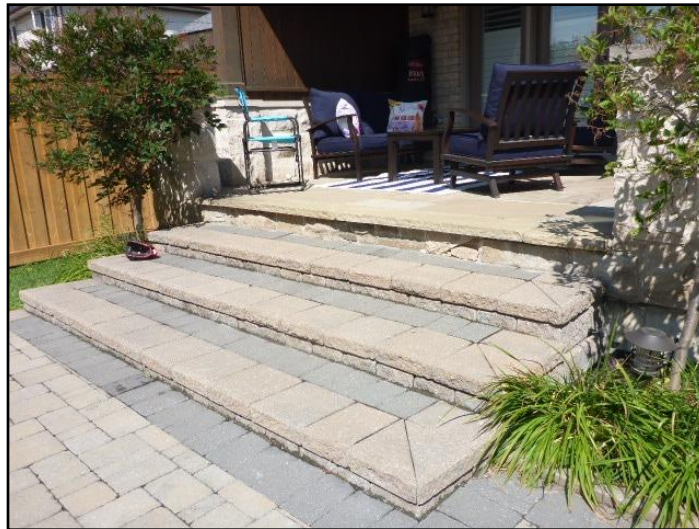
Condition: • [Missing](#)

Railings recommended

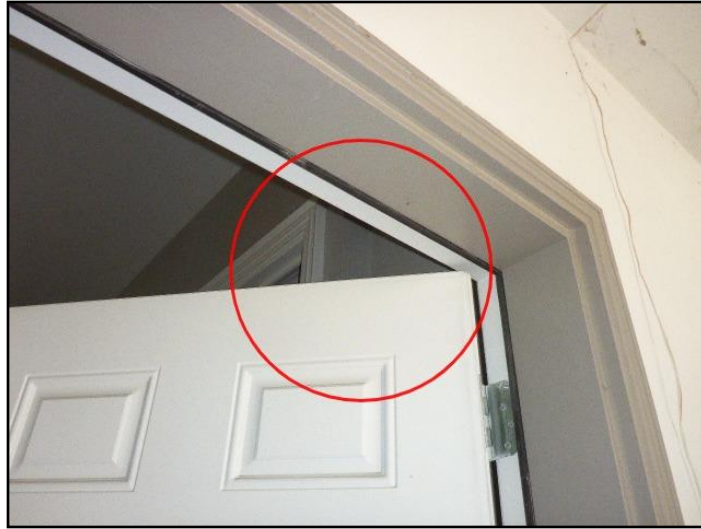
Condition: • [Man-door closer missing \(8.3\)](#)

Missing door closer

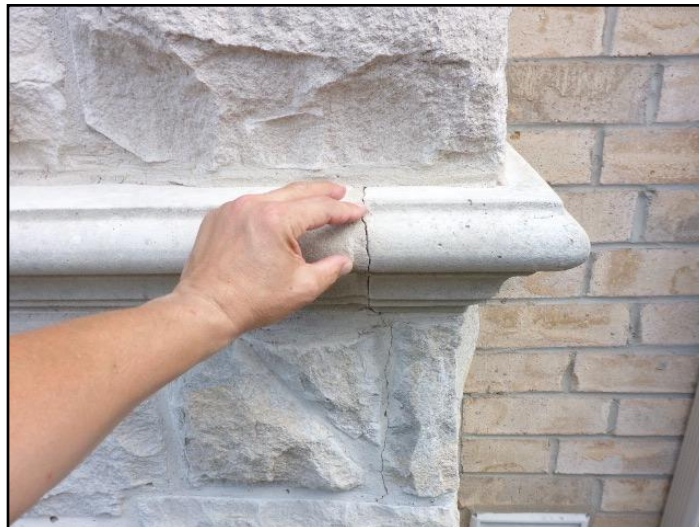
Condition: • Most foundation walls and masonry walls have small cracks due to shrinkage or settlement that occurred shortly after construction was completed. These will not be individually noted, unless leakage or building movement is noted.

Example of a typical crack

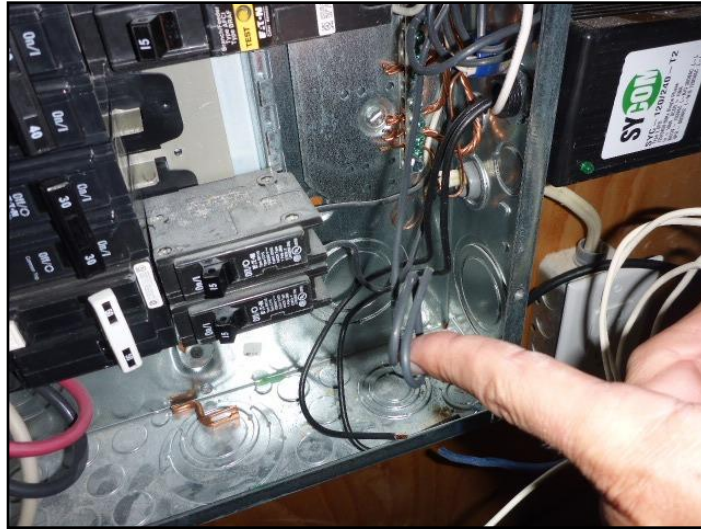
Condition: • [Abandoned](#)

Abandoned wiring in panel

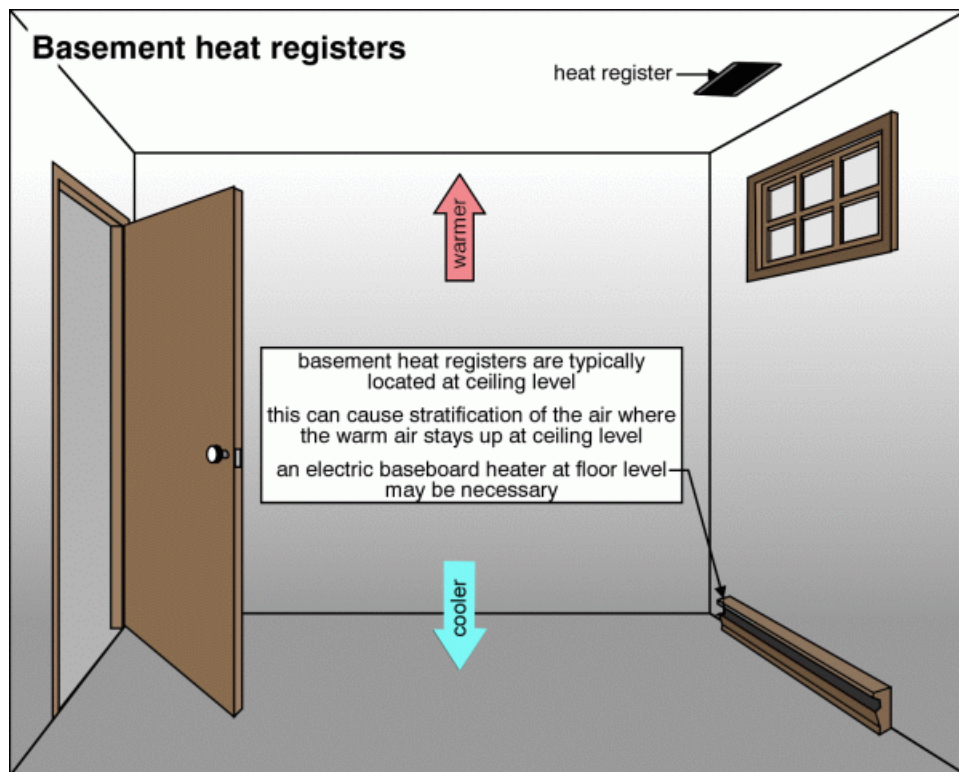
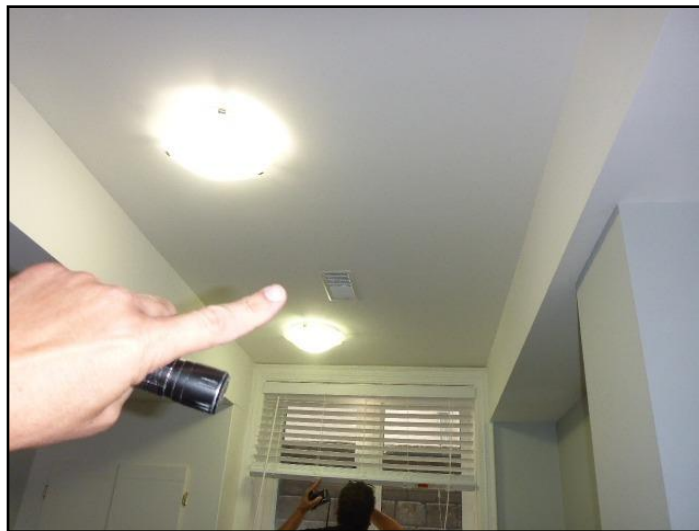
Room adjacent to furnace

Condition: • [Supply registers - ceiling locations not ideal in basement \(may result in warm ceiling/cool floor\); if necessary.](#) re-locate registers to walls (near floors) or provide electric baseboard heating

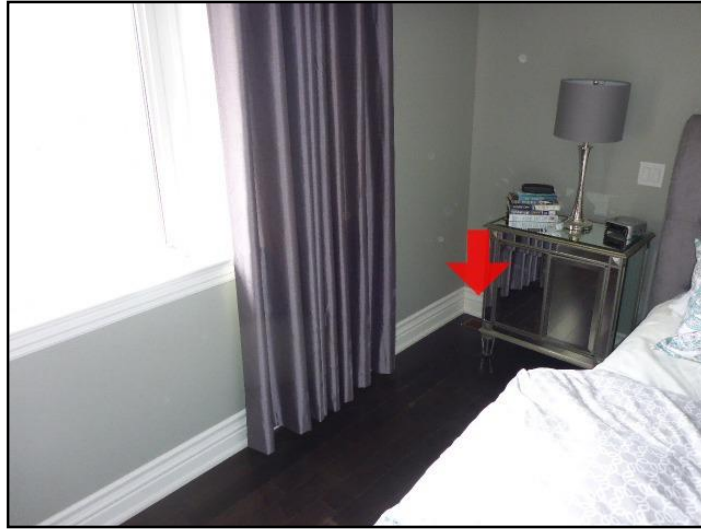
Condition: • [Supply registers - poor location](#)

Ideally, supply registers are below windows

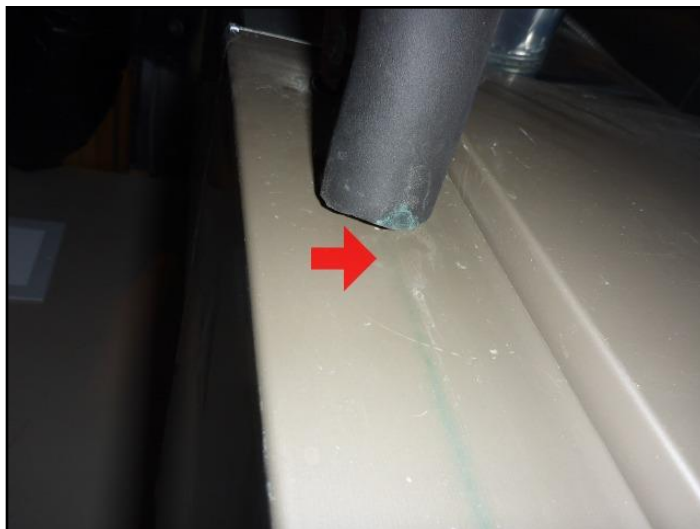
Condition: • [Unsealed gap at plenum](#)

Condensation stains noted

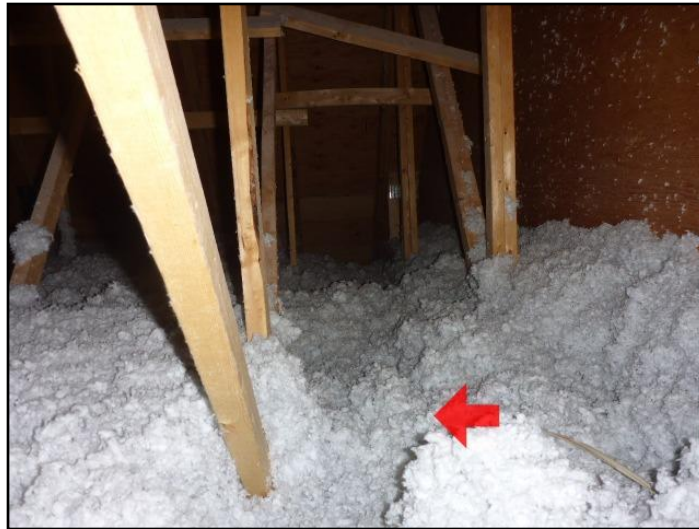
Condition: • [Insulation - voids noted](#)

Voids noted at insulation

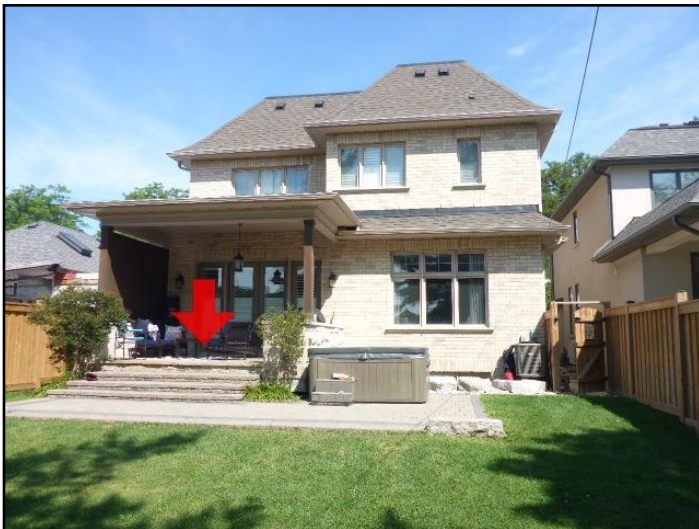
Living space below rear patio

Condition: • The storage room at the back of the basement is built underneath the rear outdoor patio. This configuration is the same as a traditional cold room/cantina featured in many homes. Traditional cold rooms should not be finished with any organic material (wood, drywall, etc.) This will support mould growth. This mould growth will form on the back side of building materials first (not detectable until considerable damage has set in).

It is likely at this home the builder/architect recognized the physics involved and has taken special precautions through design to prevent water/mould issues. Without dismantling the structure, construction details could not be confirmed. The current homeowner will likely have insight. Drawings should be reviewed and all permits and final sign off paperwork should be filed. Monitor over time.

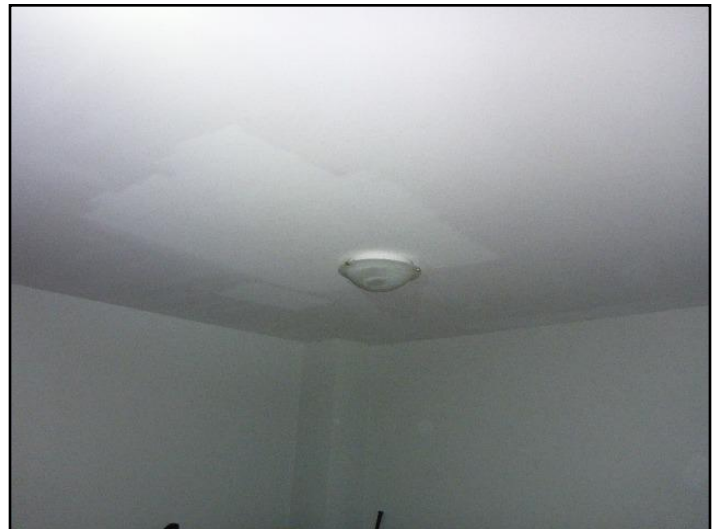
Patched ceiling?

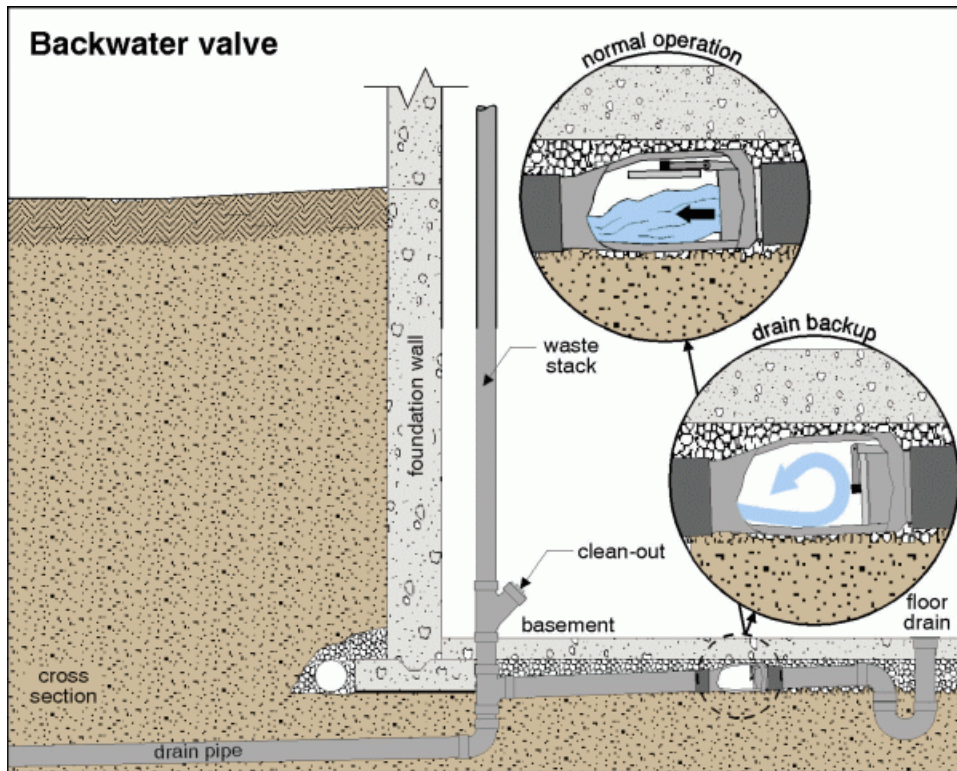
Condition: • [A backwater valve alarm should be installed.](#)

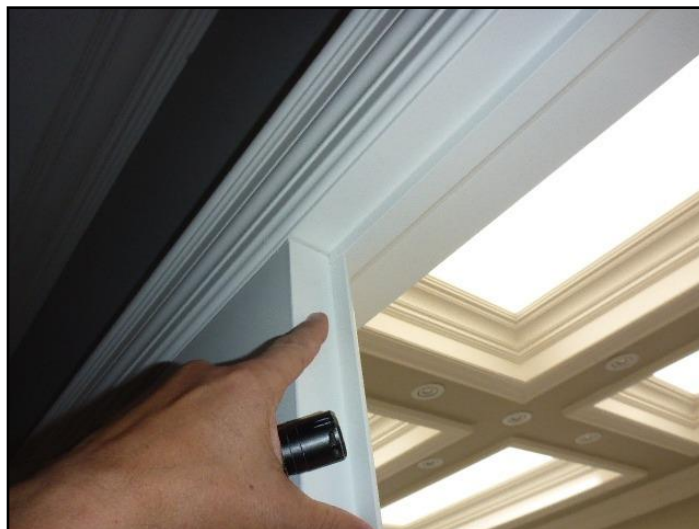
Condition: • [Hardware missing or defective](#)

Missing hardware at master bedroom door

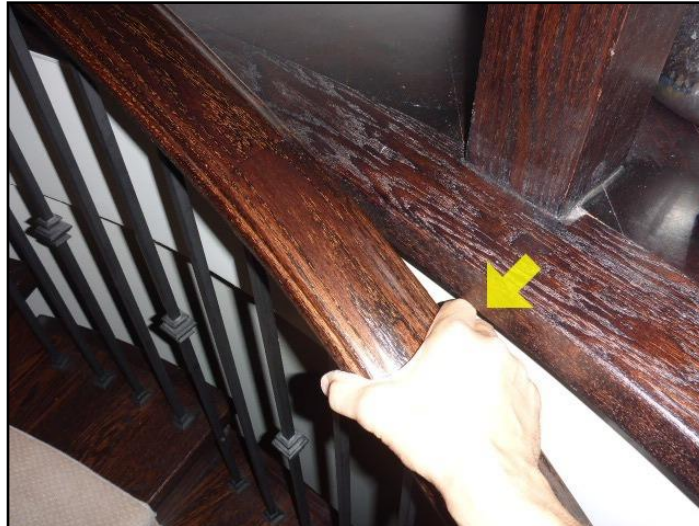
Condition: • Pinch point at railing noted.

Pinch point noted
