YOUR INSPECTION REPORT

FOR THE PROPERTY AT:
387 Kennedy Avenue
Toronto, ON M6P 3C5

INSPECTION DATE:
Thursday, February 26, 2026

RE: Report No. 9098, v.5
387 Kennedy Avenue
Toronto, ON
M6P 3C5

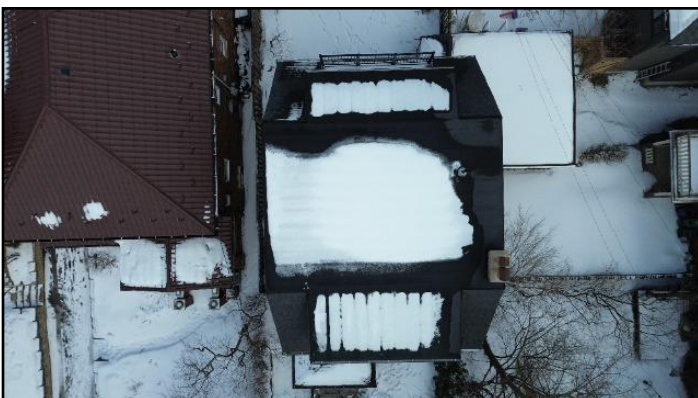
1. Roof view

Condition: • Snow on roof limited/restricted inspection. Inspect roof when accessible once snow and ice have cleared.

• Portions of the roof covering were snow/ice covered at the time of inspection, limiting full evaluation. Visible areas were inspected from the ground and or by drone where accessible.

Once snow conditions permit, these areas should be re-evaluated to confirm overall condition.

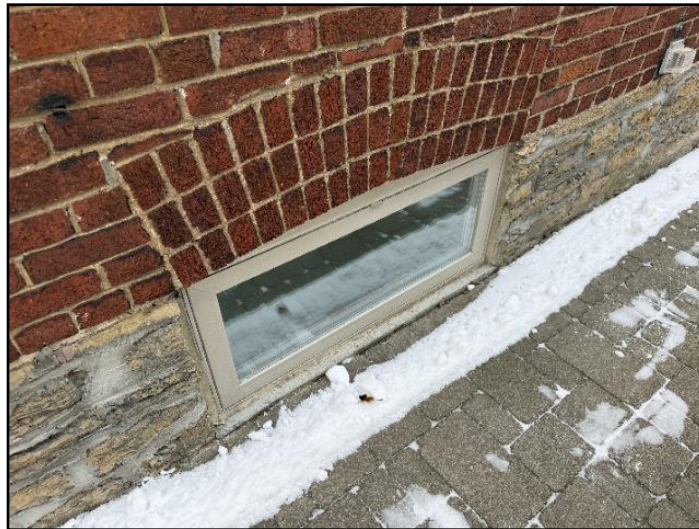
3. Sill - Near or at Grade Level

Condition: • Sill - Near or at Grade Level

Basement window at or near grade level. Modern standards recommend that the bottom of the window be at least 6 inches above grade or have a window well installed. Consider adding window well if regrading or when necessary. In the meantime, ensure windows remain well-sealed to prevent water intrusion.

Task: Monitor for moisture intrusion / Improve

Cost: If/when upgrading to window wells in the future, \$2000 and up each

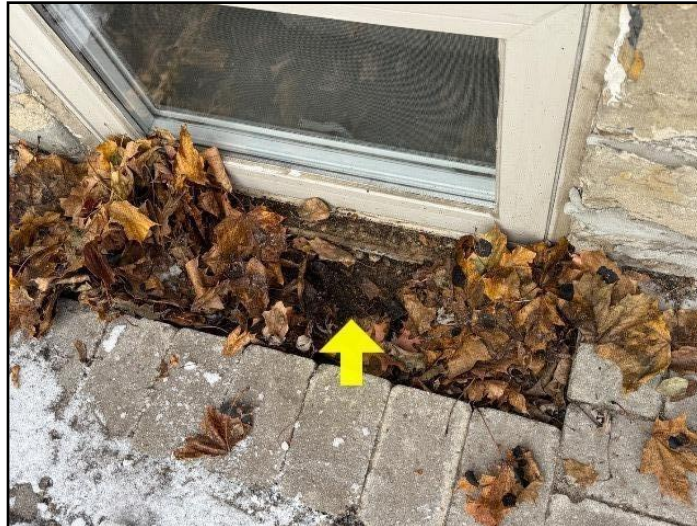
4. Rear window well

Condition: • [Missing](#)

Window well was filled with debris and organic material at the time of inspection. Less than approximately 6 inches of clearance was observed below the window frame. No gravel base or drain was visible after limited clearing of debris; presence of a drain could not be confirmed.

Time: As soon as practical

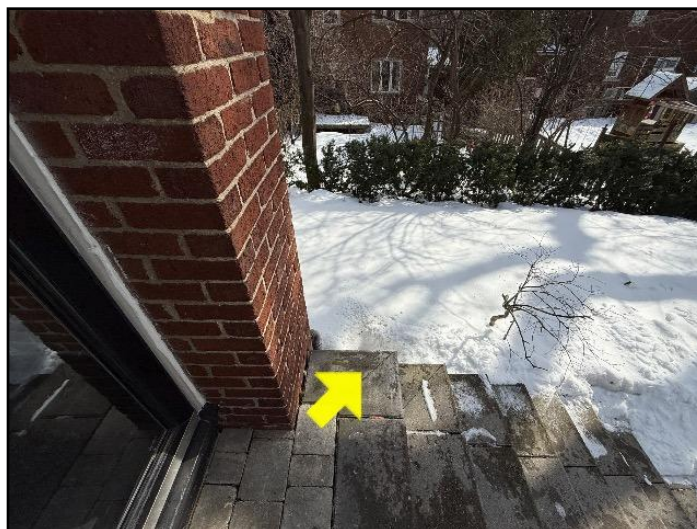
5. Missing

PORCHES, DECKS, STAIRS, PATIOS AND BALCONIES \ Handrails and guards

Condition: • [Missing](#)

Time: Less than 1 year

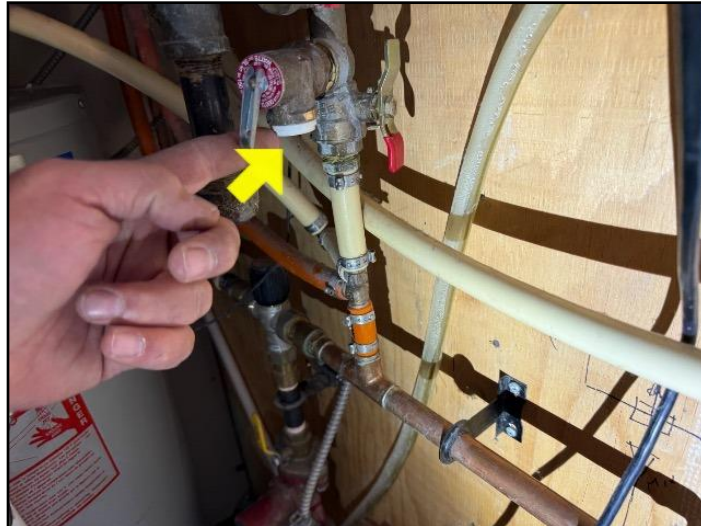
7. No pipe extension

Condition: • [No pipe extension](#)

Time: Less than 6 months

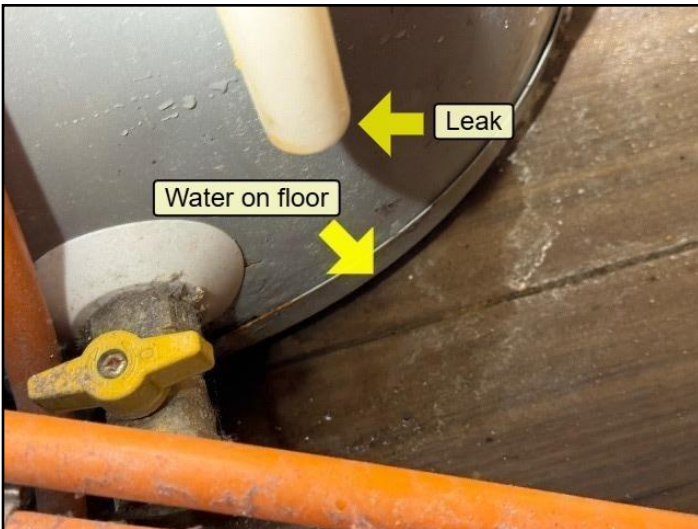
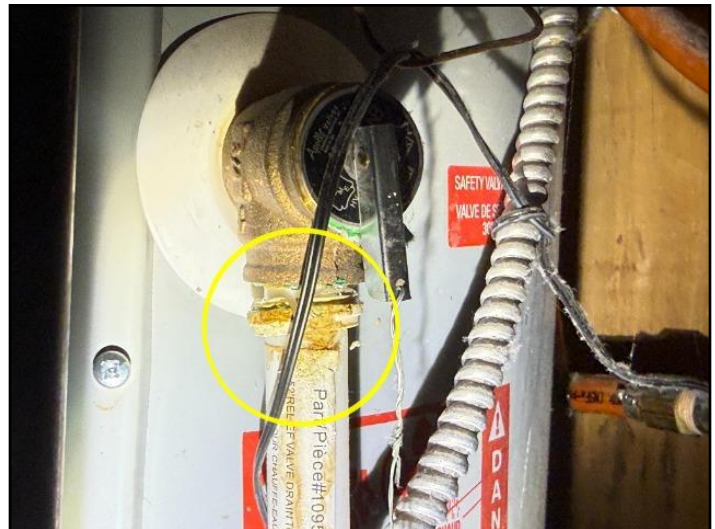
Condition: • [Leaking](#)

Implication(s): Chance of damage to finishes

9. Leaking

10. Leaking

Task: Service

Time: As Soon As Possible
