# INSPECTION REPORT

For the Property at:  
**1234 MAIN ST**  
GERMANTOWN, WI 53022

Prepared for: PAUL VANENGEN  
Inspection Date: Thursday, May 14, 2020  
Prepared by: Paul VanEngen

RE: Report No. 1003, v.2  
1234 Main St  
Germantown, WI  
53022

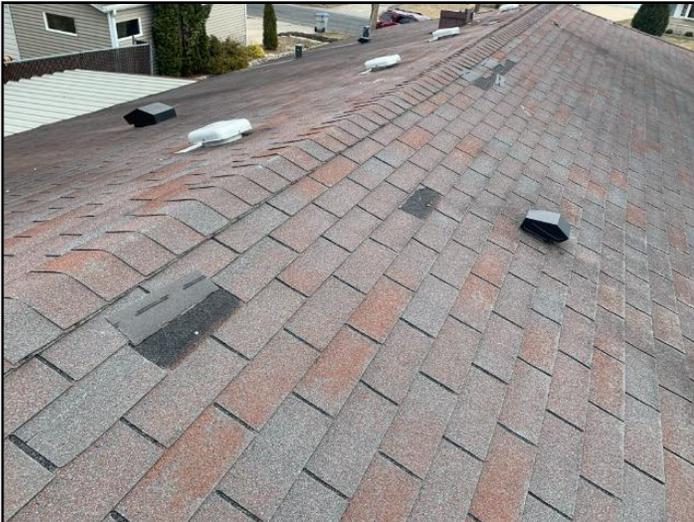
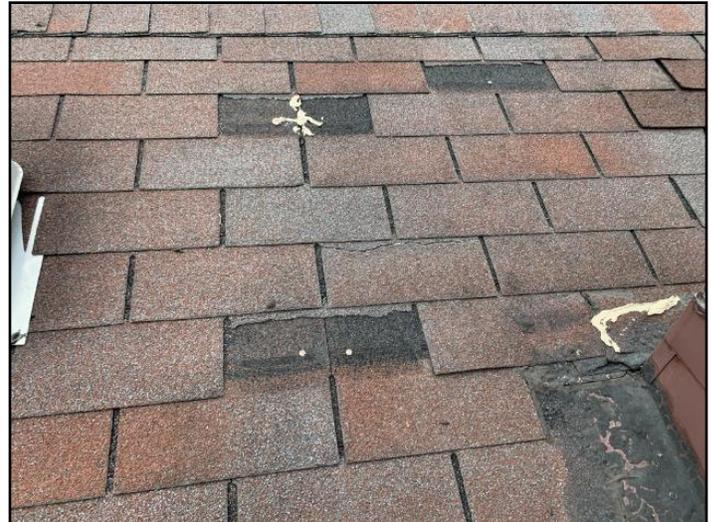
**Condition:** • [Damage](#)

**Implication(s):** Chance of water damage to structure, finishes and contents

**Location:** Throughout Exterior Roof

*Damage*

**Task:** Contact a licensed professional for repair/replacement.

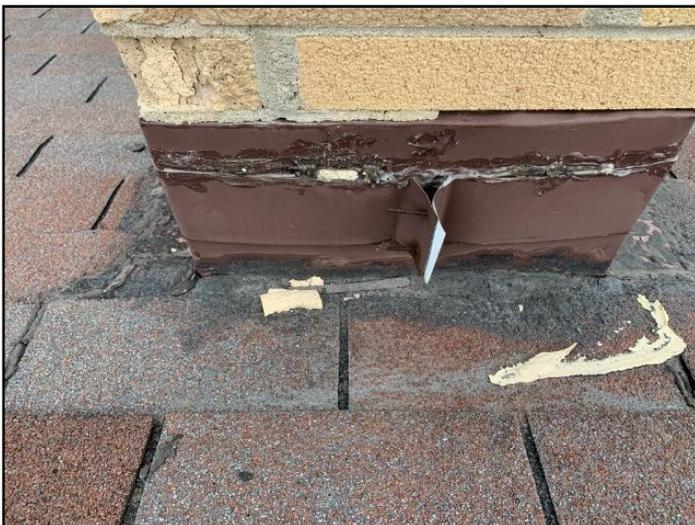
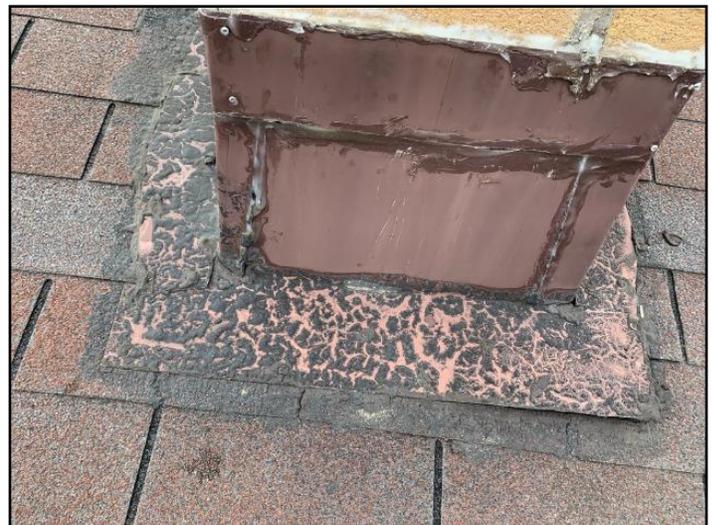
**Condition:** • [Not let into mortar joints](#)

Overall flashing on chimney is poor. Many open areas could allow moisture to enter building shell.

**Implication(s):** Chance of water damage to structure, finishes and contents

**Location:** Middle Exterior Roof

*Not let into mortar joints*

**Task:** Contact a licensed professional for repair/replacement.

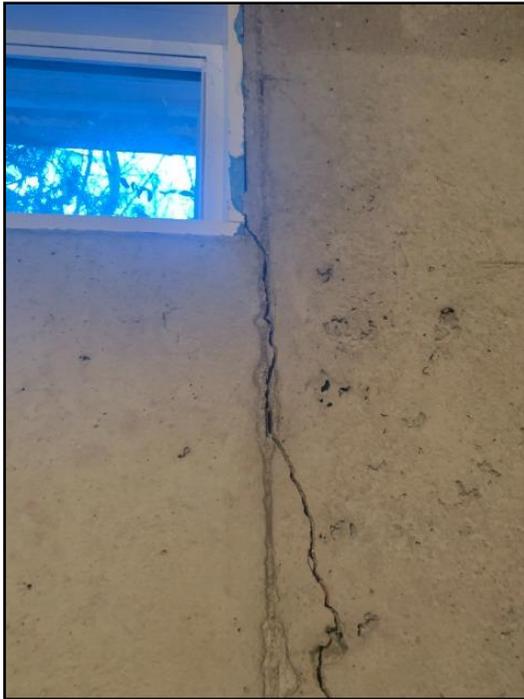
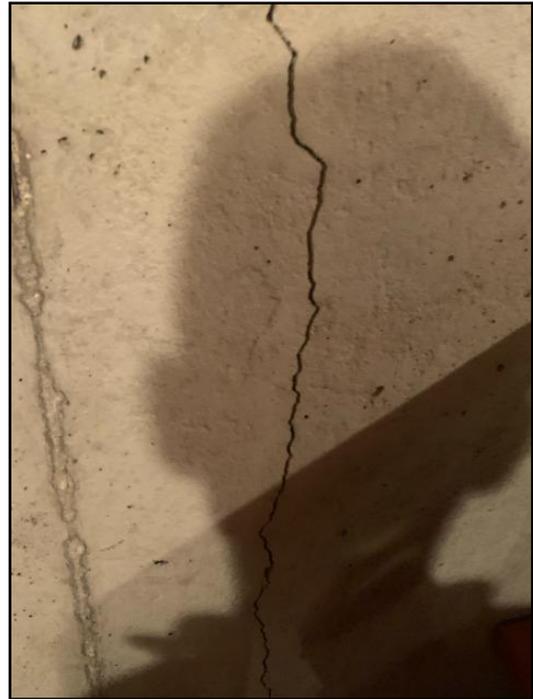
**Condition:** • [Cracked](#)

**Implication(s):** Chance of water damage to structure, finishes and contents | Weakened structure

**Location:** West Basement

Cracked

**Task:** Contact a licensed professional for repair/replacement.

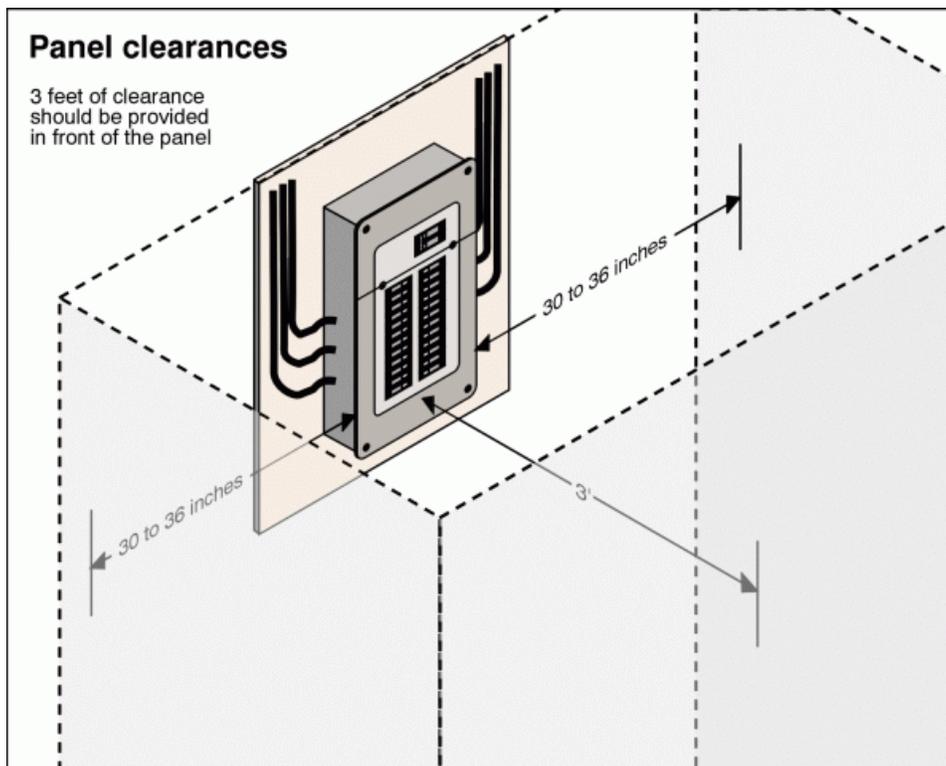
**Condition:** • [Poor access](#)

**Implication(s):** Difficult to service

**Location:** West Basement Utility Room

**Task:** Improve

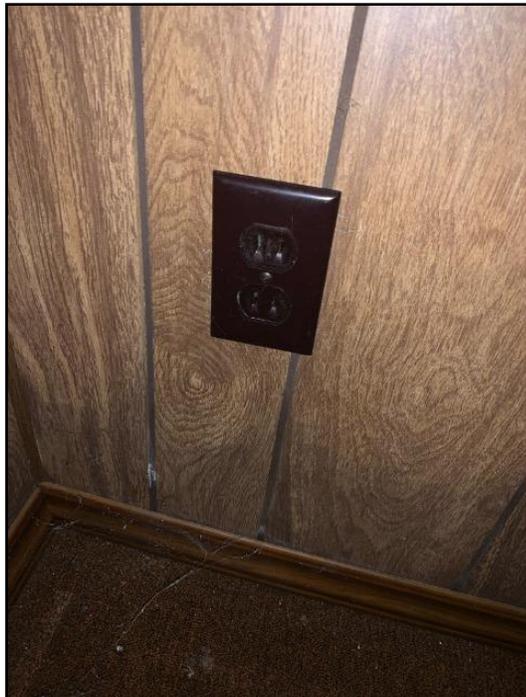
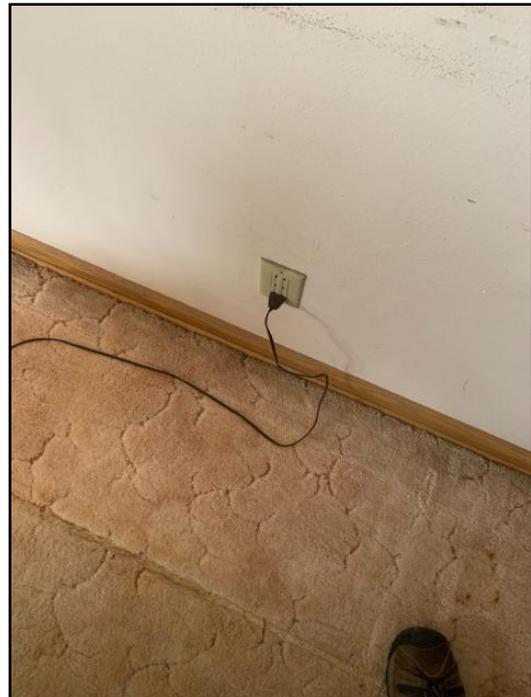
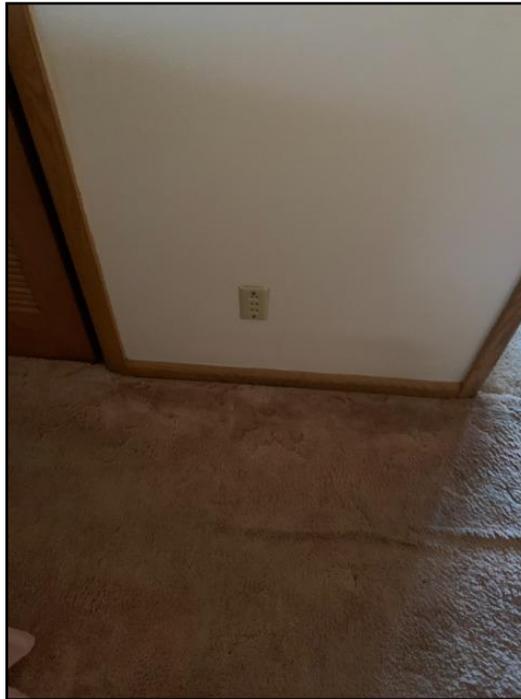
**Condition:** • [Ungrounded](#)

Majority of outlets (2 prong) throughout the house are ungrounded. Although the technique of installing GFCI devices in an ungrounded circuit doesn't ground the circuit, it does provide protection in the event that any electricity leaks to ground, thereby preventing electrical shocks and injury.

*Ungrounded*

**Task:** Contact a licensed professional for repair/replacement.

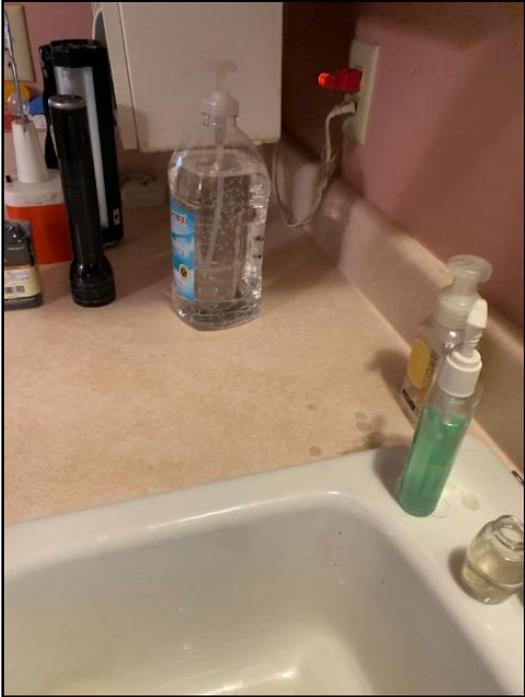
**Condition:** • [GFCI/GFI needed \(Ground Fault Circuit Interrupter\)](#)

GFCI/GFI needed (Ground Fault Circuit...)

**Task:** Contact a licensed professional for repair/replacement.

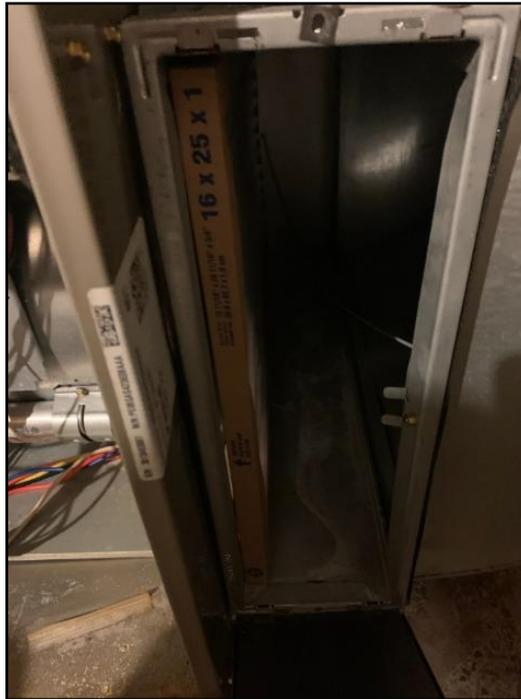
**Condition:** • [Wrong size](#)

*Wrong size*

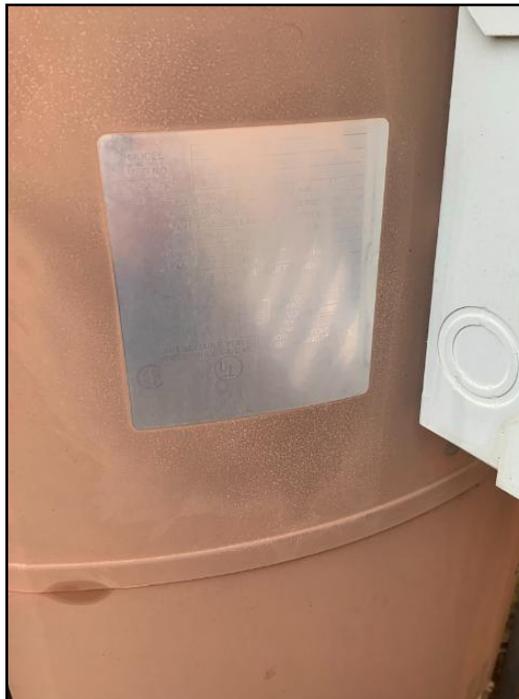
• Not legible

*Not legible*

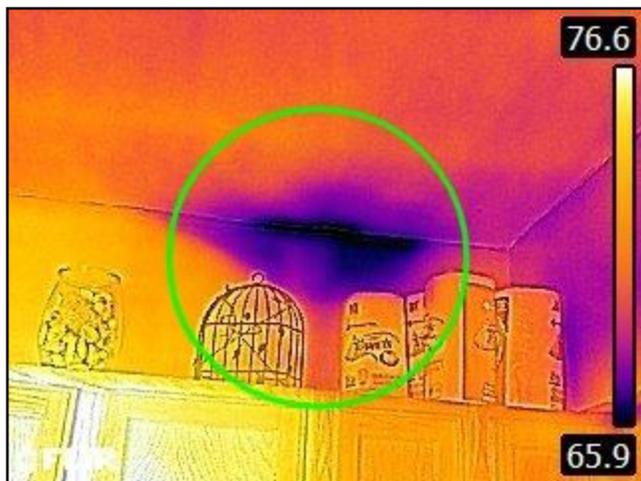
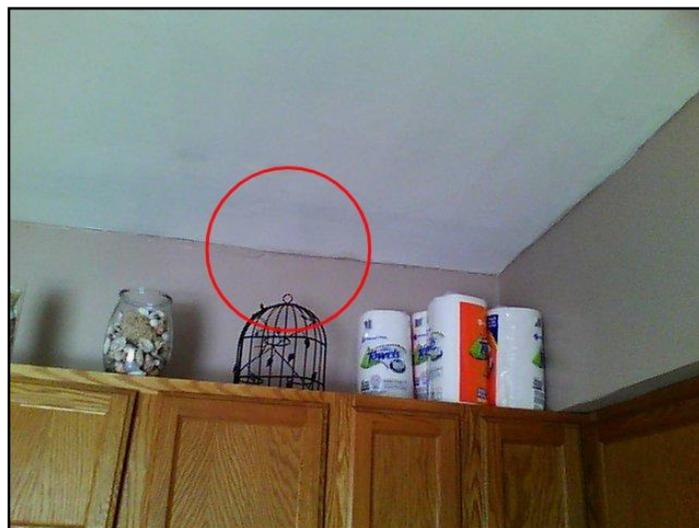
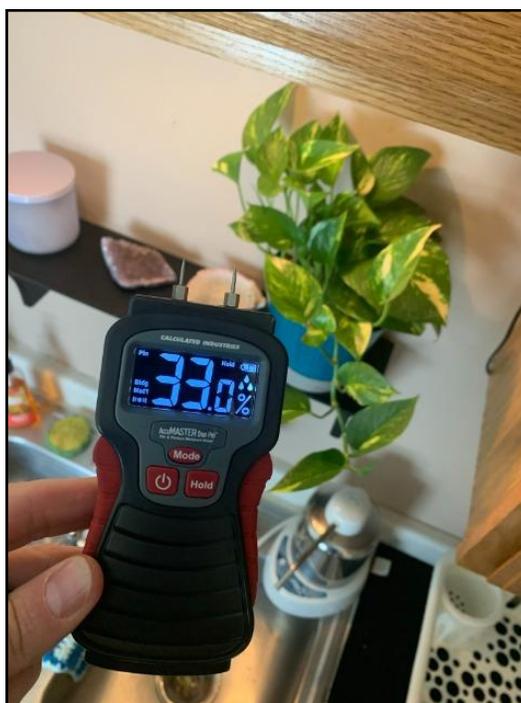
**Condition:** • [Leak](#)  
Apparent water leak from second floor bathroom. Required further in depth analysis to determine exact cause and location of source.  
**Implication(s):** Chance of water damage to structure, finishes and contents  
**Location:** Second Floor Bathroom  
**Task:** Contact a licensed professional for repair/replacement.  
**Time:** Immediate

Leak

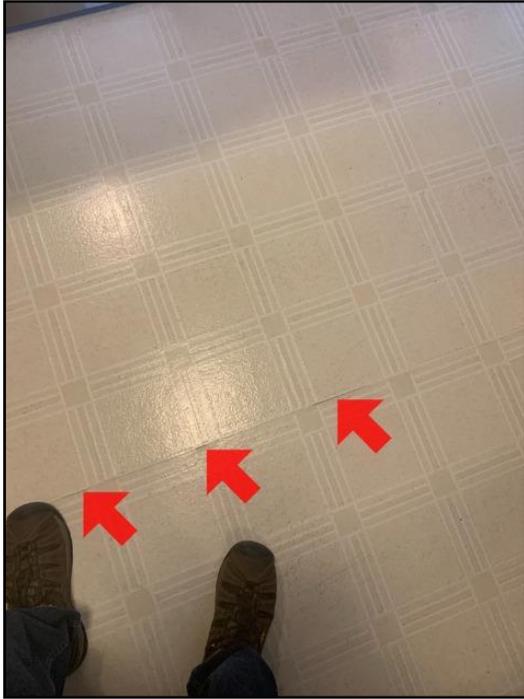
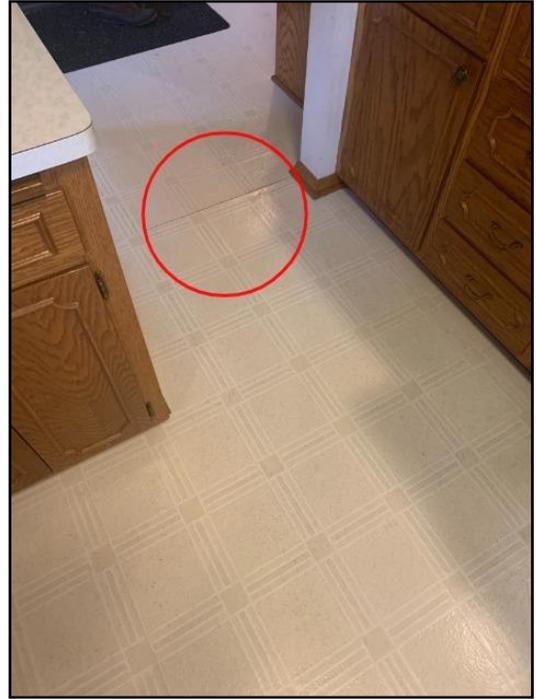
**Condition:** • [Open seams](#)

**Implication(s):** Trip or fall hazard

Open seams
