INSPECTION REPORT

12345 ADDRESS

Inspection Date: Tuesday, July 4, 2023

RE: Report No. 1498, v.2
12345 Address
Denver and all metro areas, CO

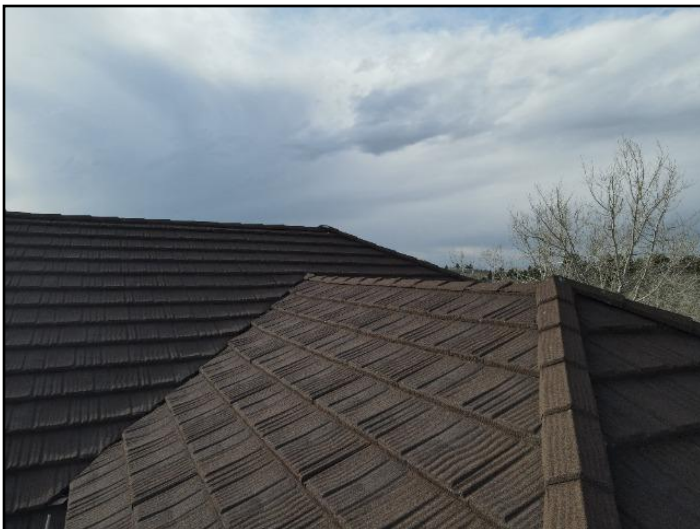
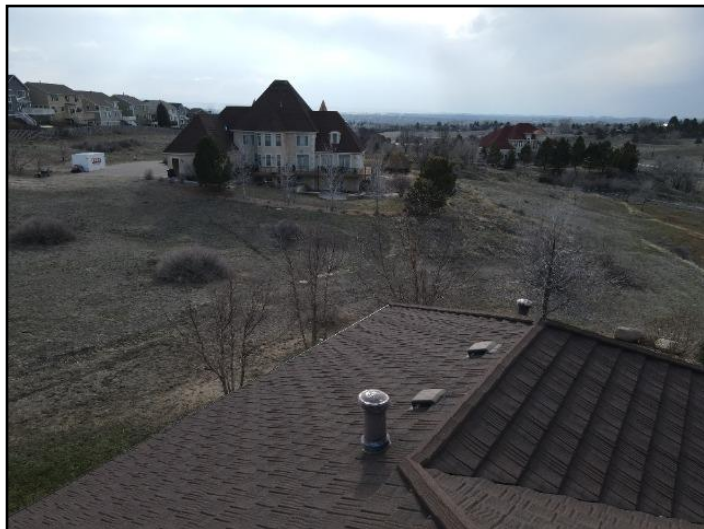
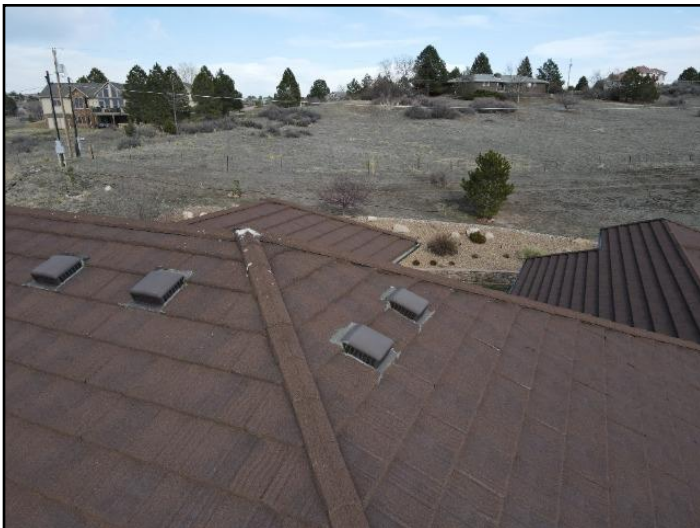
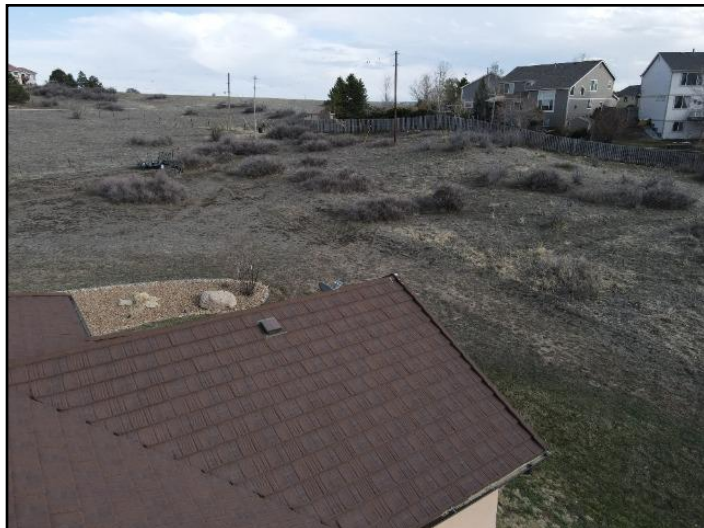
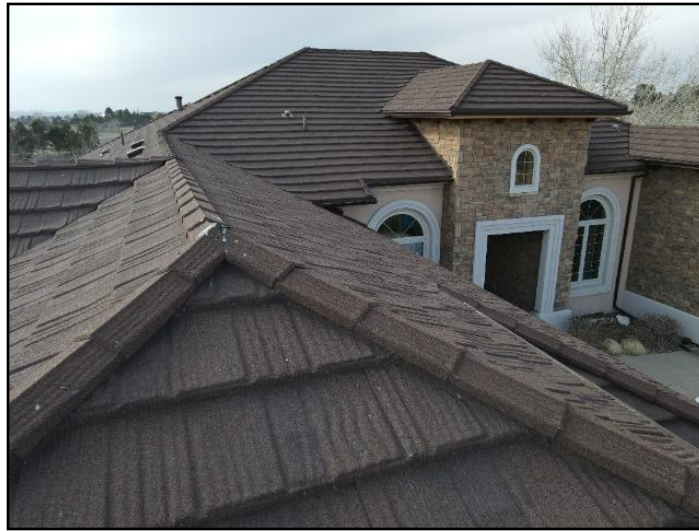
- Roof is in a serviceable condition, We recommend regular maintenance and inspections after significant hail storms. We review all high resolution photos in the office to observe any reportable issues. We also walk the roof when possible for further review when needed.

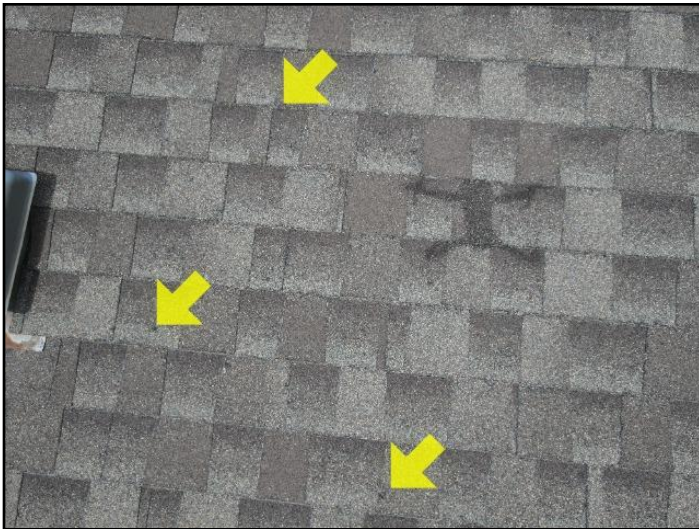
17. Hail Damage in this neighborhood

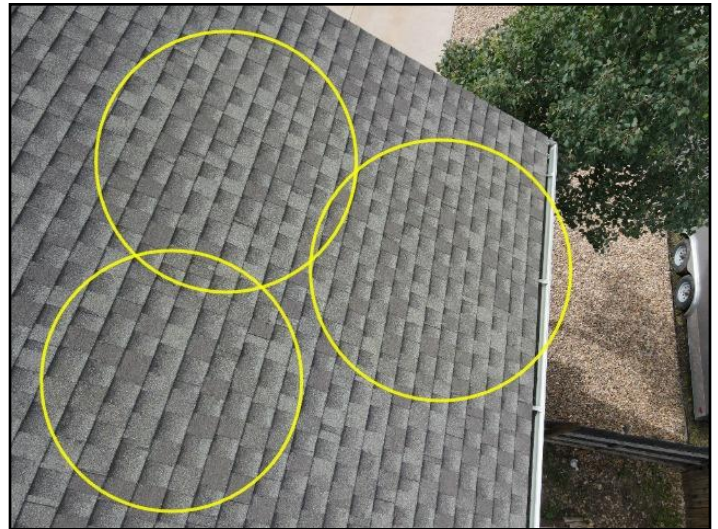
18. Evidence Of Hail Damage

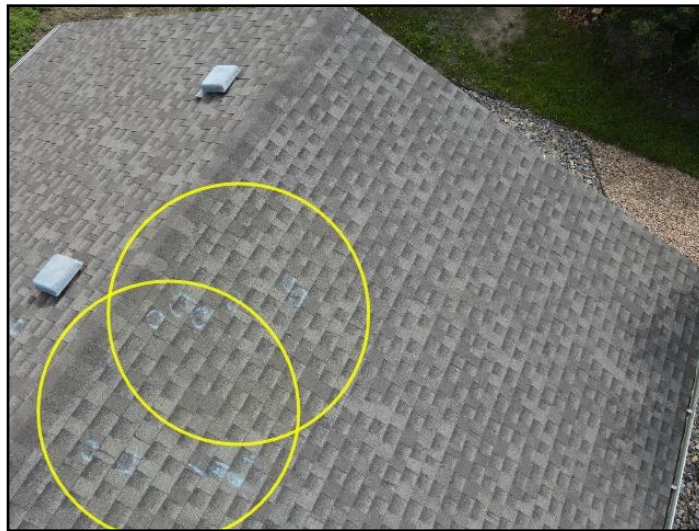
19. Evidence Of Hail Damage

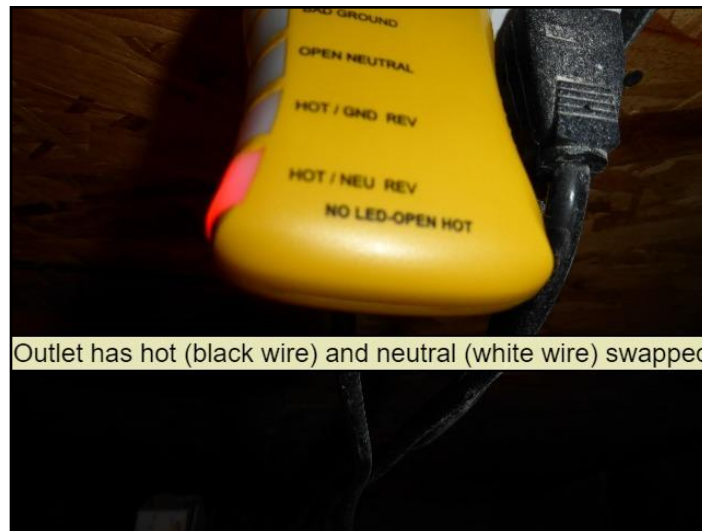
Outlet has hot (black wire) and neutral (white wire) swapped or reversed.

51. Reversed polarity

Task: Have a licensed electrician Correct/repair as needed

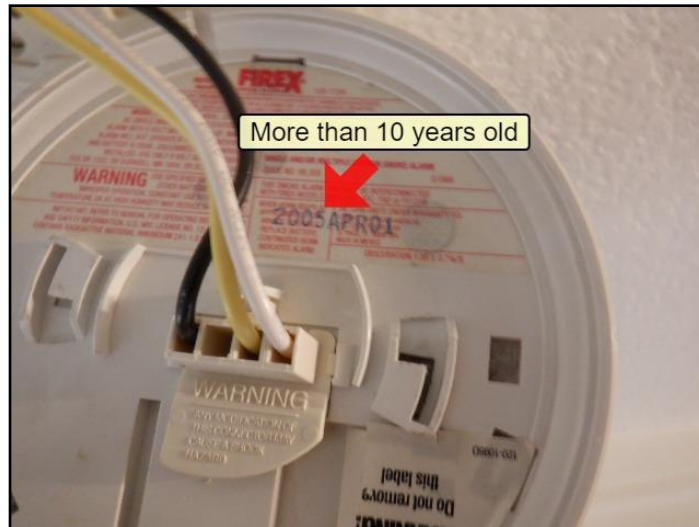
52. More than 10 years old

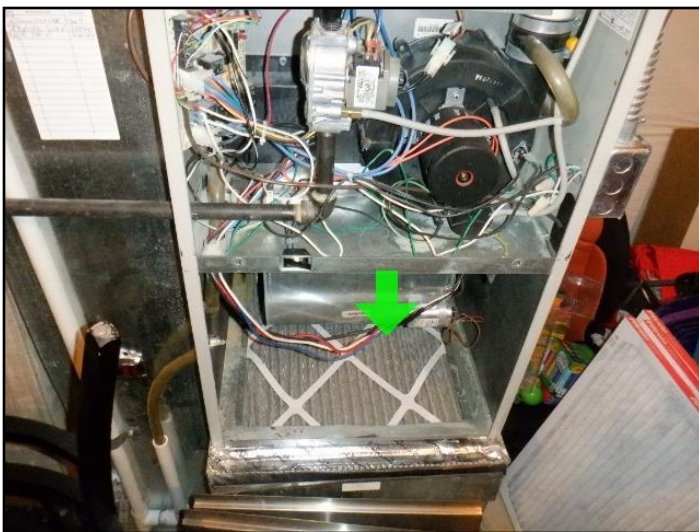
38. Condition: • MAINTENANCE (Don't Forget!): The air filter(s) should be inspected at least monthly and cleaned or replaced as required. There are two types of filters commonly used: (1) Washable filters, (constructed of aluminum mesh, foam, or reinforced fibers) these may be cleaned by soaking in mild detergent and rinsing with water. Or (2) Fiberglass disposable filters that must be REPLACED before they become clogged. Remember that dirty filters are the most common cause of inadequate heating or cooling performance. A clogged filter will cause premature failure of your furnace system and or unnecessary/preventable costly repairs or replacement of the HVAC system.

61. MAINTENANCE (Don't Forget!): The air...

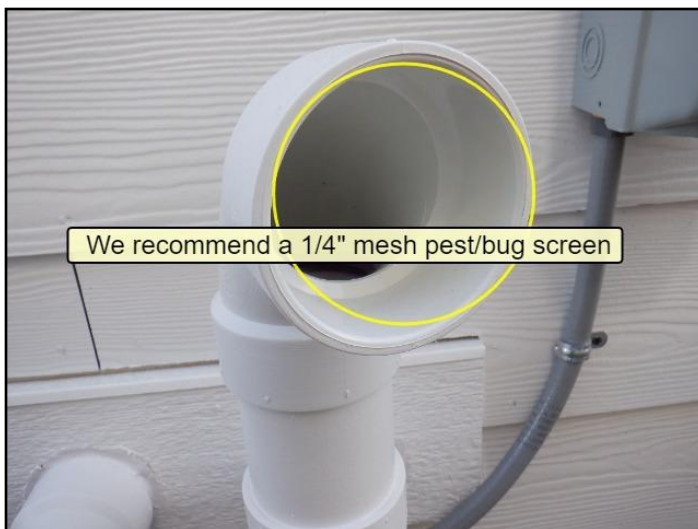
Condition: • Exterior HVAC PVC intake & exhaust vents needs a 1/4" mesh pest/bug screen . This is recommended to prevent pests, Miller Moths, from entering the furnace system and preventing children from inserting rocks or balls into the vents especially for vents reachable by small children.

66. Add 1/4" mesh

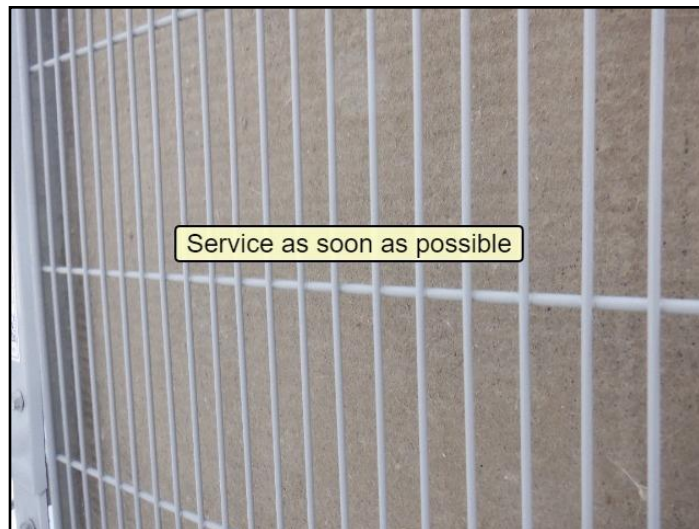
Condition: • Dust/Debris in cooling fins, reduced efficiency, have an HVAC technician, service/clean the exterior A/C unit

72. Dust/Debris in cooling fins, reduced...

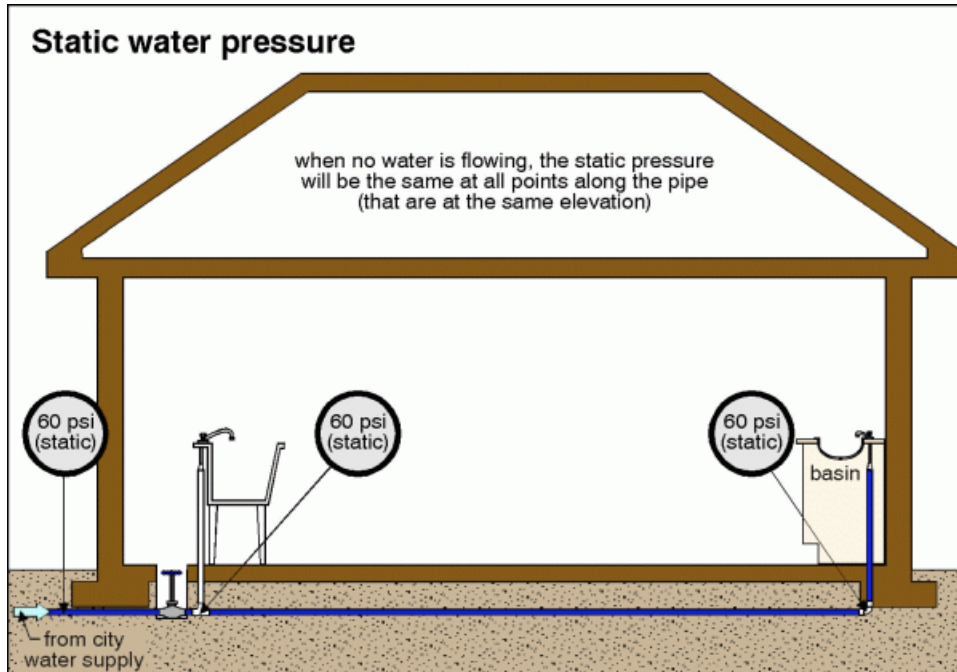
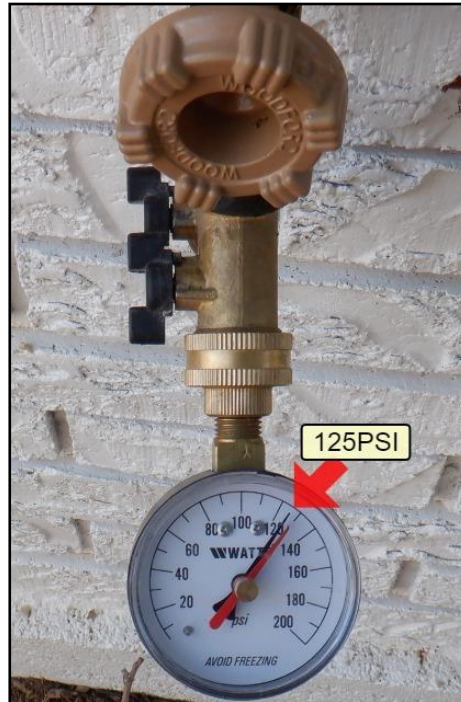
Condition: • A water pressure regulator is recommended due to high supply water pressure over 80PSI 125PSI This is too high maximum no more than 80psi

Implication(s): Damage to faucets fixtures/seals water heater, water conservation

91. A water pressure regulator is recommended...

Task: Have a qualified plumber Update as needed and install a pressure regulator

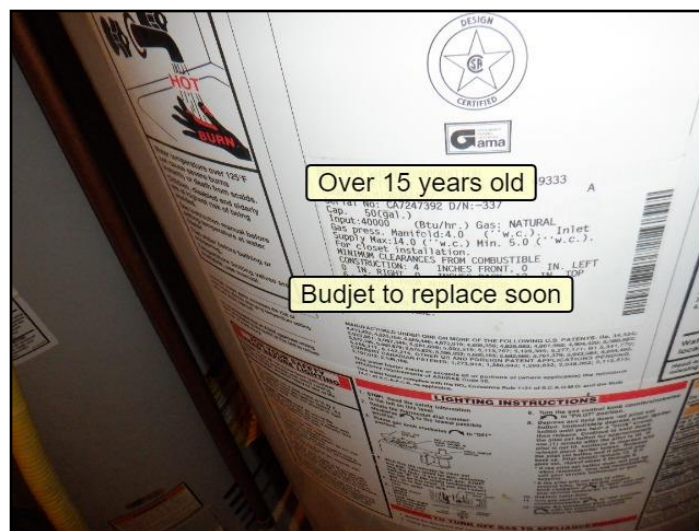
61. Condition: • Past life expectancy

92. Past life expectancy

Task: Budget to replace soon

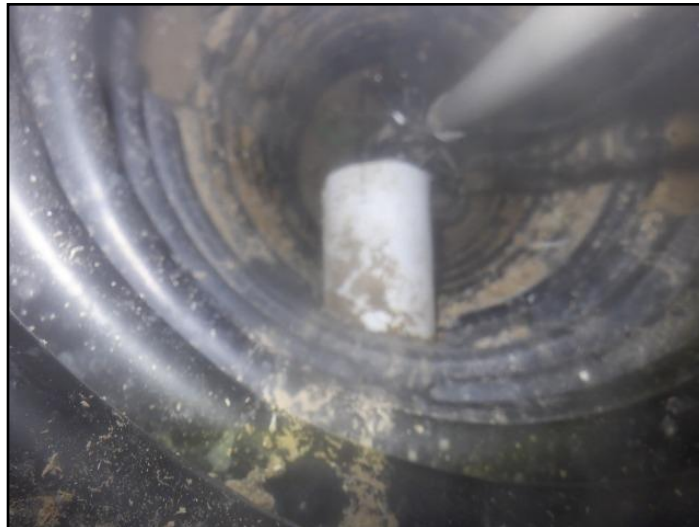
93. Monitor the sump pit during heavy rain or...

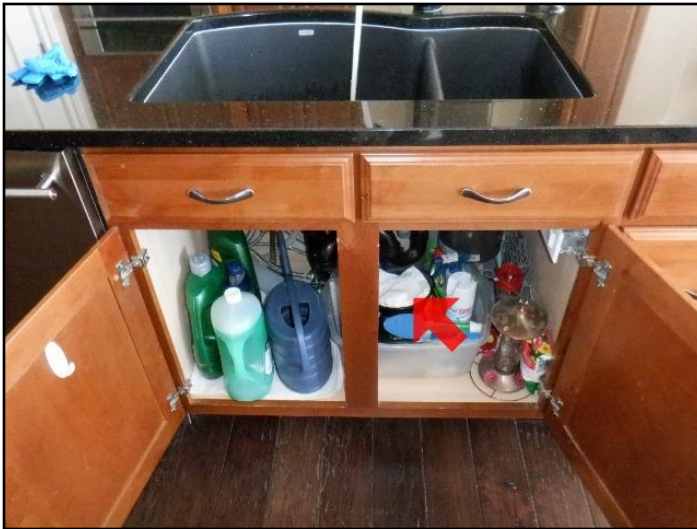
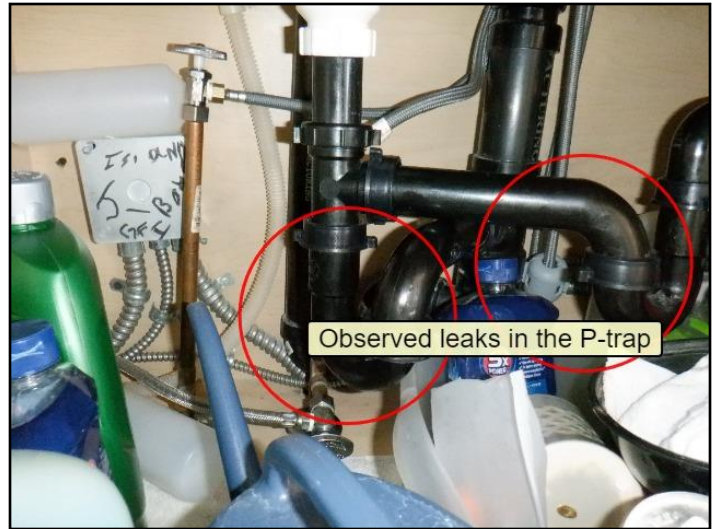
Condition: • Kitchen sink leaks were observed. Monitor sink drains and under sink components, this area is most prone to leaks resulting in potential damage to the base cabinet and potential mold issues.

Implication(s): Potential mold issues, water damage to contents

94. Kitchen sink leaks were observed. Monitor...
