Your Inspection Report

35 Aitken Circle
Markham, ON L3R 7L2

INSPECTION DATE:
Friday, April 22, 2016

RE: Report No. 1360, v.5
35 Aitken Circle
Markham, ON
L3R 7L2

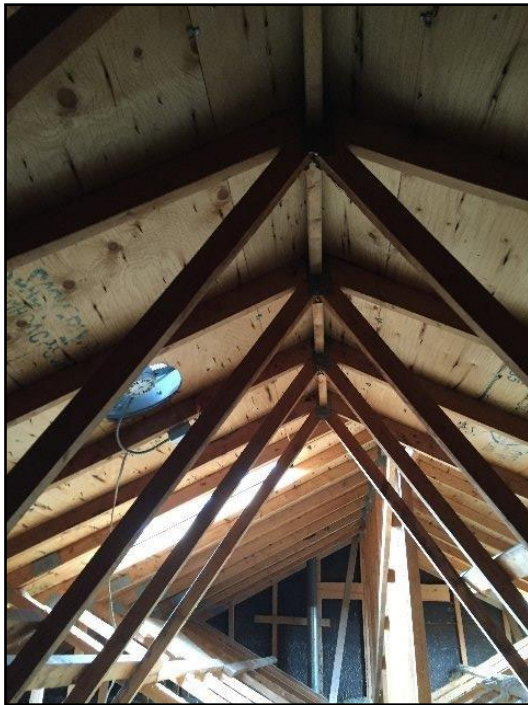
8. Trusses

In Good Condition

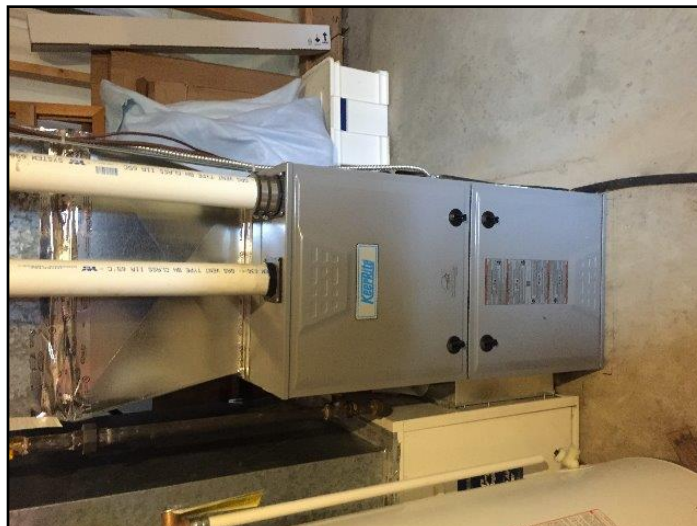
18. Keeprite

Model number: G9MXT0801716A1 Serial number: A114246695

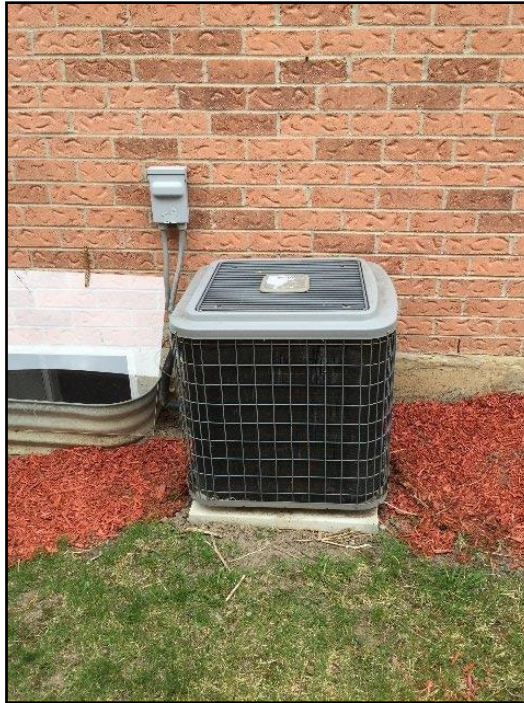
21. Air cooled

Model number: CAC030AKA4 Serial number: L021616815

Compressor approximate age: • 14 years

Failure probability: • [Medium](#)

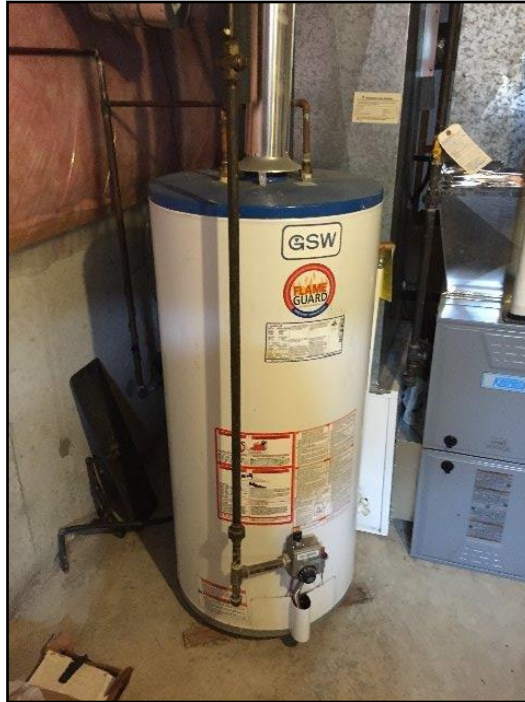
24. GSW

Water heater approximate age: • 8 years

Water heater failure probability: • [Medium](#)

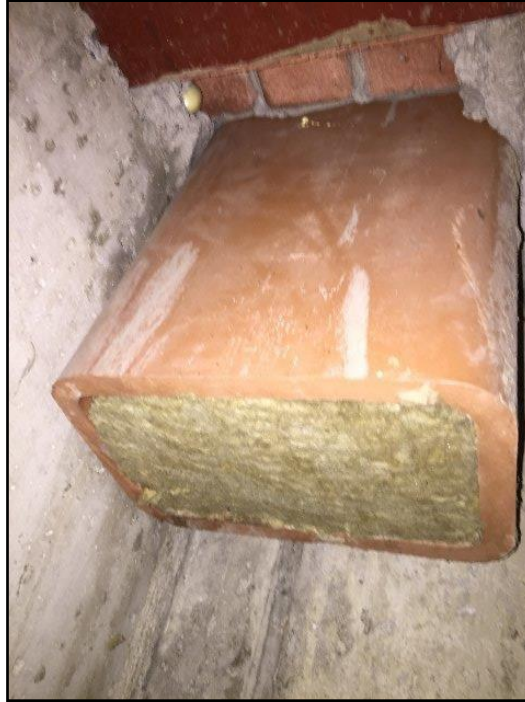
32. Fireplaces are sensitive to negative...
