# YOUR INSPECTION REPORT

FOR THE PROPERTY AT:  
30 Edwalter Ave  
Toronto, ON

INSPECTION DATE:  
Friday, April 21, 2017

RE: Report No. 2108  
30 Edwalter Ave  
Toronto, ON

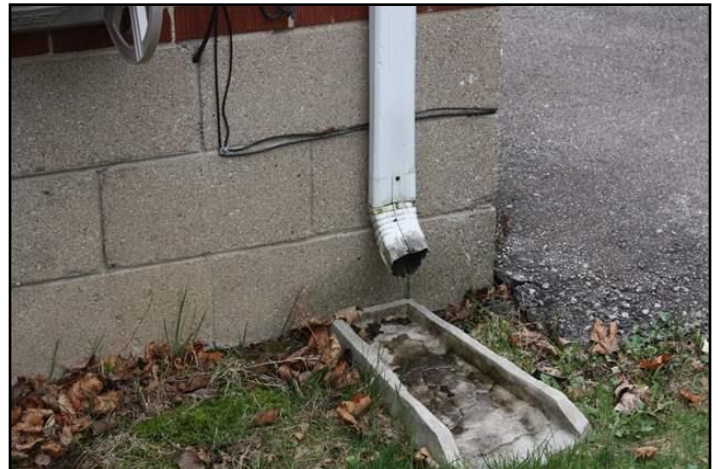
Condition: • [Should discharge 6 feet from building](#)

2. Should discharge 6 feet from building

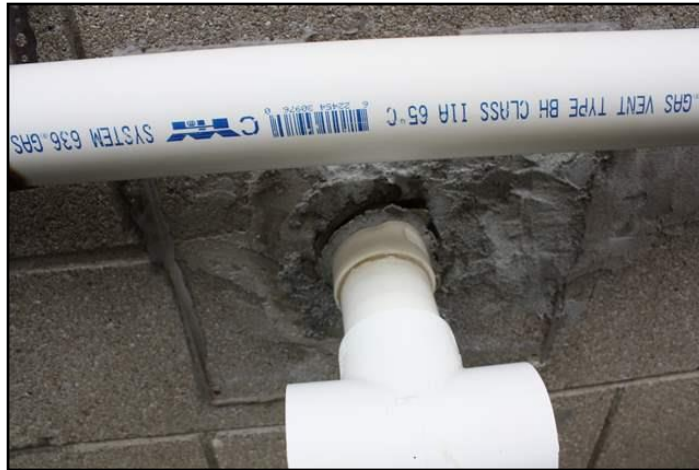
**Condition:** • [Caulking missing or ineffective](#)

3. Caulking missing or ineffective

**Task:** Improve

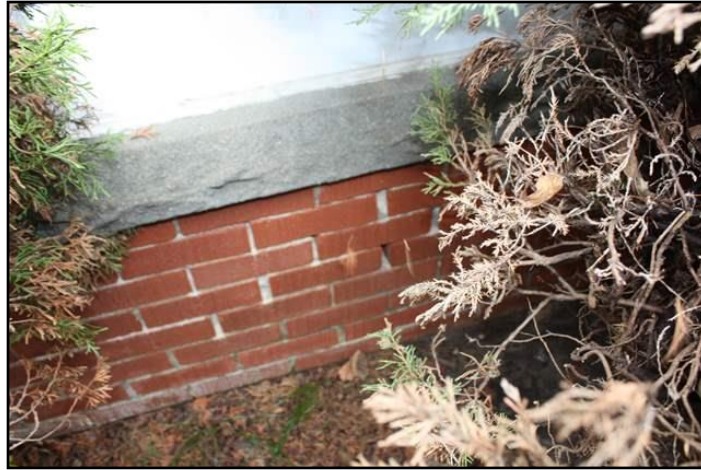
### **Condition:** • [Mortar deterioration](#)

4. Mortar deterioration

**Task:** Repair

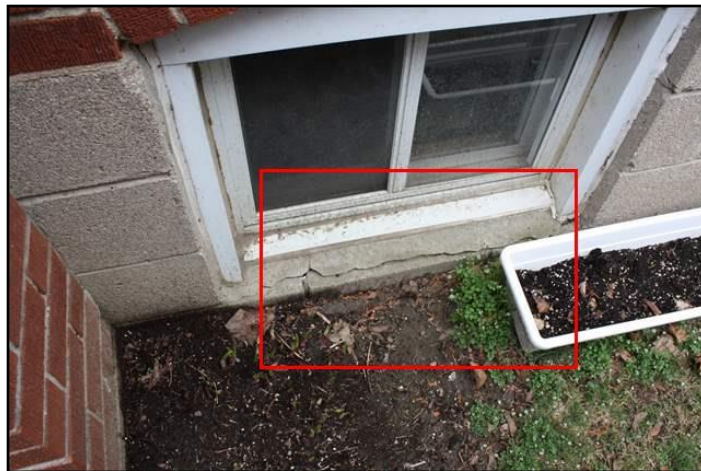
**Condition:** • [Parging damaged or missing](#)

Moisture noted in basement adjacent to this area.

5. Parging damaged or missing

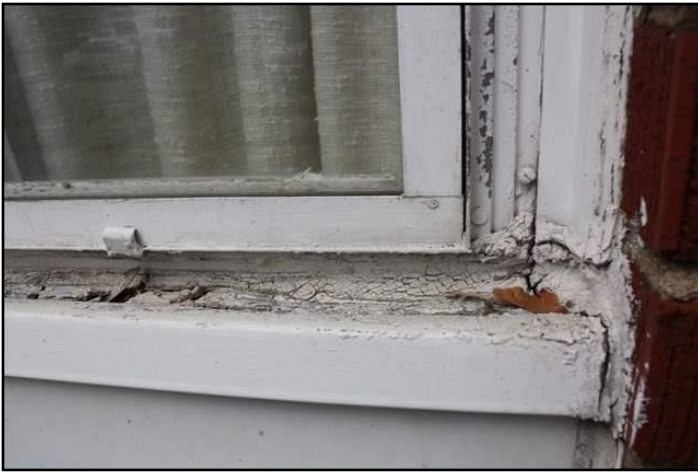
6. Caulking loose, missing or deteriorated

**Task:** Repair

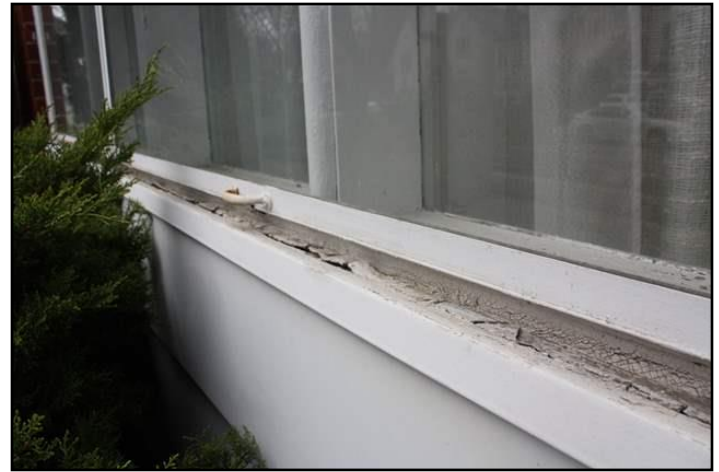
7. Caulking loose, missing or deteriorated

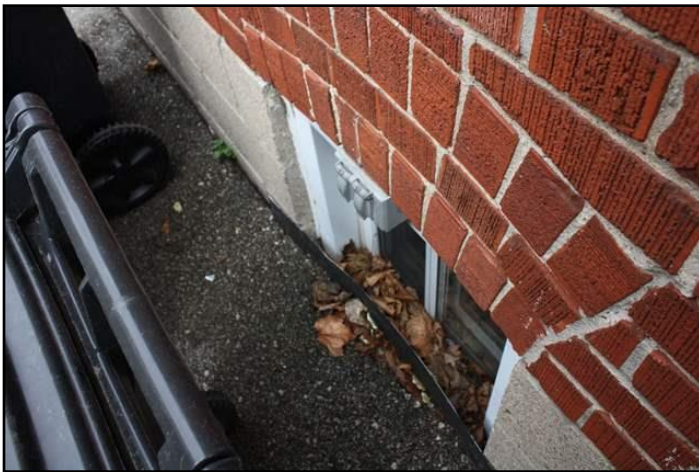
**Condition:** • [Missing](#)

8. Missing

Window wells help manage the water in areas where windows are at or below grade. A properly installed window well will help prevent water entry / damage to windows and structure. If leakage is noted, a correctly installed window well is recommended. In the meantime, you may consider adding clear window covers to manage the water in this area.

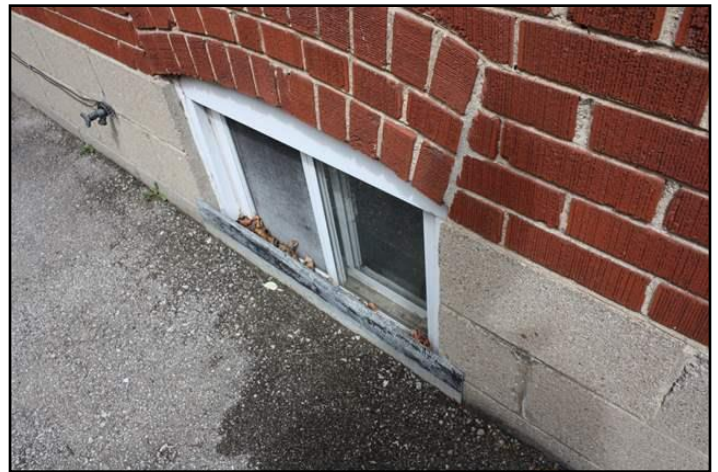
9. Missing

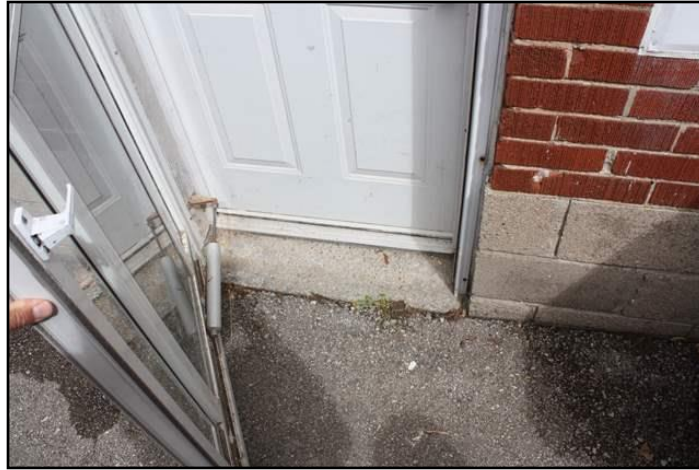
Condition: • [Sill too low](#)

10. Sill too low

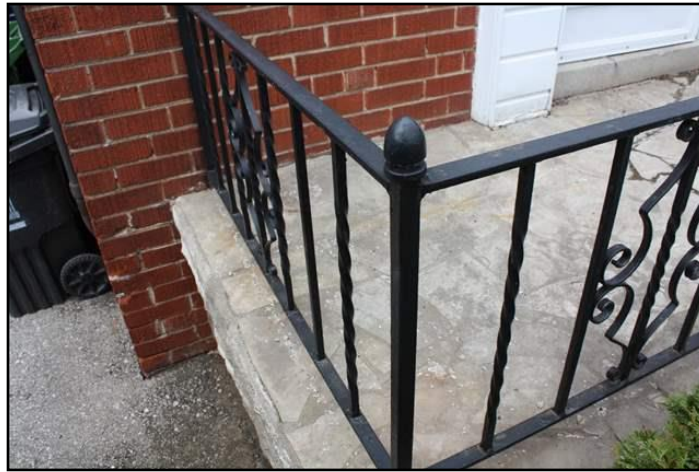
**Condition:** • [Too low](#)

11. Too low

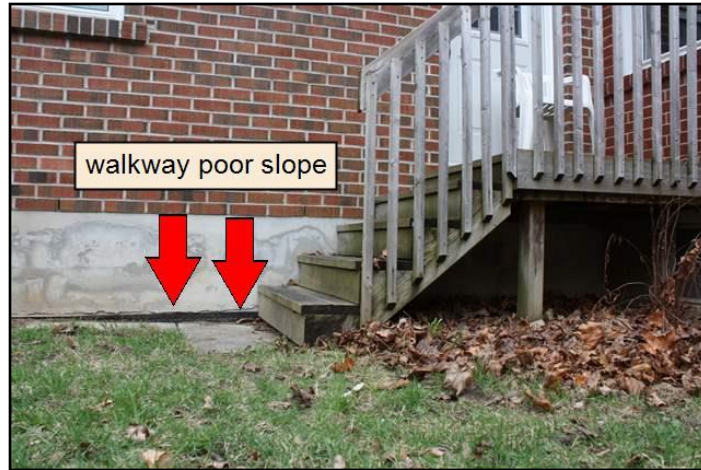
**Condition:** • [Improper slope or drainage](#)

12. *Improper slope or drainage*

**Task:** Correct

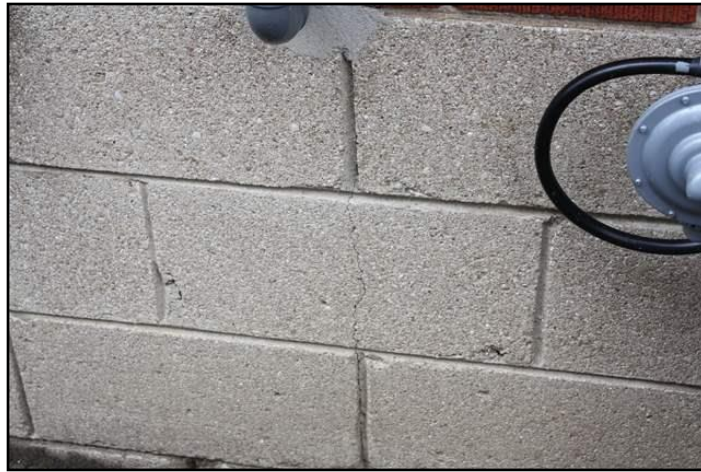
Almost all houses with concrete foundations have minor settlement cracks. Monitor all cracks for movement and nuisance water leakage. Repair cracks only if necessary

13. *Example of typical minor cracks*

**Task:** Monitor / Repair

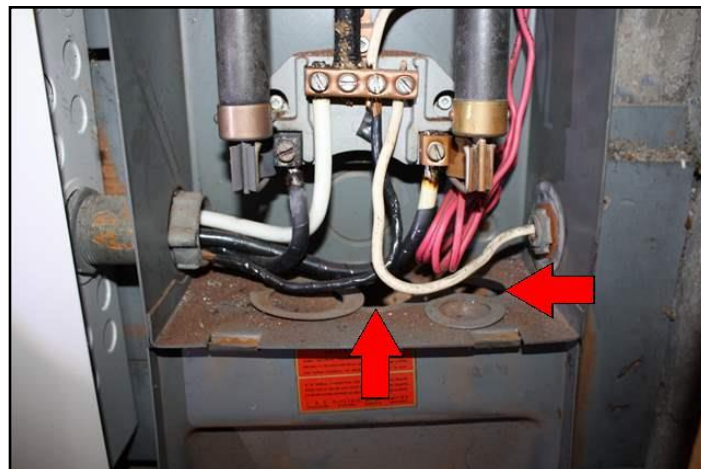
**Condition:** • [Unprotected openings](#)

14. Unprotected openings

any exposed panel openings (that would allow access to the inside of the panel) should be fitted with secure covers

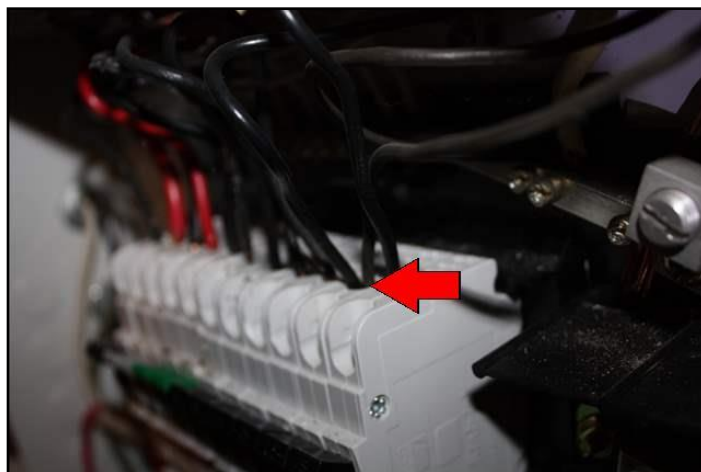
**Condition:** • [Double taps](#)

15. Double taps

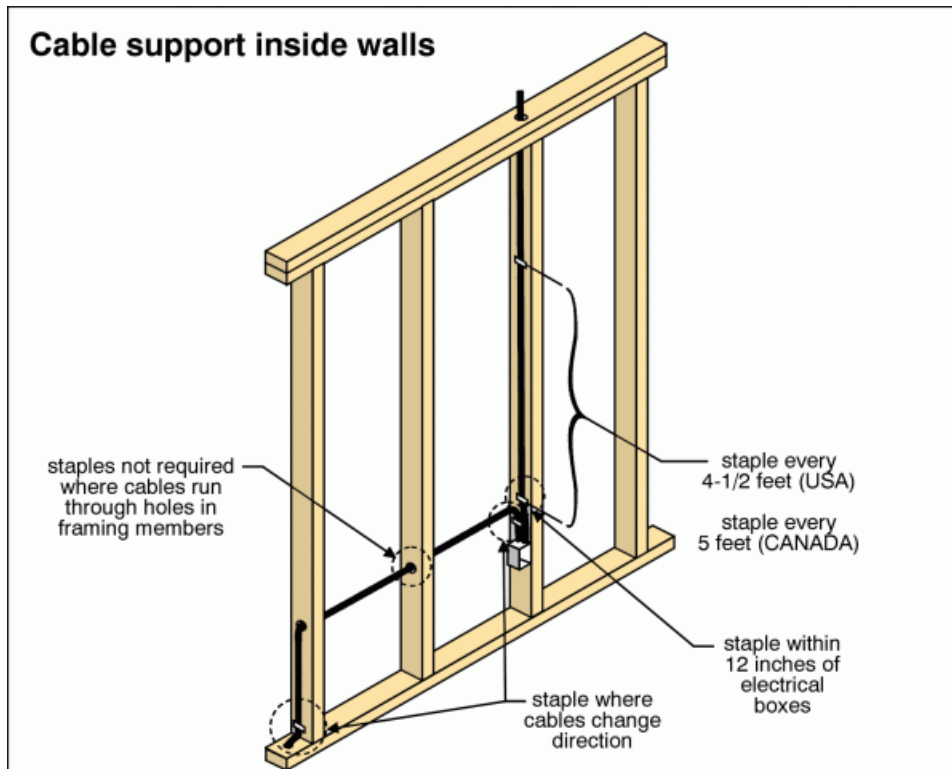
**Condition:** • [Not well secured](#)

16. Not well secured

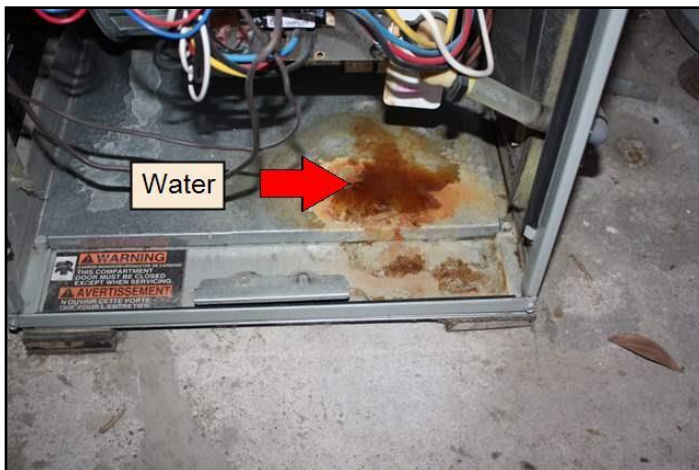
Condensate leak noted. Service by HVAC technician required. Have HVAC technician check heat exchanger for corrosion.

17. Condensate problems

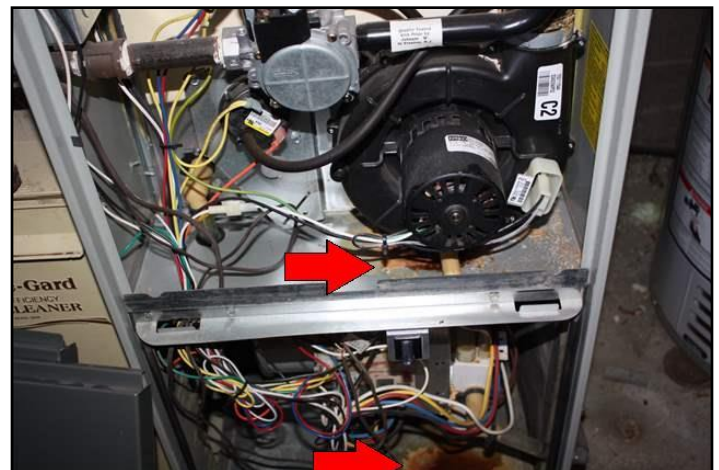
18. Condensate problems

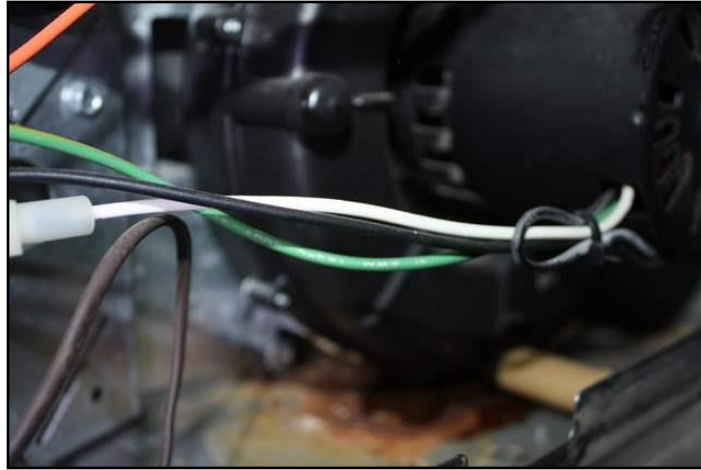
19. Condensate problems

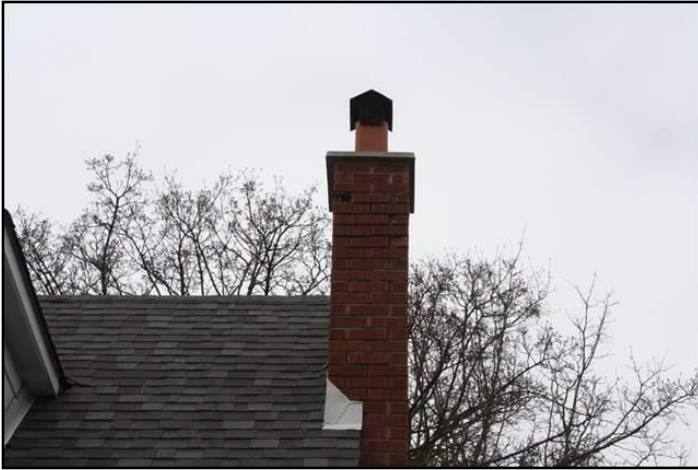
**Condition:** • [Loose, missing or deteriorated masonry](#)

20. Loose, missing or deteriorated masonry

**Task:** Repair

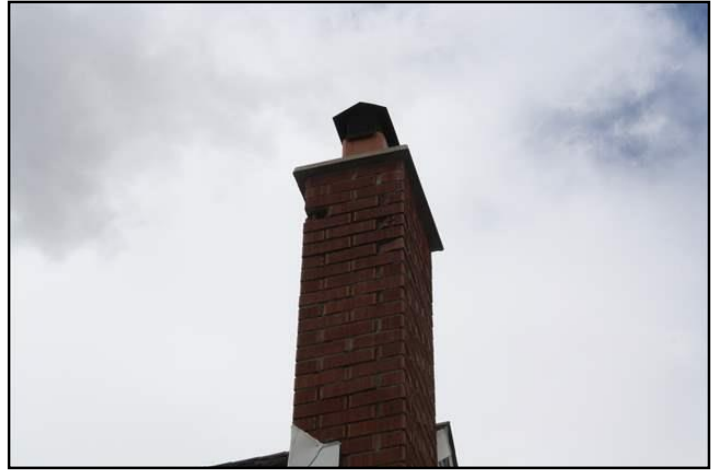
21. Loose, missing or deteriorated masonry

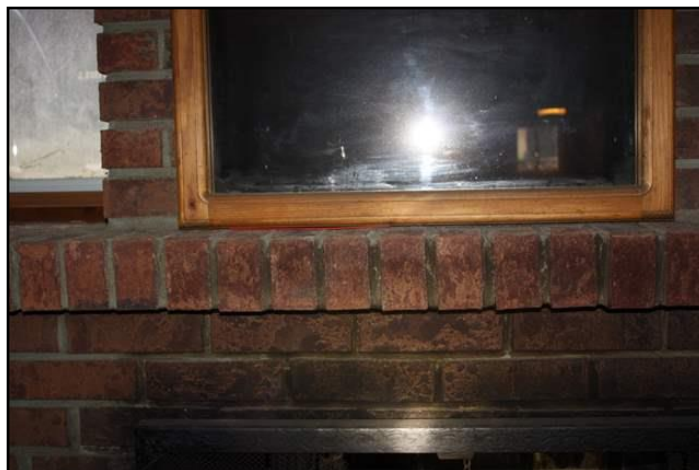
**Condition:** • [Evidence of overheating](#)

22. Evidence of overheating

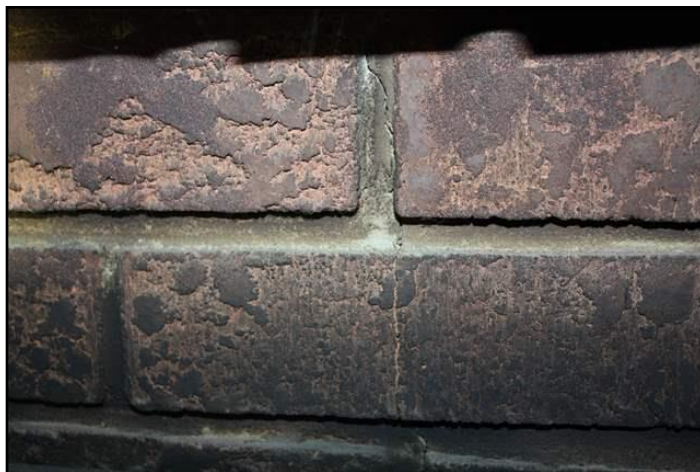
**Condition:** • [Cracked](#)

23. Cracked

**Task:** Repair

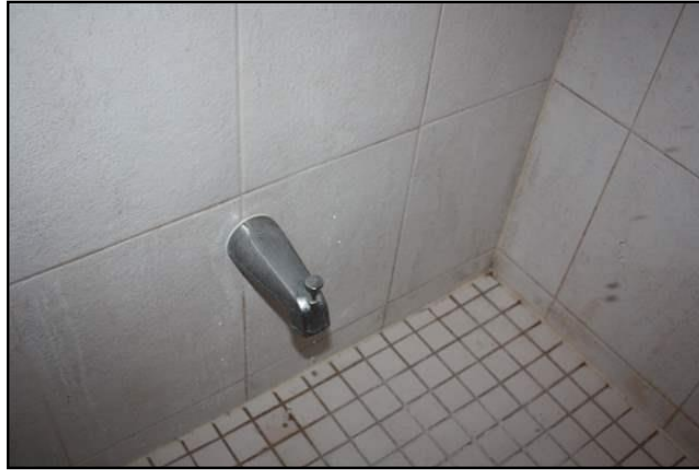
**Condition:** • [Shower diverter inoperative or defective](#)

**24. Shower diverter inoperative or defective**

**Task:** Replace

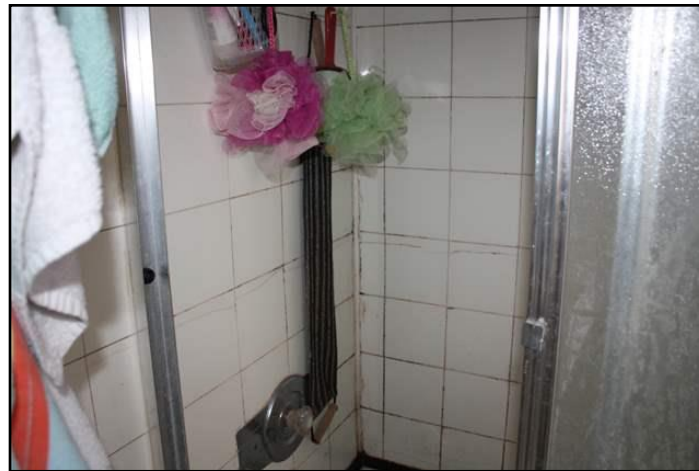
25. Tile loose, broken or missing

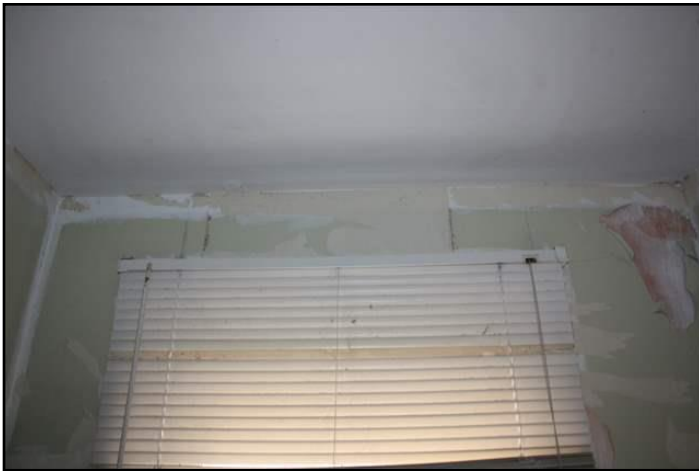
26. Damage

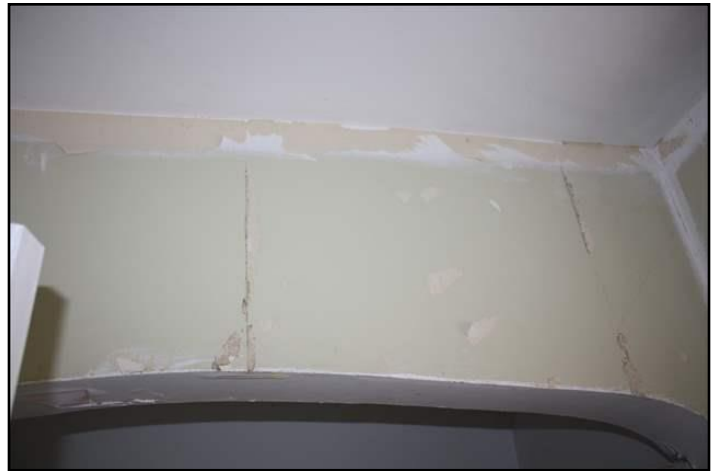
27. Damage

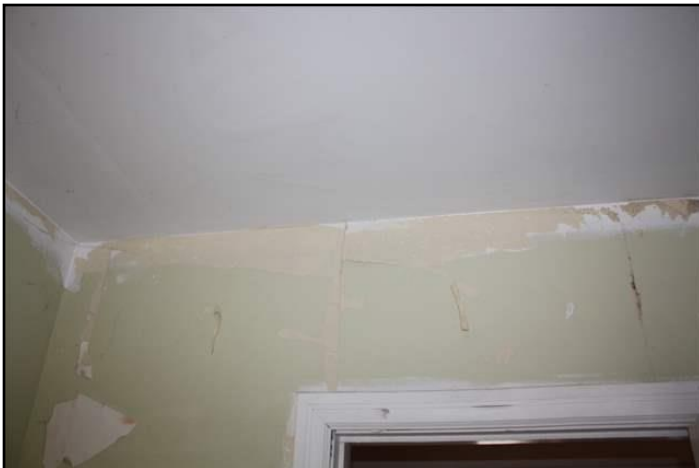
28. Damage

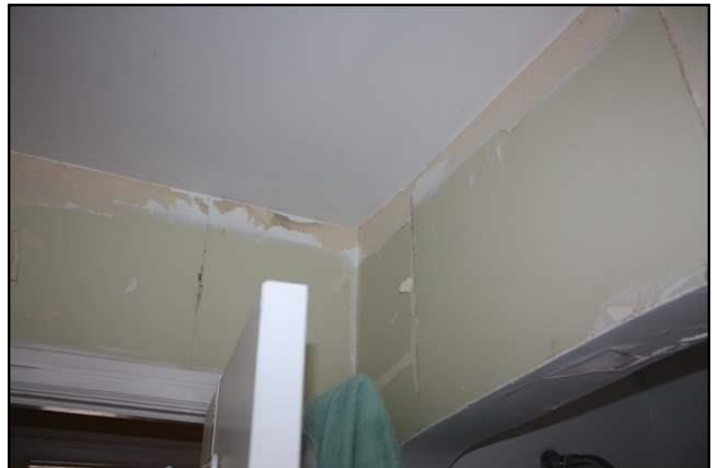
29. Damage

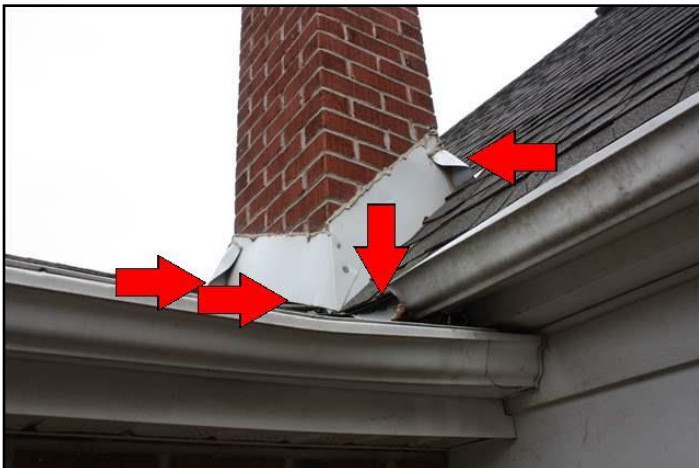
Water damage noted at ceiling and wall. Tested with moisture meter and was wet. This area is below abandoned chimney. Repair flashing and caulking at chimney and check that gutter is draining properly into lower gutter. Also ensure top of abandoned chimney is properly sealed

30. Area above water damage found in bedroom

**Task:** Repair water source first before repairing ceiling and walls

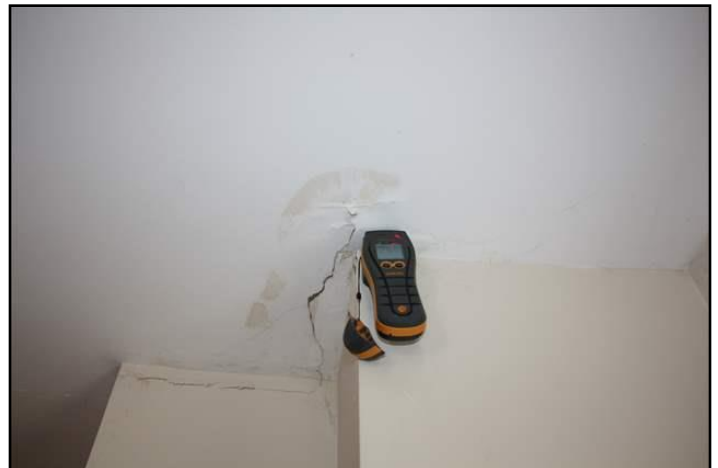
31. Water damage

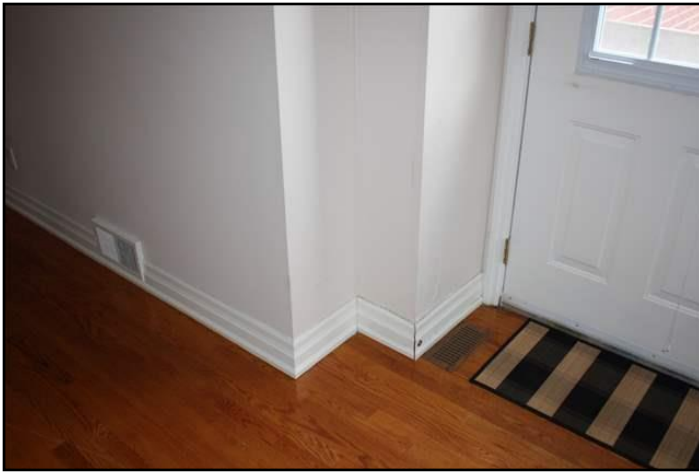
32. Water damage

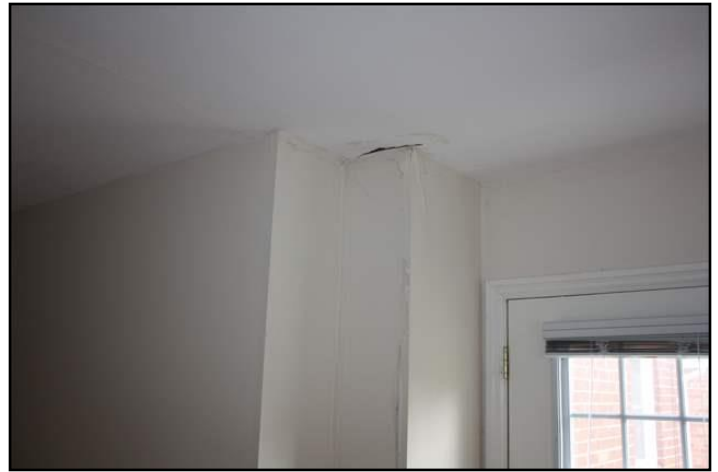
33. Water damage

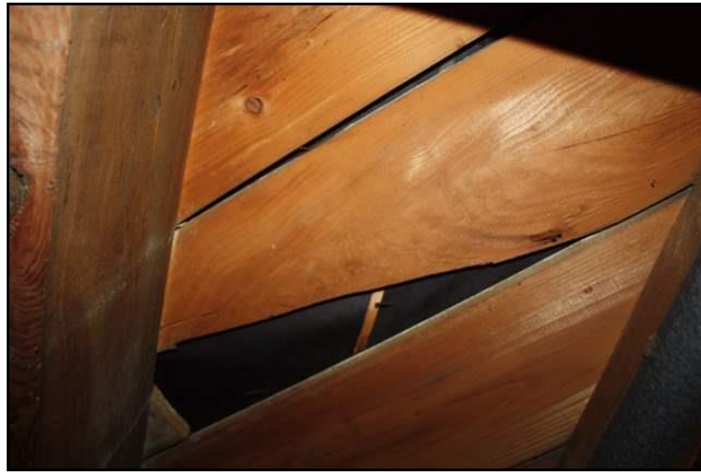
35. Damage

**Task:** Repair

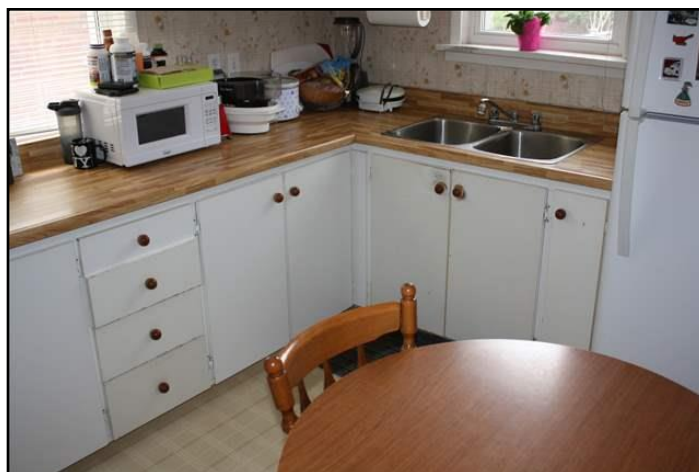
36. Stained, worn, damaged

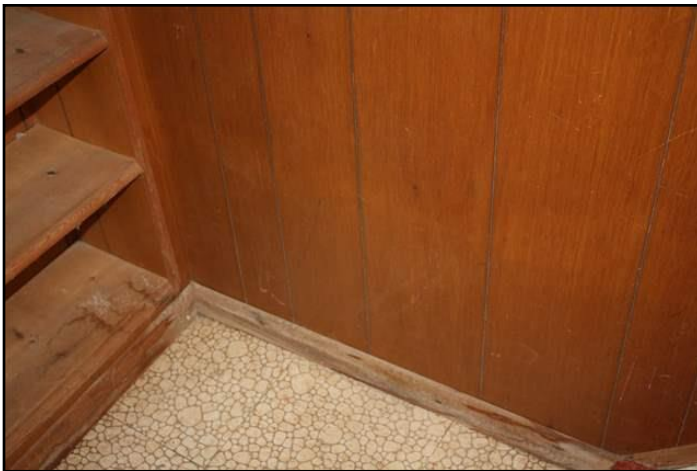
Water Stains and dampness were found at multiple areas of the front, left and right basement. Troubleshooting all the sources is outside the scope of the inspection. Consult with a professional contractor to troubleshoot all water dampness. Pictures show only a sampling.

37. Dampness on floor or walls

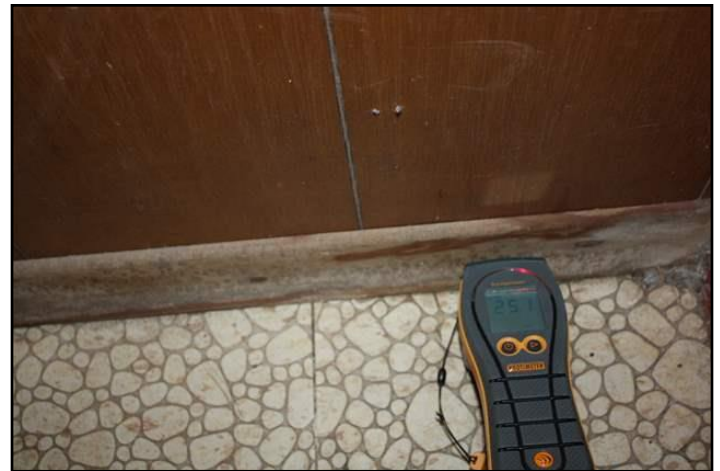
38. Dampness on floor or walls

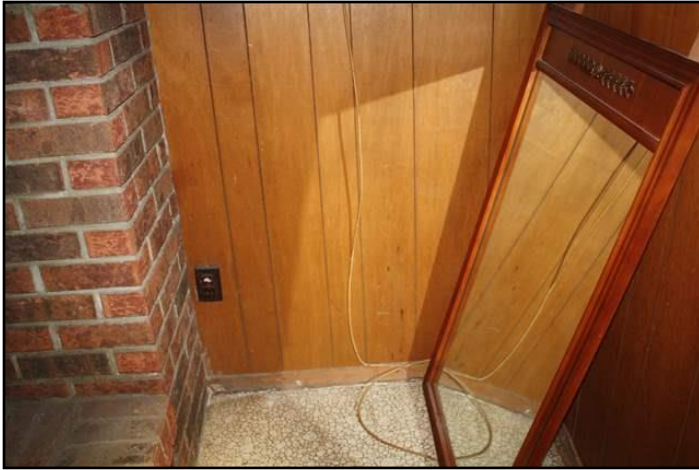
39. Dampness on floor or walls

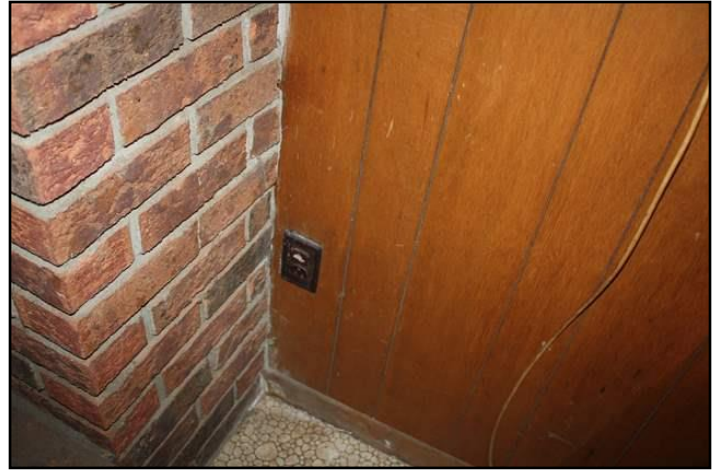
40. Dampness on floor or walls

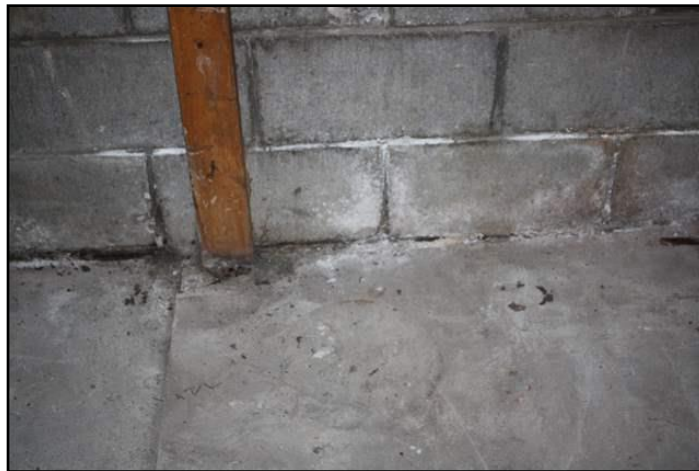
41. Dampness on floor or walls
