# YOUR INSPECTION REPORT

FOR THE PROPERTY AT:  
561 Beresford Avenue  
Toronto, ON M6S 3C2

INSPECTION DATE:  
Monday, October 6, 2025

RE: Report No. 8665  
561 Beresford Avenue  
Toronto, ON  
M6S 3C2

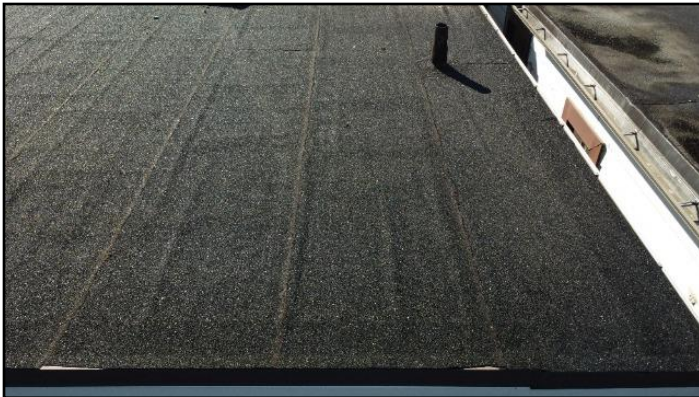
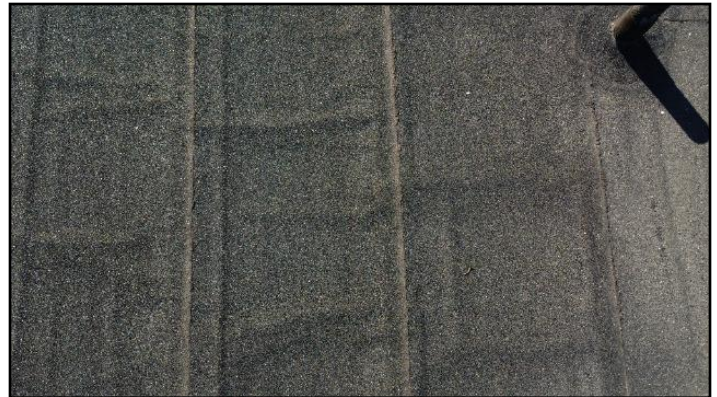
3. Blisters

**Condition:** • [Blisters](#)

Minor blistering and surface irregularities noted in the modified bitumen membrane. This is typical aging for a roof of this type.

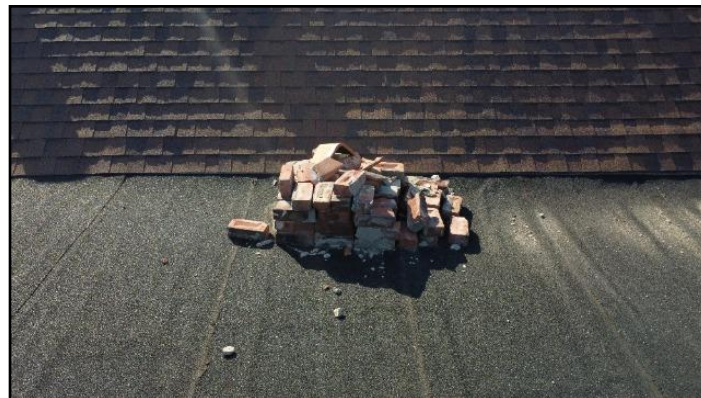
5. Debris on roof

## Condition: • [Debris on roof](#)

Old chimney bricks and mortar debris remain on the flat roof surface, likely left in place when the chimney was rebuilt approximately two years ago. Prolonged contact can damage the membrane and impede drainage.

**Task:** Remove debris and inspect underlying membrane

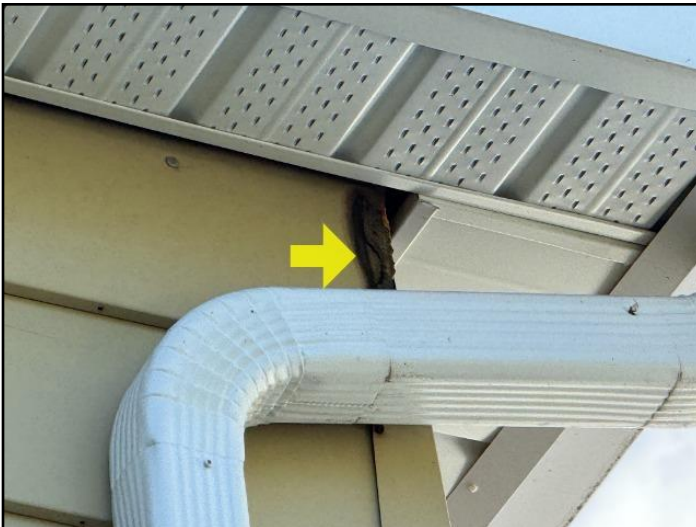
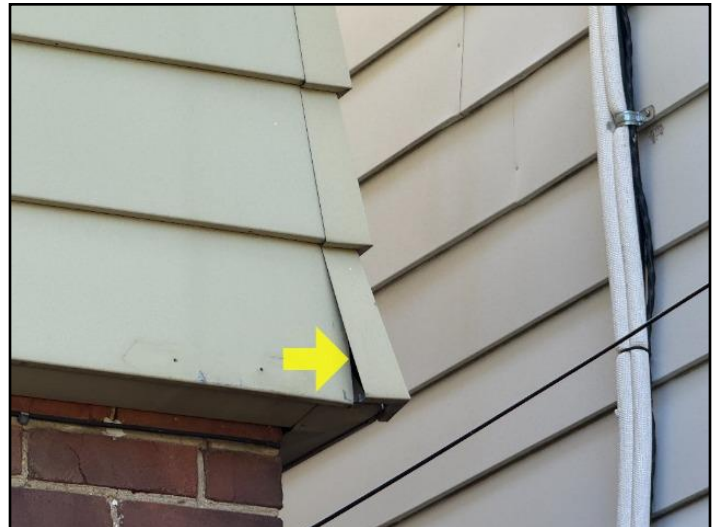
**Condition:** • [Loose or missing pieces](#)

7. Loose or missing pieces

**Task:** Repair

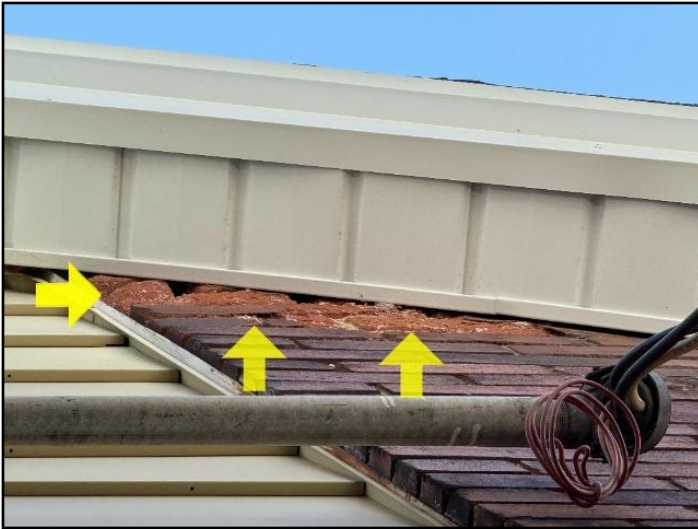
**Condition:** • Masonry and/or mortar deterioration

9. example spalling at side

Tuckpoint / Repoint mortar and patch/repair spalled masonry. This is typical maintenance for a home of this age.

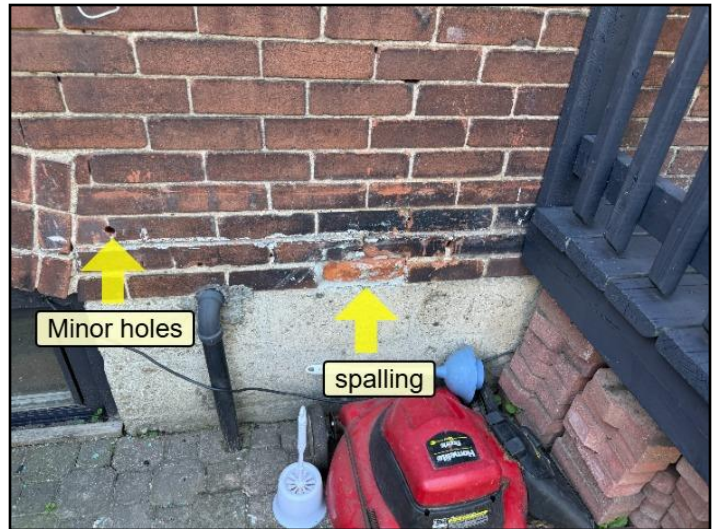
10. example at rear

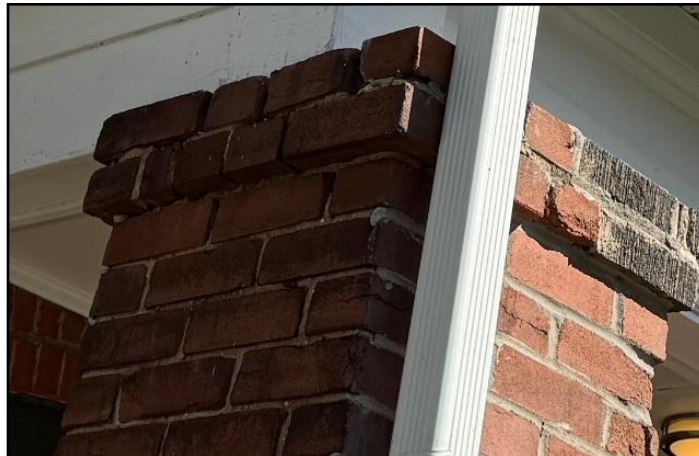
11. example at column

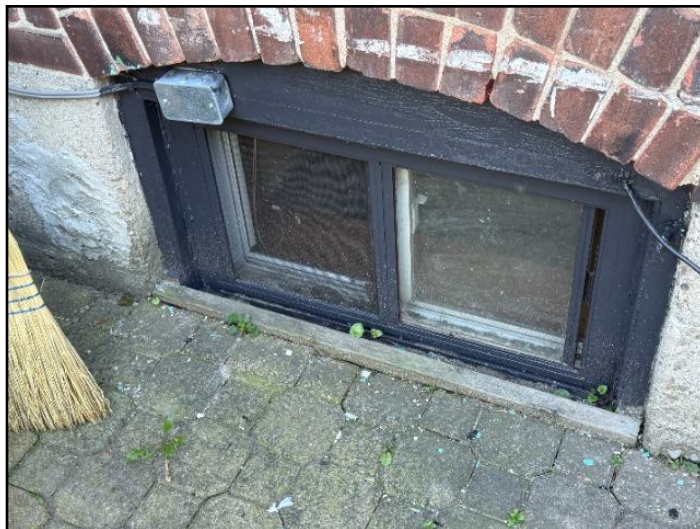
**Condition:** • Sill - Near or at Grade Level

Basement window at or near grade level. Modern standards recommend that the bottom of the window be at least 6 inches above grade or have a window well installed. Consider adding window well if regrading or when necessary. In the meantime, ensure windows remain well-sealed to prevent water intrusion.

**12. Sill - Near or at Grade Level**

**Task:** Monitor for moisture intrusion / Improve

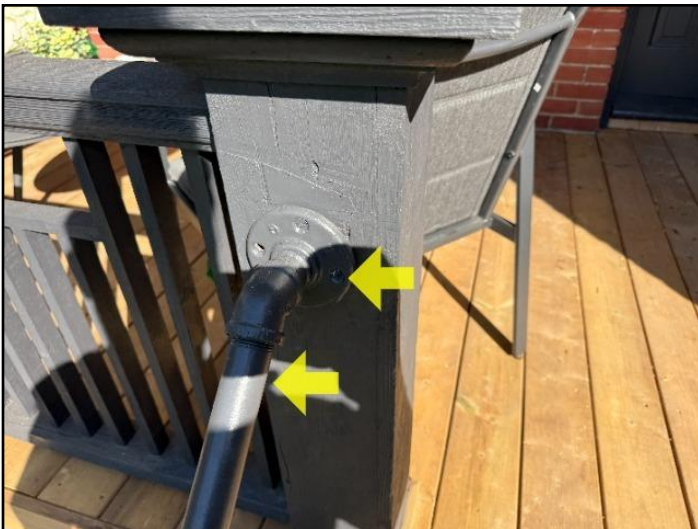
**Condition:** • [Too low](#)

Additional, handrail is loose/poorly fastened to baluster

13. Too low and poorly fastened

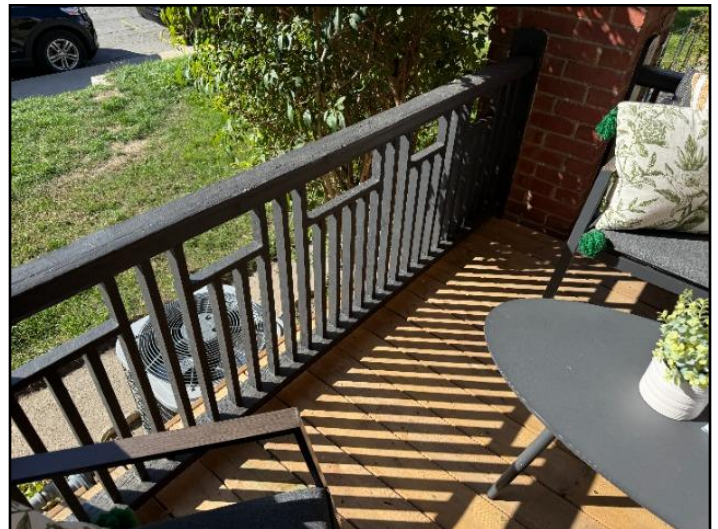
14. Too low

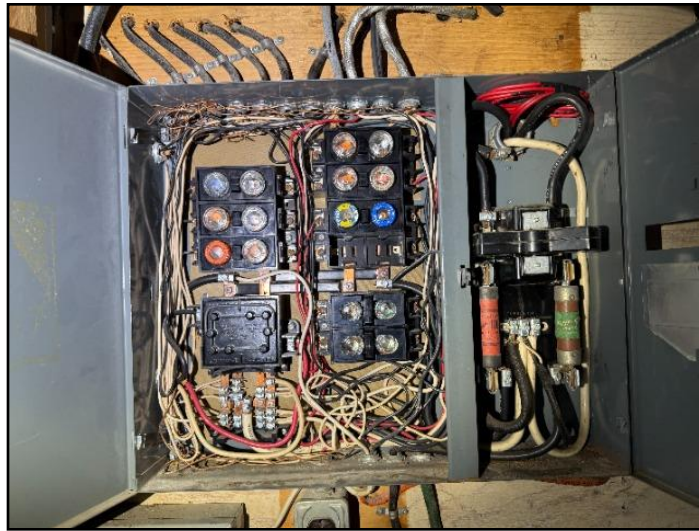
15. Fuses - basement

**Condition:** • Obsolete - Fuse panel

Many insurance companies no longer provide coverage for homes with fuse box panels. Regardless, upgrading to a breaker panel is recommended for improved safety and reliability.

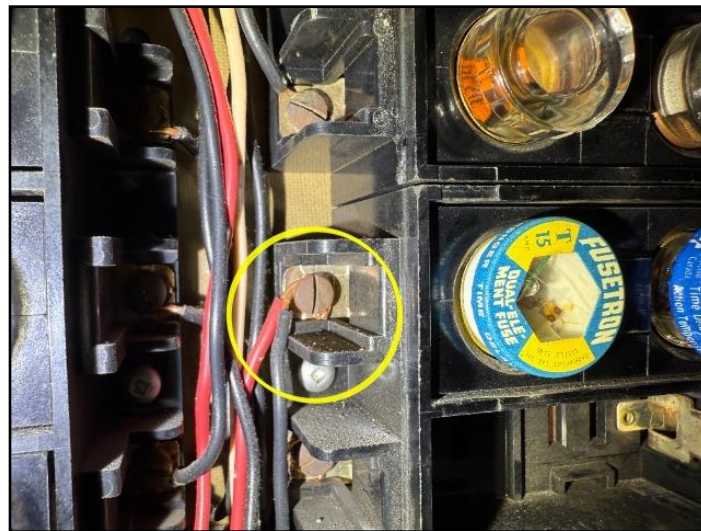
**Condition:** • [Double taps](#)

**Implication(s):** Fire hazard

16. Double taps

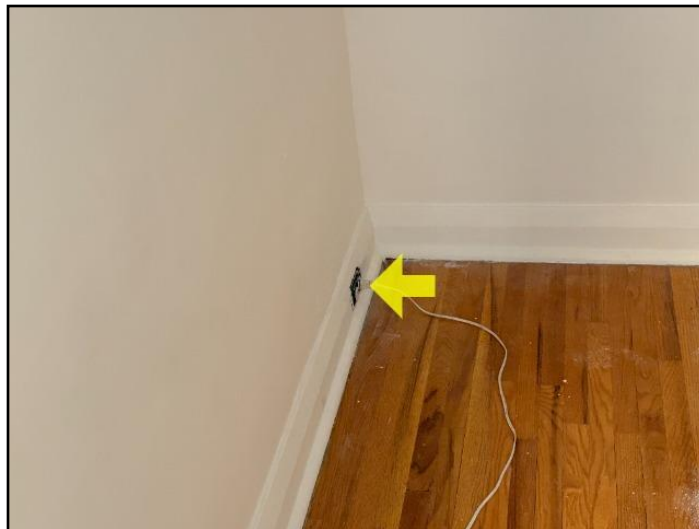
**Condition:** • For outlet (receptacle) is missing

17. For outlet (receptacle) is missing

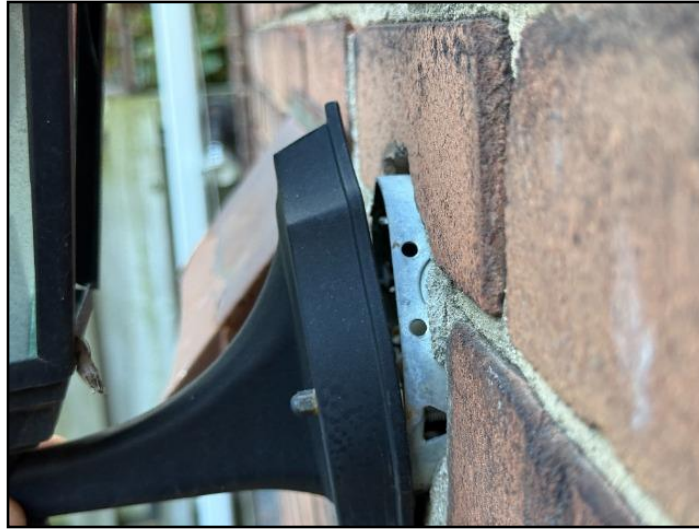
18. Loose

**Condition:** • [Loose](#)

**Implication(s):** Electric shock | Fire hazard

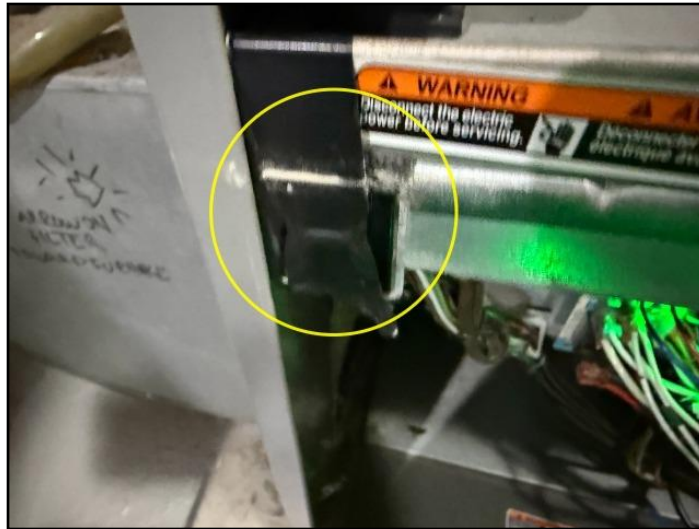
**Condition:** • Fan cover/access door interlock/safety switch inoperative

20. Fan cover/access door interlock/safety...

**Task:** Remove tape at next furnace service

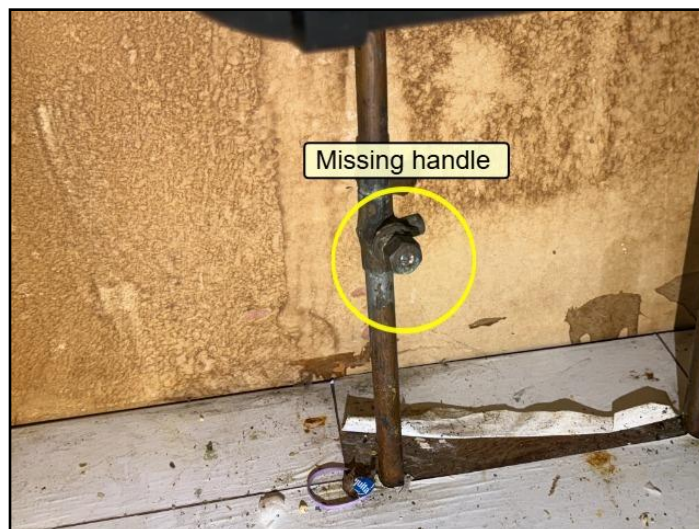
**Condition:** • [Missing or cannot be located](#)

21. Missing isolation valve handle

**Task:** Provide Isolation valve handle

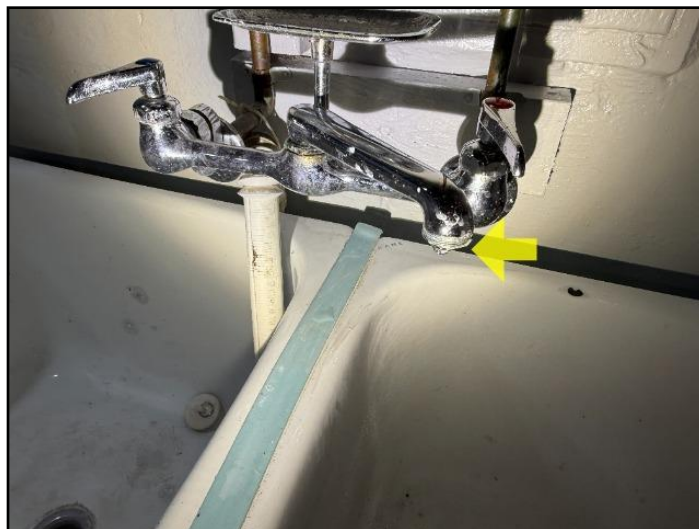
22. Drip

**Condition:** • [Drip, leak](#)

**Task:** Adjust/Repair

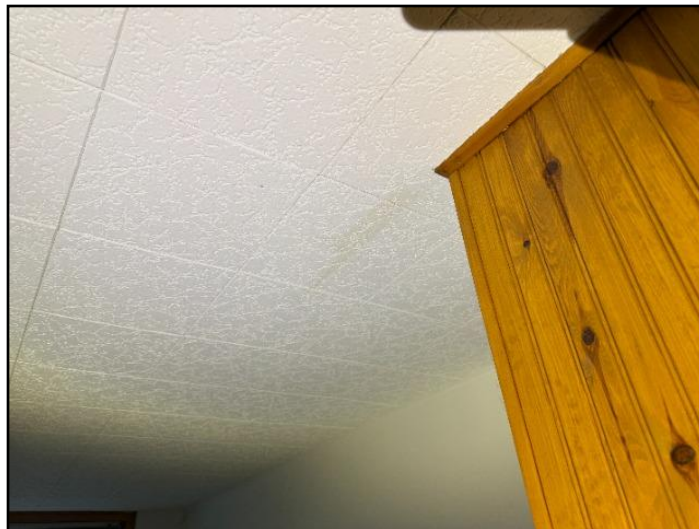
**Condition:** • Stains

Minor stain noted. Dry at time of inspection. No action needed.

23. Minor stain

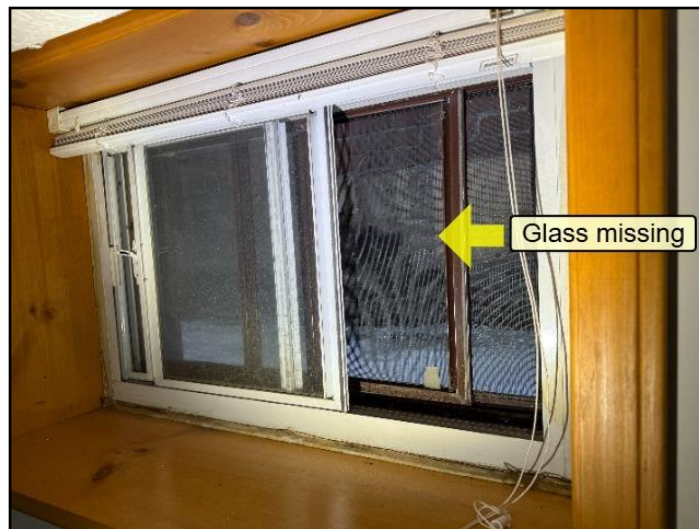
24. Missing

**Condition:** • [Missing](#)

**Task:** Replace

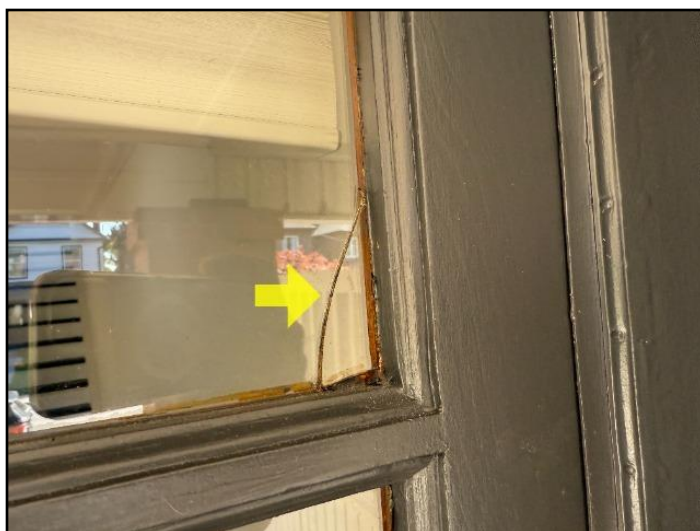
25. Cracked

**Condition:** • [Cracked](#)

**Task:** Replace

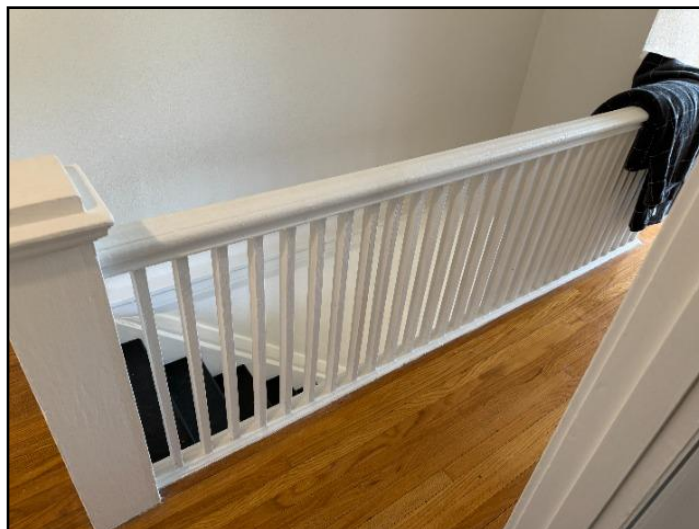
26.

**Condition:** • [Too low](#)

**Implication(s):** Fall hazard
