# Your Inspection Report

1204 Walker Line Road  
Algonquin Highlands, ON P1H 0K1

RE: Report No. 3126, v.2  
1204 Walker Line Road  
Algonquin Highlands, ON  
P1H 0K1

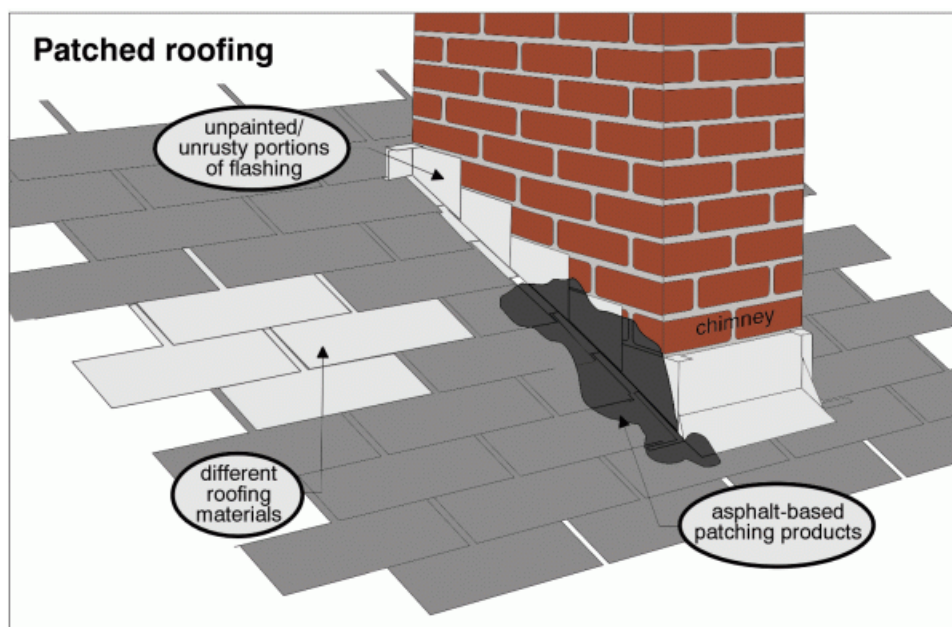
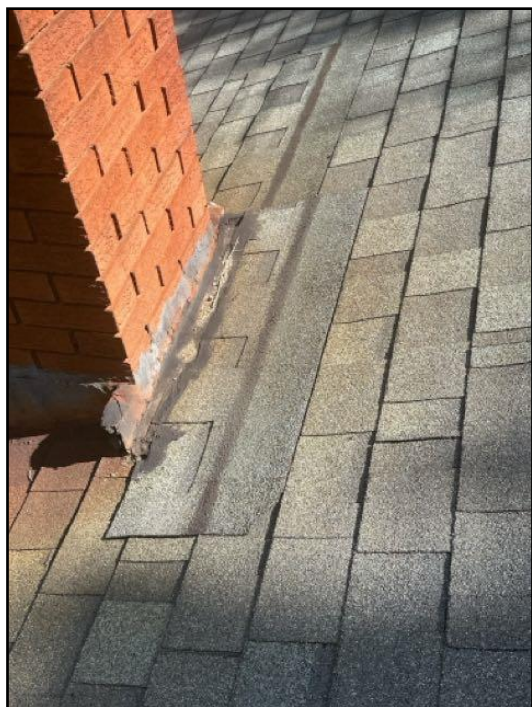
7. Patched

Roof shingles have been patched in various areas, recommend monitoring for leaks. Suspect leaks are caused from ice damming during the winter months only. Recommend adding heat on the roof above unheated areas such as rear porch and front soffit especially below masonry chimney

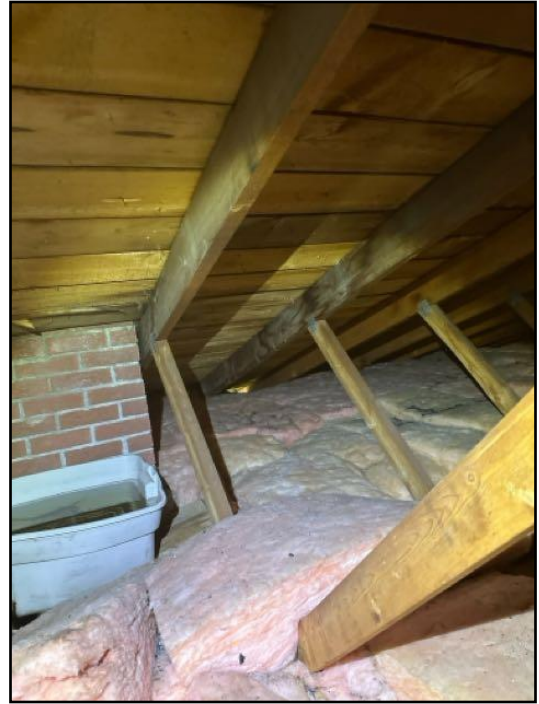
14. Vulnerable to ice damming

Various ceiling stain in living room, bedroom and kitchen. Stain are not active during inspection, ice damming seems to be occurring in various areas during the winter months. Recommend installing heat cables over unheated areas to allow water to escape. Shingles are designed to shed water not hold water. Plastic pails found in the attic space to catch water during the winter months.

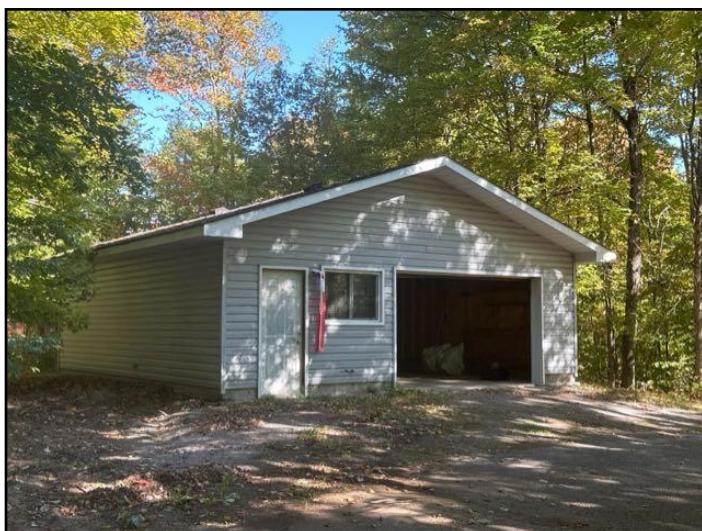
38. Detached

1. Roof shingles have past their life expectancy, recommend replacing soon. Water appears to be entering on the left side above water stains in the garage.
2. Mechanical damage to vinyl siding at the front wall.
3. Ungrounded outlets, recommend further investigation suspect a loose wire.

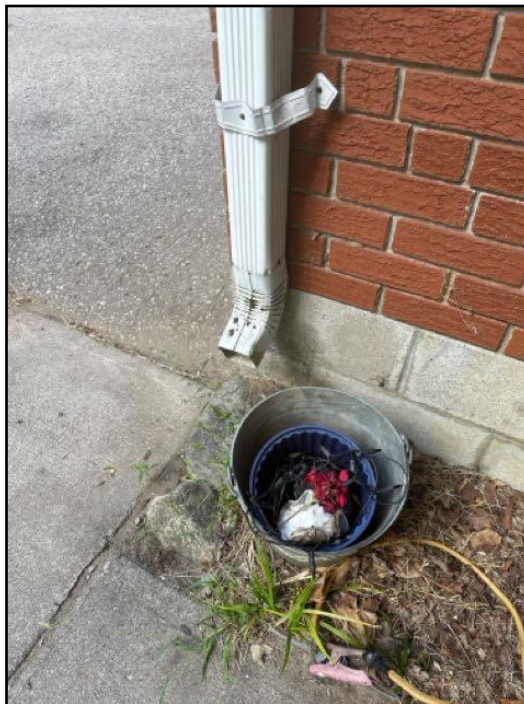
*47. Discharge too close to building*

Downspout ends too close to building, recommend adding an extension to ensure water drains far enough from foundation wall to prevent movement.

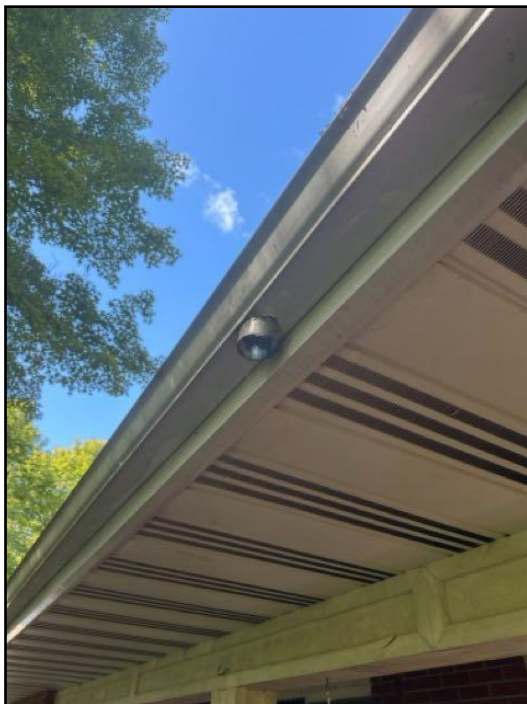
48. Missing

Missing downspouts, consider installing a plastic chain from gutter to the ground to prevent splashing of water on walls or adding downspouts.

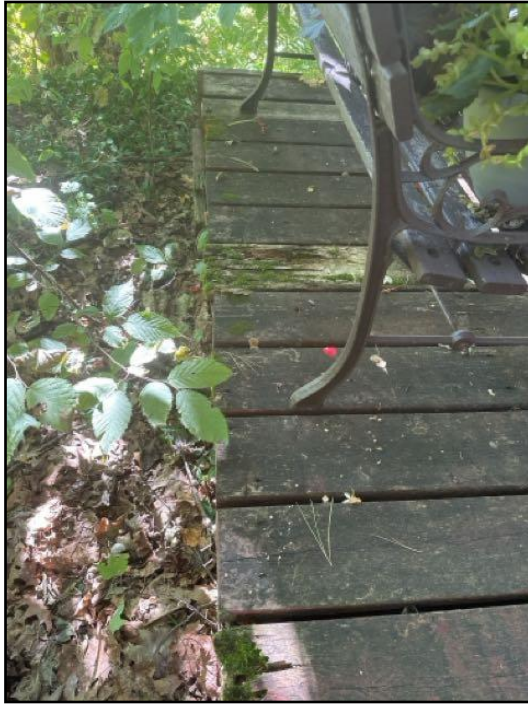
52. Rot

Rear deck floor boards and floor joist are rotten, recommend repairs or replacing within a year.

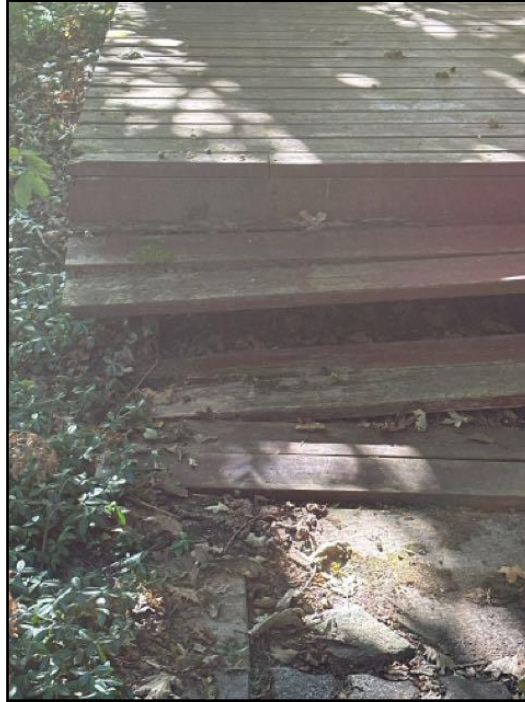
55. Rot

Staircase on the left side of exterior of house is rotten, recommend replacing.

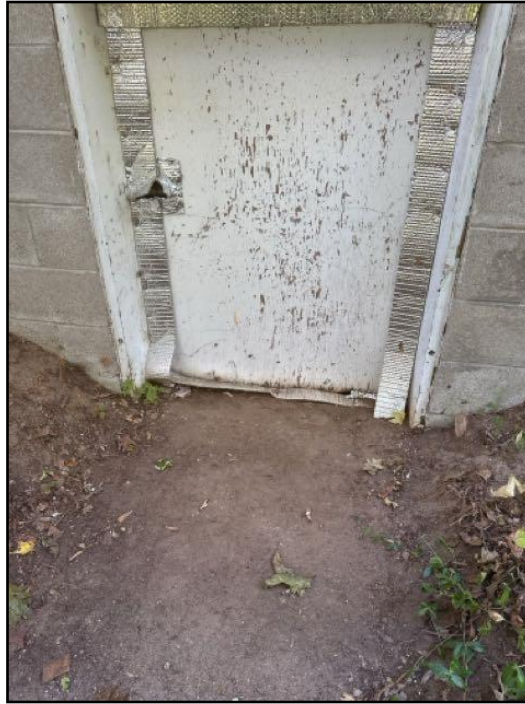
**56.** *Improper slope or drainage*

Poor drainage in front of crawlspace hatch, recommend improving grade or installing a drain to prevent water from entering crawlspace.

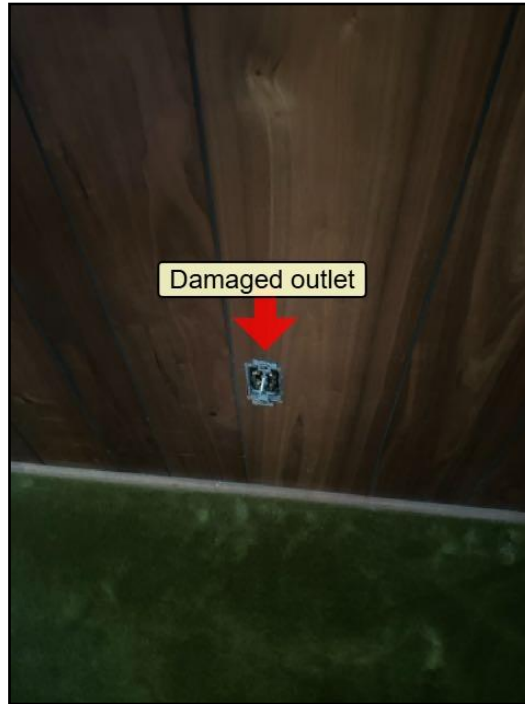
74. Damage

Damaged outlet should be replaced as soon as possible for safety.

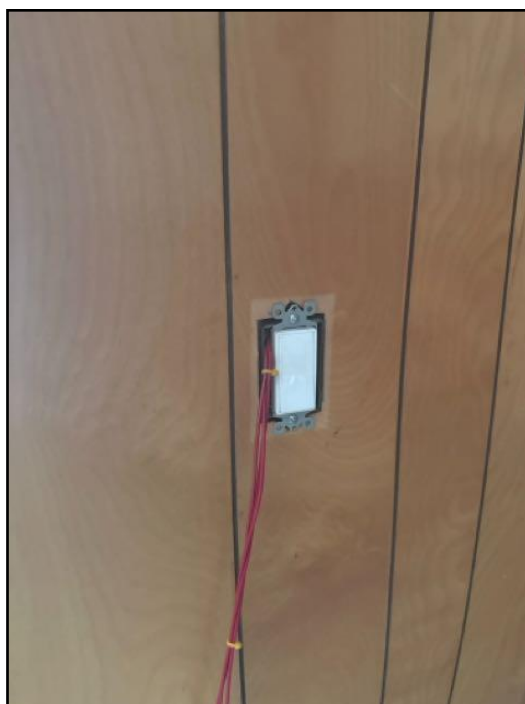
79. Missing

Missing cover plate, recommend providing, Living room.

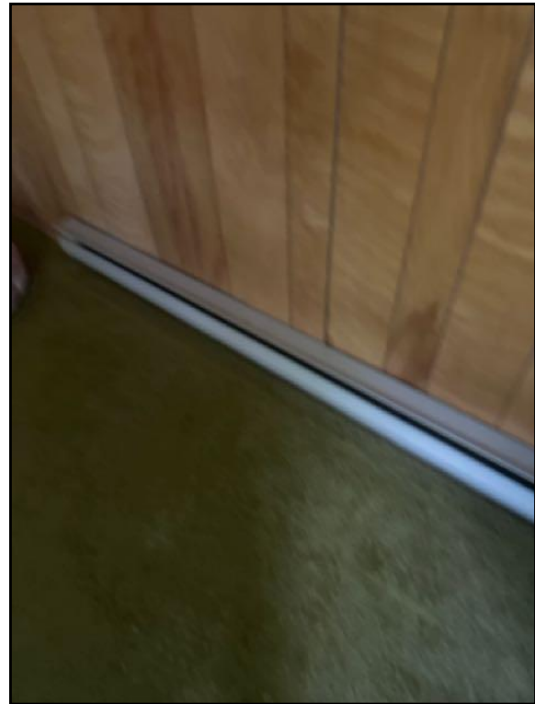
112. Inoperative heaters

Inoperative heaters in the living room and dining room, recommend further investigation, suspect a loose wire.

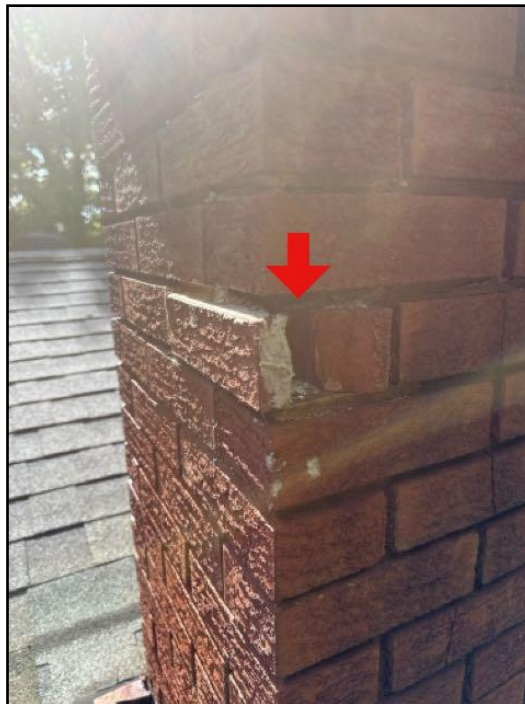
118. Spalling

Masonry Chimney is starting to spall near the top, recommend monitoring and making repairs when necessary.

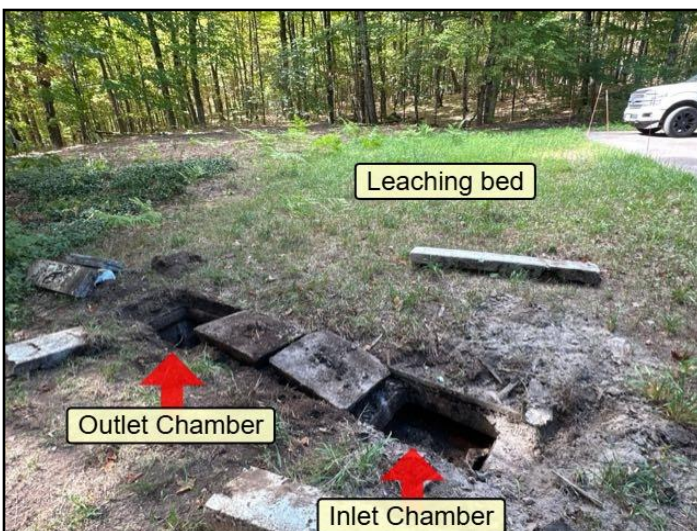
**133. Septic system**

Outlet baffle has been repaired, monitor during each pump out and replace when necessary.

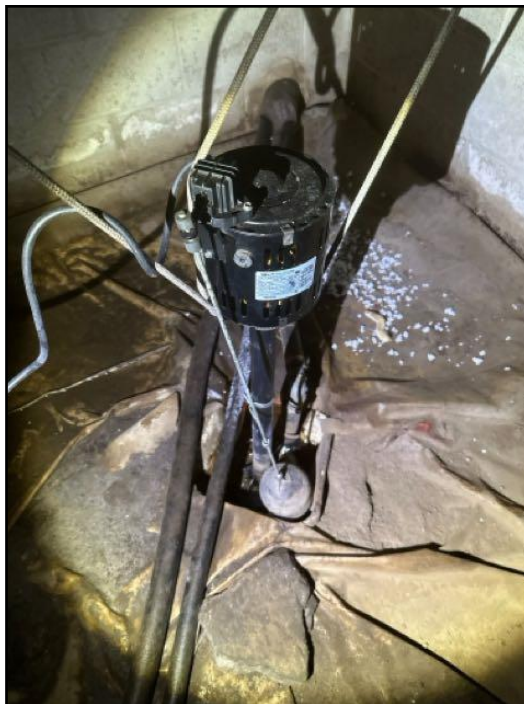
139. Sump pump

Sump pump tested fine. Recommend installing a battery backup sump pump in the event of a power failure. And monitor exterior discharge pipe for freezing during the winter months especially in the spring.

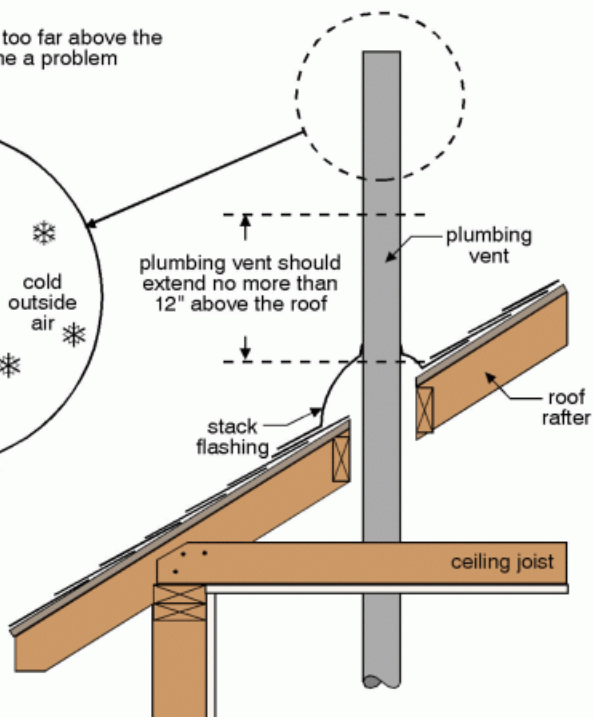
145. Vent termination problems

Both waste vent pipe are too long and should terminate only 12" from exterior wall. When kitchen sink is used during the winter months we risk moist air freezing at the very tip and eventually clogging the pipe. When the pipe is clogged gurgling sounds will be heard at the sink and possibly sewer gasses. Recommend drilling 4 holes in the pipe 12" above roof line. (1/8" holes)

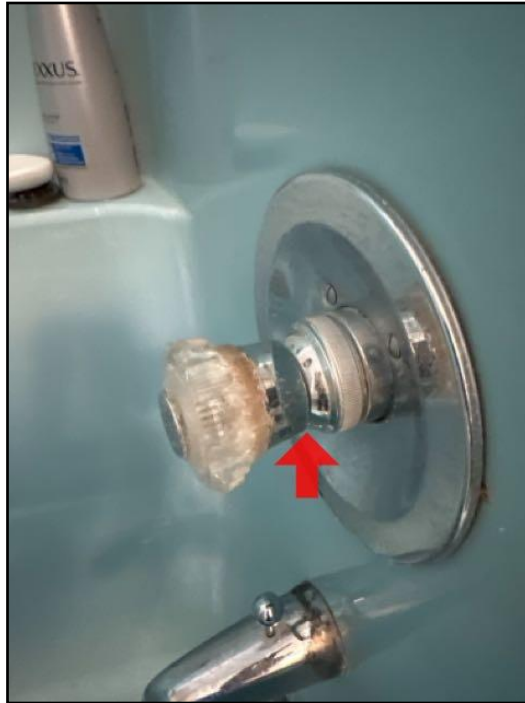
147. Drip, leak

Shower faucet has a small leak, recommend replacing cartridge or replacing faucet when remodeling.

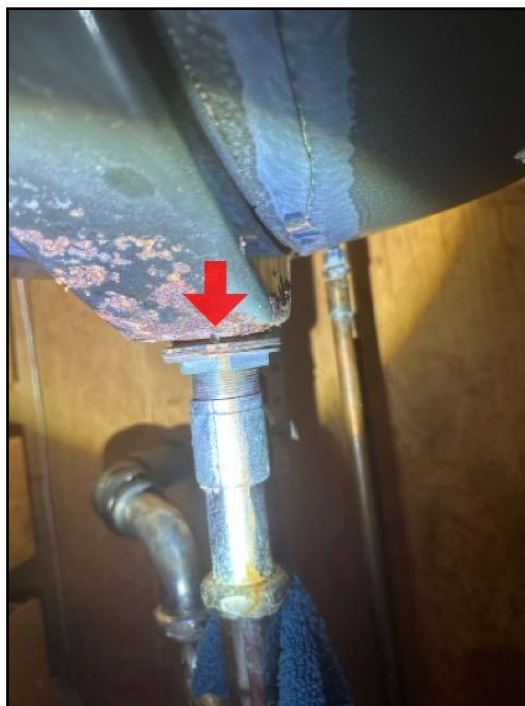
148. Rust

Bathroom sink is rusted below and has a small leak. Recommend replacing in the near future when remodeling. Laundry room bathroom.

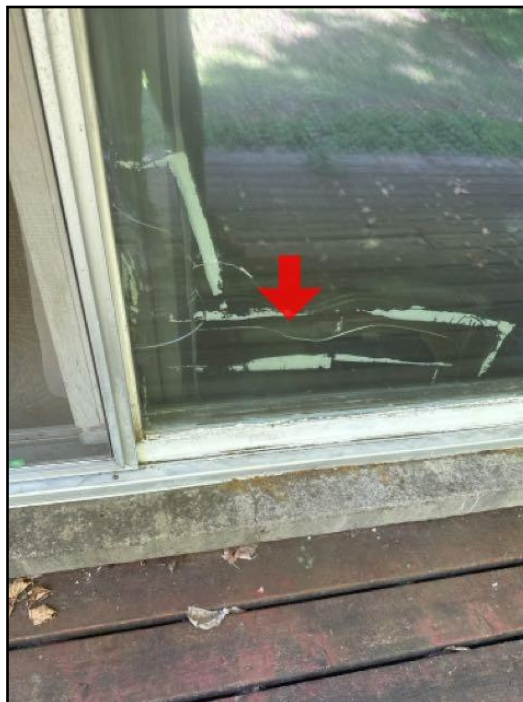
**154.** Cracked

Cracked window, recommend replacing. Main floor living room sliding exterior door.
