INSPECTION REPORT

5300 South 108th Street, Hales Corners WI
53130

July 15, 2025

4 Site Building Inspections Inc

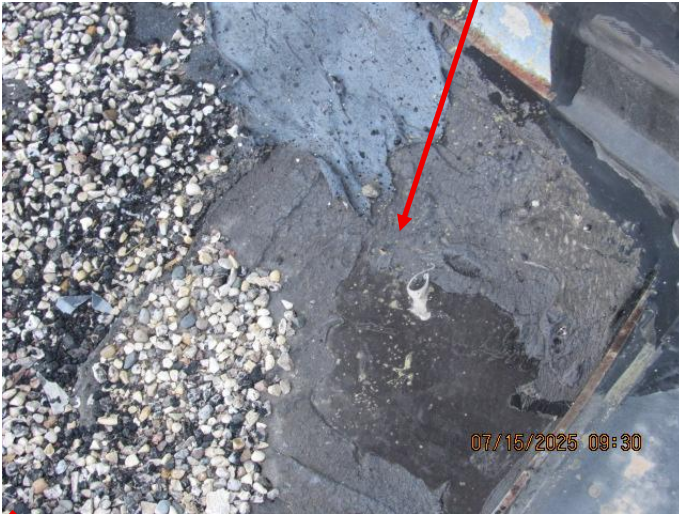
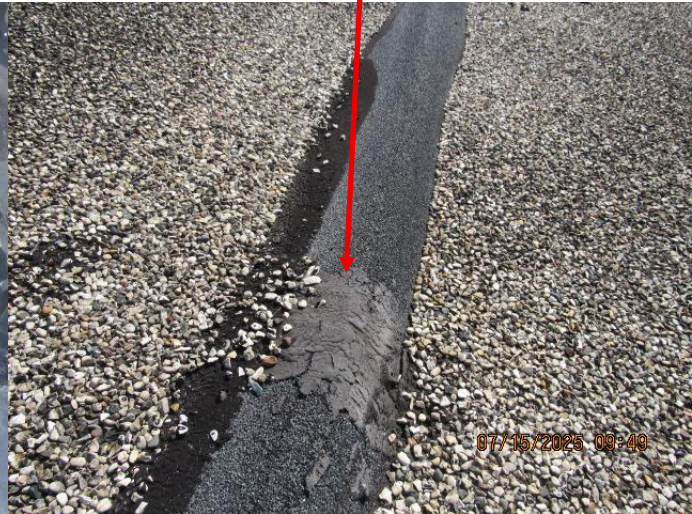
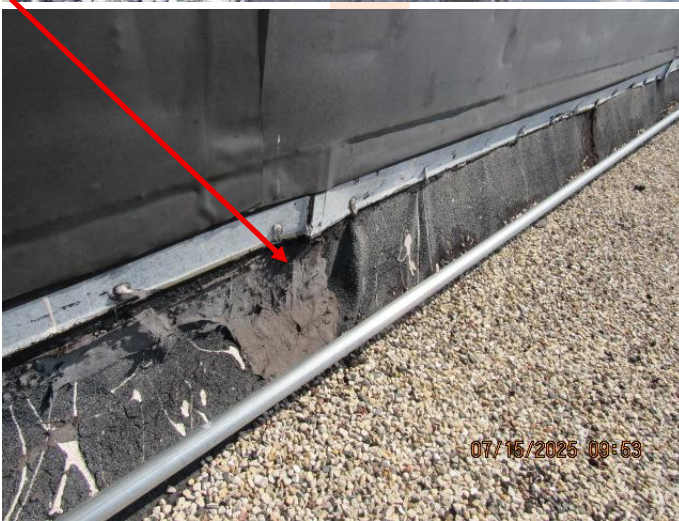
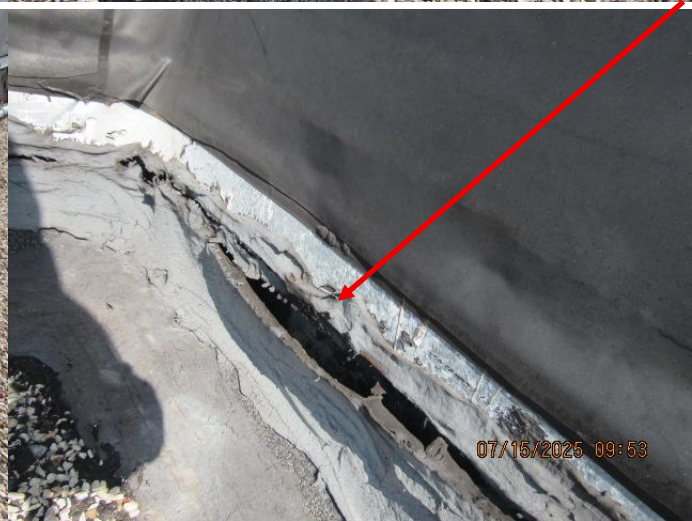
1. Approximately 40,000 square feet of roofing on the main building and various flashings are in need of replacement in the near future. The roofing material is at the end of life expectancy and damaged in various areas. Rusted/old flashings should also be replaced. A full tear off is recommended. A Certified Roofer should evaluate the roof system for replacement.

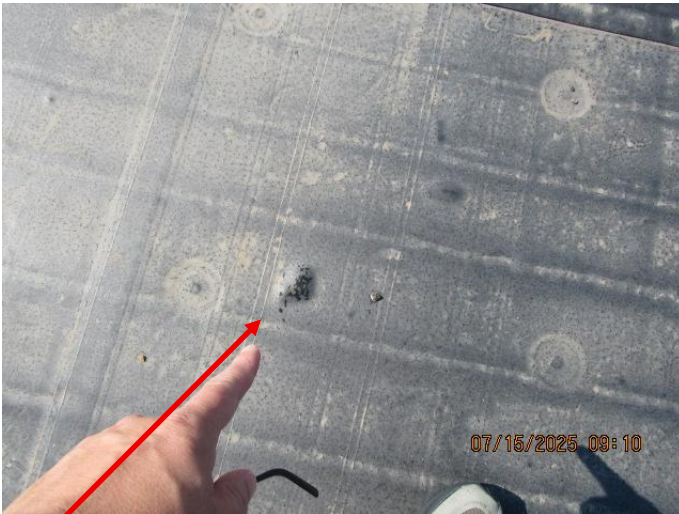
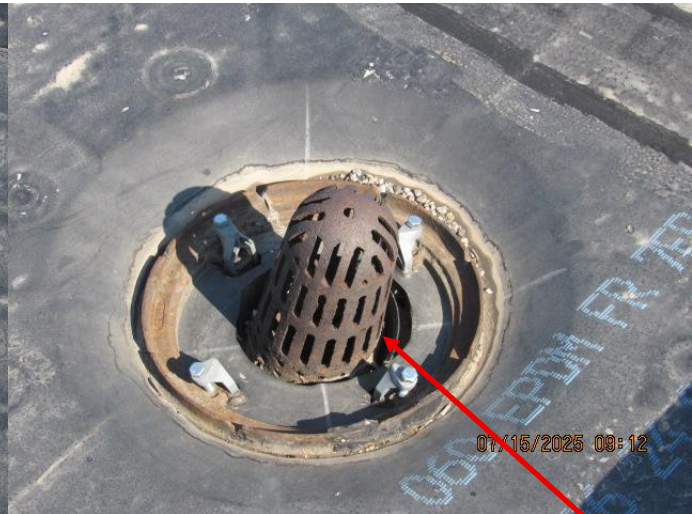
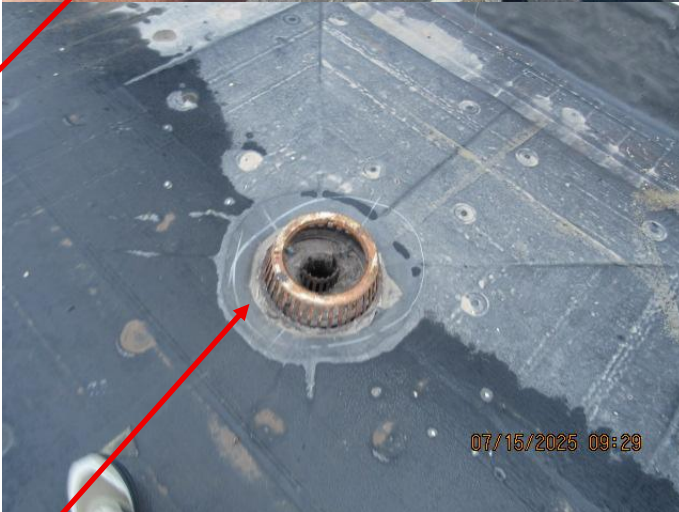
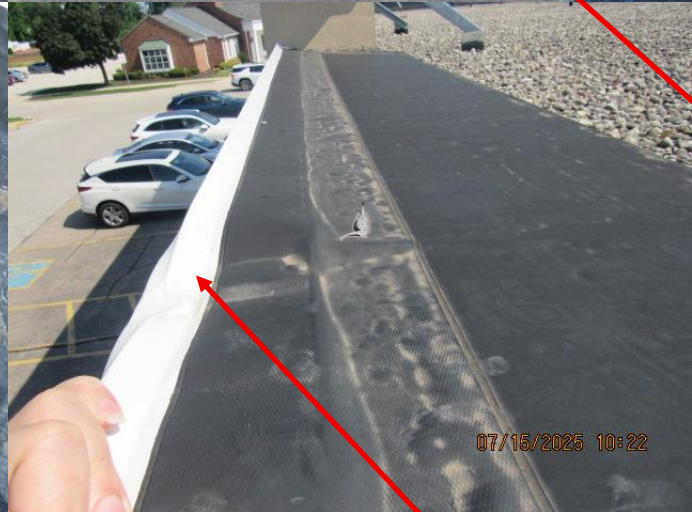
2. Roof repairs are needed in the newer rubber roof systems on the buildings. Some drains and drain covers are poor. Some seams are poor in the smaller building and damage was noted in the smaller building roof system. A Certified Roofer should evaluate the roof systems for repairs.

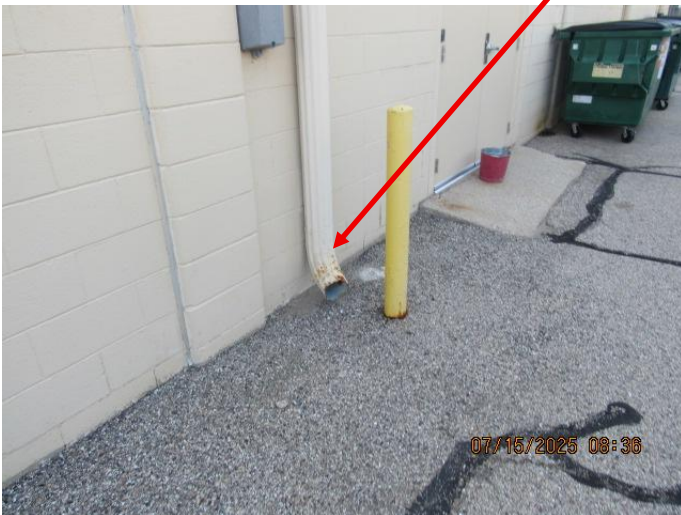
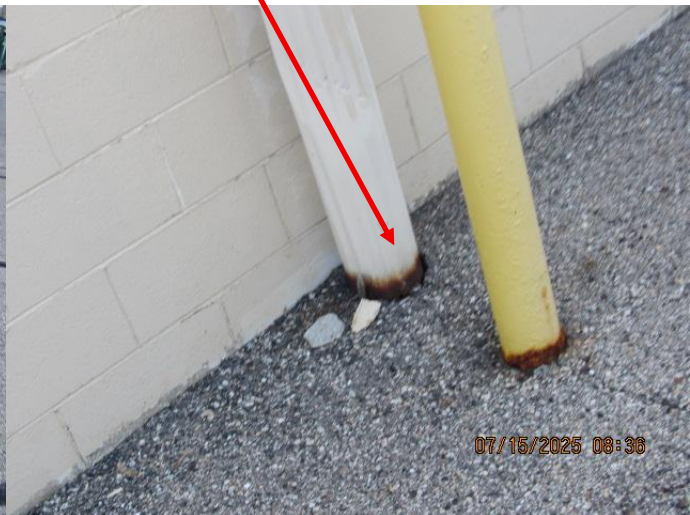
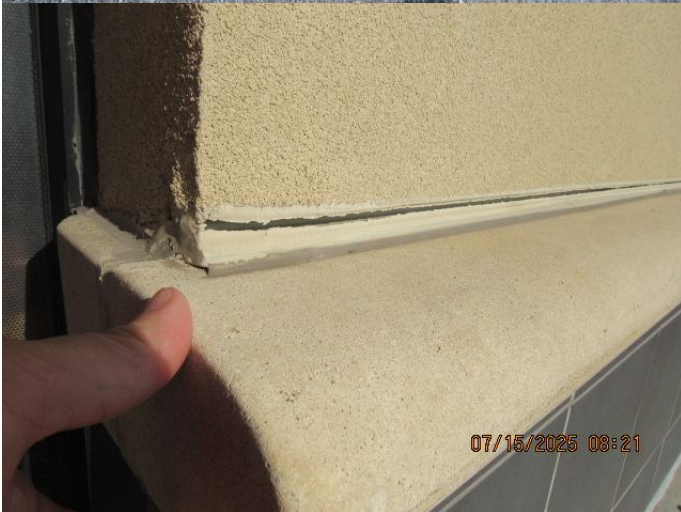
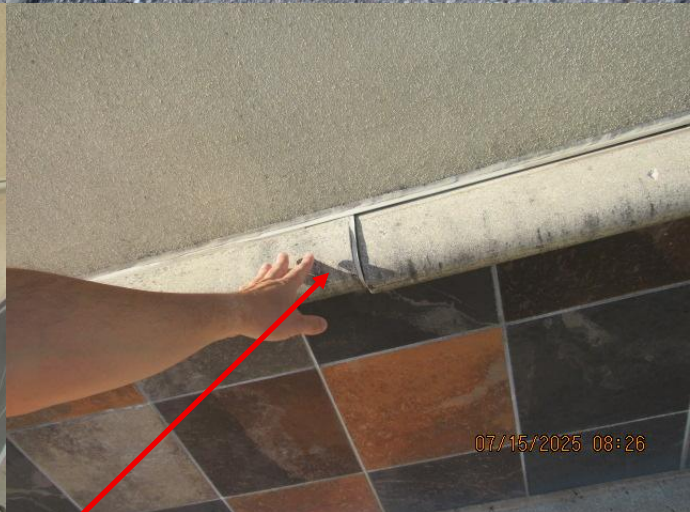
3. Downspouts are loose, damaged or rusted. Downspouts below grade may be dumping water next to the building. Scuppers show signs of poor transitions. Gutter/downspout repairs are needed in various areas.

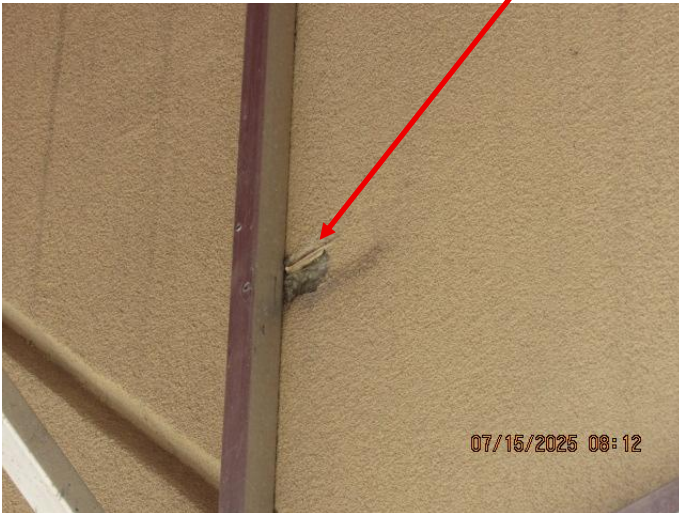
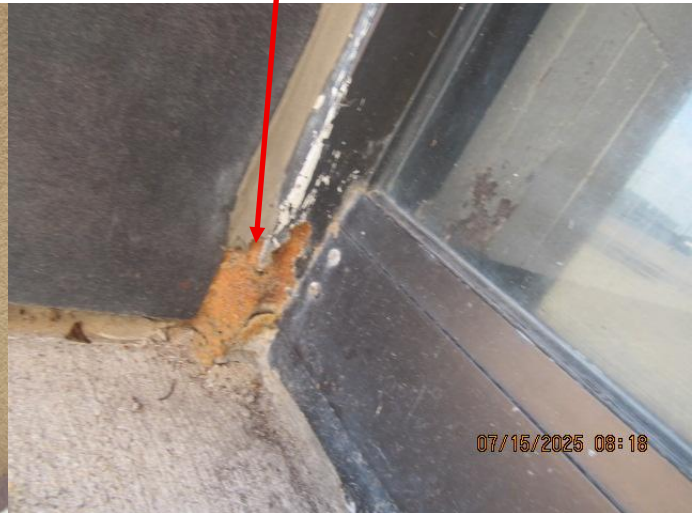
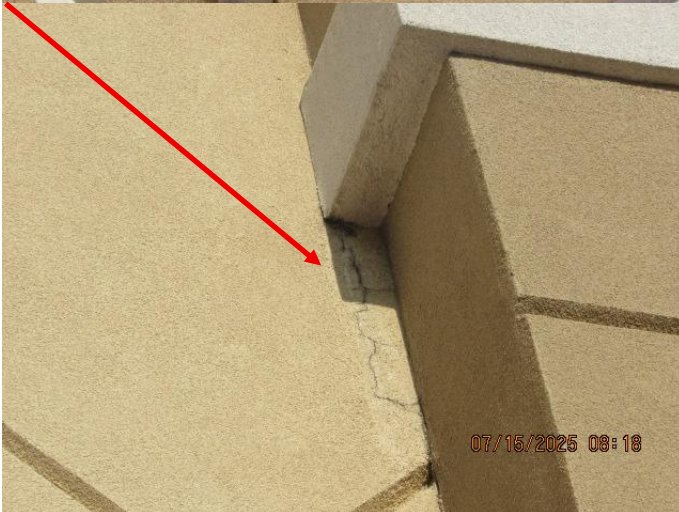
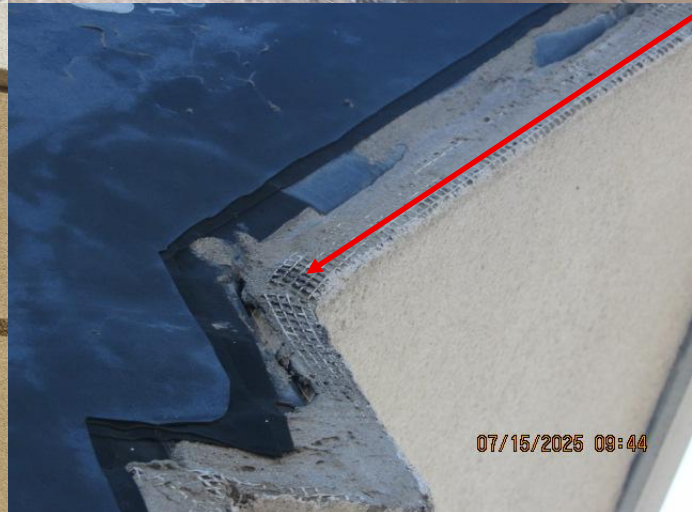
5. The Eifs has many areas where the awning is poorly fastened to the material and the EIFS can be prone to water intrusion in these areas. Damage to Eifs was noted in various areas. Some EIFS finishes are poor and should be improved. The extent of the EIFS damage that cannot be viewed is unknown. An Eifs contractor should be consulted.

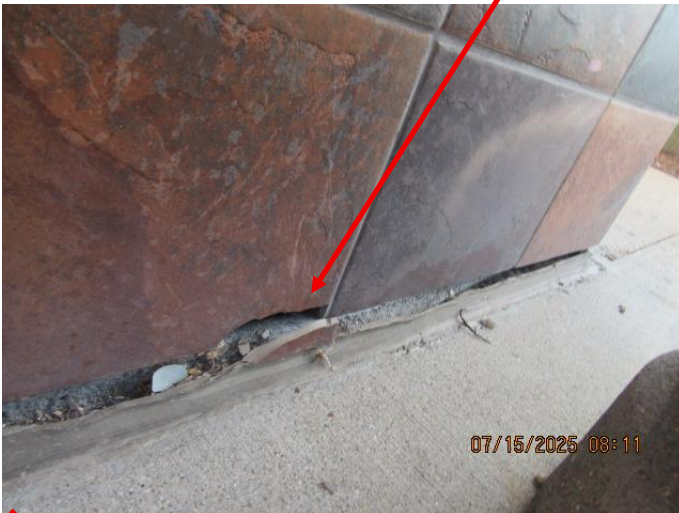
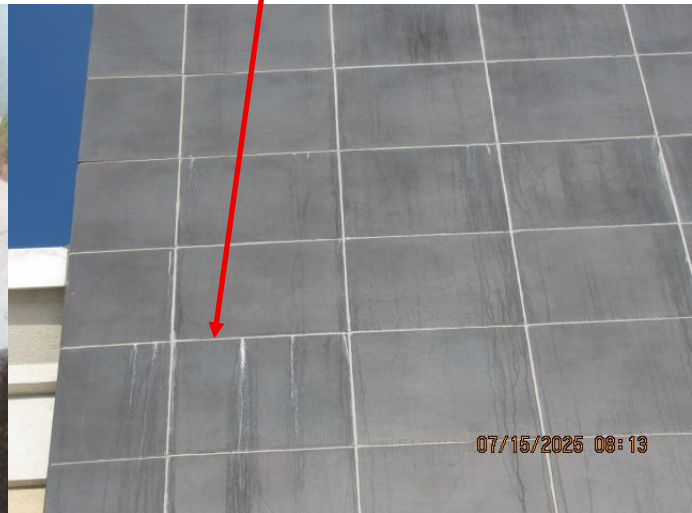
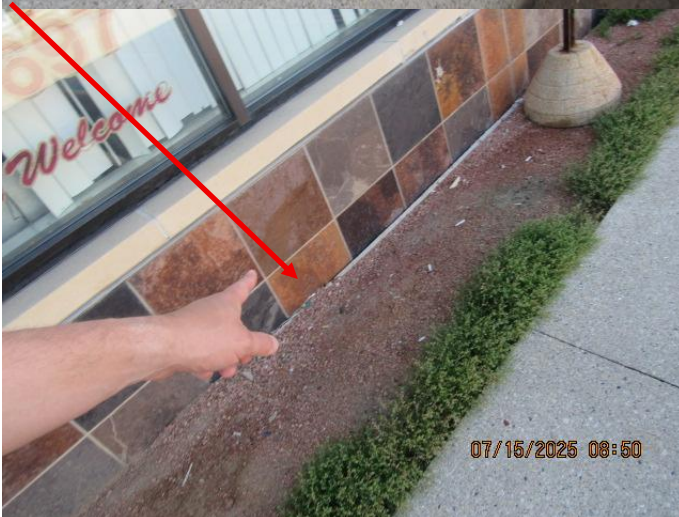
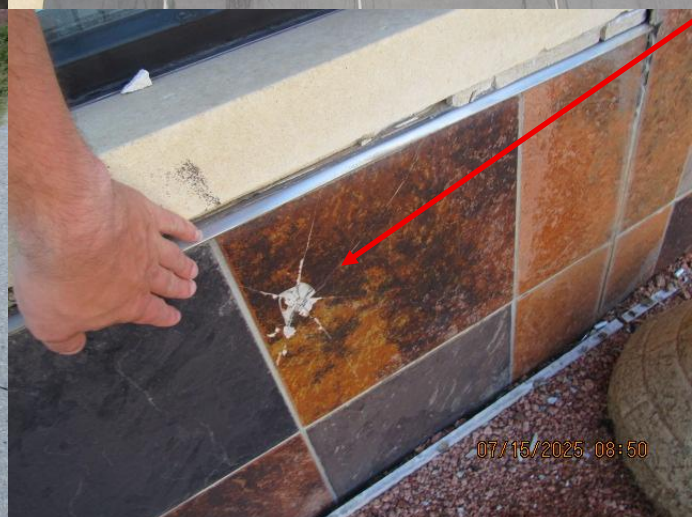
6. The tile siding has poor clearances and shows signs of damage near the ground in various areas. The tile damage and stone cap block is damaged at the front of the smaller building from impact. The tile is installed over brick and moisture is trapped behind the tile from the brick in various areas. Repair/Replacement to the tile is needed in many areas. The extent of the damage and repairs needed is unknown.

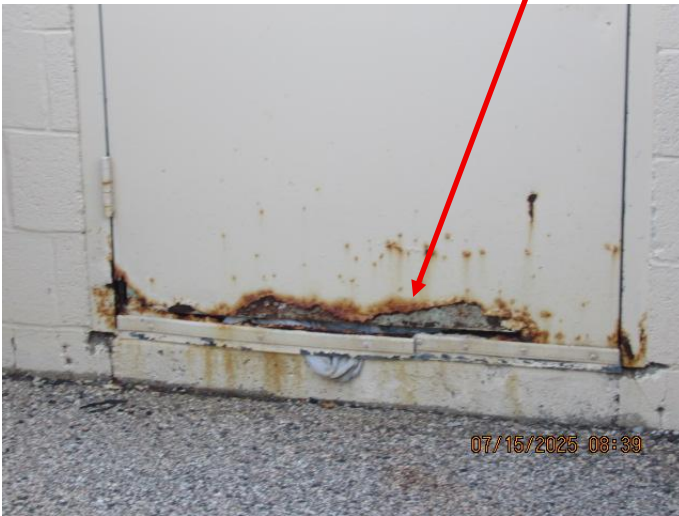
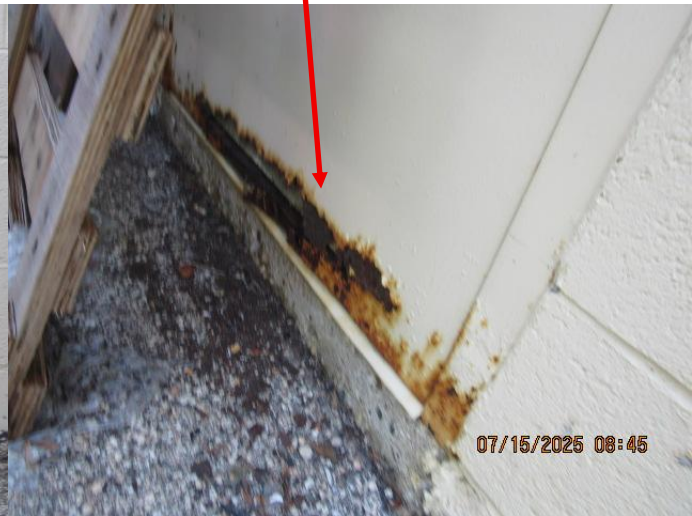
7. Many exterior doors show signs of rust/deterioration and water intrusion. Some exterior doors have been abandoned but were not removed. Repair, replacement or proper abandonment is needed at approximately 10 exterior doors.

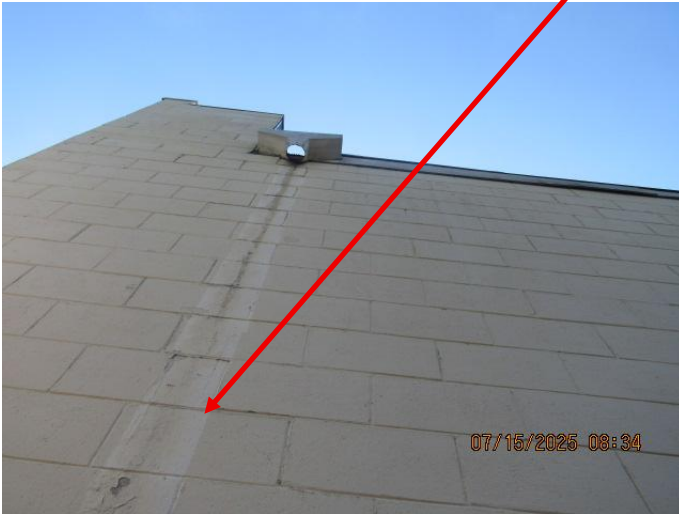
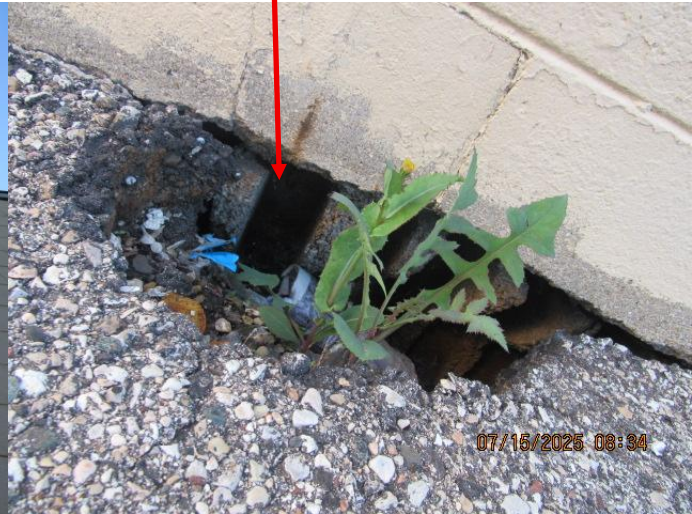
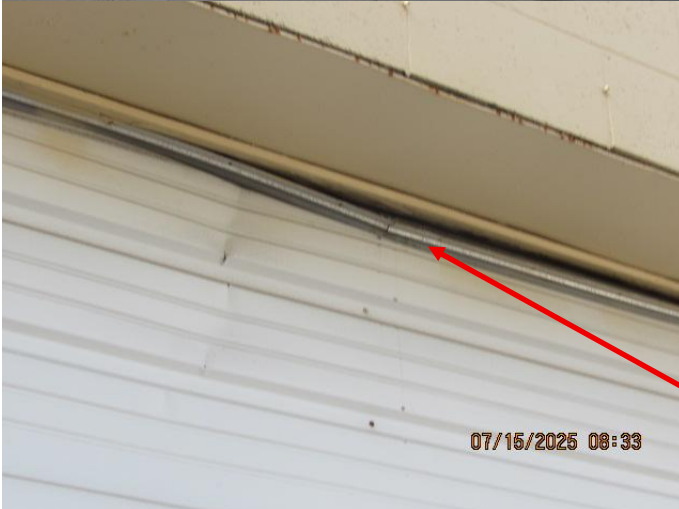
16. The foundation is in deteriorated condition due to downspout spillage below the slab. The block walls show signs of settlement. Other downspout discharges should be investigated, the extent of structural deterioration should be investigated and repairs should be made.

Damage at roll up door in liquor store.

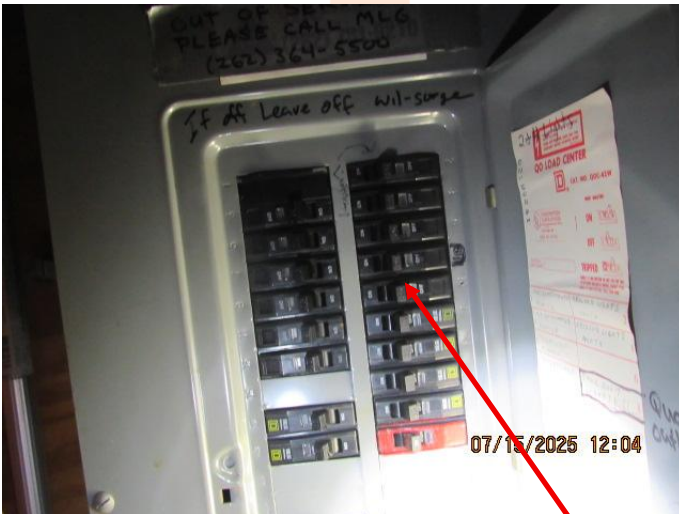
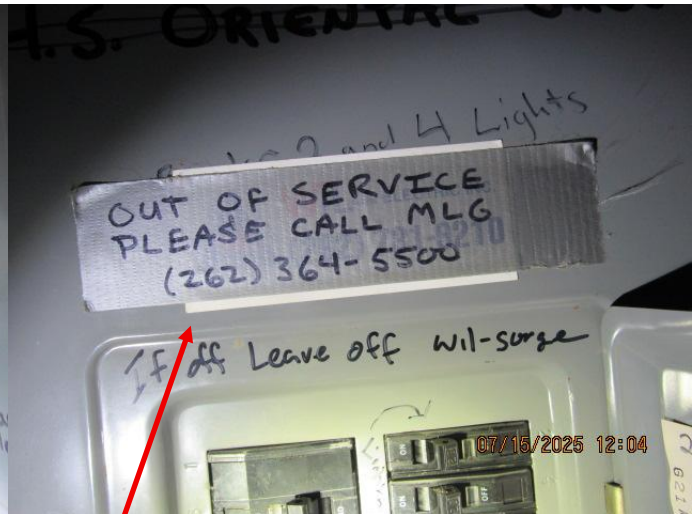
22. Electrical panel face covers should be better secured.

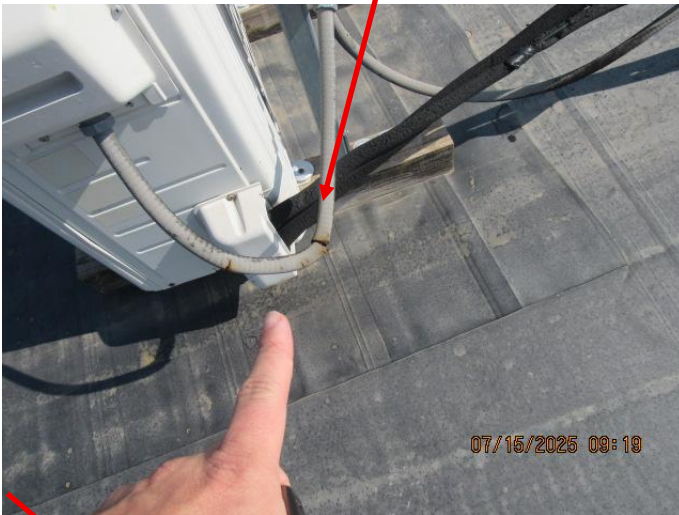
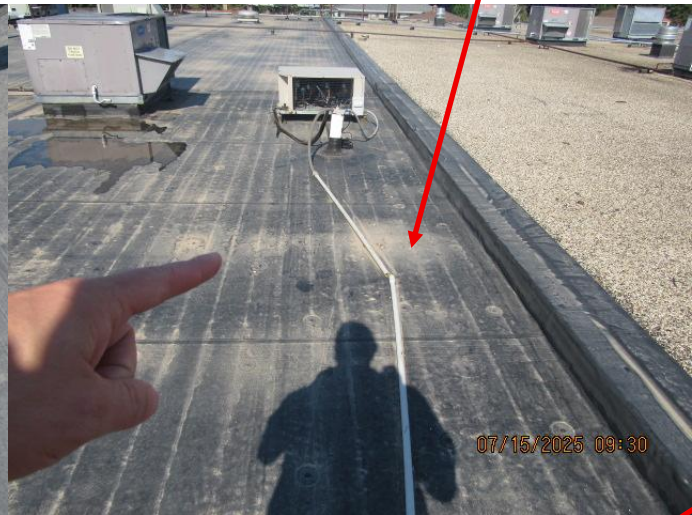
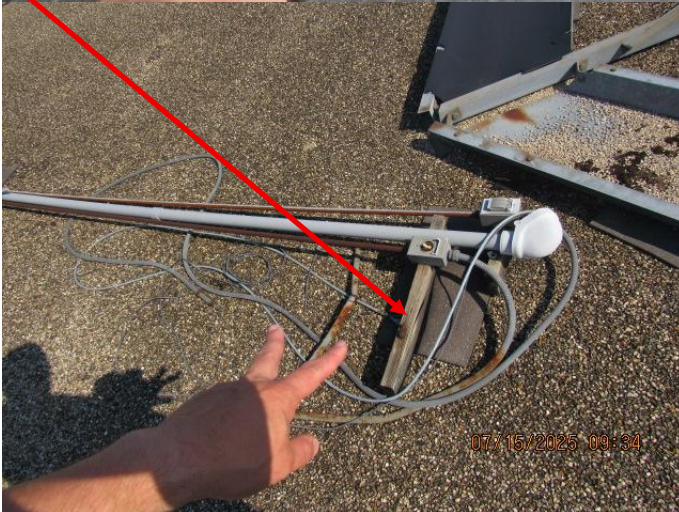
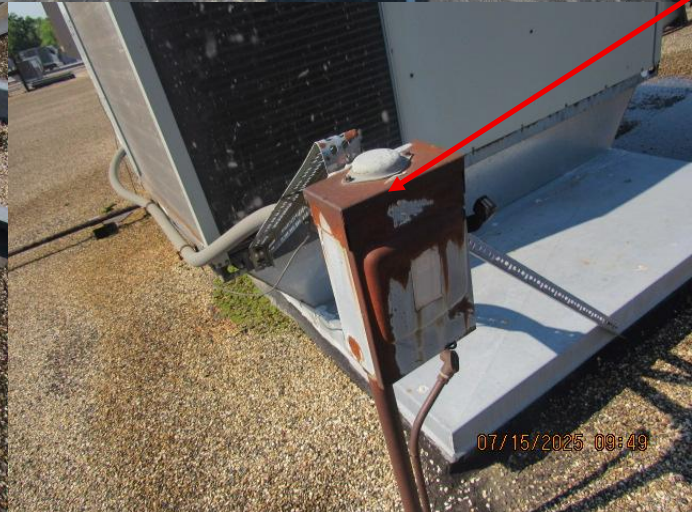
24. Rusted/Damaged conduit and junction boxes on the roof needs repairs. An Electrician should be consulted.

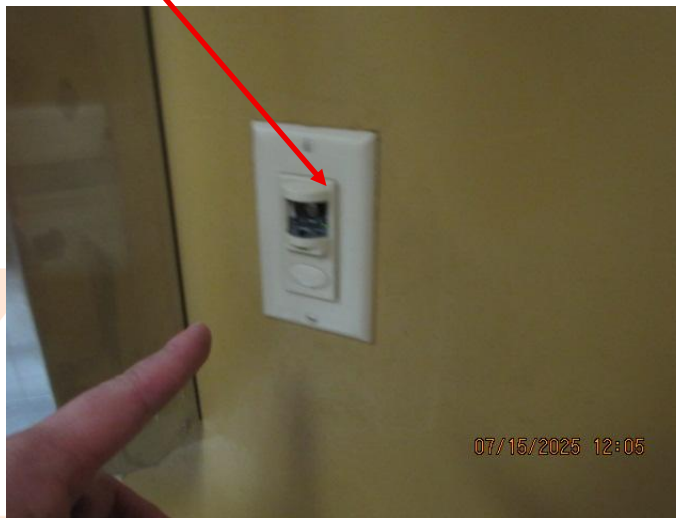
27. Damaged switch should be replaced.

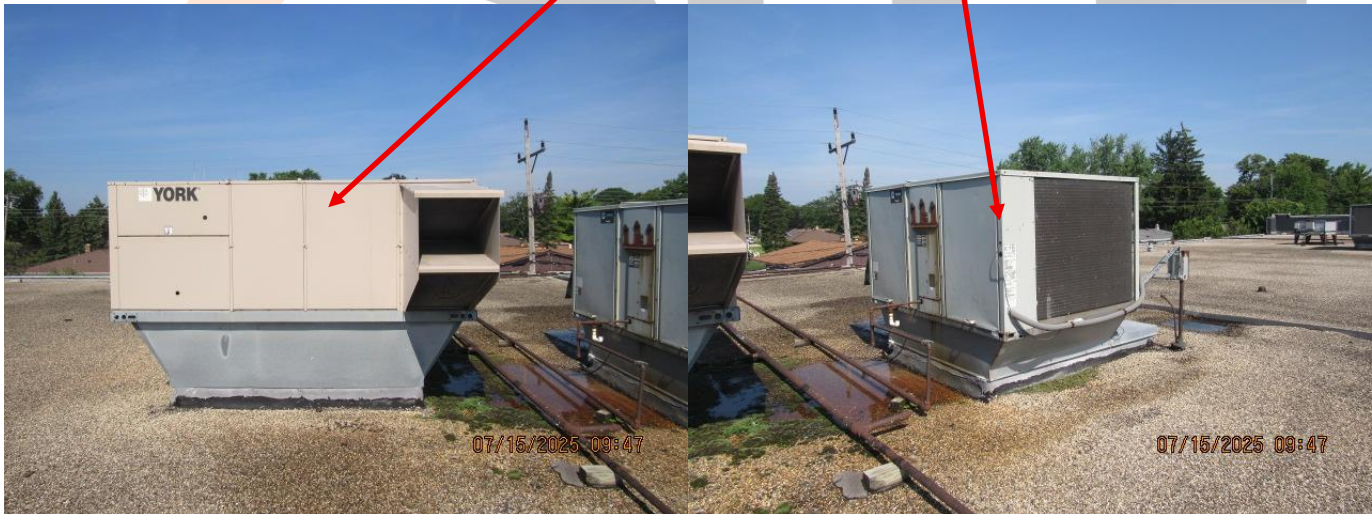
32. 4 Roof Top Units are at the end of life expectancy. A budget should be set aside for replacement.

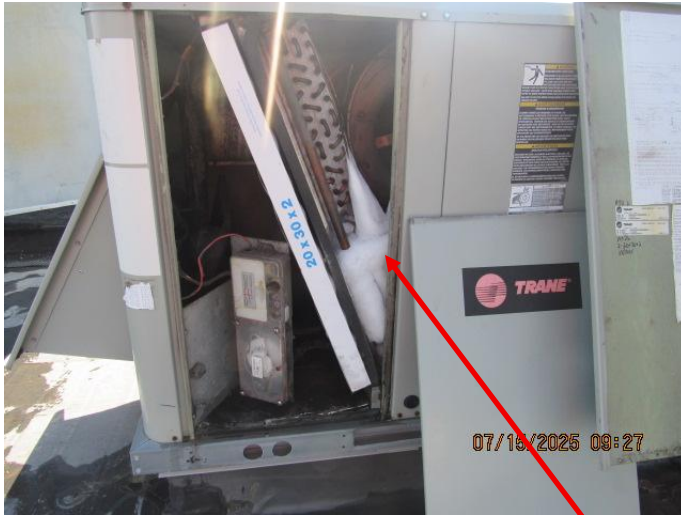
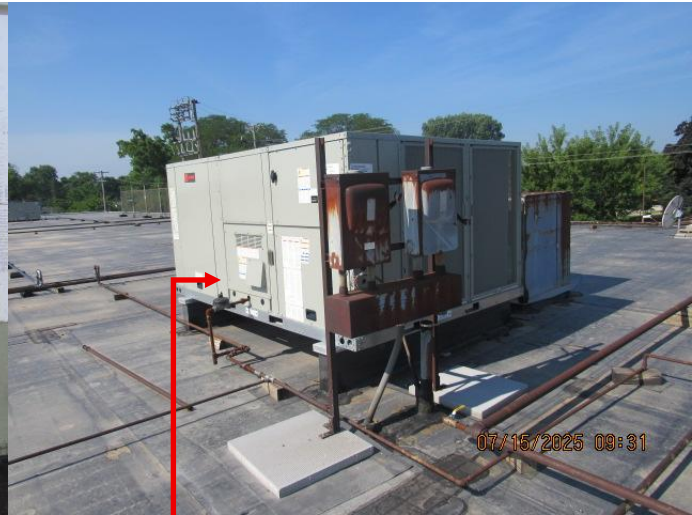
33. Approximately 7 Roof Top Units are approaching the end of life expectancy. With maintenance, some service life is still there. A budget should be set aside in the future for replacement of these units.

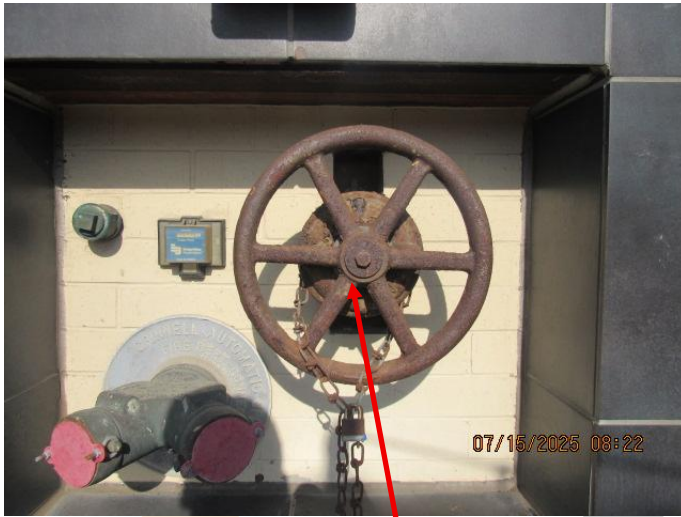
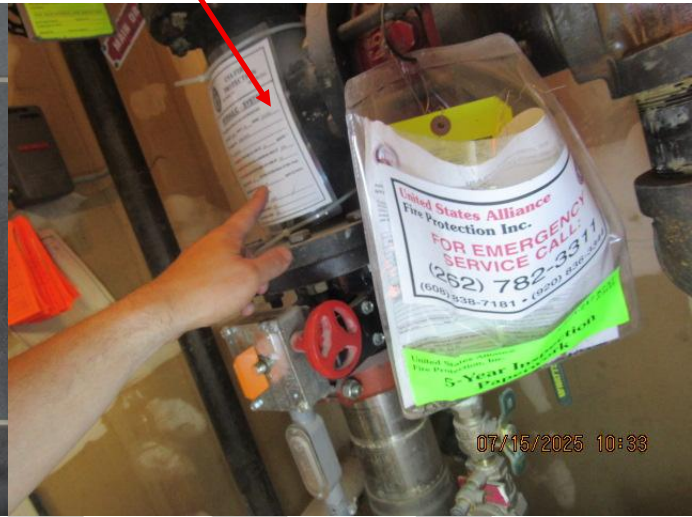
43. 5 year inspection tags were located for the fire sprinkler system was located. Annual service tags were not noted. Annual service/inspection is needed at the fire sprinkler system throughout.

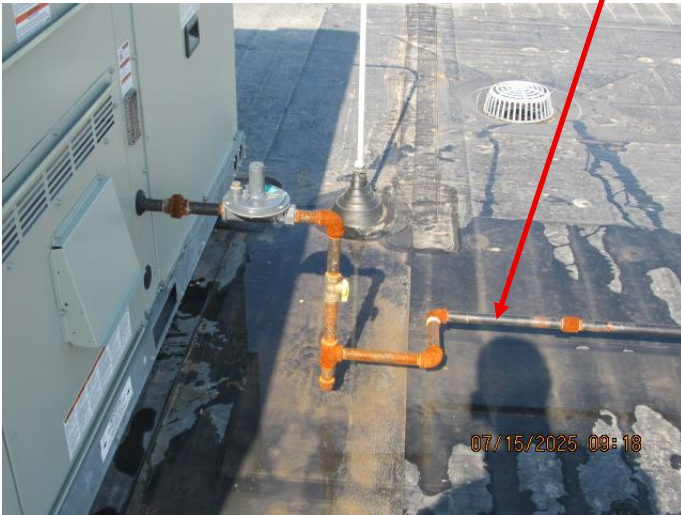
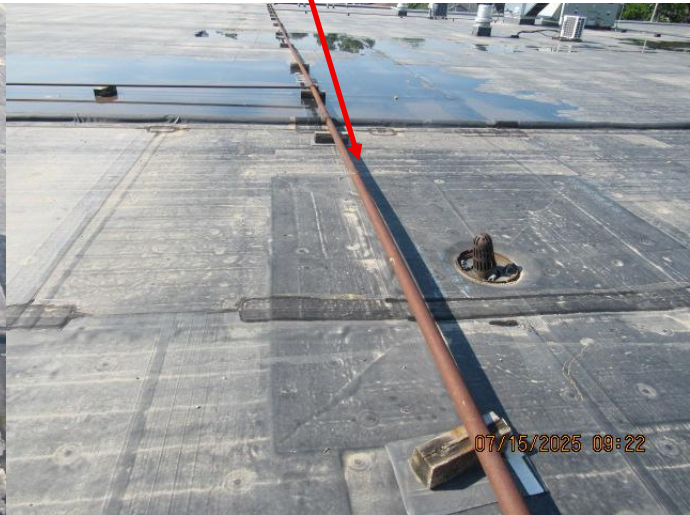
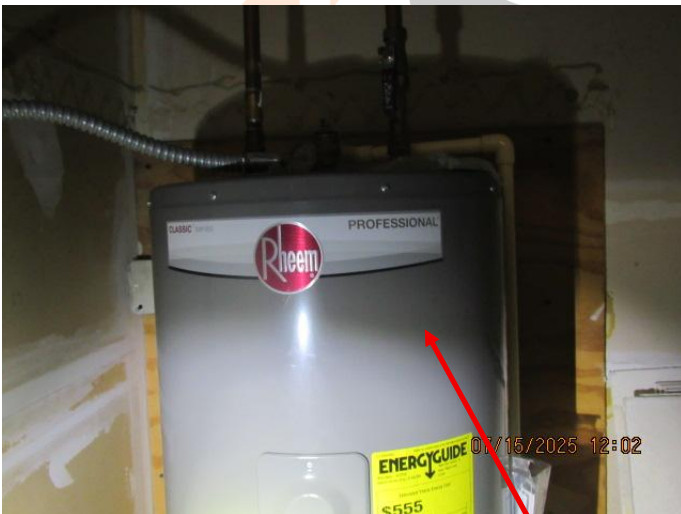
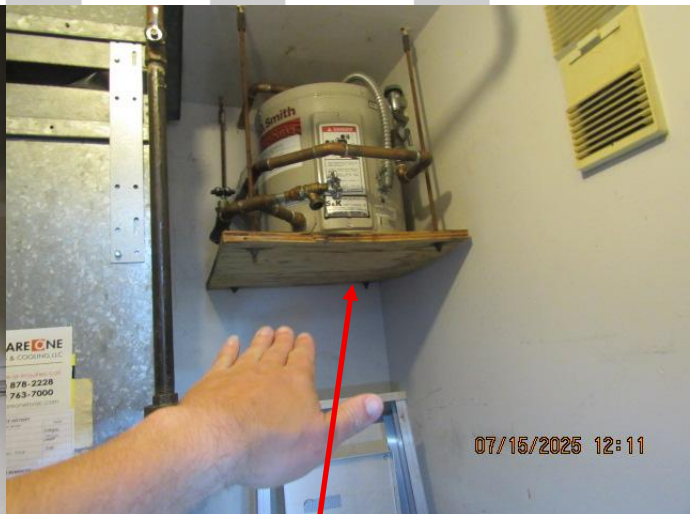
46. Rusted gas lines should be improved at the roof. Gas lines should be yellow or marked every 5 feet with gas line indicators.

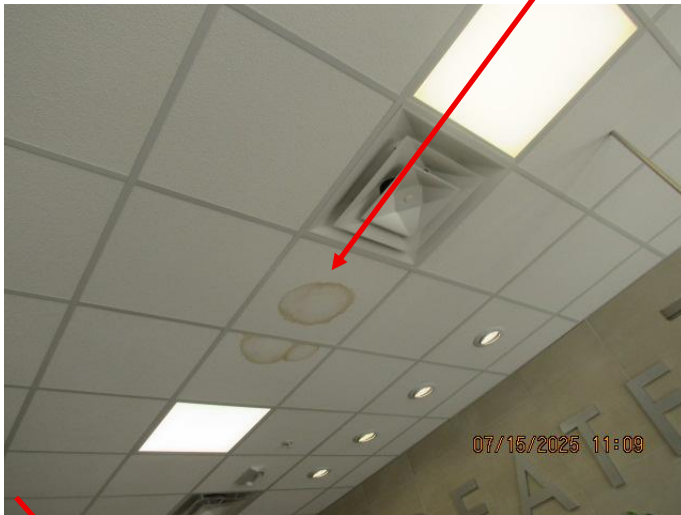
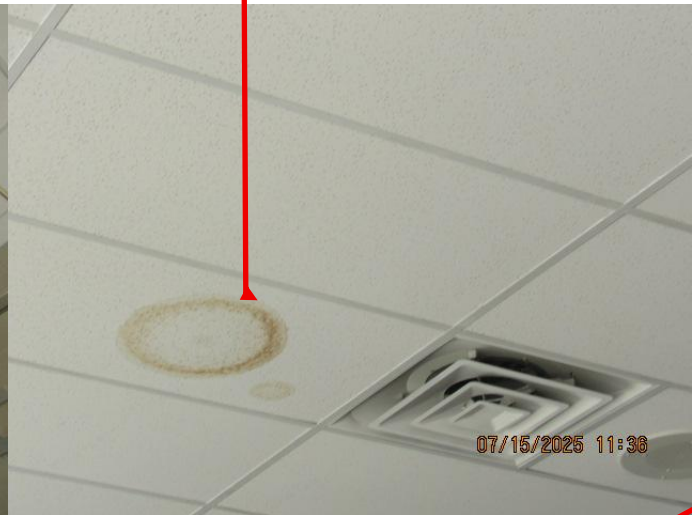
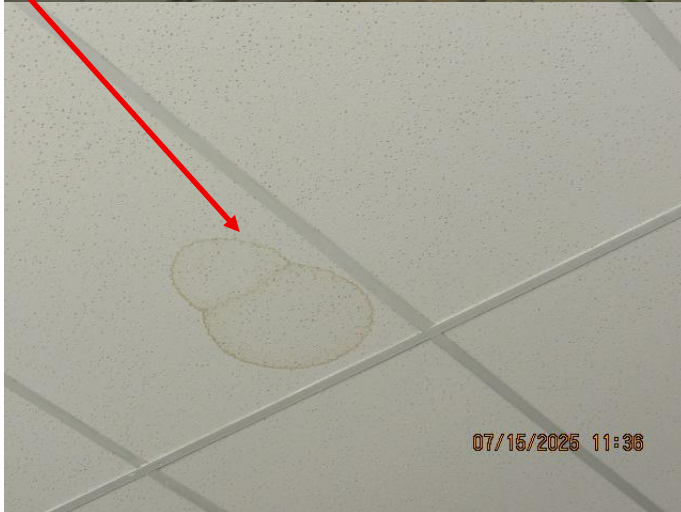
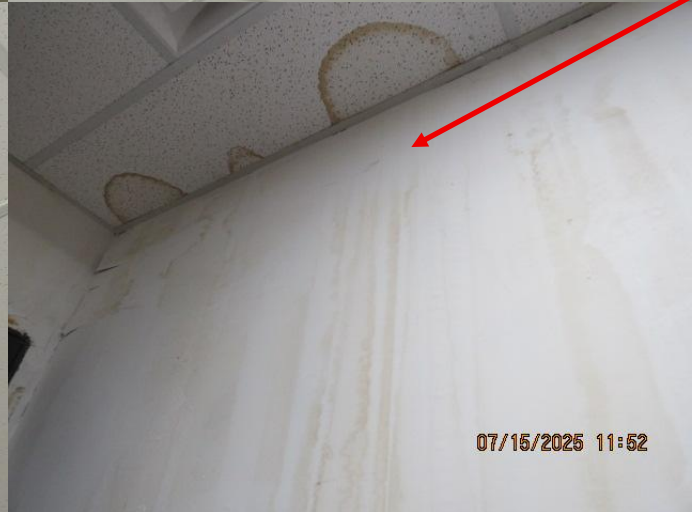
50. Water damage was noted. The cause of and extent of the water damage should be investigated and repaired.

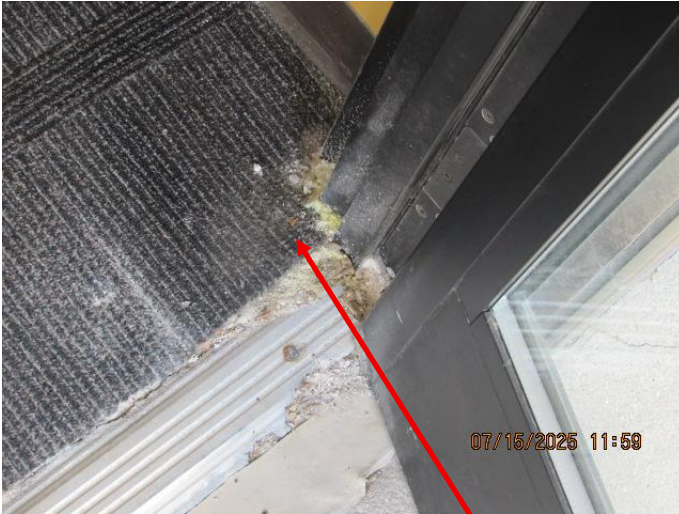
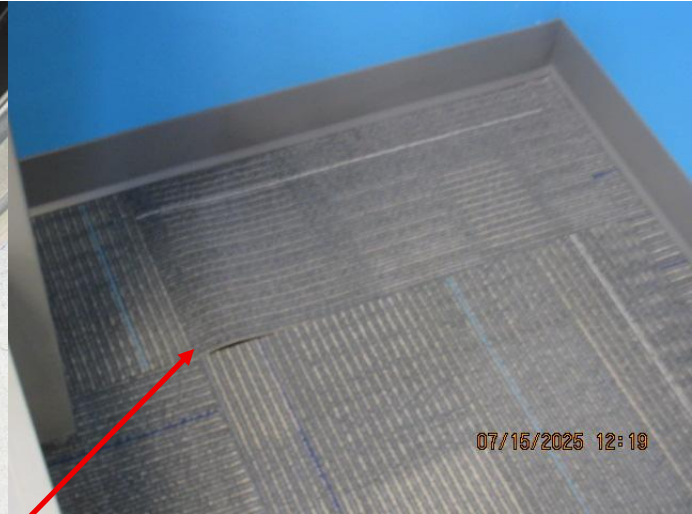
52. The vinyl flooring has damage.
