# YOUR INSPECTION REPORT

386 Durie Street  
Toronto, ON M6S 3G4

INSPECTION DATE:  
Tuesday, March 30, 2021

RE: Report No. 2863  
386 Durie Street  
Toronto, ON  
M6S 3G4

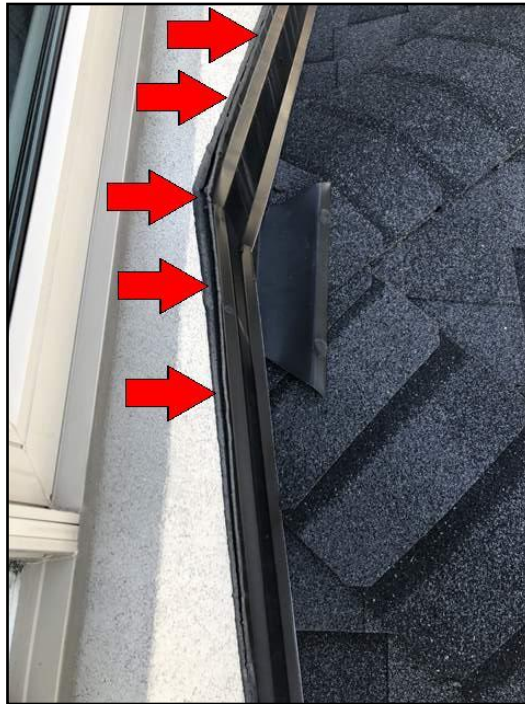
*2. Damage, loose, open seams, patched*

**Condition:** • [Damage, loose, open seams, patched](#)

**Task:** Repair

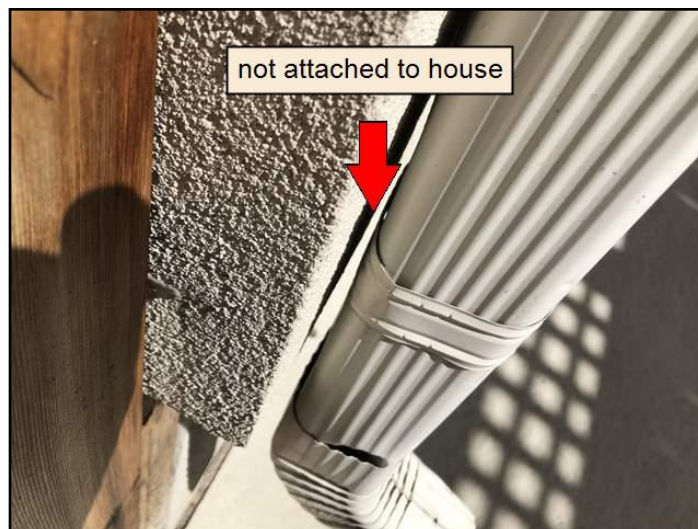
3. Loose

**Condition:** • Loose

**Time:** Less than 1 year

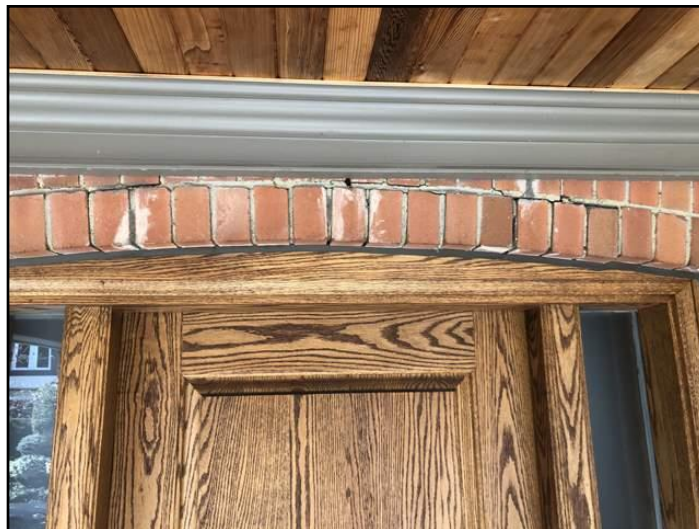
4. Cracks over door

**Condition:** • [Cracked](#)

It is common to find minor cracks on homes of this age. Patch cracks to prevent further damage. It is not possible on a one-time visit to know if cracks are active.

**Task:** Repair

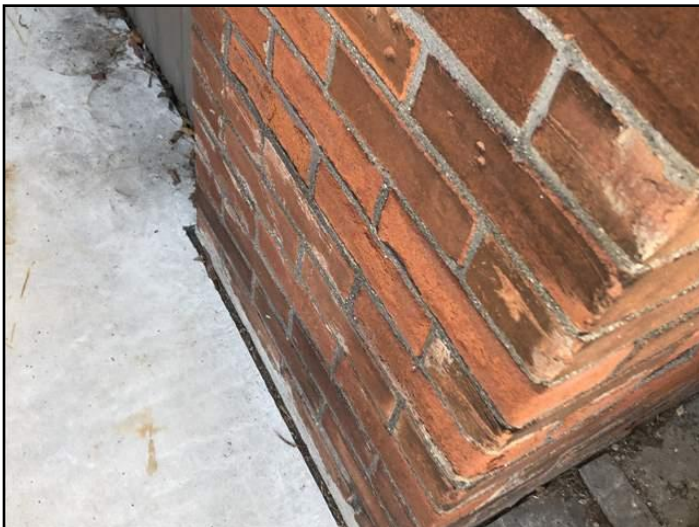
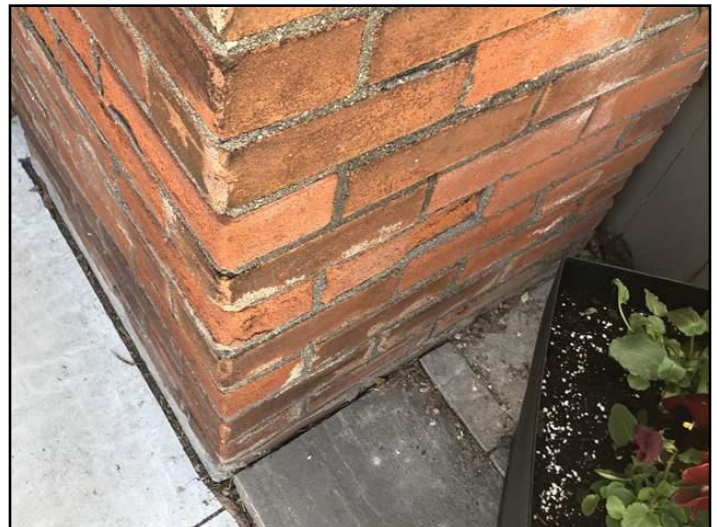
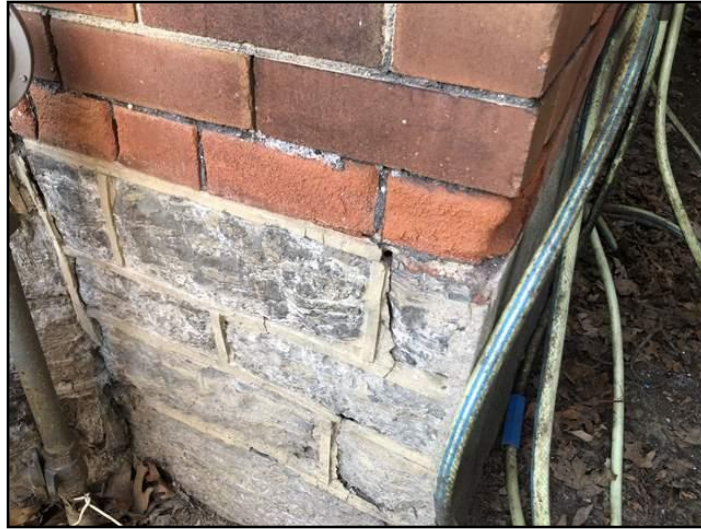
**Condition:** • [Spalling](#)

Spalling and mortar deterioration at various areas of brick. Repair / Replace / Tuck point masonry. This is regular maintenance for a home of this age. photos show a sampling. Overall the exterior walls are in good condition.

**Task:** Repair

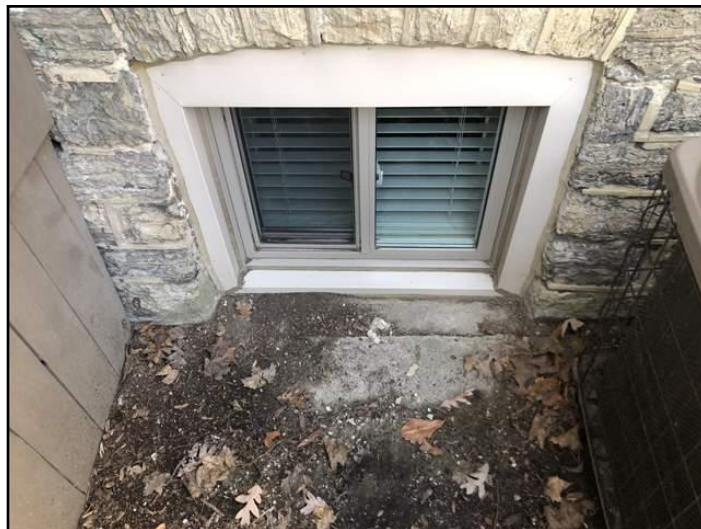
8. Sill - Near or at Grade Level

**Condition:** • Sill - Near or at Grade Level

Less than 6-inch above grade. Window appears well sealed and in good condition.

**Task:** Monitor / Improve

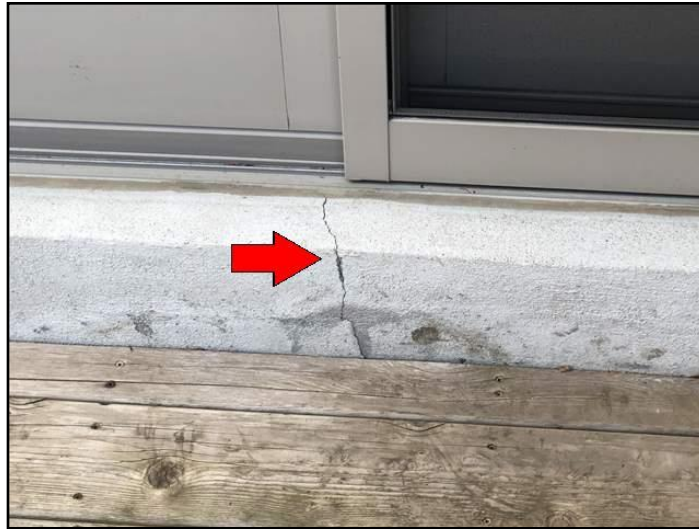
9. Damaged, cracked or loose

**Condition:** • [Damaged, cracked or loose](#)

Minor crack at sill

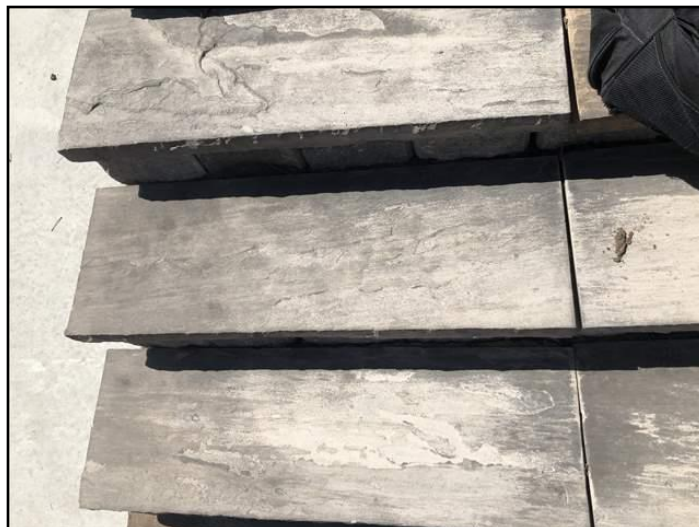
10. loose step

**Condition:** • [Steps springy, loose or sagging](#)

**Task:** Improve / Secure steps

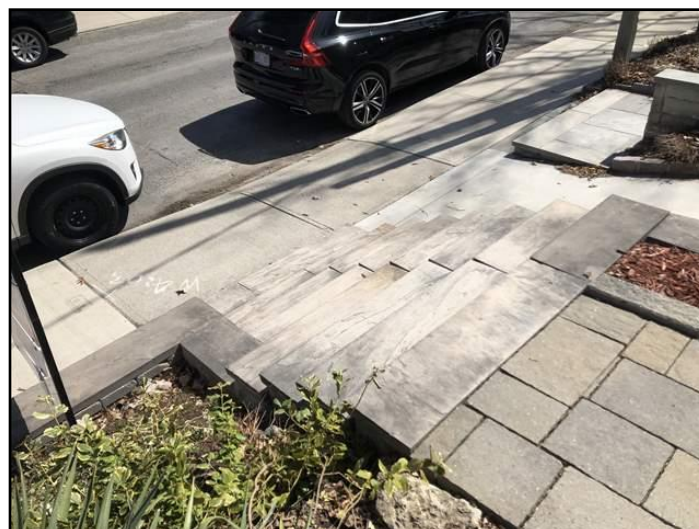
11. Missing

**Condition:** • [Missing](#)

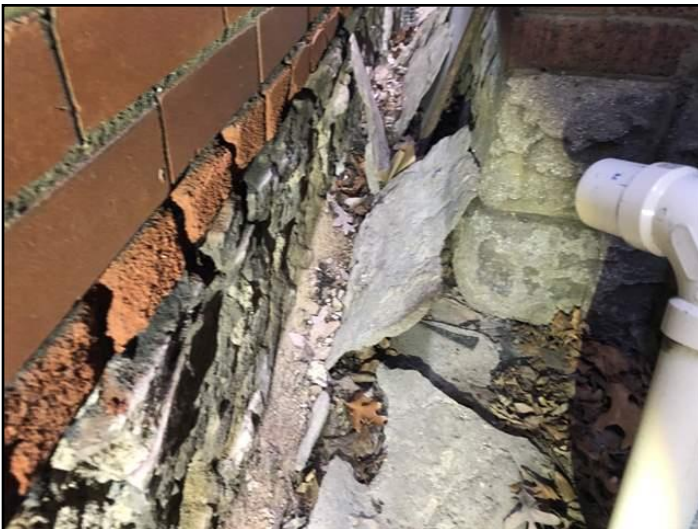
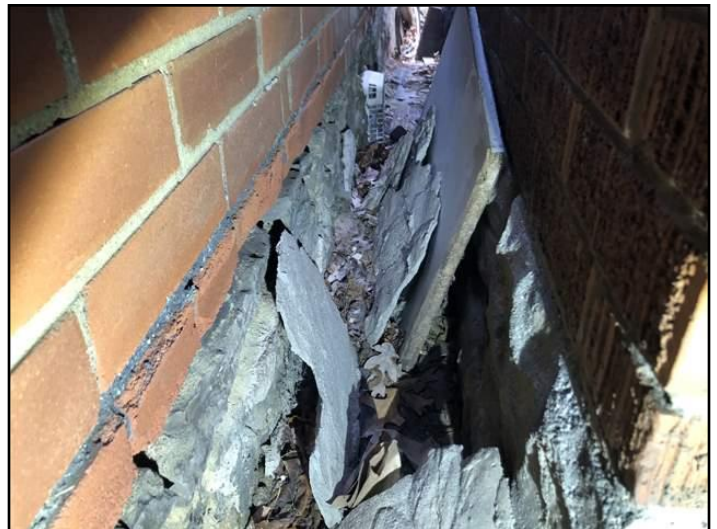
**Condition:** • [Parging damaged or missing](#)

It is common to provide parging on older stone/brick foundations. The parging will break down over time and crack/crumble. See photo for likely cause. Neighboring window roof drains water toward this area.

**Task:** Repair

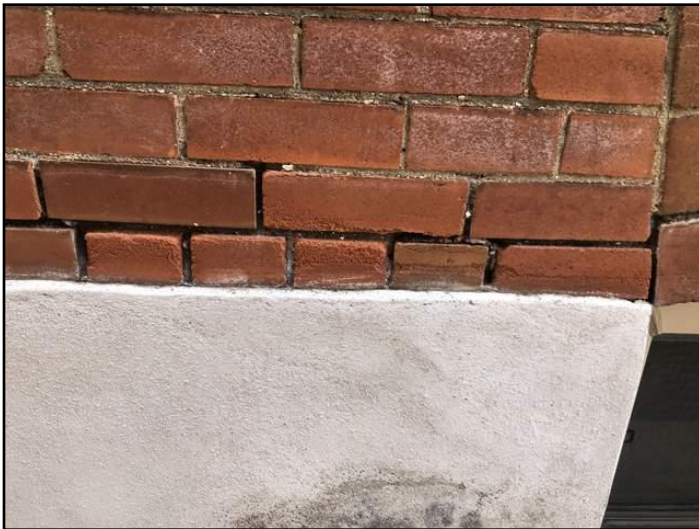
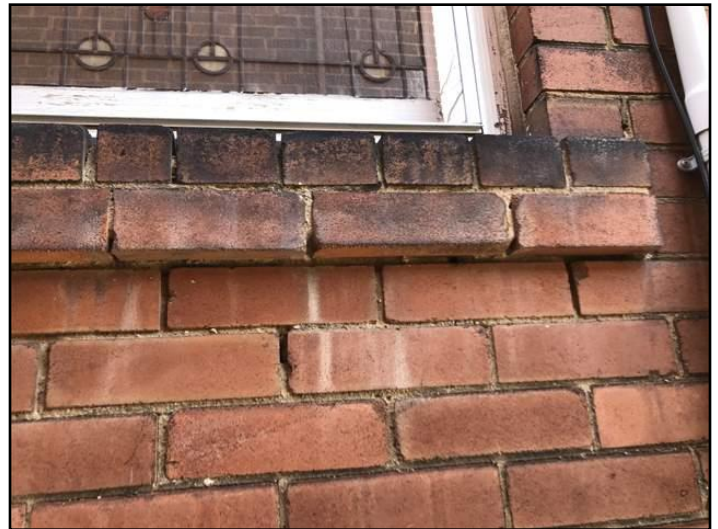
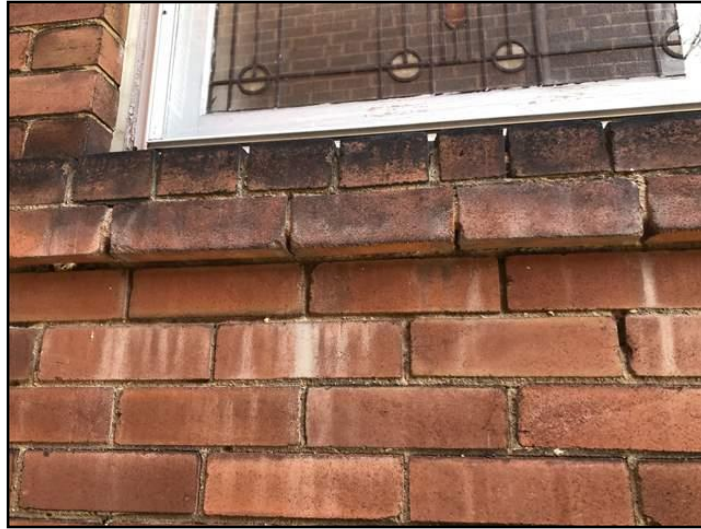
**Condition:** • [Mortar deteriorating](#)

Repointing / Tuck-Pointing of mortar needed at various areas. This is COMMON MAINTENANCE for all homes of this age. Overall brick is in good condition.

**Task:** Repair

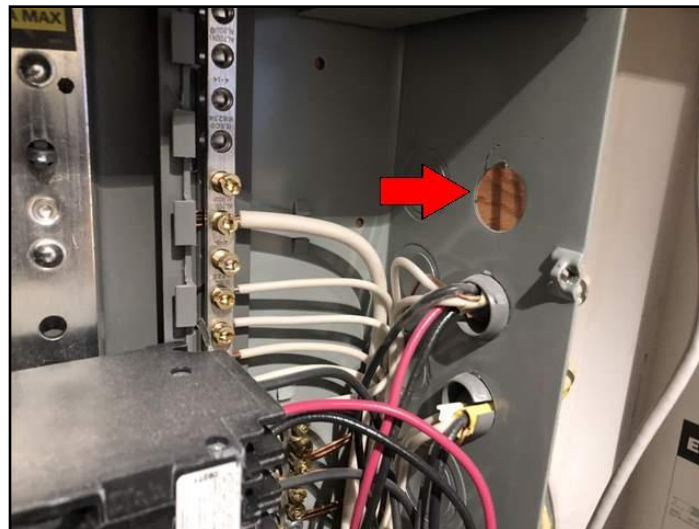
19. Openings in panel

**Condition:** • [Openings in panel](#)

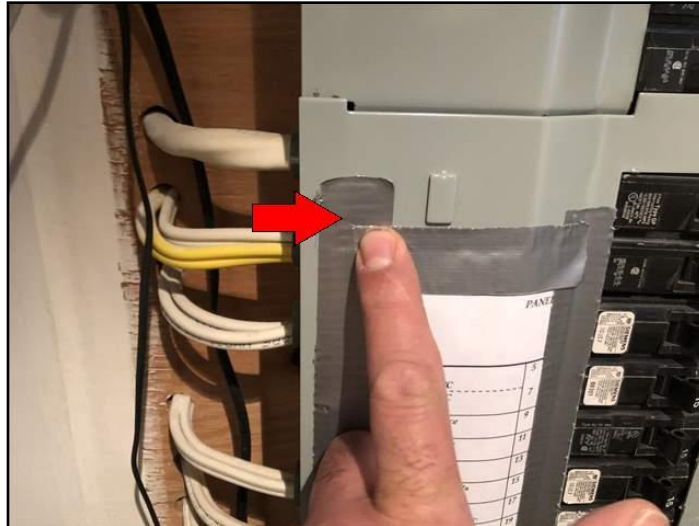
20. Missing or Improper Panel Cover Fasteners

**Condition:** • Missing or Improper Panel Cover Fasteners

Missing one fastener

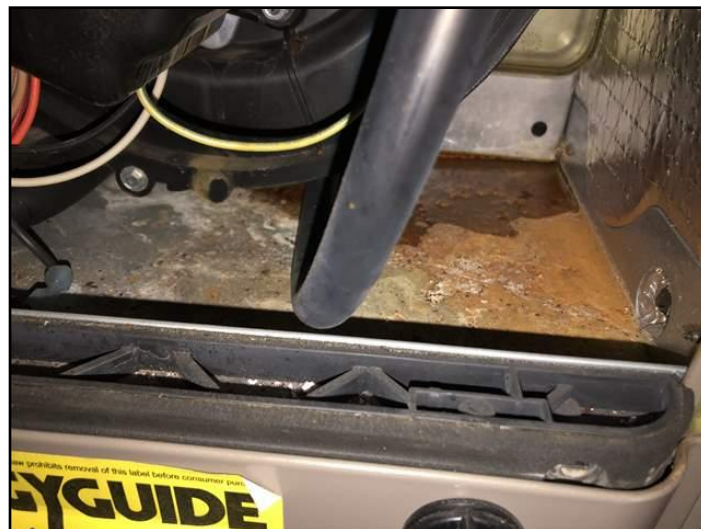
21. Condensate leak

**Condition:** • [Condensate leak](#)

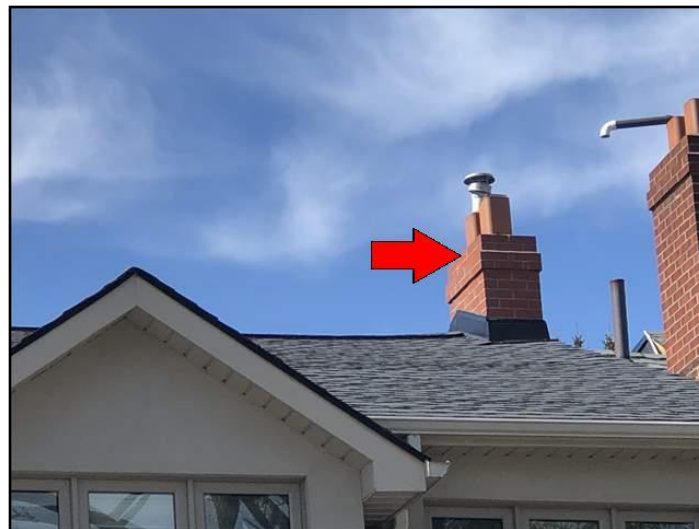
22. Missing

Condition: • [Missing](#)

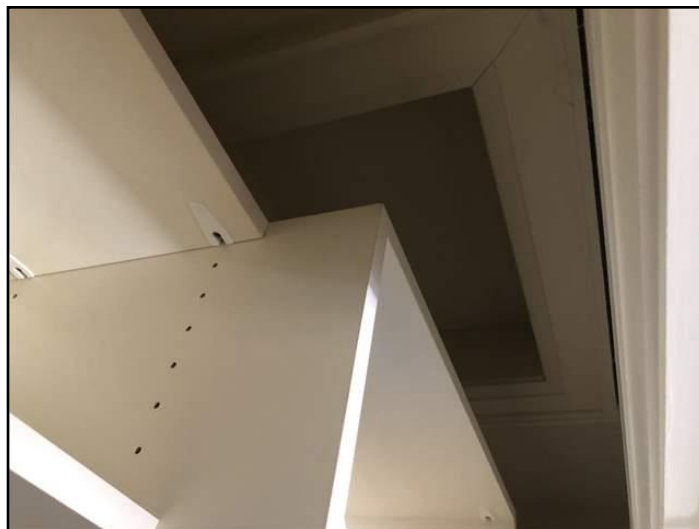
23. *Inaccessible*

**Condition:** • [Inaccessible](#)

Built-in Shelving restricted access to hatch. Attics are important areas and should be inspected from time to time for :  
Water leakage/damage, Mold, insulation levels, presence of asbestos, animal activity, ventilation, and structural integrity.

**Task:** Provide access and inspect

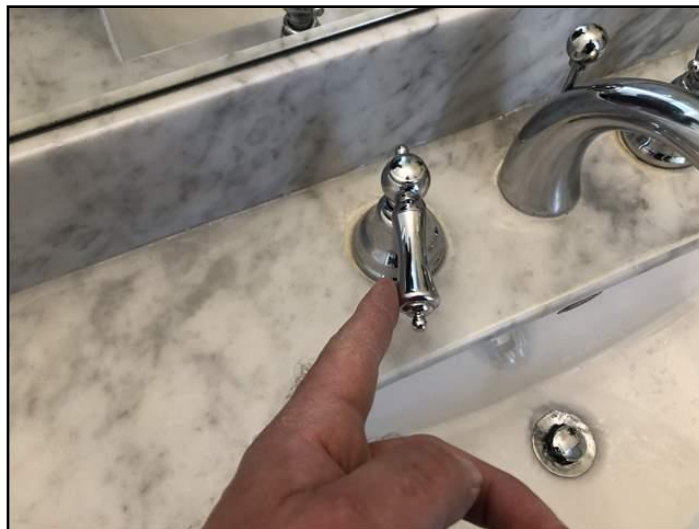
25. Stiff

**Condition:** • [Stiff or inoperative](#)

**Task:** Adjust handle
