# INSPECTION REPORT

For the Property at:  
**WELCOME HOME**  
NEW ORLEANS, LA 70115

Prepared for: MIKE SMITH  
Inspection Date: Wednesday, November 14, 2018  
Prepared by: Turk Schexnayder LHI Lic.10679

RE: Report No. 1848, v.2  
Welcome Home  
New Orleans, LA  
70115

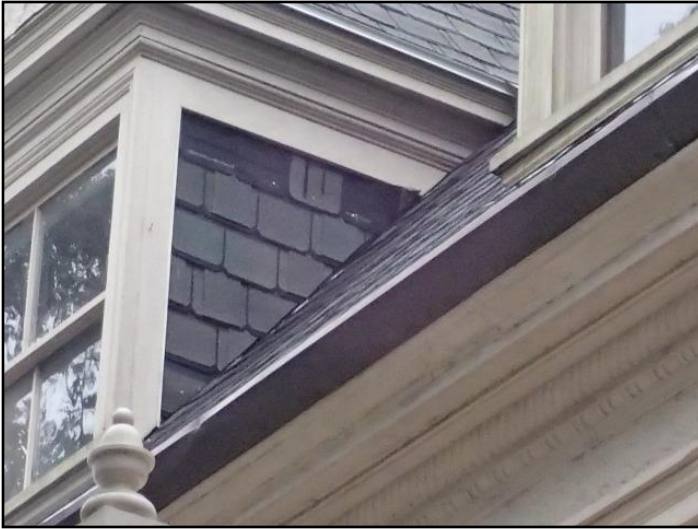
Items noted: Missing shingles on dormers, prior repair, old stains on roof decking and at valley of dormer. It is likely the stains on decking and at valley of dormer were from old leaks. Areas did not appear to be wet during inspection. It rained the day before the inspection.

4. Missing shingles

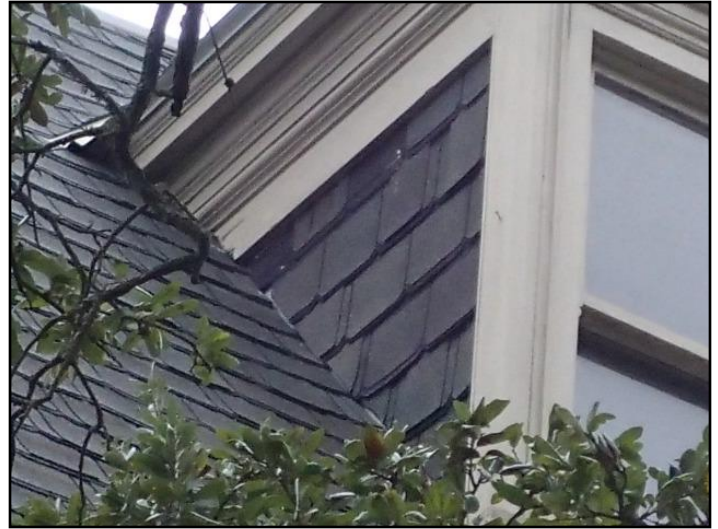
5. Missing shingles

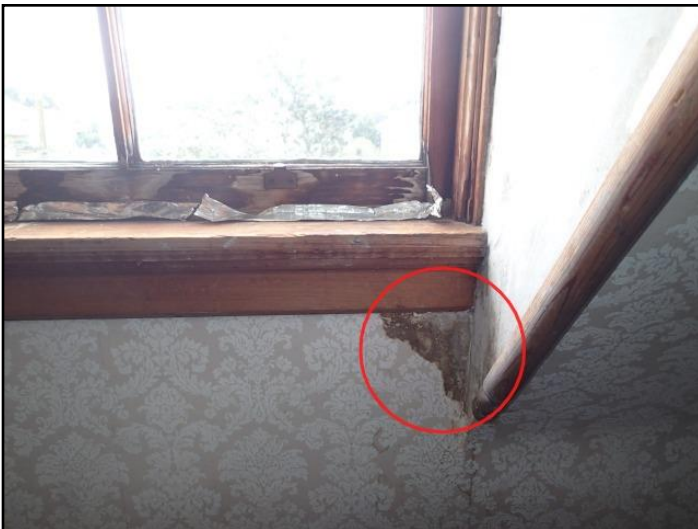
6. Stain at corner of dormer.

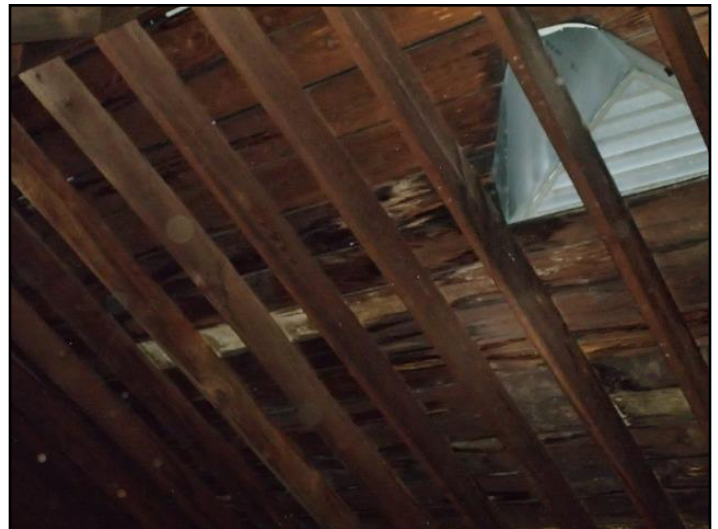
7. Old stains on decking at vent

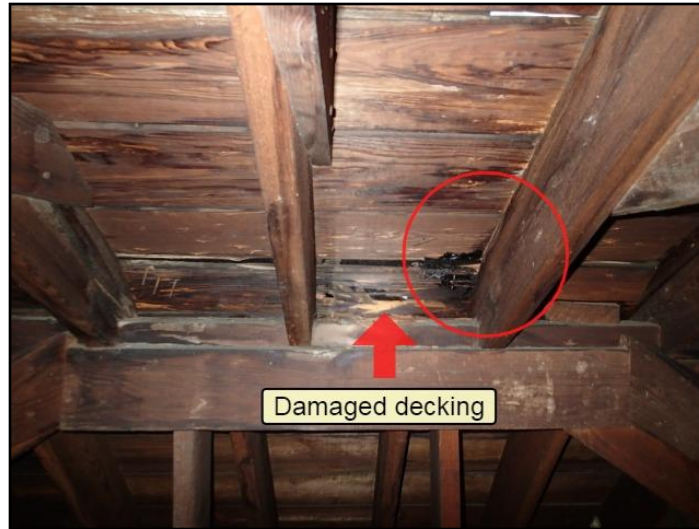
8. Prior repair in attic was noted.

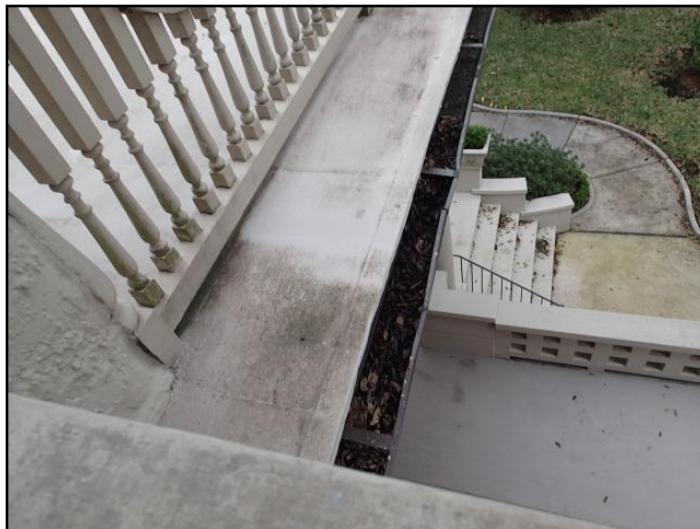
6. Condition: • Clogged

14. Clogged

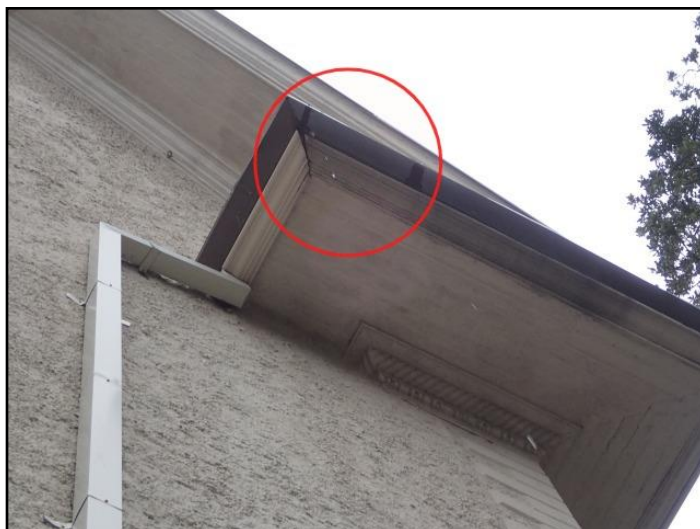
Gutter on front left was leaking at time of inspection.

15. Leak

**Task:** Repair

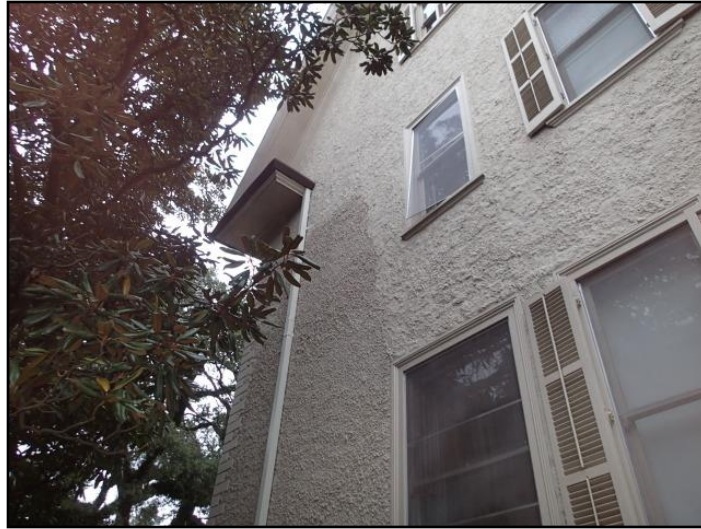
### 8. Condition: • [Prior repairs on exterior stucco were noted.](#)

16. Prior repairs on exterior stucco were noted.

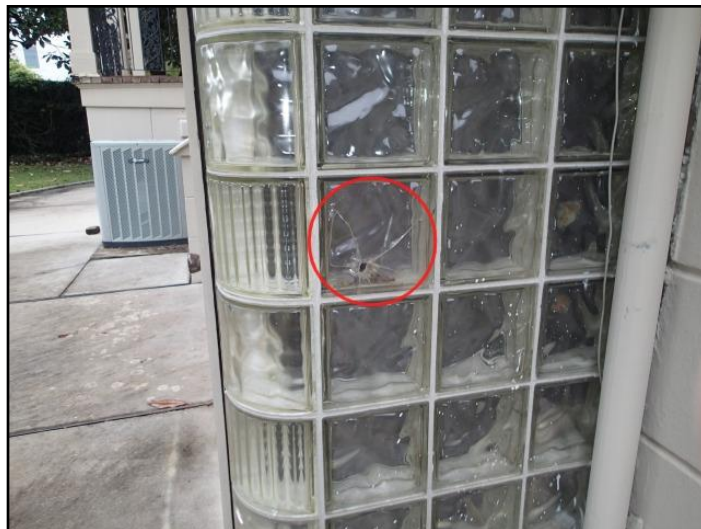
**10. Condition:** • Cracked

17. Cracked

**Task:** Repair as needed.

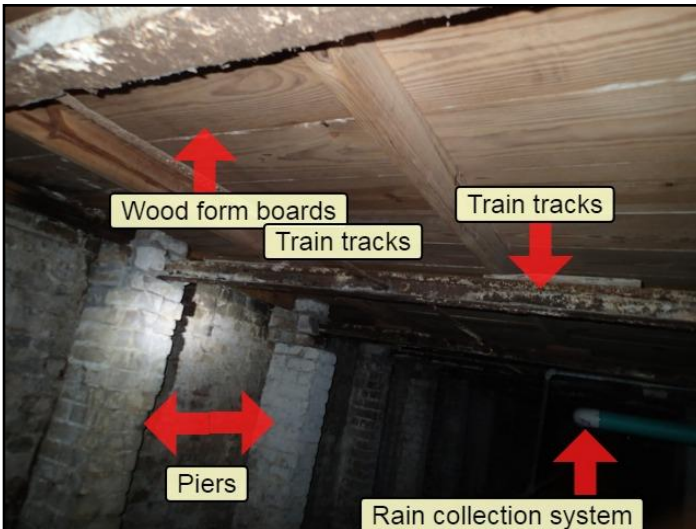
**14. Condition:** • It appears the front porch has been reworked. Existing rail road tracks and brick piers were still in place. Newer wood framing and planks were used as form boards. However, poor bearing and missing mortar was noted on piers under front porch. These items found should be addressed and corrected by a reputable contractor.

19. Form boards, piers and rain collection system

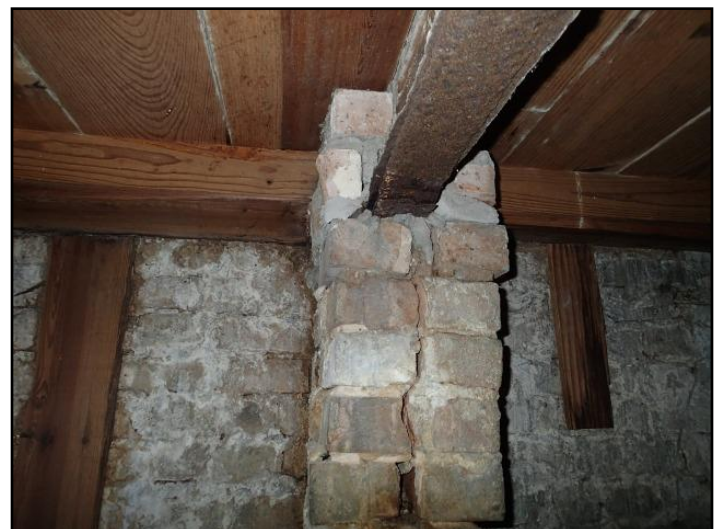
22. Missing mortar on pier

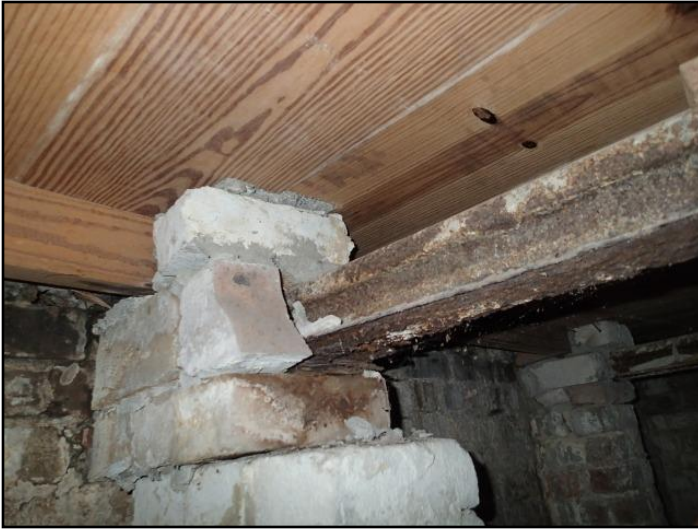
23. Poor bearing on pier

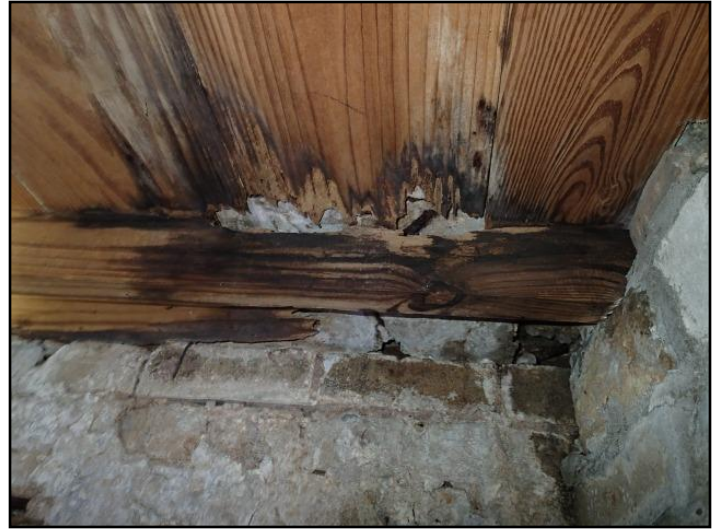
24. Moisture damage

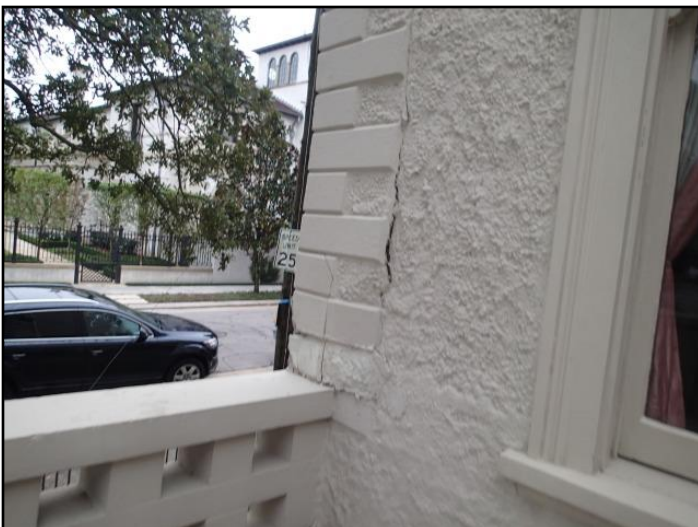
**15. Condition:** • It is my opinion the cracks on front left walls at fireplace is related to standing water and isolated settlement on left front exterior. Gutter system from front balcony drains into PVC pipes under front porch and discharges at left exterior wall. Wet area noted in area of settlement. A leak in PVC pipe under porch is causing slow damage to wood framing and should be addressed. Area below stucco openings in front left wall a pier appears to have been reworked at some point. Openings in stucco should be sealed and corrected to stop water intrusion and prevent further damage. The cracks in the exterior steps and threshold are likely the result of reworking the porch.

25. Openings in stucco

Corrective actions should include but are not limited to: Seal exterior stucco; Repair leak in downspout/gutter system in crawl space; Improve discharge location of gutter system/downspout away from building.

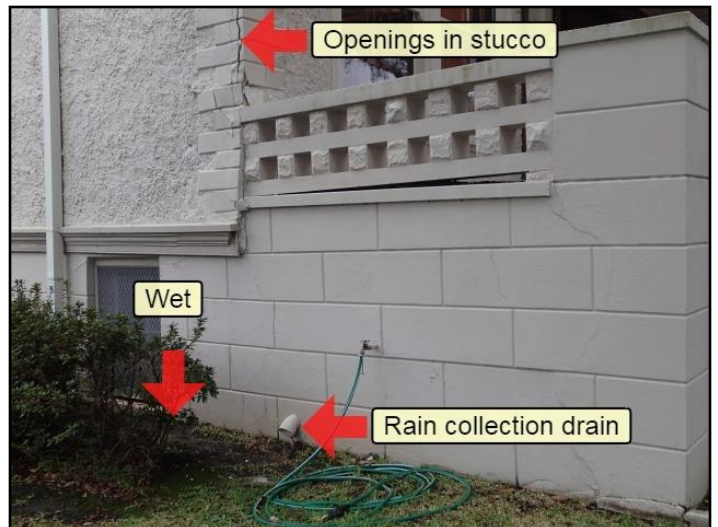
26. Settlement cracks and openings in stucco

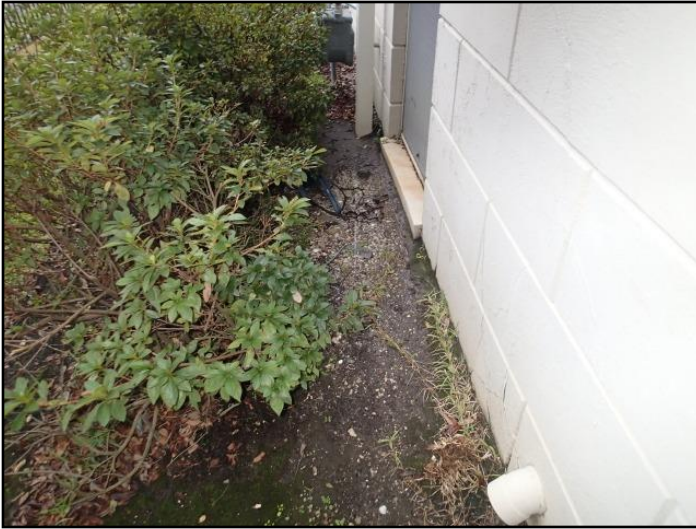
27. Wet area

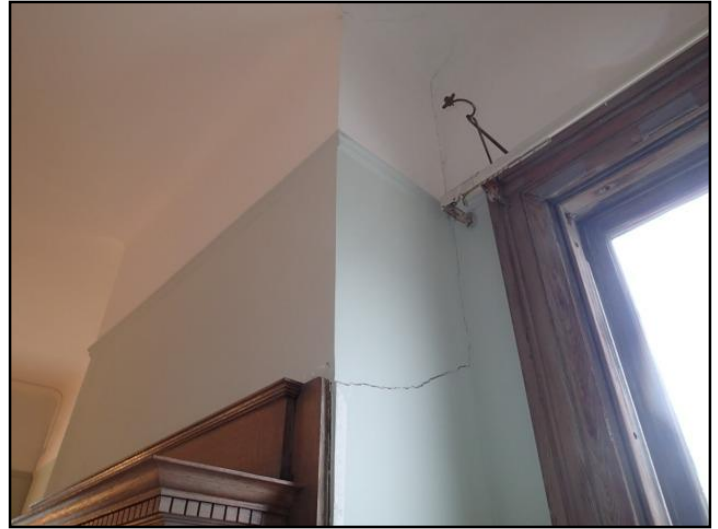
28. Settlement cracks

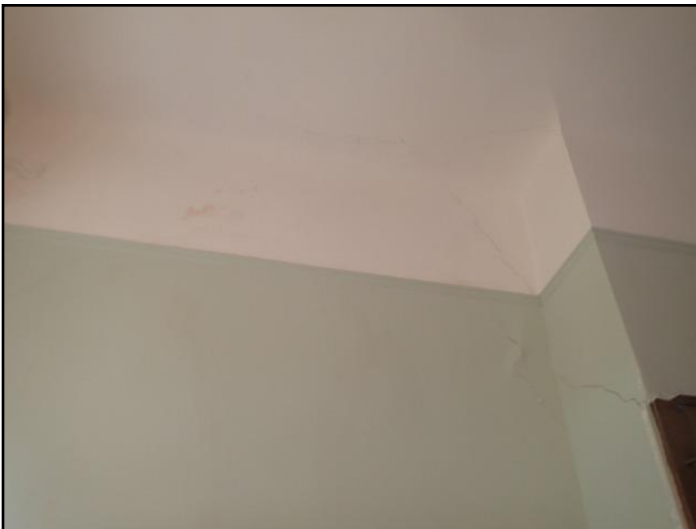
29. Settlement cracks

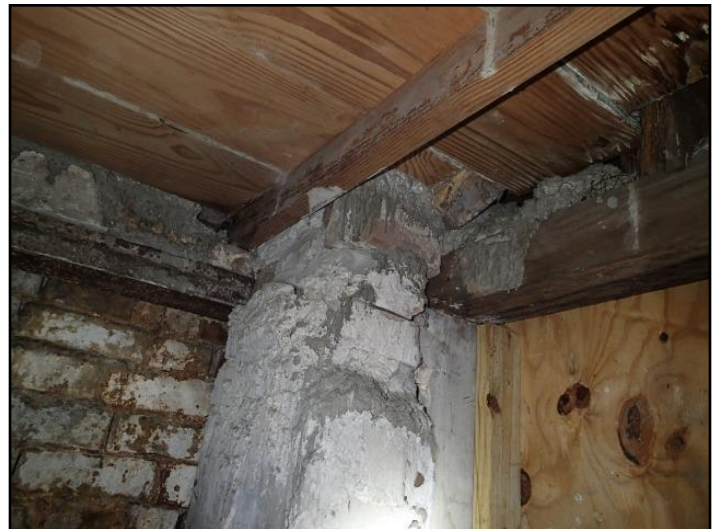
30. Reworked pier at front left corner

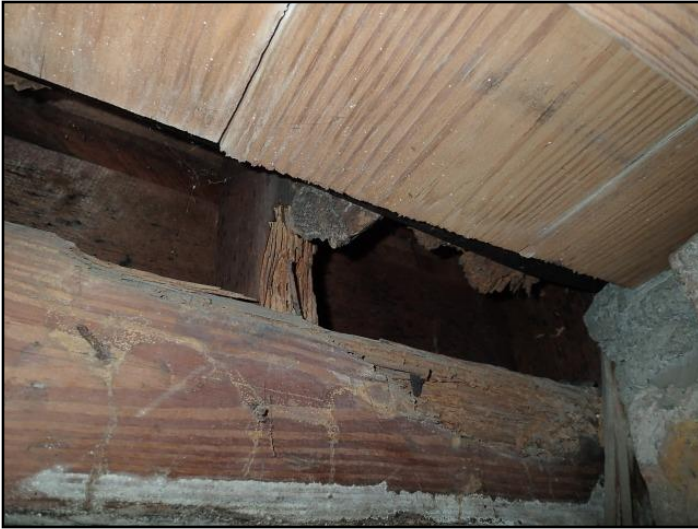
**16. Condition:** • Area below front porch appears to have been reworked. However, some damage to sills and bottoms of studs were noted. An active rain collection system from gutter to PVC pipe in crawl space appears to be leaking in crawl space at connection. Sill at top and support below was wet.

31. Damaged sill and joist

**Task:** Further evaluation and repair by a reputable contractor.

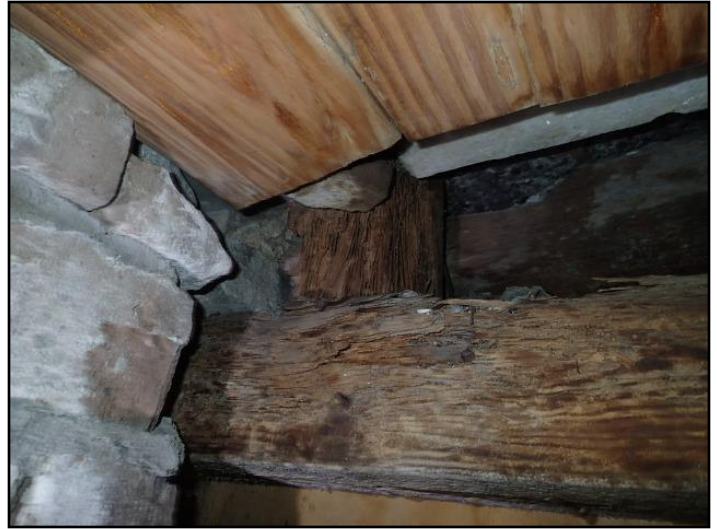
32. Damaged sill

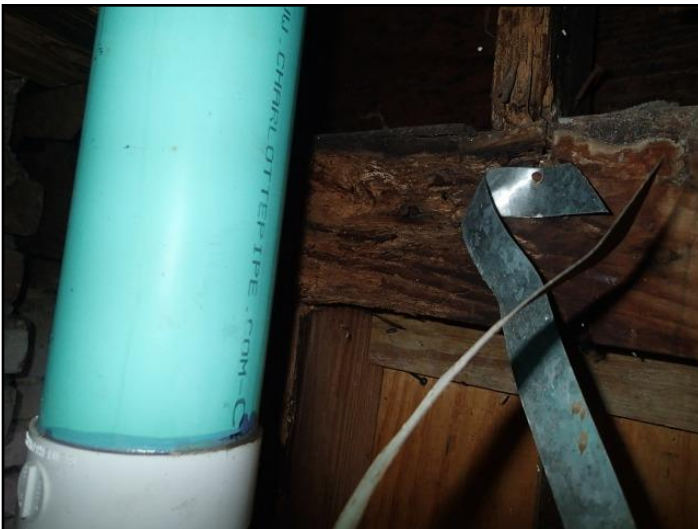
33. Damaged and wet sill

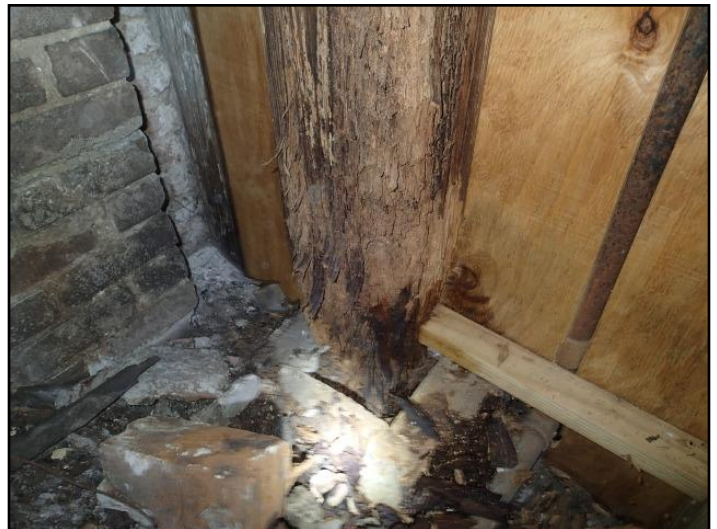
34. Damaged wet wood pier

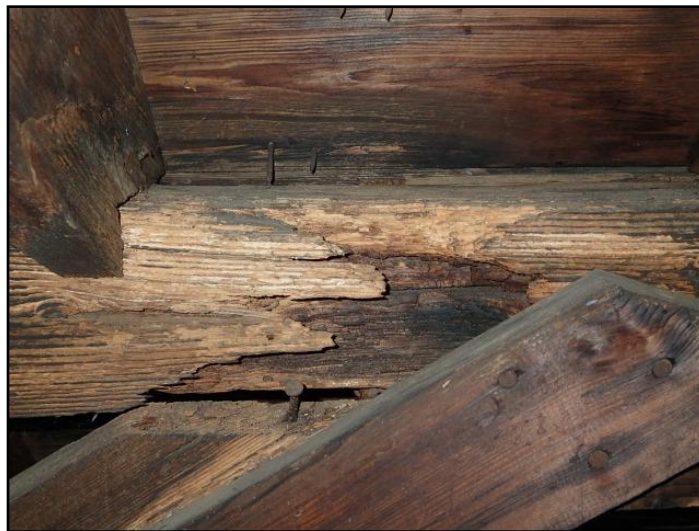
Moisture damage to knee wall support where roof changes direction. Area was dry at time of inspection.

**Implication(s):** Weakened structure

36. Rot

**Task:** Repair as needed.

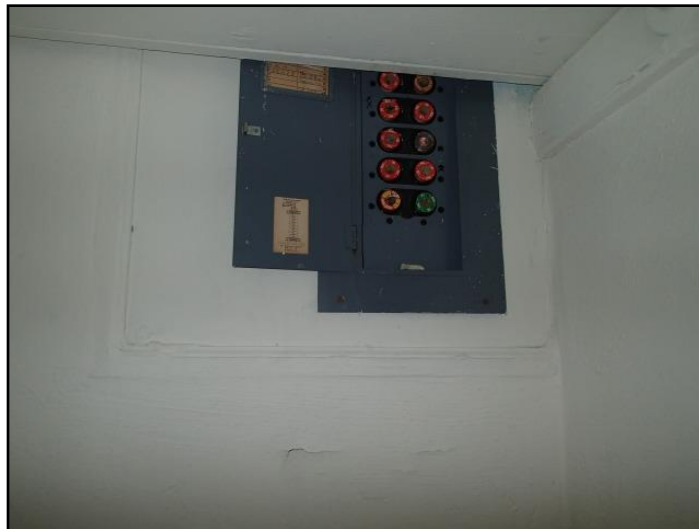
**23. Condition:** • Fuses vs.. Breakers

**41.** *Fused panel in closet*

**Task:** It is recommended that a licensed electrical contractor evaluate this older type of installation to insure that the system is functioning properly and has not been negatively altered.

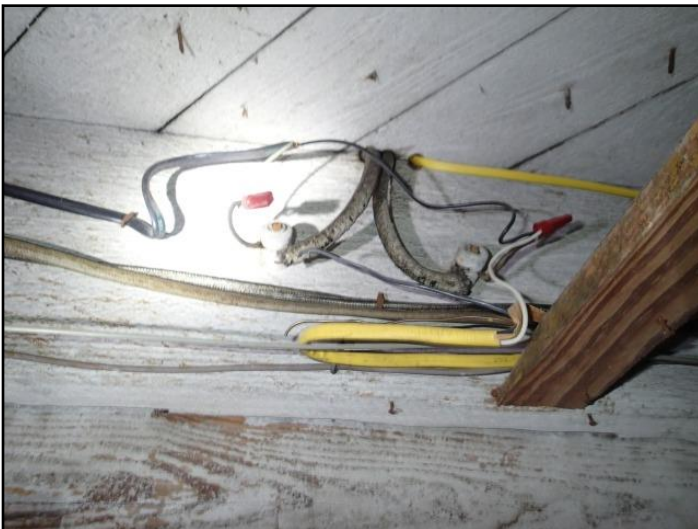
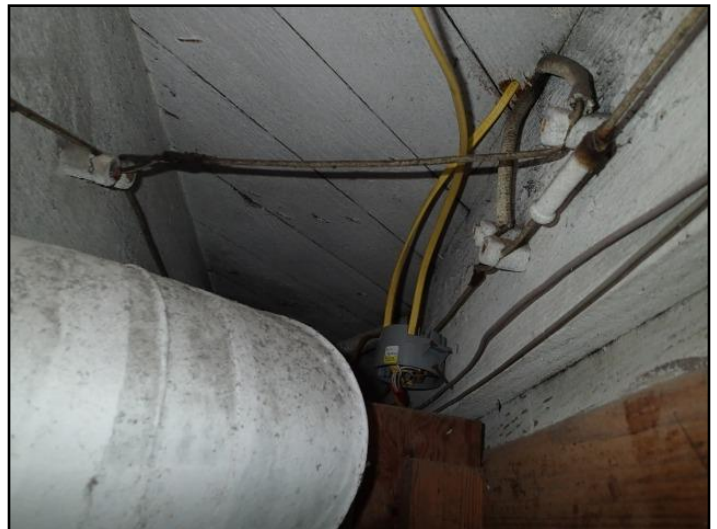
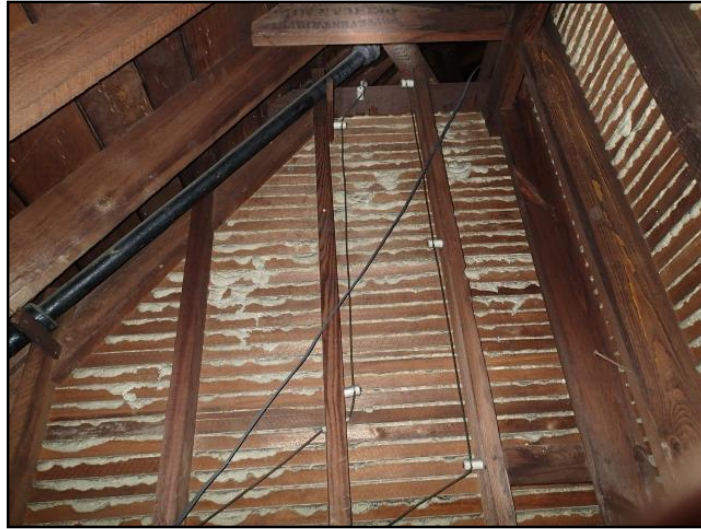
**29. Condition:** • When active knob & tube wiring is found in a home it is recommended that a licensed electrician or electrical contractor be engaged for a more detailed evaluation of the entire system. This should include recommendations and cost estimates prior to closing.

43. When active knob & tube wiring is found in...

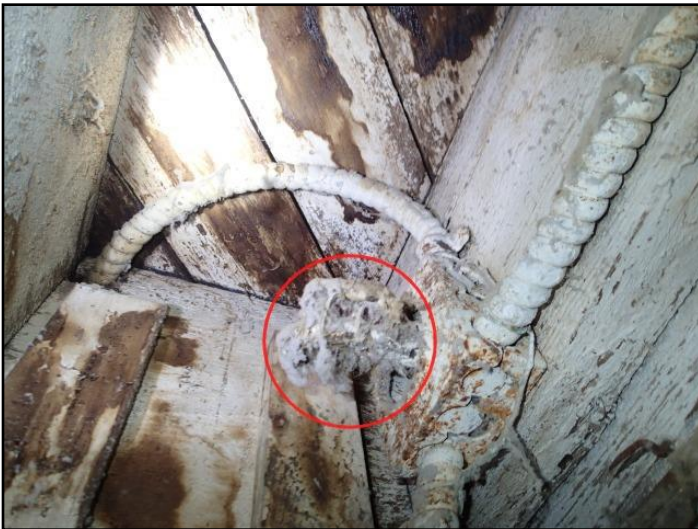
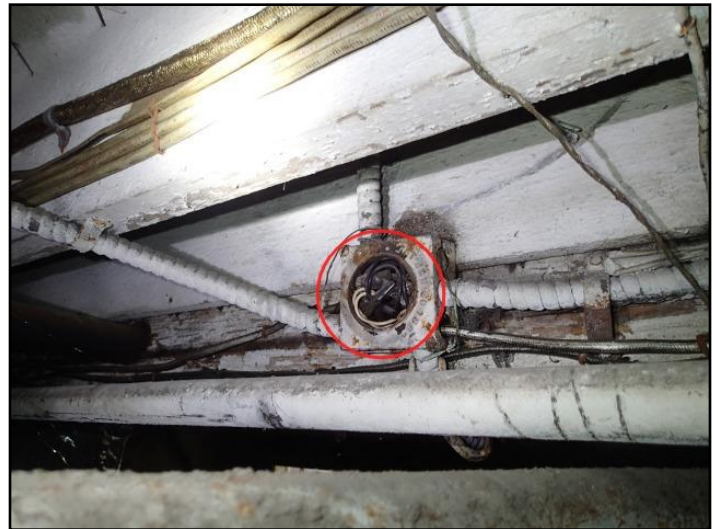
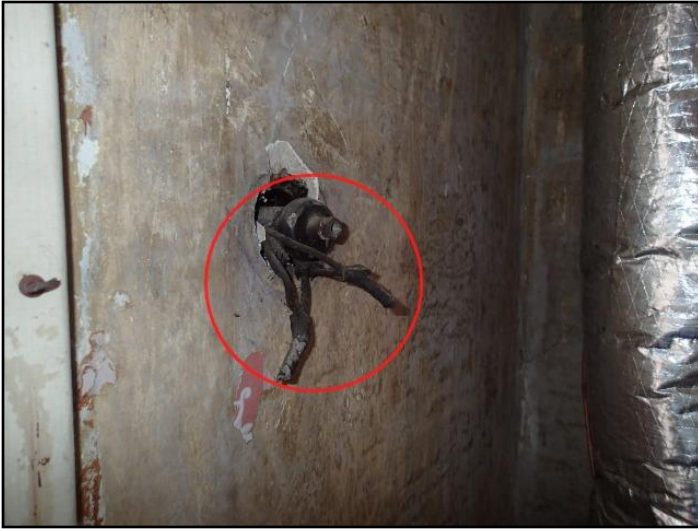
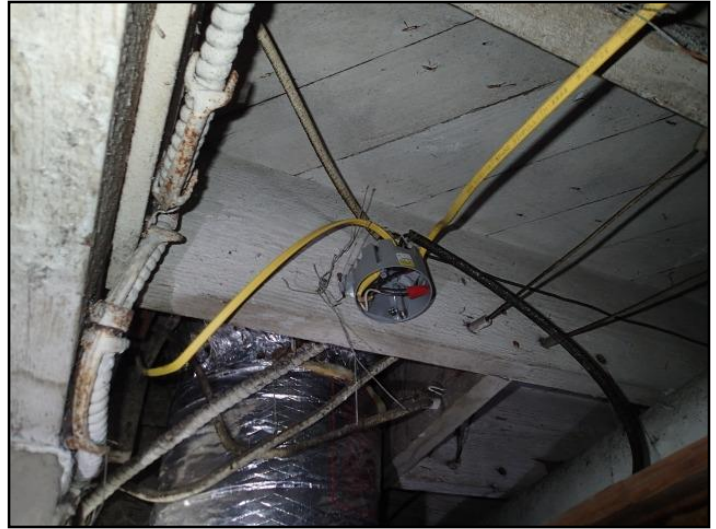
Cover loose or missing on junction boxes and switches in attic and/or crawl space. Electrical connections should be in closed junction boxes. All open junction box locations or switches may not be pictured.

**Implication(s):** Electric shock | Fire hazard

46. Cover loose or missing

**Task:** Correct

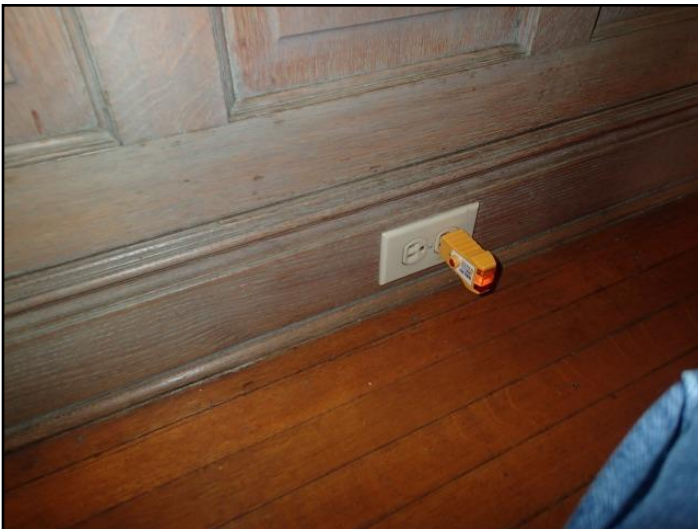
### 32. Condition: • Ground needed for 3-slot outlet

50. Ground needed for 3-slot outlet

**Task:** A licensed electrical contractor is recommended for further evaluation and/or correction

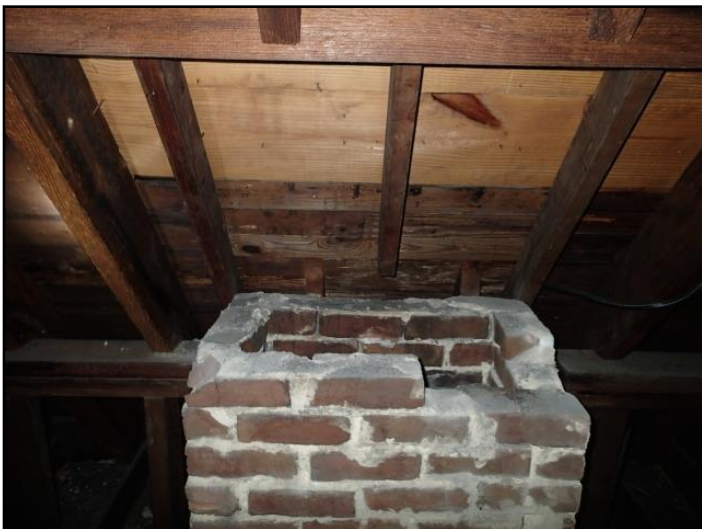
40. Condition: • Chimney terminates in attic. Does not vent to exterior.

One of the chimneys terminates in the attic. Cardboard covering possible opening in chimney on 3rd floor.

60. Chimney

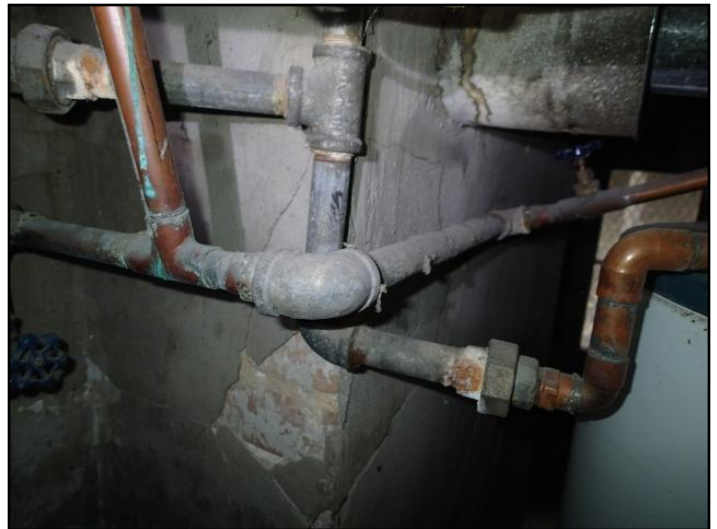
71. Galvanized steel connected to copper

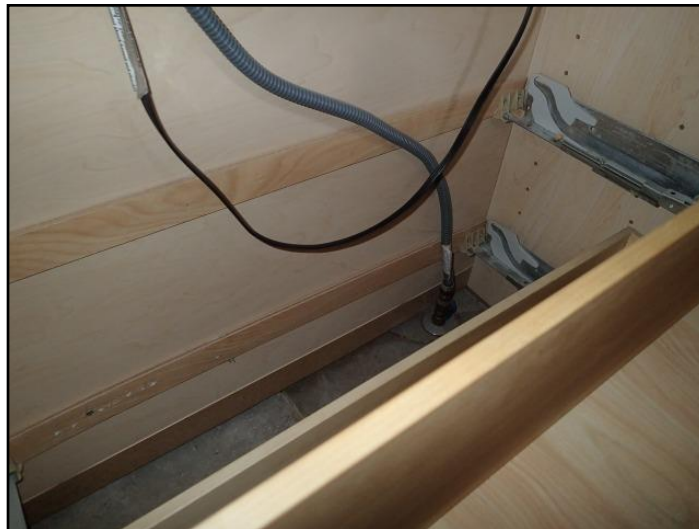
**52. Condition:** • Range shut off valve in kitchen was not accessible without taking out the bottom drawer.

72. Range shut of valve

**Task:** Improve

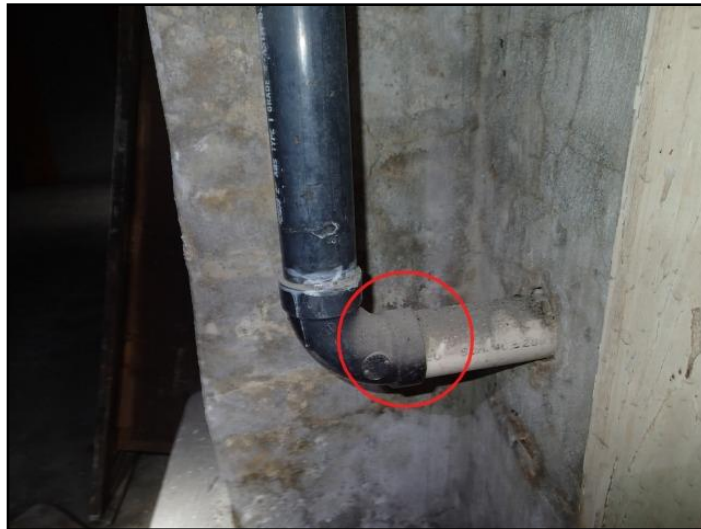
**54. Condition:** • PVC waste line connected to ABS waste line. Green glue (Oatey) is a transition cement to connect PVC to ABS pipe. Oatey glue was not visible at connections. Further evaluation is recommended by a licensed plumber.

74. PVC waste line connected to ABS waste line....

**Task:** Repair

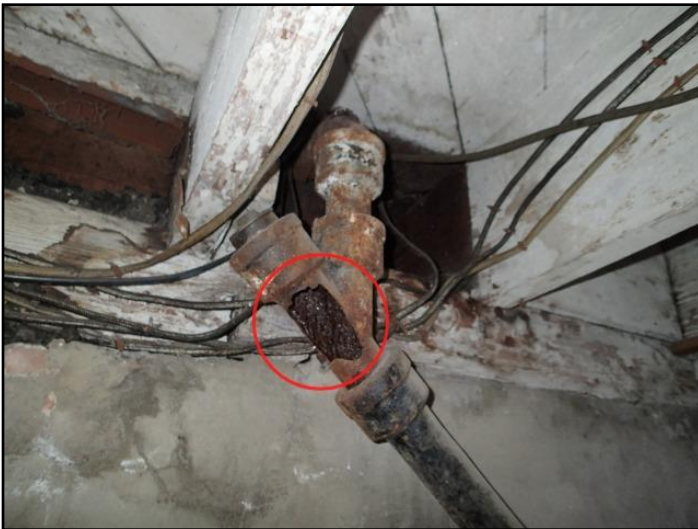
75. Rust

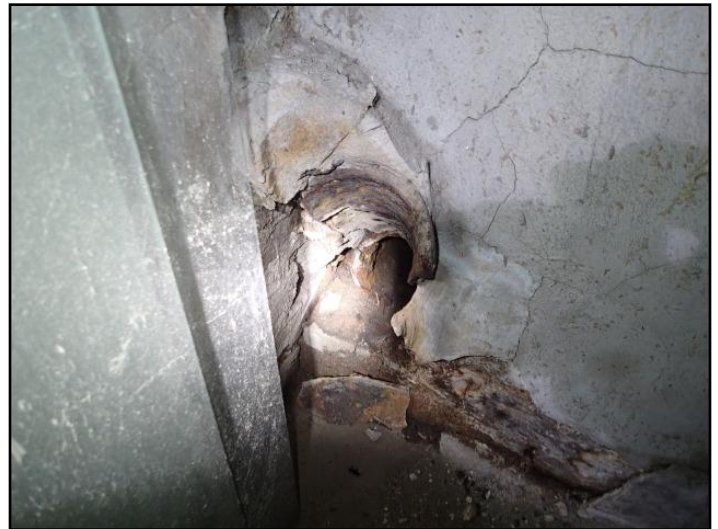
76. Abandoned.

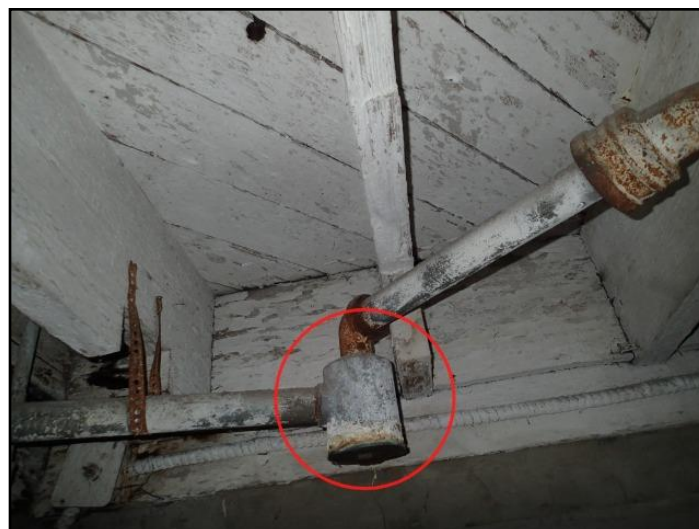
77. Wrong type

**Task:** Replace

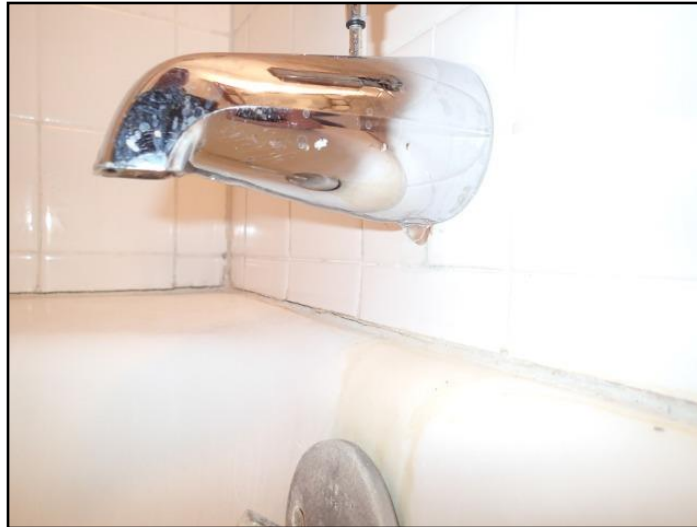
**Implication(s):** Chance of water damage to structure, finishes and contents

**78.** *Drip, leak*

**Task:** Repair

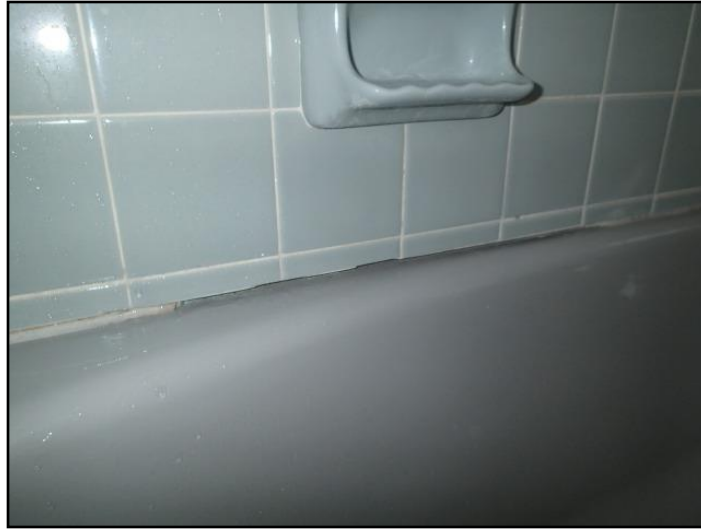
79. Caulking loose, missing or deteriorated

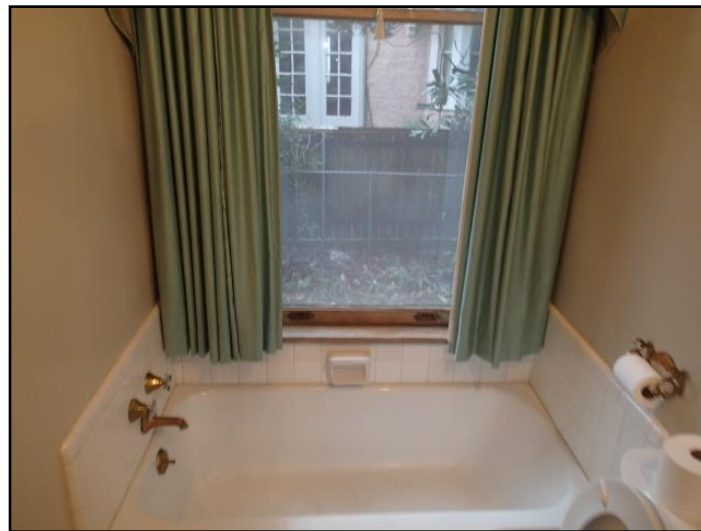
80. Unprotected window

**62. Condition:** • While a window in a tiled tub or shower enclosure is common, it has high probability of moisture damage. A stone or tile pitched sill and glass block to replace the window are good starting points. A good-quality silicone caulk will help to keep the area sealed. Remember that the window is on an exterior wall, so temperature changes will cause expansion and contraction in many of these materials. Check the area every year for cracked joints; caulk or grout as needed. Discuss options with contractor or architect prior to undertaking task of correction or renovation.

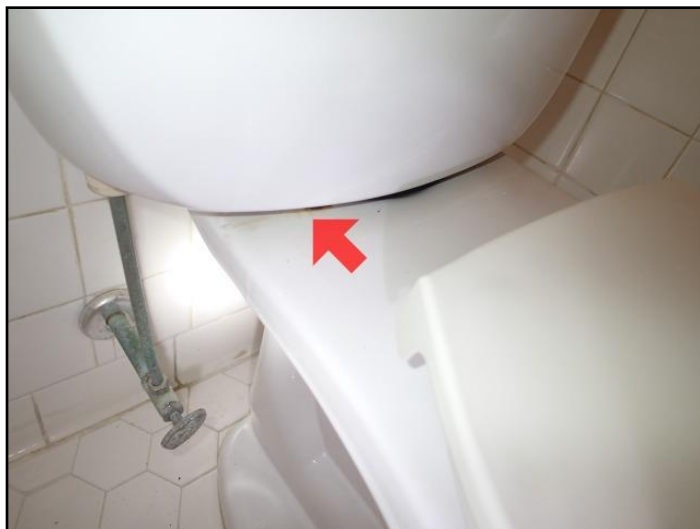
**Implication(s):** Chance of water damage to structure, finishes and contents

**81.** *Leak*

**Task:** Repair

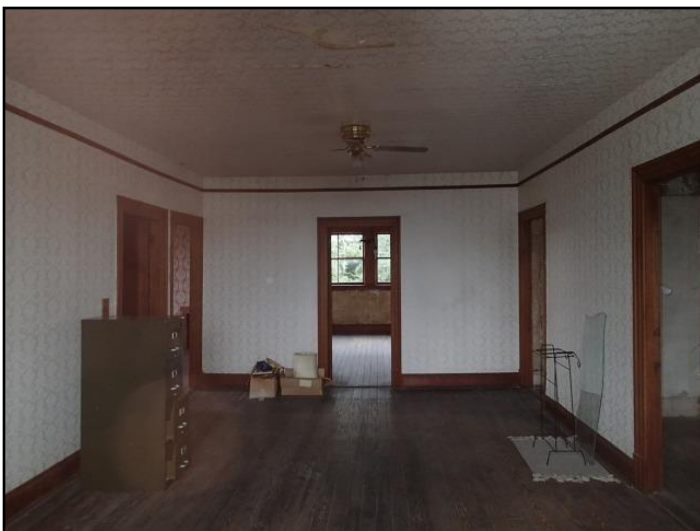
82. 3rd floor

**65. Condition:** • The 3rd floor was not finished nor was it conditioned. It is my opinion the 3rd floor was not refinished post Katrina. Most of the wall paper was removed but not all. Cracks in the plaster at various areas throughout the 3rd floor are likely from expansion and contraction of a non conditioned space with a wooden structure.

**Task:** Refinish / Remodel as needed.

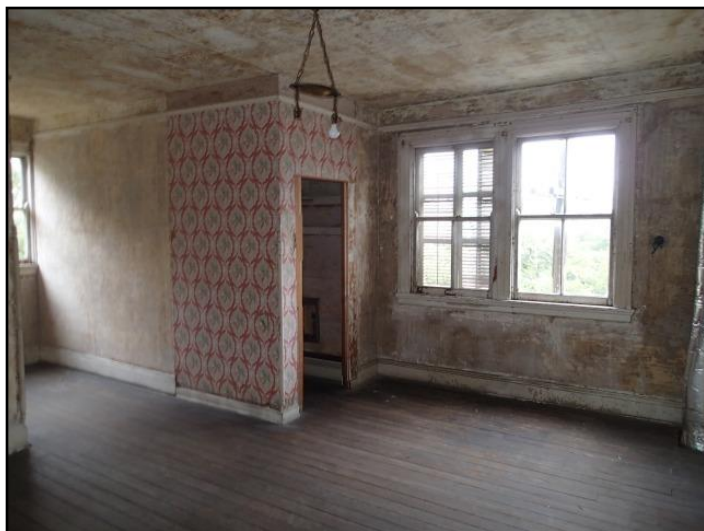
83. Cracks in walls

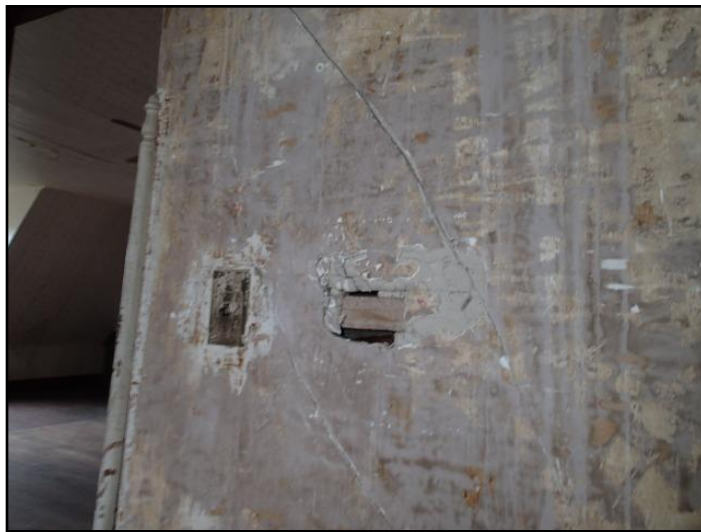
84. Damaged plaster

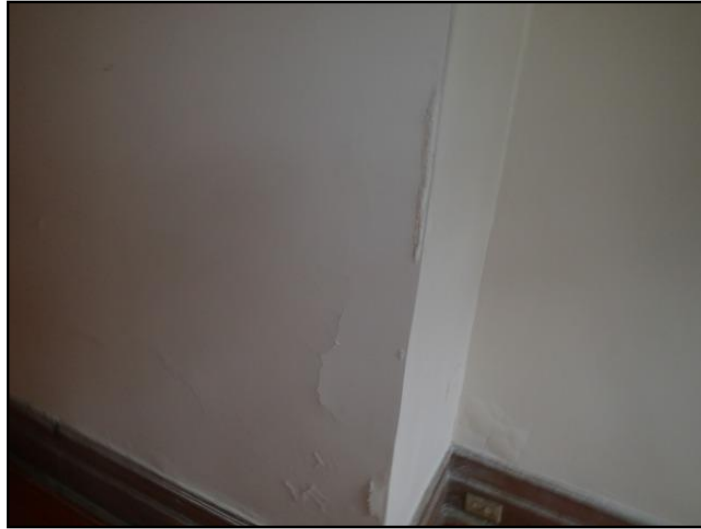
**66. Condition:** • Possible moisture intrusion on front right chimney. Prior repair noted on exterior stucco wall adjacent to this area.

85. Possible moisture intrusion

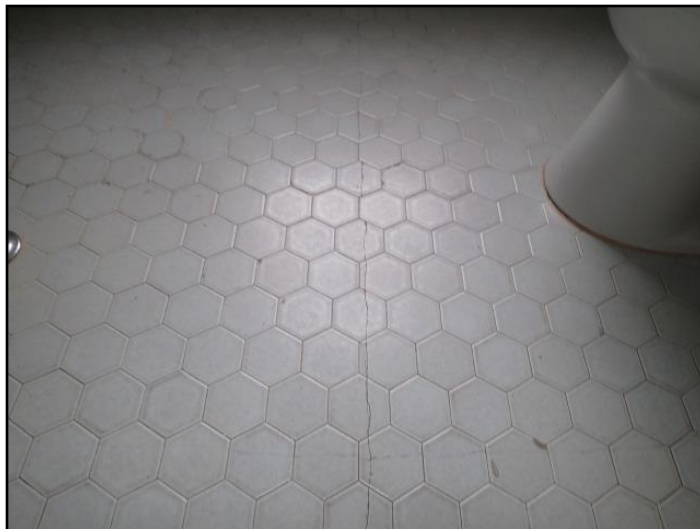
86. Tiles cracked

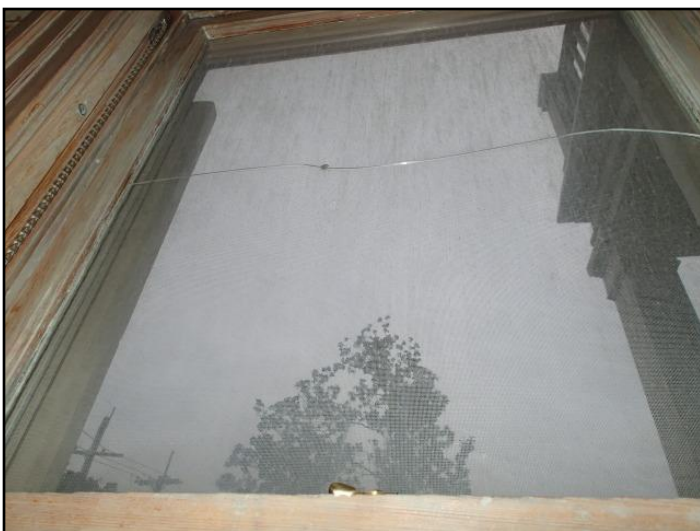
87. Cracked

**Task:** Replace broken glass where needed.

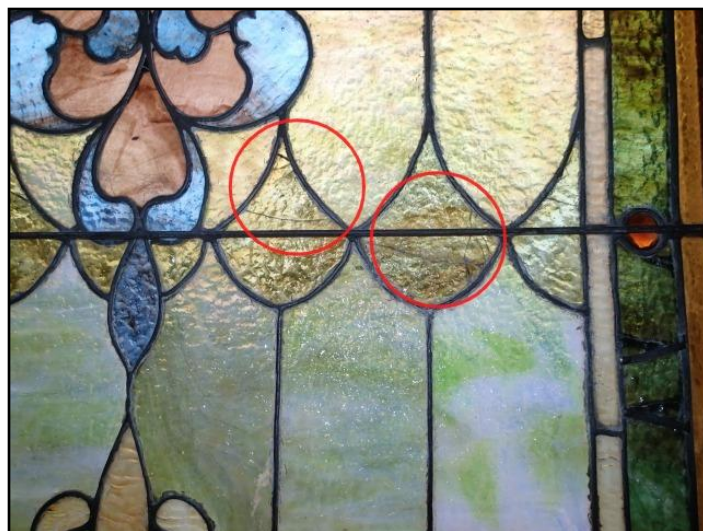
88. Cracked

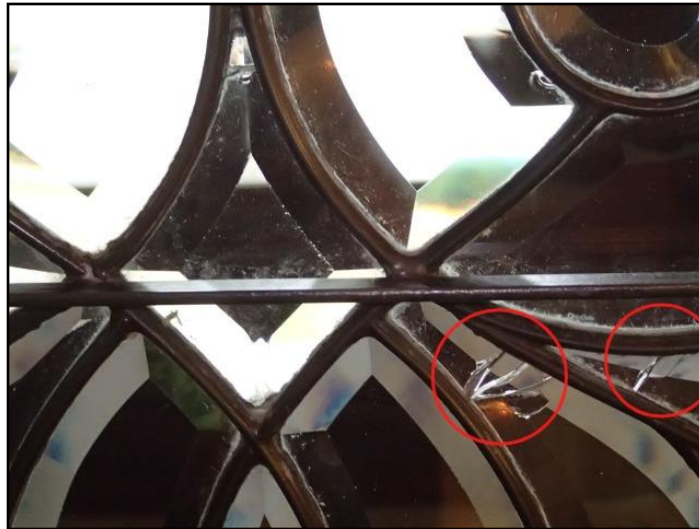
89. Cracked

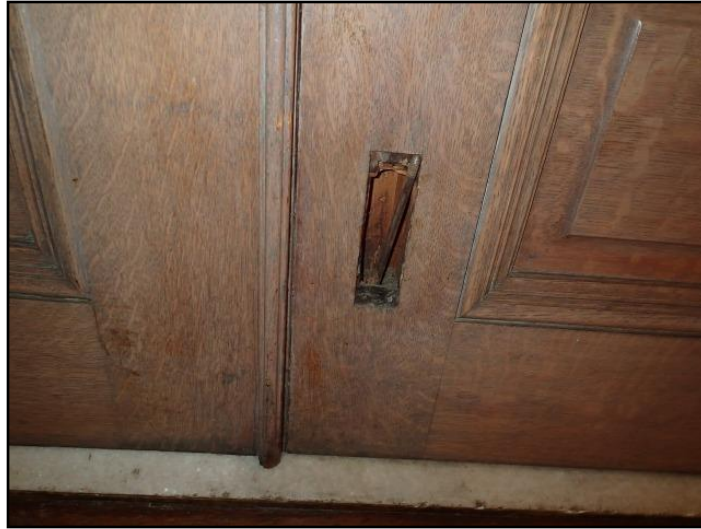
**Implication(s):** System inoperative or difficult to operate

90. Broken

**Task:** Repair

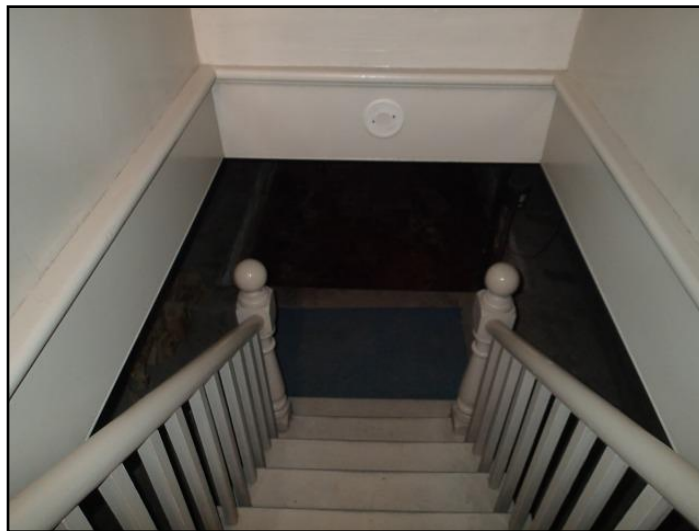
91. Basement stairs

Well-designed stairs are easy to climb. They have a maximum rise of about eight inches, and a minimum run of eight to ten inches. The headroom above each tread should be about 6 1/2 feet. Generally speaking, the lower the rise and the wider the tread, the easier the staircase is to use. Dimension rules are often broken on basement and loft stairwells. It is difficult and expensive to rearrange a poorly built staircase and, in most cases, the occupants simply live with it.

**Implication(s):** Physical injury

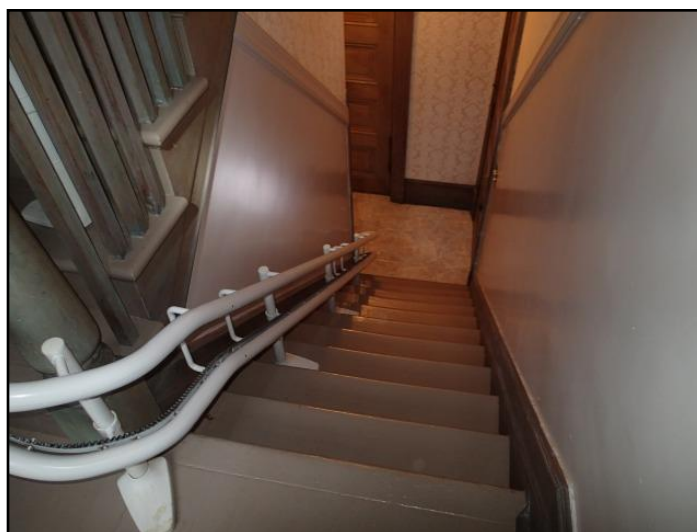
**Implication(s):** Fall hazard

92. Missing handrail

**Task:** Install rail. Remove chair lift to access hand rail.

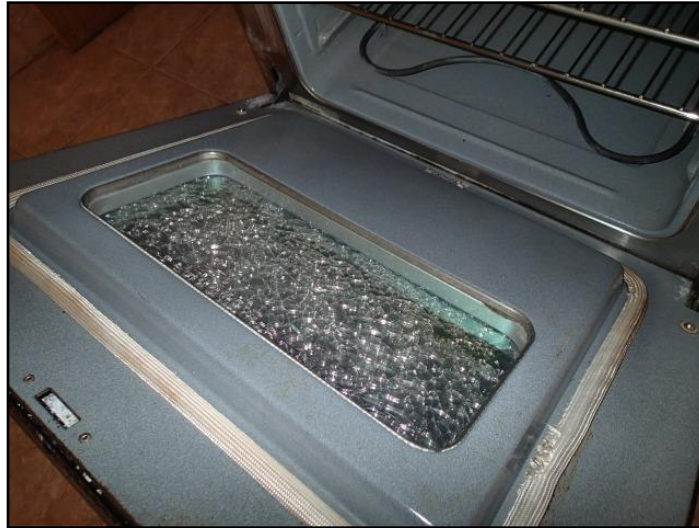
**79. Condition:** • Inner glass broken on lower oven.

**93.** Broken inner glass.

**Task:** Replace
