Your Inspection Report

123 Any Street
Any Town, TN 54321

INSPECTION DATE:
Friday, March 29, 2019

RE: Report No. 4601, v.5
123 Any Street
Any Town, TN
54321

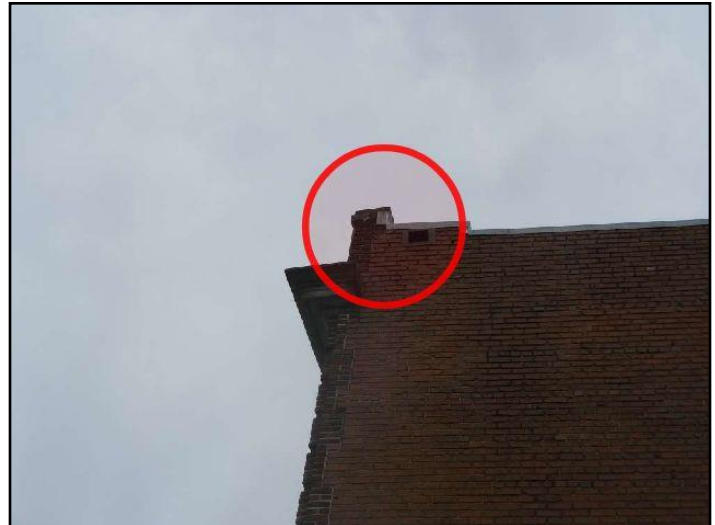
5. Masonry deterioration

Condition: • [Masonry deterioration](#)

The concrete soffit above the third-floor windows below the front of the building seems to be sagging. The mortar supporting it and the bricks below it seemed to be deteriorating. If this were to fall that could be very damaging or cause injury or death. I highly recommend that a masonry specialist come in and perform maintenance on this part of the structure to prevent damage or injury.

A masonry company that this inspector knows is experienced in repair of older masonry is Gentry Painter Masonry (G&P Masonry) They are located at 2901 S. Orchard Knob Ave., Chattanooga 37407 and their number is 423-624-9953. (This inspector is a certified masonry inspector and has dealt direct with (overseen) this company in the past)

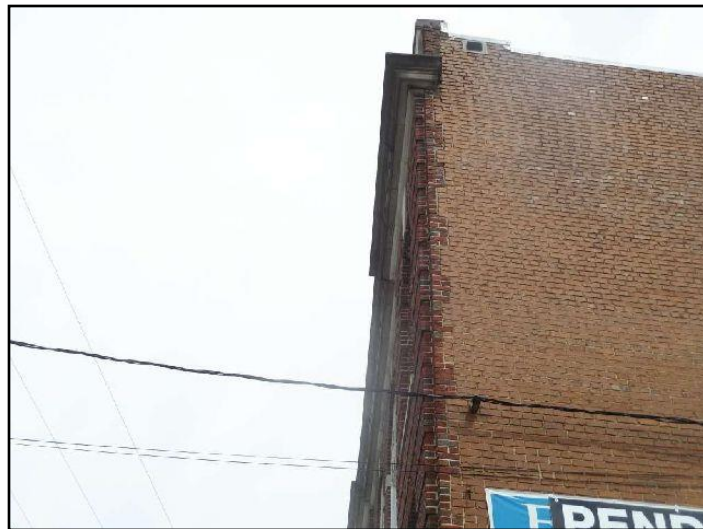
7. Masonry deterioration

Condition: • [Spalling](#)

Spalling is a common characteristic for masonry. It is non structural and cosmetic. Sealing the material could cause more damage than it can help so I do not suggest it be sealed

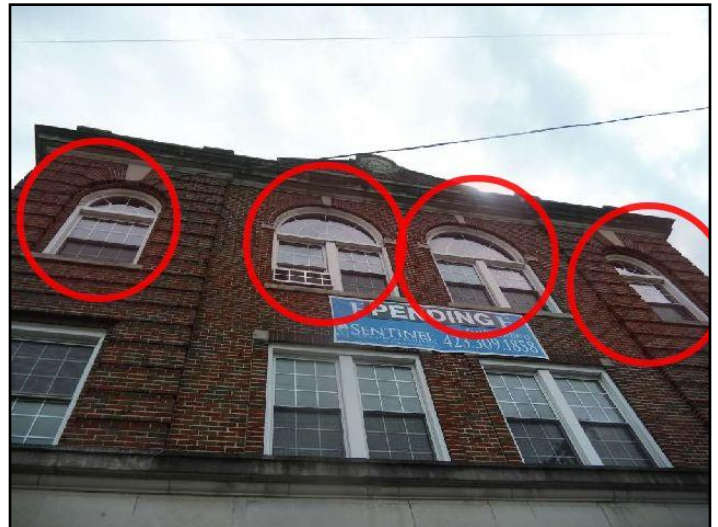
11. Paint or stain needed

Condition: • [Paint or stain needed](#)

Implication(s): Chance of water damage to structure, finishes and contents | Material deterioration

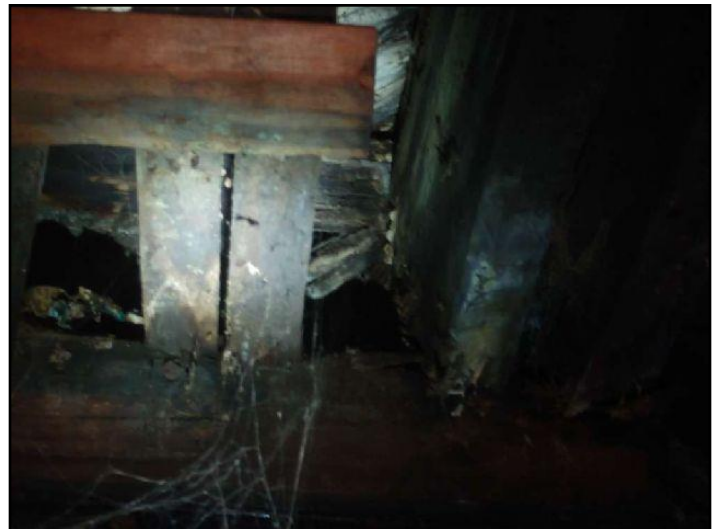
34. Rot or insect damage

Condition: • [Rot or insect damage](#)

Implication(s): Weakened structure

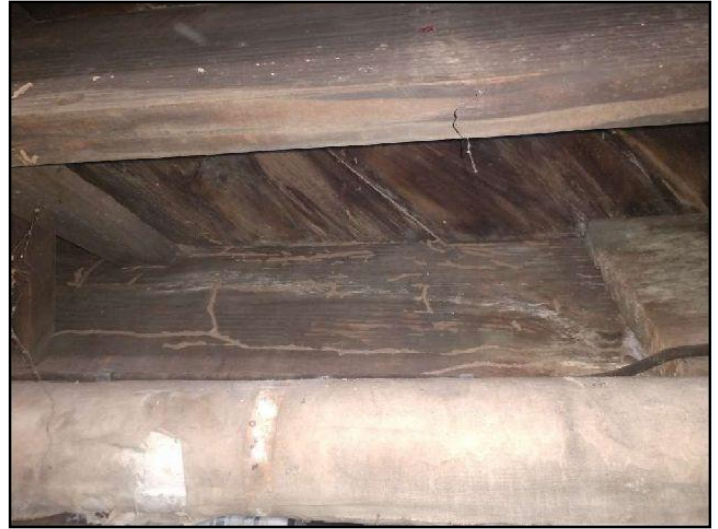
37. Rot, insect or fire damage

Condition: • [Rot, insect or fire damage](#)

is this inspector opinion that the entire area over the old boiler in the basement over to the staircase and in front of the staircase on the other side of the wall is sacrificed and needs major structural replacement. This area has a severe infestation of wood-boring insects and rot along the main beam and sill plate around the exterior wall of the structure.

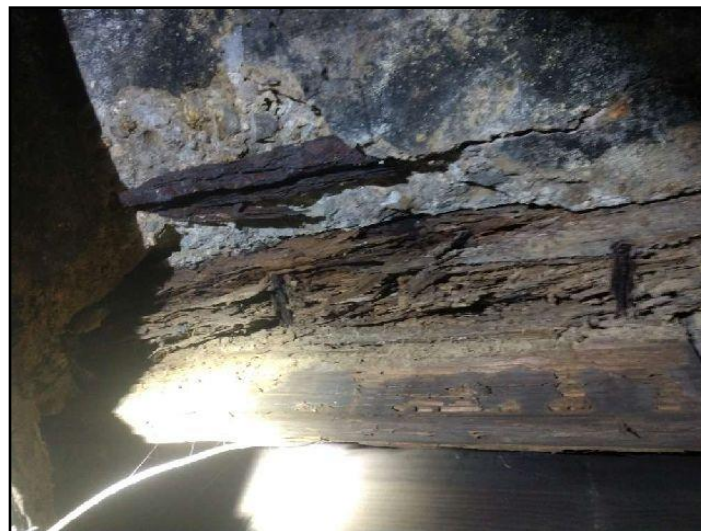
40. Rot, insect or fire damage

Condition: • [Rot, insect or fire damage](#)

Implication(s): Weakened structure

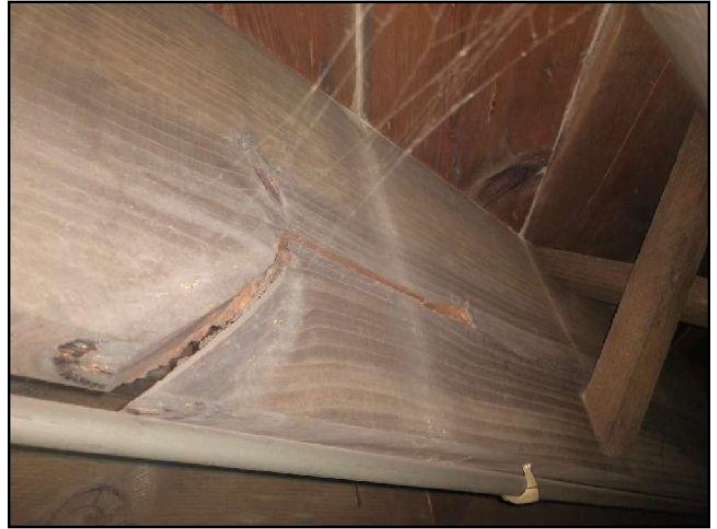
42. Split or damaged

Condition: • [Split or damaged](#)

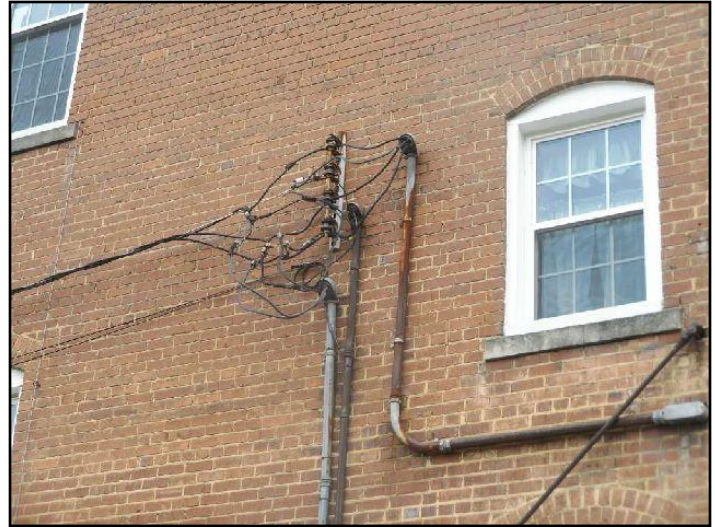
47. Insulation missing or damaged

Condition: • [Insulation missing or damaged](#)

Implication(s): Fire hazard

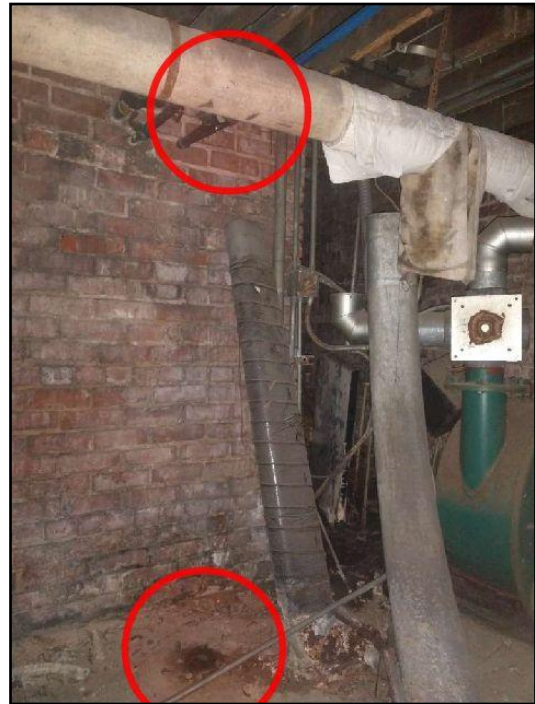
63. Leak

Condition: • [Leak](#)

Implication(s): Chance of water damage to structure, finishes and contents | Damage to equipment

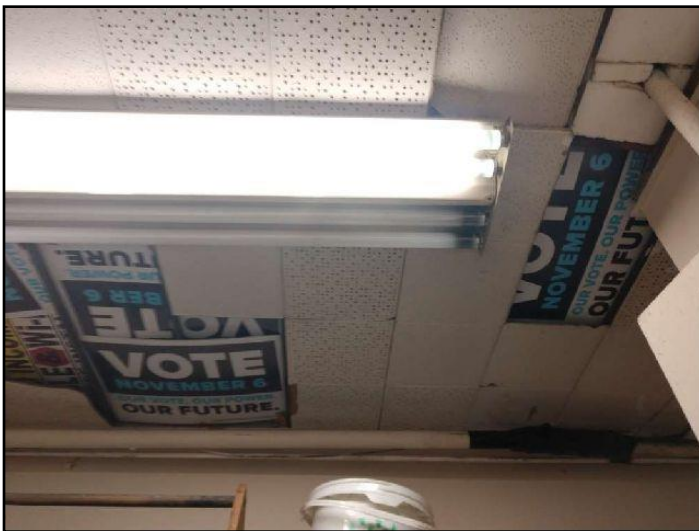
71. Water damage

Condition: • [Water damage](#)

Sales representative stated that they damage to the suspended ceiling in the first floor front suite is from where the bathroom upstairs leaked at one point. No active moisture was found when examined using infrared thermography

Implication(s): Chance of movement | Rot | Leakage

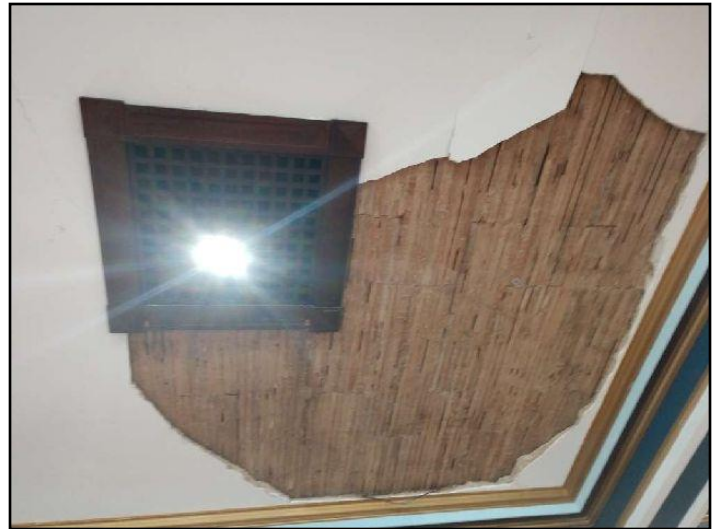
75. Damaged

Condition: • Damaged

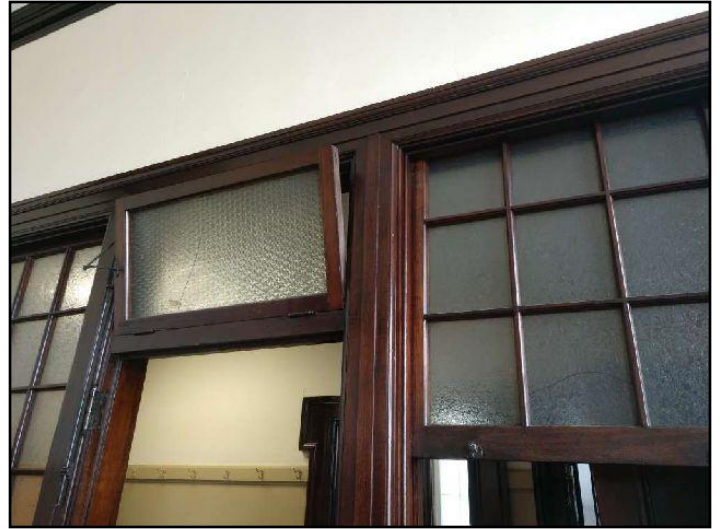
81. Broken

Condition: • [Broken](#)

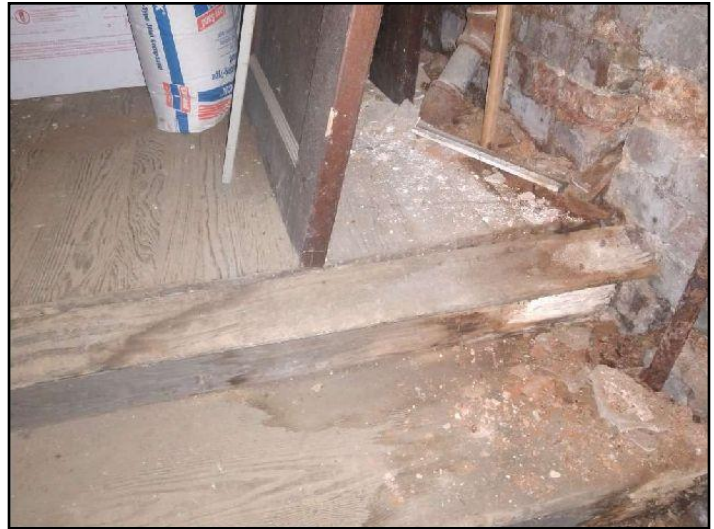
84. Worn or damaged

Condition: • [Worn or damaged](#)

Implication(s): Weakened structure | Trip or fall hazard
