Your Inspection Report

5325 Anystreet
Anytown, AB

INSPECTION DATE:
Friday, December 6, 2013

SurePro
Property Inspections

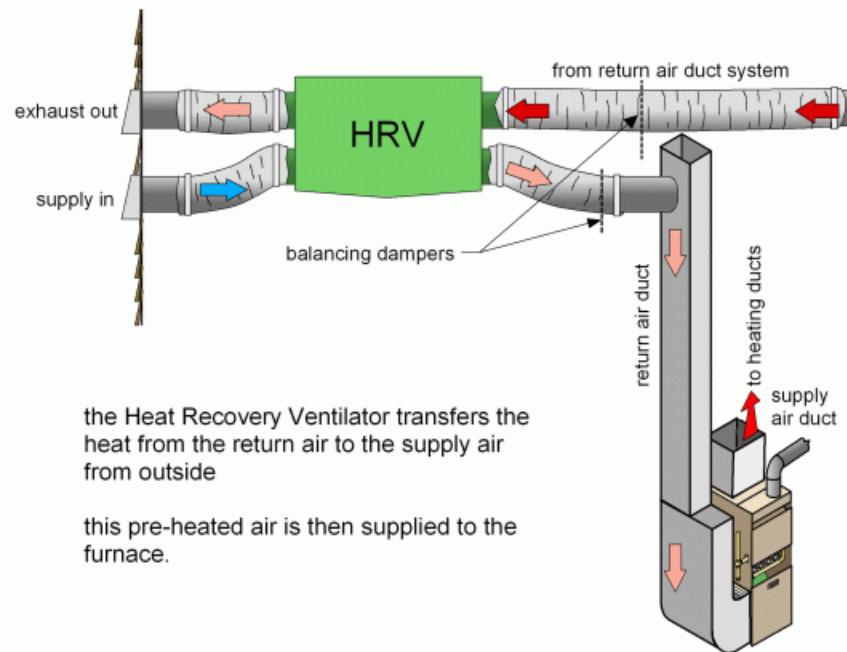
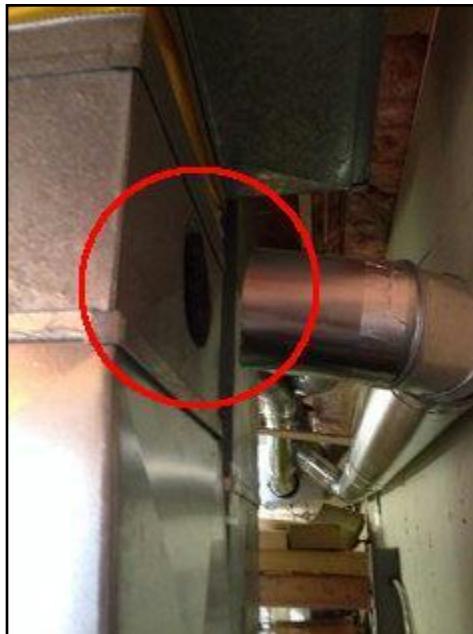
Condition: • Warm-side fresh air duct not well-connected to furnace duct

Warm-side fresh air duct not well-connected to furnace duct

Task: Further evaluation

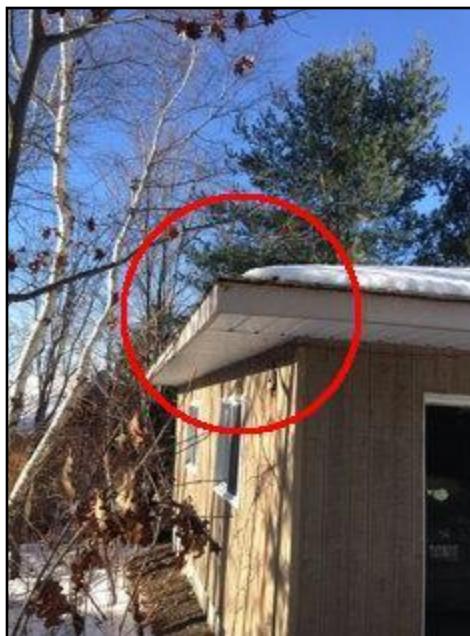
Condition: • Missing

Implication(s): Chance of water damage to contents, finishes and/or structure

Gutters Missing

Task: Provide

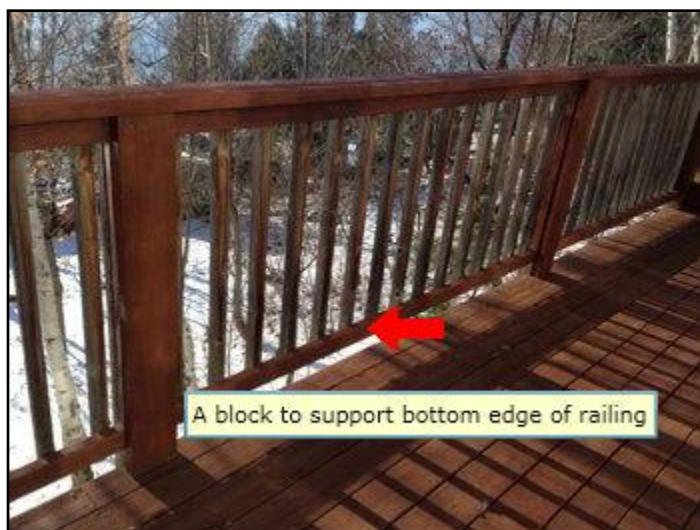
Bottom edge of railing needs support from deck floor with wood blocking

Add railing support

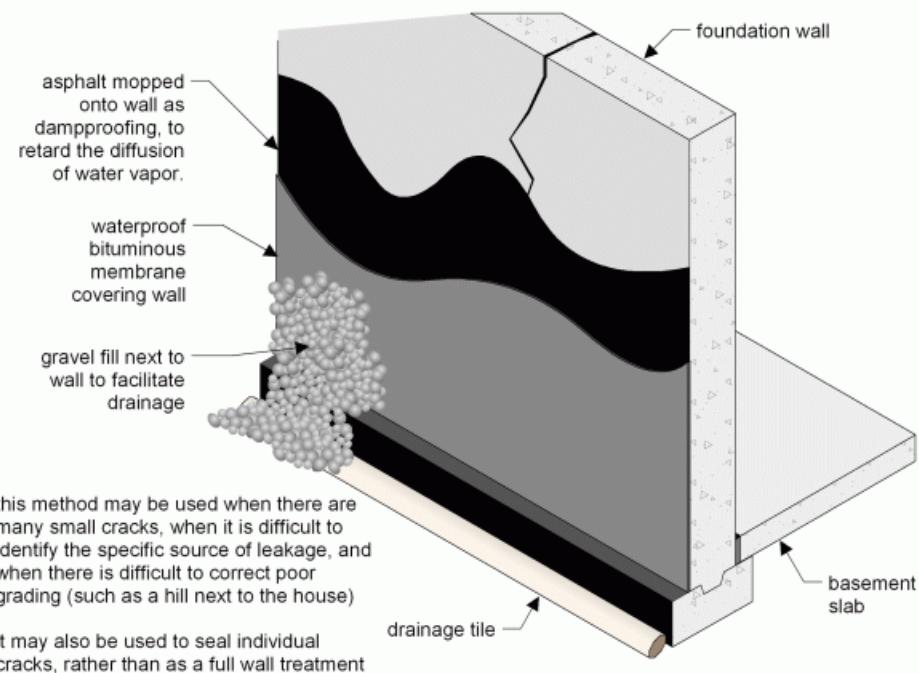
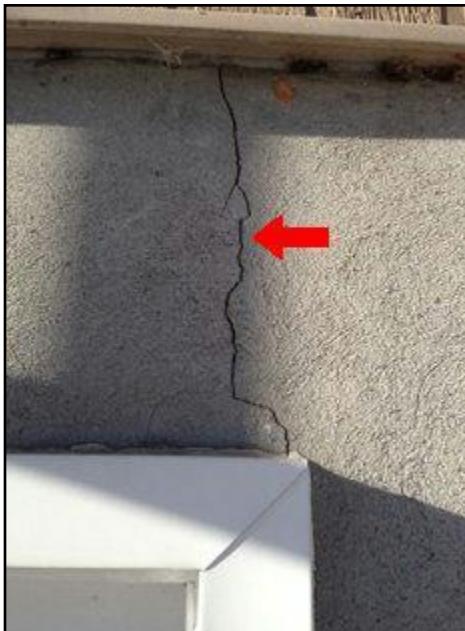
Condition: • Typical minor cracks

Implication(s): Chance of water entering building

Minor Cracks

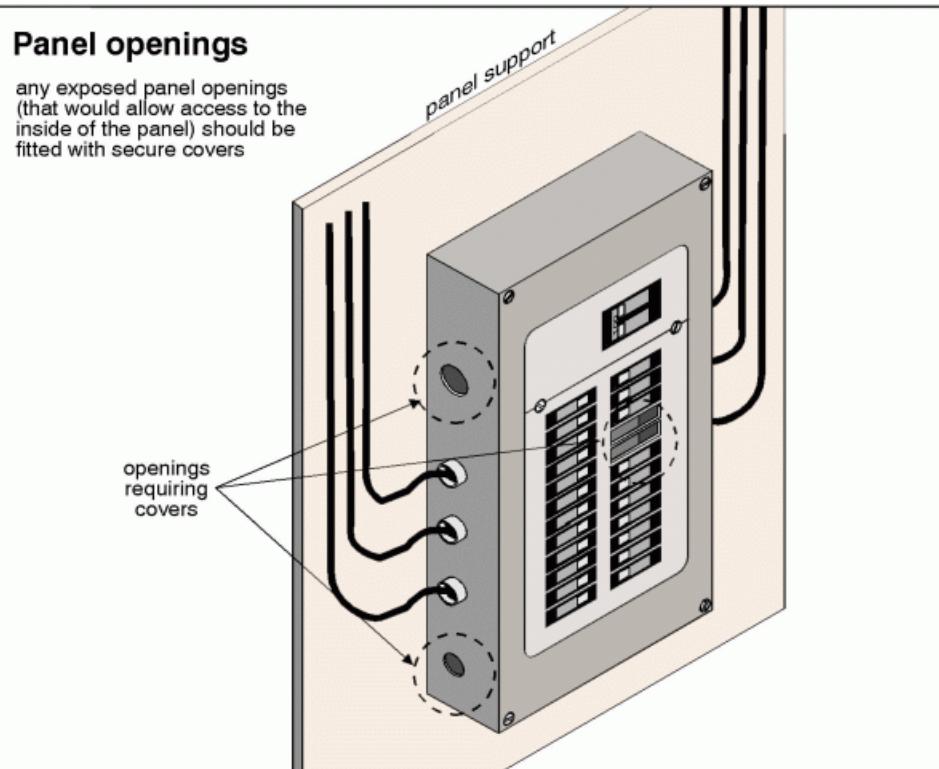
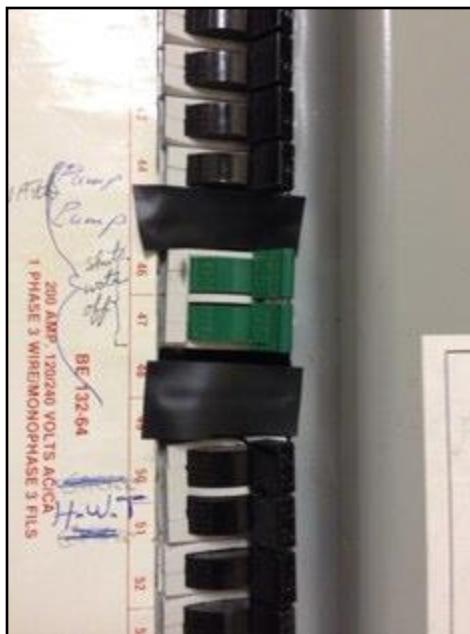
Condition: • Openings in panel**Implication(s):** Fire hazard | Electric shock

Openings in panel

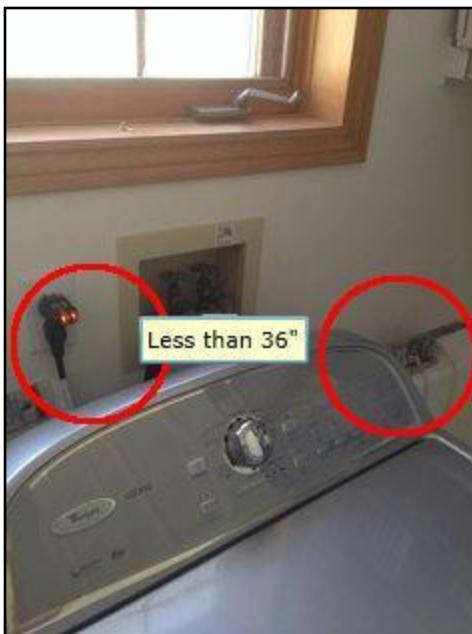
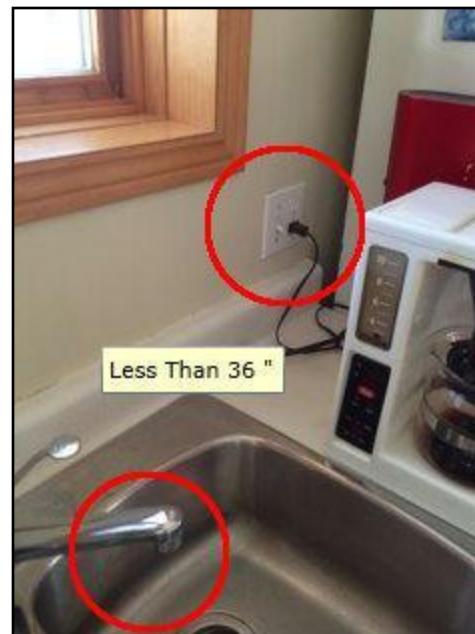
Condition: • No GFCI/GFI (Ground Fault Circuit Interrupter)

Implication(s): Electric shock

Location: Kitchen & Laundry Area

No GFCI

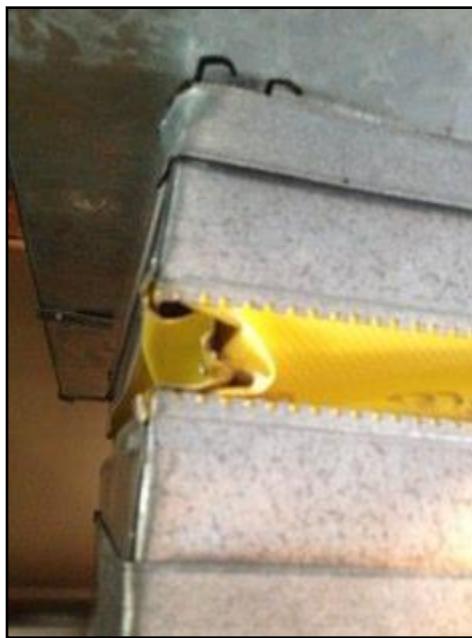
Condition: • Leak

Implication(s): Equipment ineffective

Location: Basement

Leak

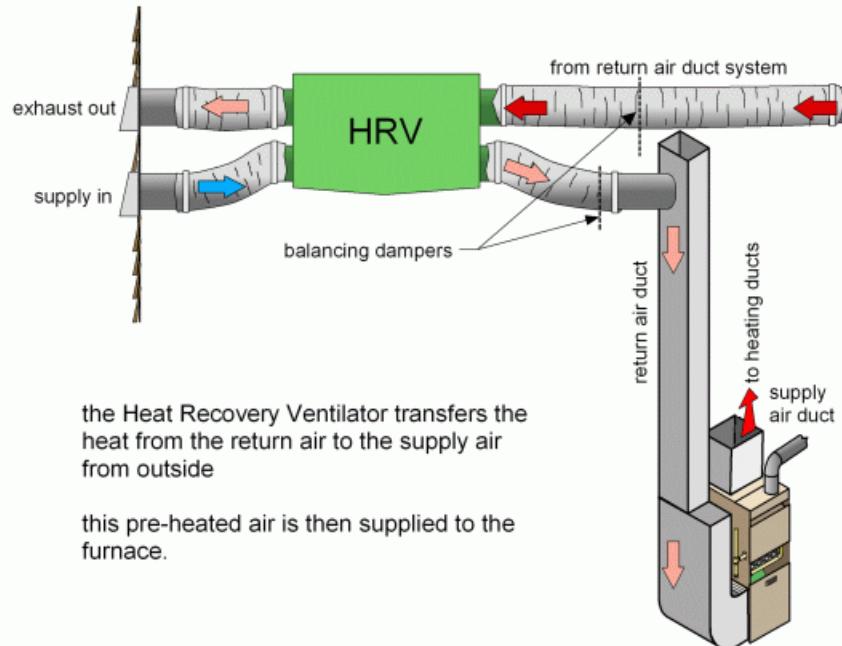
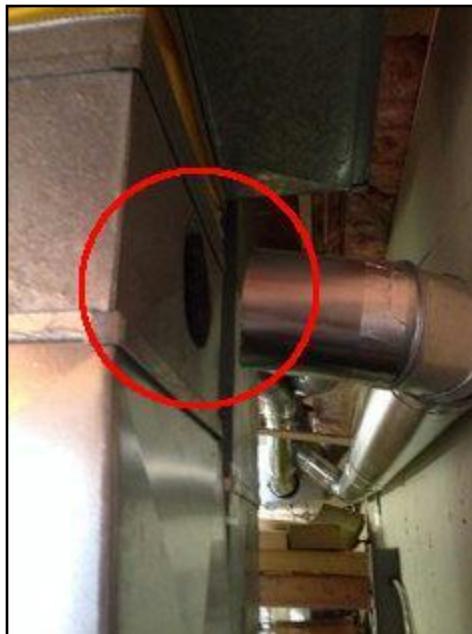
Condition: • Warm-side fresh air duct not well-connected to furnace duct

Implication(s): Equipment ineffective

Warm-side fresh air duct not well-connected t

Task: Further evaluation

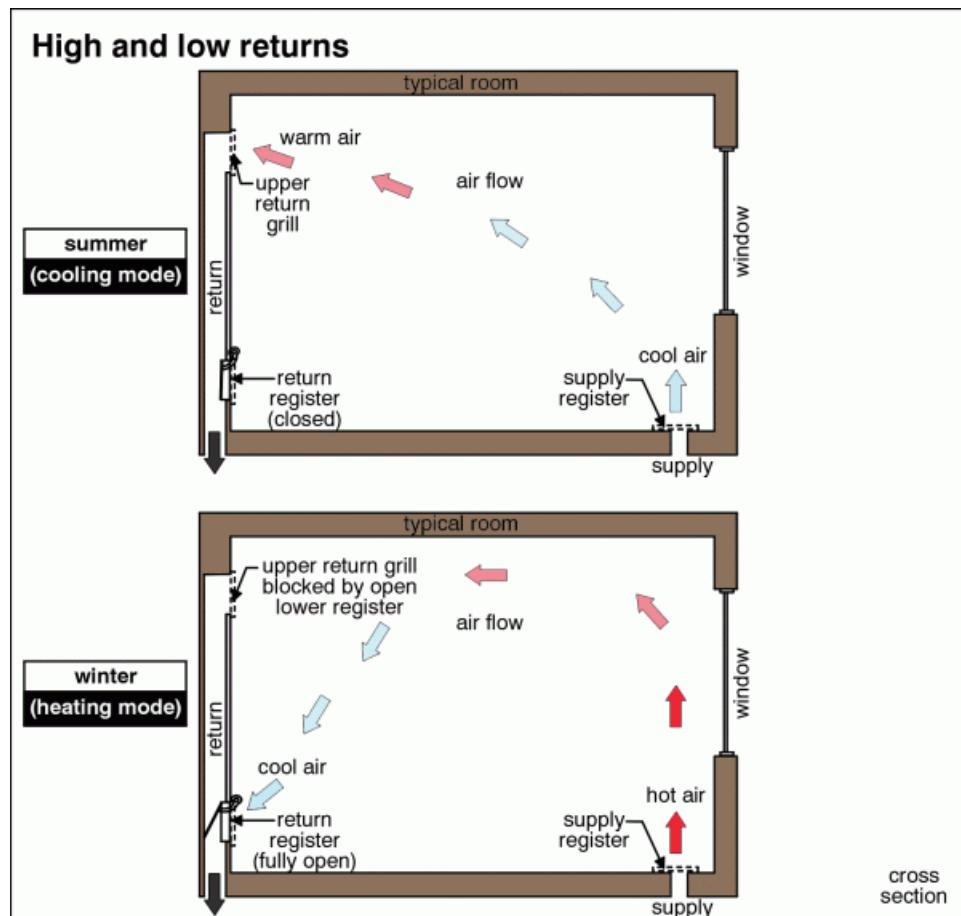
Condition: • When testing the return air ducts it was noted that the grills mounted high on the walls showed little to no air movement. I recommend further evaluation to determine proper air ventilation throughout the house.

Task: Further evaluation

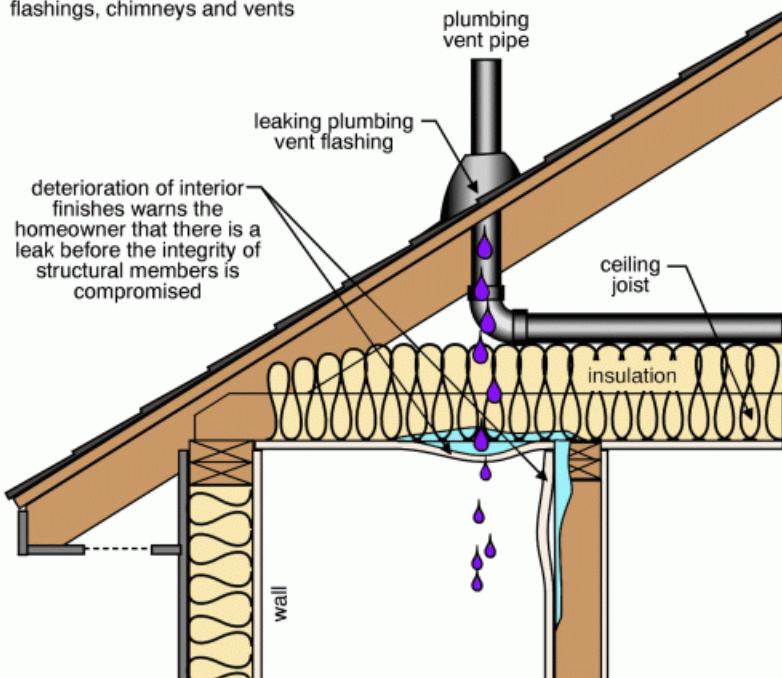
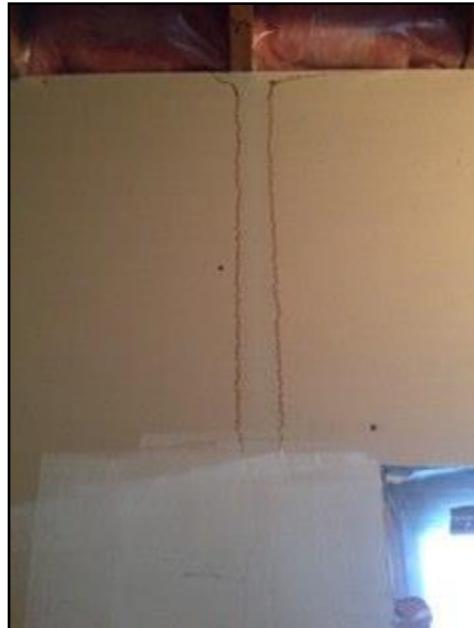
Condition: • Water damage

This appears to be a one time, old leak from something on the first floor and not a recurring issue.

Minor water damage

Task: Monitor

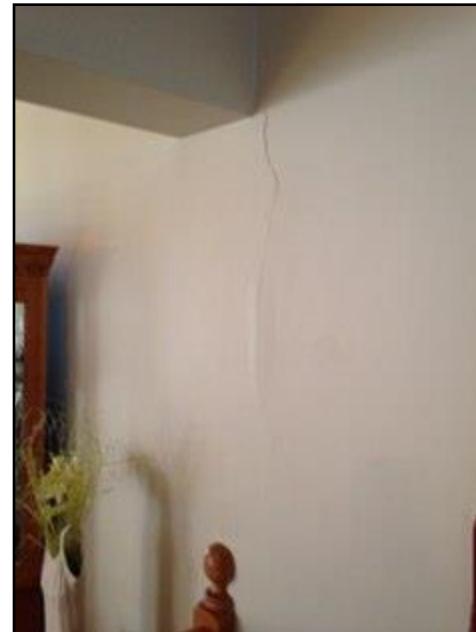
Condition: • Typical flaws

Location: First Floor Hallway Bathroom

Damaged

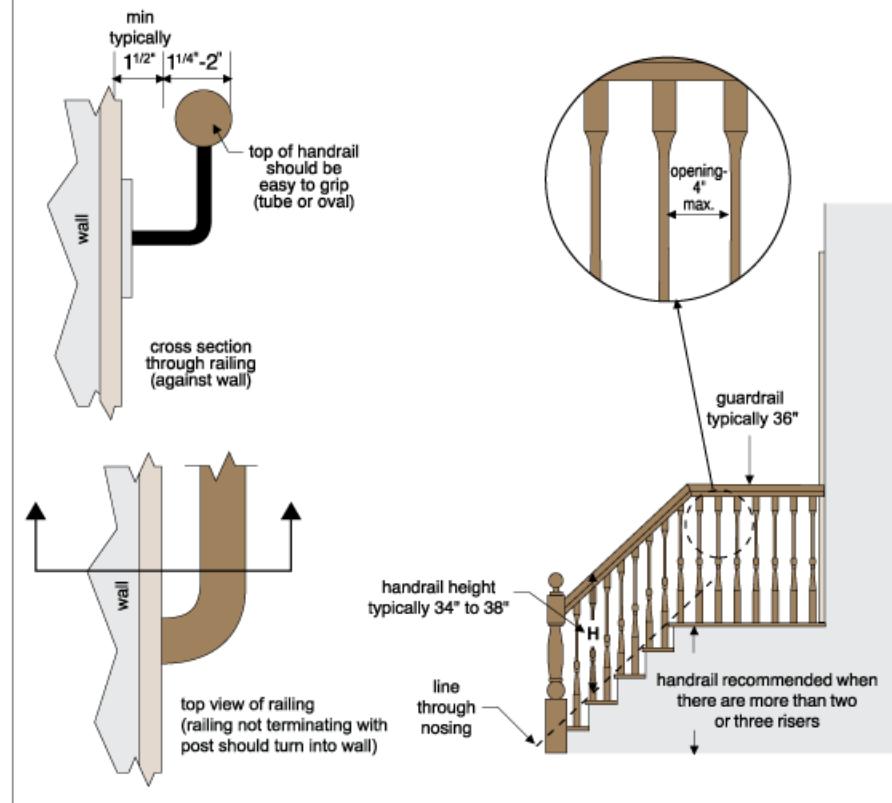
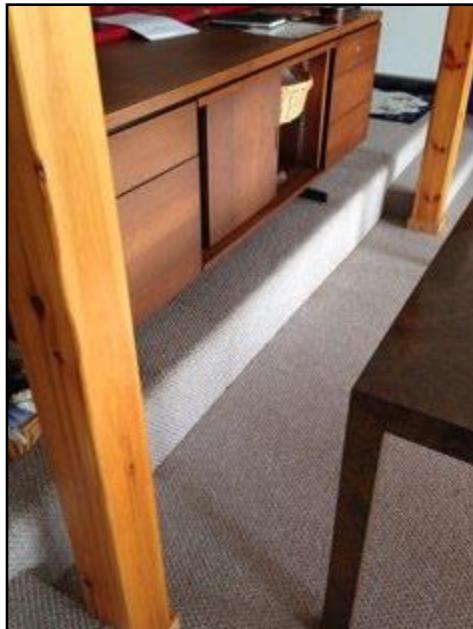
Condition: • Missing

With no obstruction between the posts the step is too high. A railing to block the step or a bridging of the two outer steps to create one continuous step is recommended.

Implication(s): Fall hazard

Missing
