INSPECTION REPORT

For the Property at:
1030 W ADDISON
CHICAGO, IL

Prepared for: ROBERT ELLIOTT
Inspection Date: Saturday, March 31, 2007
Prepared by: robert elliott

ELLIOTT HOME INSPECTION

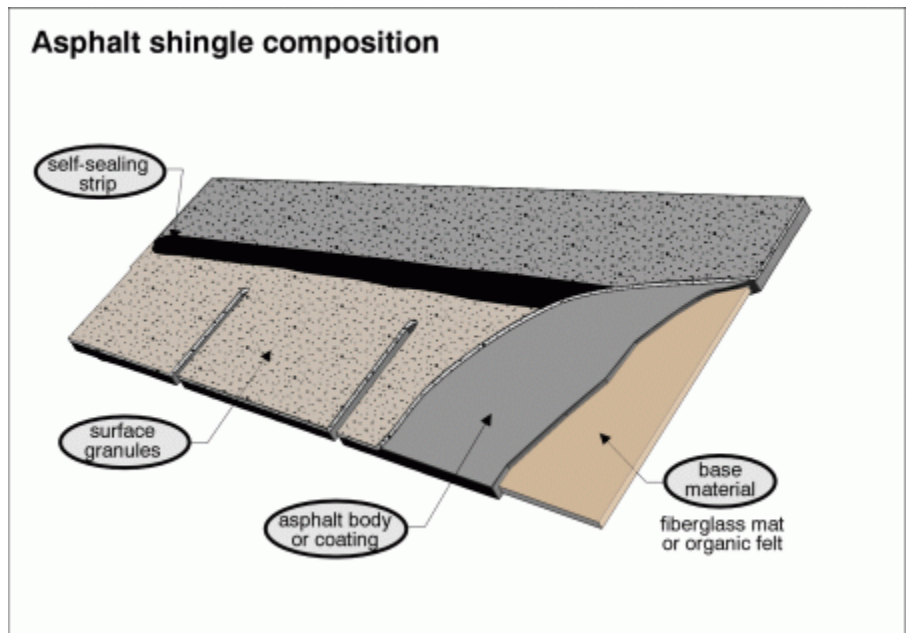
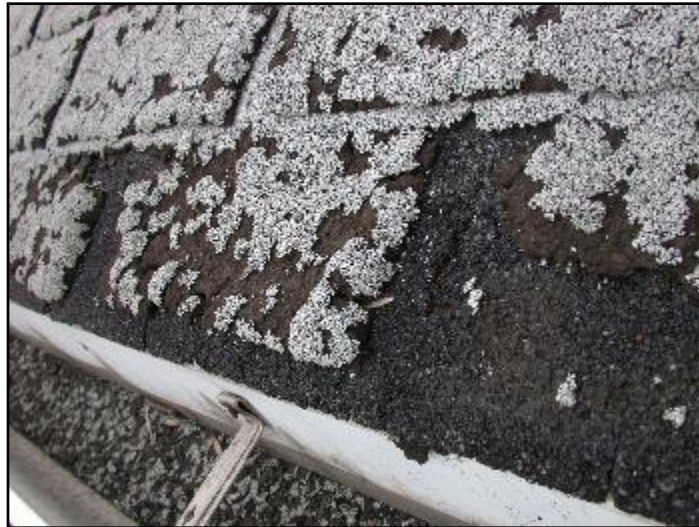
Sloped roofing \ Asphalt shingles

Condition: • [Granule loss](#)

Implication(s): Chance of water damage to contents, finishes and/or structure

Note: Granules are clogging the gutters

1. Note missing granules

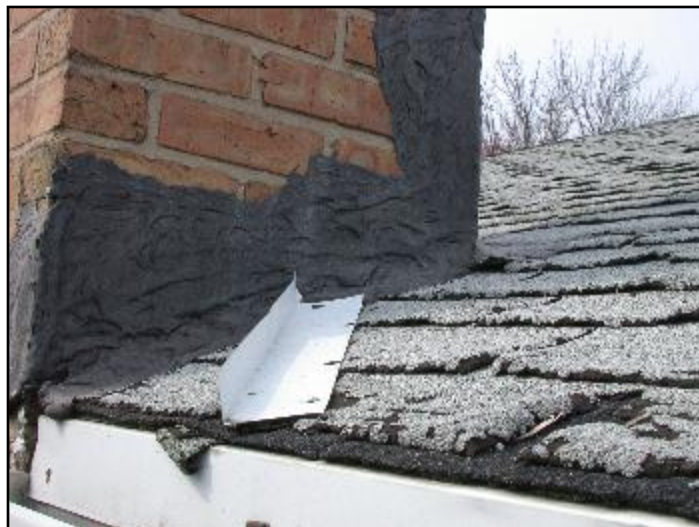
Sloped roof flashings \ Chimney flashings

Condition: • [Damage, loose, open seams, patched](#)

Implication(s): Chance of water damage to contents, finishes and/or structure

Note: Attempt to divert water from chimney was made using I shaped sheet metal.

2. Note this is an amateur attempt to divert

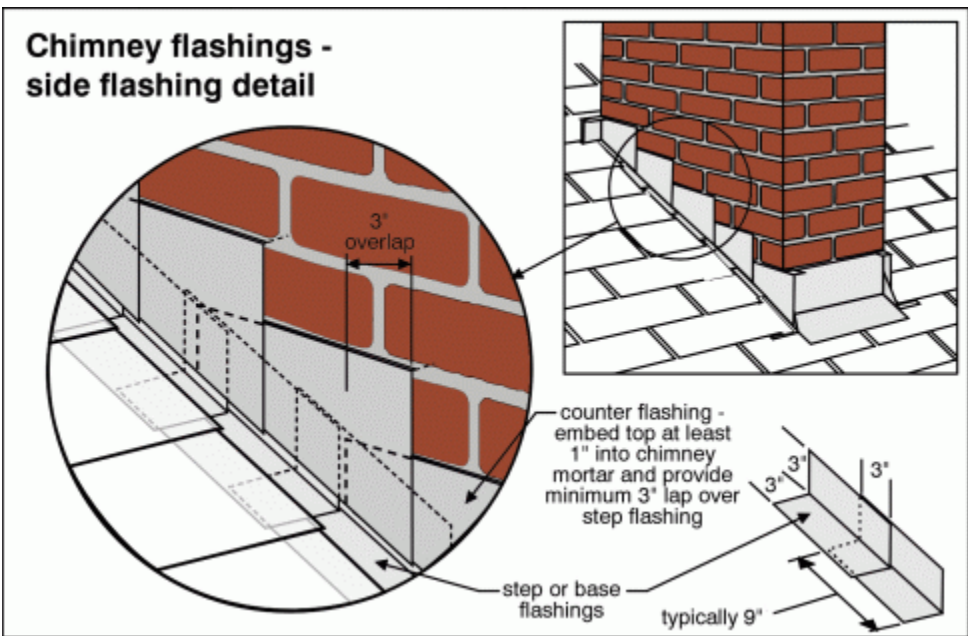
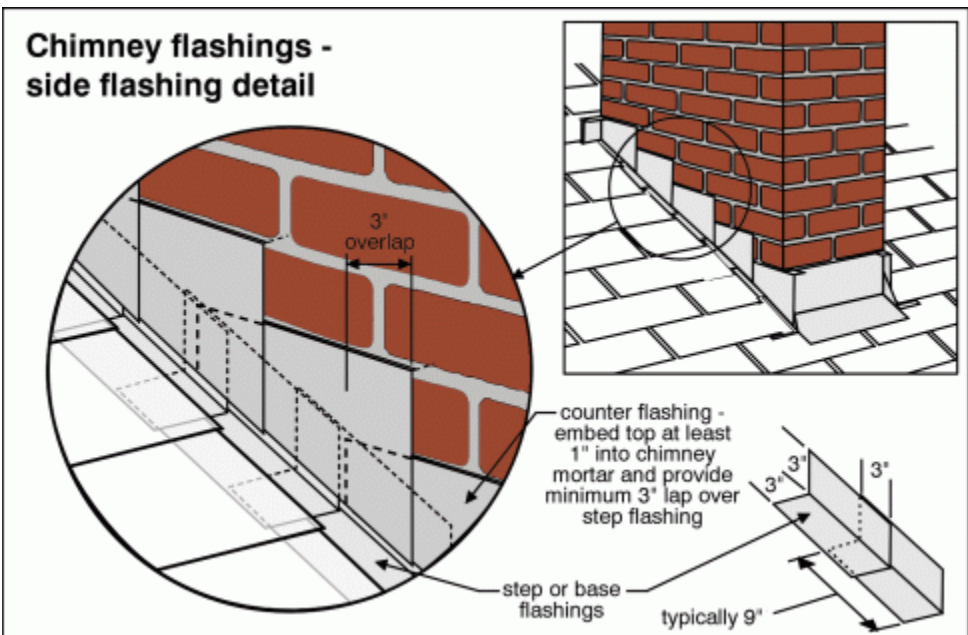
Sloped roof flashings \ Chimney flashings

Condition: • [Side flashings not set into shingles properly](#)

Implication(s): Chance of water damage to contents, finishes and/or structure

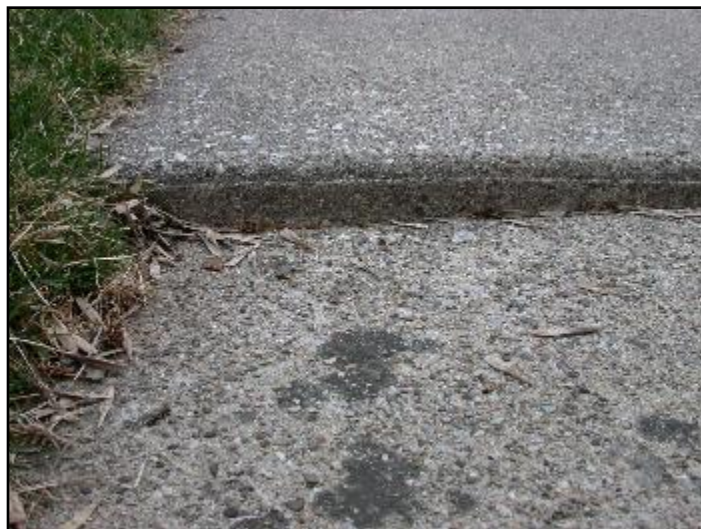
3. Greater than 1 inch differential

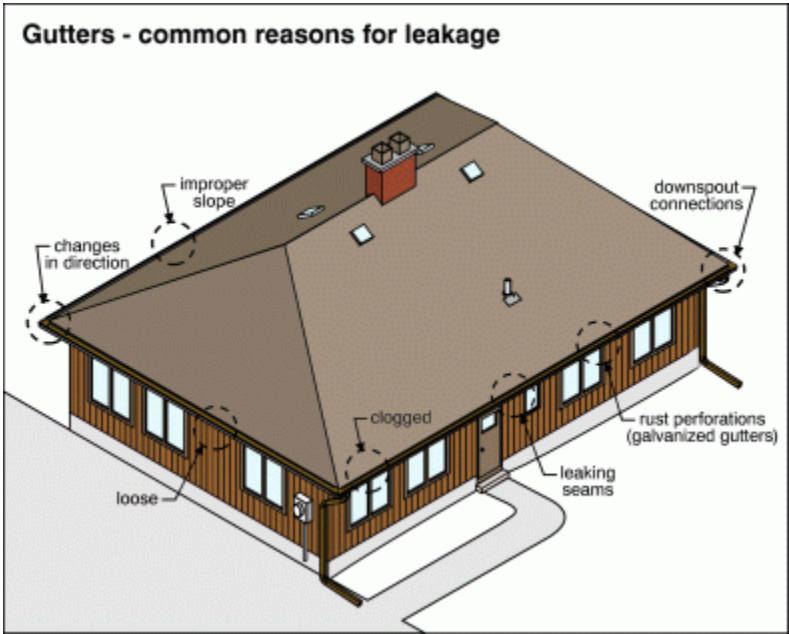
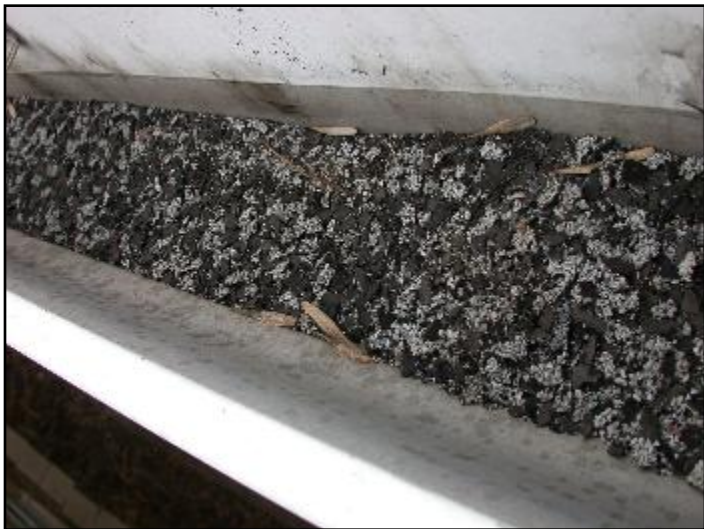
Roof drainage \ Gutters

Condition: • [Clogged](#)

Implication(s): Chance of water damage to contents, finishes and/or structure

Note: filled with roof granules

4. These are deteriorated shingle granules

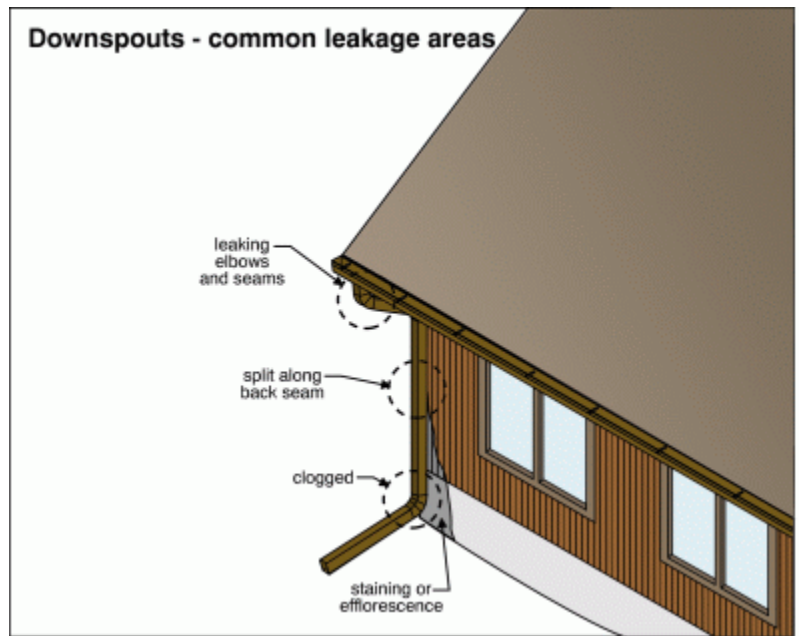
Roof drainage \ Downspouts

Condition: • [Leak](#)

Implication(s): Chance of water damage to contents, finishes and/or structure

Note: Downspouts may be clogged

Task: Monitor

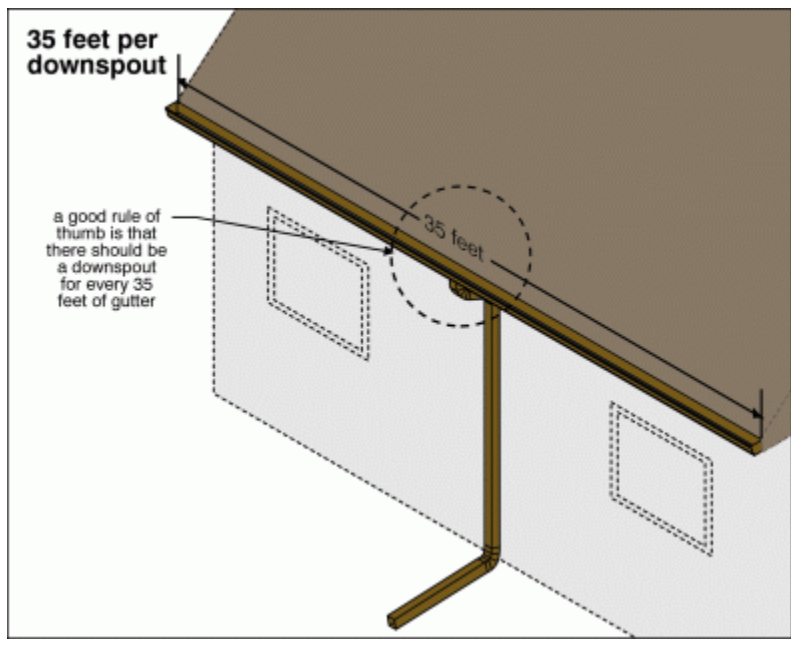
Roof drainage \ Downspouts

Condition: • [Too few](#)

Implication(s): Chance of water damage to contents, finishes and/or structure

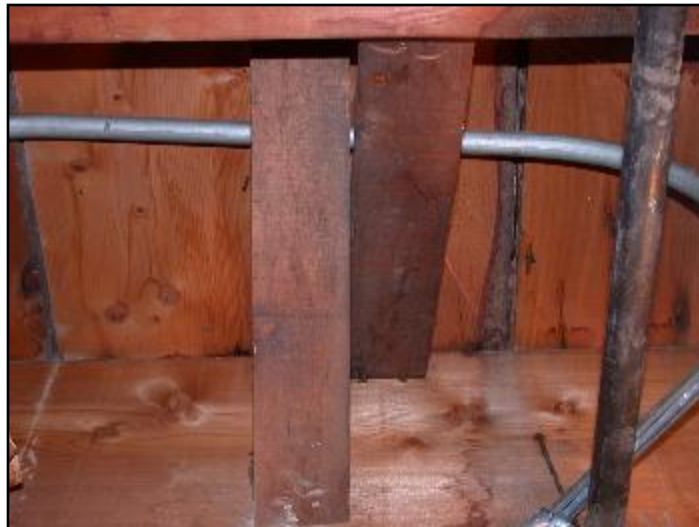
Note: Visible sections in mechanical room appear ok

5. *Note bridging used properly where seen*

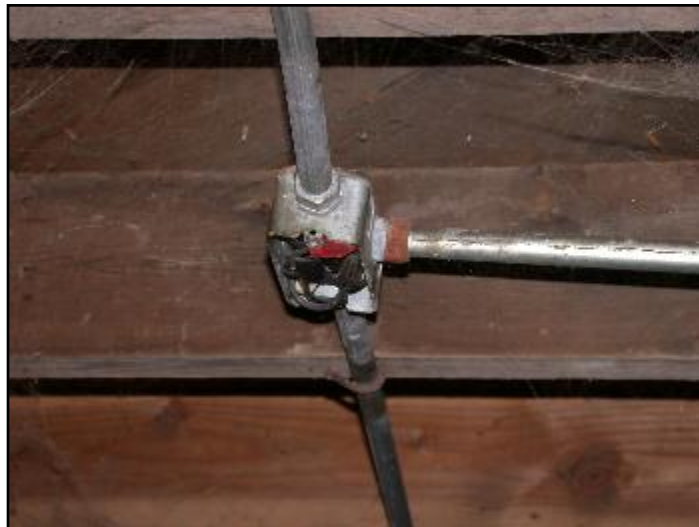
Distribution system \ Junction boxes

Condition: • [Cover loose or missing](#)

Implication(s): Electric shock | Fire hazard

7. missing cover for junction box

Task: Replace

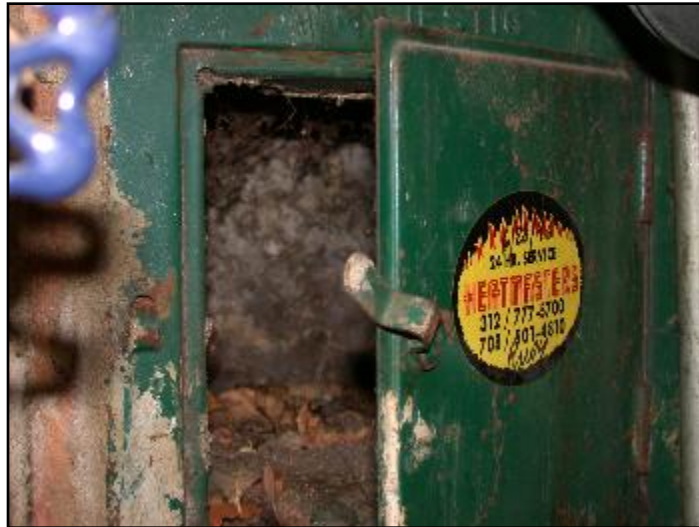
9. Clean out should be cleaned of debris

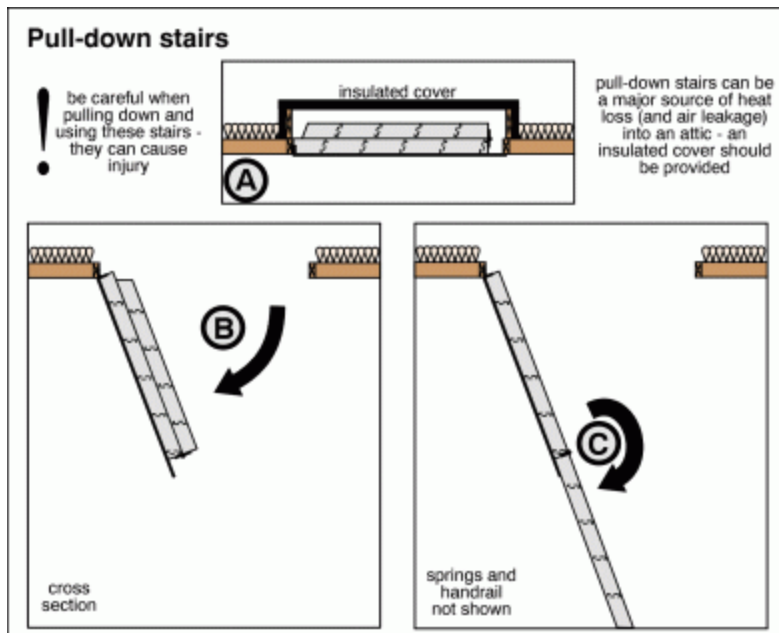
Attic/roof \ Pull-down stairs

Condition: • [Not insulated](#)

Implication(s): Increased heating and cooling costs | Reduced comfort

Note: Recommend adding insulation to attic side of drop down stairs

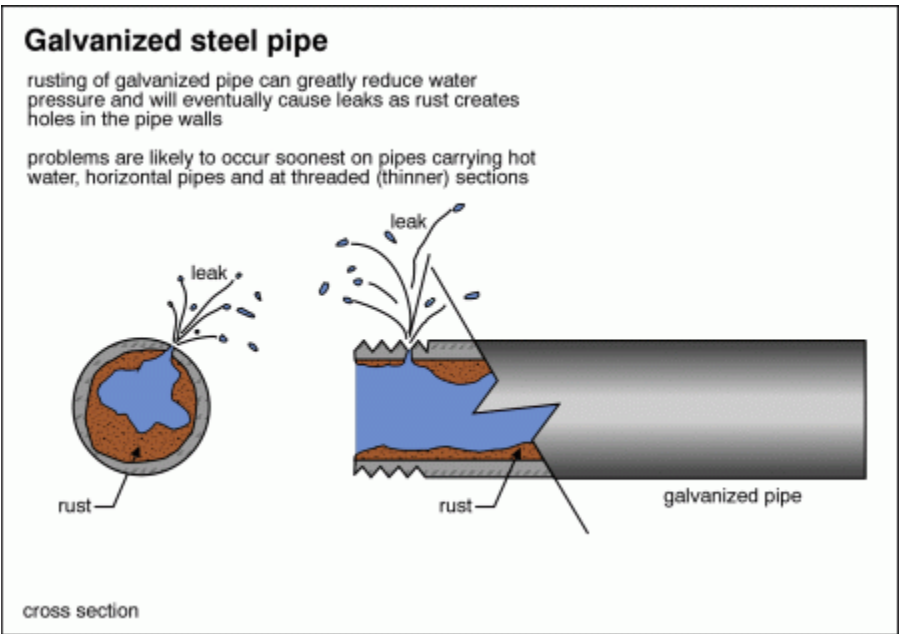
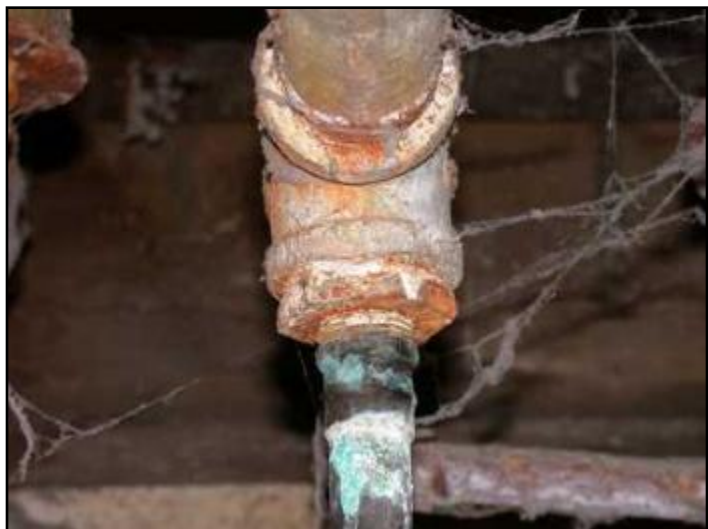
Supply plumbing \ Supply piping in house

Condition: • [Galvanized steel](#)

Implication(s): Reduced water pressure and volume

Note: Some of the pipes are made of copper and when connected to the galvanized pipe they should have a dielectric union to prevent chemical reaction between the pipes.

10. copper should not connect to galvanized

Task: install unions or change material

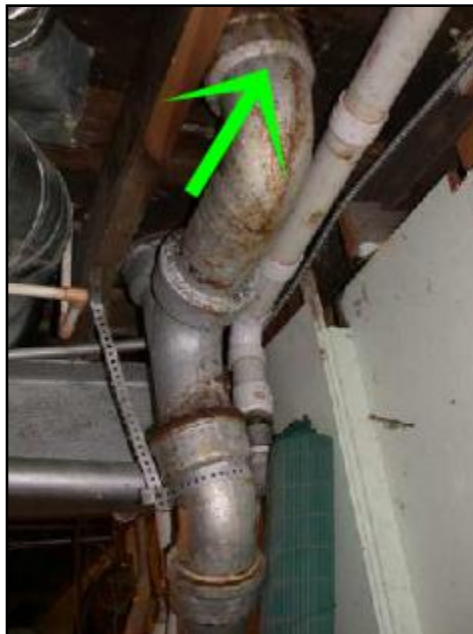
Waste plumbing \ Drain piping - performance

Condition: • [Leak](#)

Implication(s): Sewage entering the house

Note: Toilet waste pipe is leaking on to floor of basement

11. underside of toilet shows leaking

Task: replace wax seal and tighten

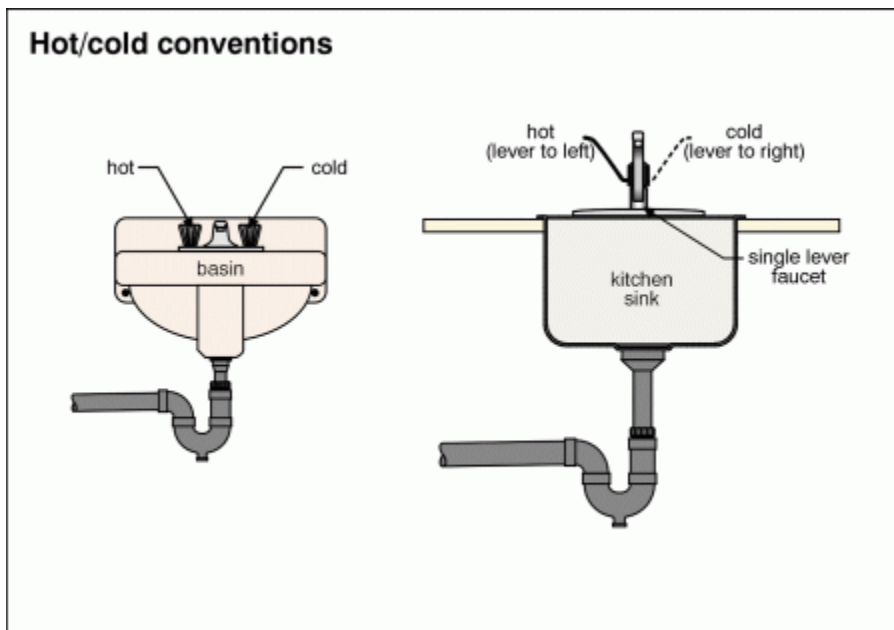
Fixtures and faucets \ Faucet

Condition: • [Hot and cold reversed](#)

Note: Hot water is normally on the left side with cold on the right, however this is reversed and may cause someone to get burnt. I would recommend correction as this is a new sink faucet.

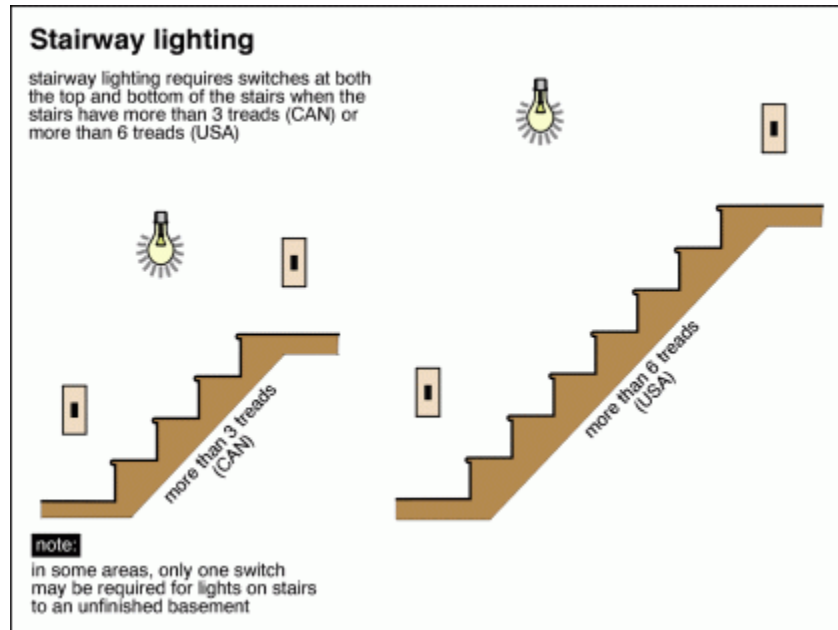
Stairs \ Lighting

Condition: • [Not controlled by three way switch](#)**Implication(s):** Trip or fall hazard**Location:** Basement**Task:** Provide**Note:** Should be installed for safety reasons.
