# YOUR INSPECTION REPORT

FOR THE PROPERTY AT:  
682 Windermere Avenue  
Toronto, ON M6S 3M1

INSPECTION DATE:  
Friday, September 19, 2025

RE: Report No. 8552, v.2  
682 Windermere Avenue  
Toronto, ON  
M6S 3M1

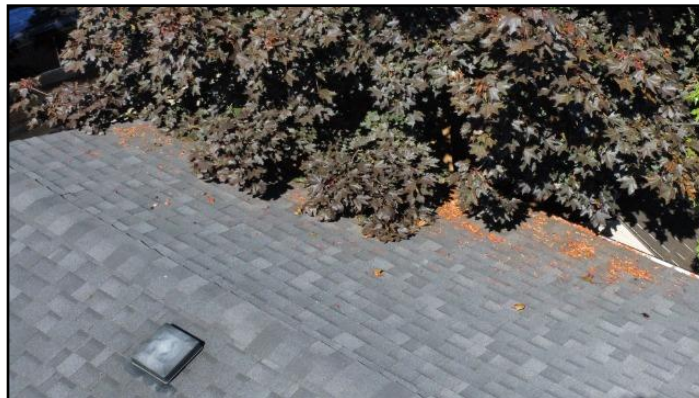
4. Tree branches touching roof

**Condition:** • Tree branches touching roof

**Task:** Correct

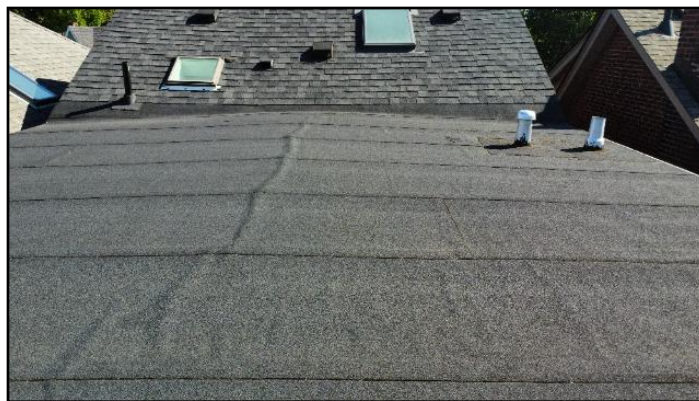
5. Blisters

**Condition:** • [Blisters](#)

**Task:** Monitor for changes; re-evaluate during routine tune-up

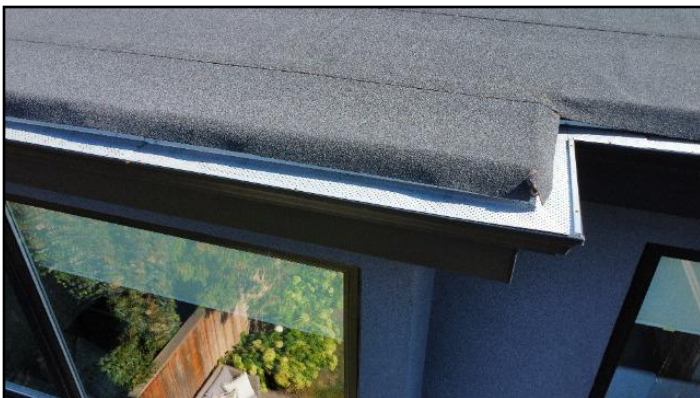
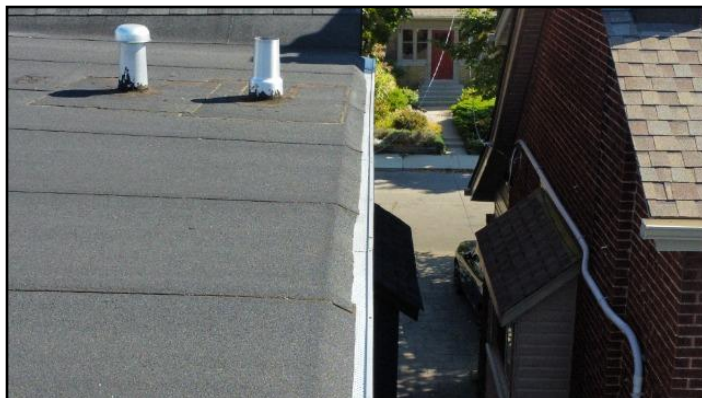
**Condition:** • [Missing, too short](#)

## Incomplete edge termination - flashing missing

(Even if flashing is present beneath, best practice is to terminate the membrane with a metal edge flashing or termination bar on top to protect the edge and prevent failure.)

**Time:** Less than 1 year

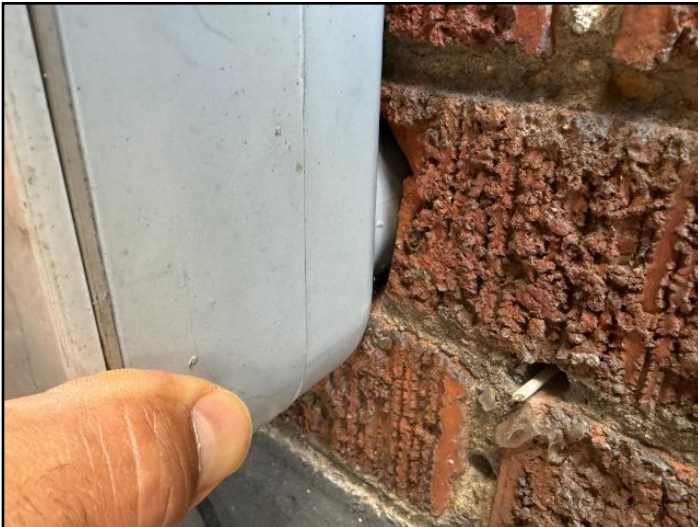
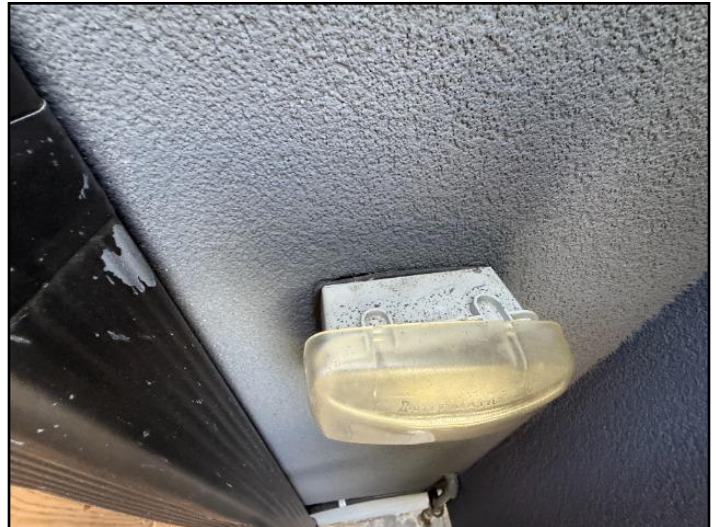
8. example at electrical conduit

9. example at outlet

**Condition:** • FOR ALL HOMES - Caulking around windows, doors, and wall penetrations should be inspected regularly and improved as needed to prevent moisture entry and air leakage.

**Task:** Seal

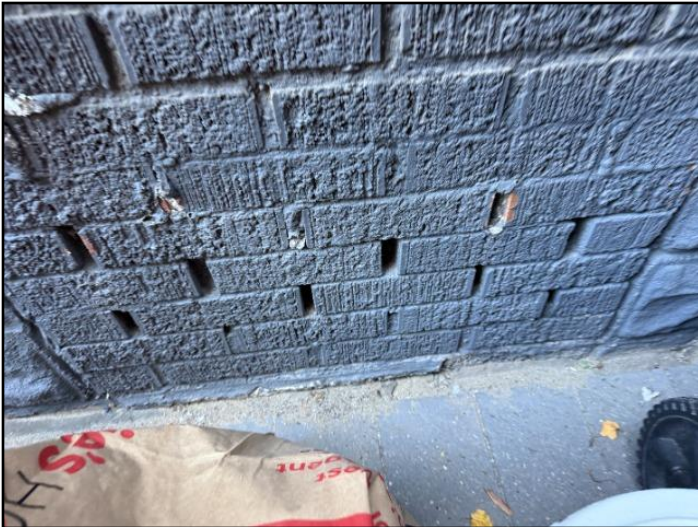
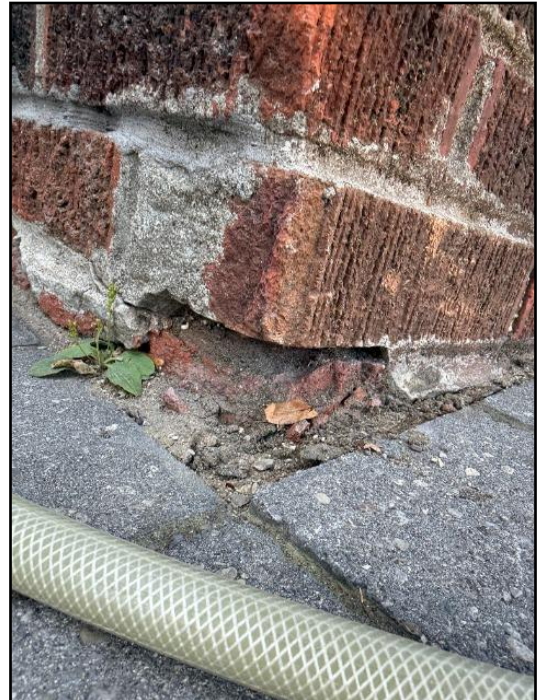
**Condition:** • Masonry and/or mortar deterioration

10. example of mortar deterioration

11. example of spalling at column

Tuckpoint / Repoint mortar and patch/repair spalled masonry. This is typical maintenance for a home of this age. photos show a sampling

**Task:** Repair

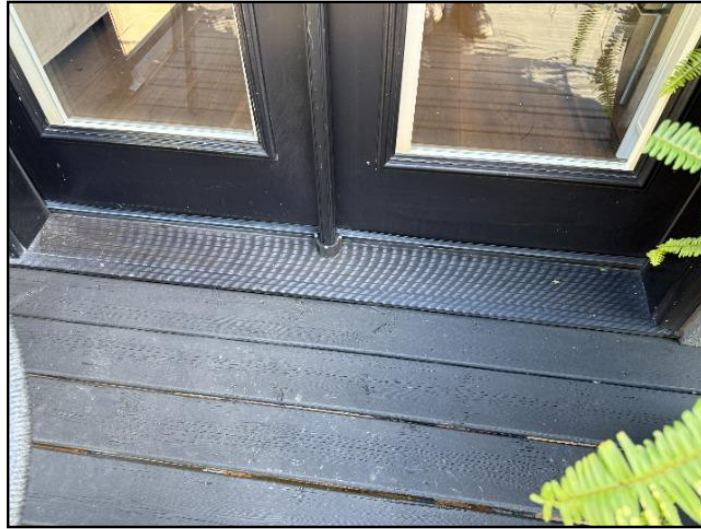
12. Threshold too low

**Condition:** • Threshold too low

Having a minimal step makes the inside/outside transition easier. On the other hand, it also makes it more prone to snow buildup/leakage.

**Implication(s):** Chance of moisture intrusion

While it is probably not practical to improve the current situation, it will be important to keep any weatherstripping/caulking in good condition.

**Task:** Monitor for moisture intrusion / Improve

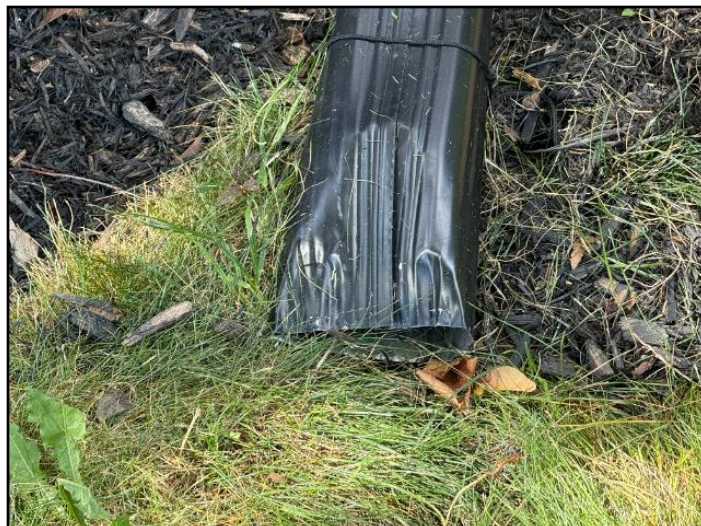
- Keep tree branches trimmed back 3 feet from roof line - ongoing routine maintenance.
- Downspouts - minor damage - front downspout - repair/replace if function is affected.

13. Minor damage at downspout

**Task:** Repair or Replace or Improve or Monitor

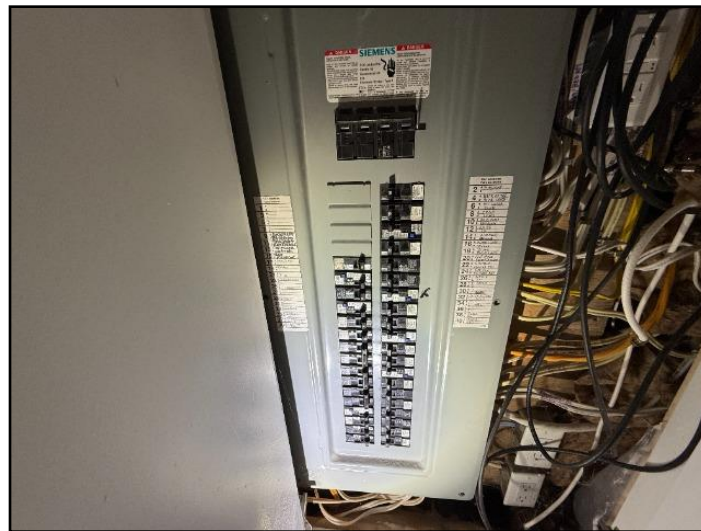
**Condition:** • [Poor access](#)

16. *Difficult access*

3 feet of clearance should be provided in front of the panel

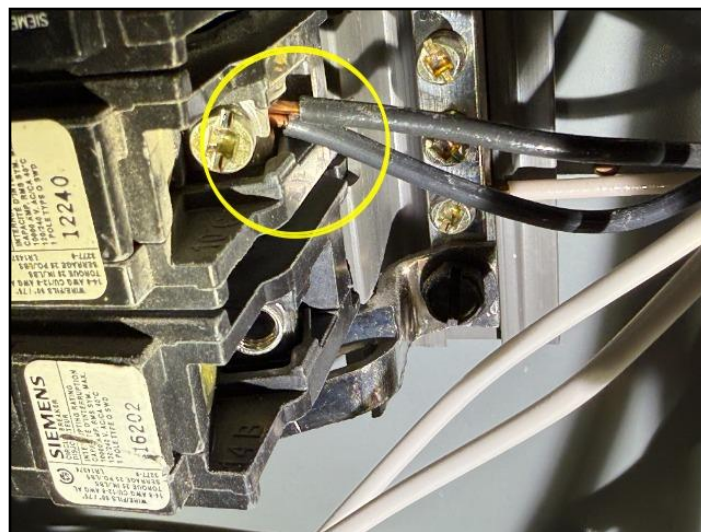
**SERVICE BOX, GROUNDING AND PANEL \ Distribution fuses/breakers****Condition:** • [Double taps](#)**Implication(s):** Fire hazard**Location:** Basement Panel**Task:** Correct**Time:** As Soon As Possible**Cost:** Minor**Double tapping (double lugging)**

**17. Double taps**

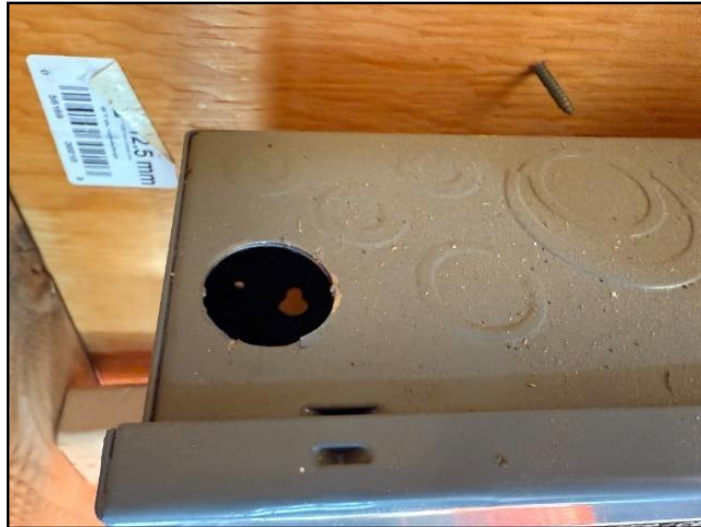
**Condition:** • Unprotected Opening(s)

18. Unprotected Opening(s)

**Time:** As Soon As Possible

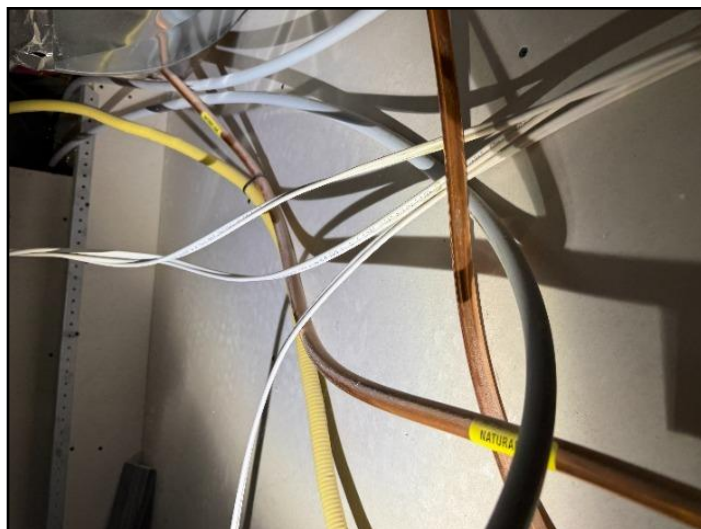
19. example

**Condition:** • [Not well secured](#)

**Implication(s):** Electric shock | Fire hazard

**Time:** As Soon As Possible

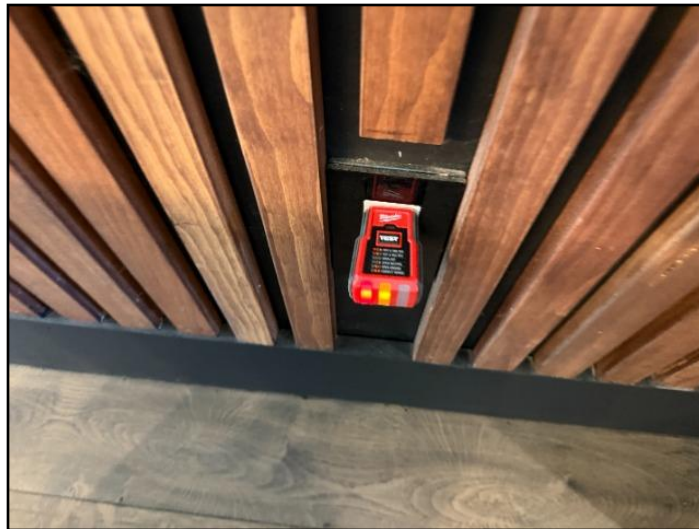
20. one example

**Condition:** • [Reversed polarity](#)

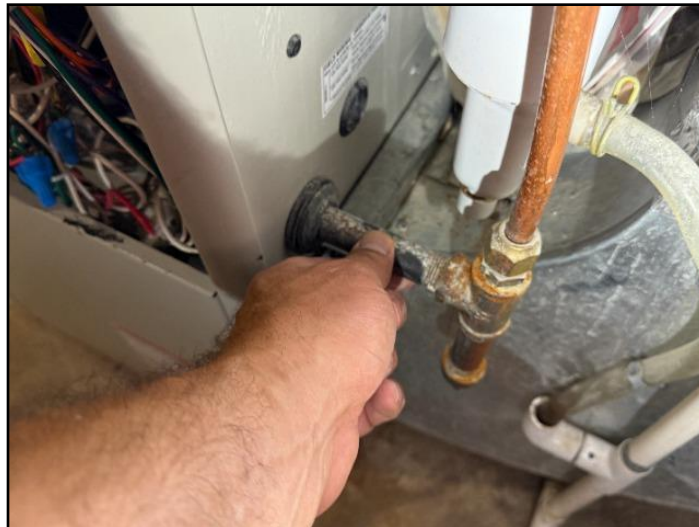
**Condition:** • [Inadequate support](#)

21. Inadequate support

**Task:** Secure

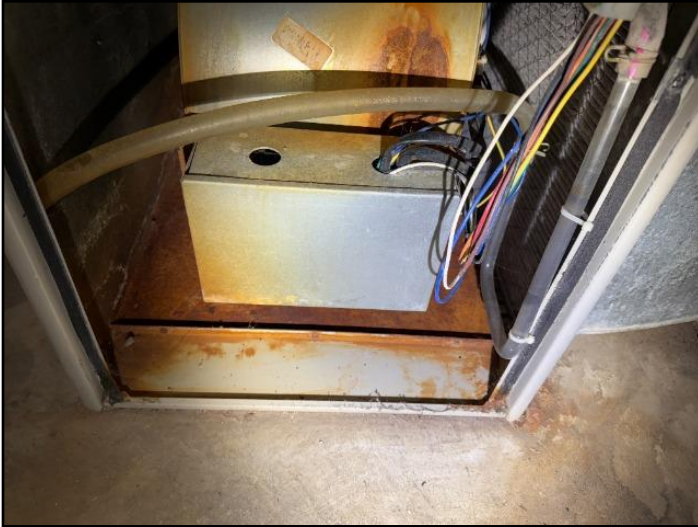
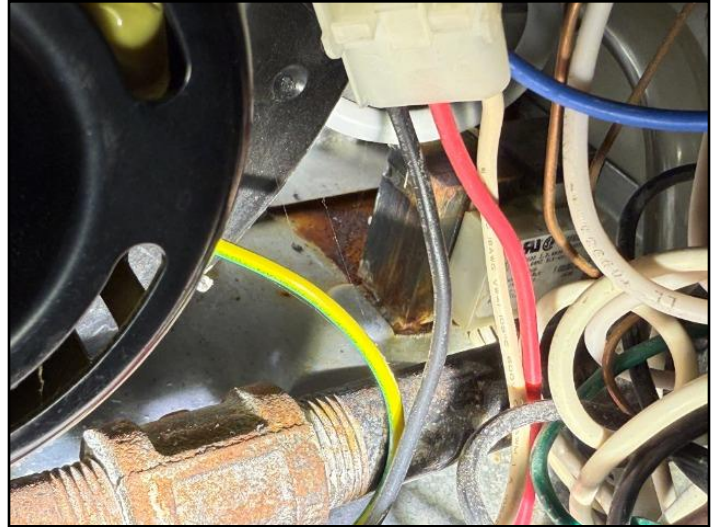
**Condition:** • [Rust](#)

Rust noted inside furnace cabinet. Prior condensate leak. Was dry at time of inspection. Unknown if issue is resolved, active or intermittent. Have HVAC technician service the unit and check all interior components at next annual servicing.

**Implication(s):** Material deterioration | Reduced system life expectancy

22. Rust

23. Rust

**Task:** For Your Information / Service annually

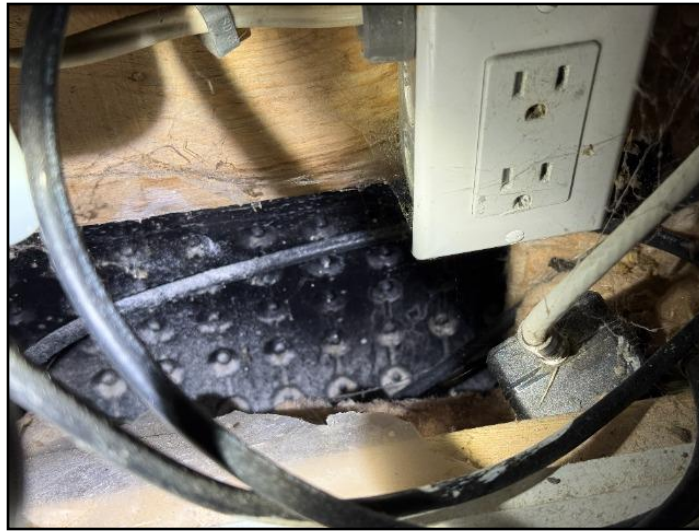
**Condition:** • [Drainage membrane](#)

Interior drainage system observed in visible areas and sump installed at basement. These water management systems are a valuable improvement measure for a home of this age.

27. Drainage membrane at interior
